1 **Circulation**

1 **Buildings and Structures**

1 Mine and Mill Complexes

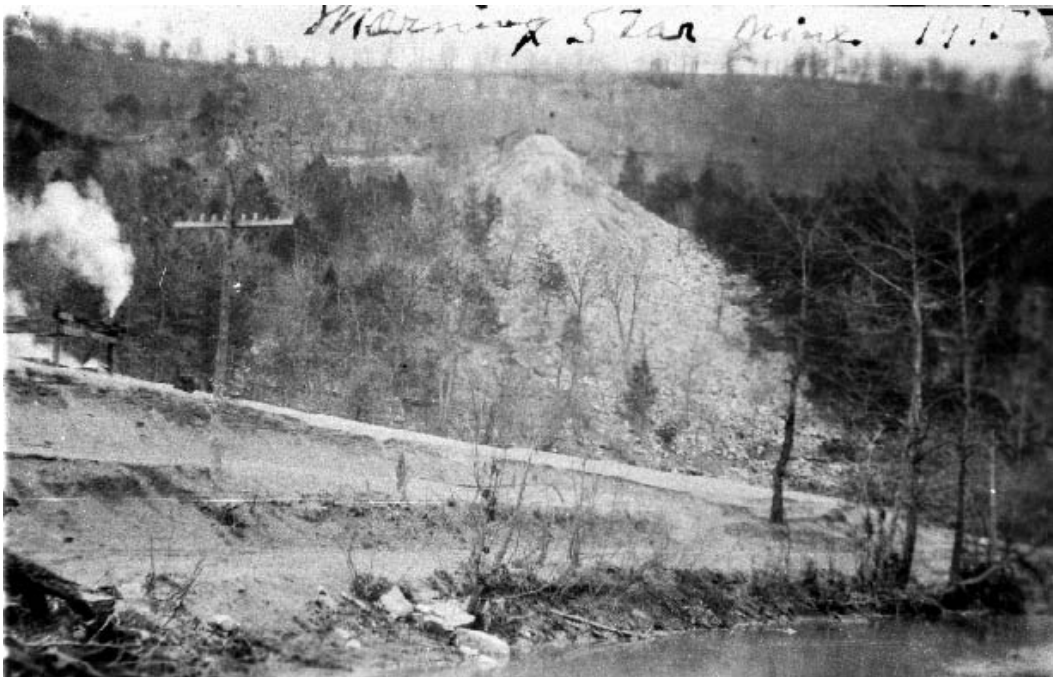
Figure 3-14. Morning Star spoils pile from, 1917. (BUFF Archives)

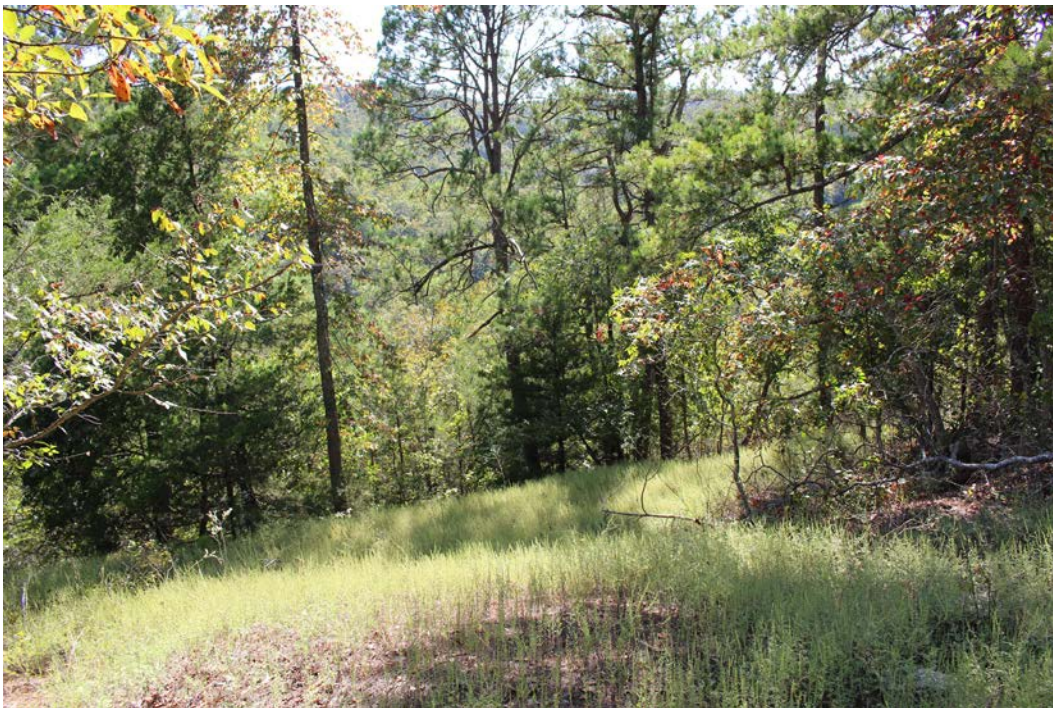
Figure 3-15. The spoils pile from Morning Star Mine (M1). Over time the spoils piles have settled and revegetated. They are easily mistaken for natural hills. (Mundus Bishop 2017)

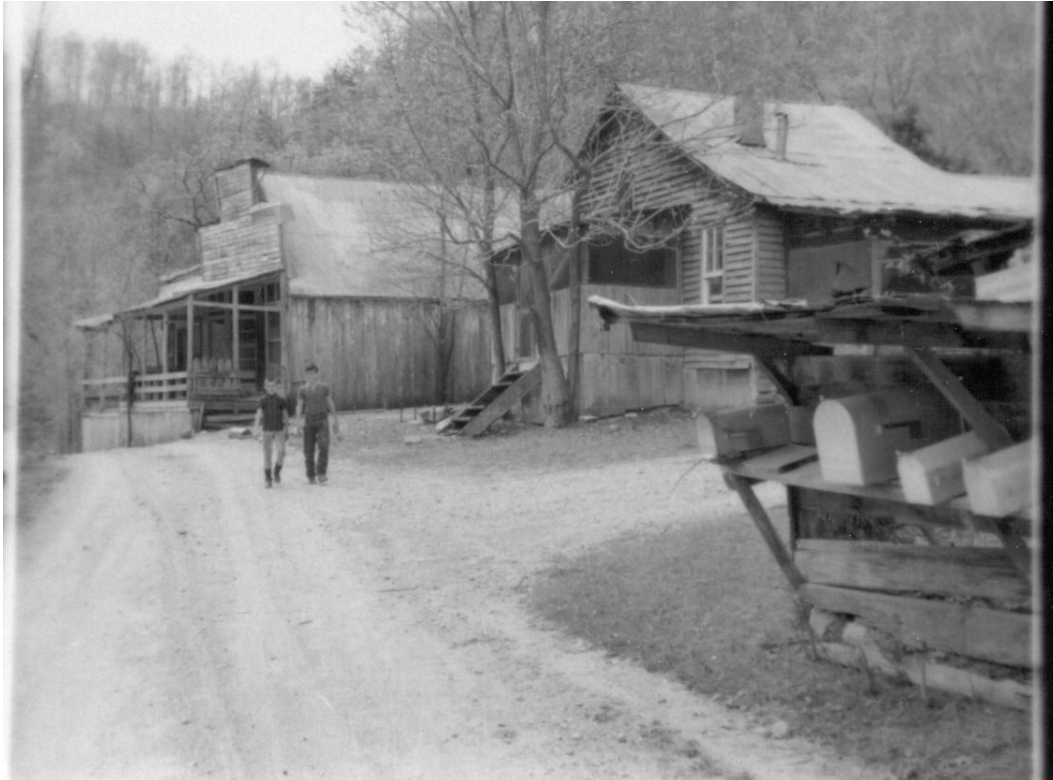
Figure 3-17. Rush Road at House Row, the Storekeeper's House and Taylor-Medley General Store at right, date unknown. (BUFF Archives)

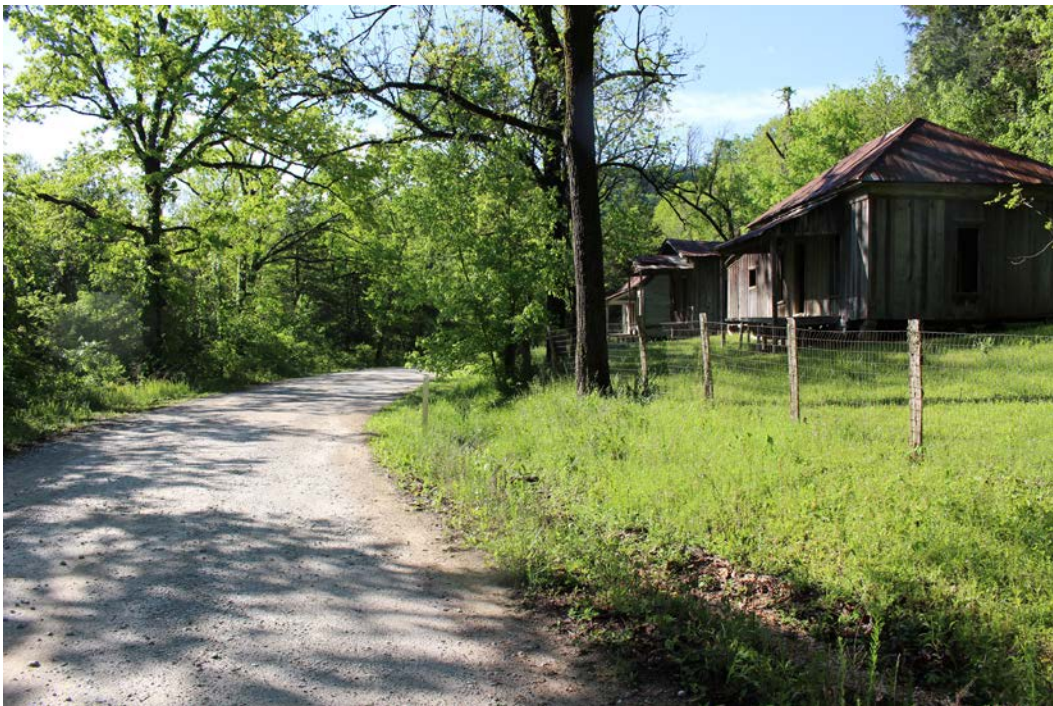
Figure 3-18. Rush Road at House Row. The road retains its historic alignment but has been widened and resurfaced since the period of significance. (Mundus Bishop 2017)

67 The study area's vehicular circulation system
68 remains similar to the period of significance
69 and retains integrity. Most existing roads
70 follow historic alignments. Modifications to
71 Rush Road include widening and resurfacing
72 completed in the 1980s, and addition of
73 parking areas and loop drive at the river
74 landing. These alterations do not diminish the
75 integrity of the road. Campground Road, built
76 in the 1990s, followed an historic route in this
77 same alignment that was part of New Town's
78 main street.

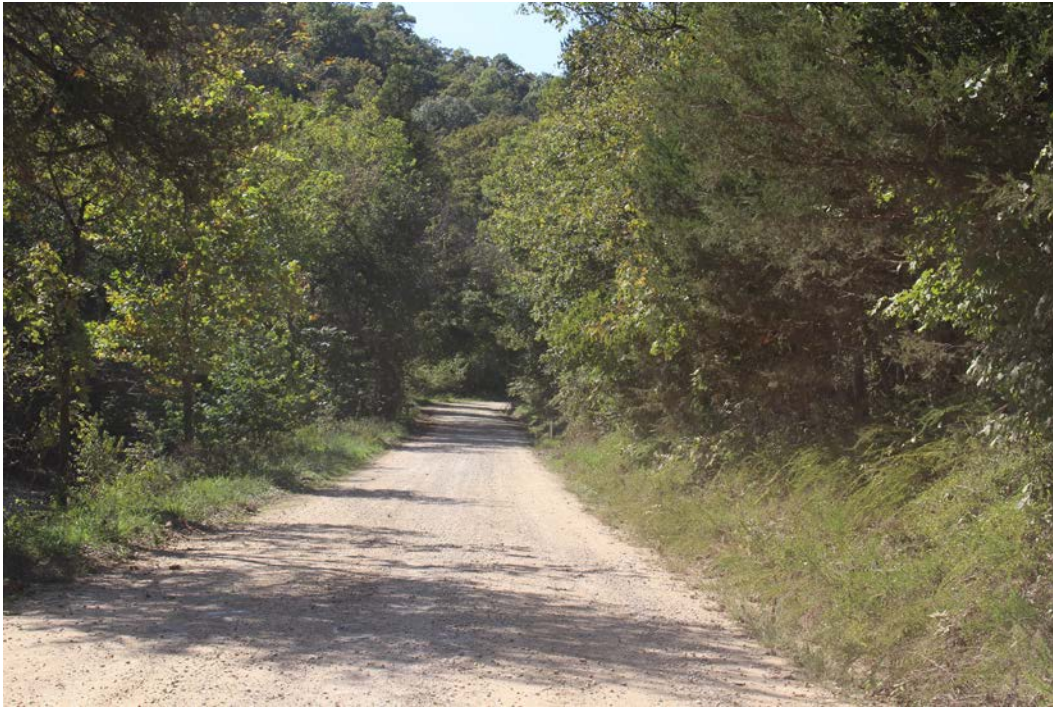
Figure 3-19. Rush Road is the major vehicular route through Rush Historic District dating to the late 1800s. It retains the original alignment following Rush Creek. (Mundus Bishop 2017)

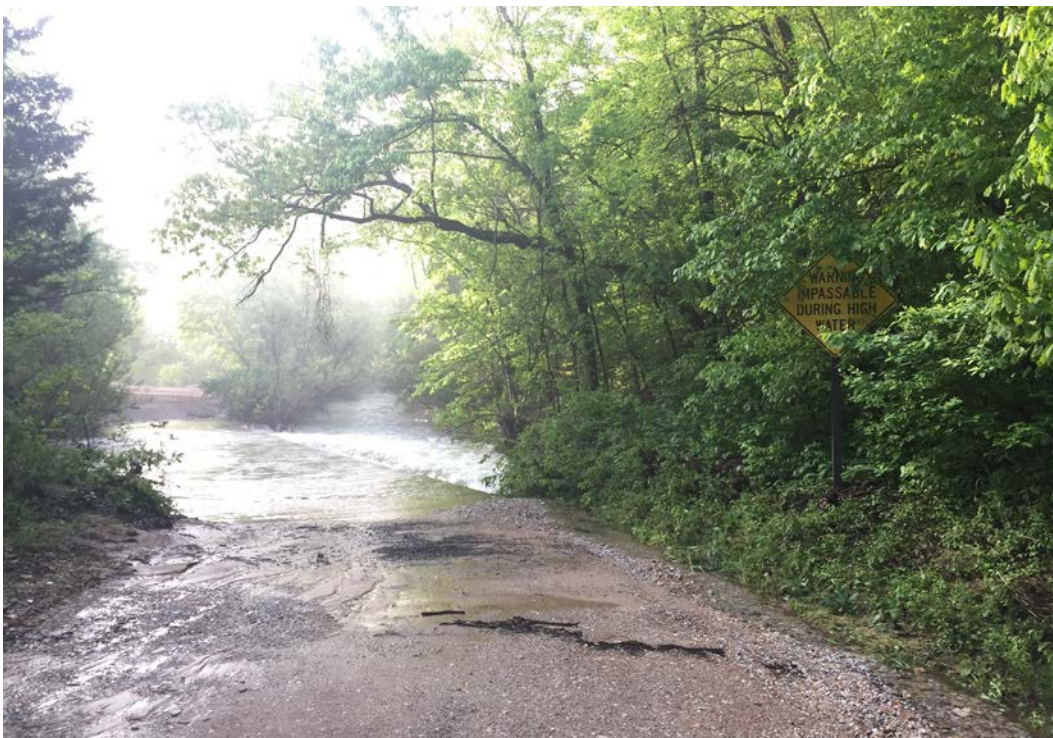
Figure 3-20. Rush Road crosses Rush Creek via a concrete water crossing near House Row. (Mundus Bishop 2017)

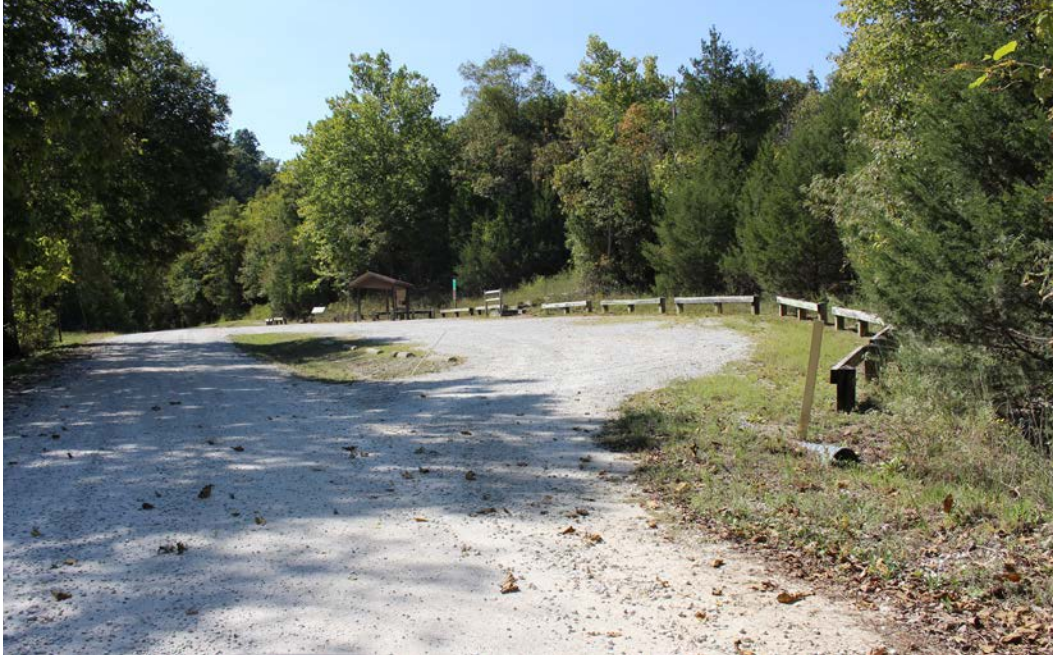
Figure 3-21. Morning Star Trail parking was added in the 1980s and is a non-contributing feature. (Mundus Bishop 2017)

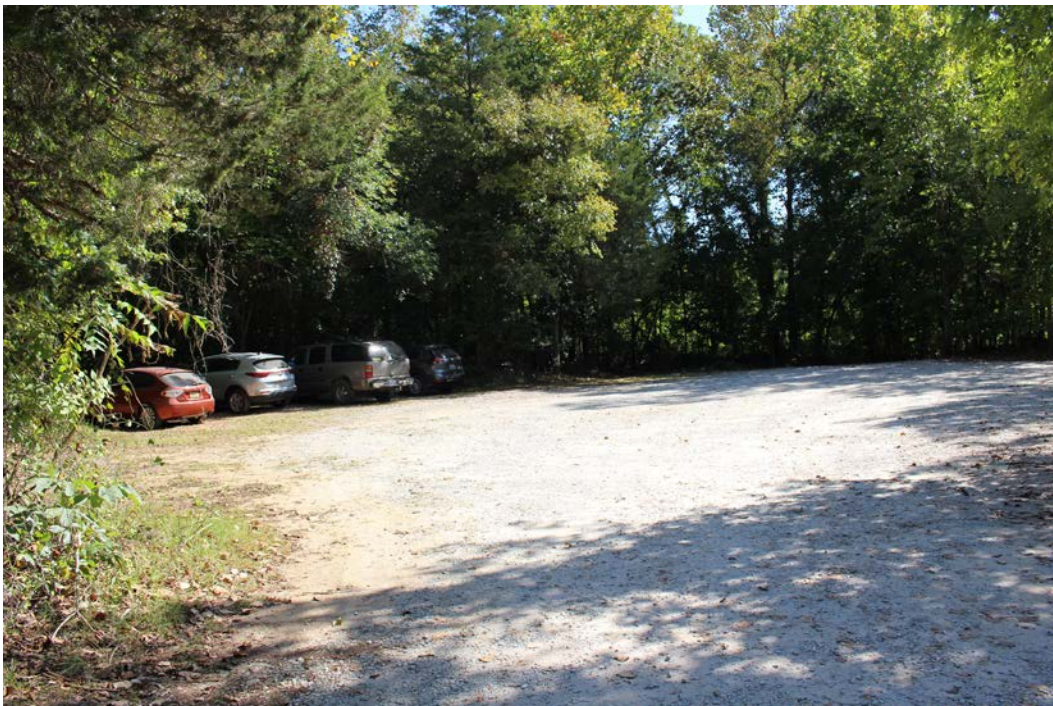
Figure 3-22. Rush Landing parking is a non-contributing feature and encroaches on the setting of the White Eagle Mill ruins, in background. (Mundus Bishop 2017)

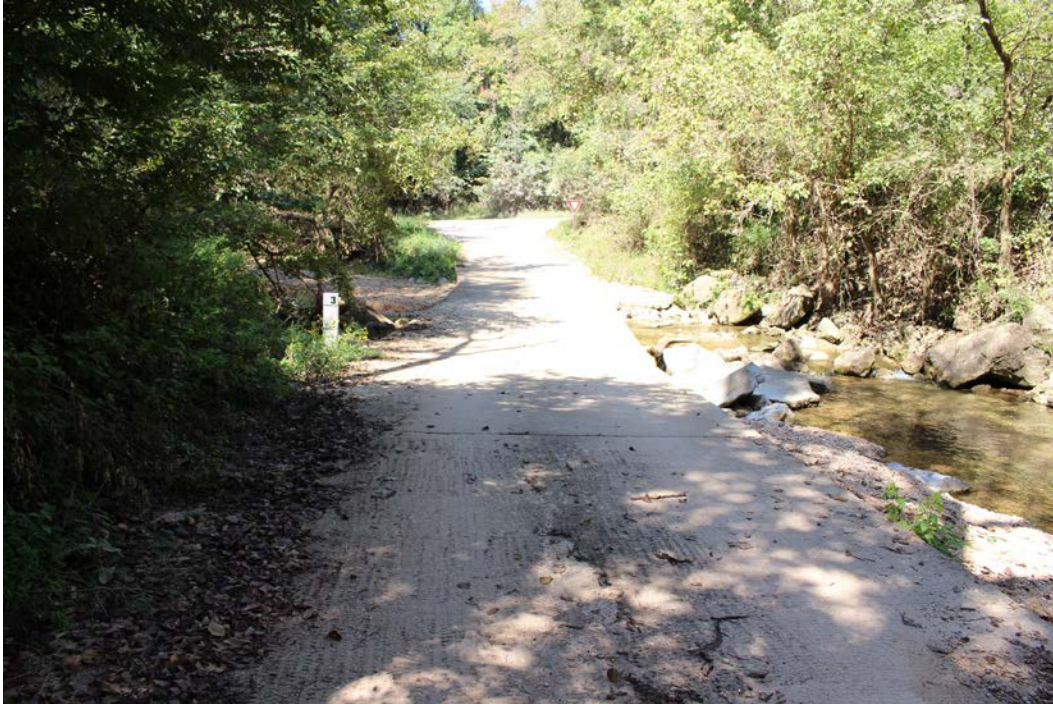
Figure 3-23. Campground Road concrete water crossing at Rush Creek. Campground Road is part of the original route to New Town, Yellow Rose Mine Complex (M7), and Edith Mine Complex (M12), established in the early 1900s. (Mundus Bishop 2017)

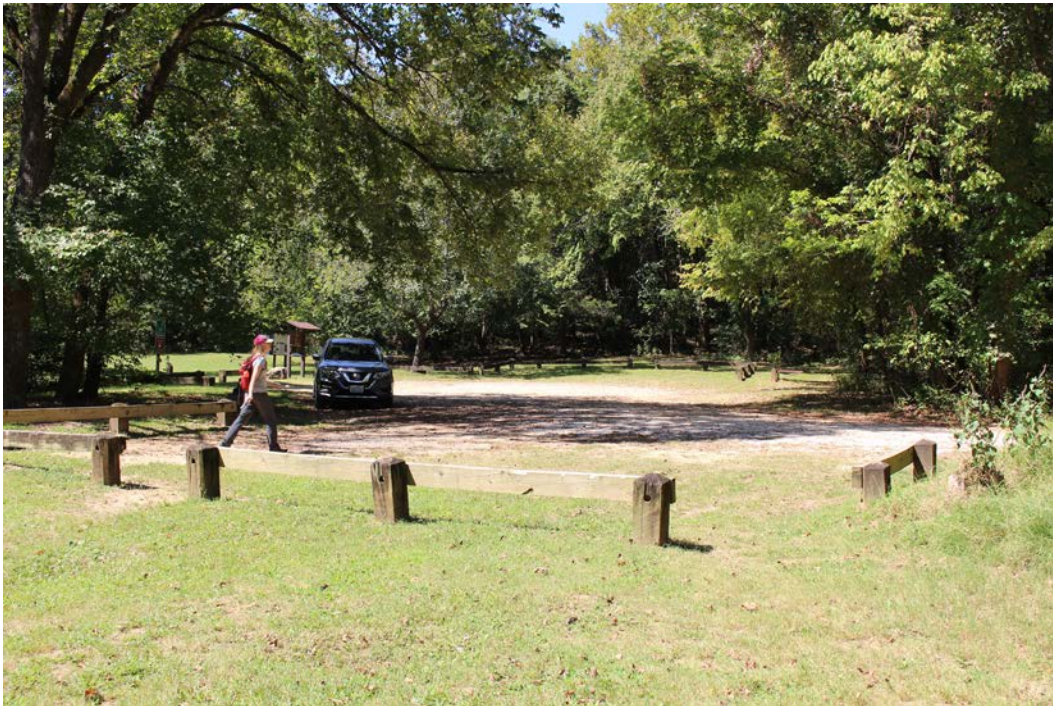
Figure 3-24. Rush Campground parking is a non-contributing feature. (Mundus Bishop 2017)

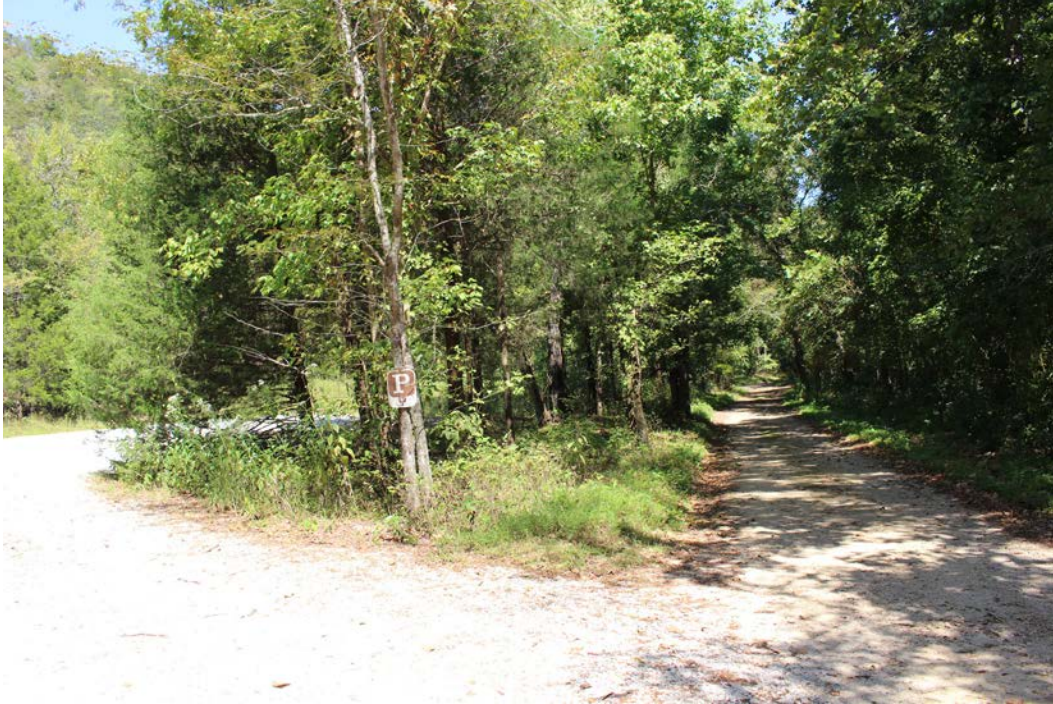
Figure 3-25. Clabber Creek Road connects to Monte Cristo Mine (M10) and Ore Wagon Road. This route also provides access to private property beyond the NPS boundary. (Mundus Bishop 2017)

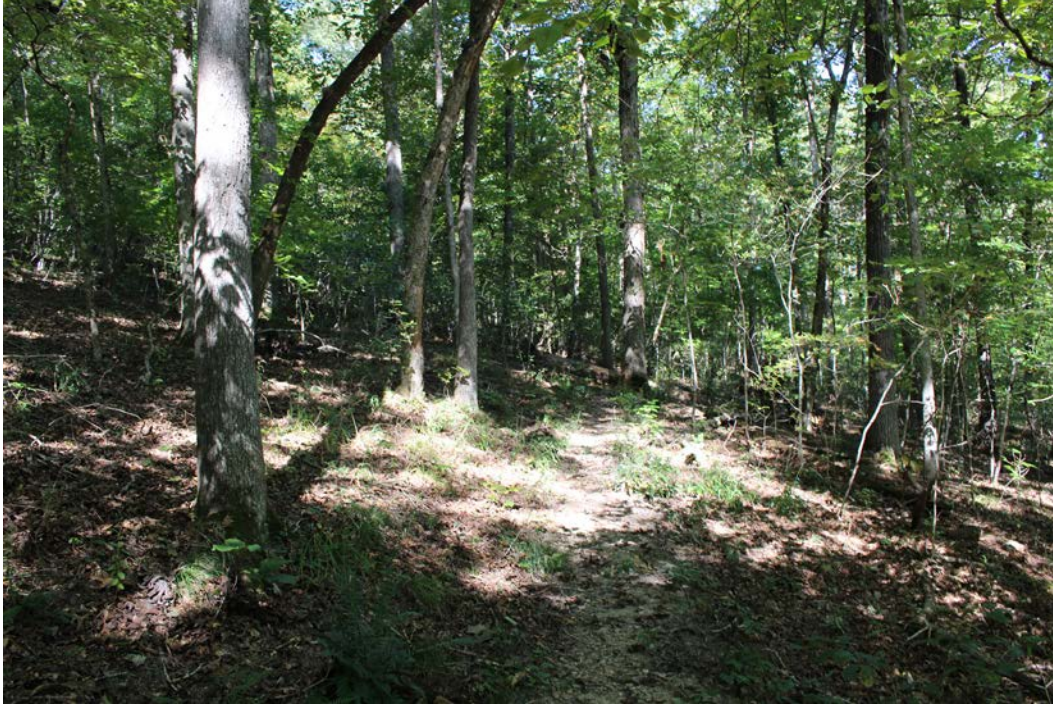
Figure 3-27. Clabber Creek Trail connects White Eagle Mine (M2) with Monte Cristo Mine (M10). (Mundus Bishop 2017)

13
14 Clabber Creek Trail connects White Eagle
15 Mill to Monte Cristo Mine (M10) on the north
16 side of Rush Mountain, where it connects to
17 Clabber Creek Road. It is unknown if this is an
18 historic route.

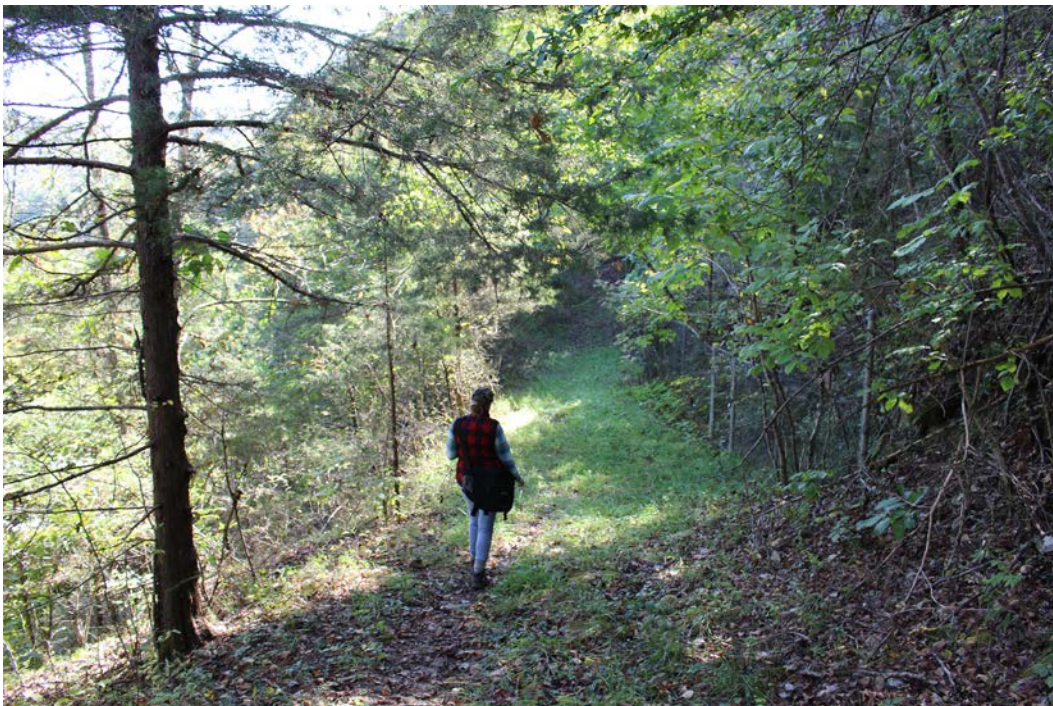
Figure 3-28. Clabber Creek Road near Monte Cristo Mine (M10). The road is narrow and set on the edge of the hillside. Clabber Creek is downhill to the left. (Mundus Bishop 2017)

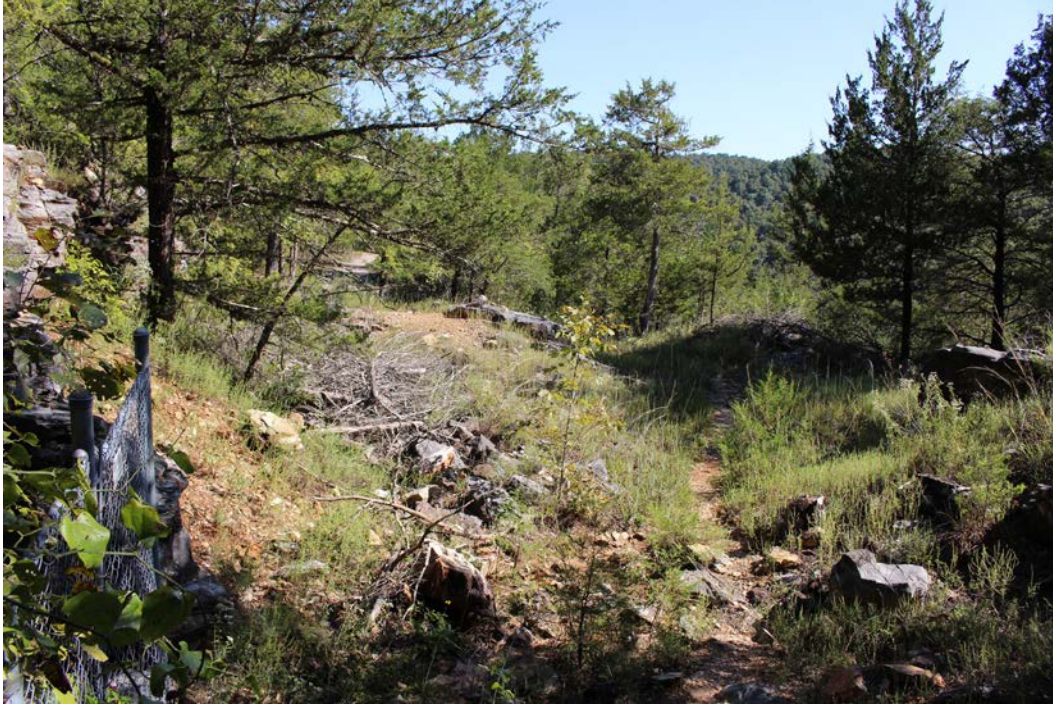
Figure 3-29. Mine Level Trail adjacent to Morning Star Mine (M1). The trail follows an older, historic route. (Mundus Bishop 2017)

4
5 The longer interpretive loop, Mine Level Trail,
6 connects to the mining level and follows an
7 historic trail that parallels the contour level of
8 the mine entrances on the south side of Rush
9 Mountain. The west part of this trail follows
10 the former tramway line that extended from
11 Capps Mine (M11) to Morning Star Mill, used
12 between 1890 and 1935 to transport ore.

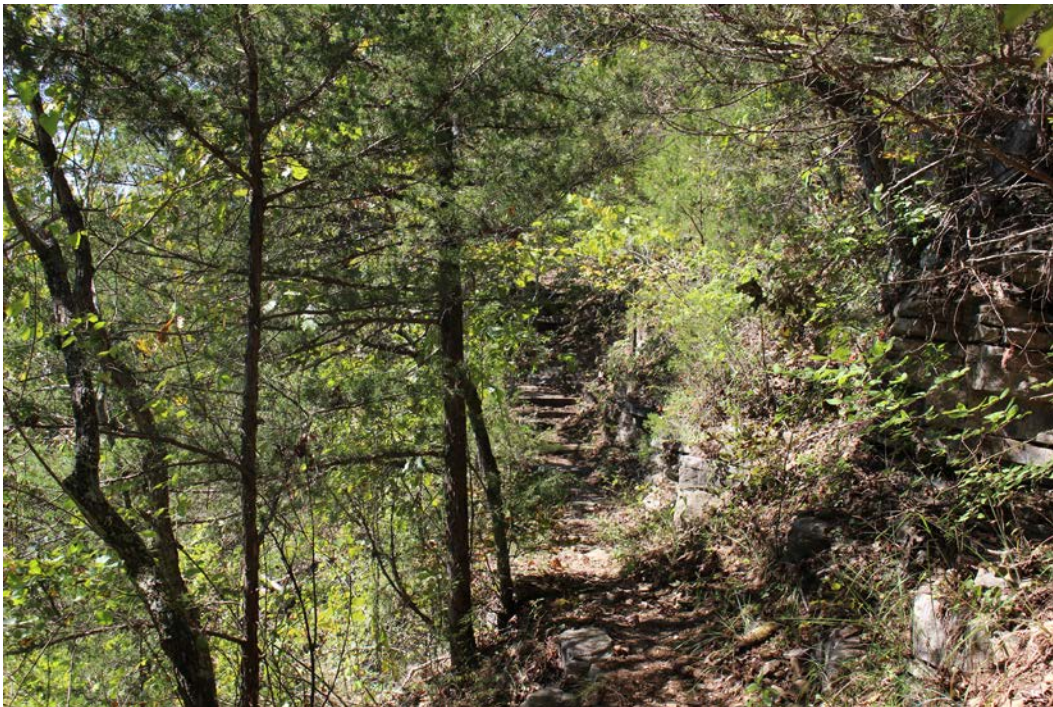
Figure 3-30. Mine Level Trail near Capps Mine (M11). This portion of the trail follows the former tramway that extended from Capps Mine to Morning Star Mill, used between 1890 and 1931 to transport ore. (Mundus Bishop 2017)

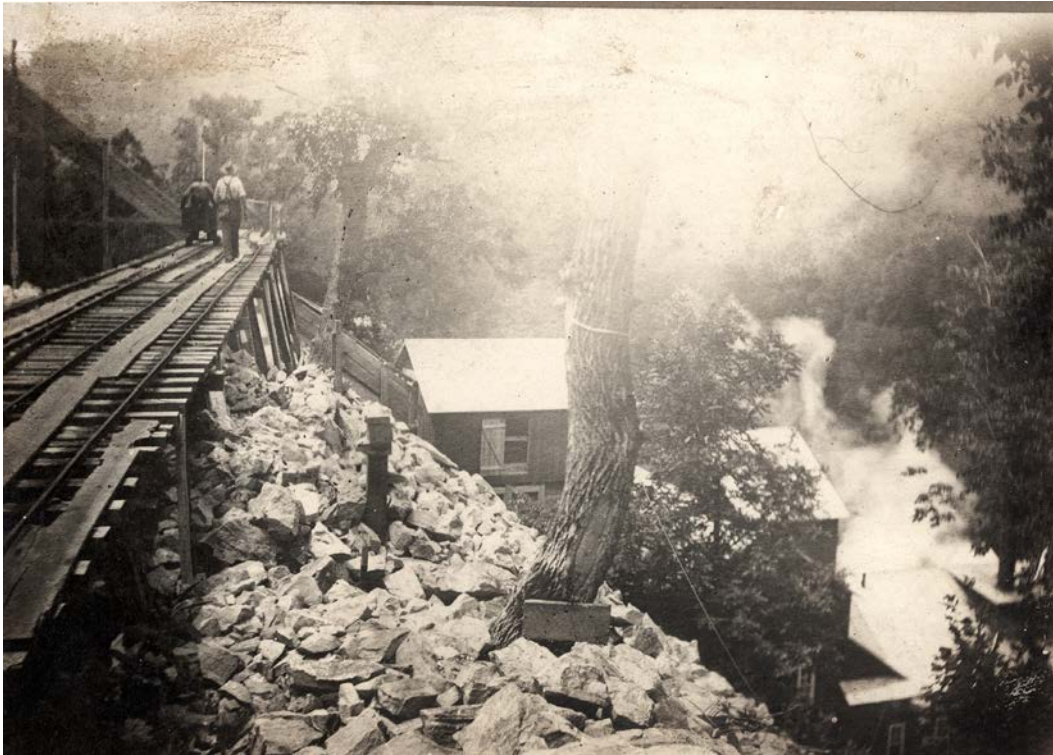
Figure 3-31. Gravity-fed tramways shipped ore from mines to mills. The exact route of these tramways is unknown, except near Morning Star Mill, where the tramway piers are extant, date unknown. (BUFF Archives)

39 Historically mines and associated mills each
40 had circulation networks of tramways that
41 transported ore from mine to mill. Tramways
42 were gravity-fed, shipping rock from the
43 mine to the mill for processing. Tramway
44 piers are extant at Morning Star Mill ruins.
45 The tramway bed from Capps Mine (M11) to
46 Morning Star Mill used between 1890 and

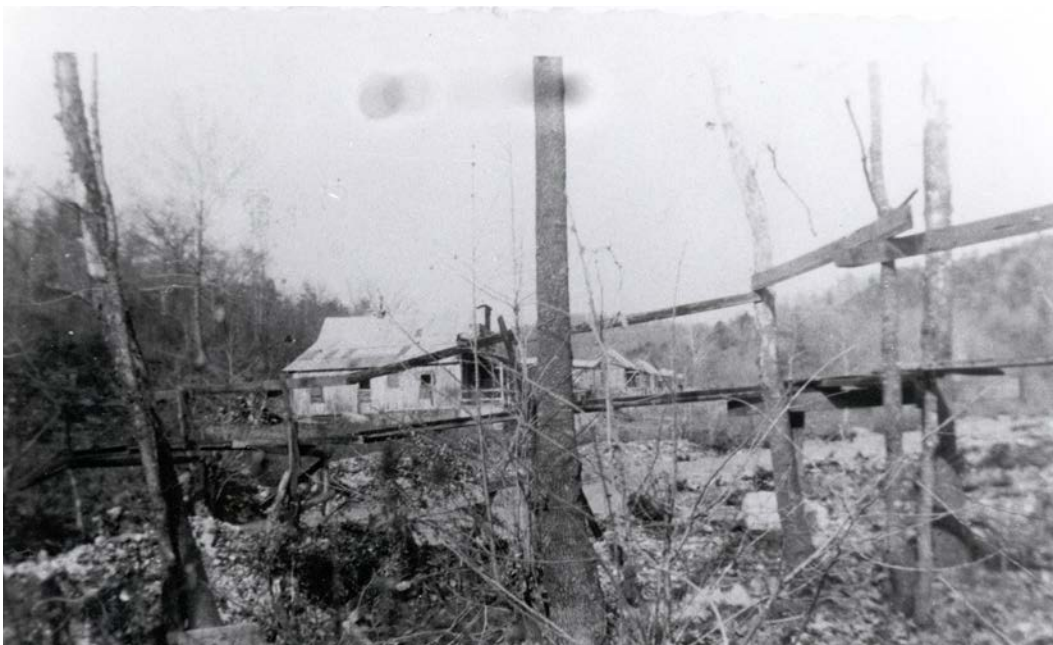
Figure 3-32. Footbridge across Rush Creek, Taylor-Medley General Store behind, date unknown. (BUFF Archives)

19
20 Historically, a footbridge connected House
21 Row with the Morning Star Mine Complex
22 (M1), and it is likely other footbridges
23 provided access across Rush Creek at various
24 points. These footbridges are non-extant.
25 Other than footbridges, the circulation system
26 did not distinguish between vehicular and
27 pedestrian routes.

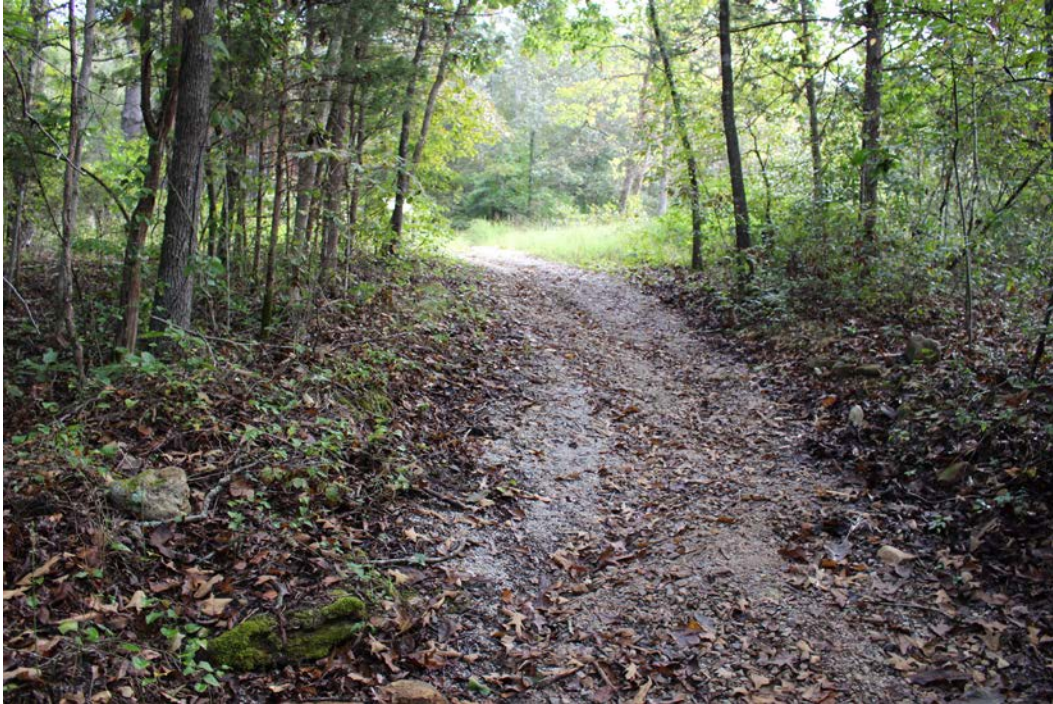
Figure 3-33. Morning Star Trail was added in the 1980s. Below Rush Blacksmith Shop the trail follows the alignment of an historic road. (Mundus Bishop 2017)

90 Morning Star Trail was built in 1988 and
91 provides an interpretive walking trail through
92 the Morning Star Hotel, Mill, and Mine

1 Community. This route follows historic roads
2 for a portion of the length, and provides a
3 view to Morning Star Mill ruins from the west.

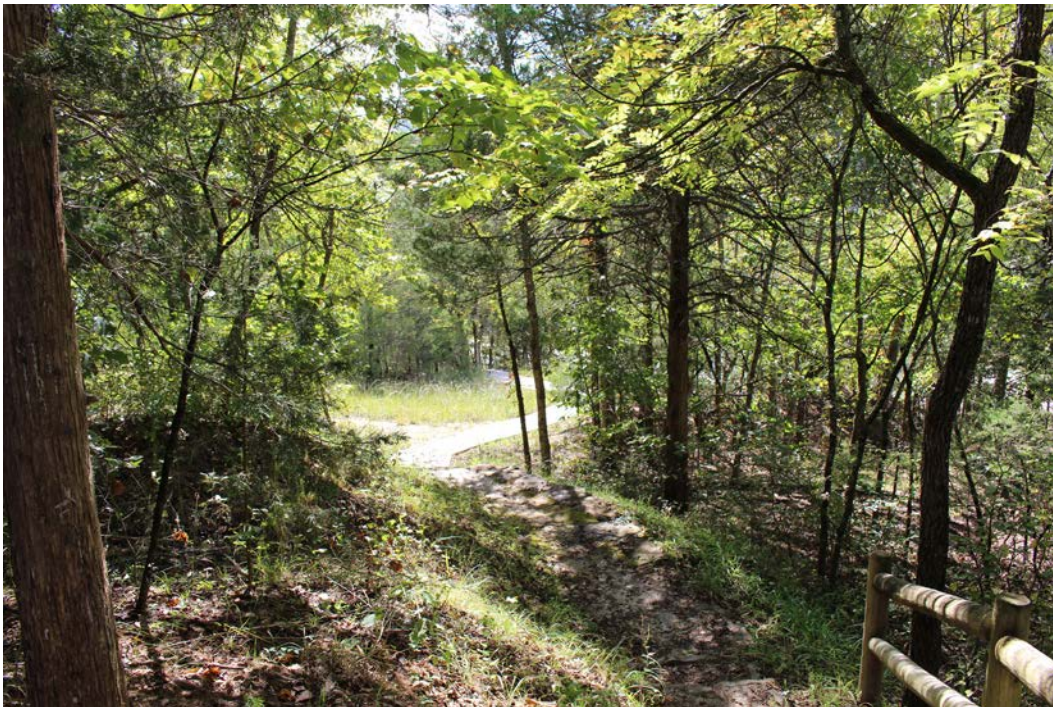
Figure 3-34. Morning Star Trail disrupts the historic spatial organization by ascending the tailings pile of Morning Star Mill ruins before crossing an historic retaining wall to meet the level terrace of the mill. (Mundus Bishop 2017)

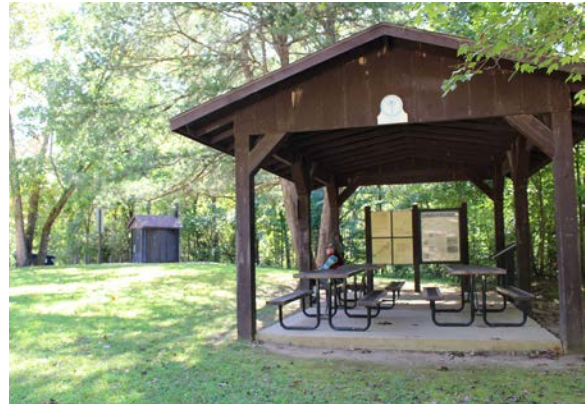
Figure 3-35. Rush Landing Shelter. (Mundus Bishop 2017)

Matrix 3-9. Study Area - Buildings and Structures				
Feature	Date	Description	Condition	Contributing/ Non-Contributing
Rush Landing Comfort Station		Prefabricated fiberglass pit toilet on concrete pad	Good	Non-Contributing
Rush Landing Shelter		Rectangular wood structure 16' x 10' on concrete pad. Picnic tables, information panels	Good	Non-Contributing
Rush Campground Comfort Station		Prefabricated fiberglass pit toilet on concrete pad	Good	Non-Contributing

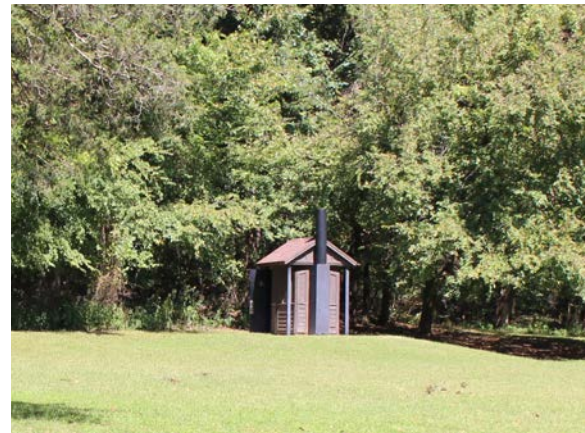
Figure 3-36. Rush Campground Comfort Station. (Mundus Bishop 2017)

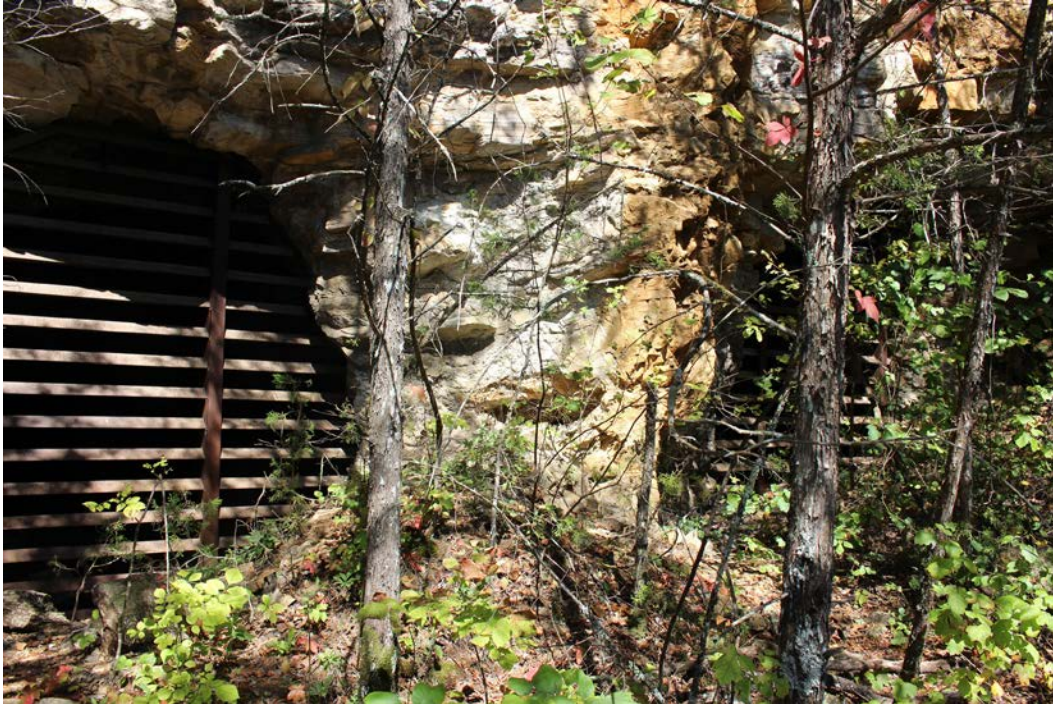
Figure 3-37. The lower entrances to McIntosh Mine (M5) are closed off with metal grates, typical of most horizontal mine portals. The dense vegetation makes it difficult to see the mine portals and rock face. (Mundus Bishop 2017)

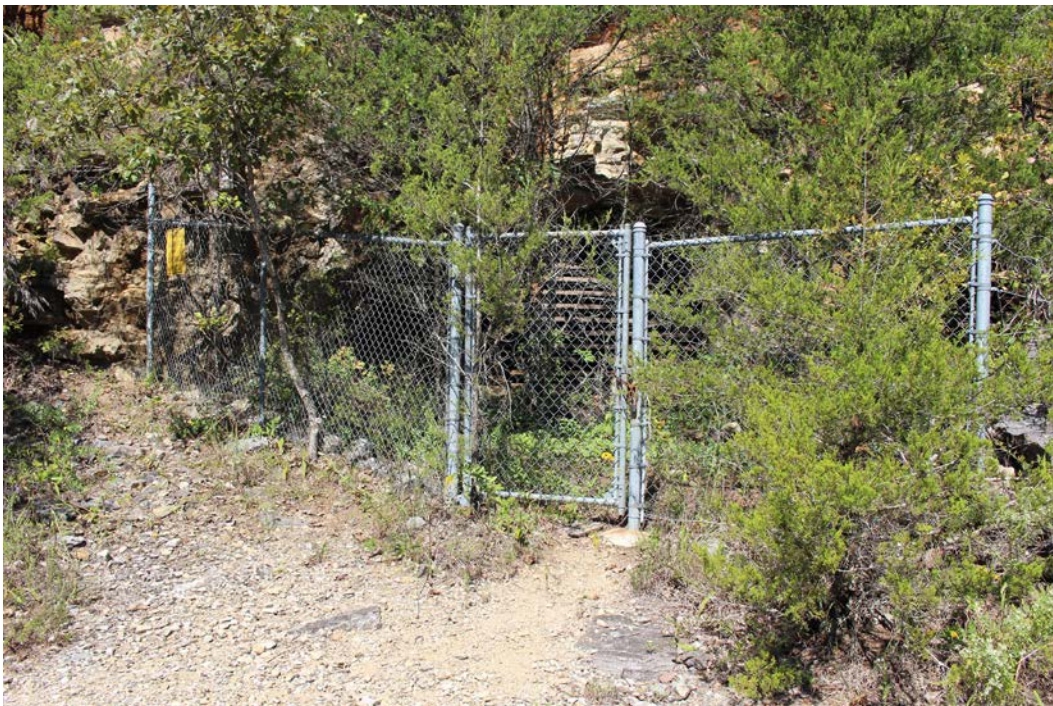
Figure 3-38. Chainlink fencing has been installed across most mine entrances. This fencing distracts from the historic character. (Mundus Bishop 2017)

1 unstable, portions were flooded, and abrupt
 2 drop-offs make the mines dangerous to
 3 enter.^{3.10} Rock fall and erosion have added to
 4 the degradation of the mining entrances, and
 5 vegetation obscures the rock outcroppings
 6 and wide portal openings. The presence of
 7 chainlink fence, at varying distances from the
 8 mine openings, diminishes from the historic
 9 setting and obscures the mine portals.

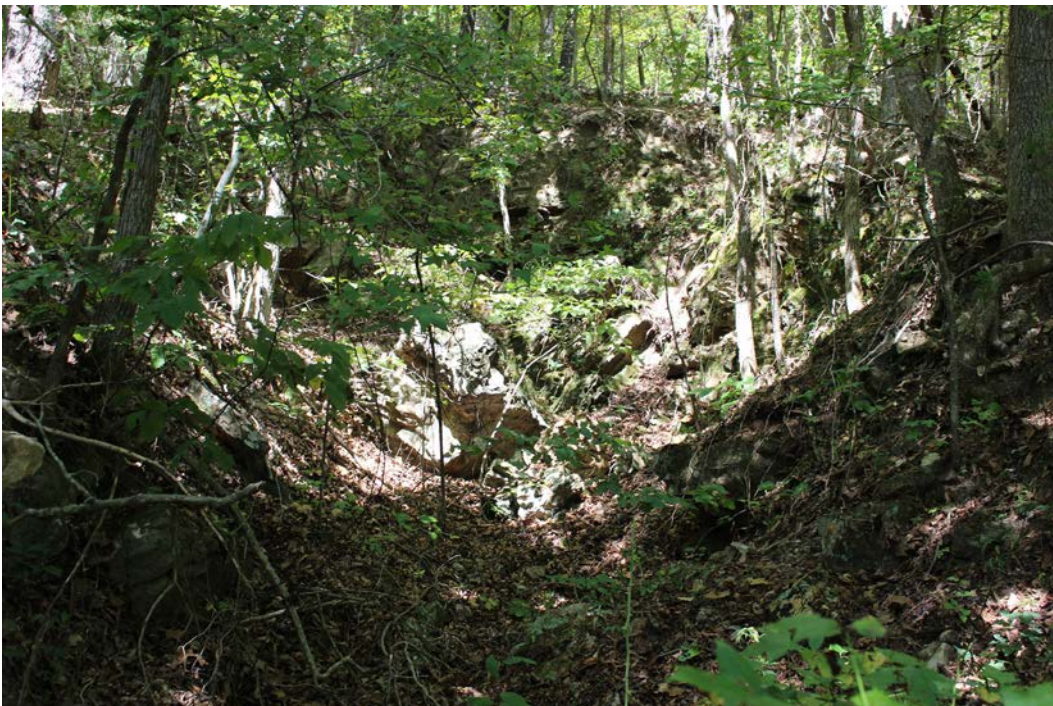
Figure 3-40. The entrance to White Eagle Mine (M2) is collapsed, with no visible portal. (USGS Photos, BUFF Archives)

30 White Eagle Mine (M2) was blasted shut
 31 after the end of the period of significance.
 32 The horizontal adit can still be seen. The
 33 mine retains integrity and contributes to the
 34 cultural landscape.

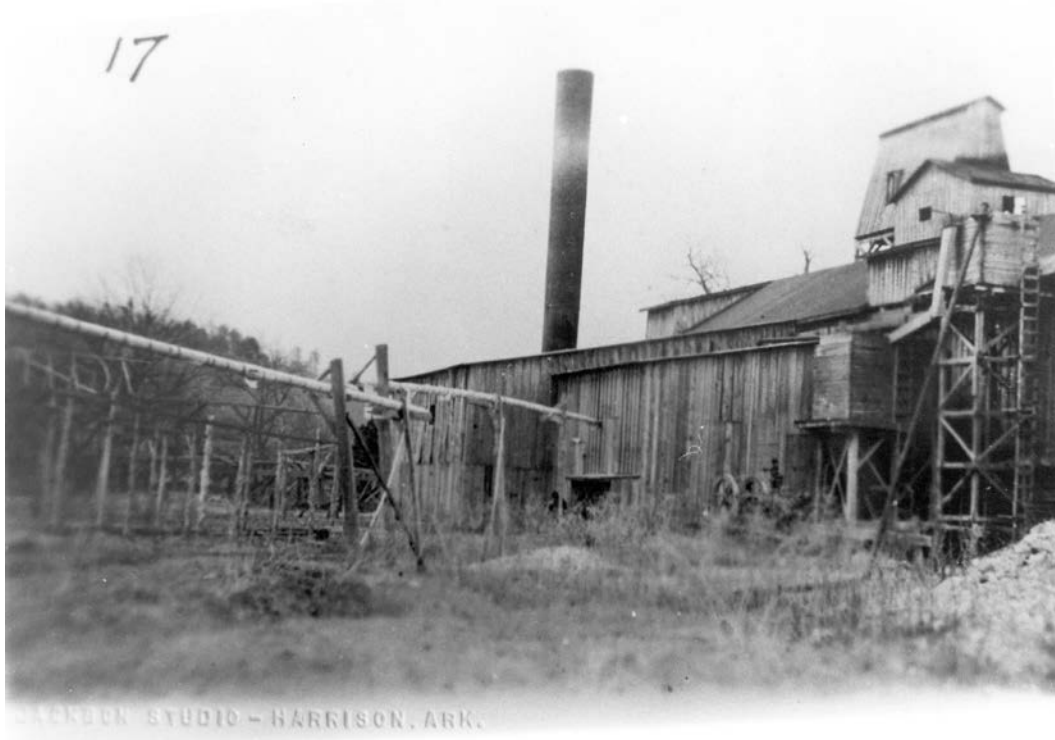
Figure 3-41. White Eagle Mill, 1917. (BUFF Archives)

64
65 Mills were the largest buildings within the
66 study area, and were prominent due to their
67 elevated position and lack of surrounding
68 trees. These structures housed large pieces
69 of equipment and were set on concrete
70 pier foundations. Elevated tramways on tall
71 trestles connected the mills to the mines.
72 Today, mill ruins are evidenced by massive
73 pyramidal concrete pier foundations. Most of
74 the superstructures were removed for scrap
75 after productive mining had ended. Additional
76 remains of the mills may occur below-grade.

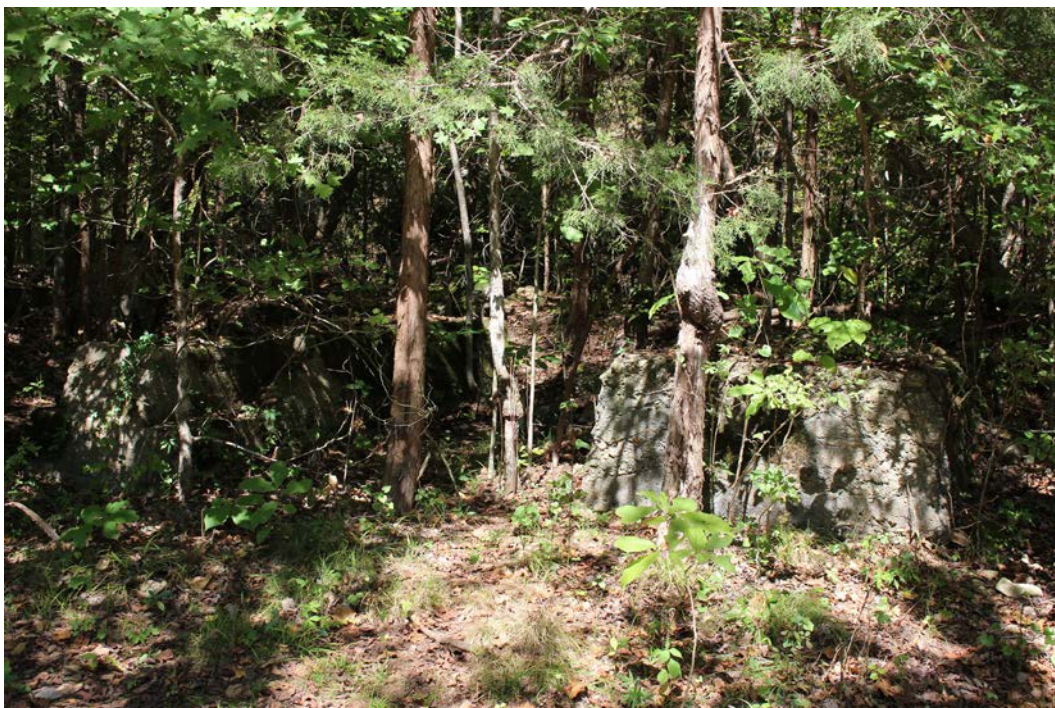
Figure 3-42. White Eagle Mill ruins are a series of concrete piers, at the edge of Rush Landing parking. (Mundus Bishop 2017)

52 White Eagle Mill ruins retain integrity
 53 although it is diminished due to the parking
 54 built over the underground ruins. The mill
 55 ruins contribute to the cultural landscape.

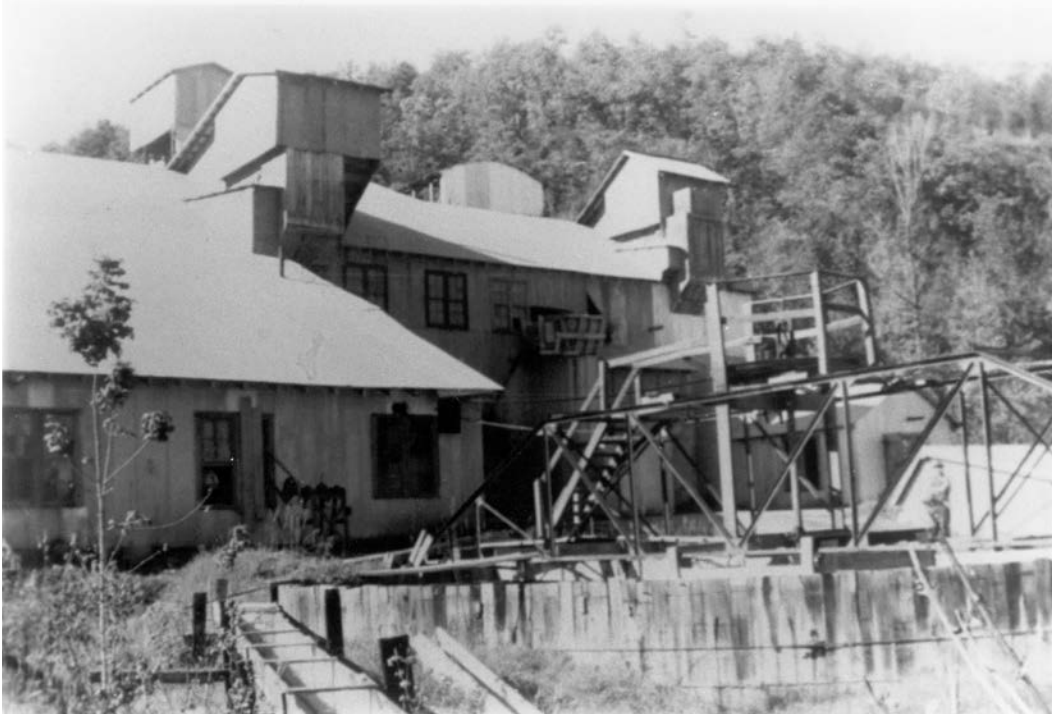
Figure 3-43. New White Eagle Mill, 1960. (BUFF Archives)

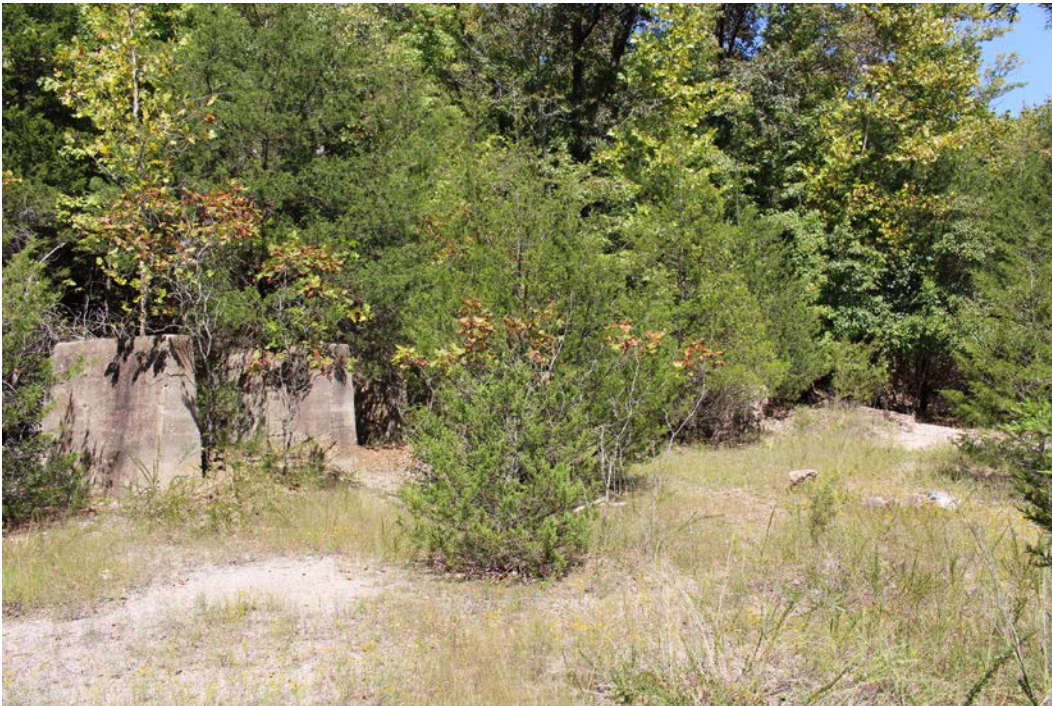
Figure 3-44. New White Eagle Mill ruins. (Mundus Bishop 2017)

59 New White Eagle Mill was active from 1959
 60 to 1962. The mill ruins are located just west
 61 of the New White Eagle parking off Clabber
 62 Creek Road. Visible ruins include concrete
 63 pyramidal piers and a wide tailings area.

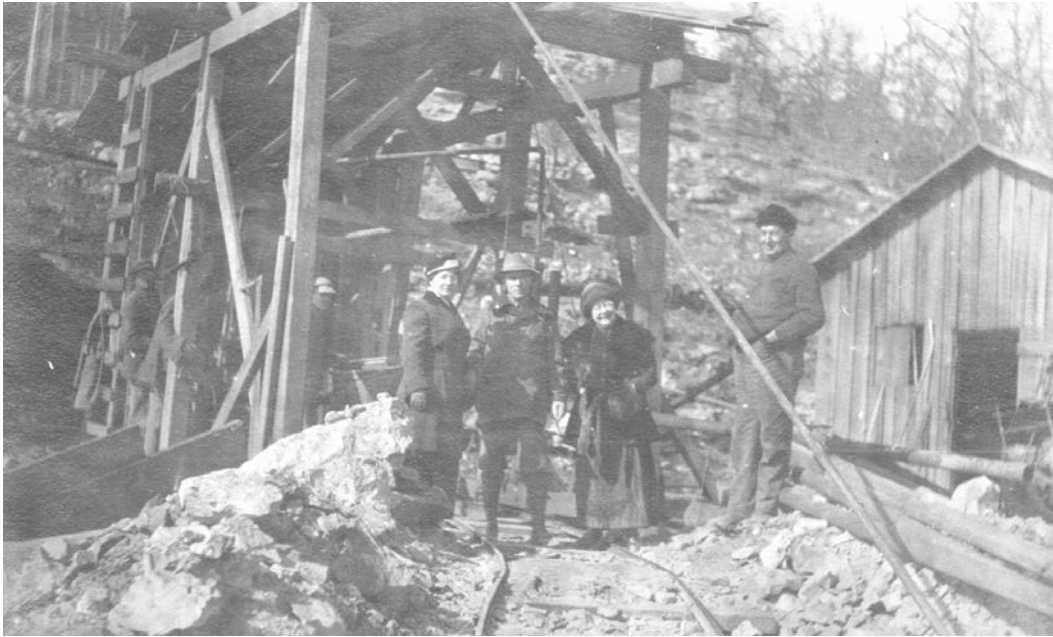
Figure 3-45. Main portal, Red Cloud Mine (M3), date unknown. (BUFF Archives)
