## Chapter 3. Existing Condition and Analysis

TITLE OF PROJECT  
**CULTURAL LANDSCAPE REPORT  
 AND ENVIRONMENTAL ASSESSMENT**  
 TITLE OF DRAWING  
**EXISTING CONDITION - STUDY AREA**  
 NAME OF PARK  
**RUSH HISTORIC DISTRICT**  
 REGION COUNTY STATE  
 MIDWEST MARION ARKANSAS

Illustration 3-1.  
 3-5

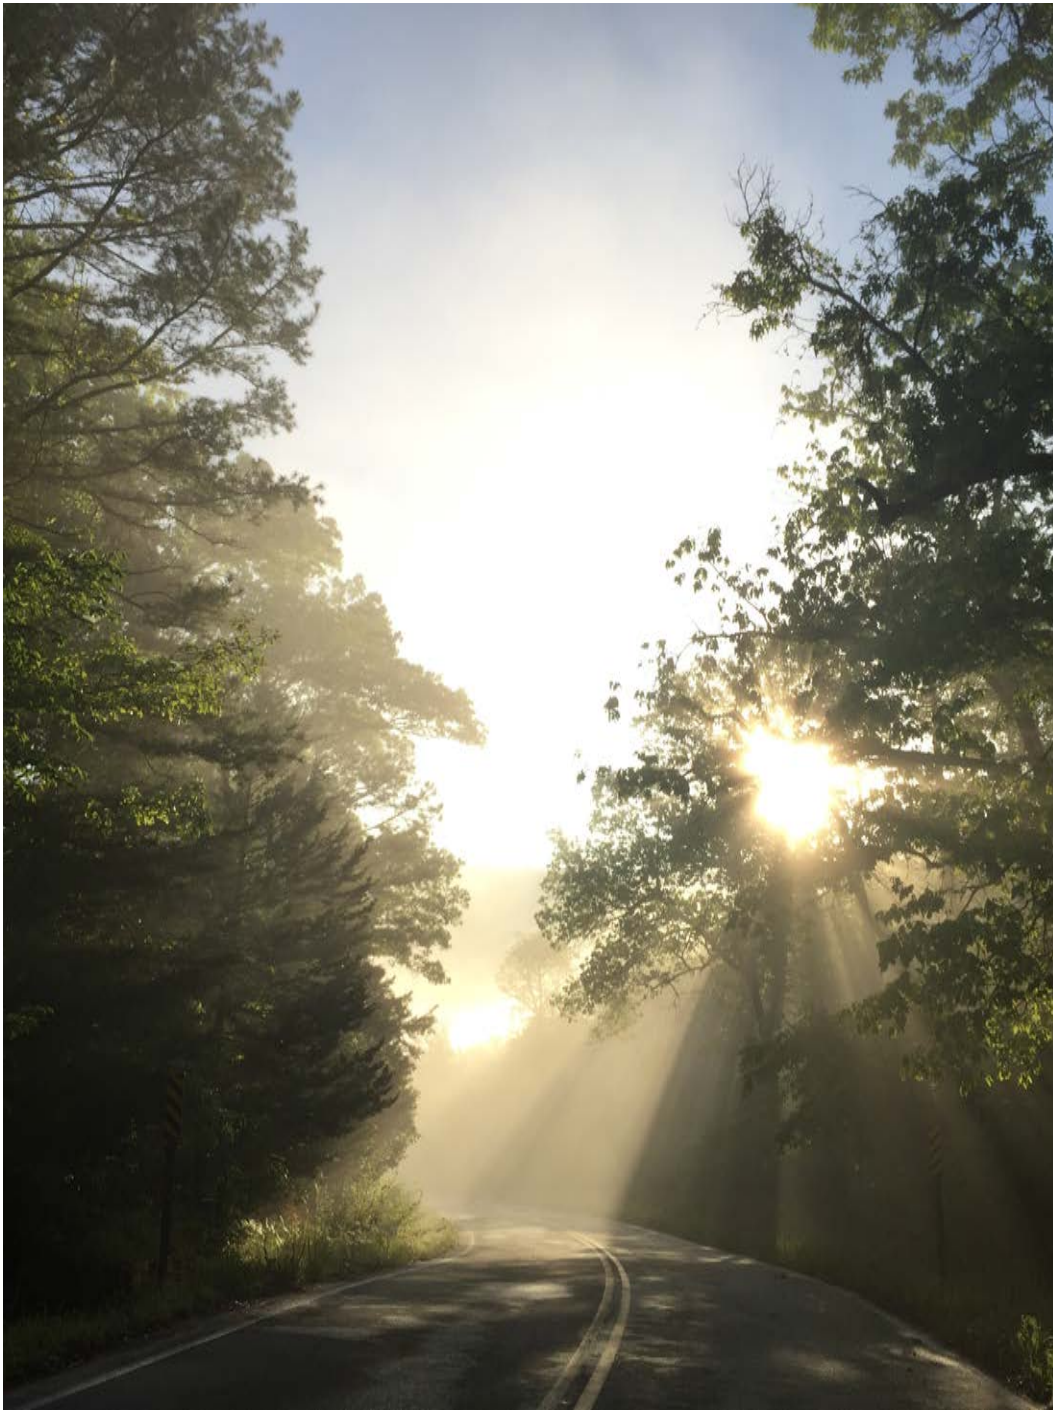
Figure 3-1. The natural setting is characterized by steep hills and valleys, and thick forests of oak and hickory. Rush Road follows the natural drainage of Rush Creek. (Mundus Bishop 2017)

31  
 32 The study area is set in the Buffalo River  
 33 valley of the Ozark Highlands. The natural  
 34 setting is characterized by steep hills and  
 35 valleys. The streams of Rush and Clabber  
 36 creeks and Buffalo River, cut deeply into the  
 37 bedrock, leaving tall vertical bluffs. Rush  
 38 Mountain is a dominant feature. A small fresh  
 39 water spring, Boiling Spring, is located along  
 40 Rush Creek.

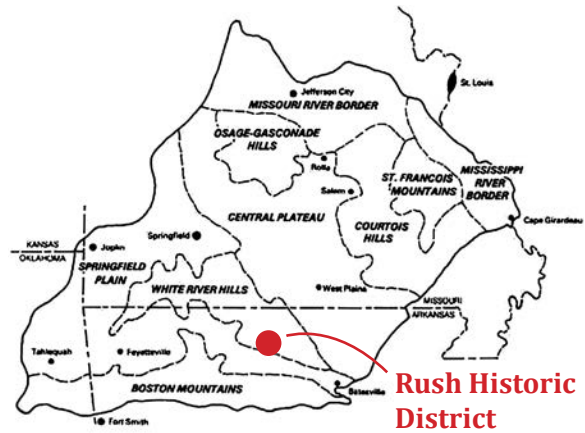
Figure 3-2. Rush Historic District is at the intersection of two physiographic regions, the Springfield Plateau and Salem Plateau in the White River Hills. (Rafferty, *The Ozarks: land and life*)

45 the approximate intersection of the two  
 46 physiographic regions: Springfield Plateau  
 47 and the Salem Plateau. The Springfield  
 48 Plateau is underlain by limestone and cherty  
 49 limestone of Mississippian age. The Salem  
 50 Plateau is underlain by rocks of the Cambrian  
 51 and Ordovician age. These rocks are primarily  
 52 limestone, dolomite, and sandstones laid  
 53 down as part of an ancient sea bed. Uplifting  
 54 and erosion over time created the landscape  
 55 of today. Water dissolved carbonate rocks  
 56 (limestones and dolomites) to form caves  
 57 and karst topography, typical of the region.<sup>3.1</sup>  
 58 Pockets of ore such as zinc and lead, formed  
 59 where the rock was broken and brecciated.  
 60 The zinc found at Rush Historic District was  
 61 the highest-grade zinc ore discovered up to  
 62 that time in the United States.<sup>3.2</sup>

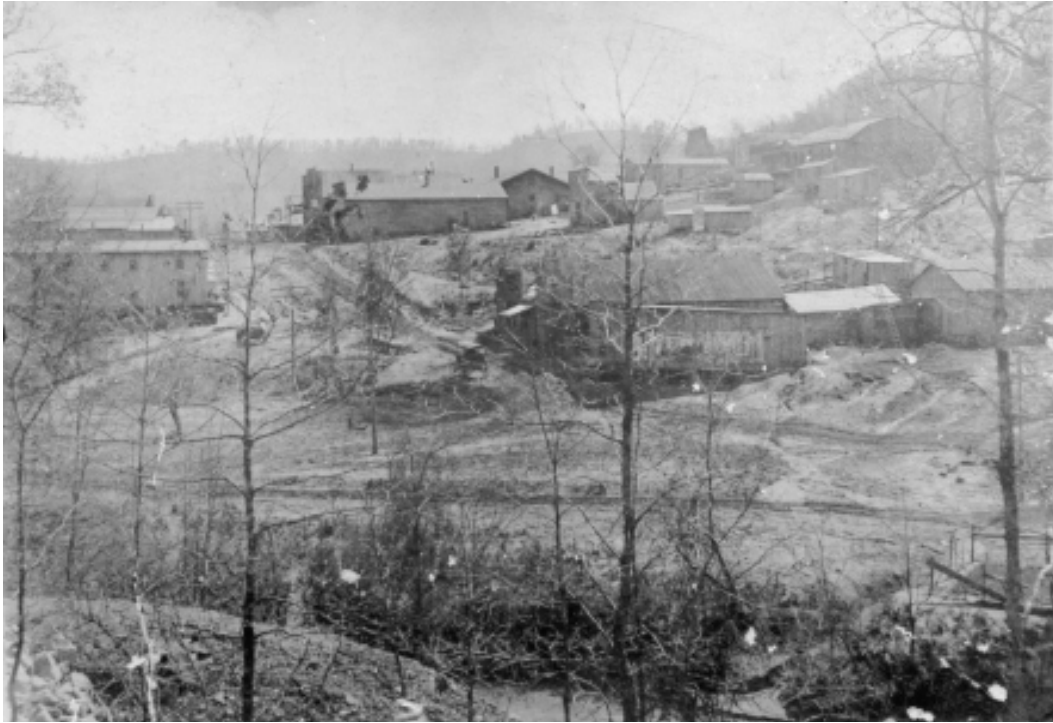
Figure 3-4. New Town as it appeared c 1916 from the north bank of Rush Creek. The development of New Town was spurred by mining expansion during World War I that led to construction of Edith Mine (M12) and a new mill at Yellow Rose Mine (M7) (uphill on right). Today only a few ruins of New Town are visible above grade. Below grade resources associated with these mine complexes likely exist as they do throughout the study area. (Buffalo National River: Dorthea Shipman Collection)

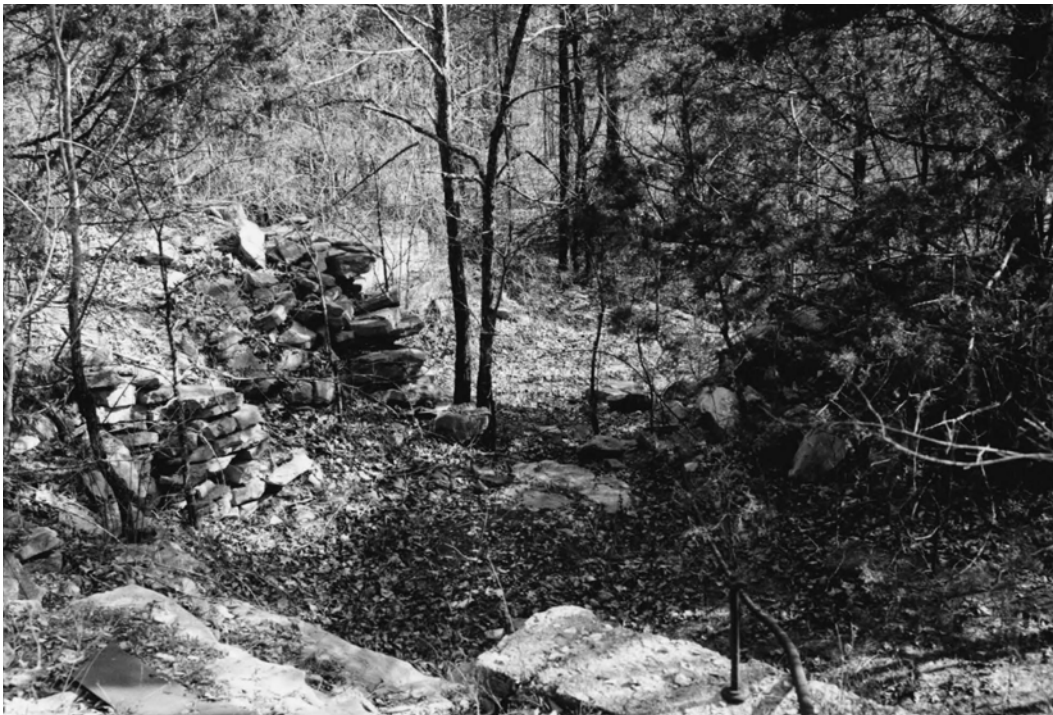
Figure 3-5. Pop Campbell House Site ruins, looking west, 1985. (S. Rogers, BUFF Archives)

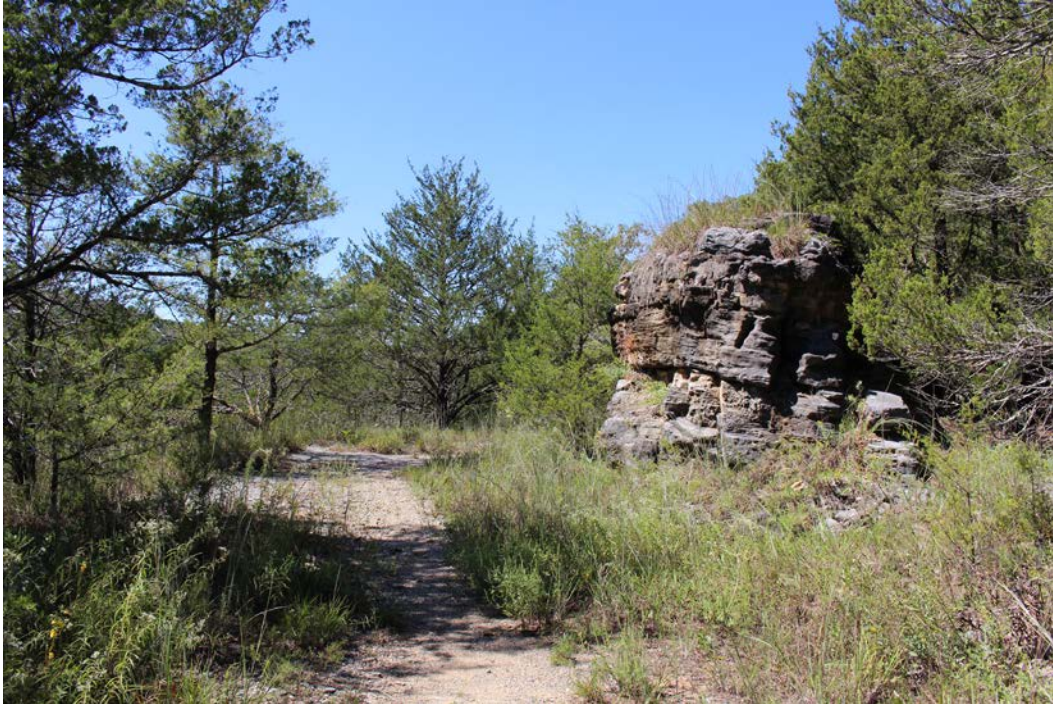
Figure 3-6. Mine Level Trail provides recreation, interpretation and access to the mines. The entrance to McIntosh Mine (M5) is on the right. (Mundus Bishop 2017)

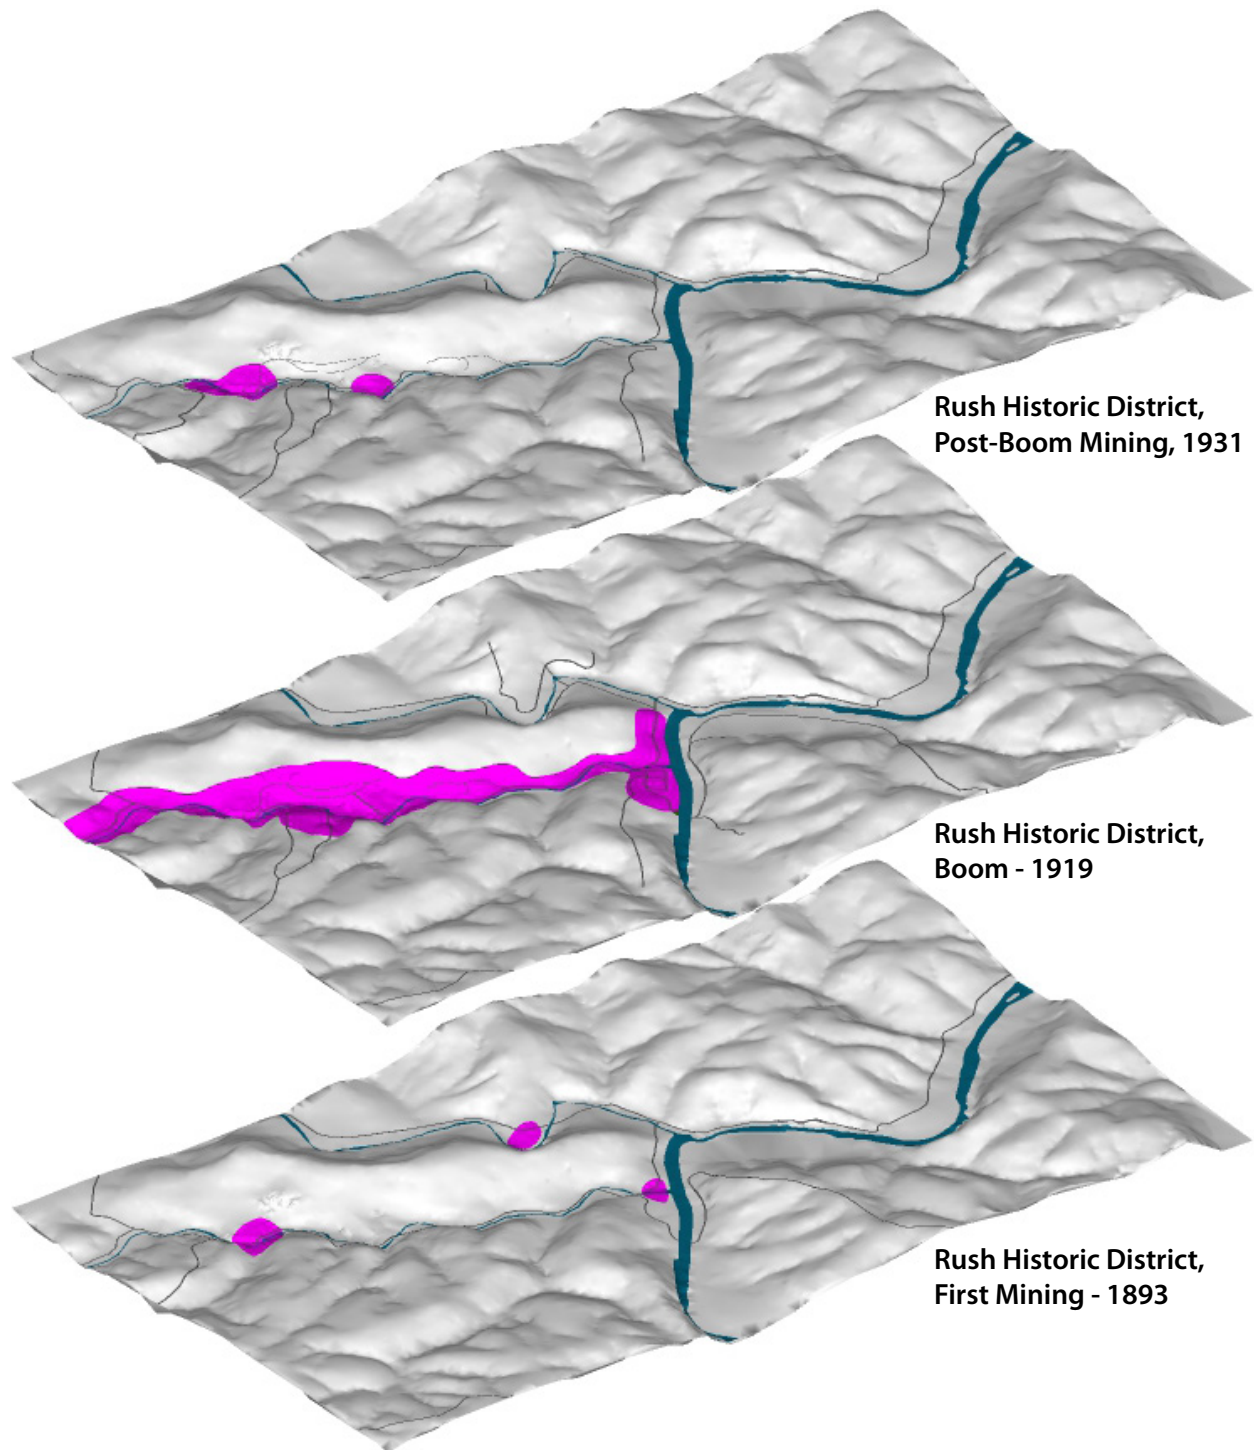
Figure 3-9. Rush land use varied through the periods of landscape development, during the period of significance the entire Rush Creek valley was one connected community. (Mundus Bishop 2018)

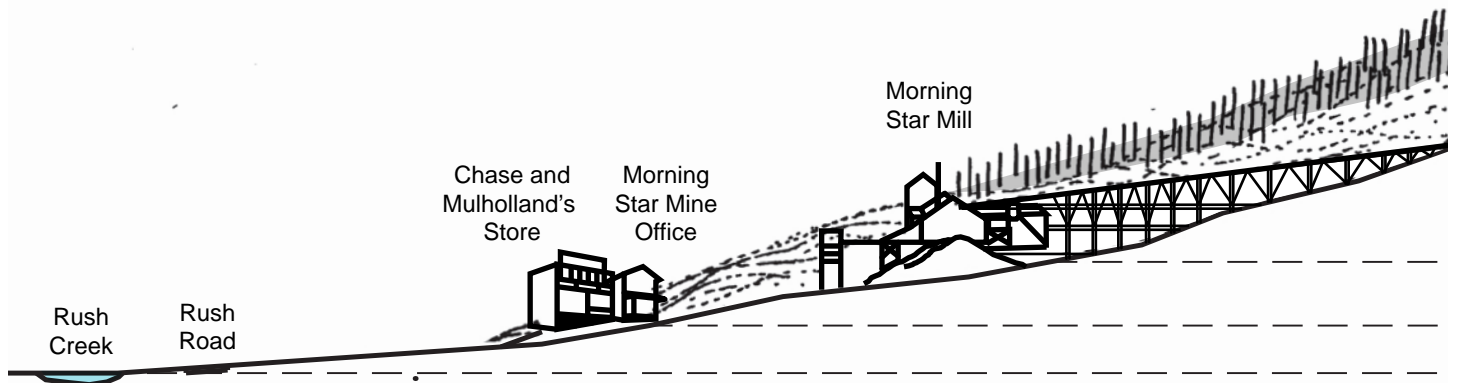
Figure 3-10. Approximate historic cross section at Morning Star Mill Complex (M1). (Mundus Bishop 2017, BUFF Archives)

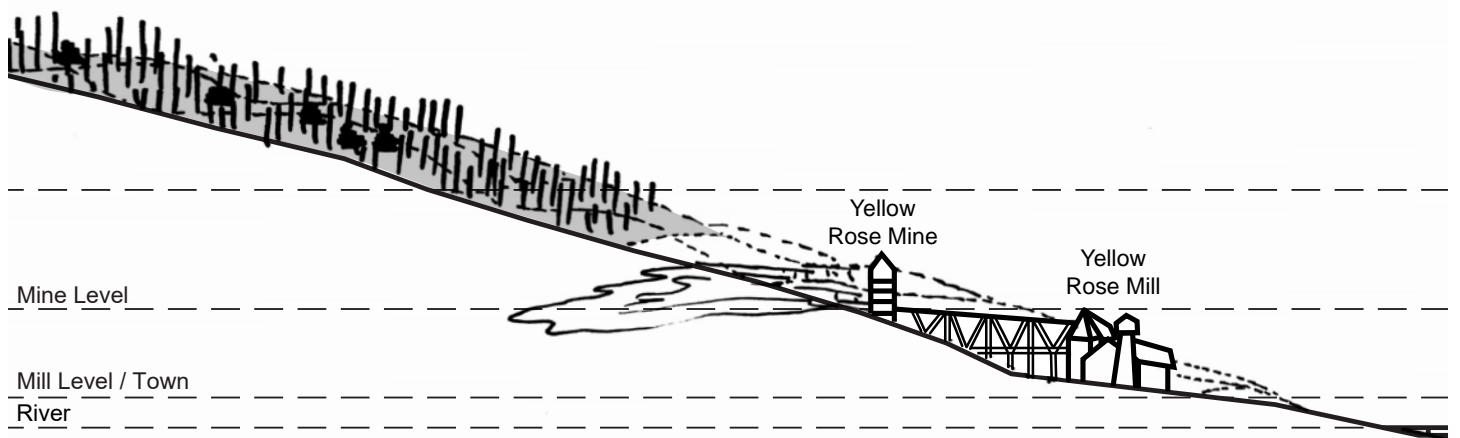
Figure 3-11. Approximate historic cross section, left to right: Yellow Rose Mill Complex (M7), Buffalo River, Red Cloud Mine Complex (M3). (Mundus Bishop 2017, BUFF Archives)

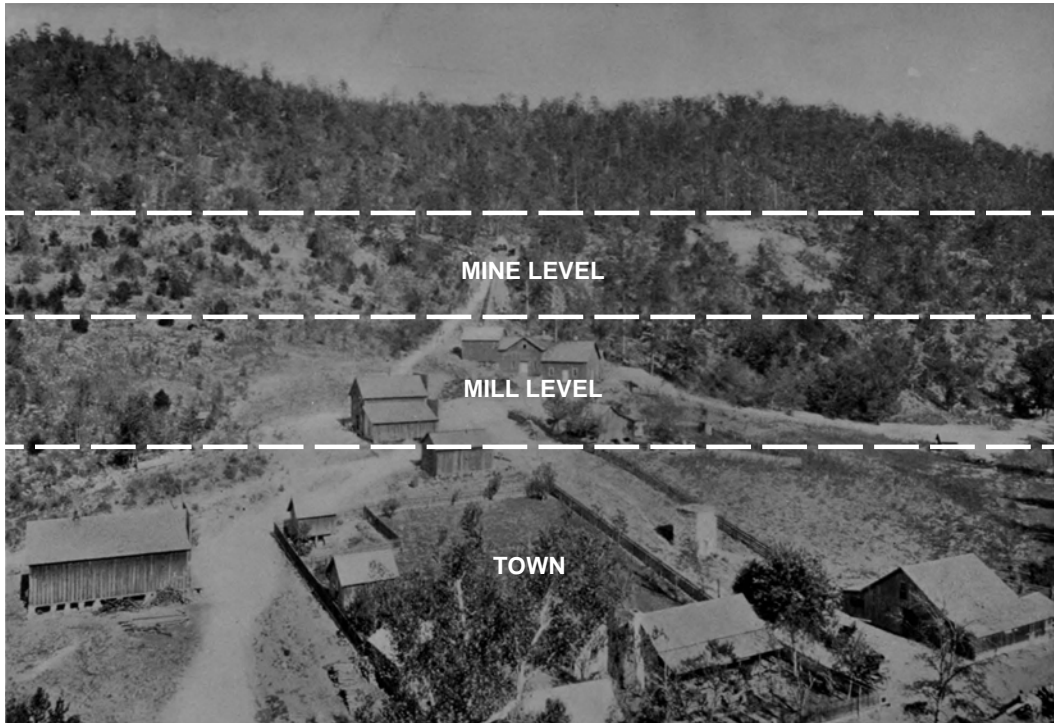
Figure 3-12. Mines were set high on hillsides. Mills were located directly below. Mining communities with support structures such as hotels, stores, and residential buildings were clustered on the valley floor. (BUFF Archives, Mundus Bishop 2017)
