Cuyahoga River HEC-RAS Study

January 2007

Cuyahoga River
HEC-RAS Study

Prepared for:
Friends of the Crooked River

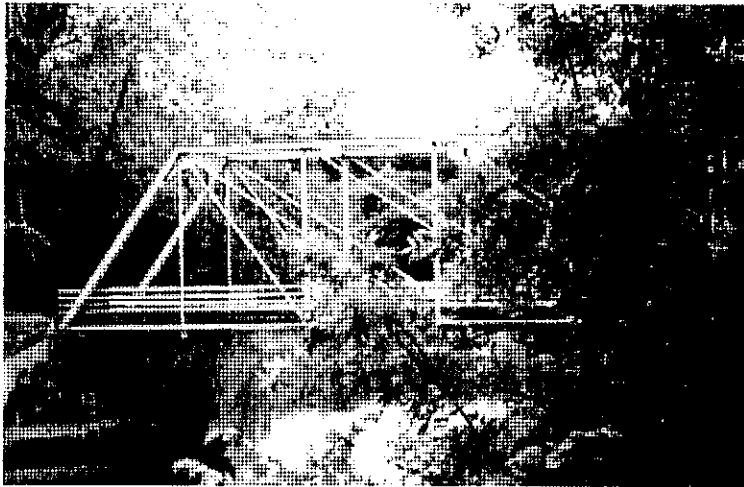
Photo 14:

*Downstream face of the
Station Road
Pedestrian Bridge over
the lower reach of the
Cuyahoga River.*

Three bridges were analyzed within the study area: the Station Road pedestrian bridge over the lower reach of the Cuyahoga River, the railroad bridge over Chippewa Creek tributary, and the Riverview Road bridge over Chippewa Creek tributary. The State Route 82 bridge, which is a high level bridge above the Cuyahoga River valley downstream of the dam, was not analyzed as a bridge for the hydraulic model; however, piers within the floodplain were modeled to accurately represent its impact. Photos of each bridge are shown below.
