GREATER PRAIRIE CREEK ECOSYSTEM RESTORATION PROJECT

Road Removal

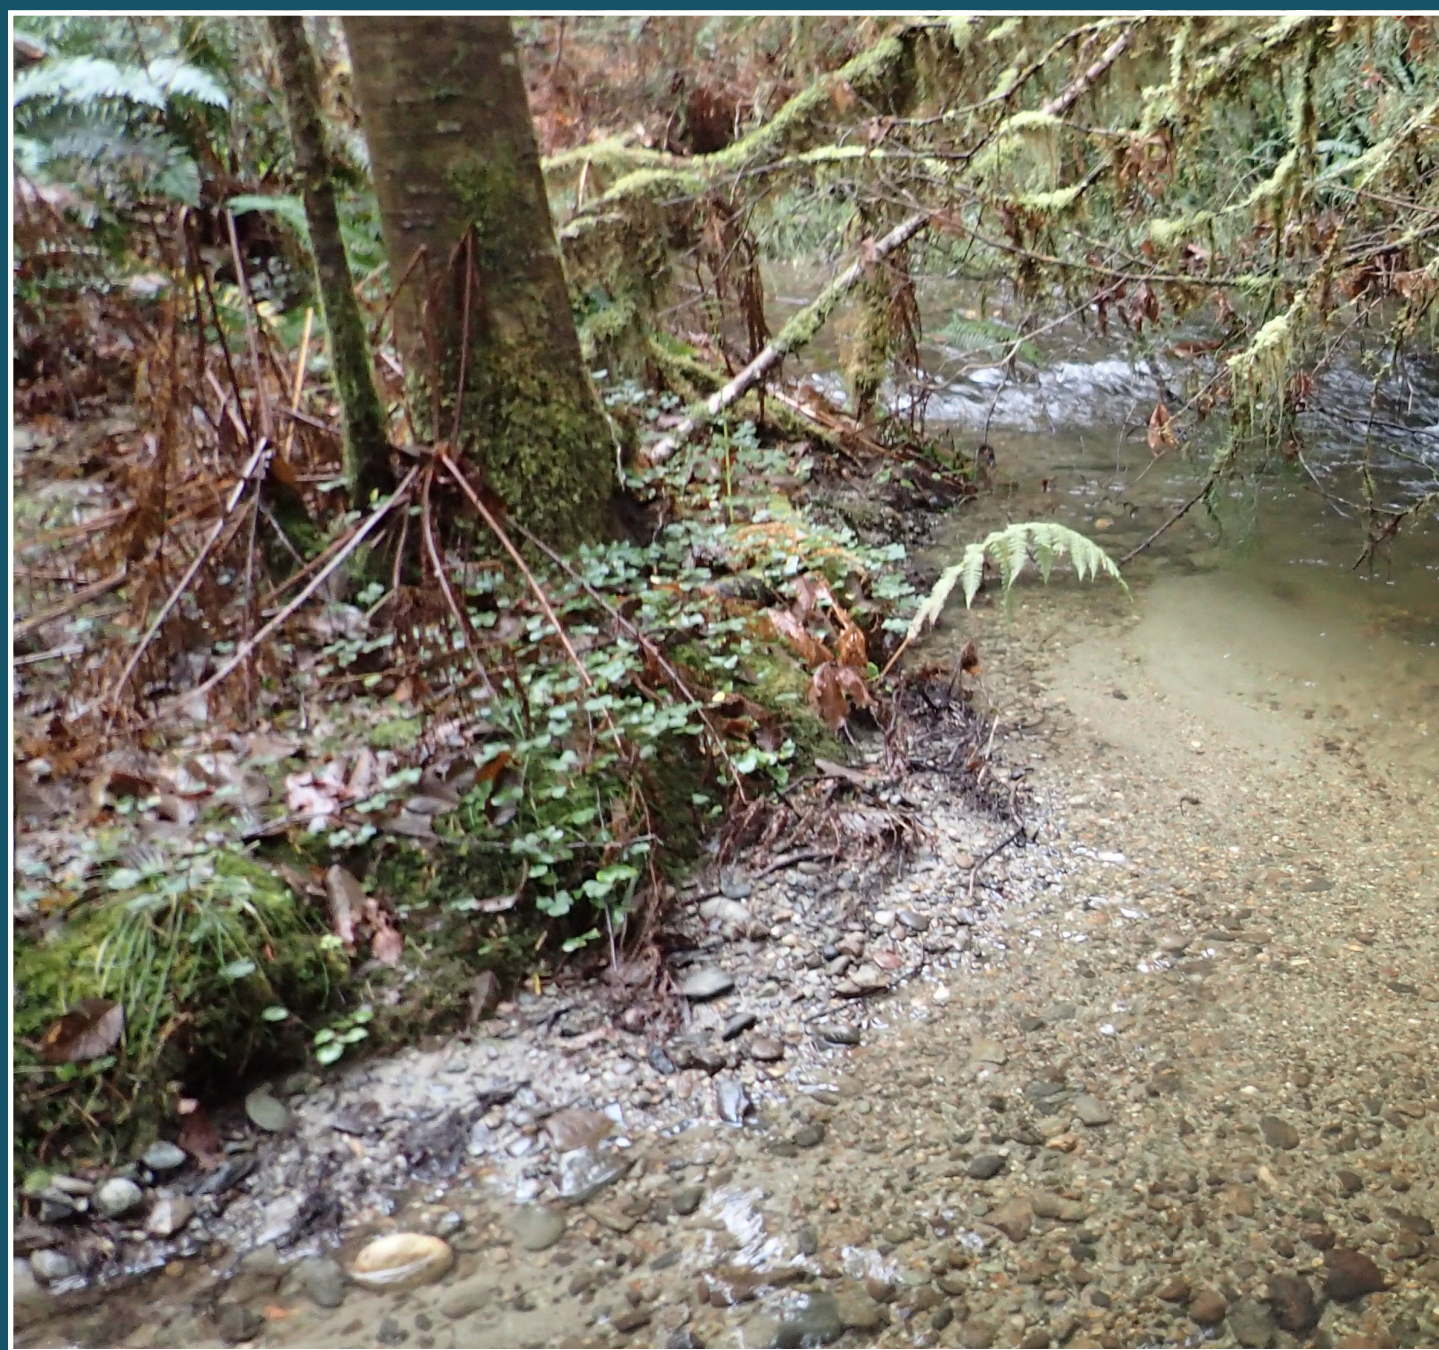
Substrate at Godwood

These two photos show the contrast between undisturbed channels and channels overwhelmed from failing road sediment. The photo on the left shows Godwood Creek, just north of the Prairie Creek Visitor Center. The photo on the right shows Lower May Creek, less than a mile away from Godwood Creek.

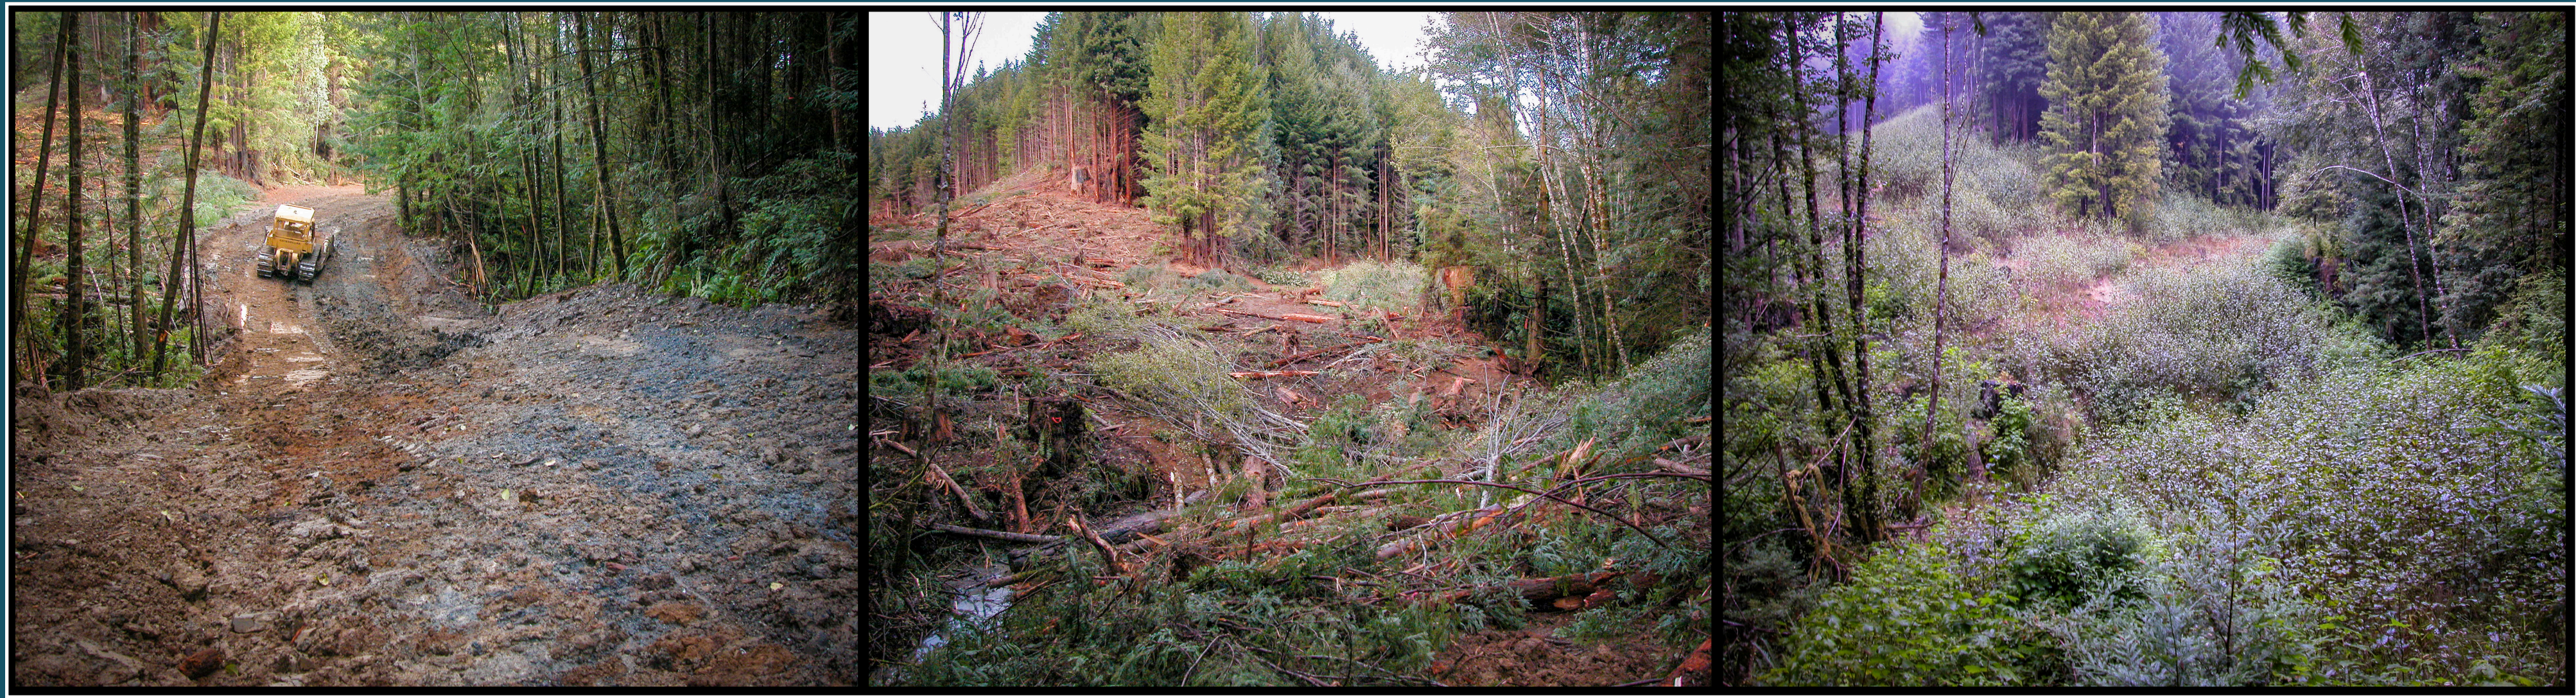
Larry Dam Road Removal Project: crossing excavation in 2003 and regrowth in 2007
