# Construct Family Cabins and Improve Site Access Environmental Assessment/Assessment of Effect

August 2019

**US Department of the Interior  
National Park Service  
Mammoth Cave National Park**

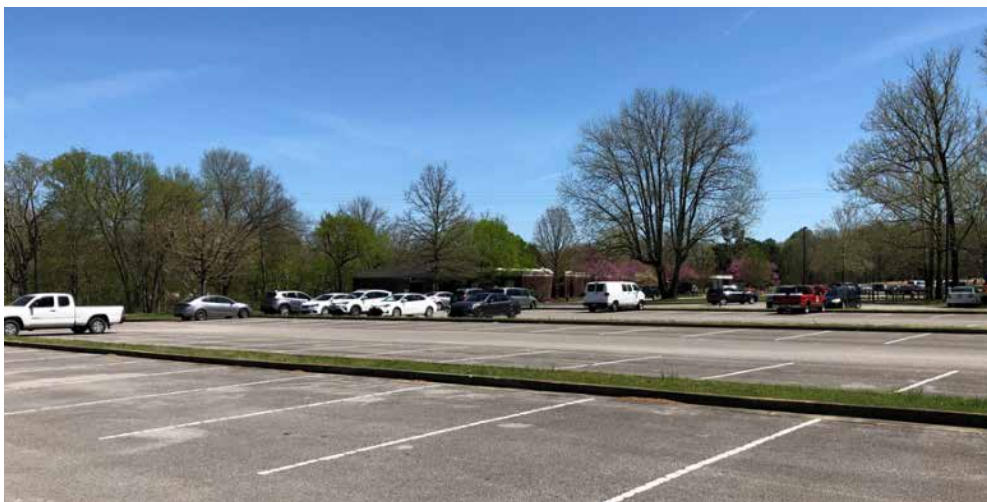
Existing parking lot with the Lodge at Mammoth Cave in background

**The parking lot has deferred maintenance issues.** The existing parking lot south of the lodge has many deferred maintenance issues including cracks in the pavement, large potholes, and crumbling of pavement along the edges of the parking lot. Additionally, the striping and arrows painted on the pavement through the parking lot is faded, which may make it more difficult for visitors to follow. In addition to the issues related to condition of the pavement, accessibility of the parking lot and walkways does not meet current accessibility standards. While the existing accessible parking spaces and walkways are generally accessible, they were constructed prior to changes in regulation of the Architectural Barriers Act Accessibility Standard.

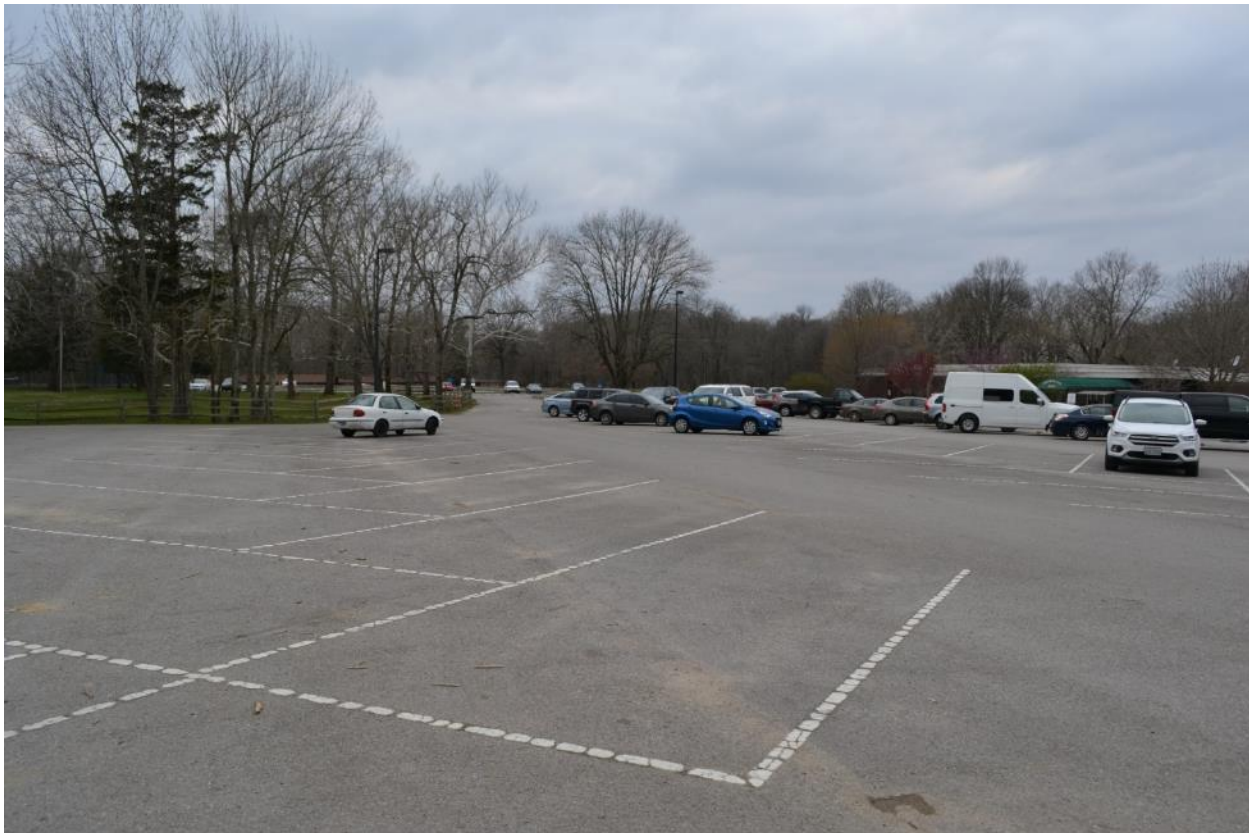
Existing parking lot south of the Lodge at Mammoth Cave

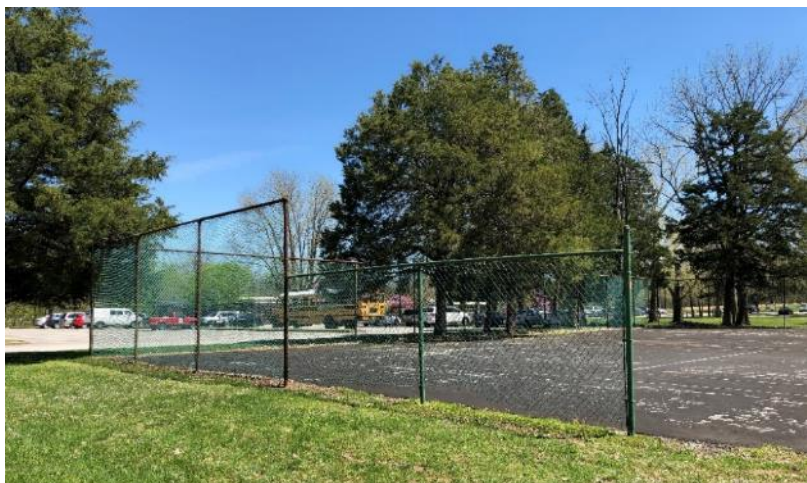
Existing tennis courts south of lodge parking lot

In addition to the lodging options for visitors, visitor use elements in the project area also include aging recreation facilities, including a dilapidated shuffleboard court and tennis courts, which were built in the late 1930s. These facilities are located to the southwest of the lodge and occasionally also serve as basketball courts but are otherwise rarely used by visitors.

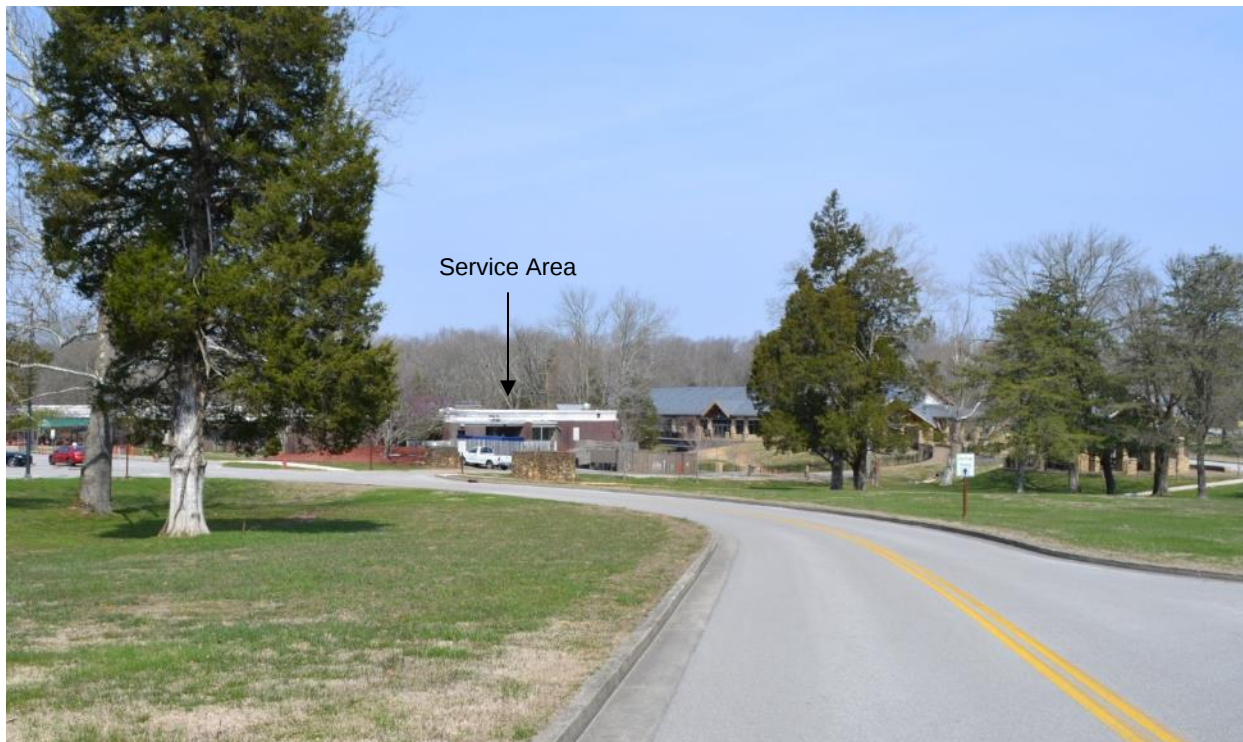
View from access road towards Lodge at Mammoth Cave with service area in center and Visitor Center in background

access road, they see a service area; this introduction to the site does not provide clear direction to the lodge entrance or other visitor areas. As visitors enter the project area, they also see a visual disconnect between the Lodge at Mammoth Cave and the visitor center, as the two buildings contrast greatly in design and materials (NPS 2013). This disconnect contributes to the lack of effective visitor orientation to the project area. It is apparent that existing parking areas were not designed at the time of the current lodge, as the lodge building relates poorly to both parking lots. This results in a series of awkward spaces and flow when experienced together by the visitor; flow is also hindered by lack of direction and any perceivable organization. Furthermore, the site does not fully meet current accessibility standards due to these issues related to pedestrian connectivity to the lodge and surrounding areas. Finally, the amount of parking currently available is inadequate during busy summer months. There are not enough parking spaces to accommodate all vehicles and visitors often park on roadsides.

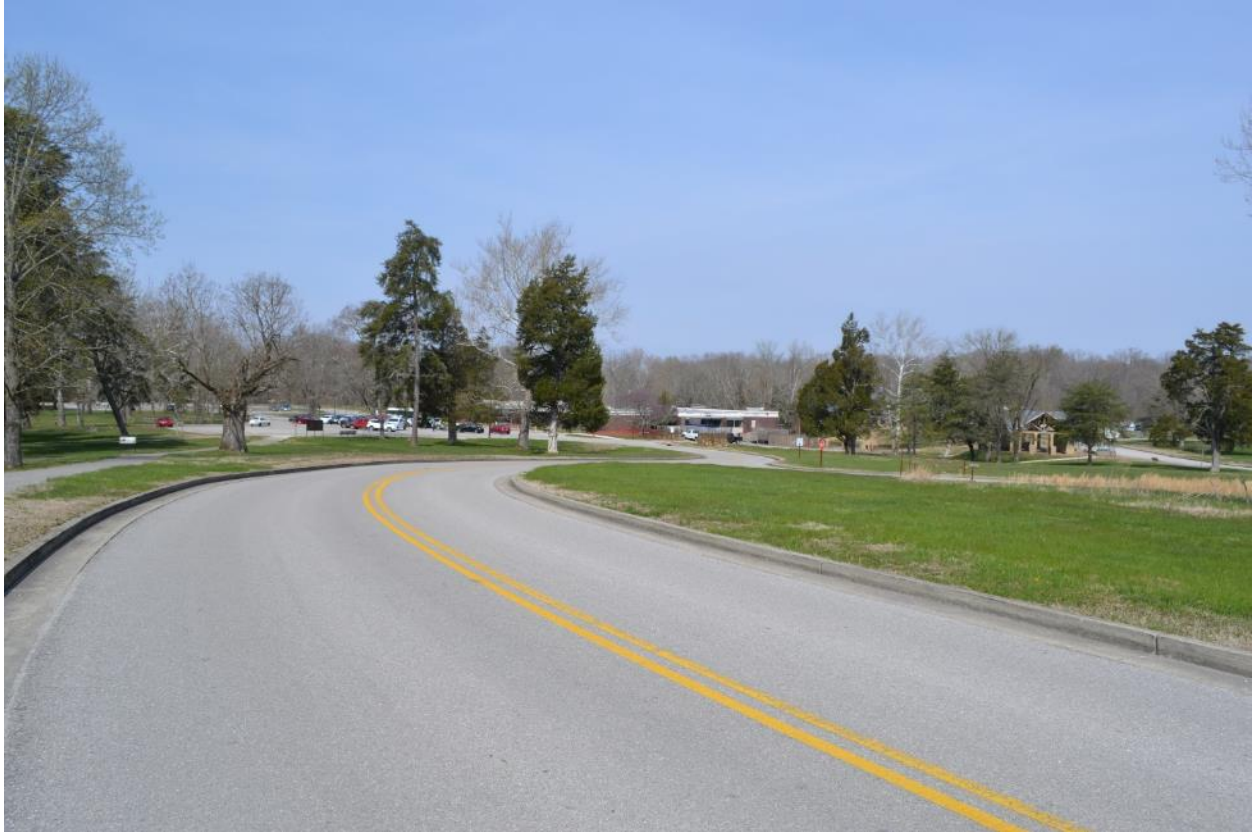
Existing view from access road towards Lodge at Mammoth Cave and associated parking lot

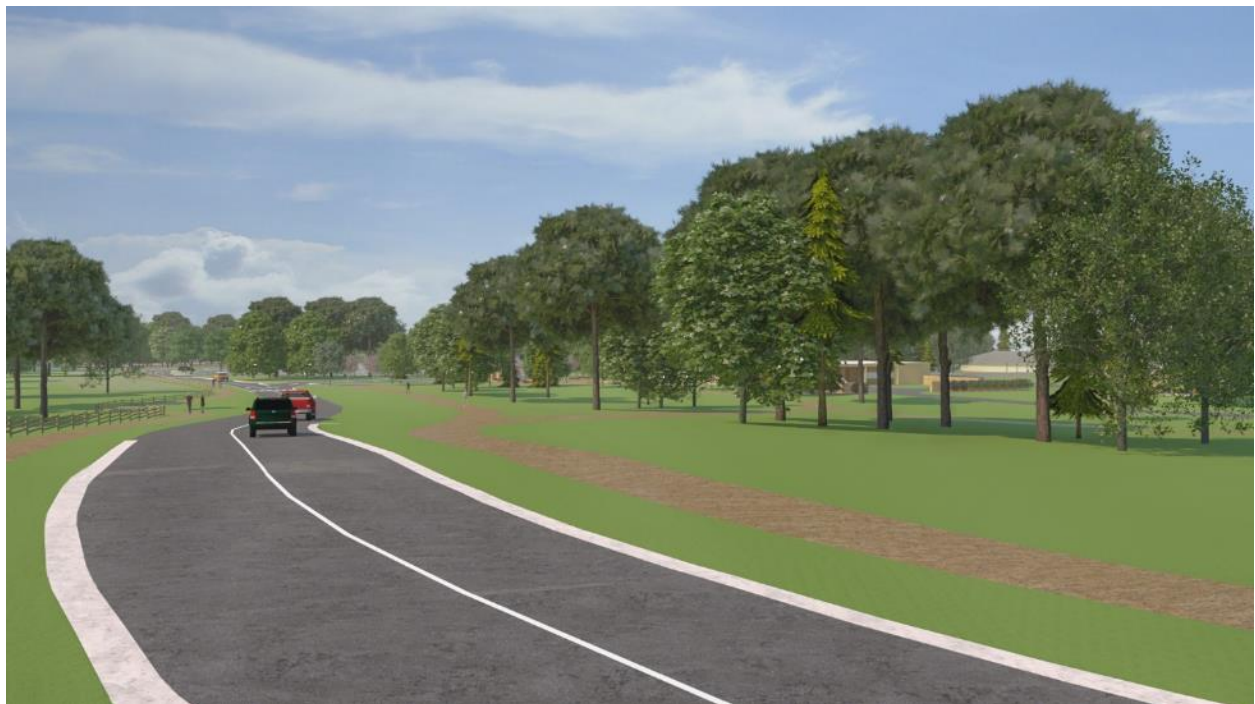
Rendering of view from proposed realigned access road towards Lodge at Mammoth Cave and associated parking lot

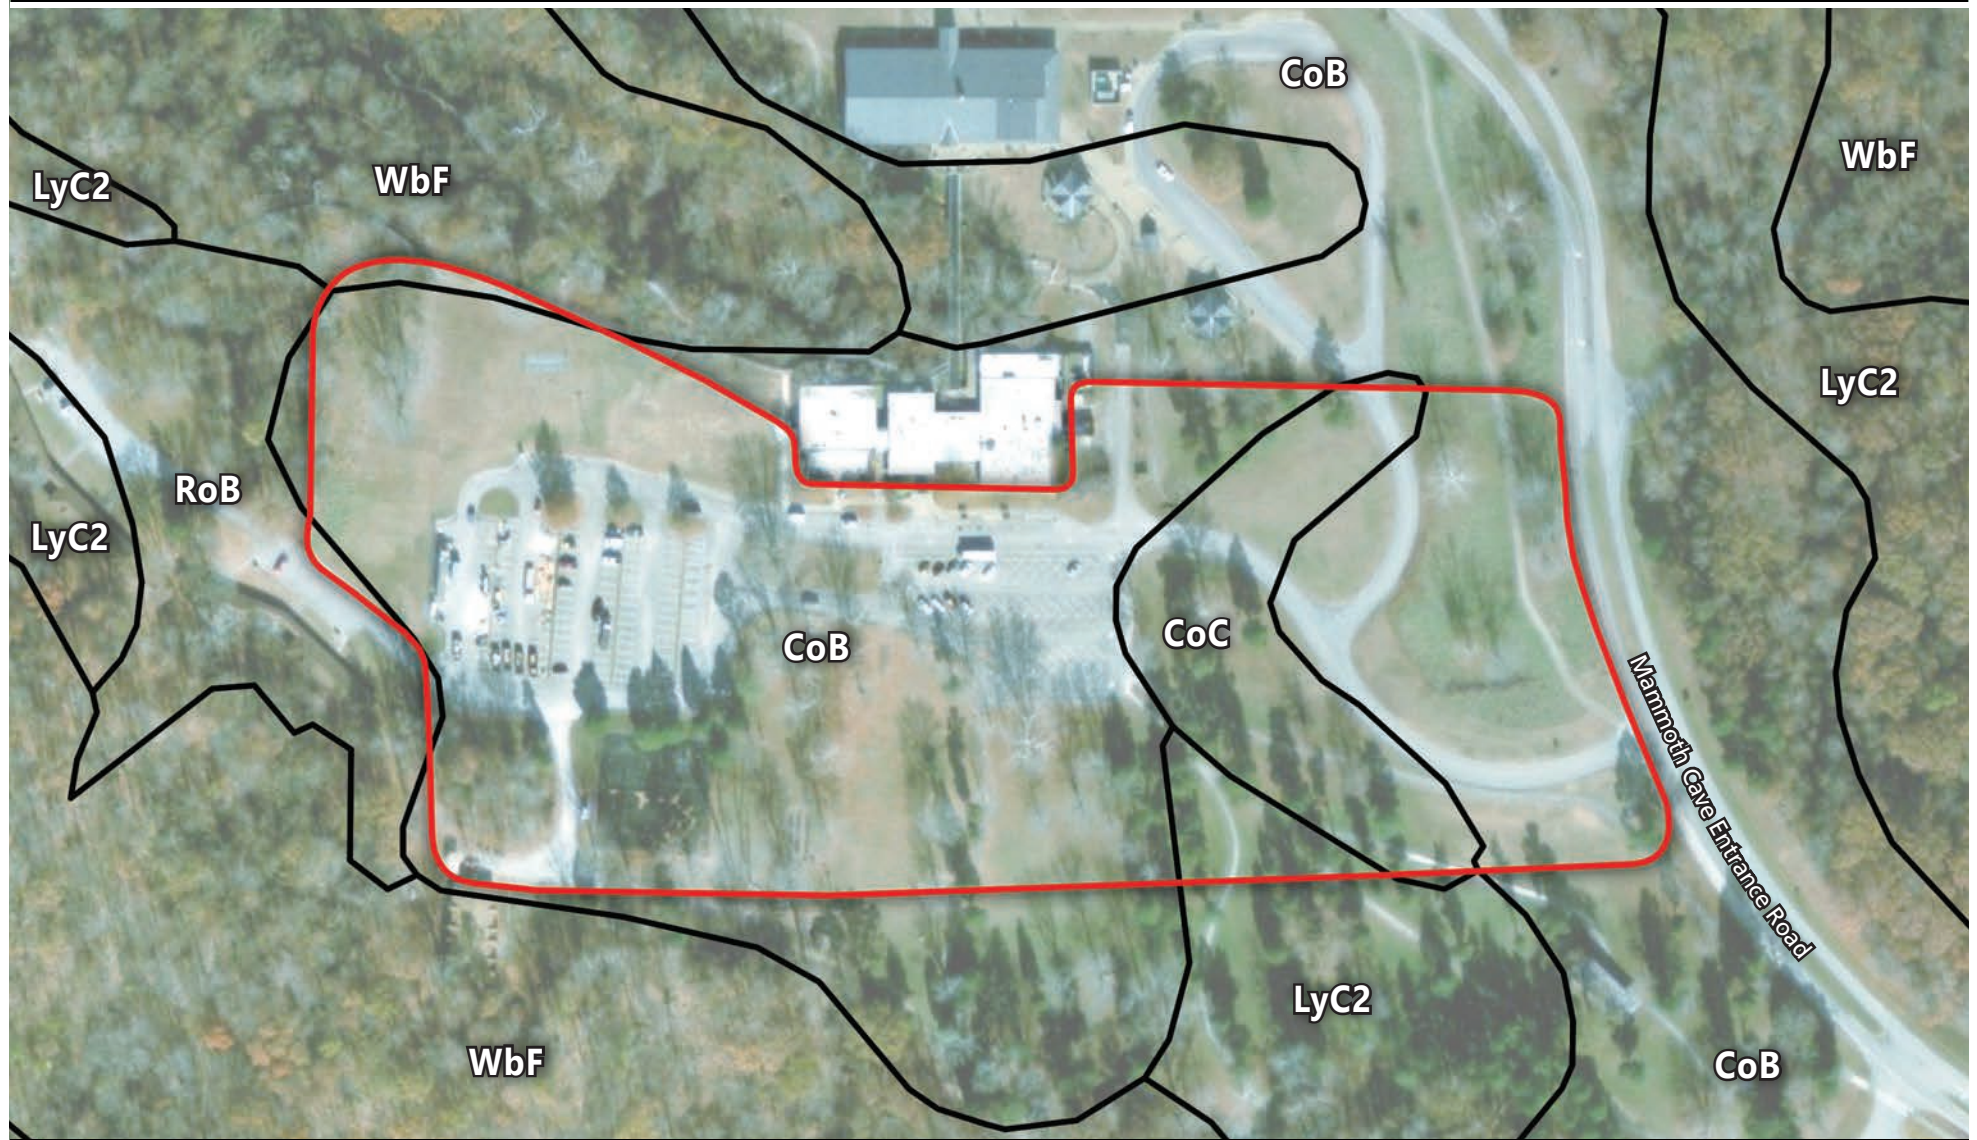
FIGURE 2  
Soils Map

- Study Area (15.16 Ac)
- Soil Map Unit Boundary
- CoB - Clarkrange silt loam, 2-6% slopes
- CoC - Clarkrange silt loam, 6-12% slopes
- LyC2 - Lily loam, 6-12% slopes, eroded
- RoB - Rosine silt loam, 2-6% slopes
- WbF - Wallen-Bledsoe-Donahue complex, 35-50% slopes, very rocky

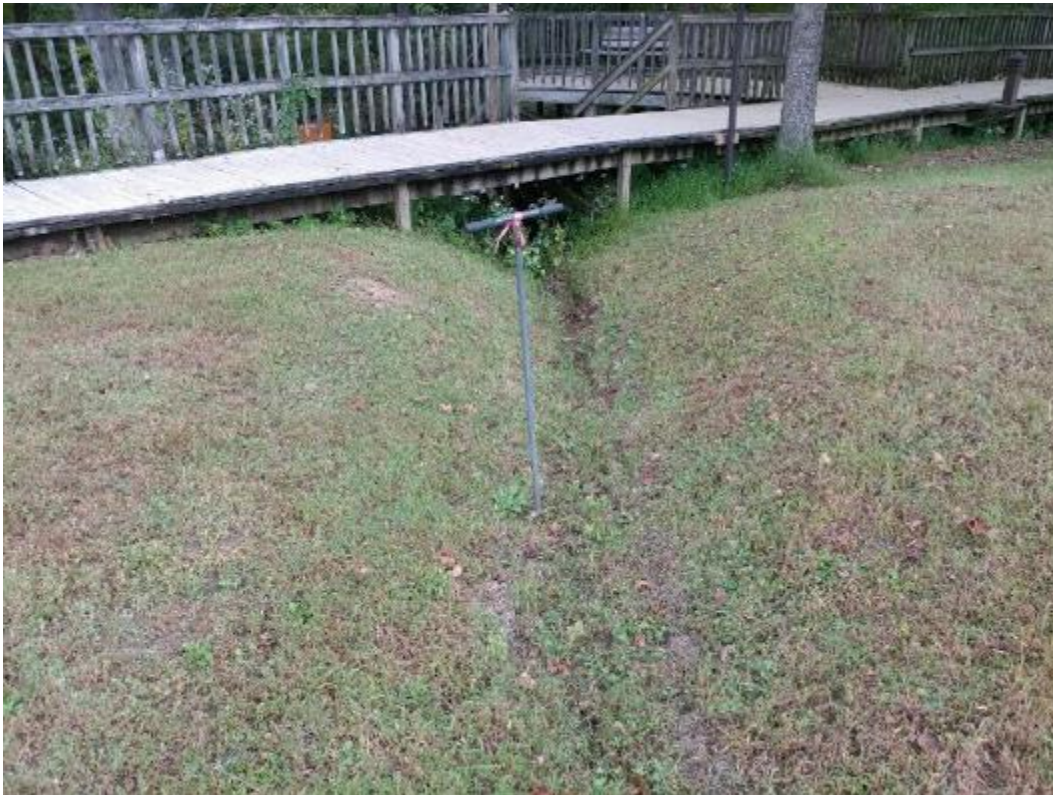
Photograph 8: View of Data Point DP-8 with a drainage feature in maintained lawn.

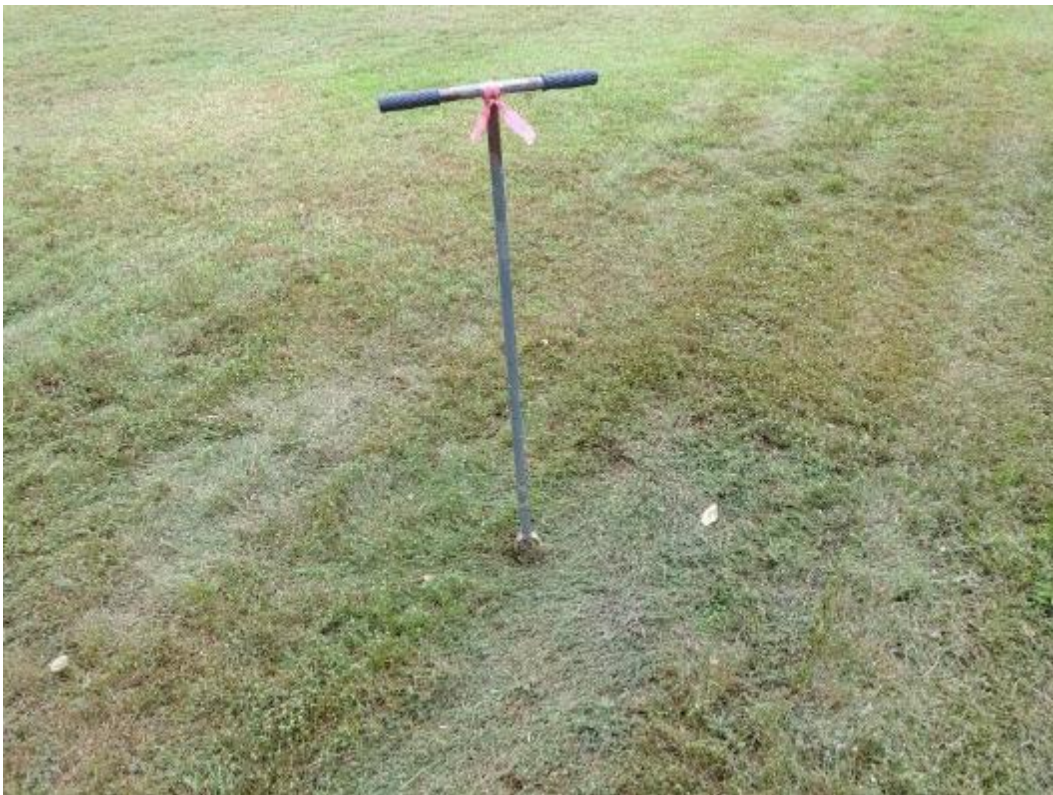
Photograph 10: View of Data Point DP-10 in herbaceous wetland adjacent to lawn.

The detailed wetland delineation conducted by VHB determined that one WOUS, a Palustrine Emergent (PEM) wetland, is present within the study area (Attachment 1; Figure 4). The PEM wetland (0.038 acres) is associated with a small depressional feature located on the flat terrace where the Lodge is located. The hydrology is provided by surface water run-off received from the parking lot and other nearby areas, and numerous hydrology indicators were observed including saturation at the soil surface. Vegetation is dominated by low spikesedge (*Kyllinga pumila*), field paspalum (*Paspalum laeve*), and creeping lespedeza (*Lespedeza repens*). Hydric soil indicator F3 (Depleted Matrix) is present within the wetland.
