Relocate and Replace Washington Suburban Sanitary Commission Sewer Line at Still Creek in Greenbelt Park

Environmental Assessment

May 2020

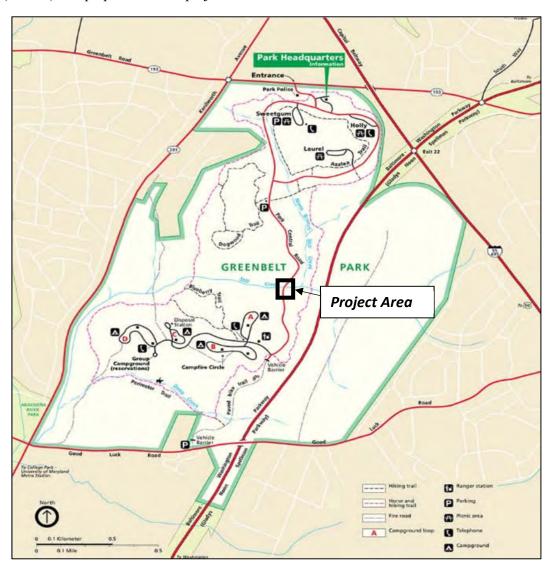
Figure 1: Project Area

The purpose of this project is to relocate a 400-foot section of a 21-inch sanitary sewer pipe located along Still Creek within the Greenbelt Park. Specifically, the NPS will issue WSSC a special use permit (SUP) for construction and access to relocate the sewer line and a right-of-way (ROW) permit for the ongoing maintenance of the utility infrastructure. The relocation is needed due to the poor condition of the pipe and to accommodate a new bridge over Still Creek currently under construction (Figure 1).

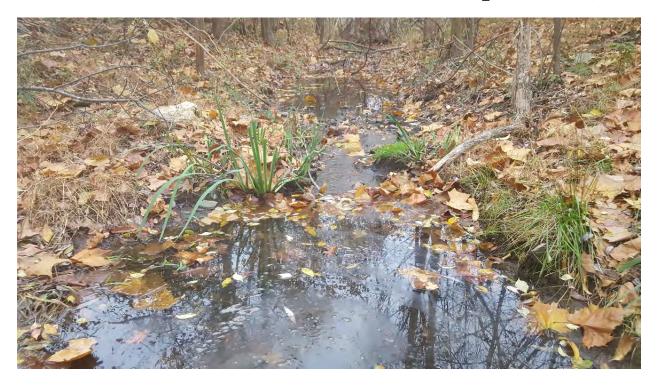
WL001 Downstream, facing west

Project: TMDL Site No. 150187UT	Date: <u>11/7/17</u>					
Stream ID: WL001	Investigators: WT, NC					
Stream Name: Unnamed tributary to Little Seneca Creek						
Use (I-IV): IV-P						
Rapanos Class:	□ NRPW					
	ittent Ephemeral					
If ephemeral, provide justification for flagging:						
Direction of flow: West	Gradient (9/): 25					
Direction of flow: West Gradient (%): 2-5						
Connection to TNW: WL001 is an unnamed tributary to Little Seneca Creek, which flows into Little Seneca						
Creek, which flows into Seneca Creek, which flows into the Potor	mac River, which is a TNW.					
Avg Width (Top of Pank): 6'	T Donth (Top of Rank): 6'					
Avg. Width (Top of Bank): 6' Avg. Depth (Top of Bank): 6'						
Avg. Water Depth: 3" Avg. Slope of Banks (°): LB 45 RB 45						
Has stream been altered? If so, how: Rip rap in channe	el					
	_					
Common Substrator						
Common Substrate:	rata					
☐ Bedrock ☐ Cobble/Gravel ☐ Concr	ete 🗆 Sand 🗀 Silt

☑ Other: Rip rap						
Habitat Complexity:						
	☐ Tree Roots ☐ Woody Debris					
Silt Deposition: ☐ Severe ☐ Moderate ☒ Minor						
Is the stream problematically incised? Yes No						
Riparian Zone:						
RB: □ Forested ☒ Shrub ☒ Herb. □ Wetla	ands Developed Maintained					
LB: □ Forested ☑ Shrub ☑ Herb. □ Wetla	•					
	ands Developed D Maintained					
Flags:						
Flags:						
Flags: WL001-001 to WL001-014						
Flags: WL001-001 to WL001-014

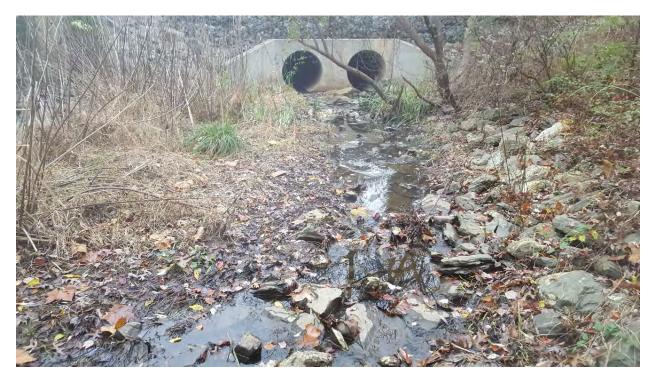
WL001 Upstream, facing east

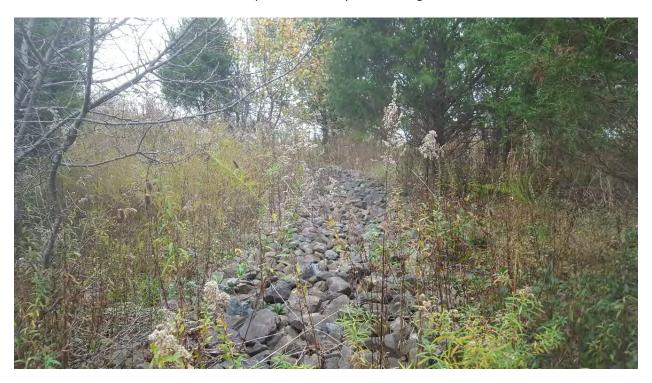
Rip rap swale in the eastern portion of the study area, facing east

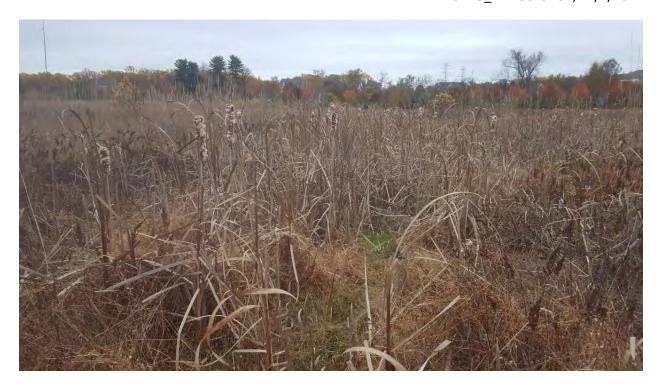
WP001-WET, facing west

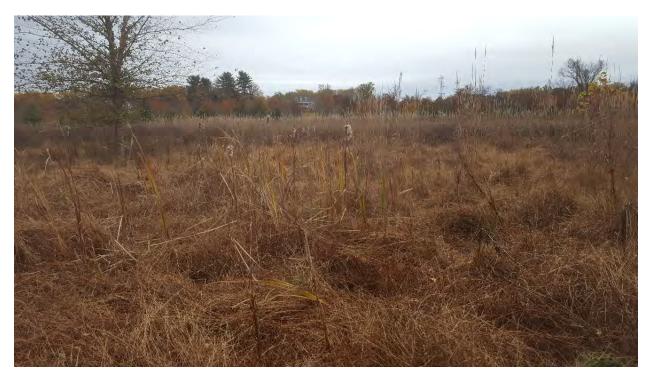
Emergent wetland in the central portion of the study area, facing west

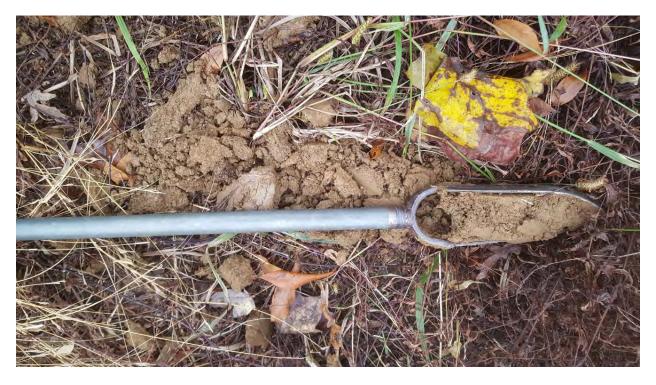
Non-hydric soil profile from central portion of the study area

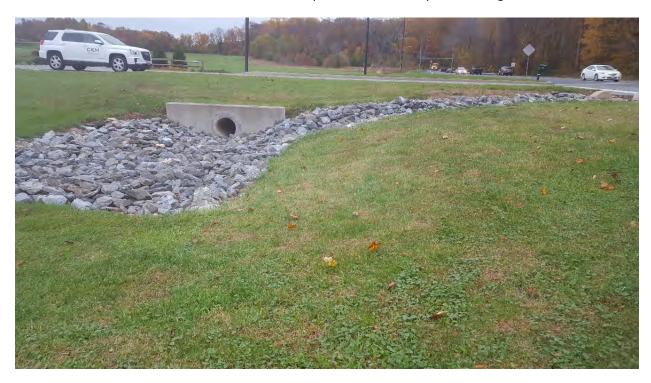
Rip-Rap swale at inlet at Volunteer Drive in the southern portion of the study area, facing east

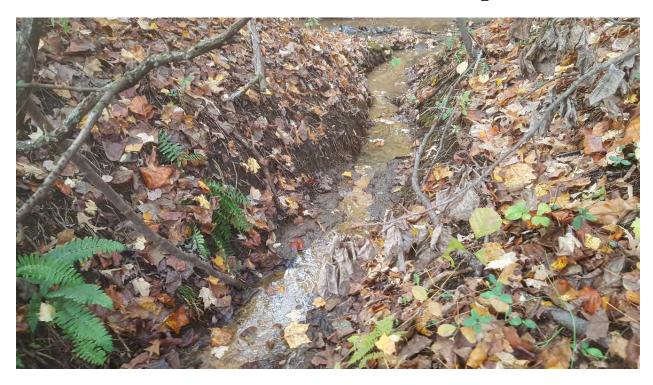
WL001 Downstream, facing west

Project: TMDL Site No. 160275UT	Date: _11/9/17
Stream ID: WL001	Investigators: WT, RS
Stream Name: Unnamed tributary to NE Br. W Br. Patuxent River	<u></u>
Use (I-IV): I	
Rapanos Class: TNW RPW	□ NRPW
Flow: ☐ Perennial ☐ Interm	
If ephemeral, provide justification for flagging:	писти Берпетега
in epitemeral, provide justification for flagging.	
Direction of flow: West	Gradient (%): 2-5
Connection to TNW: WL001 flows into WL002, which flows in	· ,
West Branch of the Patuxent River, which flows into the Northeast	
which flows into the West Branch of the Patuxent River, which flo	bws into the Patuxent River, which is a TNVV.
Avg. Width (Top of Bank): 3' Avg	g. Depth (Top of Bank): 6'

g. Slope of Banks (°): LB 70 RB 45
· ———	· · · · · · · · · · · · · · · · · · ·
Has stream been altered? If so, how: WL001 is piped a	it the upstream extent.
Common Substrate:	
☐ Bedrock ☐ Cobble/Gravel ☐ Conci	rete ⊠ Sand ⊠ Silt
☐ Other:	rete 🖾 Sanu 🖾 Siit
U Other.	
Habitat Complexity:	
☐ Riffles/pools ☐ Undercut Banks	☑ Tree Roots ☑ Woody Debris
Bank Erosion:	✓ Moderate
Silt Deposition:	☐ Moderate ☐ Minor
·	☑ No
Is the stream problematically incised? Yes Yes	∆ NU
Riparian Zone:	
RB: ⊠ Forested ⊠ Shrub ⊠ Herb. □ Wetl	ands □ Developed 図 Maintained
LB: ⊠ Forested ⊠ Shrub ⊠ Herb. □ Wetl	•
Flags:	
WL001-001 to WL001-006	
Additional Notes:

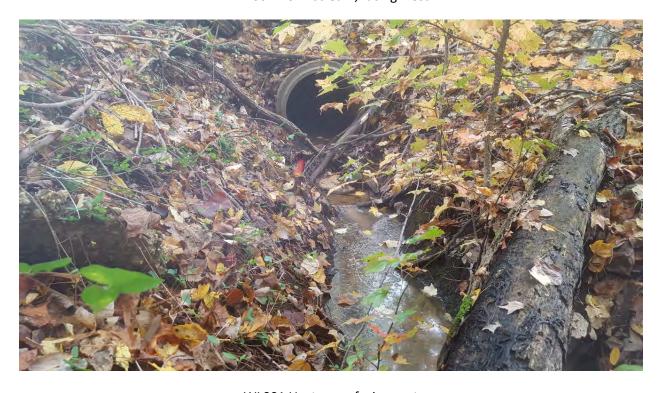
WL001 Upstream, facing east

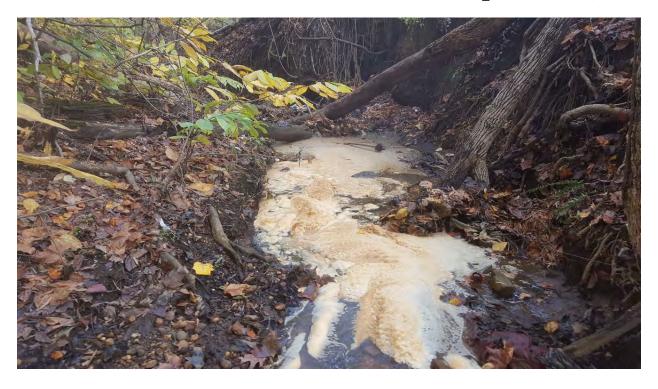
WL002 Downstream, facing north

Project: IMDL Site No. 1602/501	Date: <u>11/9/17</u>		
Stream ID: WL002	Investigators: WT, RS		
Stream Name: Unnamed tributary to NE Br. W Br. Patuxent River			
Use (I-IV): I			
Rapanos Class: TNW RPW	□NRPW		
·			
Flow: ☑ Perennial ☐ Intermiti	·		
If ephemeral, provide justification for flagging:			
Discation of flows North	Cradiant (0/), 0.5		
Direction of flow: North	Gradient (%): 2-5		
Connection to TNW: WL002 flows into an unnamed tributary			
of the Patuxent River, which flows into the Northeast Branch of the			
into the West Branch of the Patuxent River, which flows into the Pa	atuxent River, which is a TNW.		
Avg. Width (Top of Bank): 12' Avg.	Depth (Top of Bank): 10'		
Avg. Water Depth: 4" Avg.	Slope of Banks (°): LB <u>45</u> RB <u>90</u>		
Has stream been altered? If so, how: WL002 is culverted	at the upstream extent.		
Common Substrate:			
☐ Bedrock Cobble/Gravel ☐ Concre	te ⊠ Sand ⊠ Silt		
☐ Other:

Habitat Complexity:			
☑ Riffles/pools ☑ Undercut Banks ☑	☑ Tree Roots		
Bank Erosion: 🗵 Severe 🛭	☐ Moderate ☐ Minor		
Silt Deposition:	☐ Moderate		
'	No		
is the stream problematically meisea.	140		
Riparian Zone:			
RB: ⊠ Forested ⊠ Shrub ⊠ Herb. □ Wetlar	nds 🗵 Developed 🗵 Maintained		
LB: ⊠ Forested ⊠ Shrub ⊠ Herb. □ Wetlar			
Flags:			
WL002-001 to WL002-006			
Additional Notes:

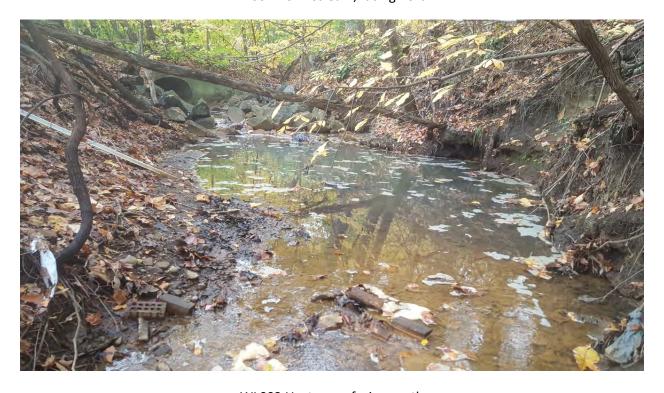
WL002 Upstream, facing south

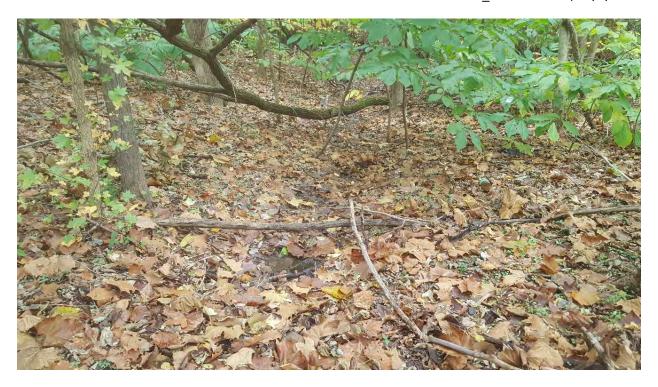
WL001 Downstream, facing west

Project: TMDL Site No. 160277UT	Date: 11/9/17
Stream ID: WL001	Investigators: WT, RS
Stream Name: Unnamed tributary to NE Br. W Br. Patux	ent River
Use (I-IV): I	
Rapanos Class: TNW	RPW 🗵 NRPW
Flow: Perennial	Intermittent 🗵 Ephemeral
If ephemeral, provide justification for flagging	g: Defined bed and banks and receives flow from sheetflow
runoff from roadway.	
Direction of flow: West	Cradiant (9/), 0.2
	Gradient (%): 0-2
	anch of the West Branch of the West Branch anch of the West Branch of the Patuxent River, which flows

-	
into the West Branch of the Patuxent River, which flow	s into the Patuxent River, which is a TNVV.
Avg. Width (Top of Bank): 3'	Avg. Depth (Top of Bank): 1'
Avg. Water Depth: 1"	Avg. Slope of Banks (°): LB 15 RB 10
Has stream been altered? If so, how:	
Common Substrate:	
,	☐ Concrete
☑ Other: Leaf litter	_
Habitat Complexity:	
☐ Riffles/pools ☐ Undercut Ba	anks Tree Roots Woody Debris
Bank Erosion:	☐ Moderate ☐ Minor
Silt Deposition:	☐ Moderate ☐ Minor
Is the stream problematically incised?	
is the stream problematically melsear	
Riparian Zone:	
	☐ Wetlands ☐ Developed ☐ Maintained
LB: ☑ Forested ☑ Shrub ☑ Herb. I	☐ Wetlands ☐ Developed ☐ Maintained
Flags:	
WL001-001 to WL001-010	
WL001-001 to WL001-010

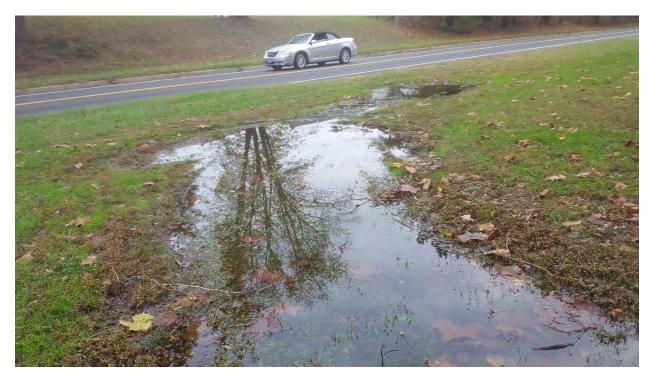
WL001 Upstream, facing east

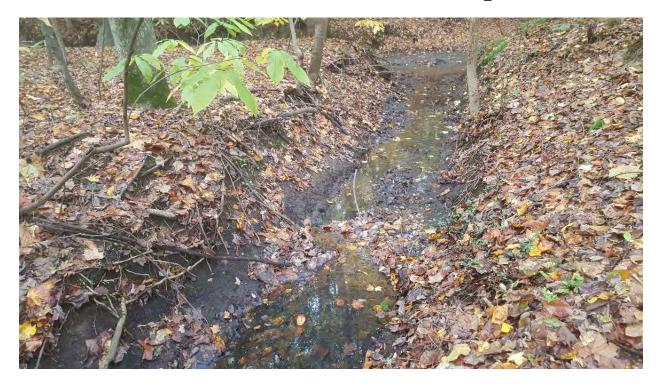
WL002 Downstream, facing west

Project: TMDL Site No. 160277UT	Date: 11/9/17
Stream ID: WL002	Investigators: WT, RS
Stream Name: Unnamed tributary to NE Br. W Br. Patuxent River	<u></u>
Use (I-IV): I	
Rapanos Class: TNW RPW	□ NRPW
Flow: ☐ Perennial ☐ Interm	
If ephemeral, provide justification for flagging:	ttent 🗀 Ephemerai
in epitemeral, provide justification for flagging.	
Direction of flow: West	Gradient (%): 2-5
Connection to TNW: WL002 flows into an unnamed tributa	· · ·
of the Patuxent River, which flows into the Northeast Branch of the	
into the West Branch of the Patuxent River, which flows into the	_
Into the West Branch of the Patuxent River, which hows into the	Fatuxent River, which is a Triviv.
Avg. Width (Top of Bank): 4' Avg	g. Depth (Top of Bank): 5'
, <u> </u>	g. Slope of Banks (°): LB 80 RB 50
Has stream been altered? If so, how:	3. Slope of Barks (). LB
nds stream been altered? If so, flow.	
Common Substrate:	
☐ Bedrock ☒ Cobble/Gravel ☐ Conci	rete 🗵 Sand 🗵 Silt

☐ Other:	ete 🖾 Saliu 🗠 Siit
U Other.	
L	
Habitat Complexity:	
☑ Riffles/pools ☑ Undercut Banks	☑ Tree Roots ☑ Woody Debris
Bank Erosion:	☐ Moderate ☐ Minor
Silt Deposition:	☐ Moderate ☐ Minor
·	☑ Moderate ☑ Millor
Is the stream problematically incised? Yes Yes	⊴ NO
Riparian Zone:	
RB: ⊠ Forested ⊠ Shrub ⊠ Herb. □ Wetl	ands □ Developed 図 Maintained
LB: ⊠ Forested ⊠ Shrub ⊠ Herb. □ Wetl	·
EB. EB FORESTER EB SHIRLD EB FIELD. EB WELL	ands Developed E Maintained
Flags:	
WL002-001 to WL002-008	
Additional Notes:

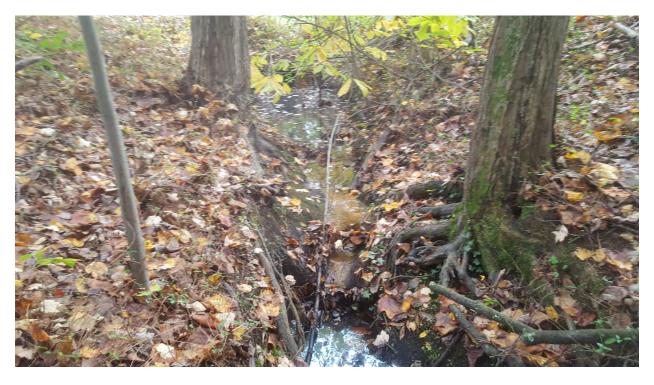
WL002 Upstream, facing east

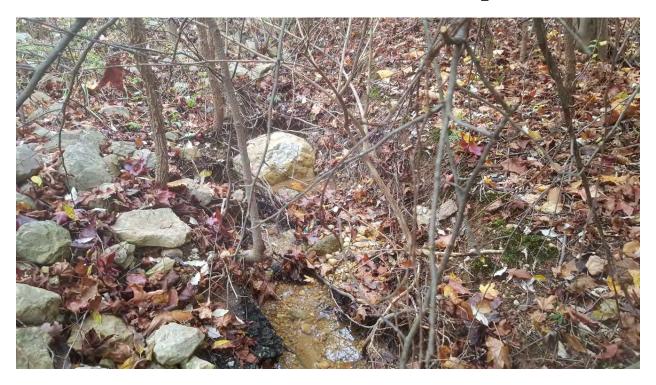
WL001-Upstream, facing southeast

Project: TMDL Site No. 160311UT	Date: 11/8/17			
Stream ID: WL001	Investigators: WT, RS			
Stream Name: Unnamed tributary to Patuxent River				
Stream Name.				
Use (I-IV): I				
	T NDDW			
Rapanos Class: TNW RPW	□ NRPW			
Flow: ☐ Perennial ☐ Interm	nittent Ephemeral			
If ephemeral, provide justification for flagging:				
Direction of flow: North	Gradient (%): 2-5			
Connection to TNW: WL001 flows into an unnamed tribut	ary to the Patuxent River, which flows into the			
Patuxent River, which is a TNW.				
Avg. Width (Top of Bank): 3' Av	g. Depth (Top of Bank): 8"

g. Slope of Banks (°): LB 40 RB 35			
Has stream been altered? If so, how: Some rip rap in o	channer.			
Common Substrate:				
☐ Bedrock	rete 🗵 Sand 🔲 Silt			
☑ Other: Rip rap				
Habitat Complexity:				
	☐ Tree Roots ☐ Woody Debris			
Bank Erosion: Severe	☐ Moderate Minor			
Silt Deposition:	☐ Moderate Minor			
Is the stream problematically incised? Yes	⊠ No			
, , ,				
Riparian Zone:				
RB: □ Forested ☒ Shrub ☒ Herb. □ Wet	lands □ Developed 図 Maintained			
LB: ☑ Forested ☑ Shrub ☑ Herb. ☐ Wet	lands □ Developed □ Maintained			
	·			
Flags:				
WL001-001 to WL001-007				
Additional Notes:	I			
Additional Notes:				
Additional Notes:

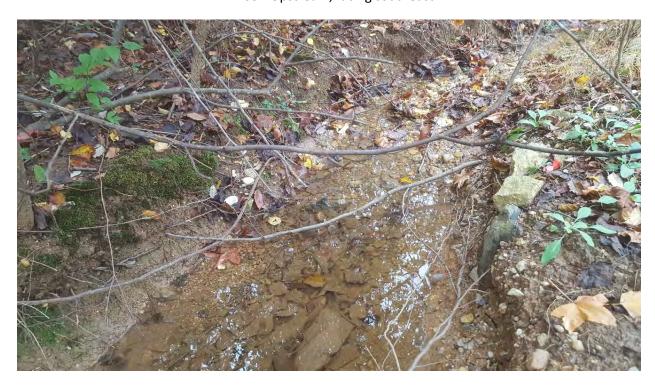
WL001-Downstream, facing northwest

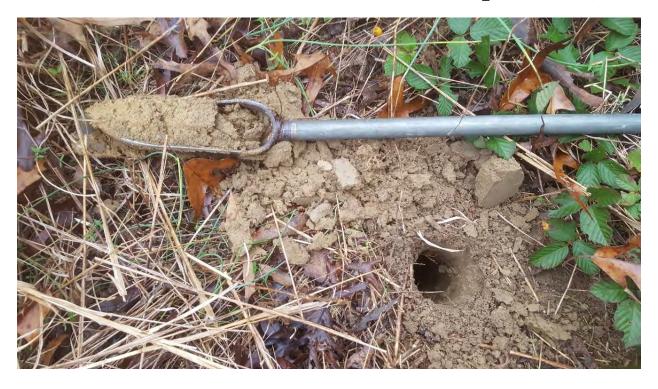
Non-hydric soil profile from western portion of the study area

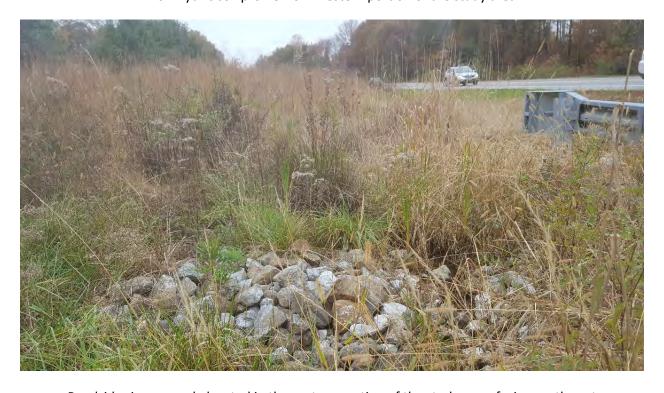
Roadside rip-rap swale located in the eastern portion of the study area, facing northwest
