Mount Vernon Trail Corridor Study

George Washington Memorial Parkway

May 2020

1. AGENCY USE ONLY (Leave blank)		2. REPORT DATE May 2020		3. REPORT TYPE AND DATES COVERED Final Report
4. TITLE AND SUBTITLE George Washington Memorial Parkway: Mount Vernon Trail Corridor Study			5a. FUNDING NUMBERS VXP4A1

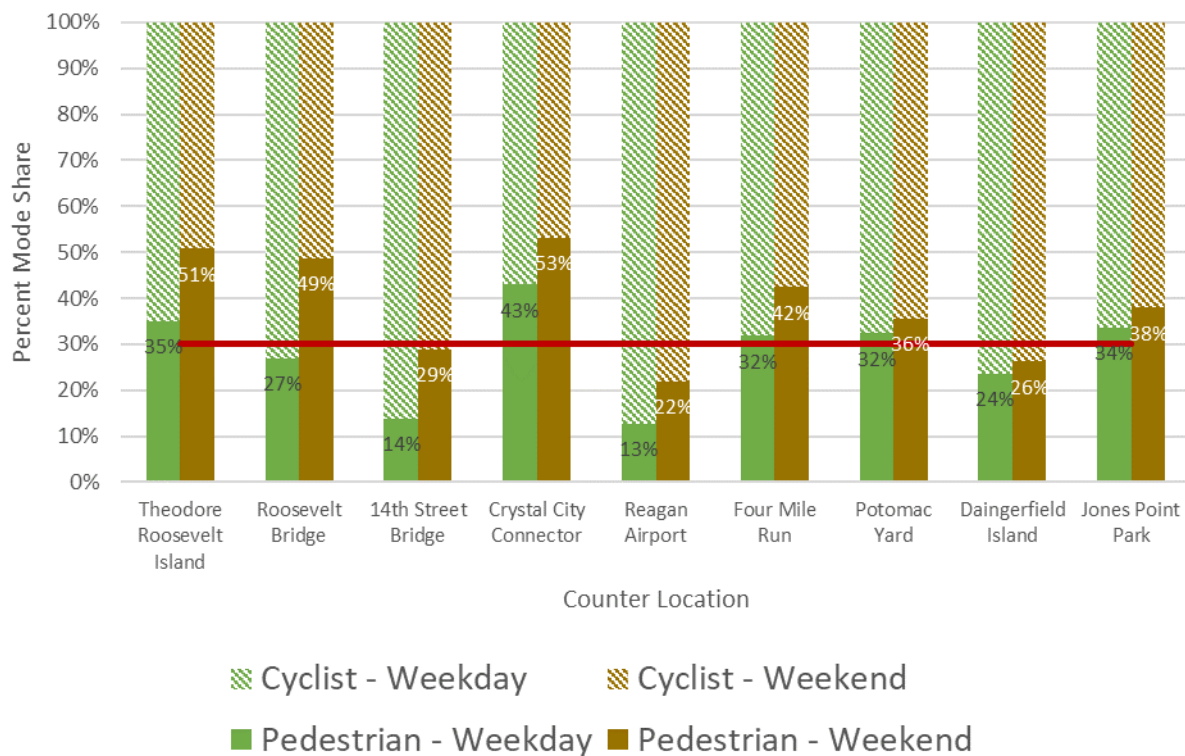
Figure 9 shows the percent bicycle and pedestrian mode share by counter location for 2016-2018 and identifies which counter locations exceed the 30 percent pedestrian mode share standard. Almost all locations either exceed or nearly exceed the threshold on weekdays, weekends, or both. Five counter locations—Theodore Roosevelt Island, Crystal City Connector, Four Mile Run, Potomac Yard, and Jones Point Park—exceed the 30 percent pedestrian mode share threshold on weekdays. Six counter locations—Theodore Roosevelt Island, Roosevelt Bridge, Crystal City Connector, Four Mile Run, Potomac Yard, and Jones Point Park—exceed the 30 percent pedestrian mode share threshold on weekends.

Figure 9: Bicycle and pedestrian mode share, 2016-2018

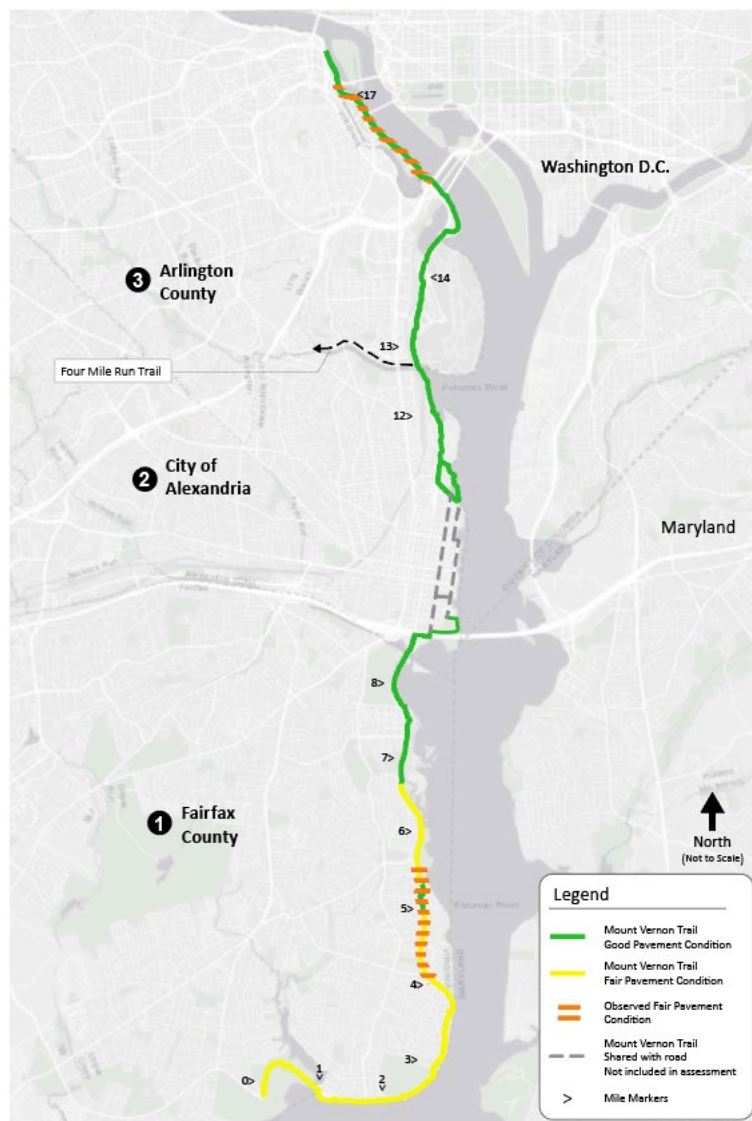
There are a total of 784 unique pavement quality issues included in the condition assessment. Based on a spatial analysis of these issues, which was validated through the site visits, the pavement in Zones 2 and 3 are generally in good condition with significantly more pavement quality issues in Zone 1 (see Figure 15). The green sections of the map have nine or fewer pavement issues, while the yellow sections have between nine and 49 issues. Roughly, the green and yellow sections correspond to good and fair pavement quality, respectively. In addition to the pavement quality issues identified in the condition assessment, the study team observed pavement condition worse than indicated in the assessment on site visits to the trail. Specifically, the team observed pavement condition mile marker 4 to 5.5 (Zone 1) and on Columbia Island (Zone 3) is in worse condition than indicated in the assessment. These areas are noted in orange in the pavement condition map. Figure 16, Figure 17, and Figure 18 show examples of the issues listed above.

Figure 15: Pavement condition map

- The majority of pavement deterioration in the lower section of the trail is between mile posts 0 and 4, with significant amounts of cracking. This section of the trail is heavily wooded, with tree roots likely contributing to the deterioration. Significant overhang and raised bumps contribute to blind spots and rider discomfort. Based on the GIS analysis, this section is in fair condition.
- There is a notable amount of weed encroachment concentrated between miles 2 and 4. This encroachment at times narrows the width of the trail.
- Tidal flooding occurs near the mile 2 post adjacent to Fort Hunt Park.
- In general, the pavement condition between miles 4 and 5.5 is fair, and the site visit revealed significant surface deterioration.

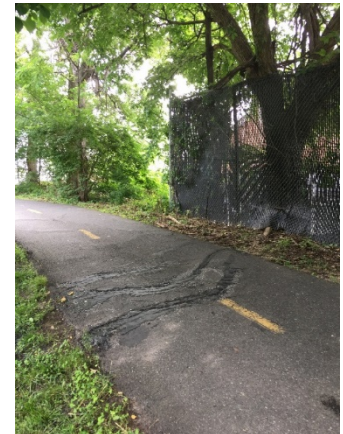
Figure 16: Example of pavement ruts

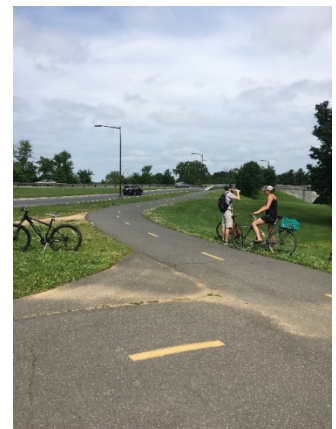
Figure 17: Example of trail cracking and weed encroachment

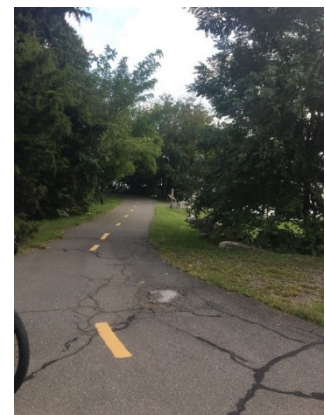
Figure 18: Example of trail cracking and uneven surface

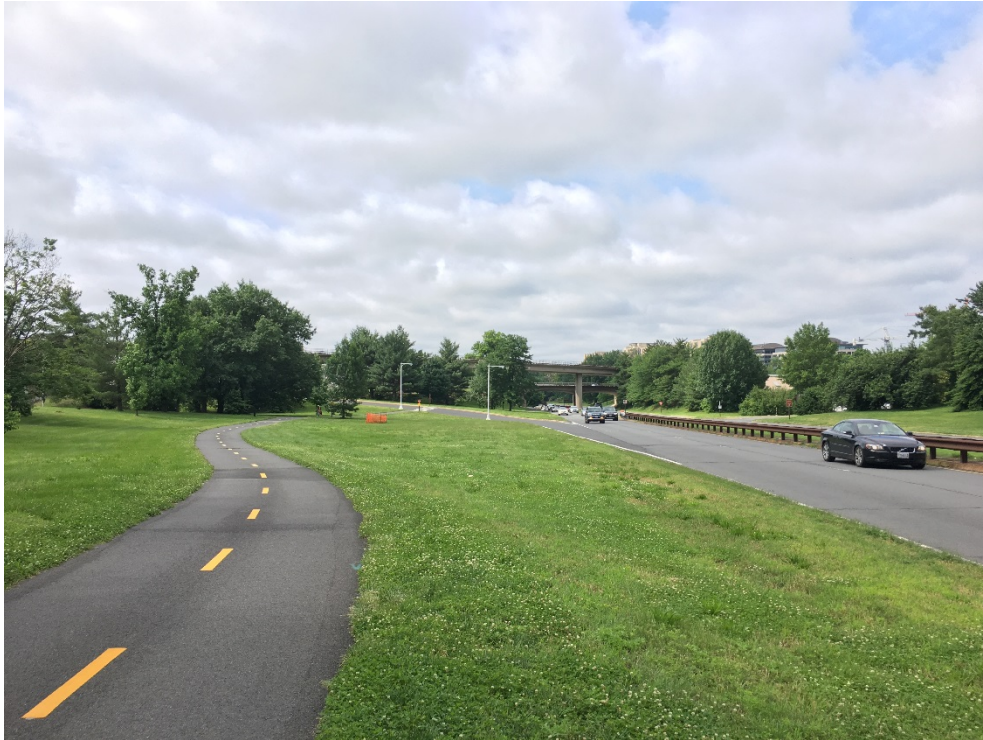
condition issues. Figure 19 shows an example of a stretch of pavement in good condition in Zone 3.

Figure 19: Example of pavement in good condition in Zone 3

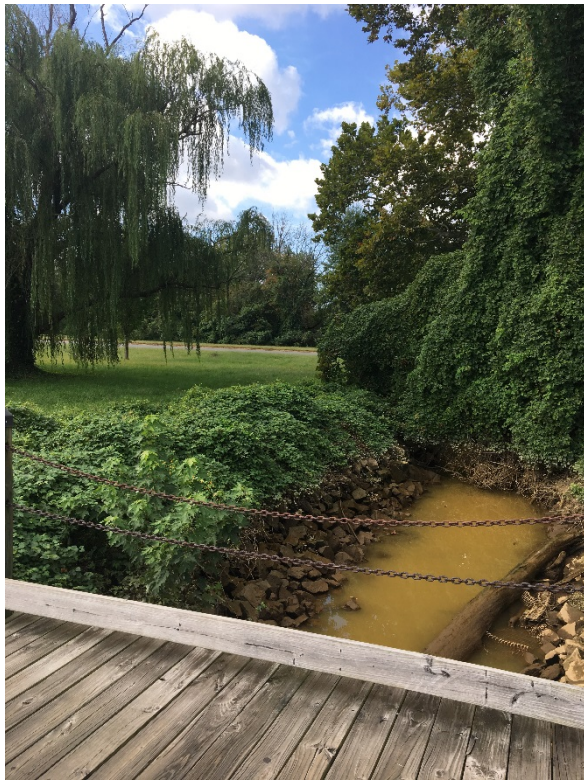
Figure 22: An example of a bridge with chain railings

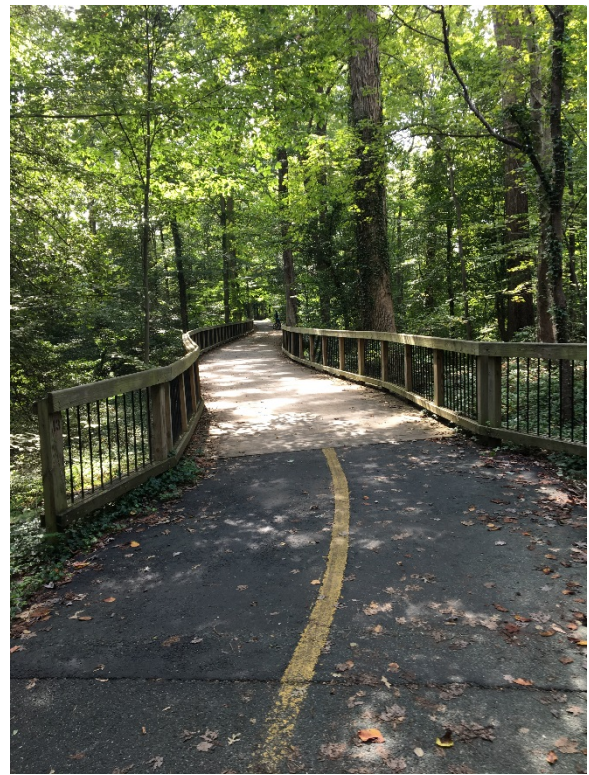
Figure 23: An example of a bridge with metal banister railings

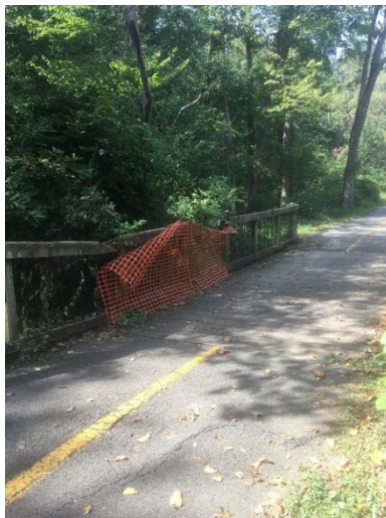
Figure 26: Bridge 2, which needs replacement railings

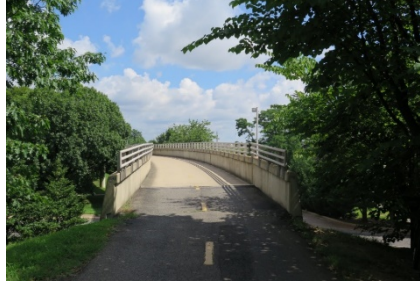
Figure 27: Bridge 29, an example of a bridge in the northern section of the trail made of concrete

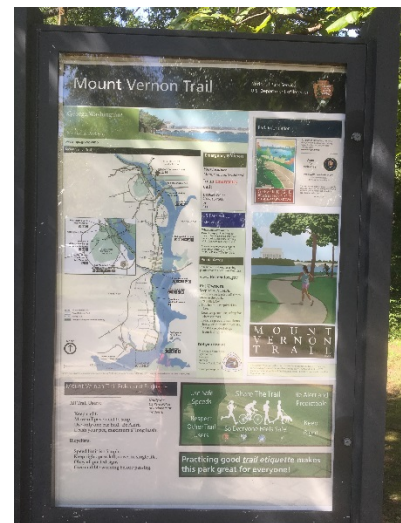
Figure 29: A trail information display and orientation map

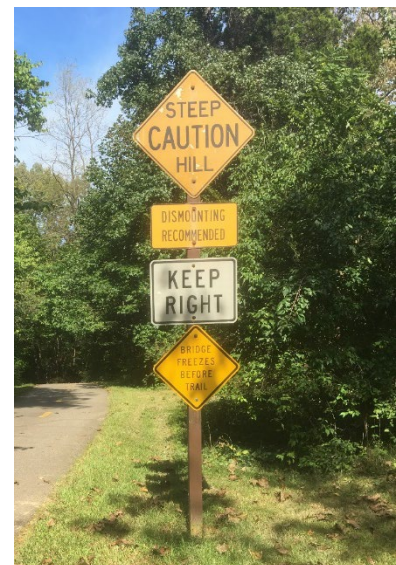
Figure 30: Warning signs on the Mount Vernon Trail

Regulatory/Warning: Regulatory and warning signs alert trail users to trail crossings and where the topography, grade, or other conditions of the trail require caution or a change of traveling speed. These types of signs are also used to give directions to users on when to limit passing or to use caution on blind curves. While signs convey important messages to trail users, too many signs can create sign clutter, disrupting the trail's natural landscape. Too many signs are also confusing to users (see Figure 30) and the message of a sign is diluted.

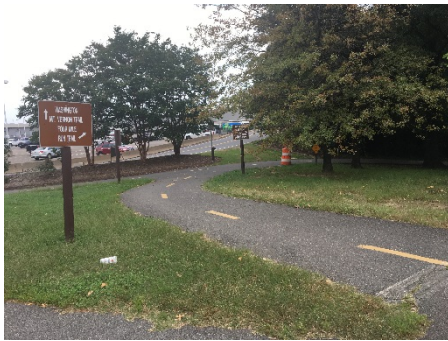
Figure 32: Wayfinding sign at Four Mile Run trail connector

Wayfinding/Directional: The MVT contains a variety of wayfinding signs added to the trail incrementally over a number of years. While familiar users are able to navigate intersections and connecting trails, new users may have a more difficult time, especially with the transition to the on-road portion of the trail in Alexandria. Figure 31 and Figure 32 below show two examples of wayfinding signs along the trail.

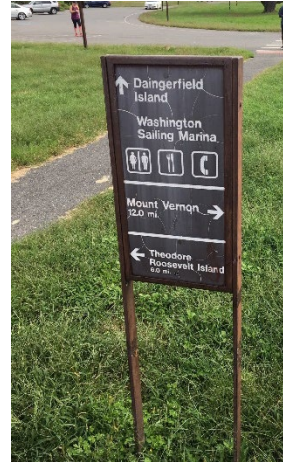
Figure 31: Wayfinding sign near Daingerfield Island

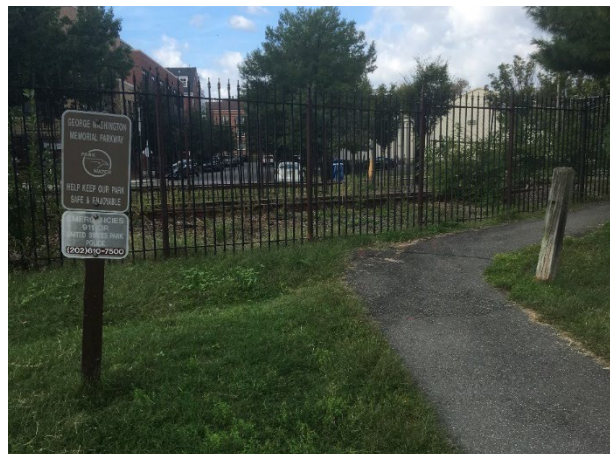
Emergency: The study team noted sporadic emergency signs along the MVT while on site visits. Most of these signs appeared severely weathered and it is unclear whether the emergency information they provide is up-to-date. An example of an emergency sign is below in Figure 33.

Figure 33: An example of an emergency information sign on the Mount Vernon Trail

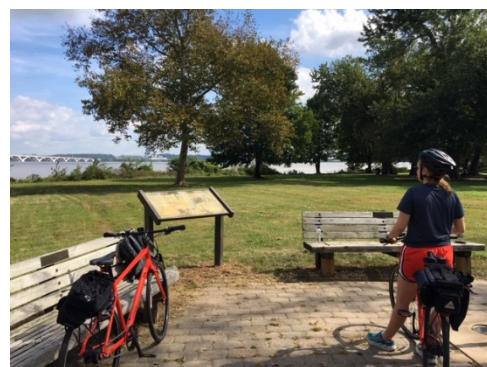
Figure 34: Interpretative wayside at Belle Haven Park

Wayside/Interpretive: The interpretative waysides provide important information and context to points of interest along the MVT. While some of the waysides appear weathered, the interpretation of cultural resources is not the focus of this study. Figure 34 shows a wayside at Belle Haven Park that overlooks the Potomac River.

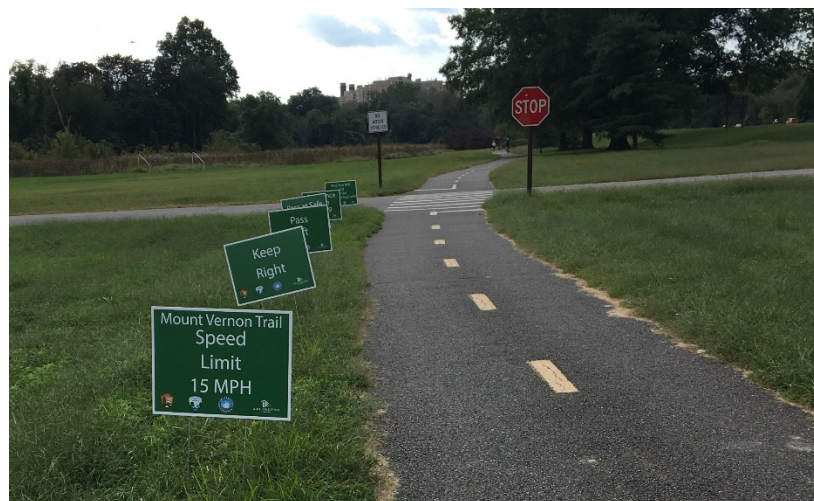
Figure 39: Mount Vernon Trail safety campaign signs

Behavioral factors. The MVT sees a mix of users on the trail (bicyclists, pedestrians, scooters, etc.) who range in experience and familiarity with the trail. Bicyclists who are familiar with the trail may use hand signals when turning at intersections and act courteous to others, or, on the other end of the spectrum, act aggressively by speeding and overtaking trail users. Large groups, families, and users who are less familiar with the trail may stop abruptly, obstructing the trail for bicyclist trying to pass. Additionally, distraction, exhaustion, and dehydration may be factors in trail safety. Education, enforcement, and emergency response are all critical to addressing these behavior factors. For example, the visitor services and trail volunteers implemented a safety culture campaign to raise awareness of these issues. The study team noted the temporary signs installed as part of the safety campaign (see Figure 39).

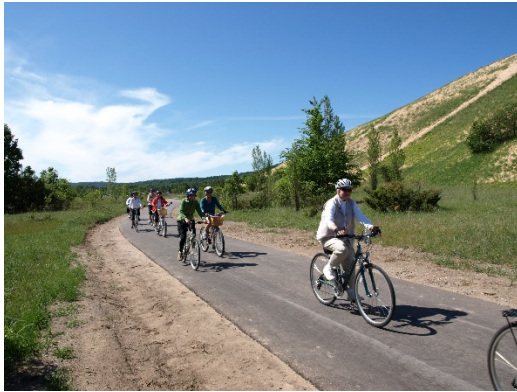
Figure 41 and Figure 42 below show examples of multi-use trails in different contexts. The multi-use trail at Sleeping Bear Dunes National Park is 10 feet wide with 2-foot shoulders. The Sleeping Bear Dunes multi-use trail is used for recreation and does not require separation of modes based on user types.

Figure 42: A multi-use trail used for recreation at Sleeping Bear Dunes National Park in Michigan (Source: NPS)

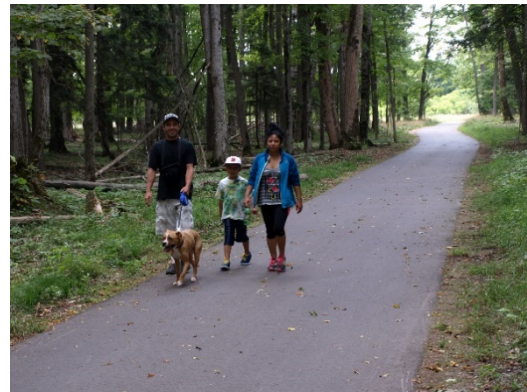
Figure 41: A family walks on a multi-use trail at Sleeping Bear Dunes National Park (Source: NPS)

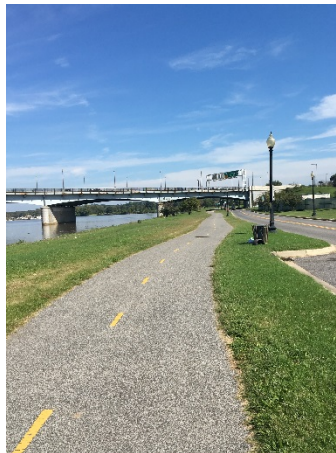
Figure 43 shows a section of the Anacostia Riverwalk Trail. First developed in 2004, the trail is 12 feet wide in this section and the trail has a yellow centerline striping with an adequate buffer from the road.

Figure 43: A section of the Anacostia Riverwalk Trail

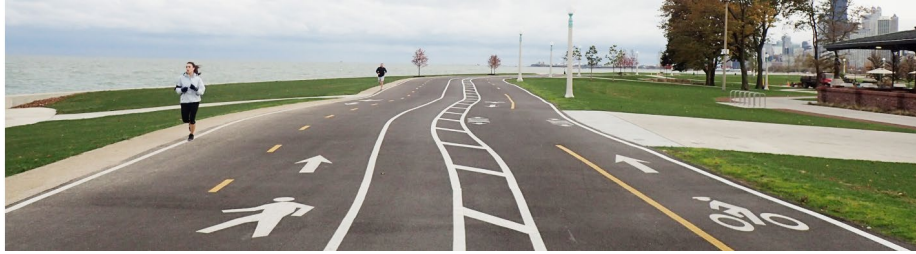
Figure 44: A section of the Lakefront Trail in Chicago. The entire length of the trail now has separate sections for pedestrians and bicyclists (Source: Chicago Park District)

The Lakefront Trail in Chicago serves as an example of an extremely high-use trail. This trail is both a transportation and recreation corridor, and pedestrian and bicycling modes are separated along the entire length of the 18-mile trail (see Figure 44).

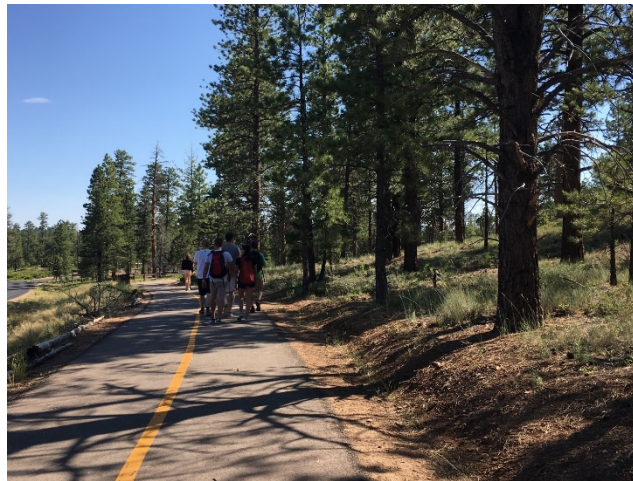
Figure 45: A section of trail in Bryce Canyon with adequate recovery zones, vertical clearance, and separation from the road

In addition to multi-use trail width, it is also important to consider the recovery area (the space adjacent to the trail on either side), separation between the multi-use trail and nearby roadways, and vertical clearance. All of these elements impact user safety and comfort. Figure 45 shows a multi-use trail at Bryce Canyon National Park with the AASHTO-recommended recovery shoulder, vertical clearance, and separation from the road.

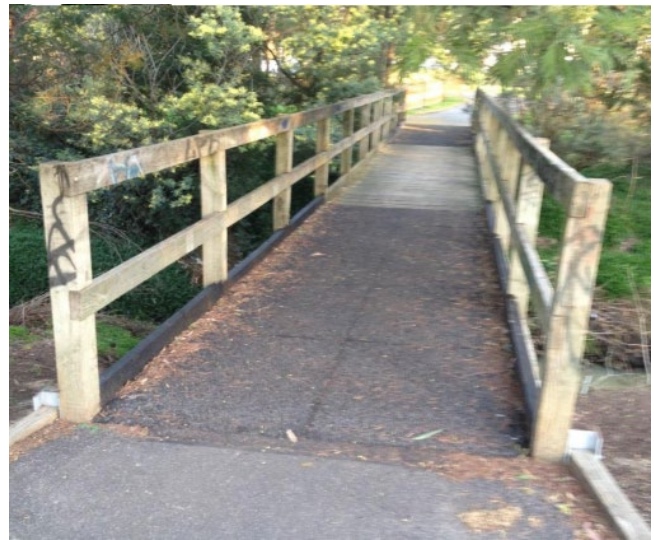
Figure 46: A timber bridge with asphalt patch (Source: Downer EDI)

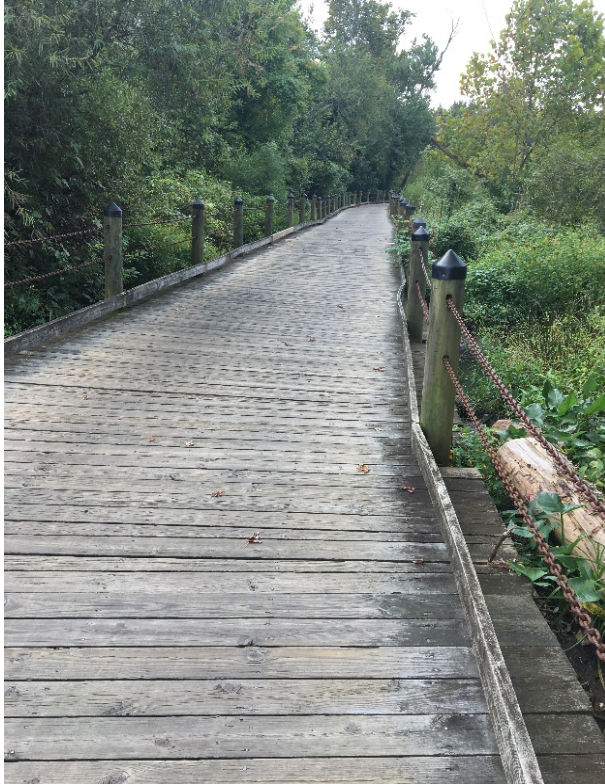
Figure 49: An example of a bridge with chain railings.

Nine MVT bridges still have chain railings, which are not suitable for bicyclist and pedestrian safety (see Figure 48). Four of these bridges are already scheduled for replacement with two more recommended for replacement. The majority of the railings on the MVT meet the AASHTO Guide for Bicycle Facilities design standards. These adequate MVT railings were installed with bridge replacements since 2004 (see Figure 49). Depending on the expected replacement date for the remaining five bridges, it may be worth replacing or retrofitting the remaining bridges with AASHTO-compliant railings.

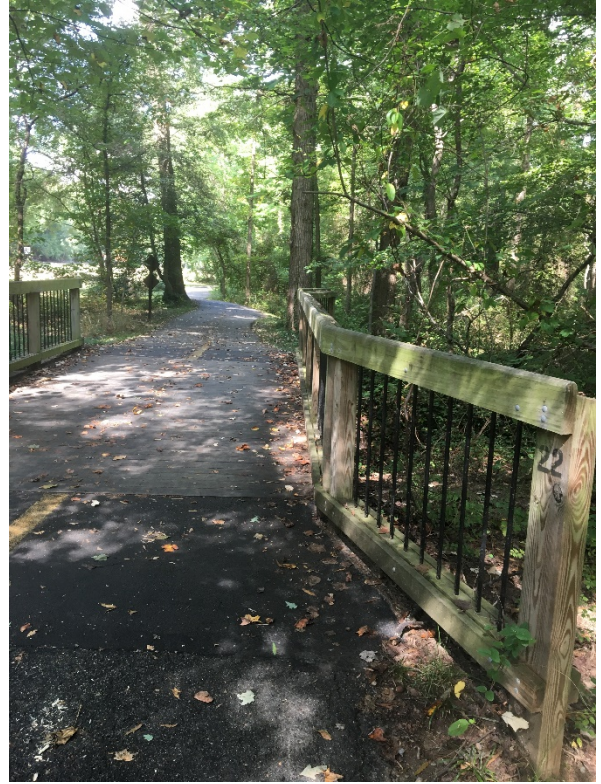
Figure 48: An example of a bridge with updated metal banister railings

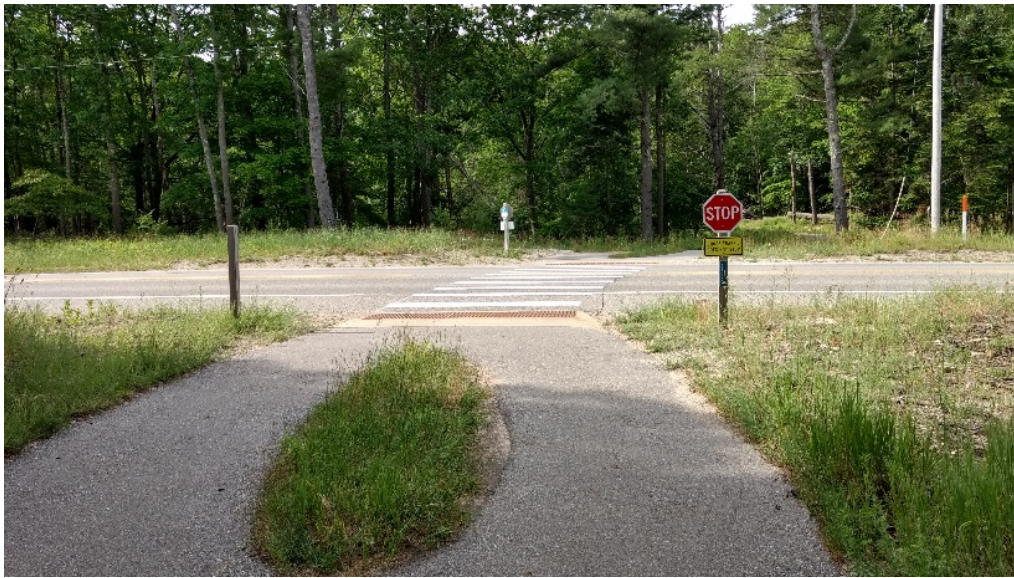
Figure 51: Example of a trail is separated into two lanes with landscaping to reduce conflict between users entering and existing crossing (Source: NPS)

Similar to bridge approaches, the use of bollards to restrict motor vehicle traffic at at-grade crossings is not recommended. Bollards create barriers for trail users and should only be used if there is a documented history of attempts by motor vehicles to use the trail or other security considerations. Figure 51 shows an example of an option for a trail crossing treatment using landscaping to reduce trail user speed approaching an at-grade crossing. The detectable warning (pictured on the pavement in red) is required for disabled trail users and helps further distinguish that the trail is crossing a roadway.

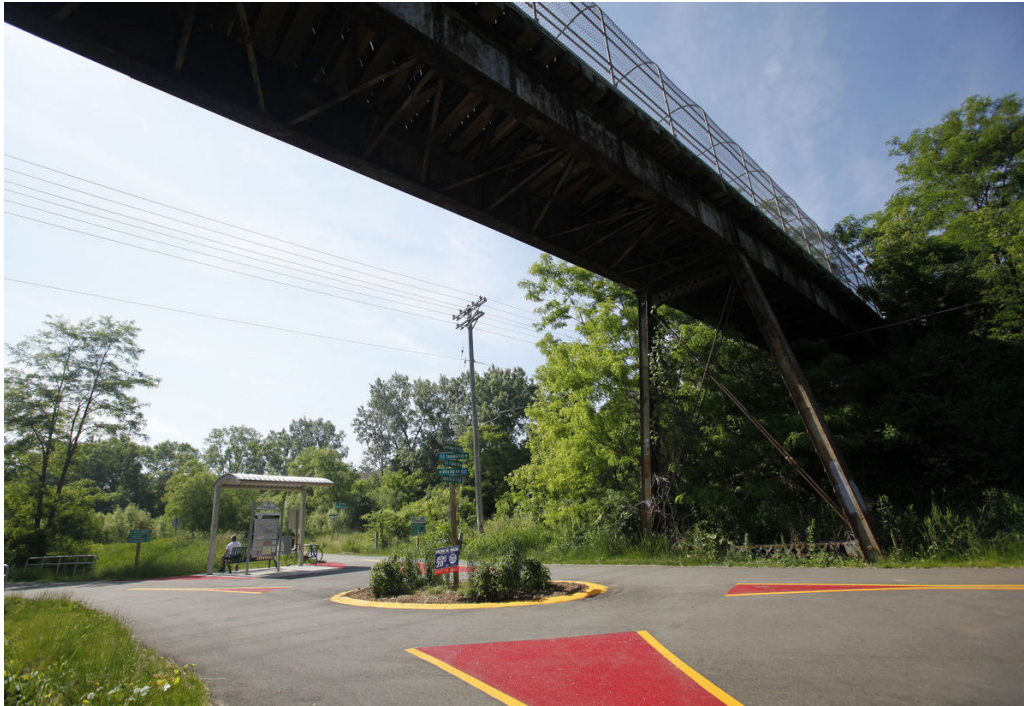
Figure 54: A small planted center island serves as a roundabout at the intersection of the Capital City Trail, Southwest Bike Path, and Cannonball Path in Fitchburg, Wisconsin (Source: Jonah Finkelstein, Mike on Traffic)

A less common, but emerging method of designing safe trail-trail intersections is trail roundabouts. In general, roundabouts are best suited for areas where there is potential for high pedestrian-bicyclist conflict or areas where crashes are more likely to occur. Roundabouts require bicyclists to slow their speeds on the approach. Trail roundabouts can be designed in different ways; adding a small planted center island within the existing trail footprint (see Figure 54) can be a simple and effective way at slowing bicyclist traffic and improving safety at intersections, though more extensive design solutions can also be used (see Figure 55).

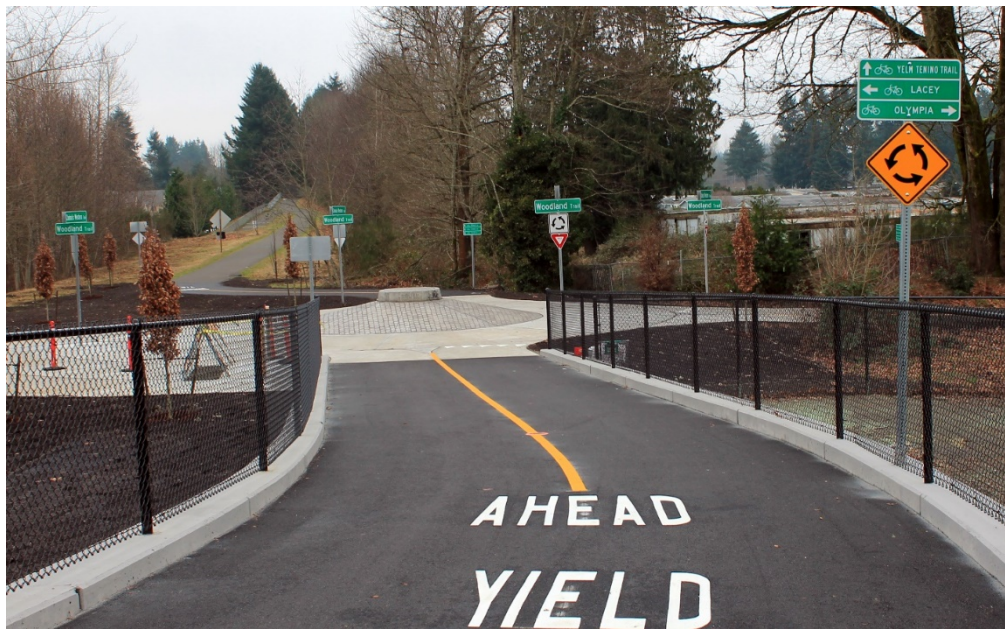
Figure 55: A raised center roundabout at the intersection of the Woodland Trail and Chehalis-Western Trail in Olympia, Washington (Source: Jonah Finkelstein, Mike on Traffic)

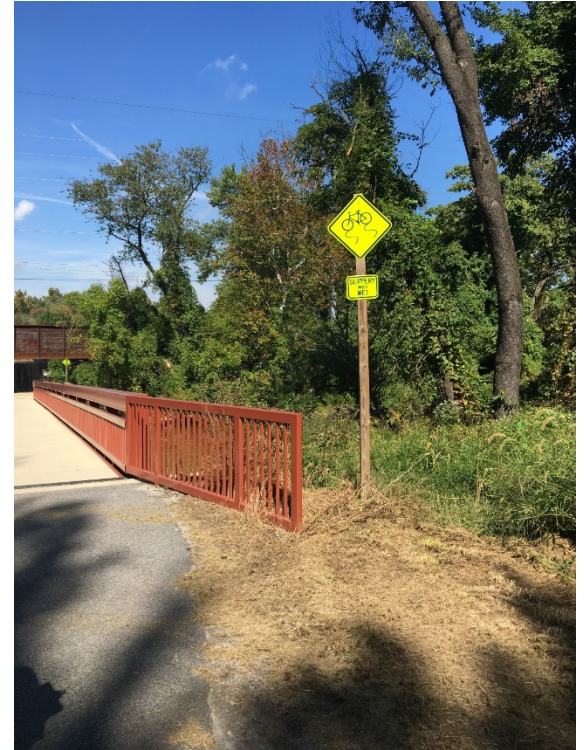
Figure 56: A warning sign indicating the bridge may be slippery on the Anacostia Riverwalk Trail (Source: Volpe Center)

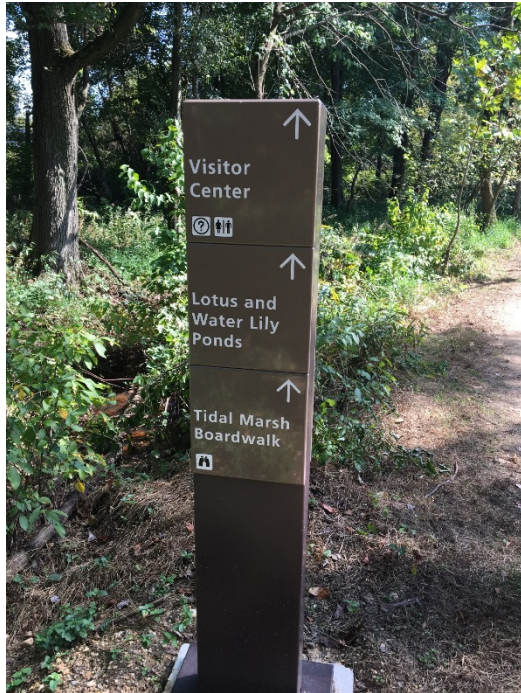
Figure 58: Example of a different style of wayfinding signs at Kenilworth Park & Aquatic Garden (Source: Volpe Center)

- **Wayfinding and guide signs.** The goal of wayfinding and guide signs are for users to quickly orient themselves to where they are on the trail and in relation to the greater surrounding area. The MVT has mile marker signs, which are examples of wayfinding signs. Where the trail crosses a road or makes a connection to another trail, a sign should provide information such as the road name or connecting trail, and notify users of connections to key destinations. Wayfinding and directional signage is generally green with a white text on roadways; however, wayfinding sign design can vary on NPS facilities (see and Figure 58 and Figure 57). Wayfinding signs should be consistent in design along the length of a trail.

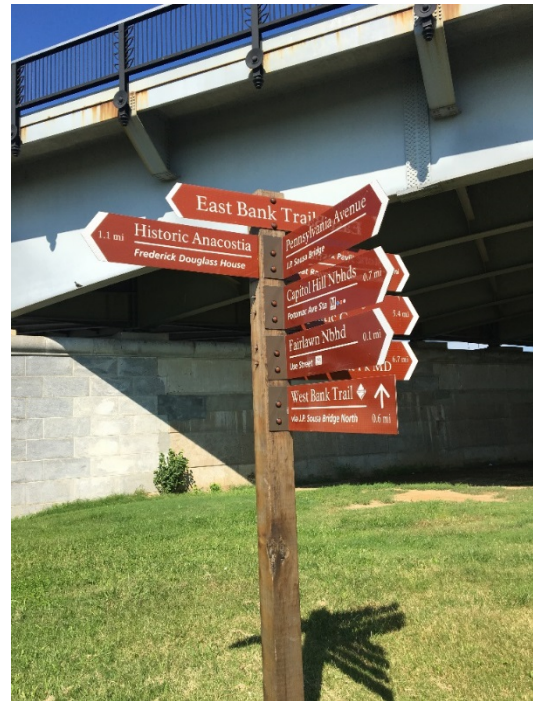
Figure 57. Wayfinding signs at the Anacostia Riverwalk (Source: Volpe Center)

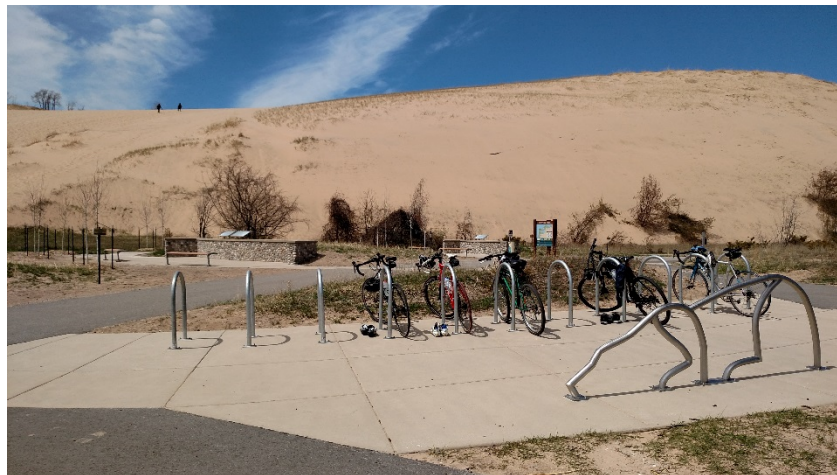
Figure 59: Recommended bike racks located at Sleeping Bear Dunes National Lakeshore (Source: NPS)

For short-term bike parking, the inverted-U and post-and-ring bicycle racks are the recommended design (see Figure 59). These racks support two bikes parked at the same time (one on each side) and can be grouped to provide additional spaces as needed.

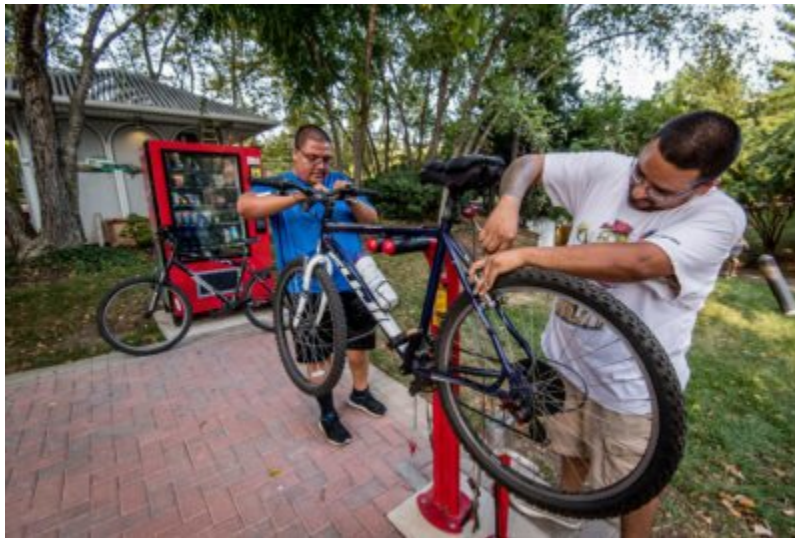
Figure 60: Public bicycle repair station in use (Source: Bike Arlington)

Public bike repair stands are standalone stations, free for anyone to use, that provide a bike pump and other tools for general bicycle repairs. They are located throughout many cities in the United States to provide safety support for bicyclists. Arlington and Washington, D.C., have several bicycle “Fixit Stands” located near bicycle parking areas at major transit stations or highly trafficked bicycle routes (see Figure 60). Bike repair stands are another amenity that can be considered for trailheads or connections along a trail. These stands provide bicyclists with the ability to address bike maintenance issues that may otherwise prevent them from continuing to their destination.
