# **Improve Visitor Safety and Mitigate Rockfall Hazards in the Paw Paw Tunnel Hollow Chesapeake & Ohio Canal National Historical Park**

## **Environmental Assessment**

June 2020

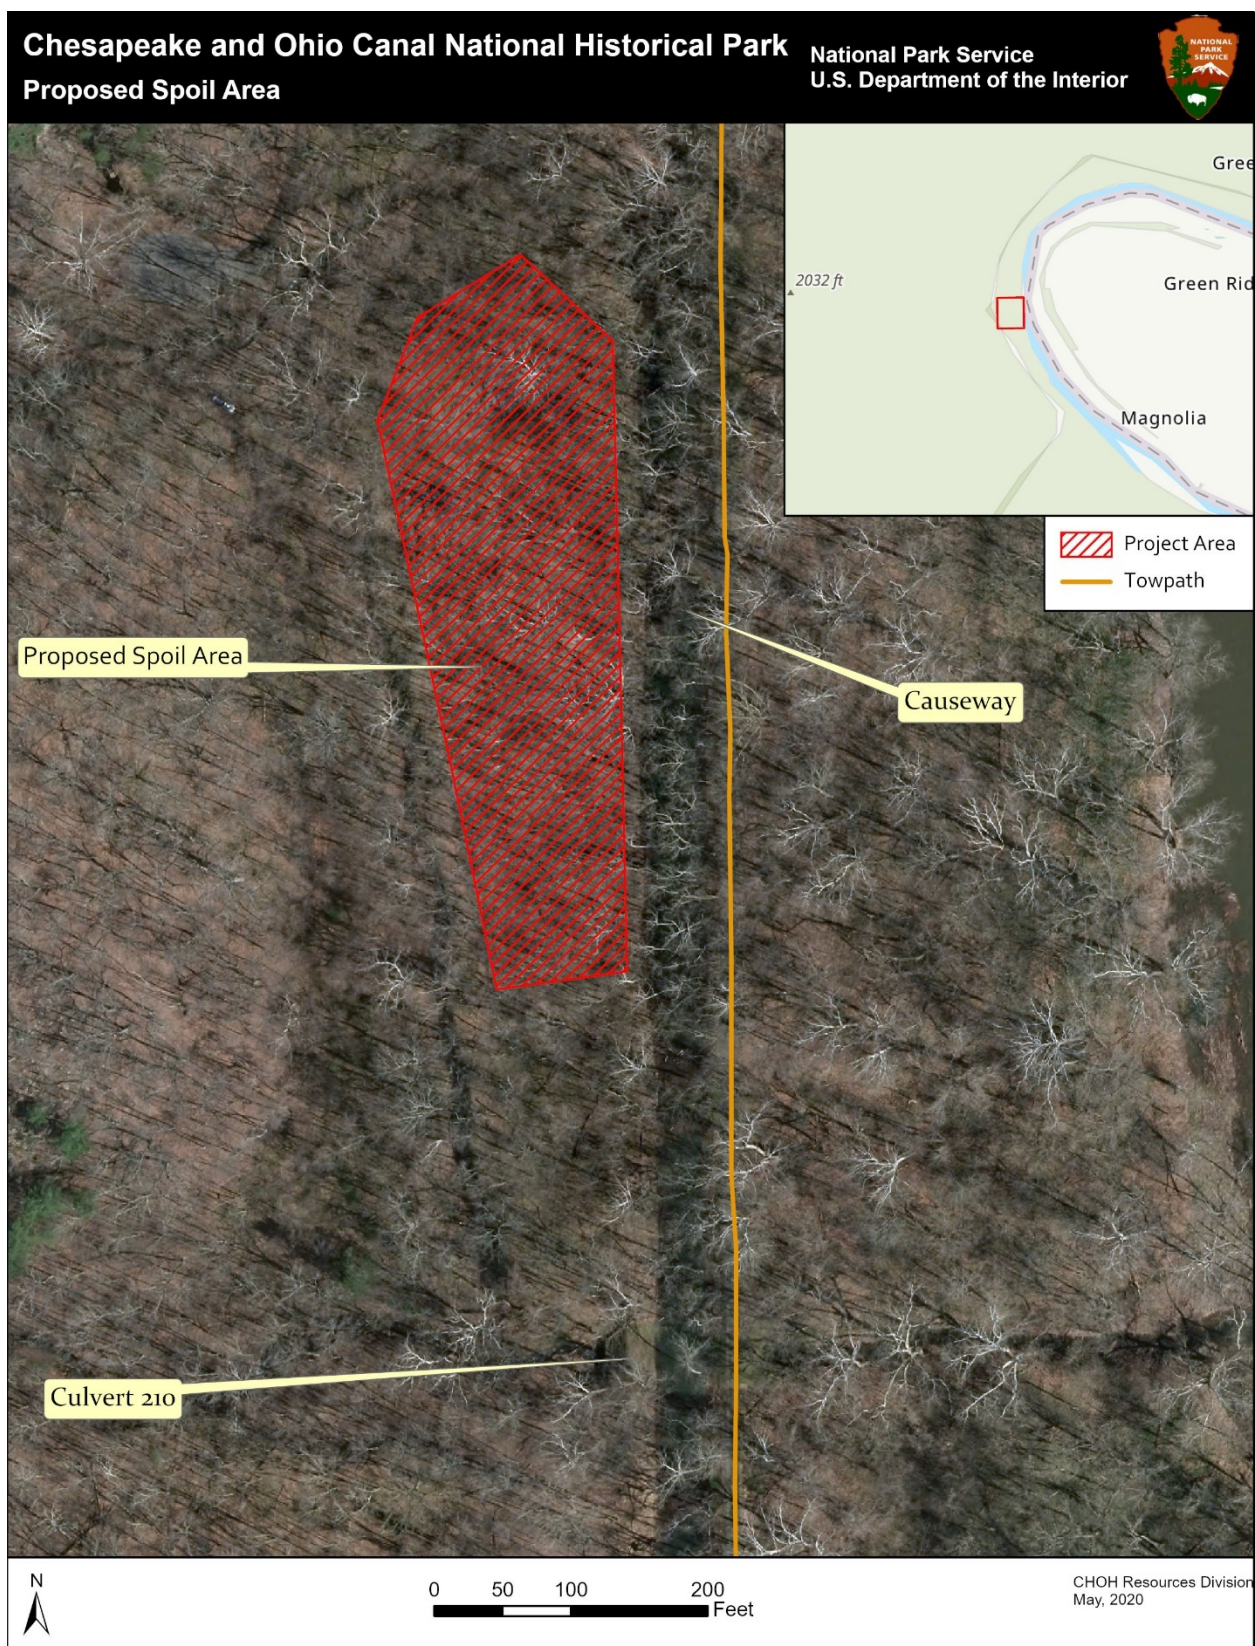
Figure 4: Proposed spoil area.

The proposed parking lot expansion covers a small area and would not require a large amount of material. The proposed spoil location in the Paw Paw Campground is along the raised entrance road and should not affect river flow during times of flood. The volume of spoil would also be small relative to the size of the floodplain. The proposed spoil location near Culvert 210 is adjacent to the existing spoil pile. The new material would be deposited in a narrow and tall spoil pile in the shadow of the existing spoil to avoid any impacts to the river flow during times of flood, the volume of spoil is also very small relative to the size of the floodplain. If it is determined that the rockfall material should not be spoiled at the proposed locations, the material will be spoiled on non-NPS land in accordance with local, State, and Federal regulation. Because this project will not significantly affect the floodplain, this topic area is excluded from further analysis.

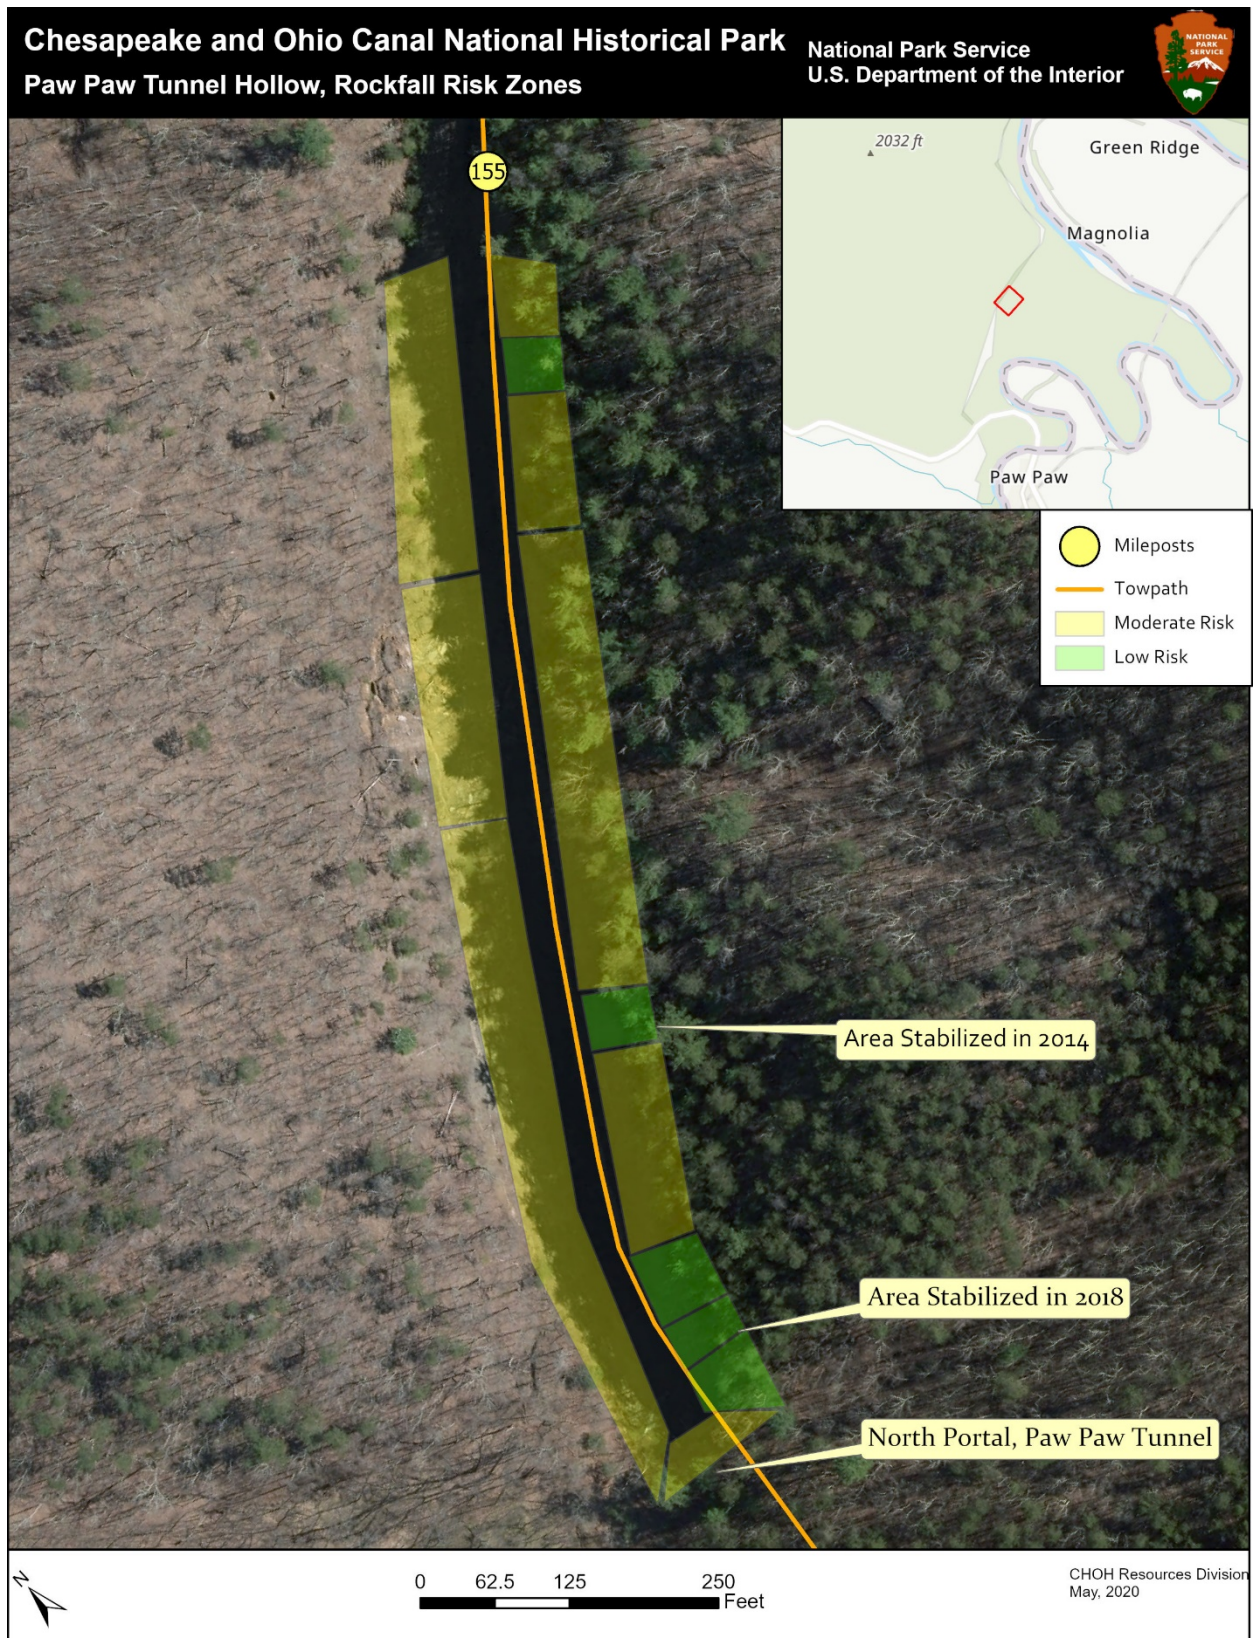
Figure 6: Rockfall Hazard Analysis of the Paw Paw Tunnel Hollow produced by Terracon Inc.

Rockfall hazards would be addressed in priority order according to the 2019 geotechnical report. Draped mesh installed during the 2017-2019 emergency stabilization project would be removed. The slope under the removed mesh would be scaled and pinned mesh would only be added to the upper portions of the cliff where the rock planes lie perpendicular to the rock face. Rock bolts would be ineffective in these areas which experience differential weathering among the many different exposed rock planes.

A 2019 inspection of the Paw Paw Tunnel Hollow (Tunnel Hollow) by Terracon Consultants, Inc. revealed rockfall hazards throughout the deep cut on both the east and west sides of the canal prism. The inspectors divided the Hollow into zones and assigned each zone a risk score which was based on a number of factors including slope height, available catchment area, structural condition, volume of material, history of rockfall, and water activity. This analysis revealed moderate visitor safety risks in all of the zones except for the areas that had been stabilized during previous projects (Figure 6).

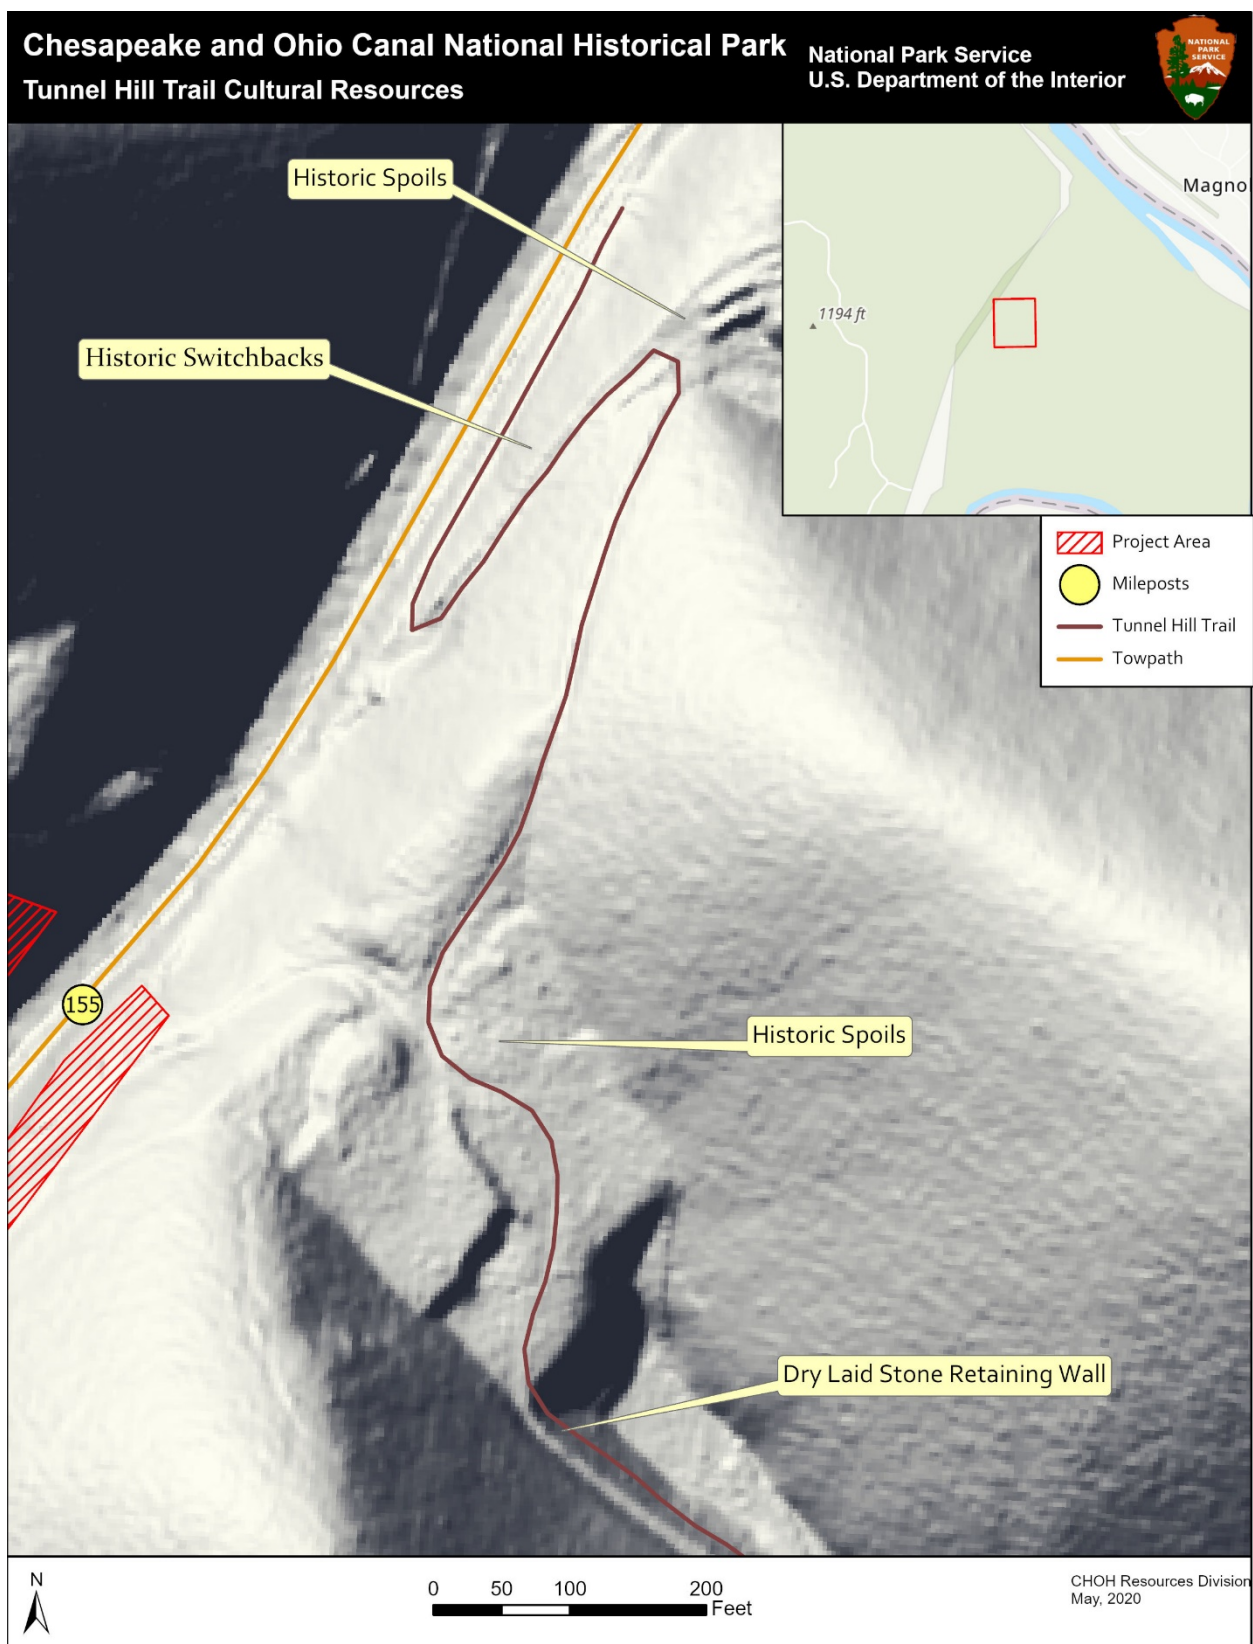
Figure 8: Tunnel Hill Trail cultural resources.

The portions of Tunnel Hill Road and Tunnel Hill Trail within the project area both follow historic road traces and have been regraded and graveled several times. A 2020 pedestrian survey of the Tunnel Hill Trail located several historic features, including a dry laid stone retaining wall, historic spoil piles, and a historic switchback. The dry laid stone wall is located 2,700 feet downhill from the intersection of Tunnel Hill Road and Tunnel Hill Trail. It is 4.5 feet from the edge of the road and 18 feet long. Running parallel to the road, it acts as a retaining wall. From a point 2,730 feet downhill from the intersection to a point 3,300 feet from the intersection, the trail runs atop of historic spoil excavated from the Paw Paw Tunnel (Figure 11). The historic switchbacks are located between a point 3,580 feet downhill from the intersection and continue until Tunnel Hill Trail meets the towpath. The switchbacks are cut into rock and may have historically had dry laid stone retaining walls along the downhill sides. Along these switchbacks, the trail comes to its narrowest width of seven feet.

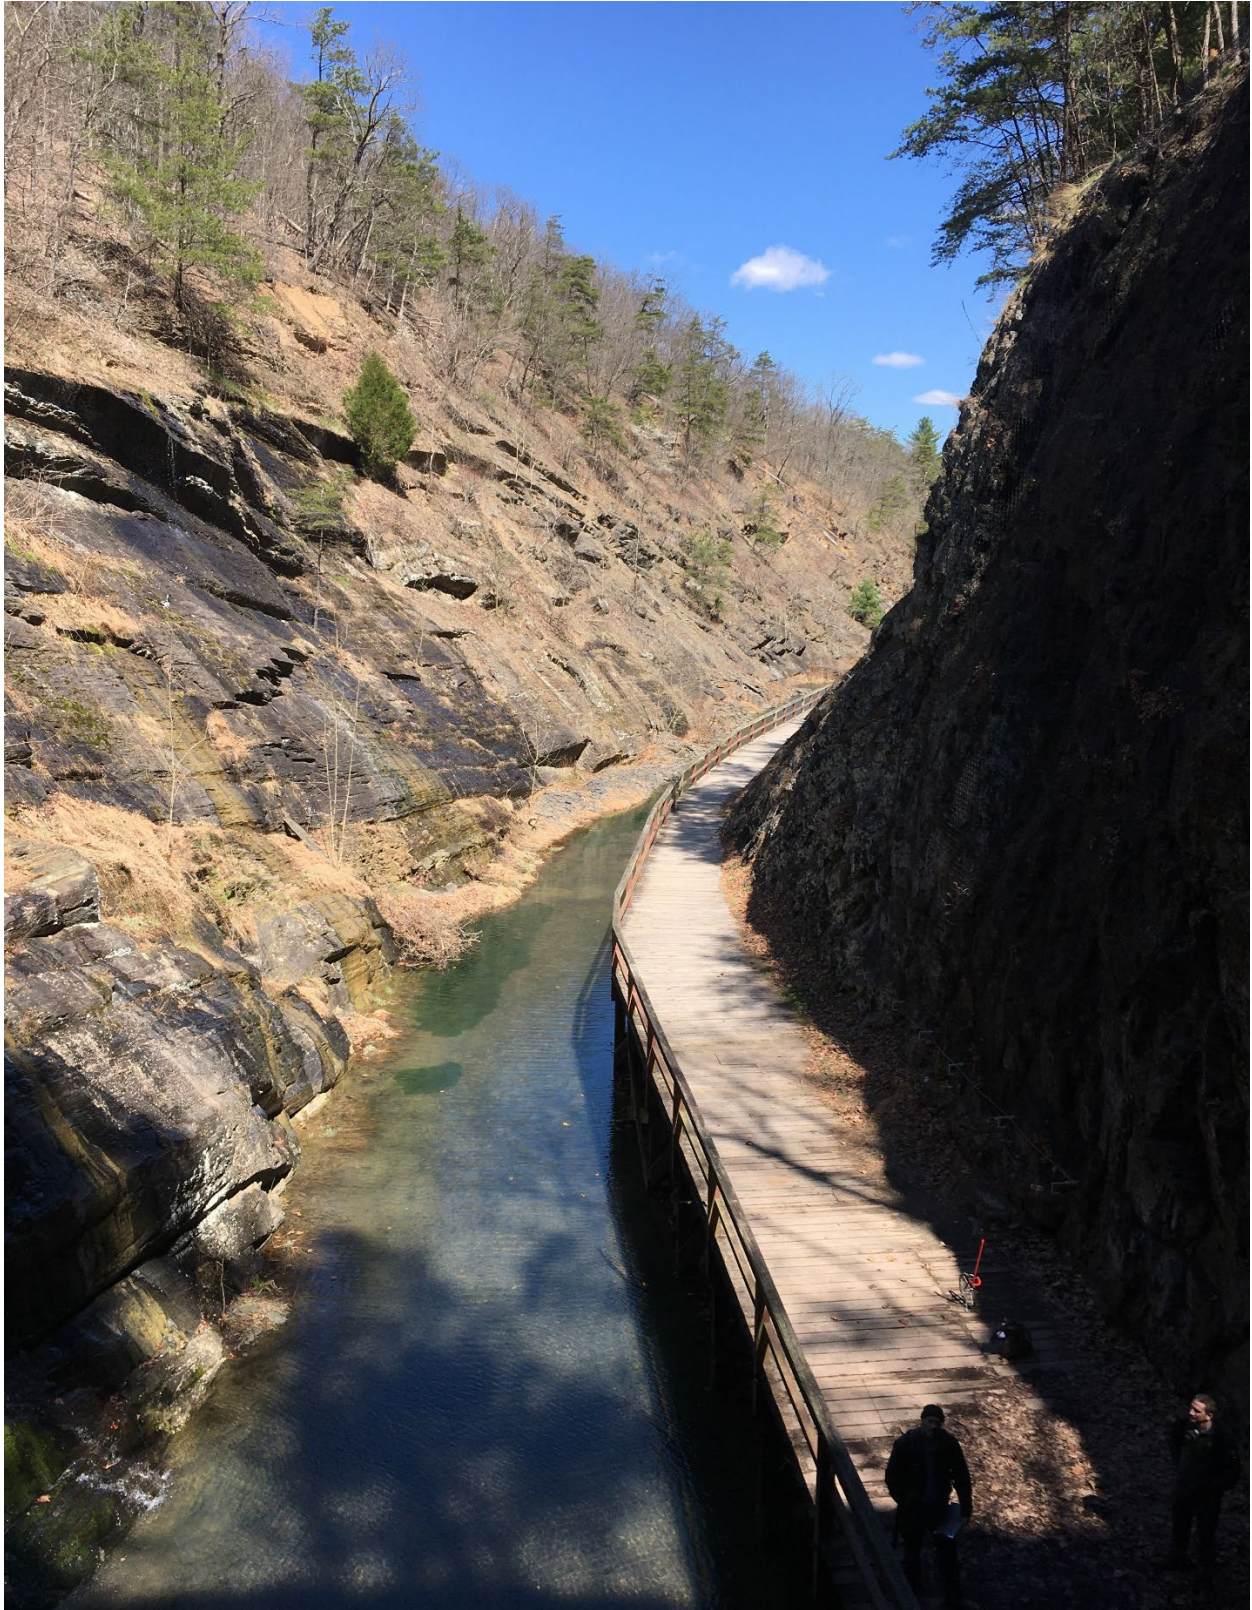
*Figure 9: The Paw Paw Tunnel Hollow, as seen from the North Portal of the Paw Paw Tunnel. West slope of Tunnel Hollow on left, canal in center left, boardwalk towpath in center right, east slope of Tunnel Hollow on right.*

The cultural landscape in the project area has not been evaluated for National Register eligibility. However, the Paw Paw Tunnel and Tunnel Hollow offer a unique viewscape that has been a popular attraction since construction was completed (Figures 9 and 10). The rock scaling and reconstruction of the boardwalk would have only temporary impacts to this viewscape. The rock itself naturally fragments and falls as it weathers and rockfalls have been noted throughout history back to the excavation of the hollow. Rock bolts and pinned mesh would have lasting negative impacts on the cultural landscape. The rock pins and shear keys protrude several inches from the rock face and are very noticeable. The existing rock mesh in the hollow would be removed from the lower 18 feet of the rock face. Any new mesh would only be installed above this line, lessening the impact of the mesh on the cultural landscape.

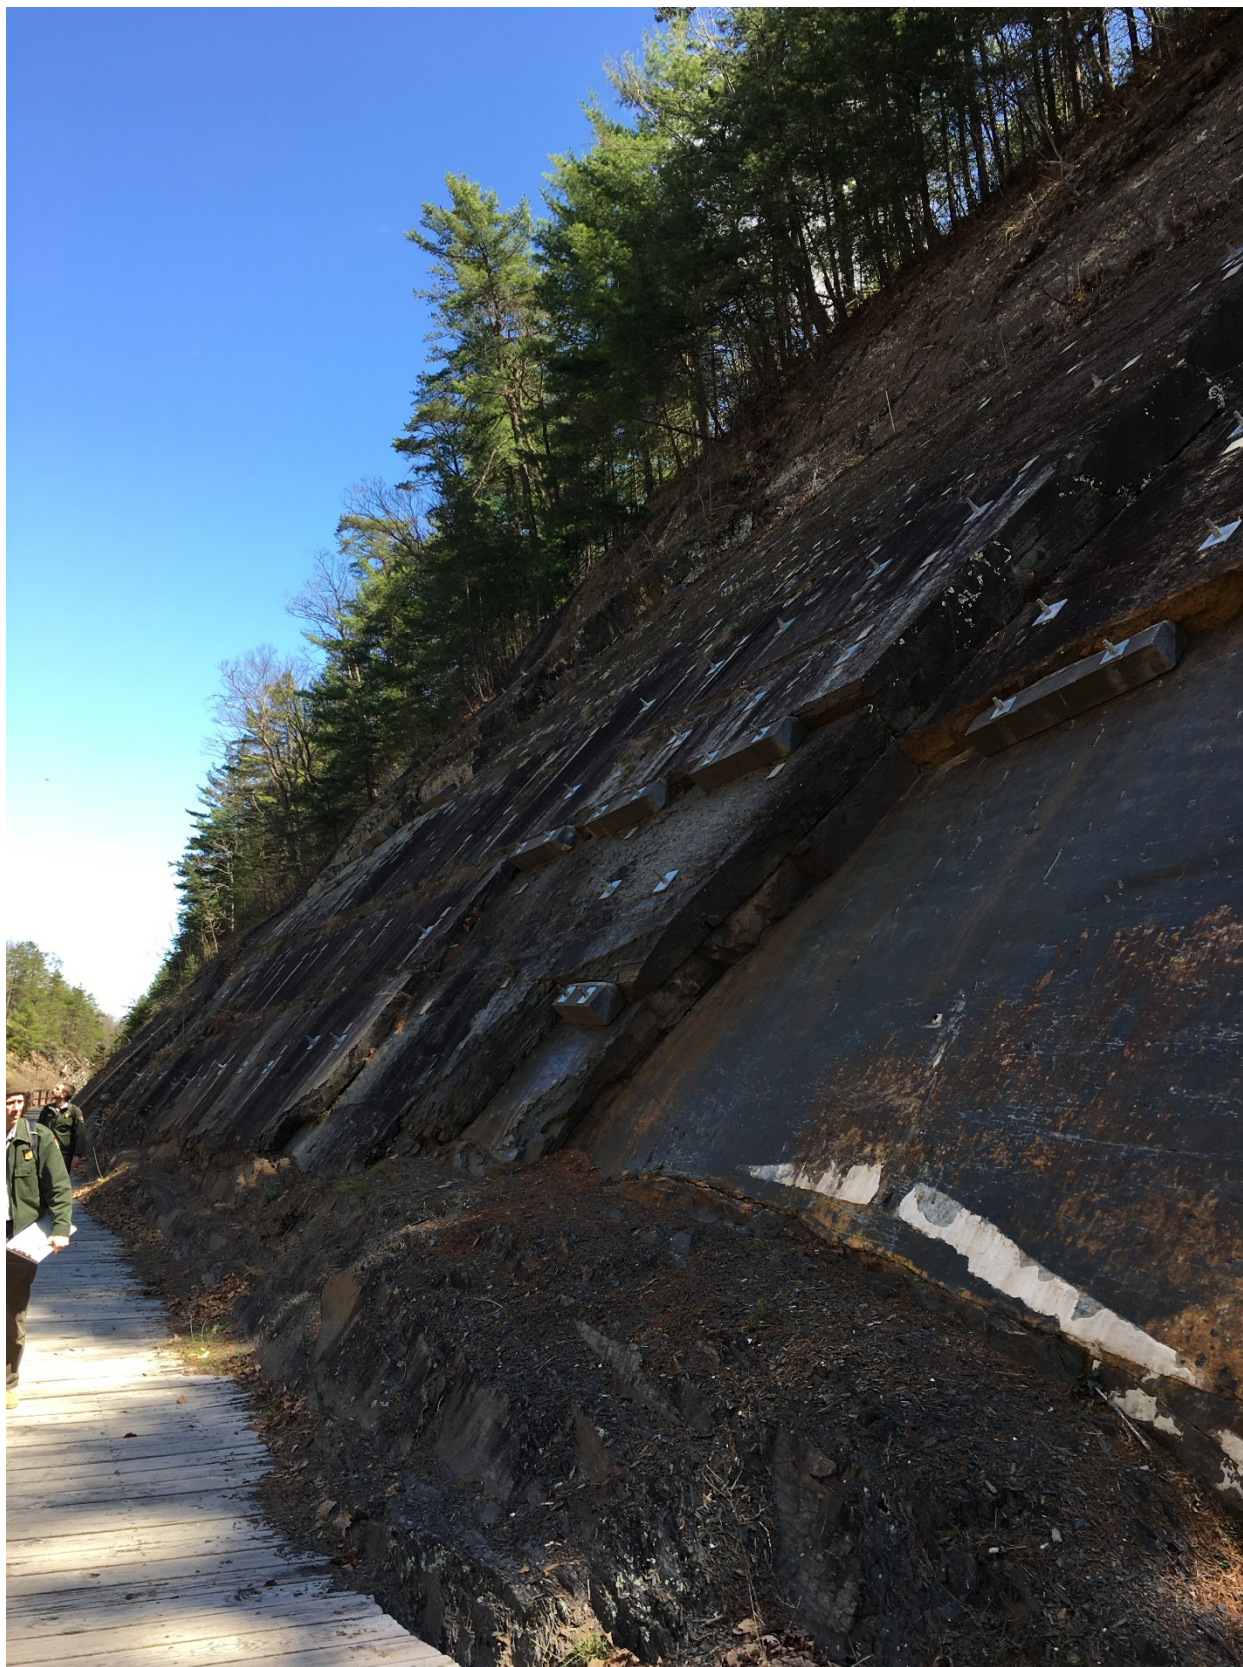
*Figure 11: Rock bolts in the Tunnel Hollow from the 2018 stabilization.*

Rock stabilization would include scaling, rock bolts, shear blocks, pinned mesh, and rock drains as needed. Scaling, rock bolts, and rock drains have been used by NPS in this area since the 1970s. Scaling involves manually or mechanically removing loose or fractured rock from the cliff faces until reaching a stable rock surface. Rock bolting involves drilling holes 10 to 15 feet deep into the rock face and inserting steel rods to restrain unstable rock mass. Shear blocks also involve drilling deep holes in the rock face; however, concrete blocks are attached to the ends of these bolts. Shear blocks are placed under unstable rock ledges to provide support. Pinned mesh is a combination of anchors and steel rockfall mesh; it is used to catch and retain rockfall against the face of the slope the slope instead of letting it fall or bounce away from the slope into areas that are more likely to have visitor traffic. Rock drains are used to relieve groundwater pressure between layers of rock and reduce the weathering of the rock from freeze-thaw cycles by drilling holes into the rockface and installing PVC pipe to drain water from areas with noted water infiltration.

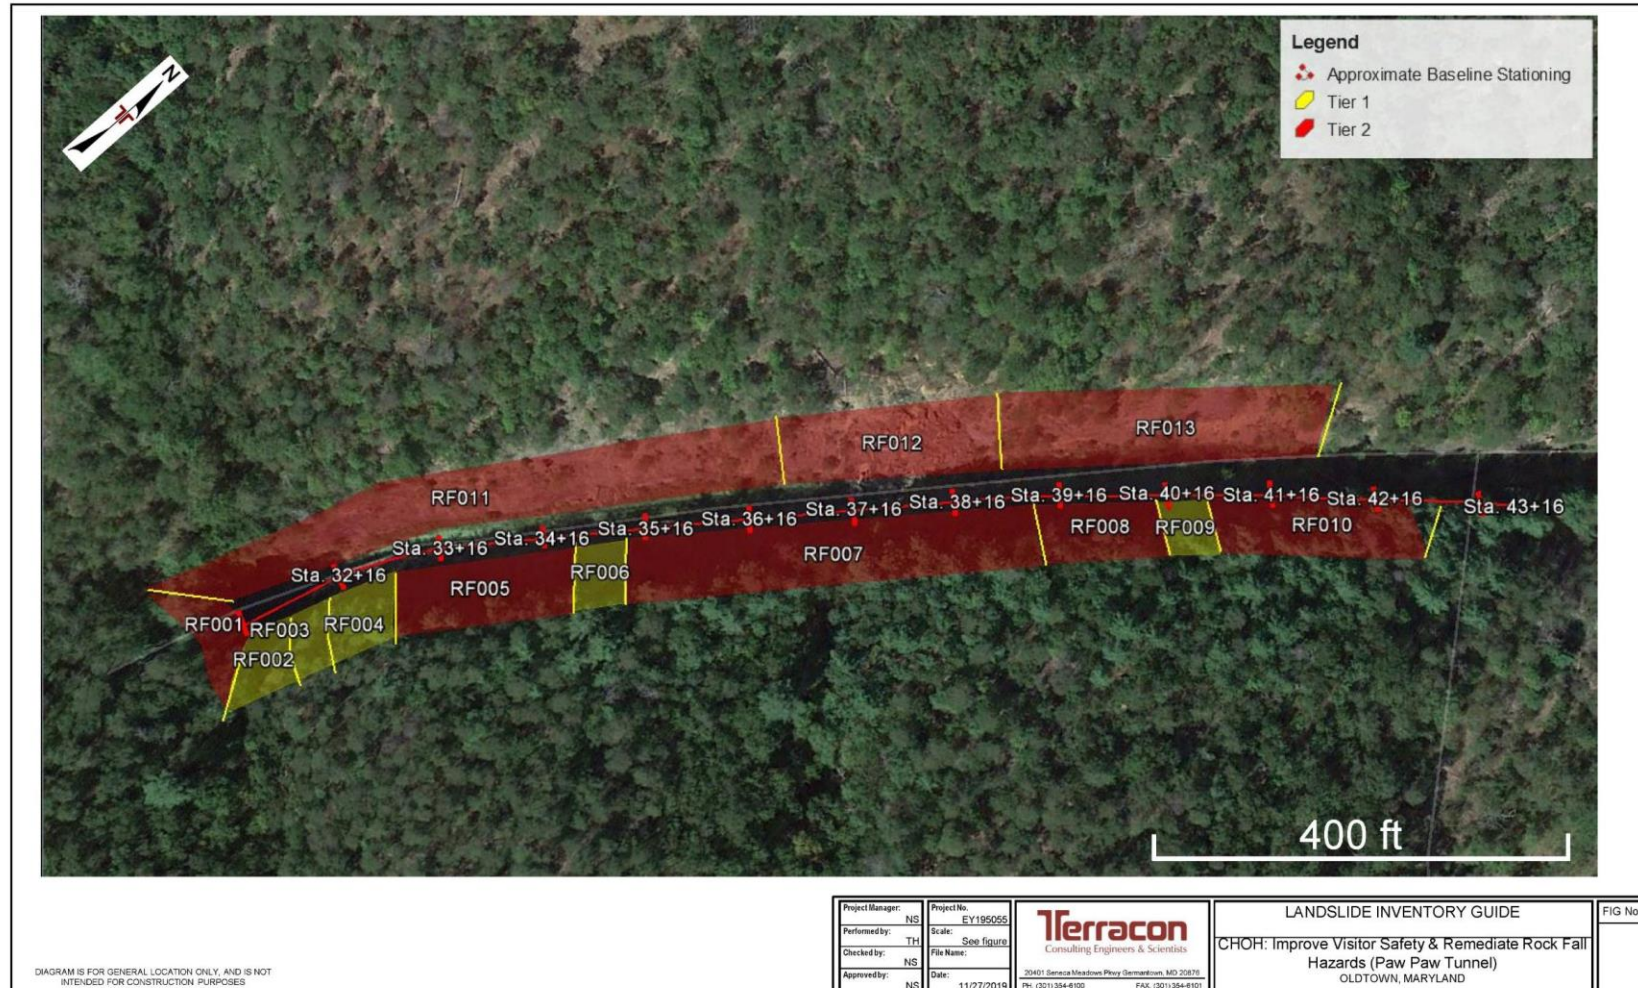
**Figure 2. Project components, including scaling, pinning, or rock netting, will occur within red polygons. Area RF001 lies above the downstream portal of the Paw Paw Tunnel.**

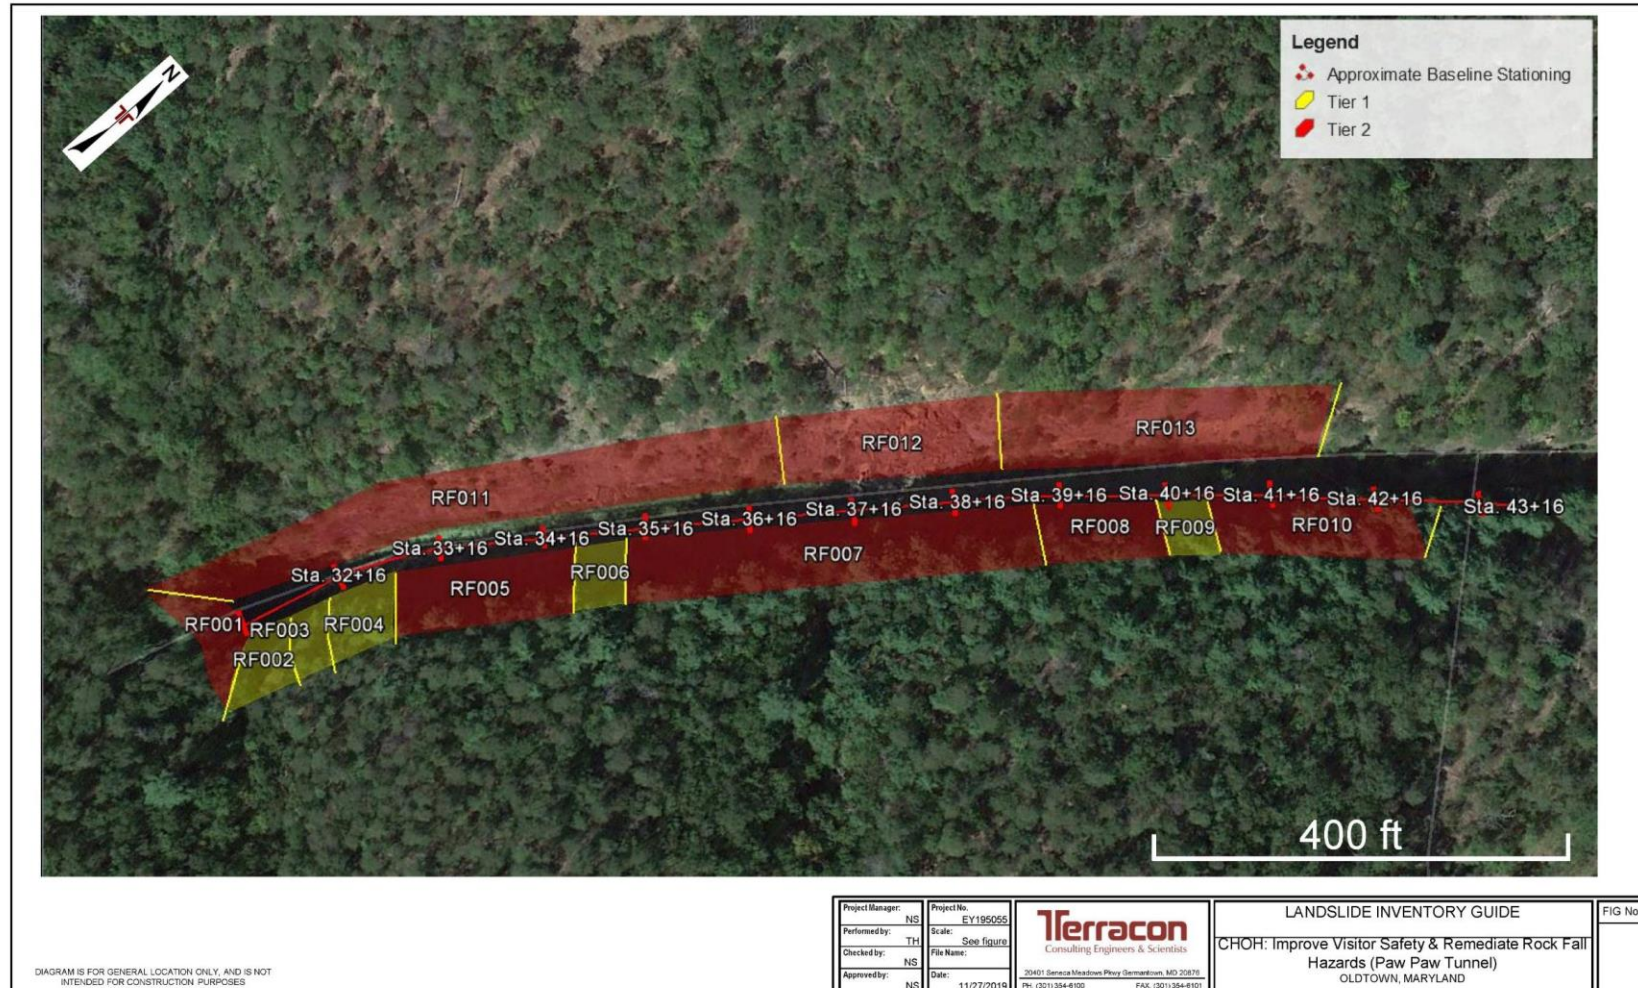
**Figure 2. Project components, including scaling, pinning, or rock netting, will occur within red polygons. Area RF001 lies above the downstream portal of the Paw Paw Tunnel.**

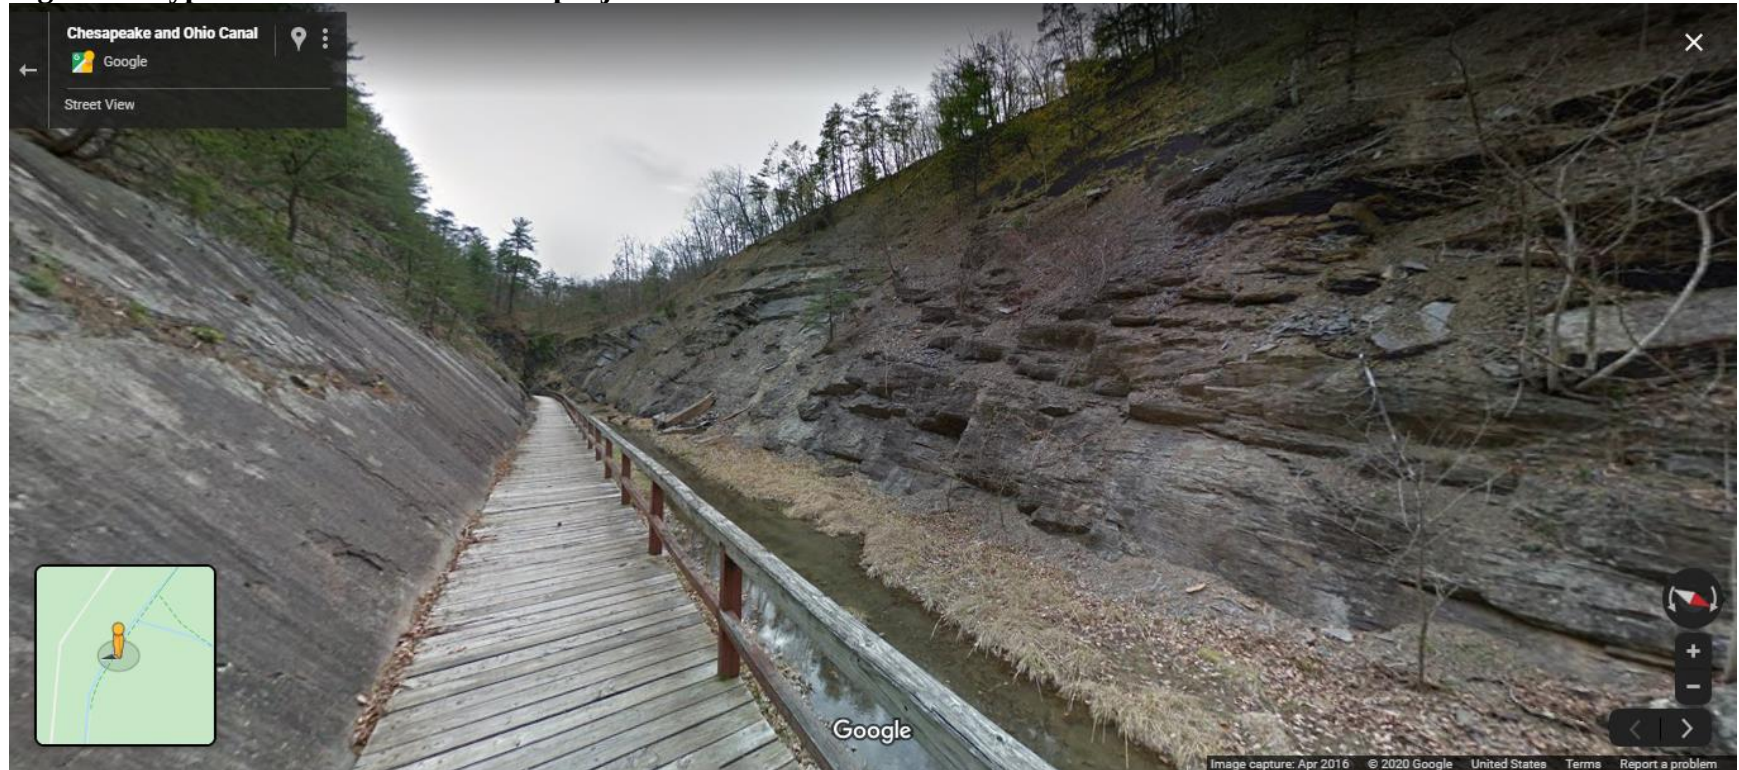
**Figure 3. Typical conditions within the project area.**

The project area is within an Appalachian shale barren community, with steep, shale slopes (Figure 3). NPS conducted surveys of the project site for State-listed rare plants between June and August 2019 and we identified seven rare, threatened, or endangered plant species within the project area (Attachment 1). We again surveyed the project area in Spring of 2020 to capture any spring ephemeral plant species, though no additional species were discovered beyond that which is noted in the report. We identified evening primrose (*Oenothera argillicola*), glade bluecurls (*Trichostema brachiatum*), low bindweed (*Calystegia spithamea*), whorled milkweed (*Asclepias verticillata*), sessile-fruited arrowhead (*Sagittaria rigida*), shale barren ragwort (*Packera antennariifolia*), and heart-leaved skullcap (*Scutellaria ovata*). Most of these species were found in pockets of soil in the shale on the western slope of the Paw Paw Tunnel Hollow while *S. rigida* was found in the shallow water of the canal prism. *P. antennariifolia* and *S. ovata* are found throughout the project area and while individuals will be impacted, it is likely that these species will recolonize the project area after work is complete. *O. argillicola* is similarly spread throughout the project area and will be affected by this project. The more densely populated area closer to the tunnel portal will likely be avoided. NPS previously consulted with the DNR State Botanist regarding impacts to *S. rigida* and *A. verticillata* in the project area (Attachment 2). Impacts will be minor and the species may recolonize the habitat after the project is complete. *C. spithamea* was only observed growing within the rockfall debris that fell in 2016, and only a single specimen of *T. brachiatum* was discovered downstream of the rockfall. The proposed area for spoiling the rock material did not contain any State listed plant species.

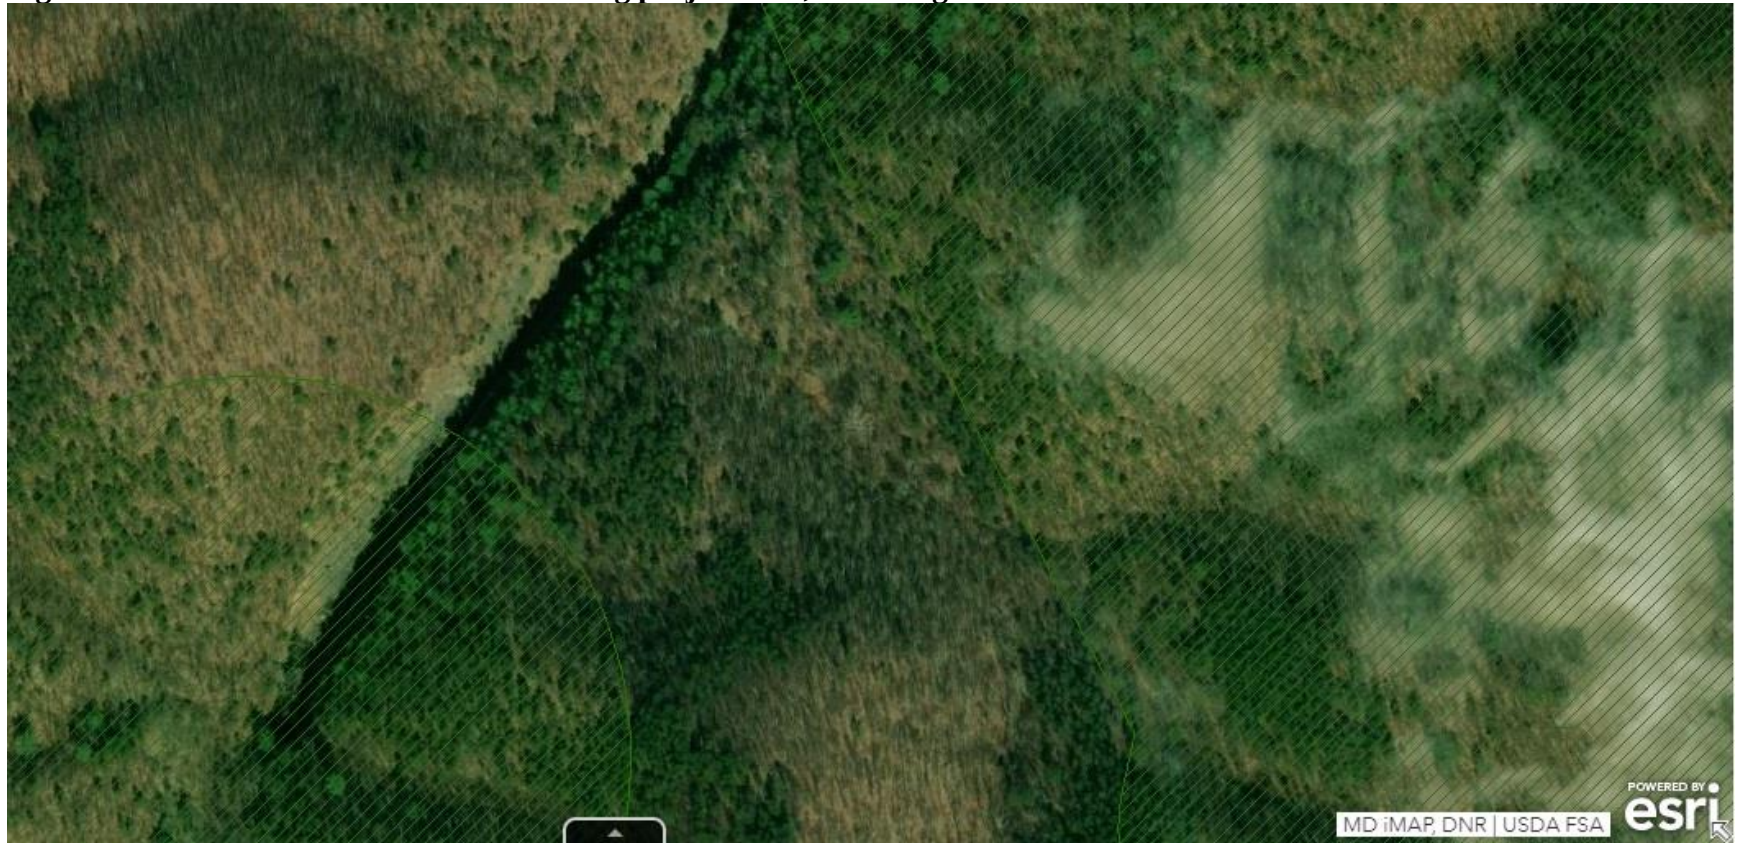
**Figure 4. Screenshot from MERLIN showing project area, including Review Area ID 609.**

With this letter, we are requesting your consultation on State Rare, Threatened, and Endangered Species. Please advise if your agency is tracking any additional species of flora or fauna of special concern in this area. The MERLIN mapping web application indicates that portions of the project area fall within Review Area ID 609, a Group 1 area (Figure 4). We are concurrently consulting with the US Fish and Wildlife Service for federally listed species, per Section 7 of the Endangered Species Act.
