United States Department of the Interior

Memorandum

To: Superintendent, Channel Islands National Park
Through: Dan Kimball, Chief, Water Resources Division (WRD)
From: Kevin Noon, PhD, Wetland Scientist, WRD
Subject: Report for Travel to Channel Islands National Park during May 11-16, 2003.

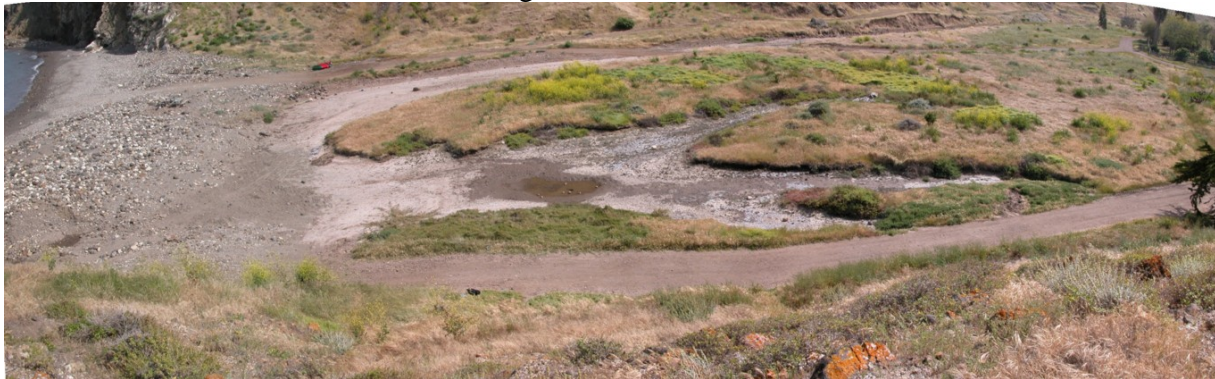
Photo 1. Scorpion Cove Estuary

There are three classes of wetlands that are landward of the subtidal area, i.e., above the low tide limit, of Scorpion Cove. All three areas are contiguous. The rocky shoreline area is classified as Marine/Intertidal/Rocky Shore. Above the shoreline the habitat is Estuarine/Intertidal/Emergent. The remaining wetland area is stream channel which is defined by side slopes and a channel bottom, and is classified as Riverine /Lower Perennial/Rock Bottom (see Attachment: Scorpion Ranch Cove Wetland Delineation, and Photo 1.).

Field investigations and a cursory review of historic photographs and documents suggest that approximately 75 percent of the lower floodplain riparian and wetland areas have been inundated with sediment. Some of the area appears to be flat and may have been graded (see the far right edge of Photo 1.).

The floodplain area above the remaining estuary appears to have received large amounts of sediment and may have been graded to create a flat area in front of the adobe building. There are three small channels in the remaining estuary area that have survived being filled with sediment and/or grading (see Photo 1.). These are located at the lowest end of the watershed. The hydrologic conditions created in the Scorpion Ranch Cove estuary (i.e., periodic inundation with salt water during the rainy season and then a long summer dry period), support a unique assemblage of plants and animals in a very small area. Any restoration or management activity that changes the hydrologic condition (either period of inundation and/or soil salinity) will likely cause the plant composition to change.

If preservation and expansion of the existing unique plant community is a priority, then I recommend that there be no effort to artificially encourage intertidal exchange; the intertidal gravel beach should be left intact or unbreached. In addition, the area of this unique habitat could be increased; i.e., excavate several new channels (to extend forty to sixty feet) into the graded area above the existing channels. These recommendations do not consider any other management needs.

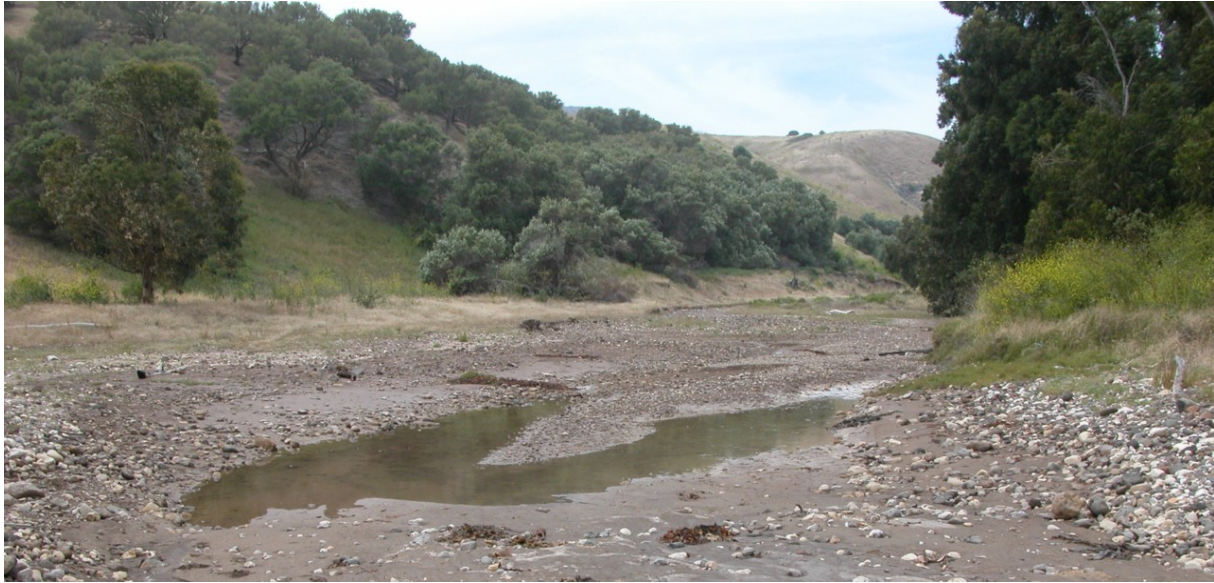
Photo 2. Smugglers Creek looking upstream from the intertidal beach and bar. Bank slope fill is right of center. The archeological site is far left and center.

There are two classes of wetlands that are landward of the subtidal area, i.e., above the low tide limit, of Smugglers Cove. Both areas are contiguous. The rocky shoreline area is classified as Marine/Intertidal/Rocky Shore. The remaining wetland area is stream channel which is defined by side slopes and a channel bottom, and is classified as Riverine /Lower Perennial/Rock Bottom. See Attachment: Smugglers Cove Wetland Delineation, and Photo 2.

An archeological site sits at the mouth of Smugglers Creek, just upstream of the intertidal beach and bar. Within the past few years park staff stabilized 75 feet of the bank slope on the north side of the channel approximately 50 feet from the archeological site. The purpose was to protect the archeological site from further erosion. Park staff placed tree boles at the base of the cut slope and backfilled over them, with soil, to the top of the bank. The area has since revegetated with grasses; however, stabilization of the soft soil fill within the stream channel has not yet been challenged by heavy or intense storm events.

There are no signs of erosion along the bank slope stabilization fill area (described above) and there is a healthy community of herbaceous plants covering the surface of the slope. Major storm events may erode the fill area. Since the bank is not armored with large rock and the subgrade fill material is sand, gravel, and cobble, it would be appropriate to monitor the condition of the stabilization periodically. It may be appropriate to establish tree and shrub species (e.g., willows) or implement an engineered treatment on the fill slope to increase stability and discourage erosion.

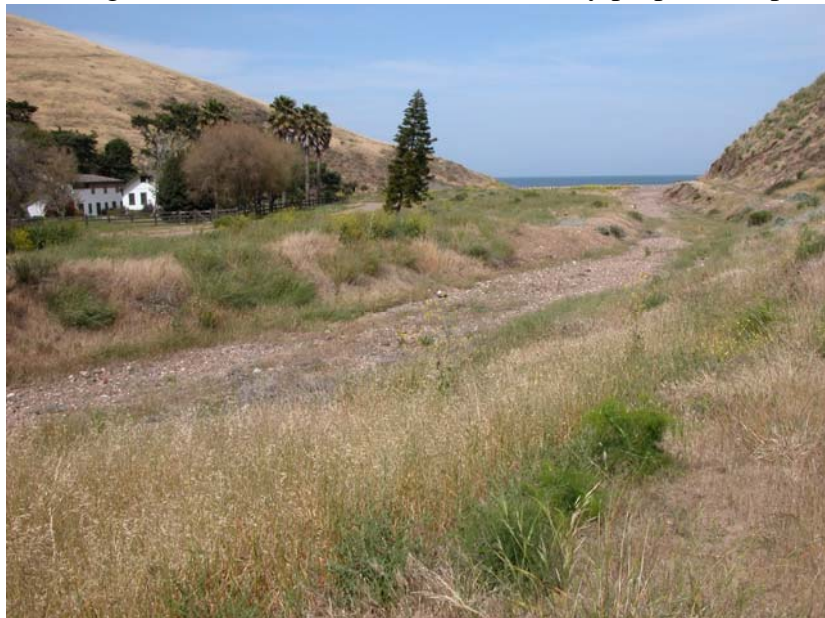
Photo 3. Scorpion Cove Dredged Stream Channel

The lower end of the Scorpion Creek riverine wetland channel, including part of the estuarine wetland has been dramatically altered by dredging over the past 100 years. A channel approximately 800-foot long by 35-foot wide (0.6 acre) has been periodically dredged in order to confine and control the creek flows along the south bank. See Photo 3. In addition, sand and cobble material is periodically dredged from the cobble beach and bar along the shoreline located at the end of the stream channel. Prior to grazing and channelization, the stream channel likely meandered back and forth across the entire valley floor through a series of braided channels. In that predisturbance situation, the riverine and palustrine wetlands likely extended across the entire valley floor.

Any dredging activity (within the stream channel or from the cobble beach and bar along the shoreline and at the end of the stream channel, for example see Photo 3) will require a

permit review from the Corps and will need 401 water quality certification from the State. I spoke with Antal Szijj (805 585 2147, U.S. Army Corps) concerning the need to protect historic structures from flooding by periodically dredging the stream channels. Antal has extensive experience with processing permits for this type of activity. His response was: the dredging is an activity that probably does not fall under any nationwide permit. The activity will likely require an individual permit review. He stated that this activity does not sound like something that would not be permitted. Any proposed impacts to any of the wetlands delineated will also require review and evaluation according to NPS Directors Order 77-1.

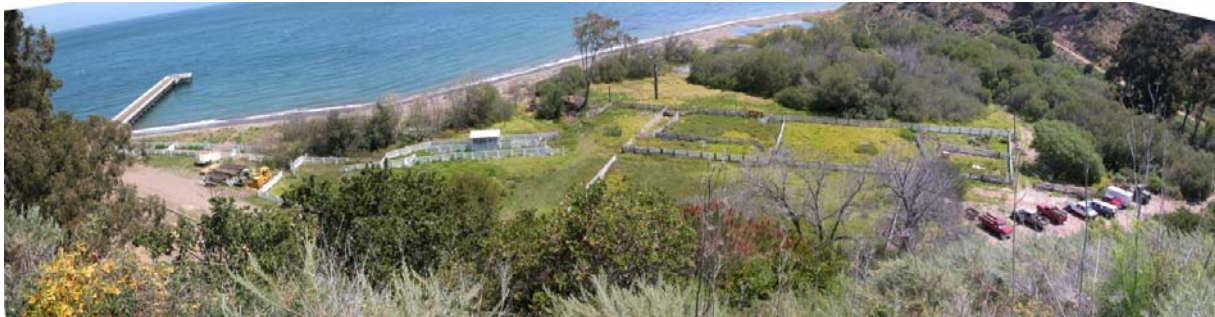
Photo 4. Prisoners Harbor: The “triangle” area. Recent fill pile (center, base of tree); parking lot, scrub/shrub wetland, and river channel (far right).

The hydrologic and hydraulic changes caused by any proposed changes to the floodplain and river conditions, that may affect the archeological mound site (located in the upper right side of photo 4), will have to be evaluated using hydrologic models. The mound appears to have stood for thousands of years before the recent human modifications and it stands to reason that the mound will not be adversely affected by shifting the river flow back through the floodplain. The dredging activities keep the river flowing down the east side of the floodplain (far right side of photo 4) and adjacent to the mound. The original dredging operation may have cut away part of the mound site in order to connect the river to the bay. There is evidence that some water from storm events is backing up behind the beach berm and causing erosion of the mound edges.

Restore the estuary within the triangle created by the river channel, the dock access road, and the shoreline. This would require discovering the extent of the original wetland area, removing the wetland fill (likely within and beyond the corral area), removing the dike (including the concrete pads) adjacent to the river channel, and replanting the restored estuary.

The restoration would likely double the size of the existing wetland. An increase of one or two acres is a significant increase to the overall acreage of wetlands on the islands. By design, the restoration could reduce the amount of exotic species, restore the biological integrity of this nearshore wetland area, and restore the historic scene prior to disturbance.

- Remove the recent fill (soil and tree limbs) that was dumped in the wetland at the edge of the corral and prohibit future dumping in the wetland.
- Remove the piled fence rails, any other debris, and the tractor from the floodplain area.
- Remove the parking lot from the floodplain and restore the area. The storage of NPS and Nature Conservancy vehicles within the 100-yr. floodplain and adjacent to the river seems unnecessary. There may be more appropriate areas (at higher elevations) to park vehicles, just south and across the river near the pump station or in the nearby Eucalyptus grove.

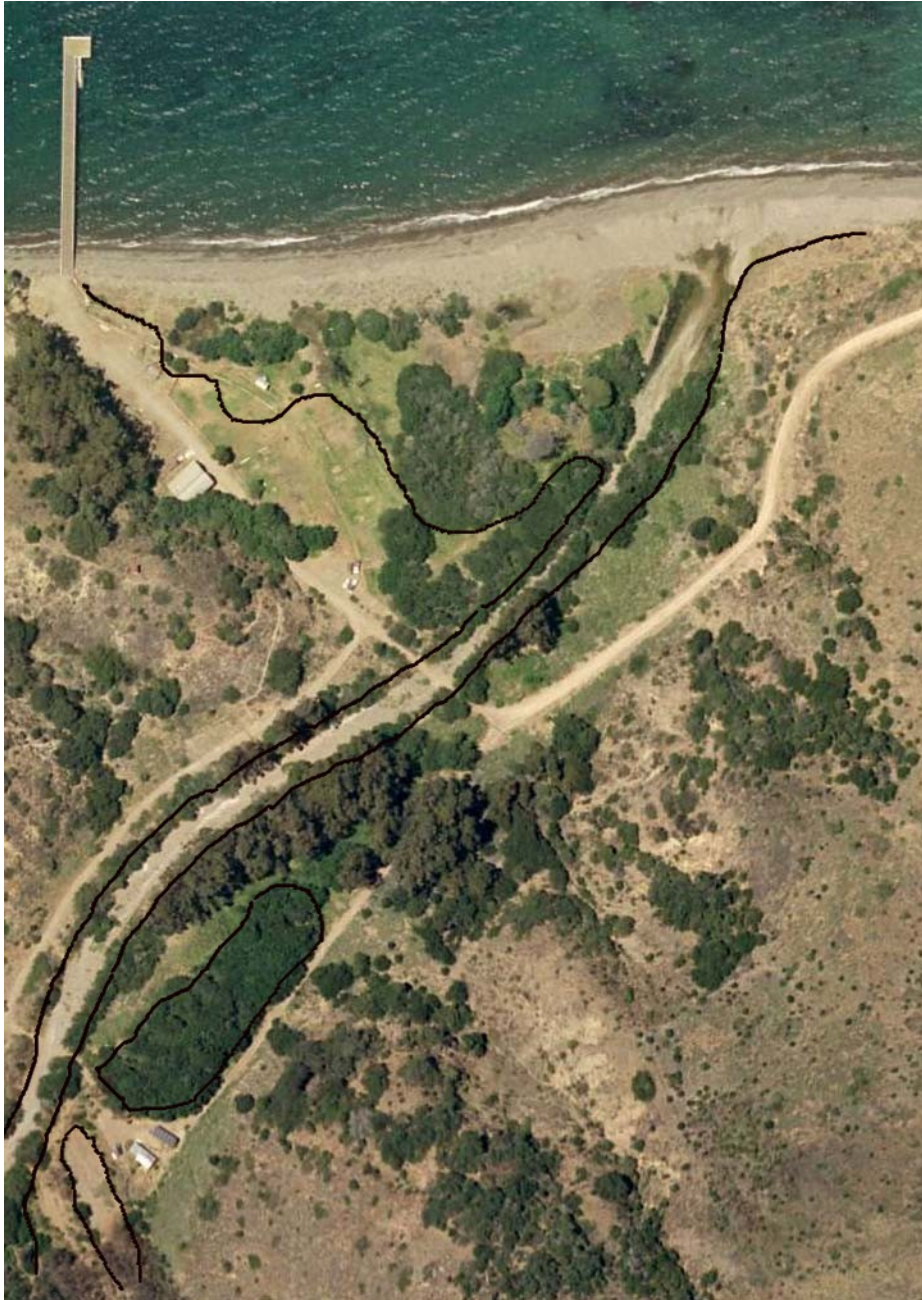
Prisoners Harbor Wetland Delineation

There are three classes of wetlands that are landward of the subtidal area, i.e., above the low tide limit, of Prisoners Cove. All three areas are contiguous (see Attachment: Prisoners Harbor Wetland Delineation). The rocky shoreline area is classified as Marine/Intertidal/Rocky Shore. Above the shoreline the habitat is either Palustrine/Emergent/Persistent, Palustrine/Scrub-Shrub/Broad-Leaved Deciduous, or Palustrine/Forested/ Broad-Leaved Deciduous. The remaining wetland area is stream channel which is defined by side slopes and a channel bottom, and is classified as Riverine /Lower Perennial/Rock Bottom.
