# Mammoth Cave National Park

## Rehabilitate Cave Trails: Frozen Niagara

## Frozen Niagara Trail Overview

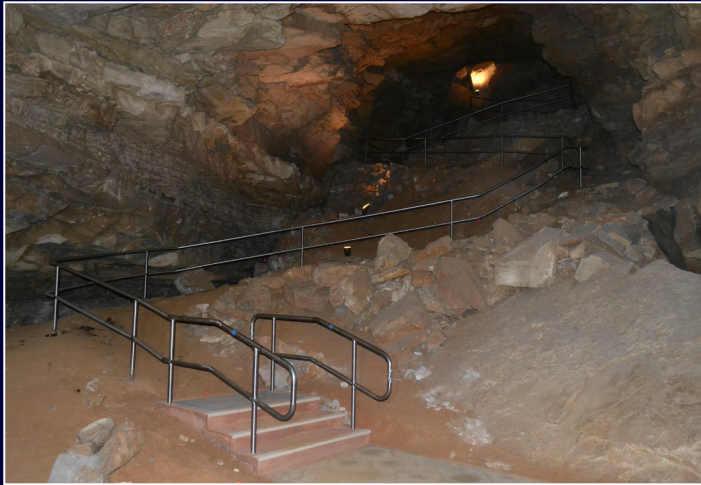
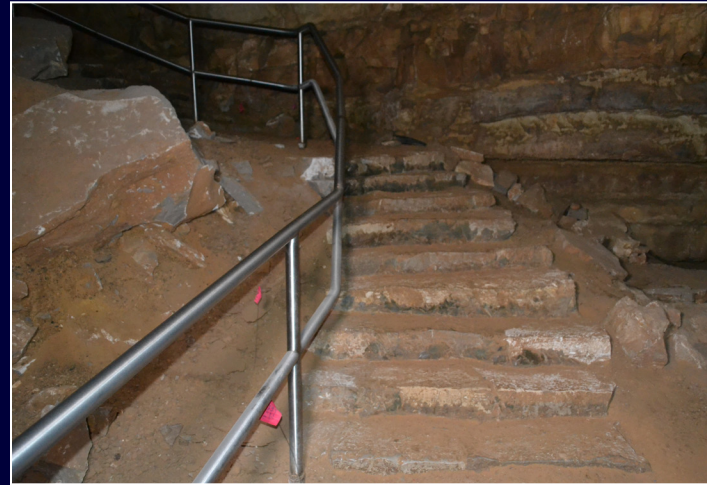
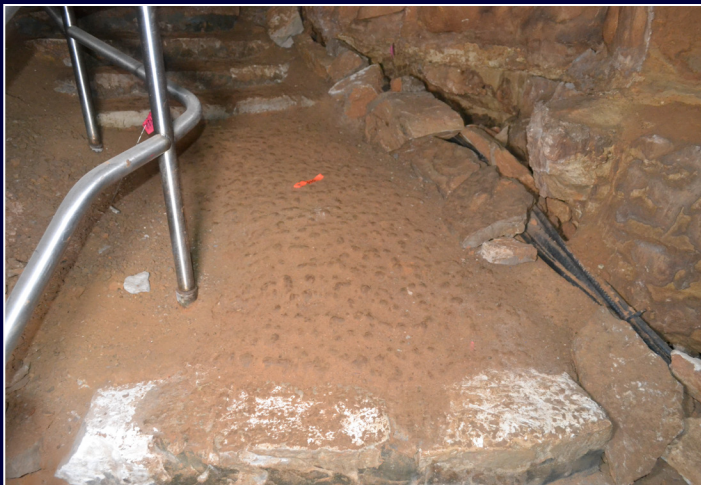
## Big Break Steps – Existing Conditions

Big Break Steps - Overall

Big Break Steps - Lower Steps

Big Break Steps - Landing

## Issues at Big Break Steps:

- Steep slopes
- Historic limestone steps
- Historic stacked stone walls
- Uneven trail surfaces

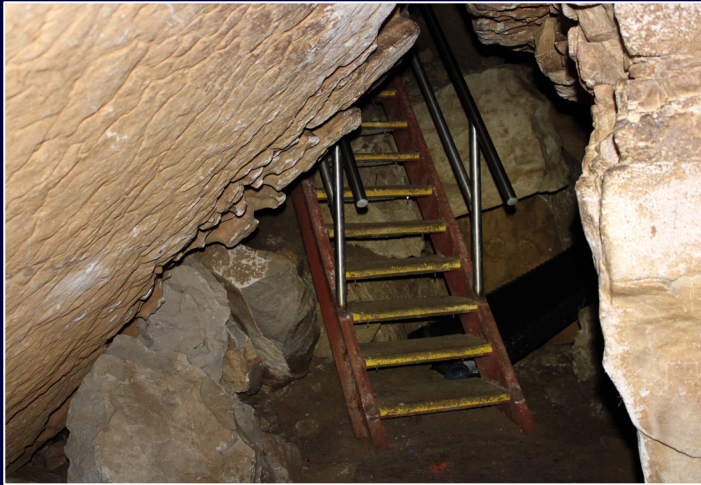
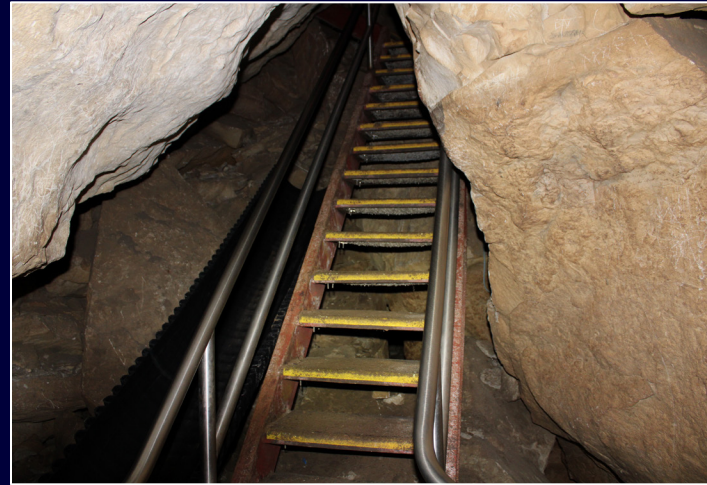
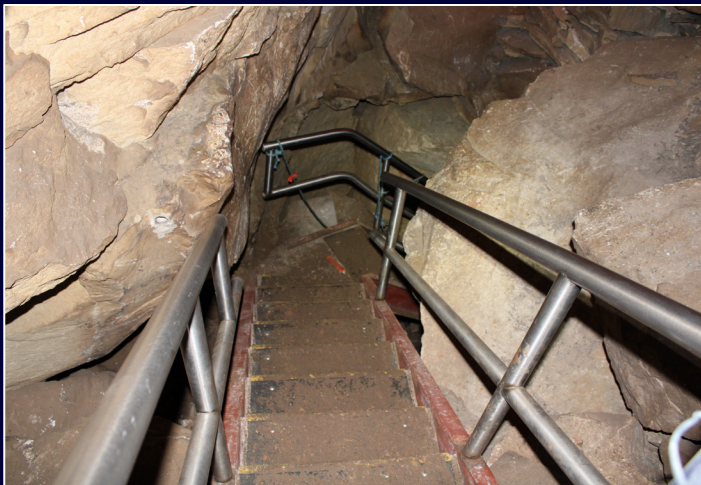
## Trail Reroute – Existing Conditions

Metal Stairs - Bottom Landing

Metal Stairs - Looking Up

Metal Stairs - Looking Down

## Issues at Trail Reroute Area:

- Three sets of very steep, ladder-like stairs
- Low head clearance
- Very narrow
- Historic stone retaining wall adjacent to trail
- Understructure encased in lead paint

- Reroute existing trail to improve head clearance issues, width constraints, and steep steps
- Minimize disturbance to existing stone/rubble
- Minimize impacts to existing stone wall built by the Civilian Conservation Corps

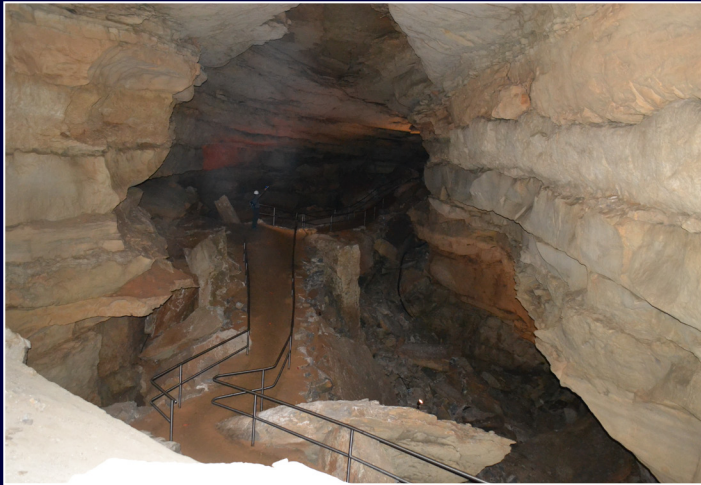
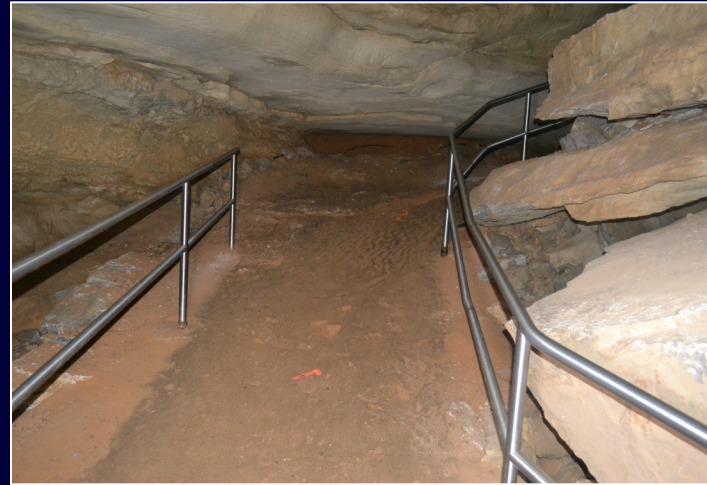
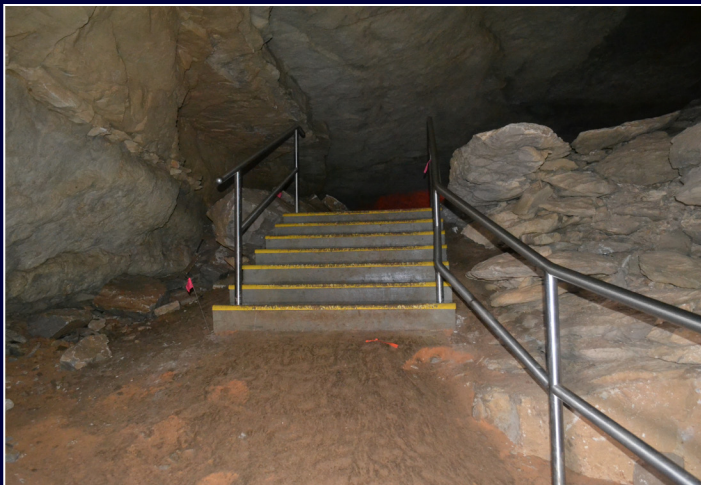
## Lover's Leap Trail – Existing Conditions

Lover's Leap Trail - Overview

Lover's Leap Trail - Switchback

Lover's Leap Trail - Steps

## Issues at Lover's Leap Trail:

- Steep, narrow trail
- Switchback with low head clearance
- Non-compliant handrails
- Uneven trail surfaces
- Historic stacked stone wall

- Elevated deck to create an overlook at Lovers Leap
- Steps at grade to the concrete trail
- Steps or elevated walkway to bypass switchback

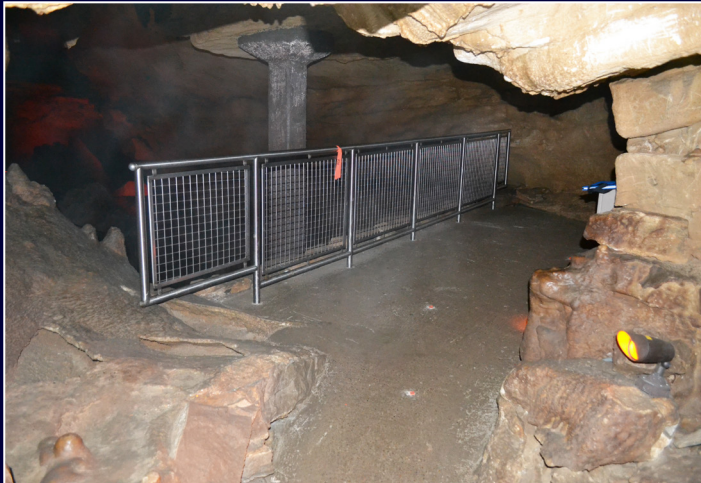
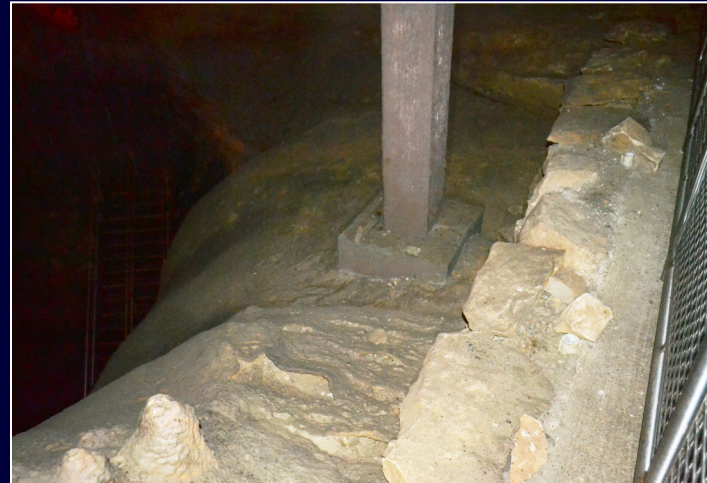
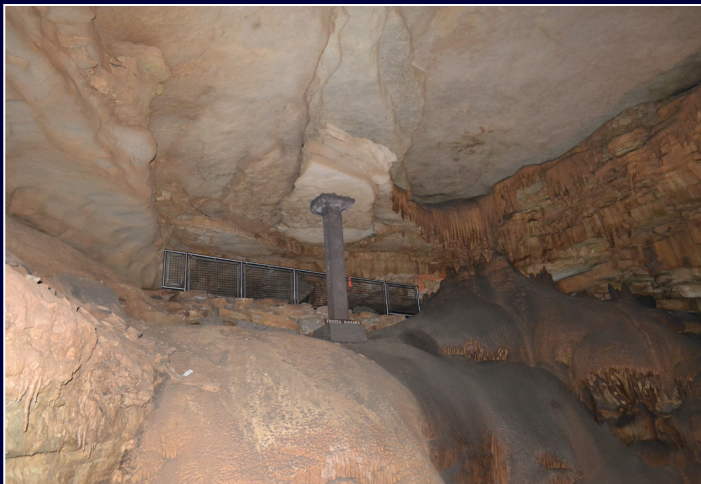
## Frozen Niagara Overlook – Existing Conditions

Frozen Niagara Overlook from Trail

View of Rock Wall and Pillar over Fence

Frozen Niagara Overlook from Below

## Issues at Frozen Niagara Overlook:

- Concrete pillar partially blocks view
- Metal handrail is set back from overlook
- Uneven trail surfaces

- Extend overlook surface outward to improve viewshed
- Protect concrete pillar
- Replace existing metal guardrail

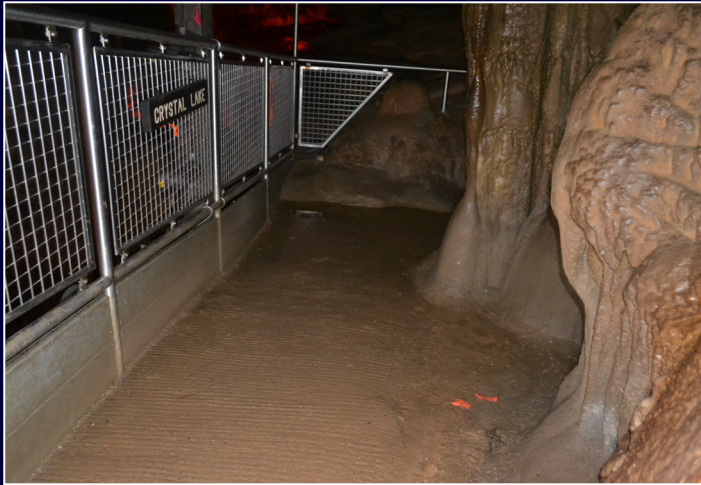
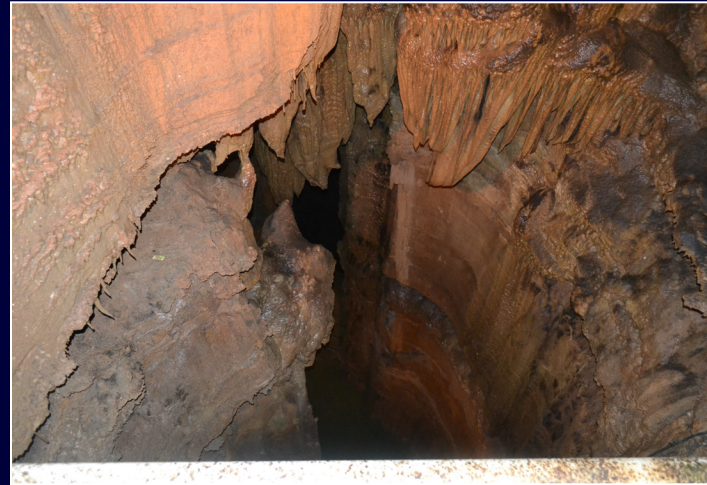
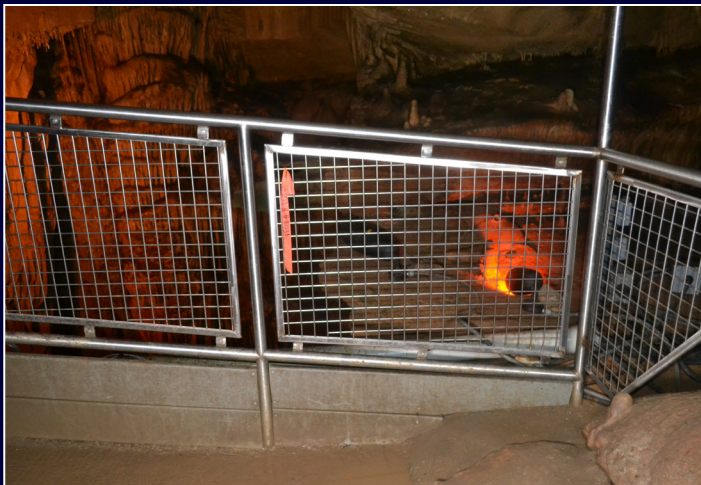
## Crystal Lake Overlook – Existing Conditions

Crystal Lake Overlook Decking

Partially-Obstructed View Below

Crystal Lake Overlook Guardrail

## Issues at Crystal Lake Overlook:

- Concrete decking and metal guardrail partially obstruct the view to the lake below
- Water management issues
- Age of existing infrastructure

- Replace concrete with open grate decking
- Replace guardrail with vertical pickets
