# Foundry Branch Trestle Bridge Demolition

## National Historic Preservation Act Section 106 Consulting Party Meeting #1

Rock Creek Park  
Virtual Meeting  
March 30, 2021

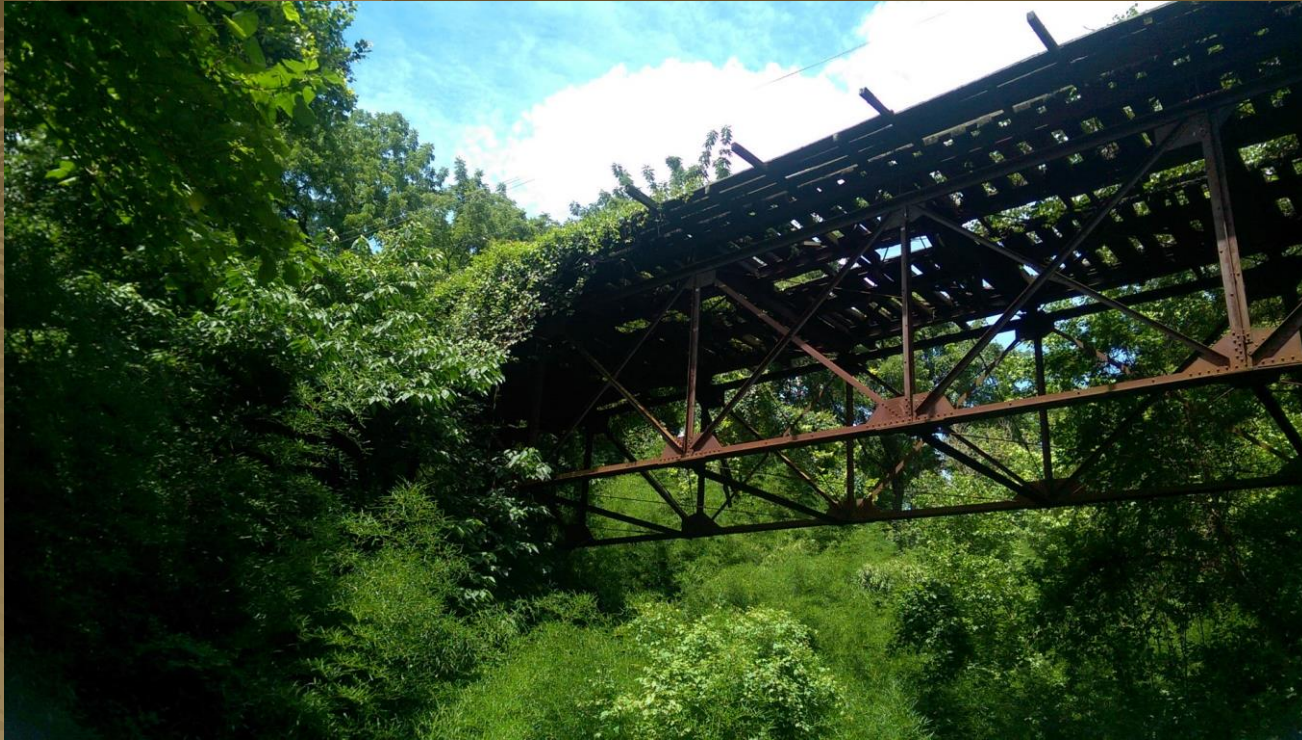
# Foundry Branch Trestle

- Listed as a contributing resource in the Glover-Archbold Park NRHP nomination. The structure retains integrity and is associated with the history of development in northwest Washington.
- The trestle is a 260 ft long x 20 ft wide steel, concrete, and wood structure.
- Structurally, the trestle is a Pratt truss, suspended by 22 steel towers (12 on the east side and 10 on the west side.) The trestle is supported by 22 concrete footers and 2 concrete abutments.

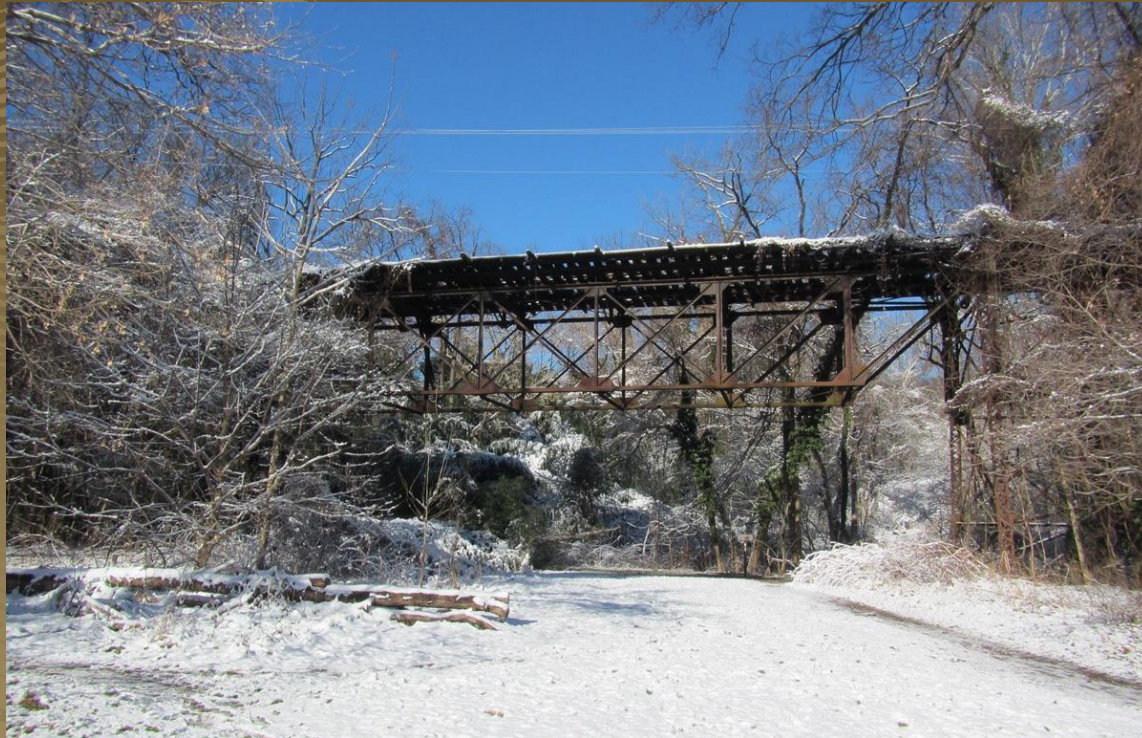
# Foundry Branch Trestle

- Numerous studies indicate the structure is in poor condition. At least 3 of 22 steel towers are compromised, and probably more.
- WMATA owns most of the land associated with the structure, although the trestle spans NPS land, and four of the pedestals are located on NPS land.

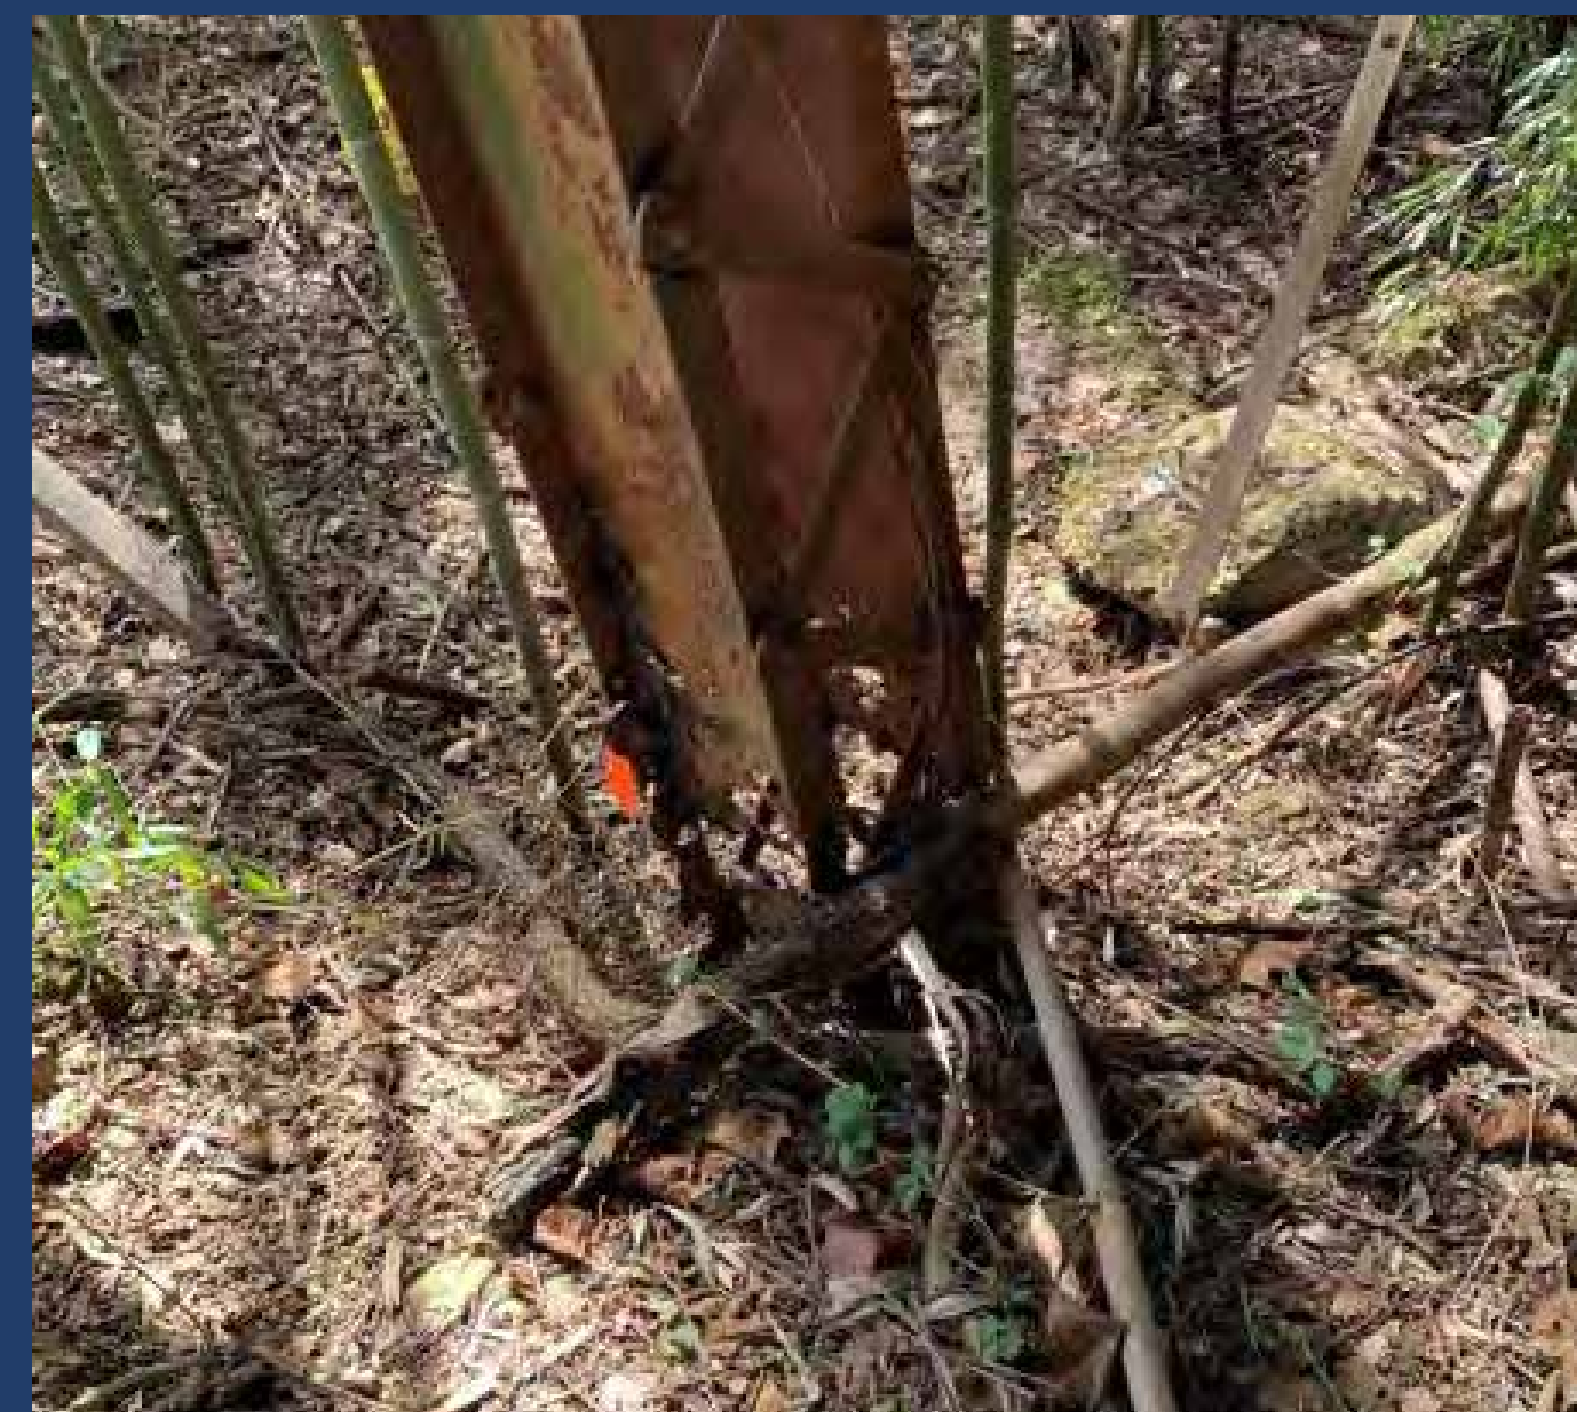
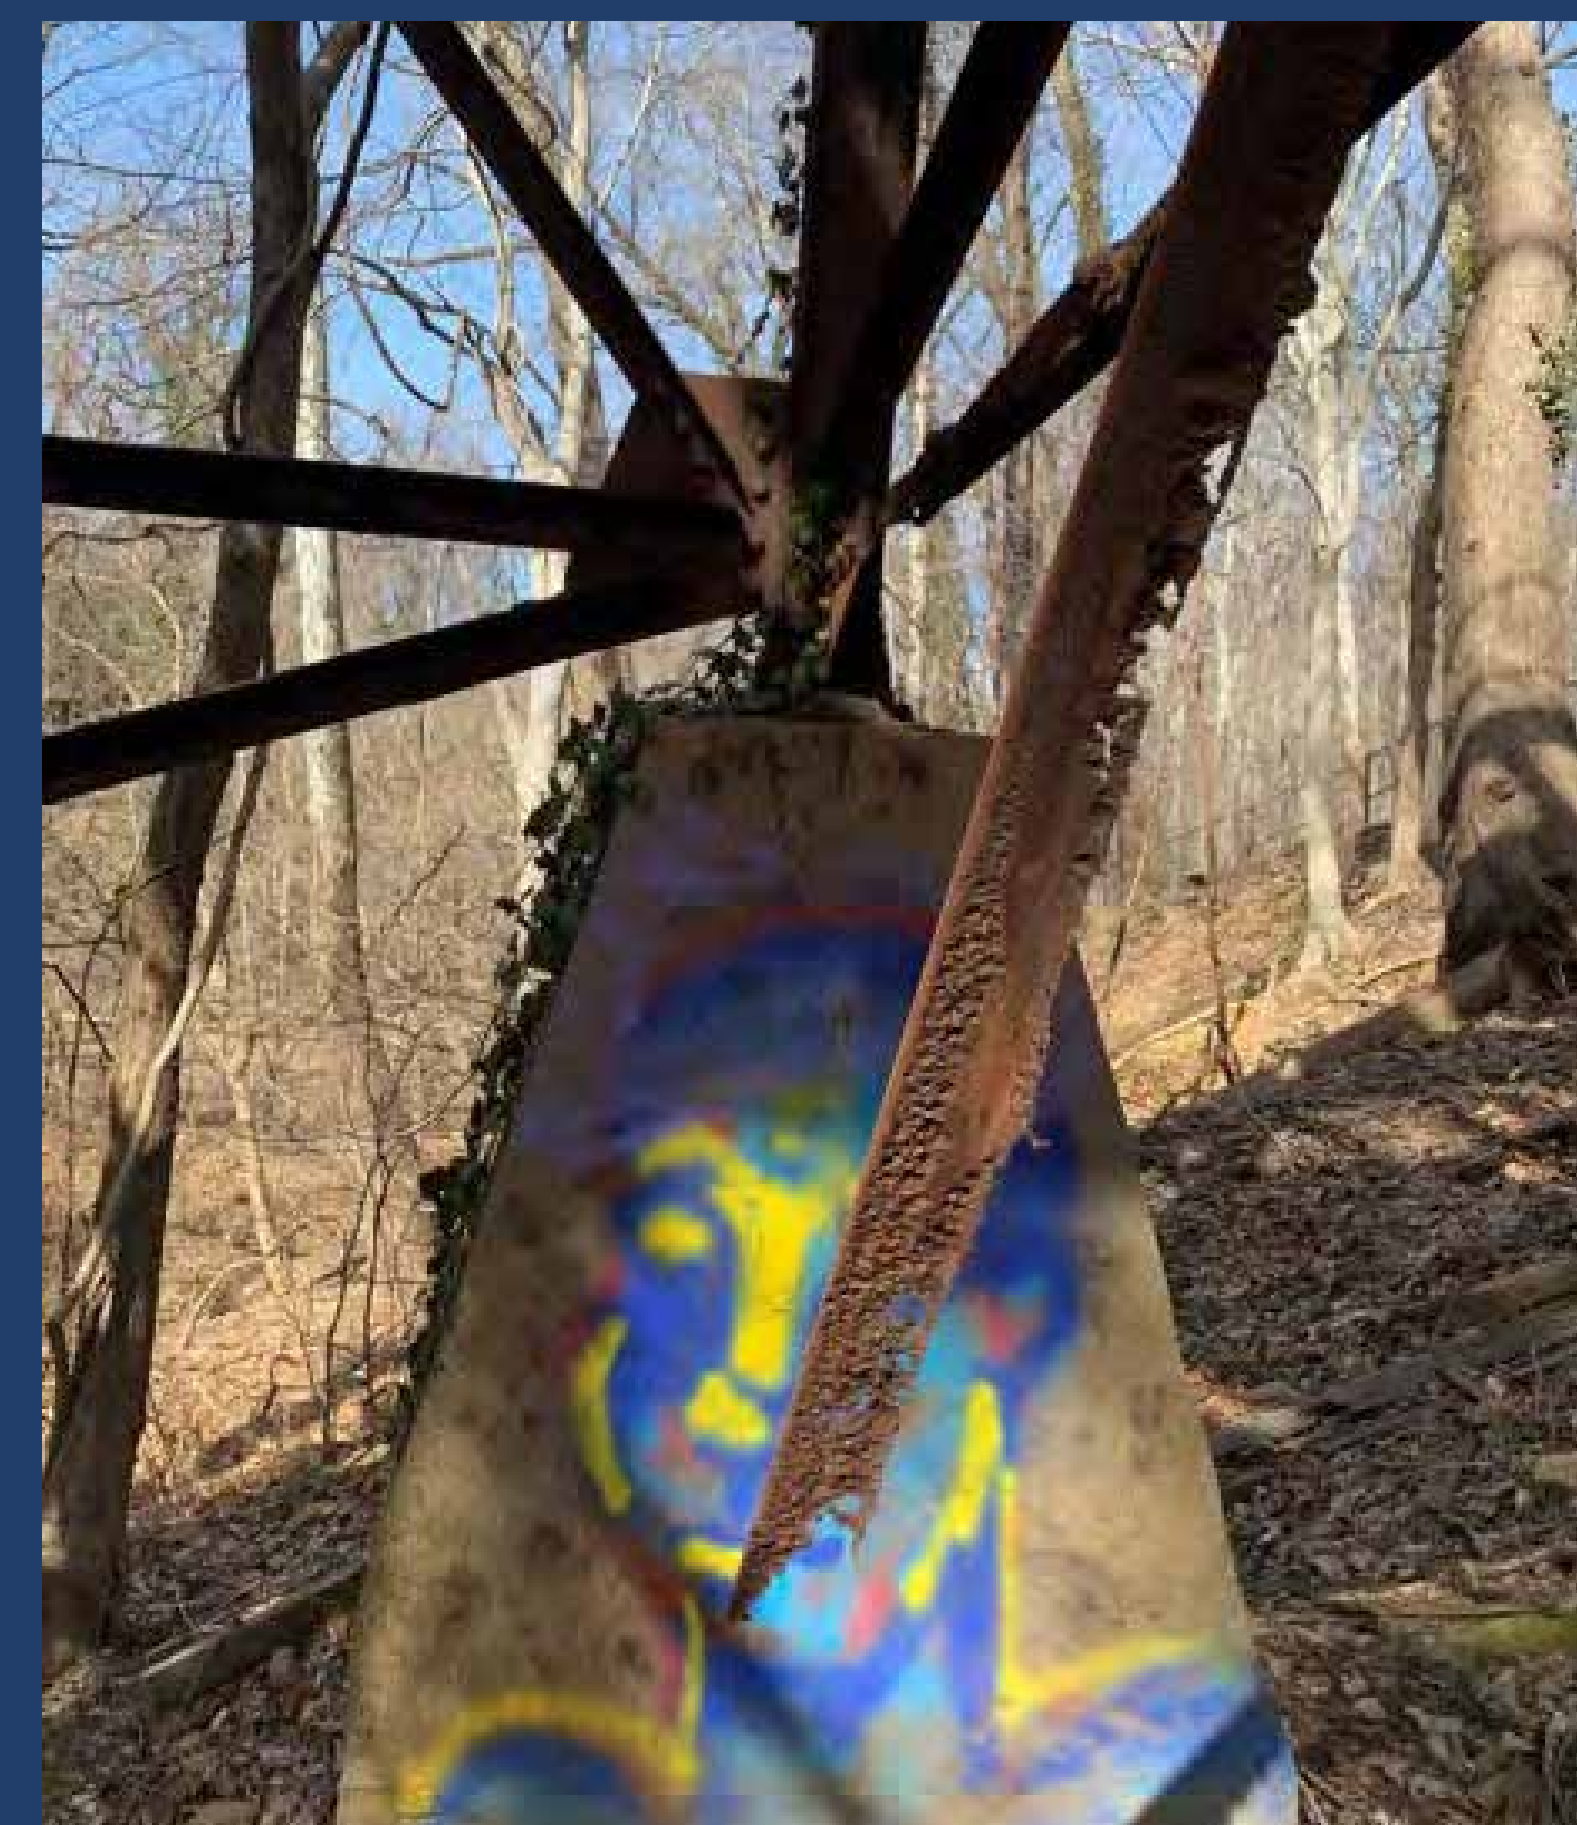
*Images from inspection findings*

- In poor condition
- Improvements needed:
- Multiple members need to be replaced due to their deteriorated condition
- Many members need to be strengthened to carry applied loads

- Show significant deterioration
- Likely additional unseen deterioration where moisture is trapped beneath rail ties

- Can support the loads resulting from a 12-ft wide pedestrian trail
- Improvements needed:  
Dismantle truss, clean, paint and repair steelwork. Reassemble with replacing riveted connections with bolts

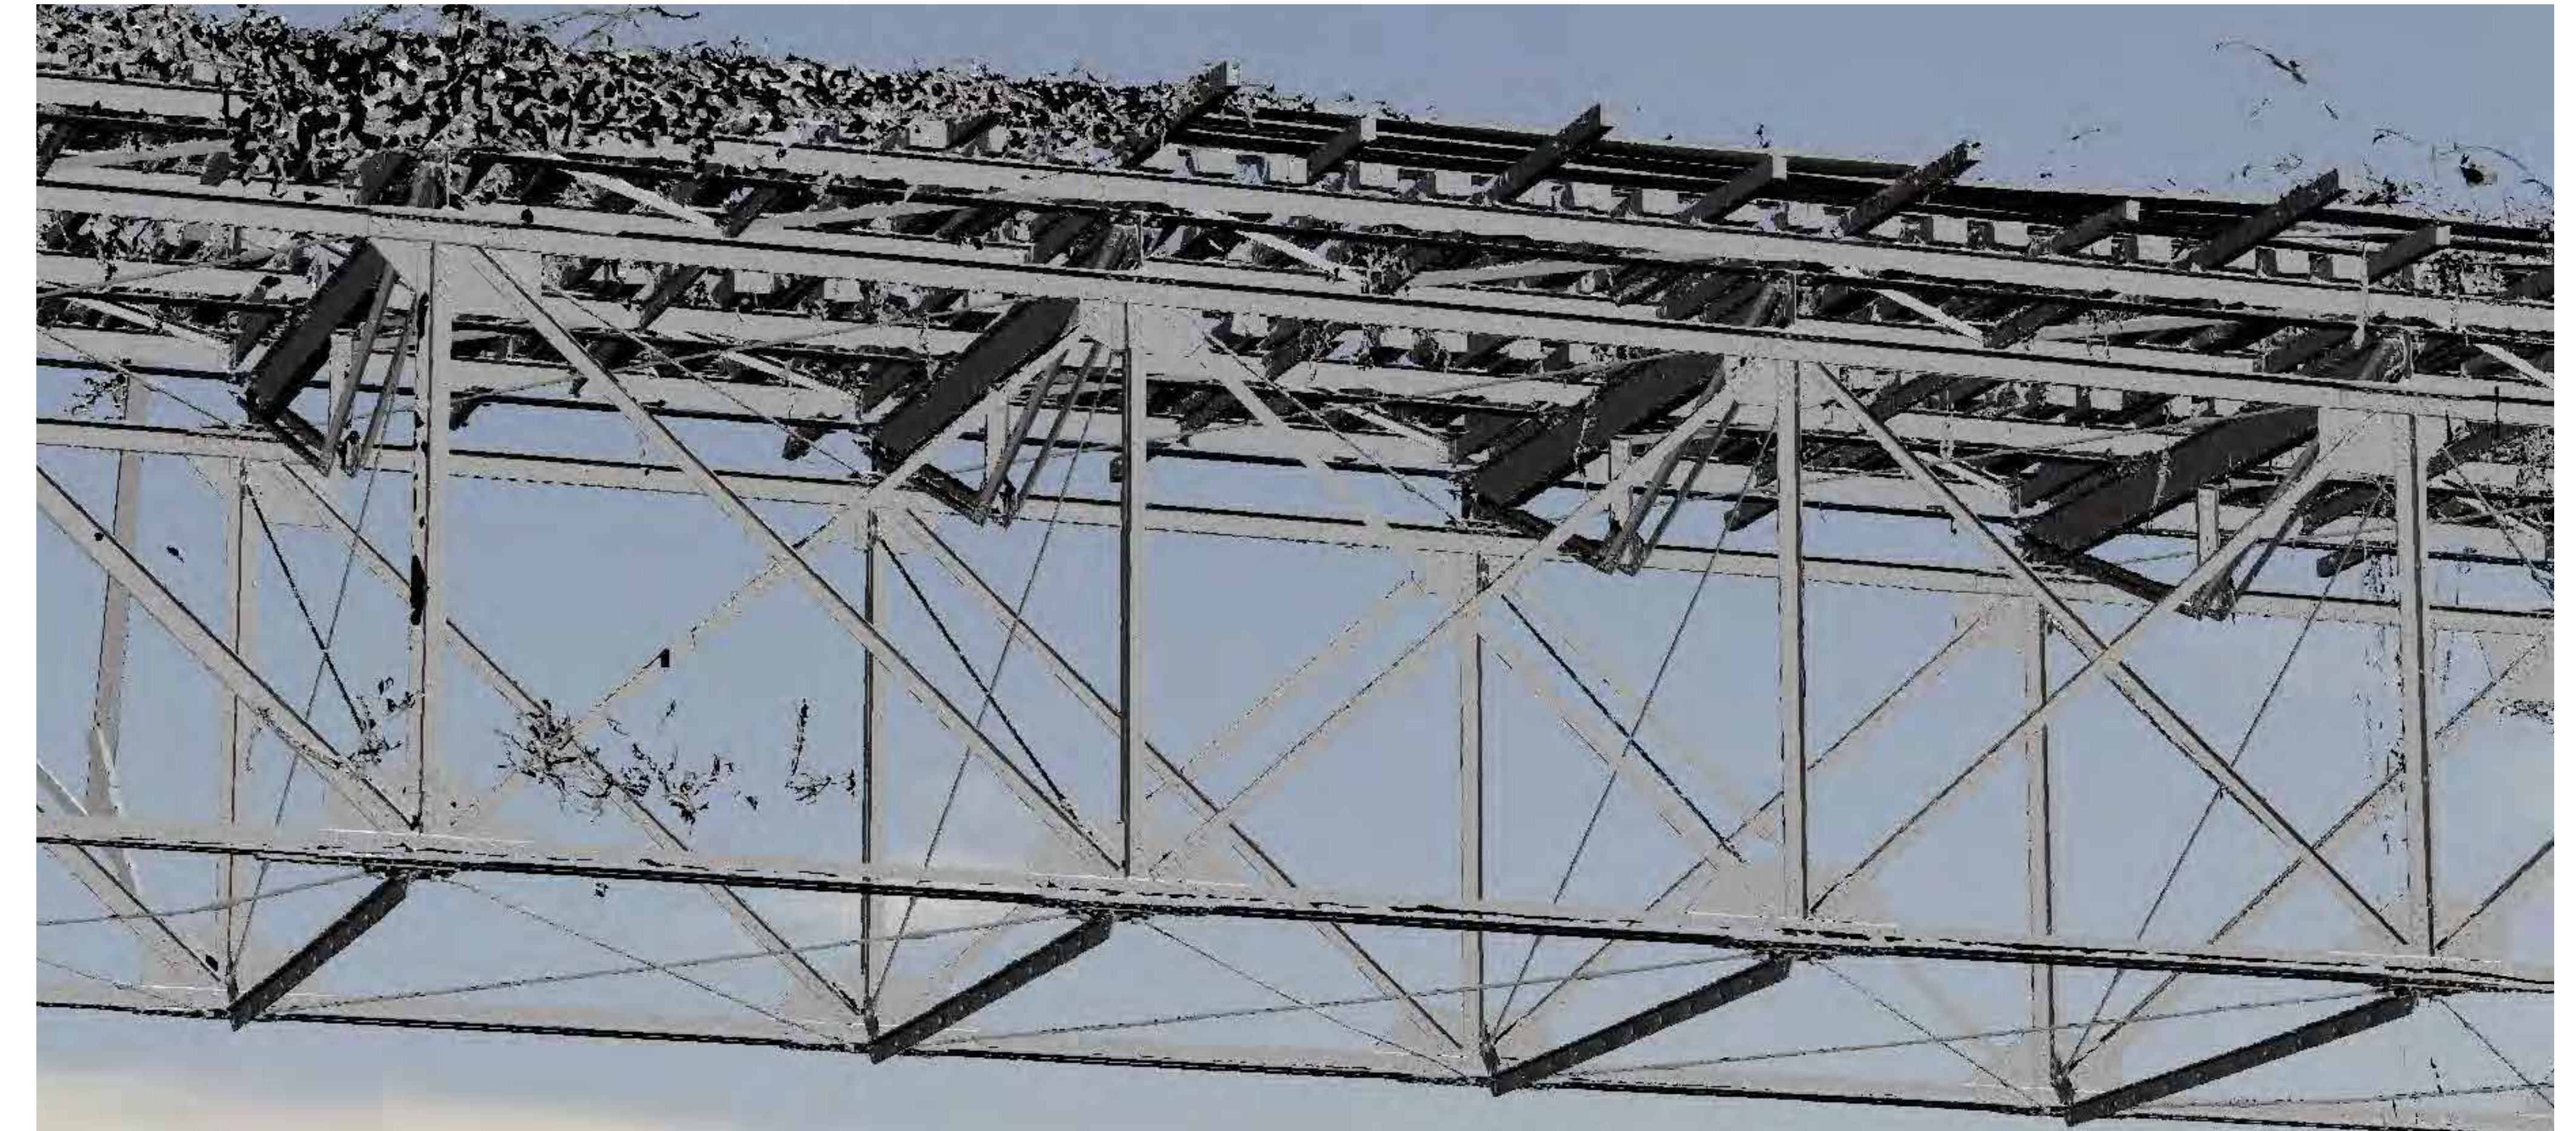
## BRIDGE LASER SCAN IMAGES

- Site Inspection
- 3D Scans
- Document geometry and condition of the bridge
- Develop structural analysis model
- Check if the structure can support a pedestrian trail
- Develop conceptual ideas for rehabilitating the bridge
- Planning level cost estimate for the rehabilitation
