WAR DEPARTMENT ERA, 1869-1933

DEVELOPMENT AND BEAUTIFICATION, 1869-1882

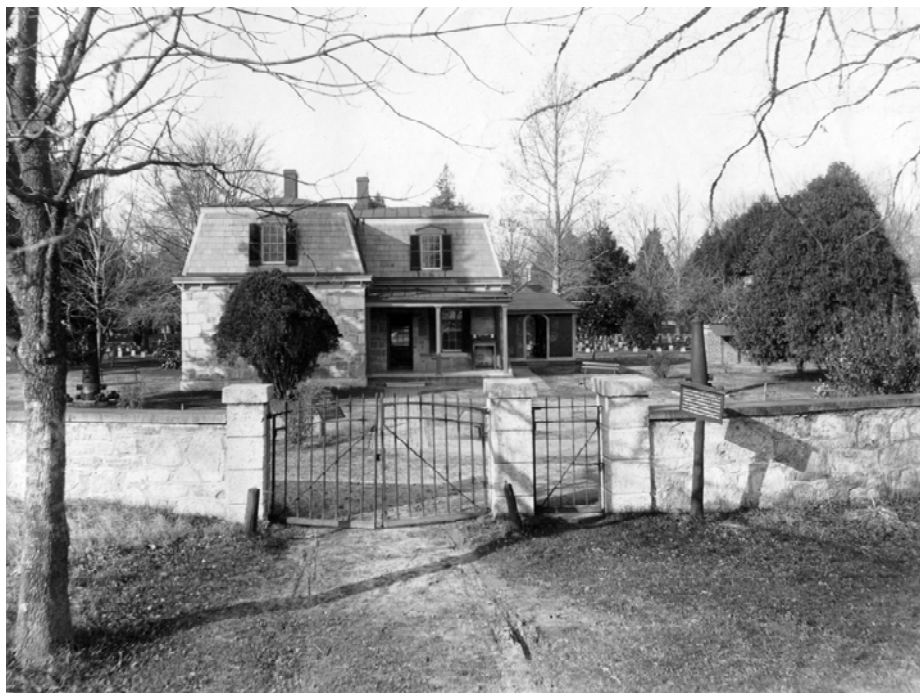
Figure 1.41: The main entrance to City Point National Cemetery, a second-class cemetery (6.7 acres), showing Meigs-type lodge (1871), photographed 1902. Also note enclosing stone wall and iron gates (c.1875), gun (cannon) monuments (c.1869), and iron tablets (plaques) (c.1882). Records of the Quartermaster General, RG 92, Still Pictures Division, National Archives II, College Park, Maryland.

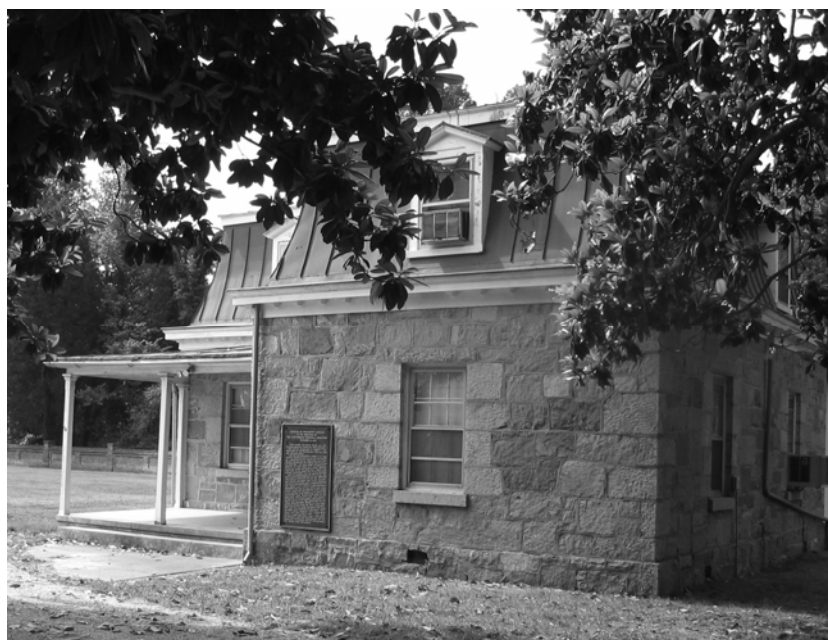
Figure 1.43: The Poplar Grove lodge, built in 1871, view of the front façade looking southeast from an existing photograph [replace with historic photograph?]. The building historically had dark trim and a monochrome slate roof with diamond-shaped slates. The tablet affixed to the building, installed prior to 1933 and a standard feature at Civil War-era national cemeteries, is Lincoln's Gettysburg Address. SUNY ESF.

On October 24, 1871, Kyran Murphy began construction of the new stone lodge, and by the end of the year, the building was substantially complete.¹⁹ The building featured the standard overall plan and form, with a concave mansard roof sheathed in diamond-shaped monochrome gray slate, six-over-six double-hung sash windows, a front porch with simple squared posts, overhanging eaves ornamented by dentils, and random-course, rough-faced ashlar with varying shades of grays and browns (origin of stone not known), similar to the stone used at the City Point lodge. [Figure 1.43] Work on finishing the interior lasted into the spring, and in April, Miller moved into the lodge. Soon after this, Miller moved the old frame lodge to the rear of the new lodge for use as a kitchen and storage room.²⁰

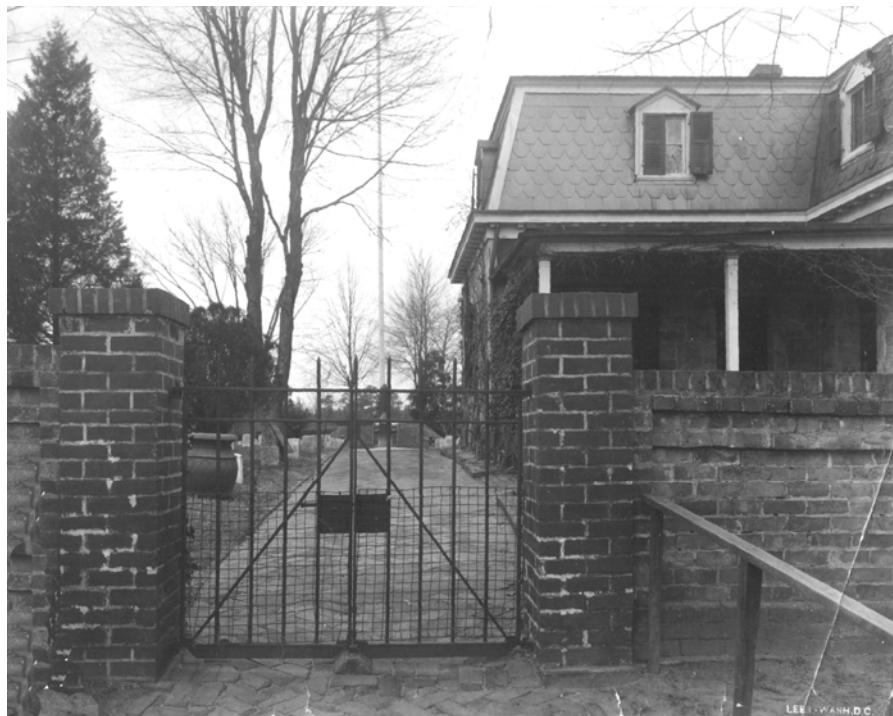
Figure 1.45: Cold Harbor National Cemetery, a typical third-class cemetery (1.4 acres), photographed 1902. This shows the lodge (1870), brick enclosing wall with single gate (1871), central entrance drive (c.1866), and in the distance, the flagstaff and flagstaff mound (c.1866). Records of the Quartermaster General, RG 92, Still Pictures Division, National Archives II, College Park, Maryland.
