ANALYSIS & EVALUATION

This chapter provides an analysis of the Poplar Grove National Cemetery landscape and an evaluation of its historical significance based on the findings of the site history and existing conditions. Because the landscape encompasses the entire cemetery site, this chapter makes site-wide recommendations for historical significance, addressing both natural and built features that comprise the landscape. These recommendations have been developed according to the National Register Criteria for Evaluation and the NPS *Guide to Cultural Landscape Reports: Contents, Process, and Techniques*.¹ National Register documentation for Petersburg National Battlefield, currently under development, will comprehensively address all areas of significance for Poplar Grove National Cemetery as a unit of the larger park.²

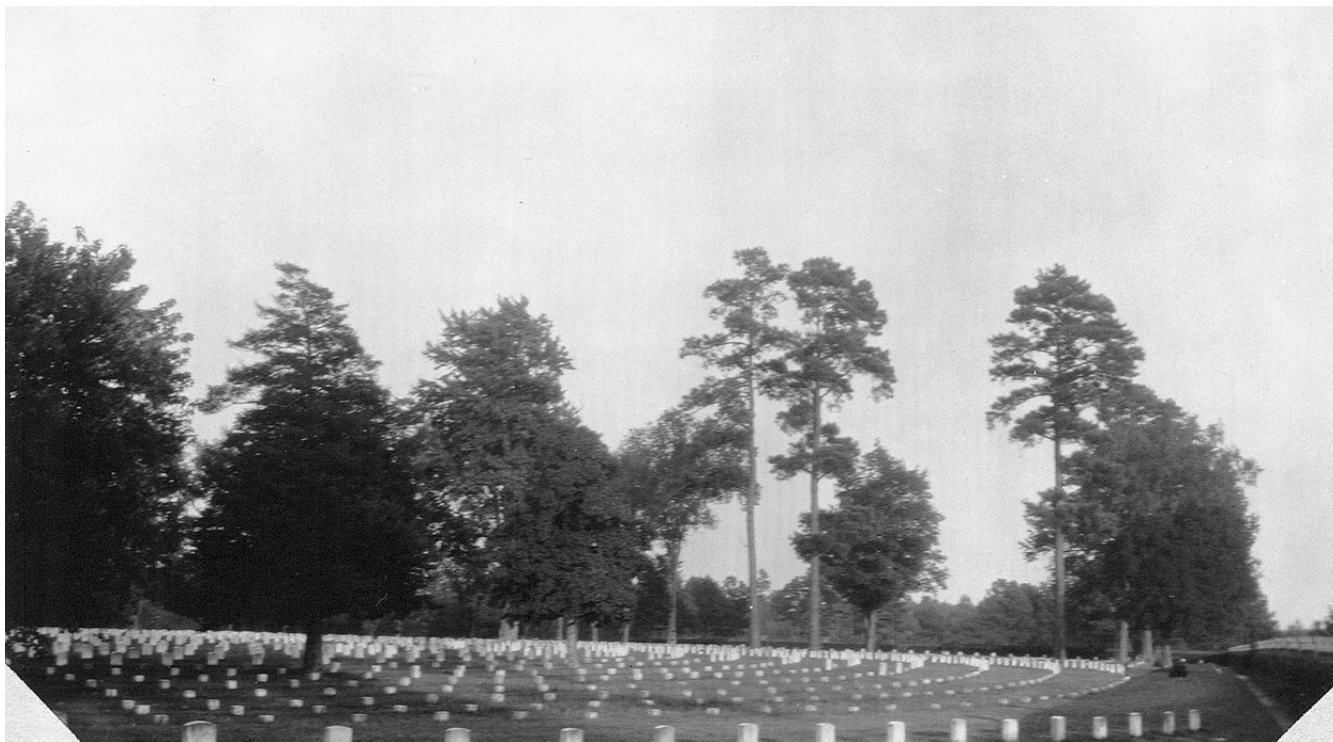
Figure 3.3: General view of the burial grounds at the end of the historic period in 1932, taken from near the rostrum looking east along the south wall showing the upright Civil War-type headstones and blocks defining grass drives and walks, and widely spaced specimen trees. Also note ivy bed along wall. RG 92, Entry 1891, Office of the Quartermaster General, Correspondence, Geographic File, 1922-1935, box 1773, National Archives II, College Park, Maryland.

Since the end of the historic period, the Civil War-type grave markers have been dramatically altered. In 1934, workers from the Civilian Conservation Corps (CCC) under the direction of the NPS sunk the blocks flush with the ground and cut the headstones and laid the upper portions flush with the ground in an effort to simplify lawn maintenance and improve the aesthetics of the landscape [see Figure 3.4]. In addition to this change, since the end of the historic period the condition of the stones has deteriorated, most notably through heavy chipping along the edges from mowers. Despite this, nearly all of the markers remain legible. Since the end of the historic period, approximately ninety-five of the Civil War-type headstones have been replaced with different styles of grave markers. Of the 3,355 blocks originally installed, there remain 3,277 today (some of these were replaced during the historic period after 1903 with headstones).

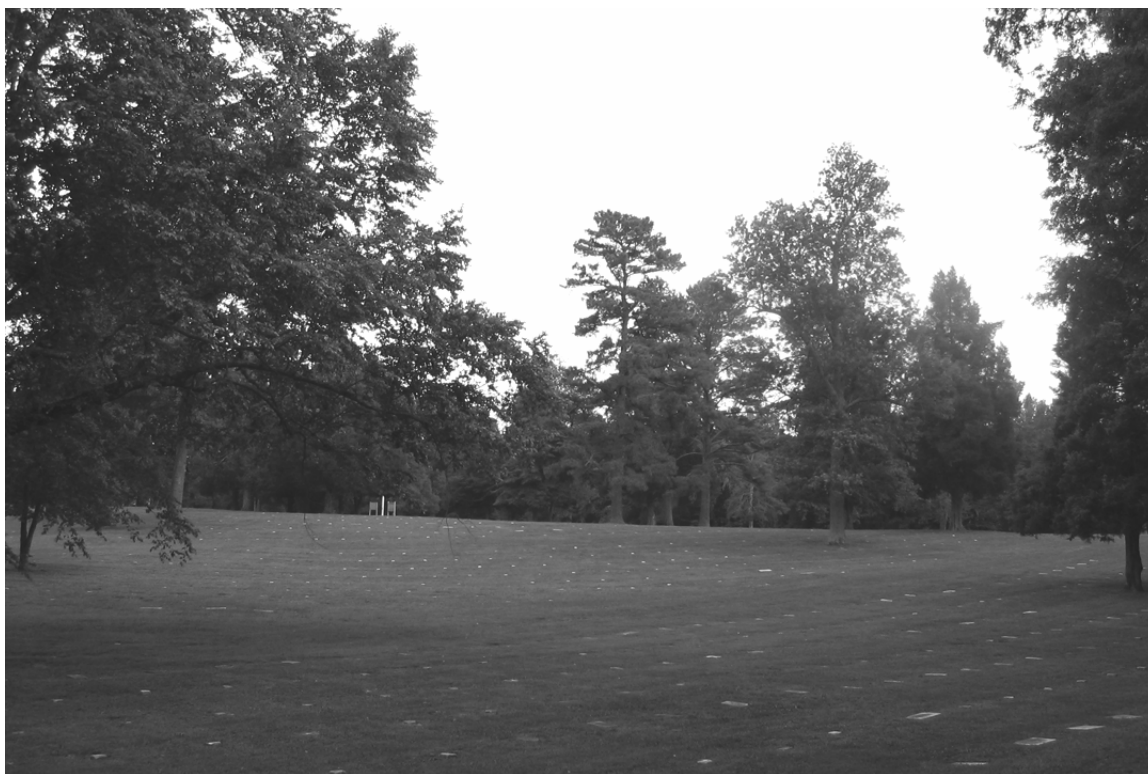
Figure 3.4: Similar view of the burial grounds today, showing change to landscape from alteration of the grave markers undertaken in 1934 and loss of specimen trees. SUNY ESF, 2006. [replace with view to match 1932 photograph]
