An Enslaved Residents' Quarter at the Washington-Era Ferry Farm Site
(George Washington's Boyhood Home National Historic Landmark):
Archaeological and Historical Documentation and Evidence
for Proposed Implementation of Phase 1-B of a Landscape
Rehabilitation

David Muraca
Director of Archaeology
The George Washington Foundation
March 2021

Documentation of Enslaved Residents' Quarter and Landscape Rehabilitation, in Relation to NPS Conservation Easement and Reviews

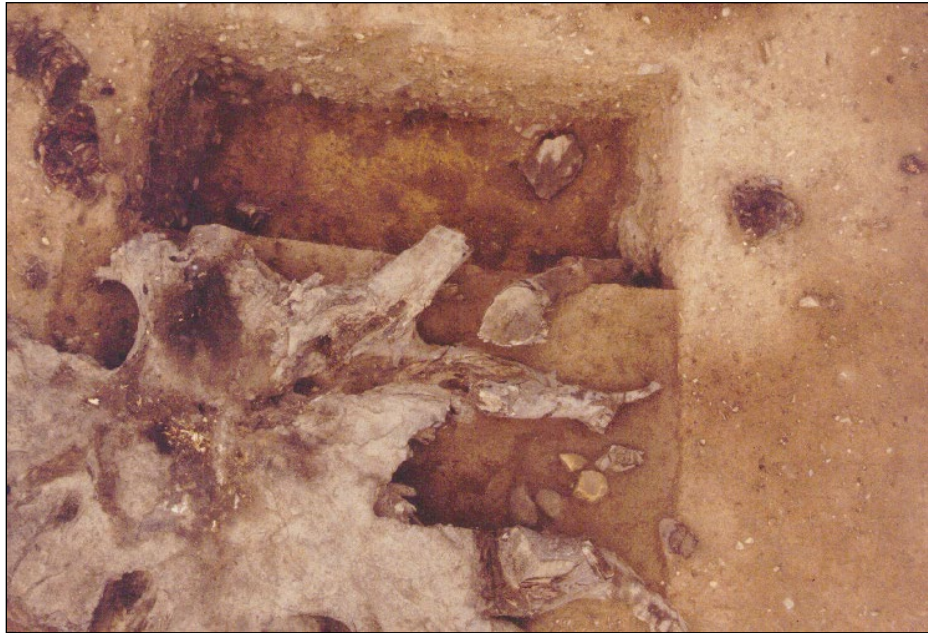
Figure 2. Aerial View of Root Cellar intruded by Remains of a Tree.

The surviving architectural element of this structure is a medium sized root cellar, also called a subfloor pit, which measured 5.5 ft. by 5.5 ft. The root cellar contained the remains of a large tree stump that allowed for only a little more than half of the feature to be excavated. The tree covered most of the eastern half of the cellar making excavation of this portion impossible. The cellar is square in shape, and was filled in a single event. The cellar had slightly sloping walls and a flat bottom. The fill layer (1.7 feet deep) suggests this cellar was abandoned and filled prior to the destruction of the structure.

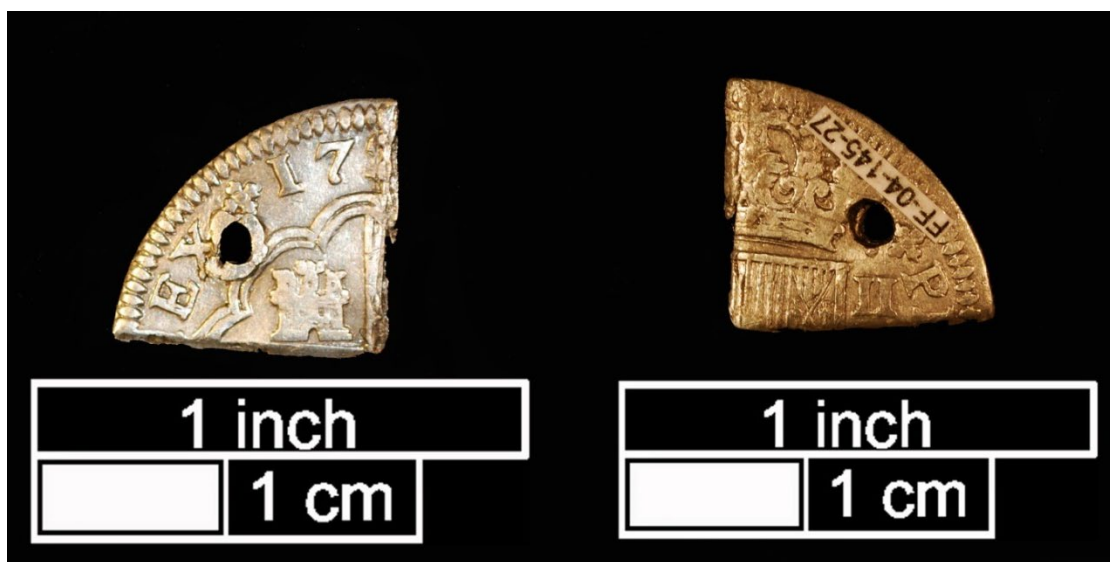
Figure 5. Quartered and Drilled Spanish Coin, Ferry Farm root cellar.

The small finds from all three structures support the contention that the buildings served as homes of enslaved people. Each contained a variety of artifacts associated with domestic occupations. Several different types of artifacts were present at all three including clothing items (shoe buckles and buttons), coins, ammunition, table accoutrements (table glass and knives) and sewing items (straight pins and scissors). Thimbles were recovered from both Palace Lands and Ferry Farm. Of particular note were the coins found at Ferry Farm's root cellar and North Hill quarter. They were quartered and featured a drilled hole, attributes that are frequently ascribed to coins owned by enslaved people.
