A Storage Building at the Washington-Era Ferry Farm  
(George Washington's Boyhood Home National Historic Landmark):  
Archaeological and Historical Documentation and Evidence  
for Proposed Implementation of Phase 1-B of a Landscape  
Rehabilitation

March 2021

## **Documentation of Storage Building and Landscape Rehabilitation, in Relation to NPS Conservation Easement and Reviews**

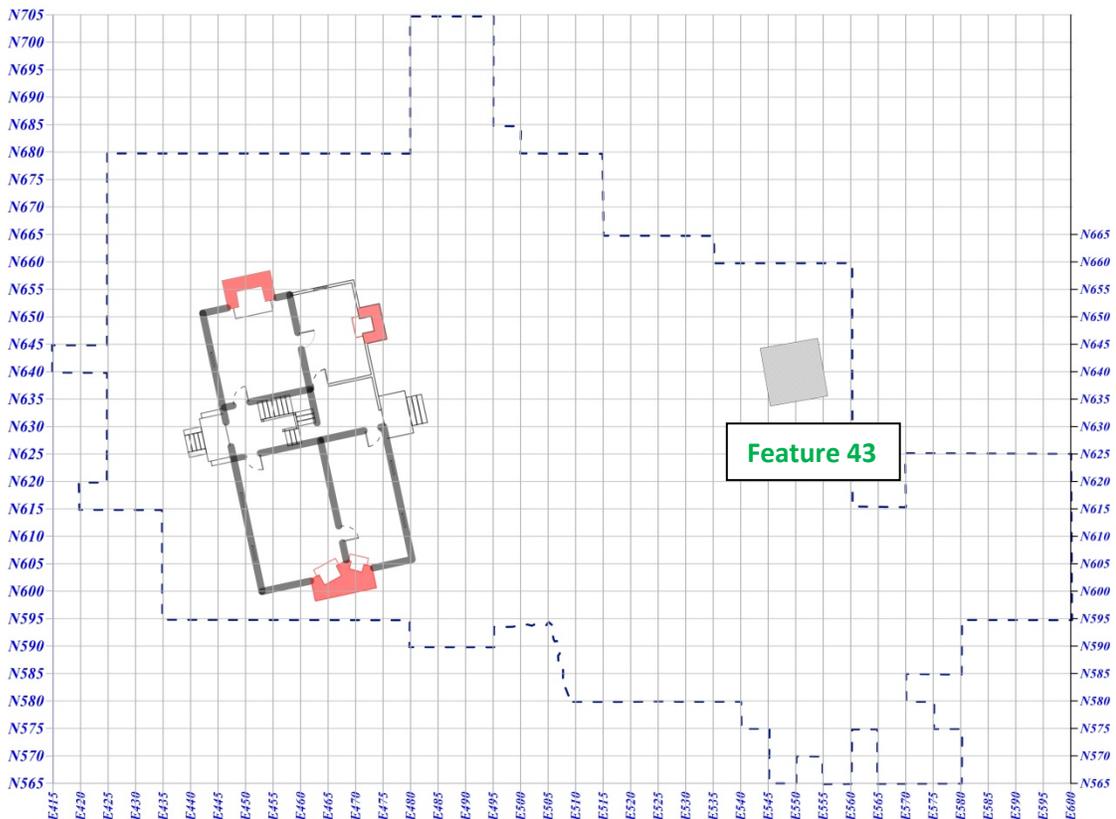
Figure 1. Location of Storage Building (right) in relationship to the Washington House (left).

Feature 43 is a medium sized, colonial-era cellar and the only architectural remnant of a dependency structure once a prominent element of the Washington-dwelling workyard at Ferry Farm. George Washington Foundation archaeological staff uncovered it during the FF20 excavation in 2013 and located about 65 ft. east from the center back (east wall) of the Washington house. Feature 43 was nearly square in shape and measured 7.8 ft. by 8.0 ft. The cellar was intruded by two twentieth-century utility trenches: Feature 12 cut the southwest corner and Feature 23 impacted the east edge.

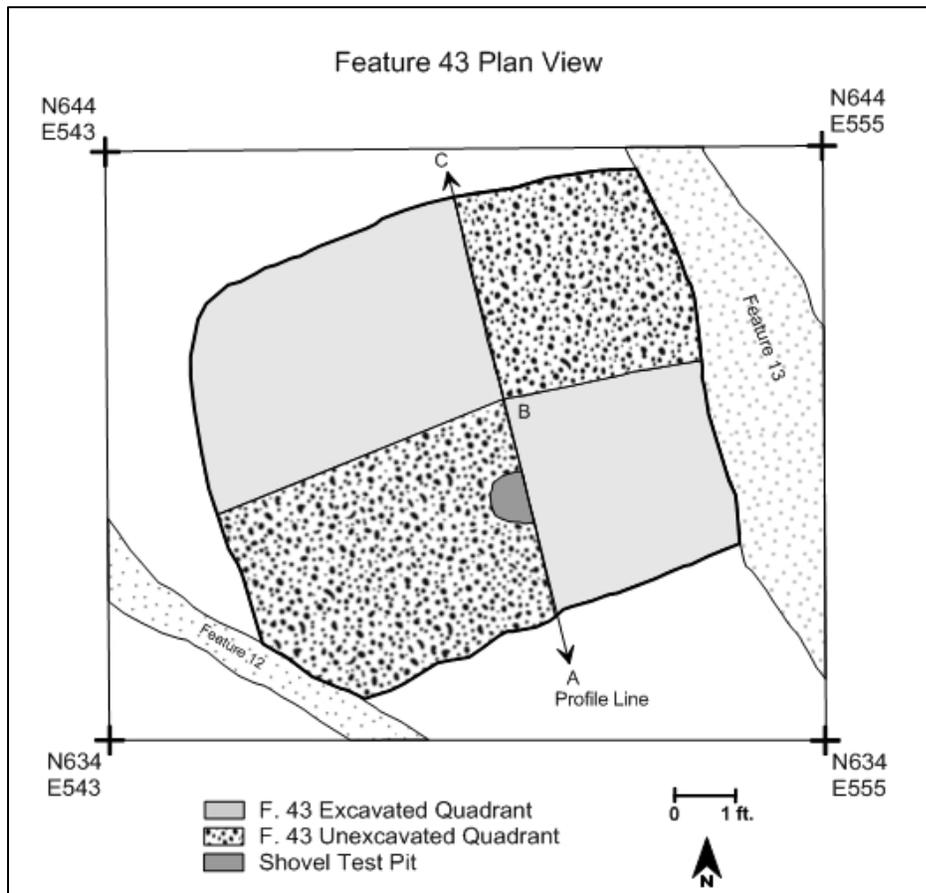
Figure 2. Feature 43 Plan View.

Other than being vertically clipped by two twentieth-century utility features, the cellar was found horizontally intact (not truncated by plowing) and was encountered below undisturbed stratigraphy. The stratigraphic location of the frame outbuilding which this cellar served suggests that it was built by William Strother III, who sold the plantation to Augustine Washington. The artifacts found within the excavated layers, including ceramics, suggests the outbuilding was demolished in the second half of the eighteenth century.

Two quadrants of the feature were excavated – the northwest and southeast, leaving the other two quadrants in situ. The cellar intruded subsoil to a depth of 2.9 ft. The cellar walls were

unlined and the floor made of subsoil. There were impressions of sills on the north and south side of the structure indicating a wooden structure once sat directly on the ground. No evidence of a fireplace or a floor was present.

The structure covered a large storage pit. This unlined feature measured approximately 8.0 ft. (N-S) by 8.0 ft. (E-W) and intruded the ground to a depth of 2.9 ft. deep. The intact vertical sides of the pit indicate those were always protected by a building. No silt was uncovered at the lowest levels of the pit confirming that a building served to protect the pit from collapse. On opposite sides of the pit are impressions left by bearing members of some kind. These impressions are parallel to the adjacent sides of the pit, one on each side, and indicate that the building was only slightly larger than the pit itself. The size and nature of the pit precludes the building from serving as housing for enslaved individuals.

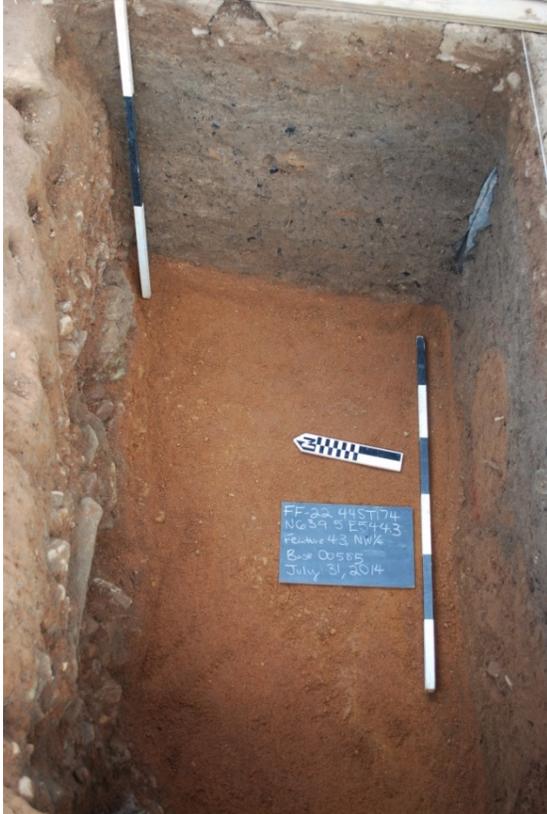
Figure 5. Feature 43 Northwest Quadrant After Excavation.

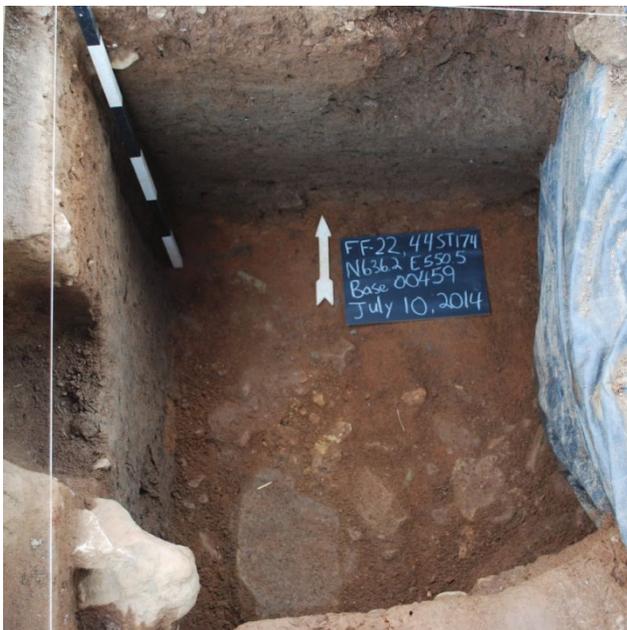
Figure 6. Feature 43 Southeast Quadrant After Excavation.

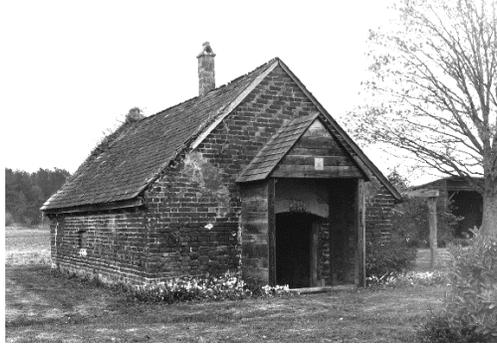
Figure 9. Wessels Root Cellar, Northampton County, VA, probably late 18<sup>th</sup> century.

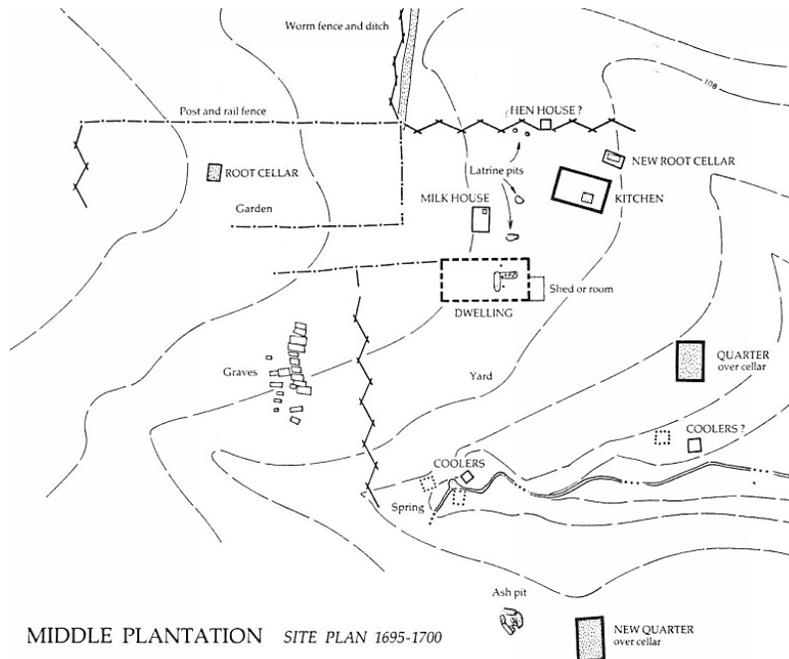
Archaeology further demonstrates the point. On 17<sup>th</sup>-century sites, brick-lined cellars are more often associated with outbuildings, than with houses. Middle Plantation in Anne Arundel County Maryland supplies an example. By c. 1700, the site had at least two quarters built over full cellars, while two detached cellar features were also extant at the time. During this same period, the main house had only a few small storage pits.

Figure 10. From: “Impermanent Architecture of the Southern Colonies,” *Winterthur Portfolio*, 1981.

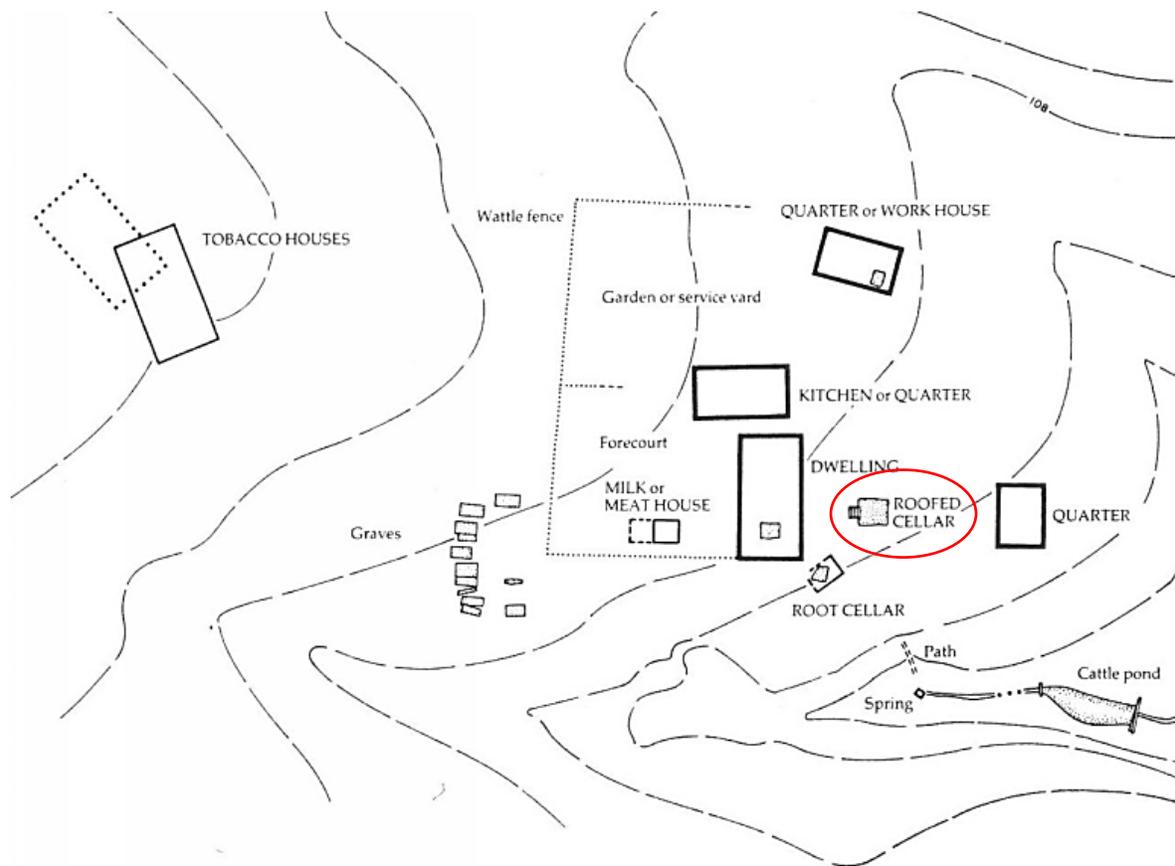
MIDDLE PLANTATION SITE PLAN 1730-35

By c. 1720, the earlier cellars on this Maryland site had disappeared, while a sizable “Roofed Cellar” and a smaller “root cellar,” both free-standing, had been created in the meantime. Still, there was no cellar in the main house (Figure 11).

Figure 11. From: “Impermanent Architecture of the Southern Colonies,” *Winterthur Portfolio*, 1981.

The archaeological and historical evidence at Ferry Farm indicates that a “roofed cellar,” similar to that discovered at Middle Plantation, existed in the Washington work yard. Colonial plantations grew plants for both food and medicine that required specialized storage. The main purpose of the storage building was to preserve roots, vegetables, and fruits—a purpose reflected in its design- and construction choices.
