# Enchanted Valley Chalet National Historic Preservation Act Section 106 Consultation

Public Informational Session  
November 15, 2021

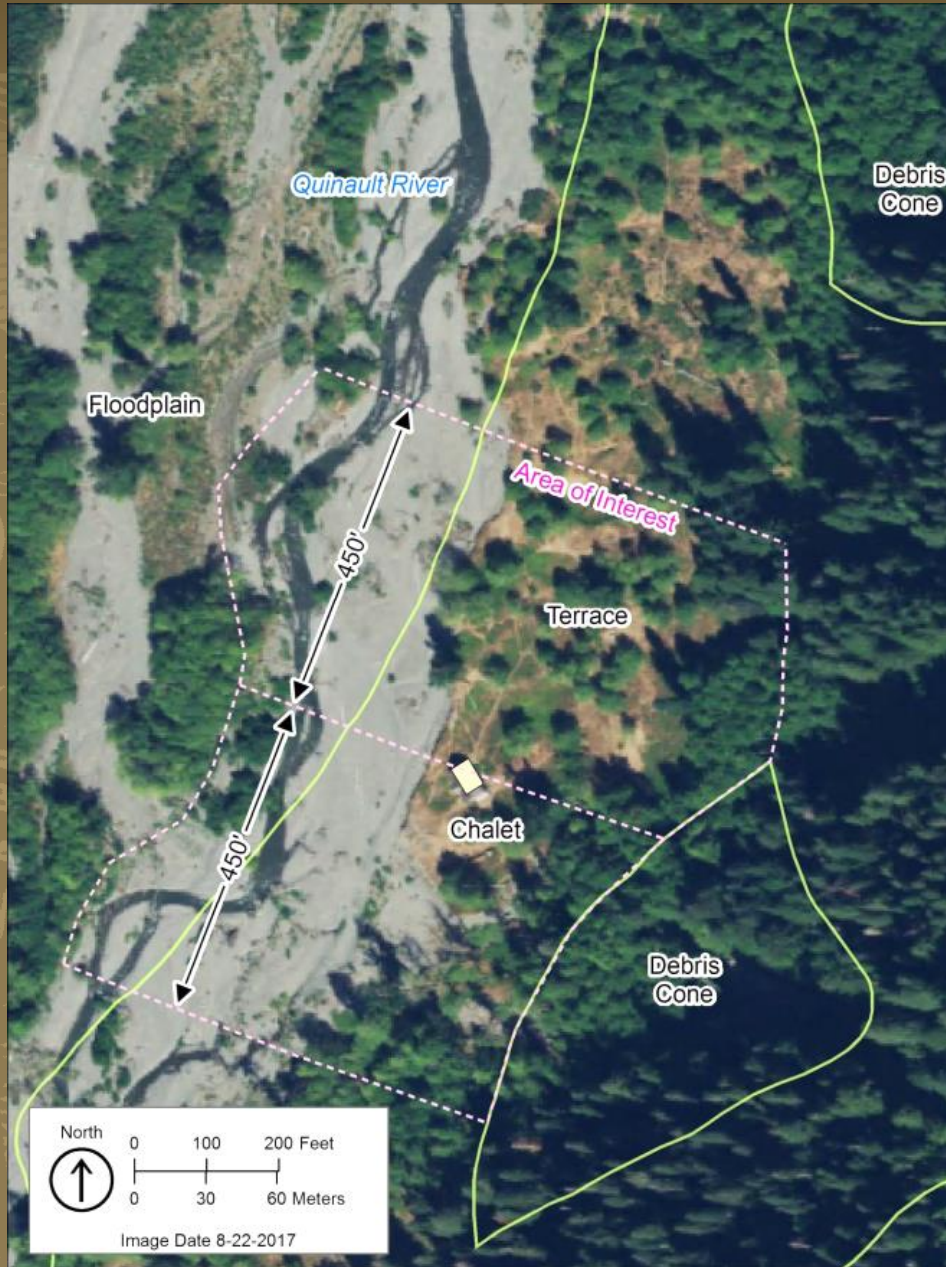
**Hazard analysis area  
(potential move sites)**

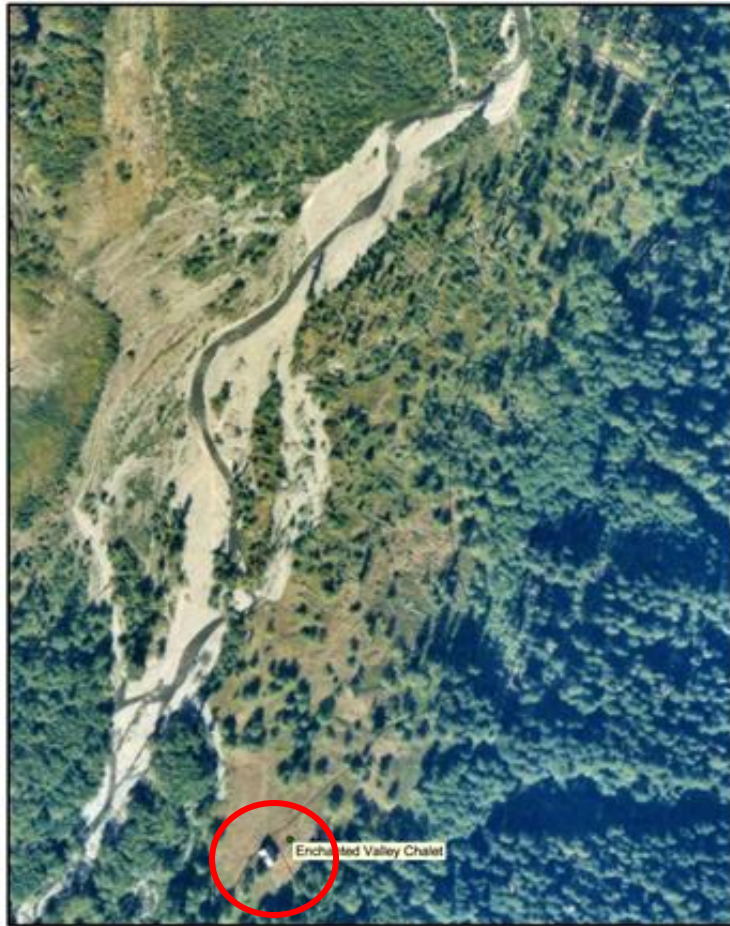
Enchanted Valley  
Year 2002

0 100 200 300 400 Feet

Scale 1:3,000

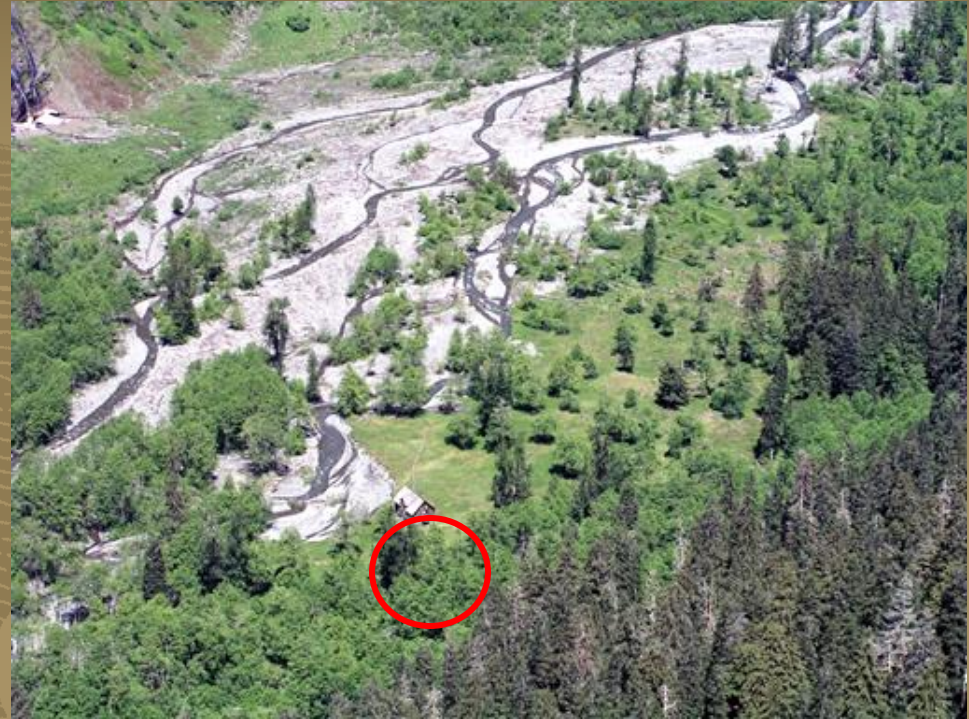
Above Image: 2004

Left Image: 2002

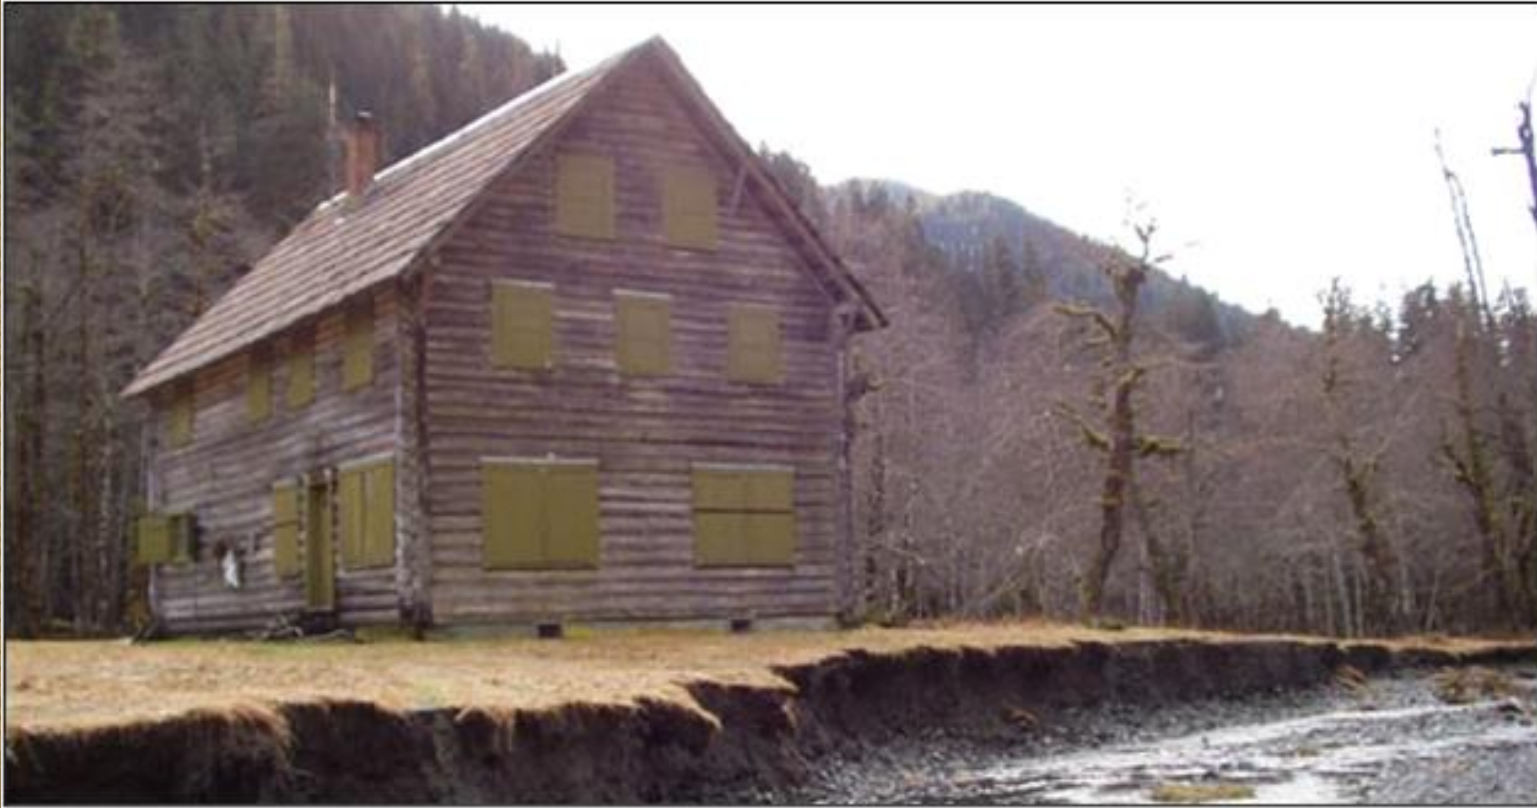
Between 1990 and 2006, the river moved over 350 feet, threatening the chalet for the 1<sup>st</sup> time.

Photo interval	Channel change (feet)	Annual rate (feet/year)
1990-2006	350.0	21.9
2006-2013	11.2	1.6
2013-2015	16.2	8.1
2015-2016	20.5	21.0

Average annual bank erosion was 15.3 feet/year (4.7 meters) from 1990 to 2016.

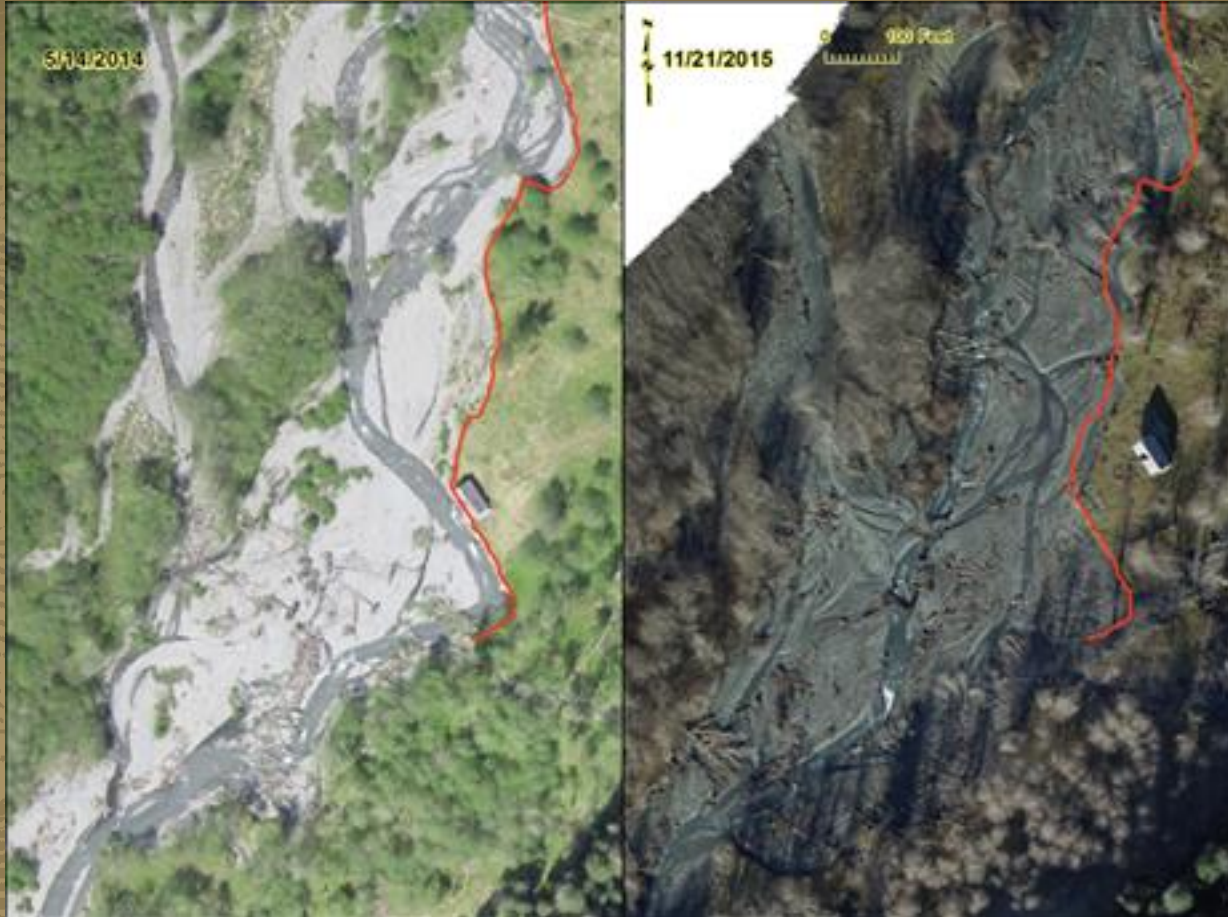
In 2013, the river was on the move again, undermining the chalet in early 2014.

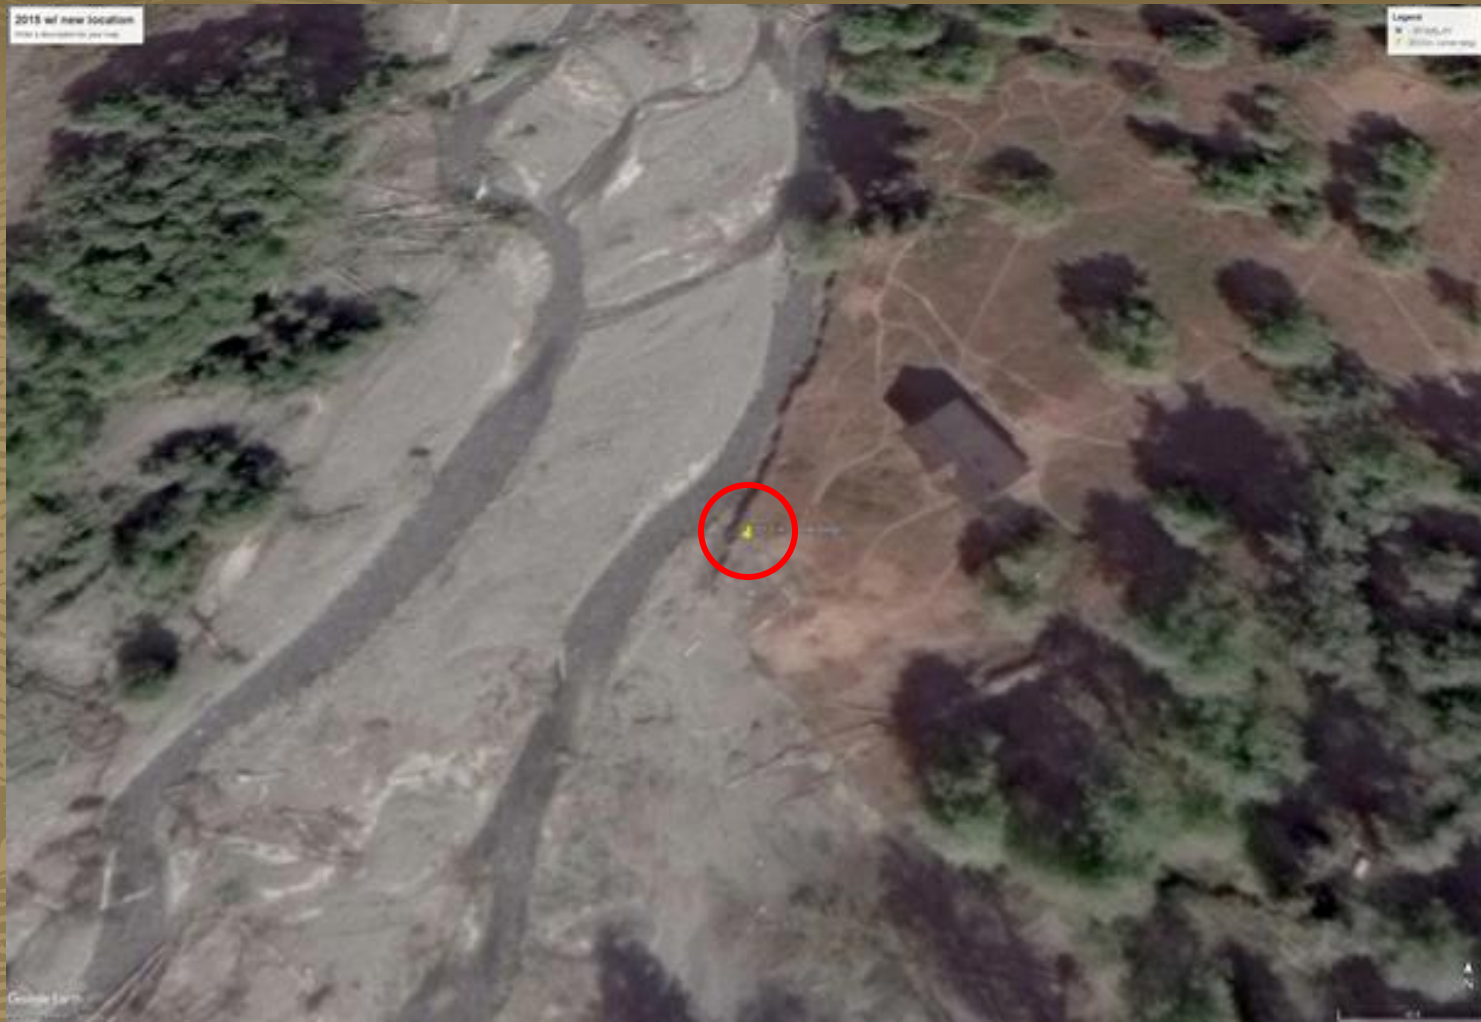
The chalet was moved to its present location Sept. 2014.

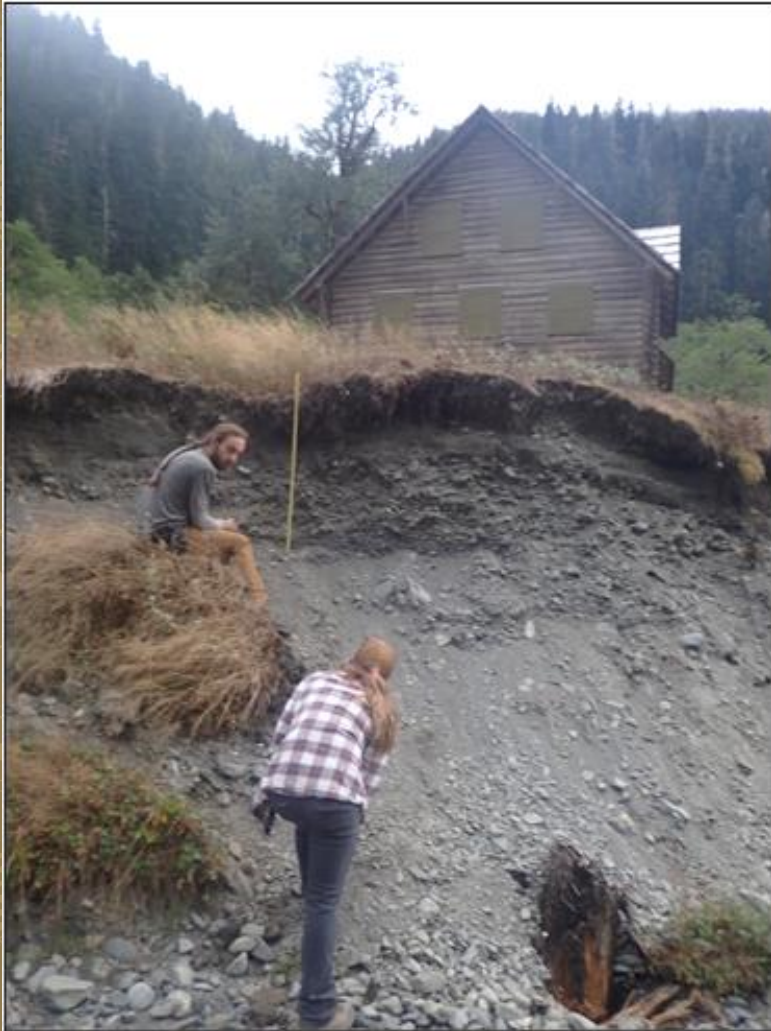
- Despite precautions, sample #189, tested as a recent tree.
- Sample #203 represents a max terrace age of  $\sim 1,500$  AD;
- Conventional radiocarbon age of sample #203 is  $320 \pm 30$  before present (BP), which corresponds to the age range of 1482 AD to 1594 AD years old (calibrated dates, 95% probability)

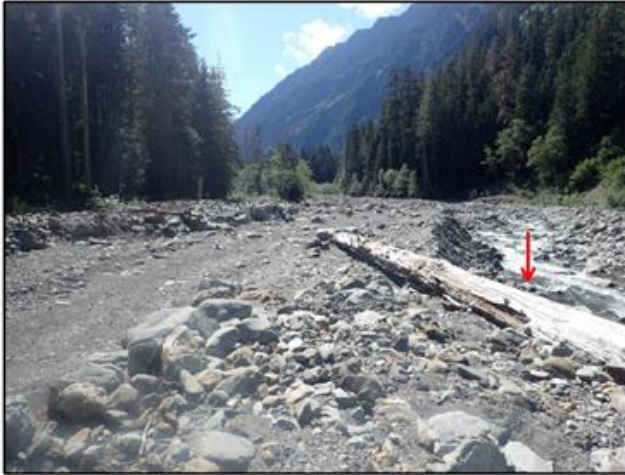
1st  
Order

Figure 19. Mature (incised) 1<sup>st</sup> order bulge.

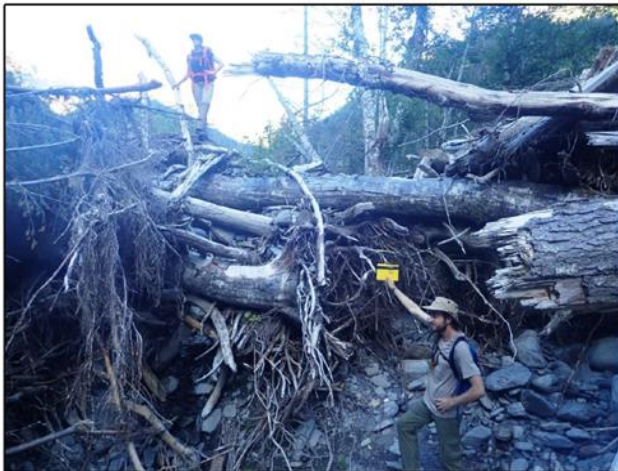
3rd  
Order

Figure 21. 3<sup>rd</sup> order bulge

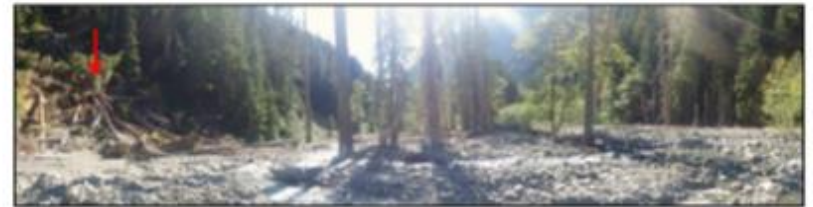
Figure 18. Bulge associated trail damage (a, b)

(a) Stream pushed valley left (looking downstream). Note valley wall erosion (arrow).

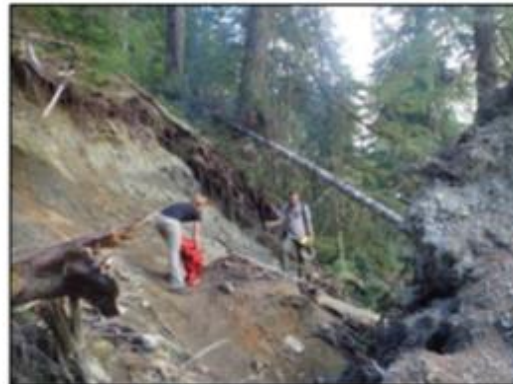
2nd Order

(b) Associated trail damage (higher up, valley left).
