United States Department of the Interior

NATIONAL PARK SERVICE
Denali National Park & Preserve
Mile 237 Parks Highway
P.O. Box 9
Denali Park, AK 99755

Subject: National Historic Preservation Act Section 106 Consultation for the Polychrome Area Improvements Project

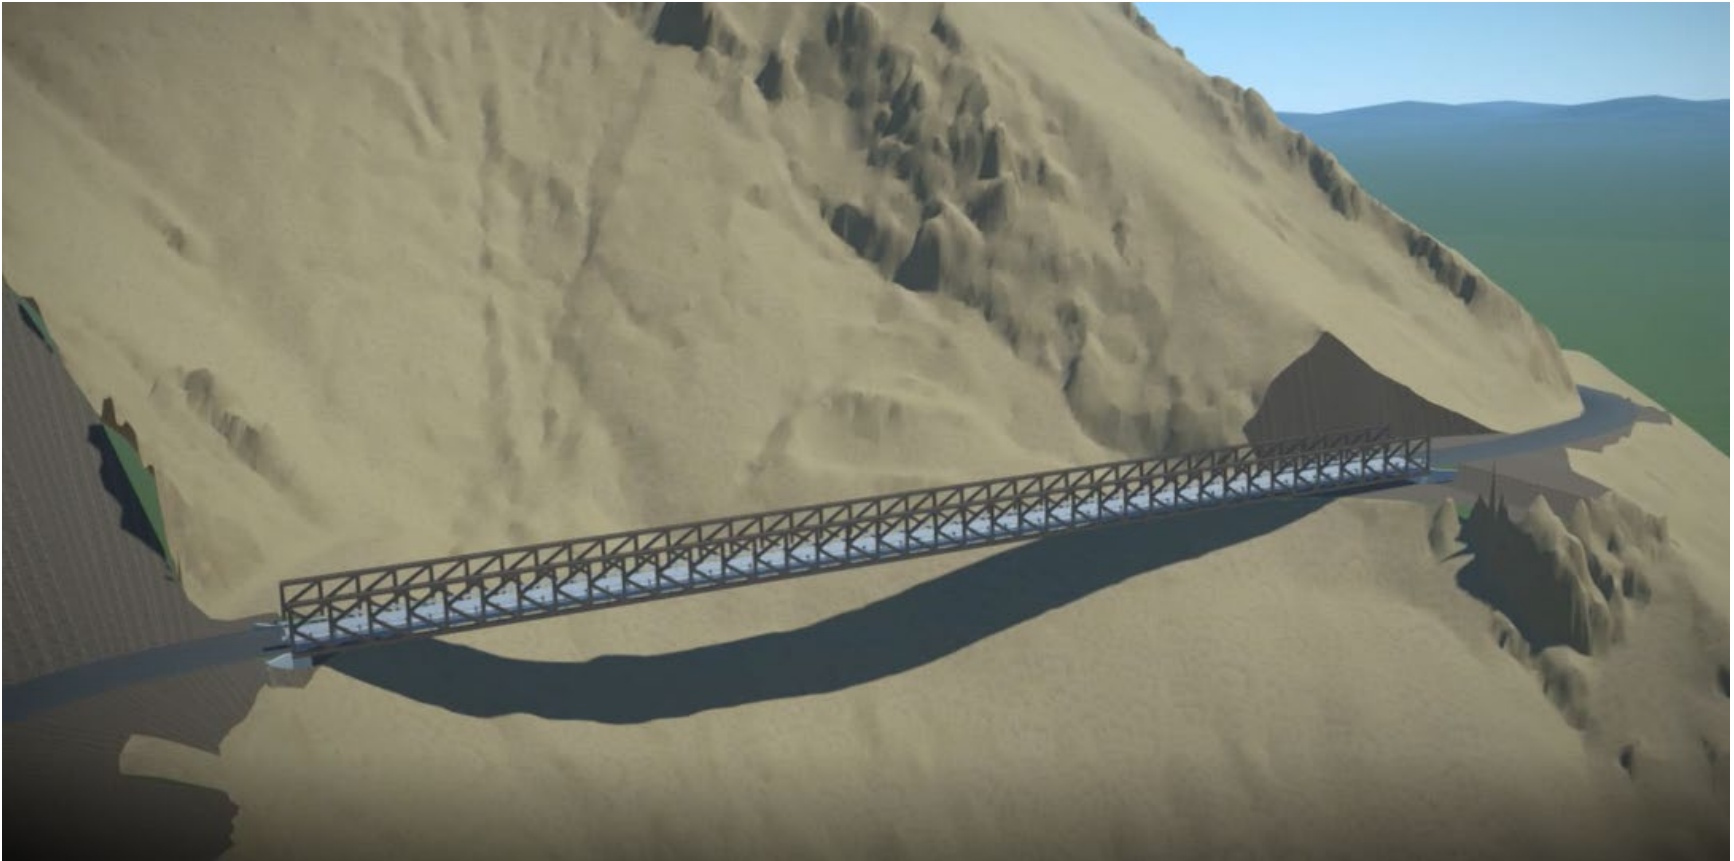
FIGURE 2. DIGITAL REPRESENTATION OF THE PROPOSED PRETTY ROCKS BRIDGE (LOOKING EAST)

Note: The darker areas on each side of the bridge show where excavation would take place. The dark area under the bridge depicts the shadow of the bridge.

The NPS would construct a steel bridge spanning the Pretty Rocks Landslide site (Figure 2). The bridge would be approximately 400 feet long and have an overall width of 24 feet and would be attached to abutments at both ends. Abutments would be concrete and steel pilings drilled into the bedrock. The bridge would be one lane and traffic would stop at existing pullouts at either end, yielding to vehicles on the bridge.

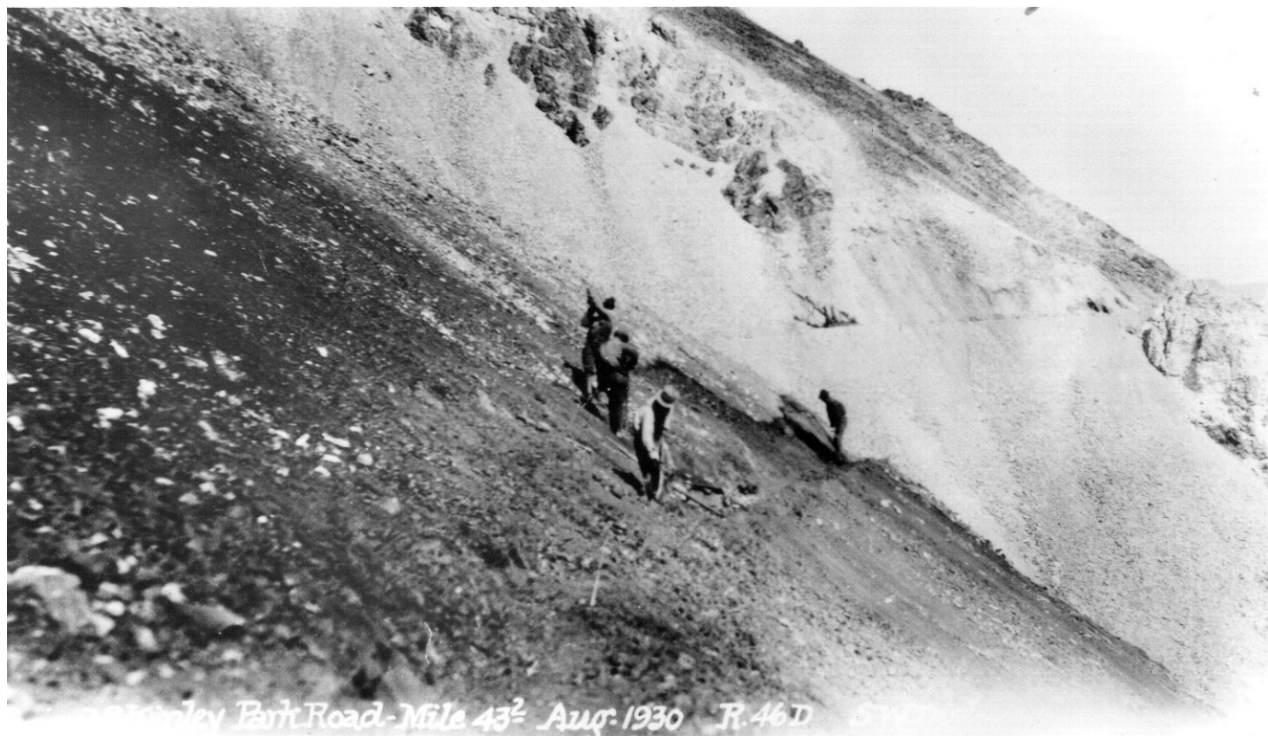
FIGURE 6. ETCHING THE ROAD IN AT PRETTY ROCKS (LOOKING EAST), AUGUST 1930 (ALASKA STATE LIBRARY, ALASKA ROAD COMMISSION COLLECTION, 61-2-230).

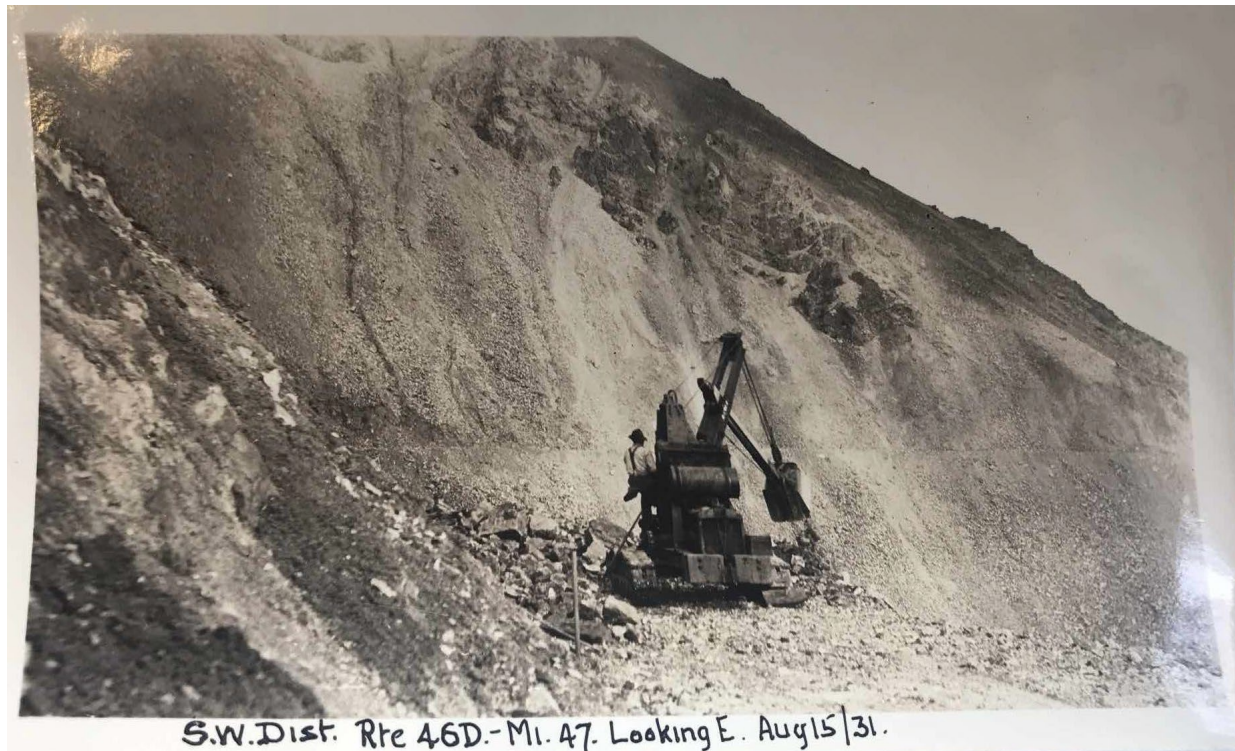
FIGURE 7. HIGH LINE ROAD BEING BUILT AT PRETTY ROCKS IN AUGUST OF 1931 (EDMUNDS COLLECTION, BOX 1, ANCHORAGE MUSEUM).

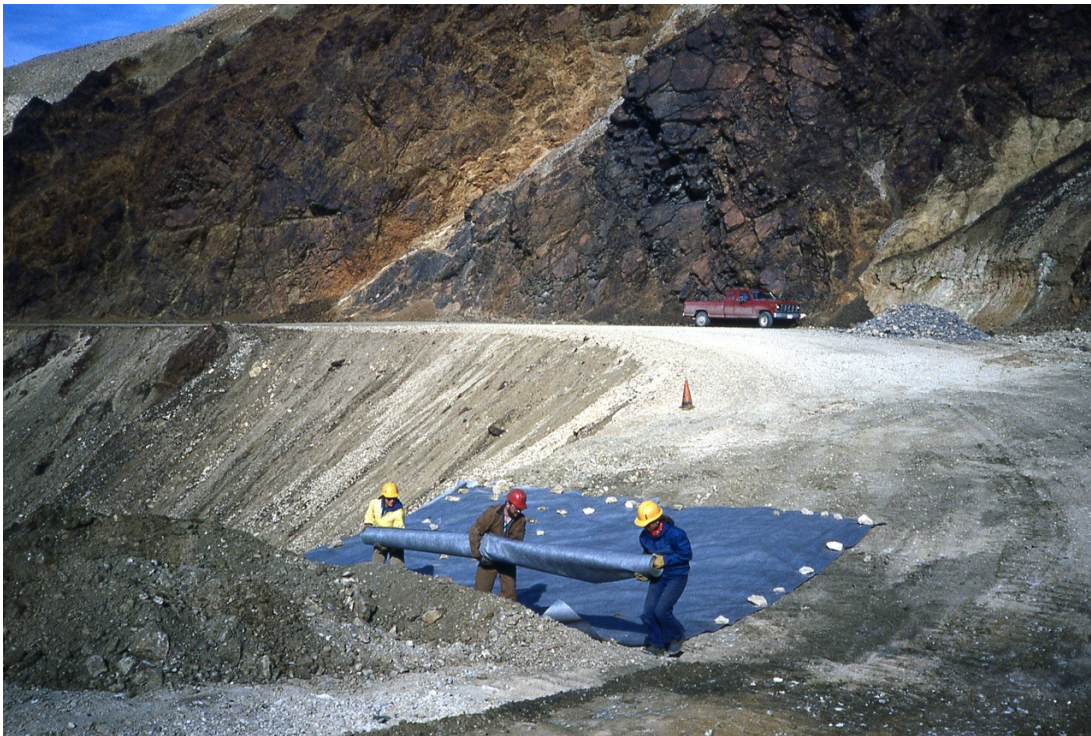
FIGURE 12. INSTALLING GEOSYNTHETIC LAYER REINFORCEMENT AT PRETTY ROCKS, 1987 (FEDERAL HIGHWAYS PHOTO).

resulted in road travel being prohibited or restricted over a 9-day period until conditions stabilized (NPS 1990). In 1987, drains and geotextile were placed at Pretty Rocks in an effort to mitigate the slumping (NPS 1986); these have failed in subsequent years.

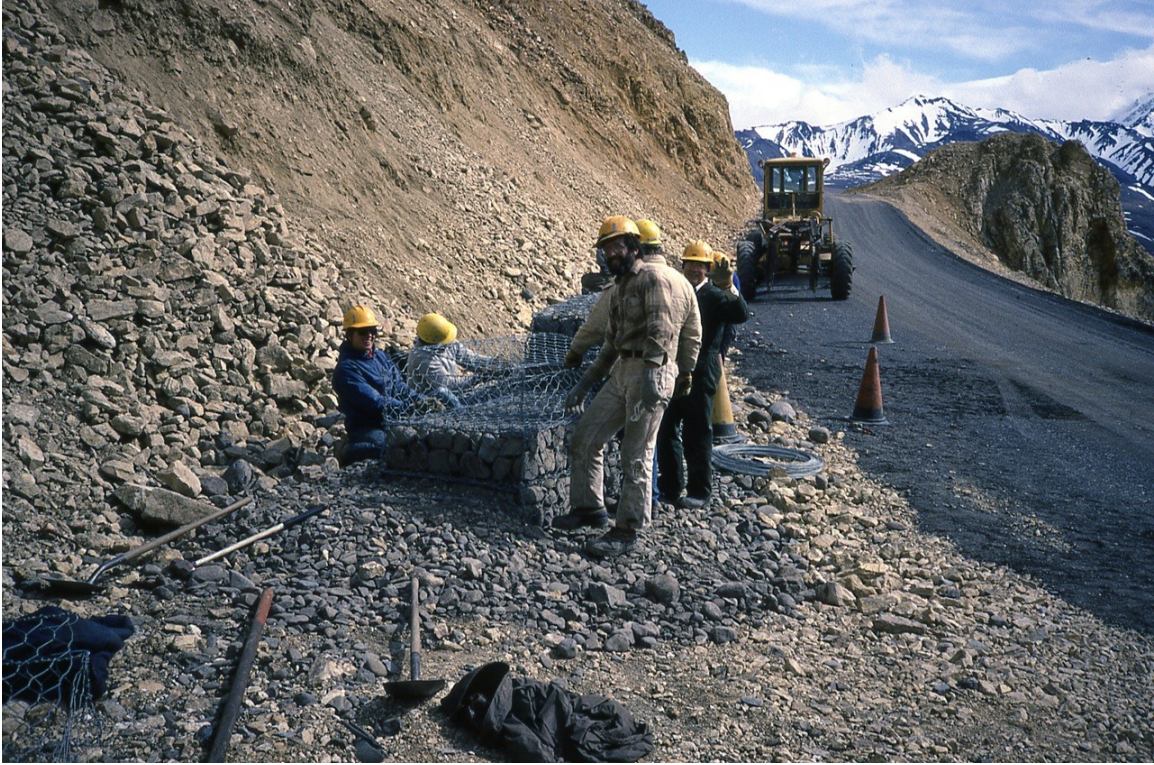
FIGURE 13. INSTALLING SUBSURFACE DRAINAGE, PRETTY ROCKS, 1987 (FEDERAL HIGHWAYS PHOTO).

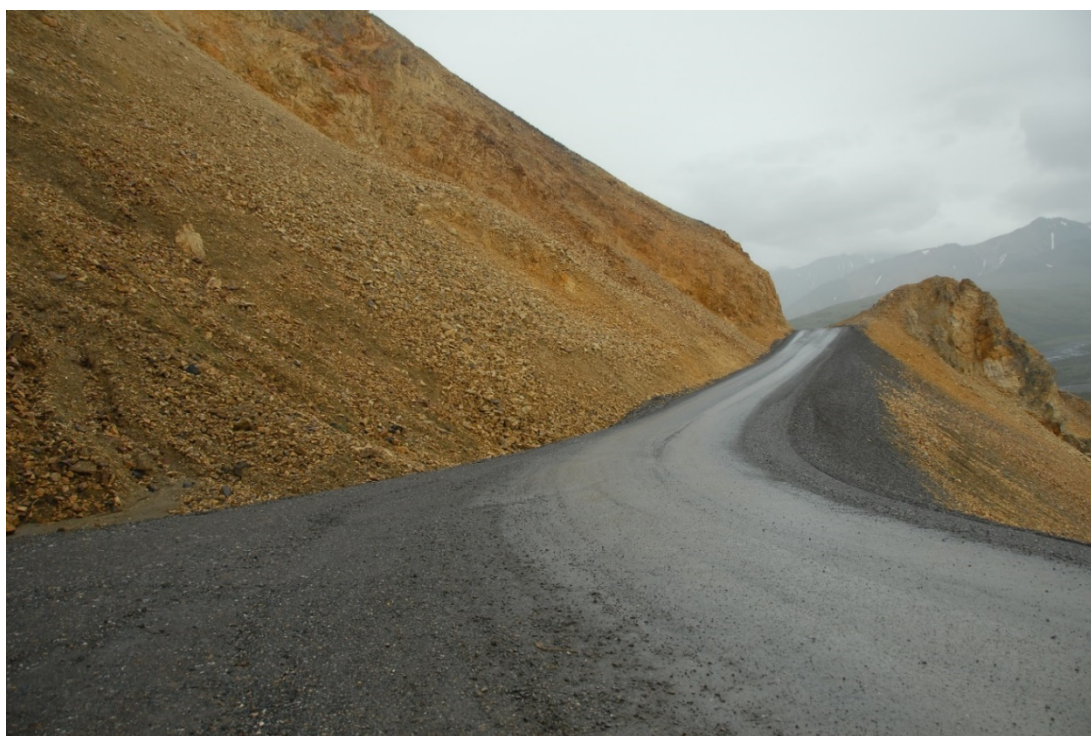
FIGURE 16. PRETTY ROCKS LANDSLIDE LOOKING EAST, AUGUST 2014 (NPS PHOTO).

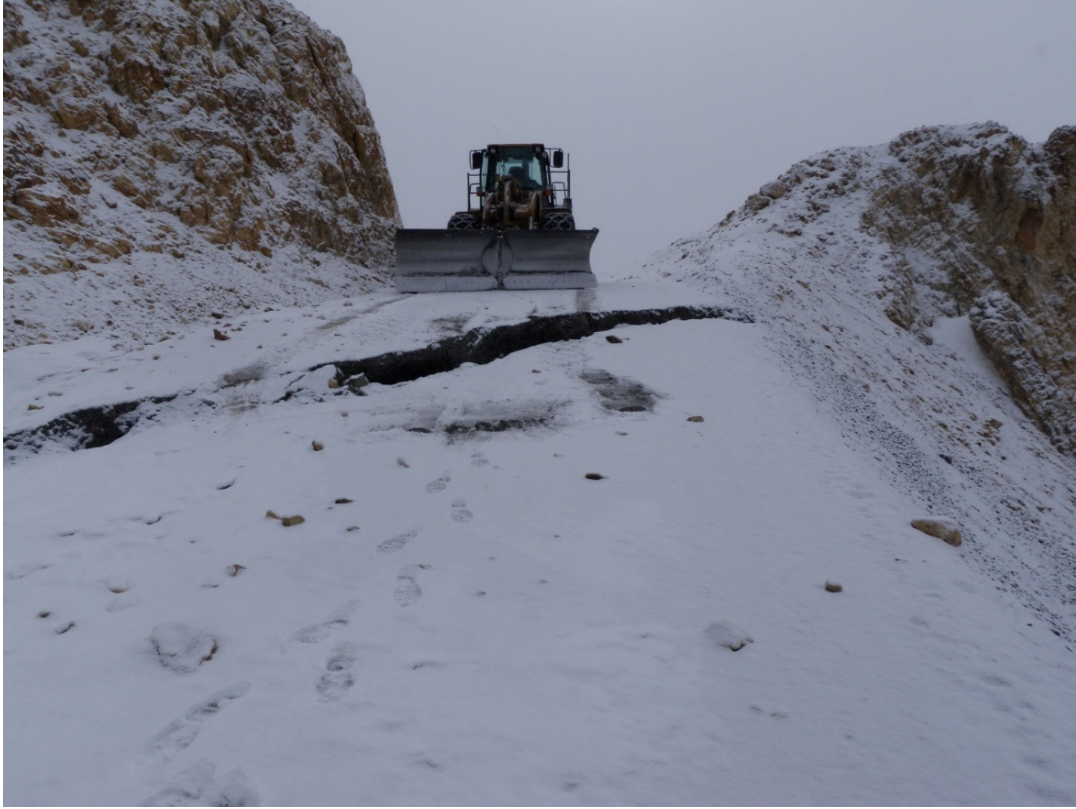
FIGURE 17. PRETTY ROCKS LANDSLIDE LOOKING EAST WITH SLUMPED/ CRACKED ROAD, APRIL 2015 (NPS PHOTO).

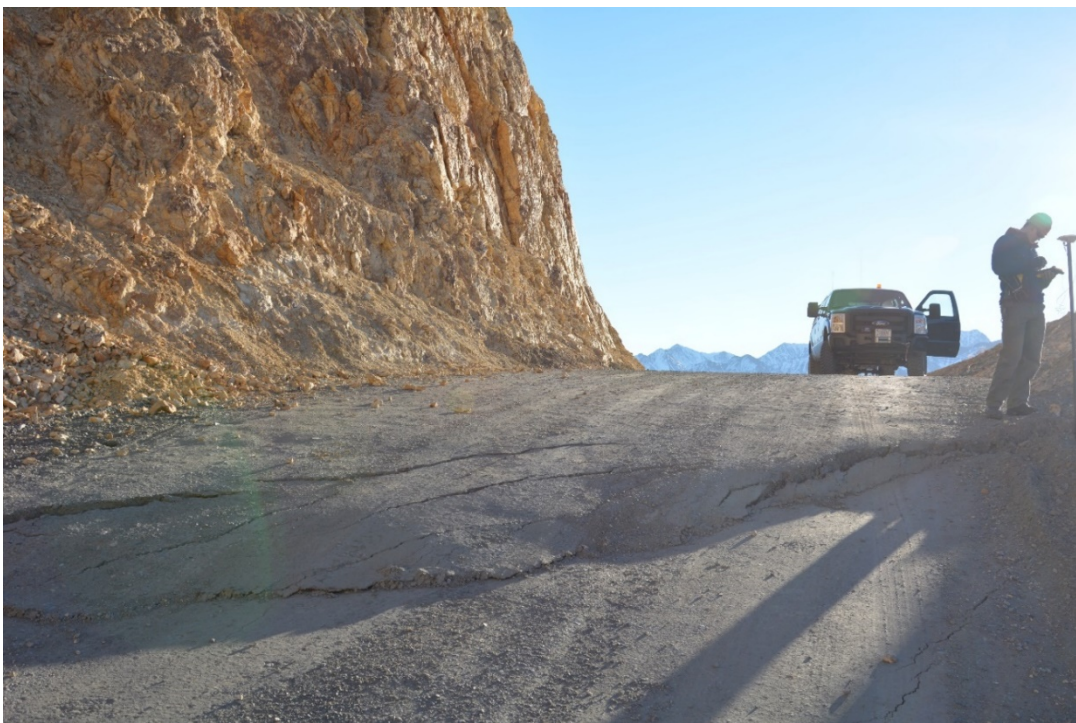
FIGURE 18. PRETTY ROCKS LANDSLIDE LOOKING EAST, OCTOBER 2016 (NPS PHOTO).

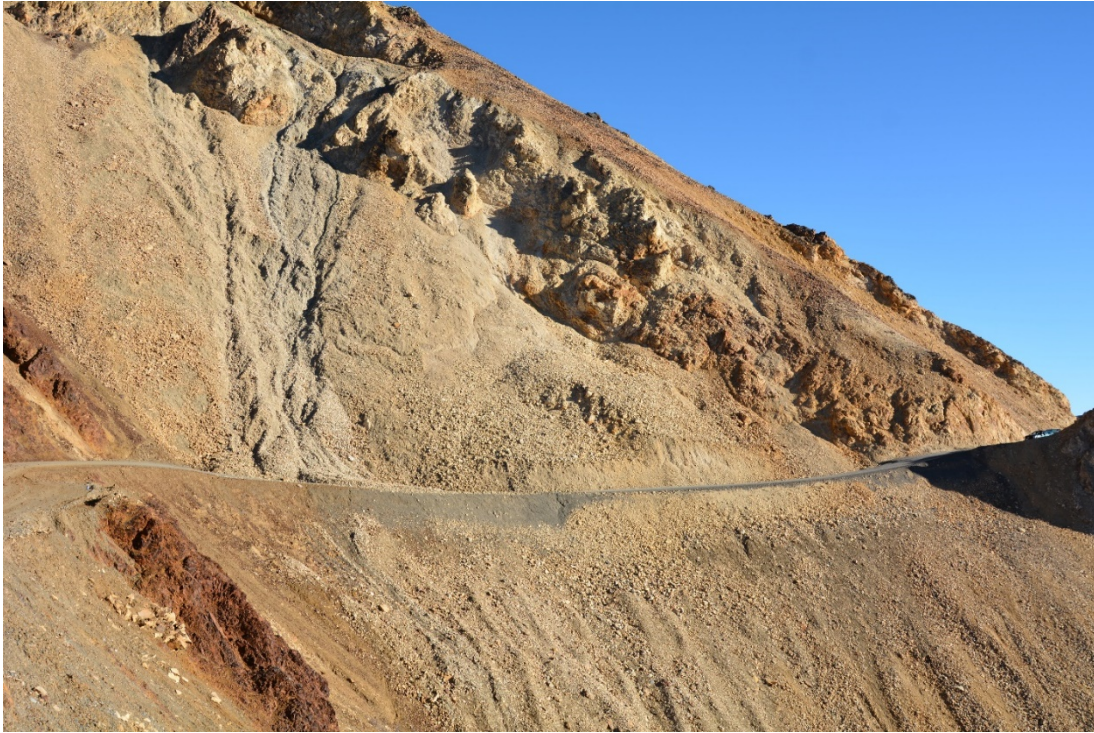
FIGURE 19. PRETTY ROCKS LANDSLIDE LOOKING NORTHEAST, OCTOBER 2016 WITH EVIDENCE OF ROCK SIDE ON MOUNTAIN FACE ABOVE THE ROAD (NPS PHOTO).

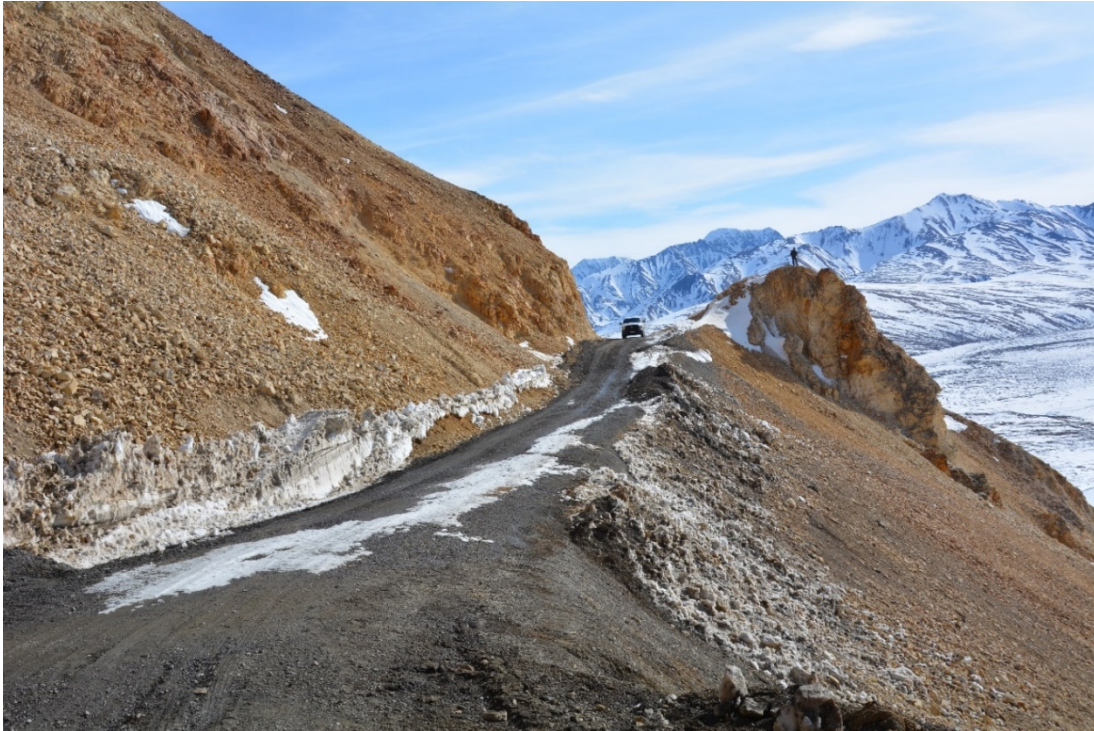
FIGURE 20. PRETTY ROCKS SLUMP LOOKING EAST WITH SLUMP, SPRING 2016 (NPS PHOTO)

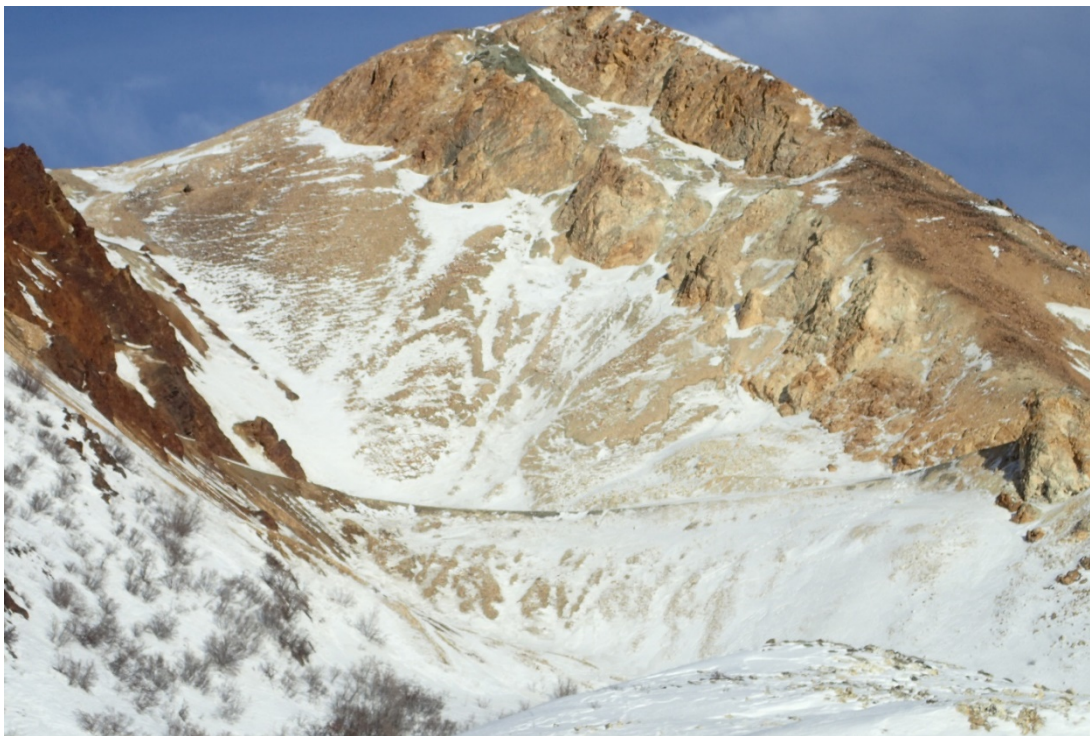
FIGURE 21. PRETTY ROCKS LANDSLIDE LOOKING NORTH, FEBRUARY 2018 (NPS PHOTO)

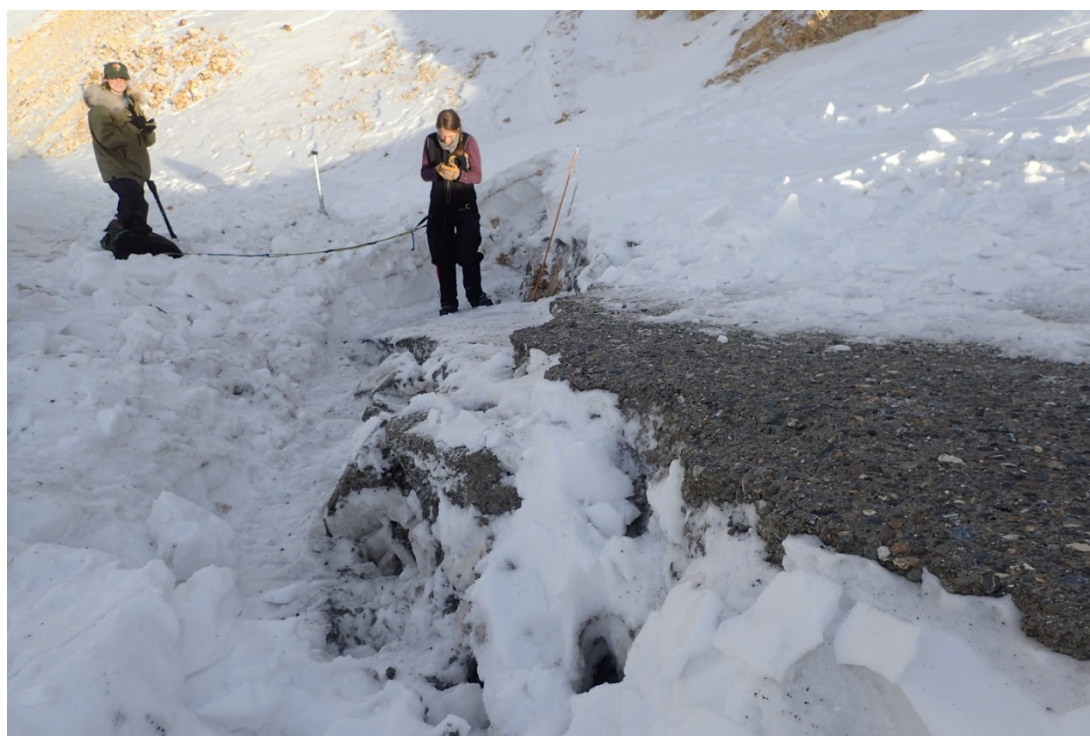
FIGURE 22. PRETTY ROCKS LANDSLIDE, FEBRUARY 2018; PEOPLE ARE STANDING ON SLUMPED SECTION OF ROAD, GRAVEL IN FOREGROUND IS UNSLUMPED ROAD (NPS PHOTO).

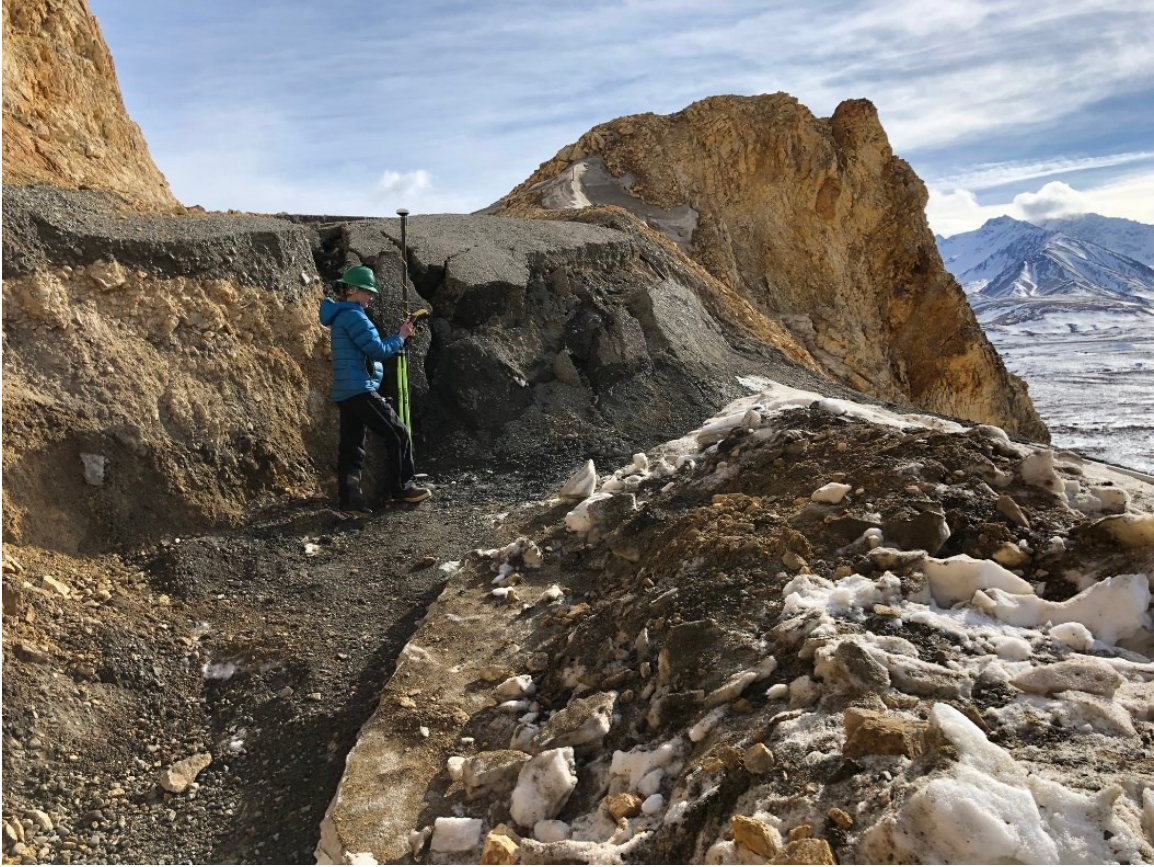
FIGURE 23. THE EASTERN PRETTY ROCKS LANDSLIDE SCARP THROUGH THE ROAD ON 3/22/2019. THE ROAD HAD BEEN LAST GRADED ON 9/14/2018. SURVEY ROD HELD BY PARK EMPLOYEE IS 6.5 FEET (2.0 M) TALL AND IS PLACED NEAR CENTER-LINE OF THE ROAD (NPS PHOTO).

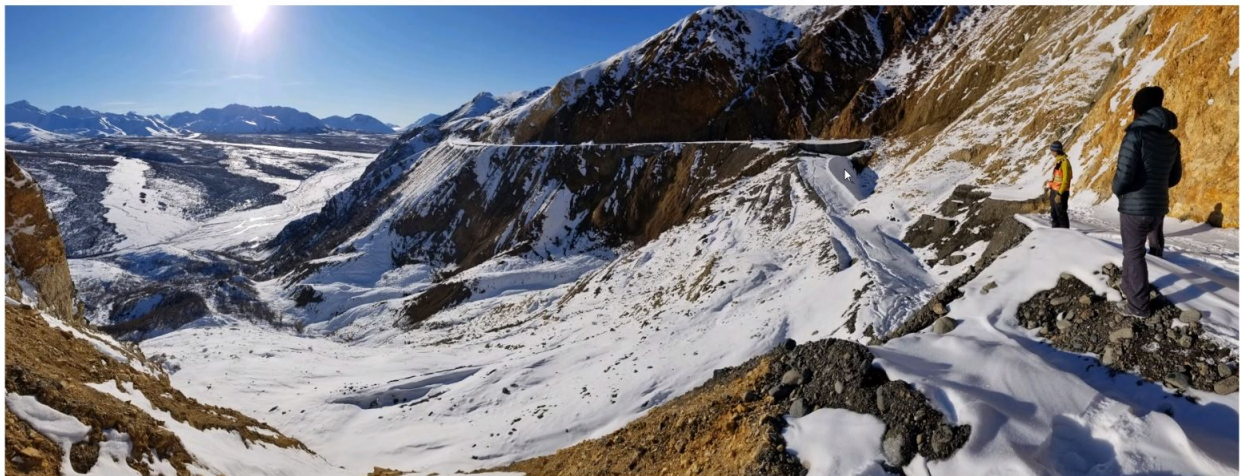
FIGURE 24. PANORAMIC VIEW OF EASTERN PRETTY ROCKS LANDSCAPE SCARP THROUGH THE ROAD ON 09/28/2021.

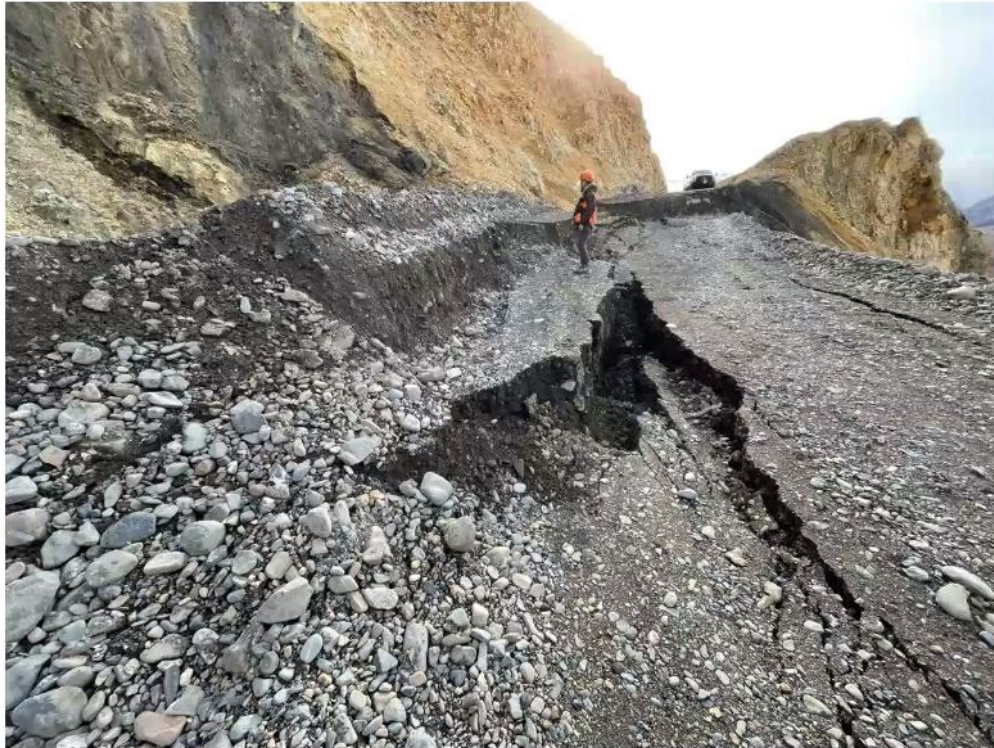
FIGURE 25. VIEW OF EASTERN PRETTY ROCKS LANDSCAPE SCARP THROUGH THE ROAD ON 09/07/2021, LOOKING EAST.

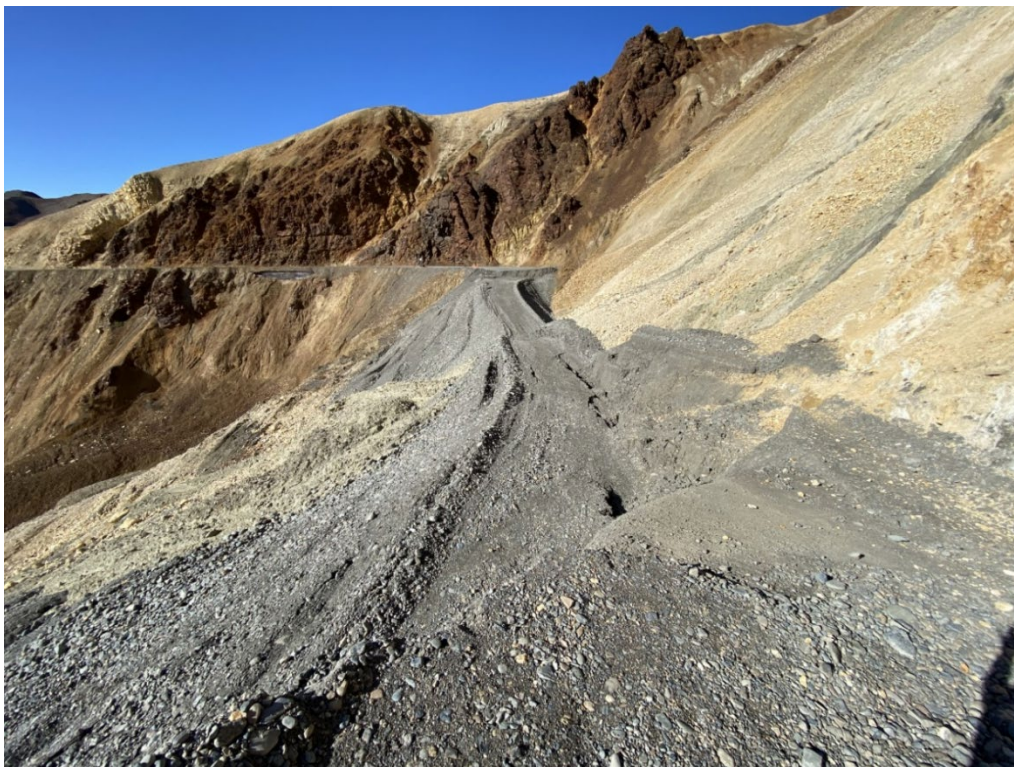
FIGURE 26. VIEW OF EASTERN PRETTY ROCKS LANDSCAPE SCARP THROUGH THE ROAD ON 09/13/2021, LOOKING WEST.
