STATEMENT OF FINDINGS
FOR
EXECUTIVE ORDER 11988 FLOODPLAIN MANAGEMENT

REPAIRS TO ADMINISTRATION BUILDING, DOCK AND GROUNDS AT RED HOOK AREA

PMIS # 244626
PEPC # 86197

VIRGIN ISLANDS NATIONAL PARK
US VIRGIN ISLANDS

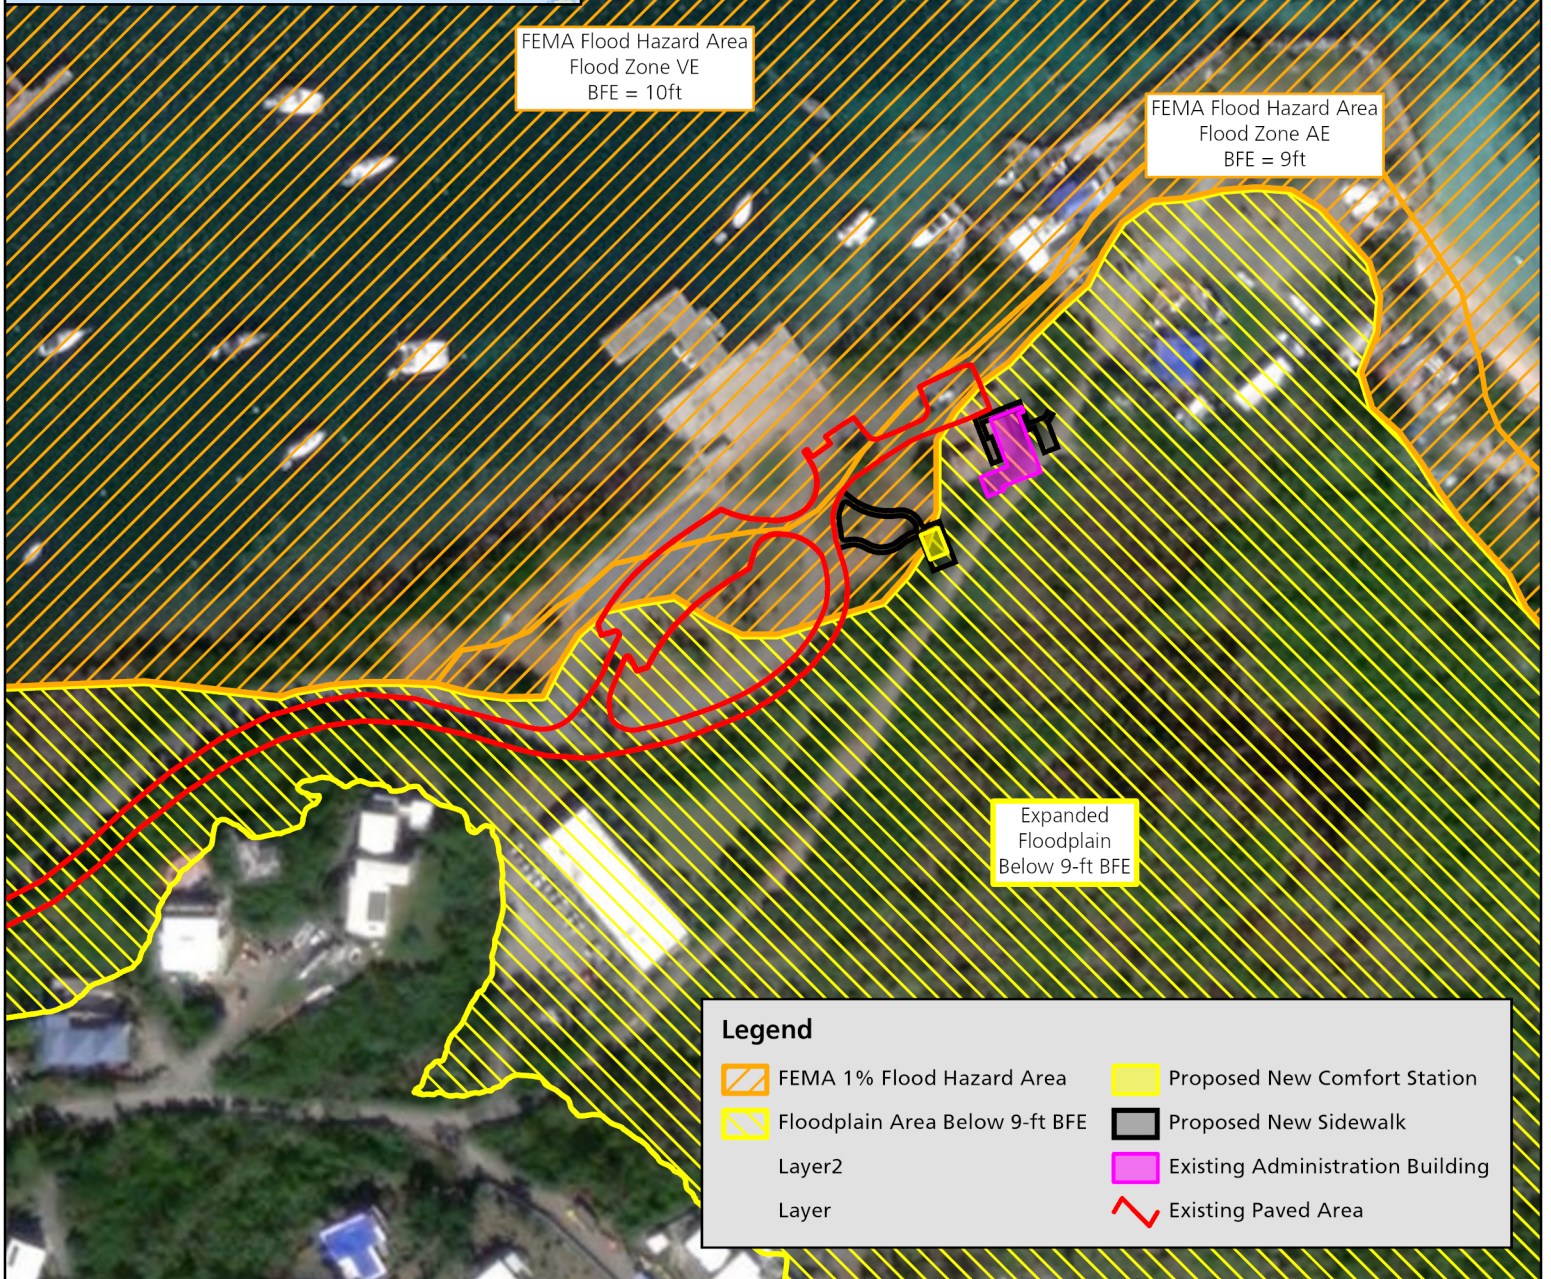
VIIS 244626 Repairs to Administration Building, Dock and Grounds at Red Hook Area (MARIA) Floodplain Map

Nearly all the grounds and structures at Red Hook are located within the FEMA 1% Annual Flood Hazard Area (See Attachment 2, Floodplain Map). Additionally, the entire Red Hook site is below the 100-year base flood elevation (BFE) of 9 feet (NAVD88), and much of it is within the coastal high hazard flood area. This facility is therefore subject to frequent inundation and high wave actions such that drainage and flooding problems often result from storms. The dominant source of flooding is wind-driven storm surge in association with hurricanes and other severe storms.

The existing Administration Building facility is located mostly in Flood Zone AE (low-lying regions subject to inundation), although portions of the ground nearest to the dock and shoreline occur in Flood Zone VE (coastal flood zone with velocity hazard due to wave action). The elevation of the grounds surrounding the Administration Building averages approximately 4 to 5 feet above sea level (NAVD88), and the Zone AE BFE at this location is 9 feet above sea level. Given the low elevation of the site, it is likely that the FEMA floodplain limits are incorrect and that additional areas outside of FEMA's defined flood hazard area are within the coastal floodplain. Therefore, additional floodplain areas below 9 feet elevation have been included in this assessment (see Attachment 2).
