Floodplain Statement of Findings

Paces Mill Unit Rehabilitation

May 2022

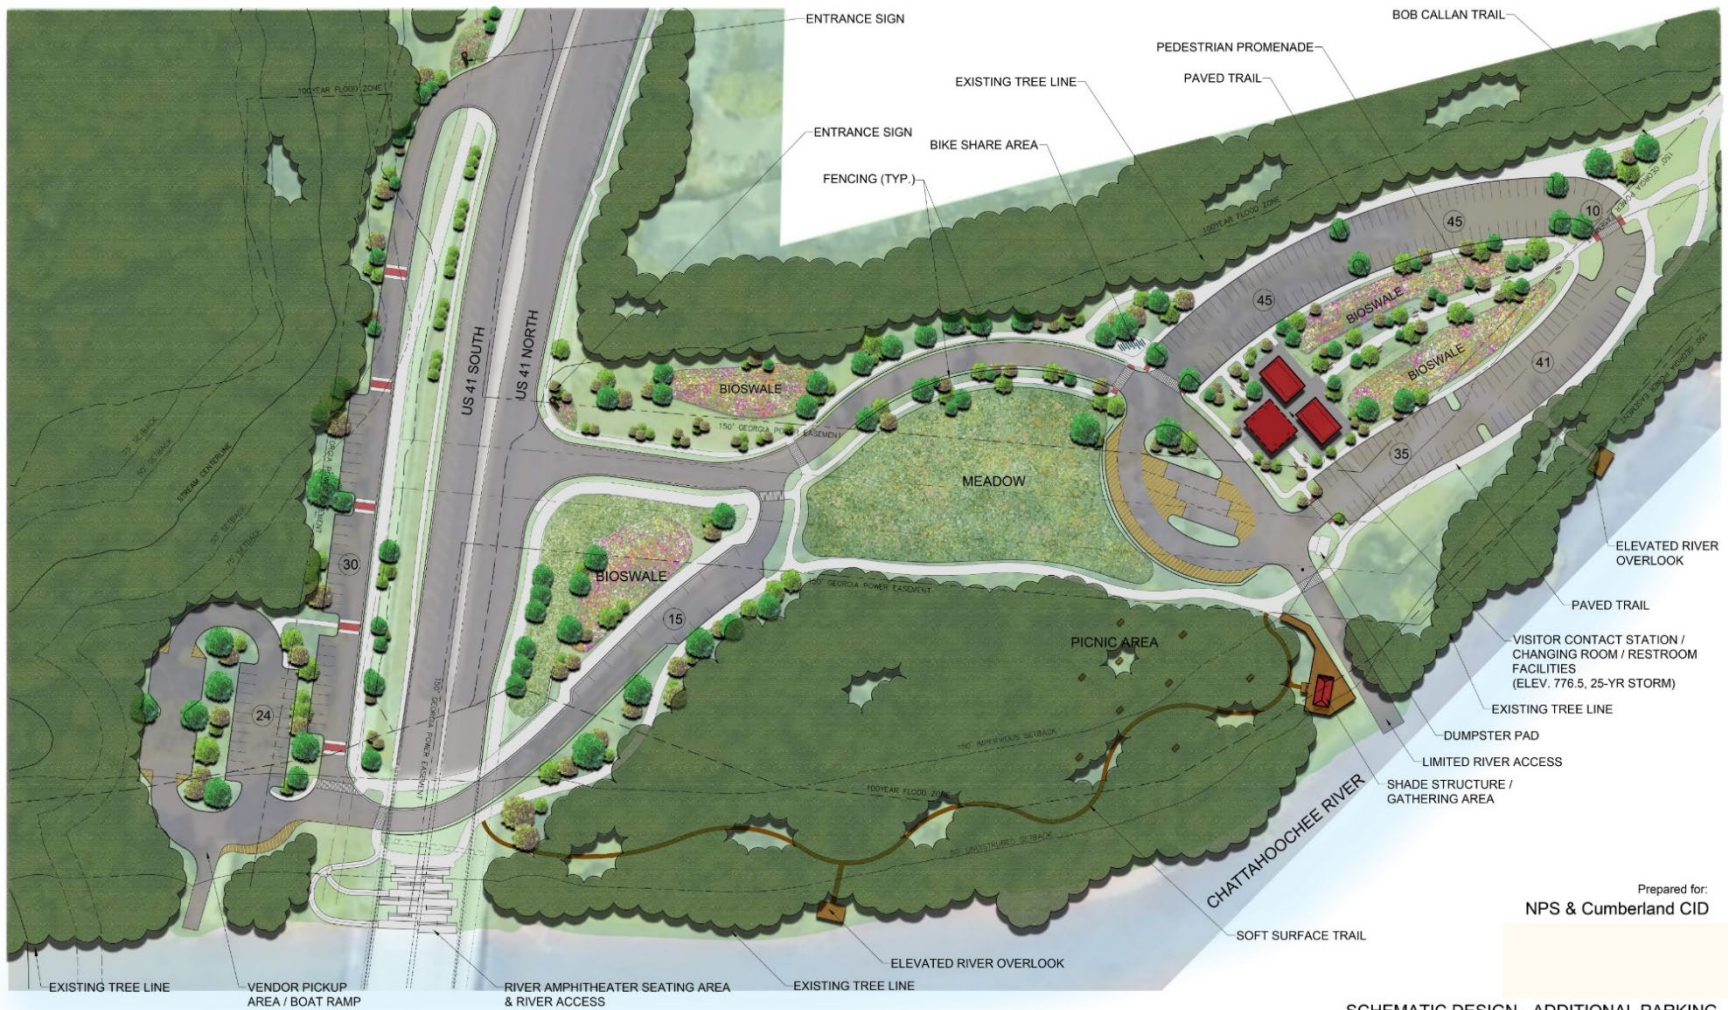
Figure 3. Proposed Action Schematic Design (1 of 2)

SCHEMATIC DESIGN - ADDITIONAL PARKING

The National Recreation Area is proposing to rehabilitate and reconfigure Paces Mill (table 1, figures 1–4). This includes upgrading the physical design, appearance, and infrastructure to address current deficiencies; to create a sustainable unit with a strong NPS identity; and one that is safe, easy to access, and enjoyable to visit. Additional detail can be found in the environmental assessment (NPS 2022) for this project, including design documents in the appendixes. During construction, staging and work would be phased to keep river access open. The unit would be impacted by construction activity and not have available parking, but a boat ramp would remain open for emergency response. Construction is expected to last 8 to 11 months. Standard and customized best management practices would be implemented as described in the environmental assessment (NPS 2022).
