Current River – Chilton Creek Area Fluvial Geomorphology Final Report

Revision 1

**Prepared for:
Ozark National Scenic Riverways
Van Buren, Missouri**

**Prepared by:
Chris Cash, P.E.**

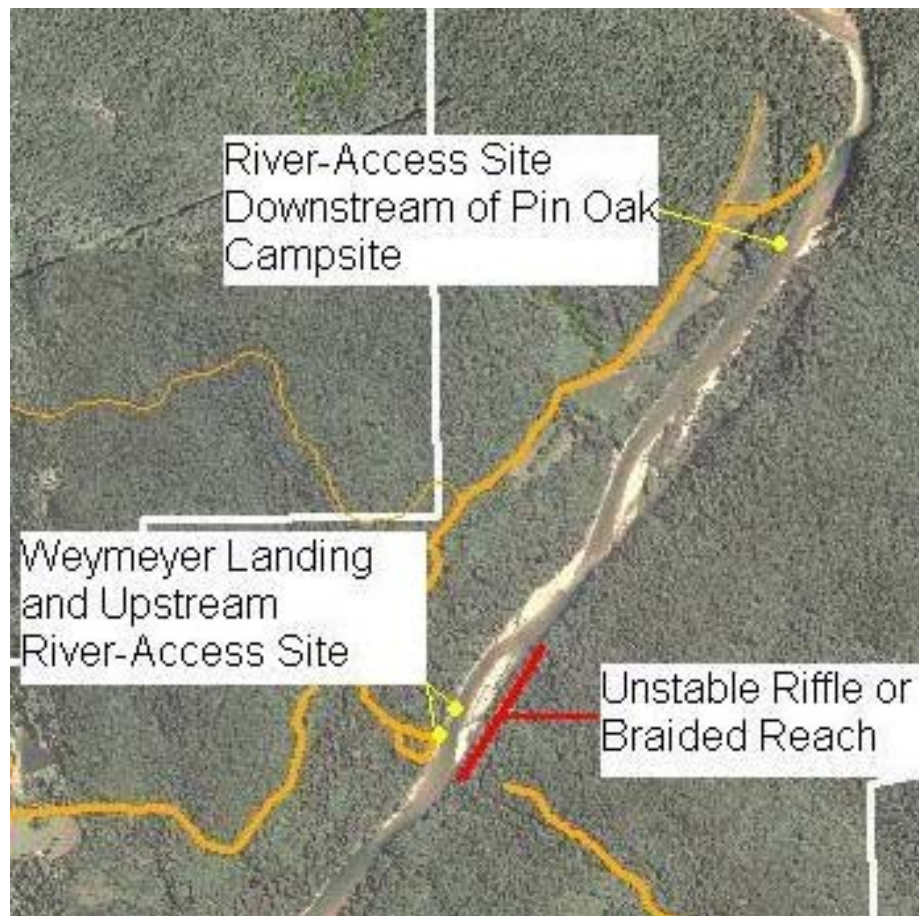
Figure 1. Study-Reach Limit and Details.

Overall, the study-reach is a pool-riffle system with mobile bed and bank sediments. Figure 1 illustrates this pool-riffle system with darker areas indicating pools and lighter areas showing riffles in the river channel. This figure also

identifies an unstable riffle area located immediately upstream from Waymeyer Landing and the upstream adjacent site. Figure 1 shows the unstable riffle has now developed into a braided or multi-channel reach with no defined thalweg. This unstable riffle was observed and documented in the June 9, 2008 site investigation.

In the reach of the unstable riffle or braided channel, the banks consist of easily erodible materials, and major flooding including a considerable sediment aggregation has occurred in the past few months. Therefore, a braided reach has developed upstream from Waymeyer Landing and the upstream adjacent site. The impact of this braided channel will cause significant river channel adjustments and increased erosional forces on the river-access sites located downstream.

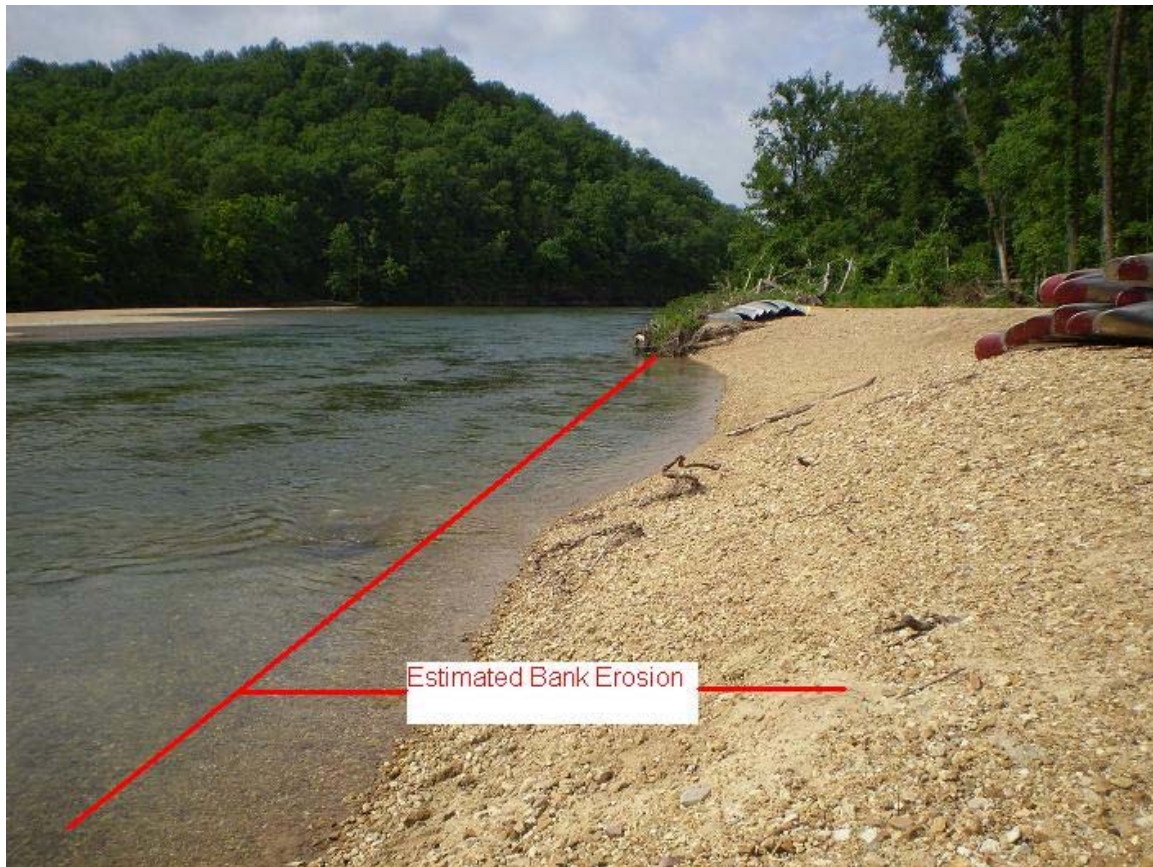
Figure 3. Estimated bank erosion at Waymeyer Landing.

Over the past few months, Waymeyer Landing has experienced substantial bank loss as shown in Figure 3. The bank retreat is the result of hydraulic erosion and geotechnical failure of the non-cohesive soil. Hydraulic erosion has occurred due to parallel and impinging flow removing the non-cohesive soil. Fluvial entrainment by water flowing parallel to the bank causes erosion by removal of

soil particles when fluid shear stresses exerted on the bank are greater than the shear resistance of the bank material. Fluvial entrainment is a common cause of bank retreat, and indicates that the bank material is unable to withstand the near-bank velocities imposed by the flow in the channel. To be successful, any type of mitigation must deal with this imbalance either by reducing velocities or by increasing bank erosion resistance. This imbalance occurs mainly during high, in-bank flows, is usually concentrated on the lower third of the bank, and is characterized by a lack of bank vegetation and a steep bank-slope.

Impinging flow attacks the bank at an angle to the long-stream direction. Erosion can occur at a range of discharges because of the intense turbulence generated when impinging flow strikes the bank. Impinging flow will usually occur downstream of braided channels due to concentration and conveyance of flow energy into the bank by bars and fallen trees.

Geotechnical failure has occurred due to the steepness of the bank slope. The non-cohesive soil will only be stable with a bank angle of 40 degrees or less. Geotechnical failure is the downward movement of soil masses. It occurs when the down-slope shear stress (weight) exceeds the shear strength (resistance to weight) of earth material. Shear stress is the driving force from gravity and/or loads acting on the slope. Shear strength is the characteristic of soil, rock and root structure that resists one unit of material sliding along another. Any cause that increases the shear stress or conversely decreases the shear strength will cause geotechnical failure.

Waymeyer Landing can be stabilized with considerable development and maintenance. The entire bank must be graded to have a 3-to-1 (3 horizontal to 1 vertical) slope. Any material for a boat ramp and erosion control must be a flexible solution like the proposed ACM (articulating concrete mattress). A combination of erosion control methods with vegetation could be used to provide stability. Yet, substantial maintenance would be required to maintain stability and public use at the access. In addition, bank-toe scour and bank-key design would be vital to achieving an effective instability countermeasure.
