# CULTURAL LANDSCAPE REPORT ANTIETAM NATIONAL CEMETERY

October 2014

Resource Stewardship and Science Division of Cultural Resources, National Capital Region

## ANTIETAM NATIONAL BATTLEFIELD SHARPSBURG, MARYLAND

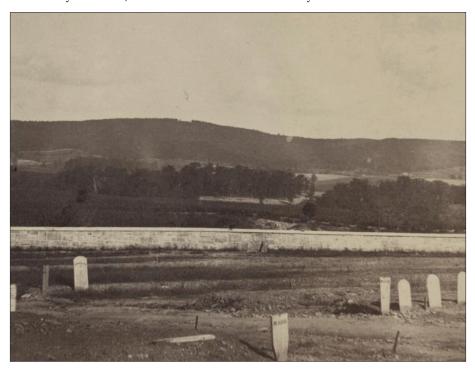
Figure 3. Wooden headboards used at Antietam National Cemetery following its establishment in 1865 (Library of Congress, LC-B8184-5078).

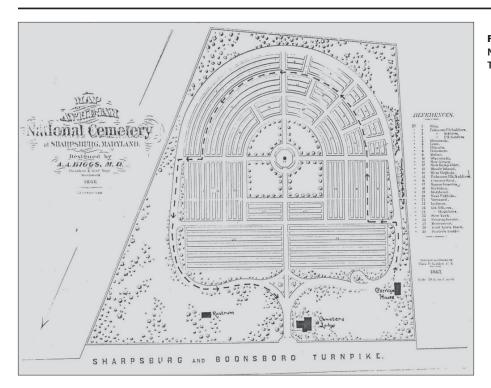
**Figure 5.** Biggs Plan for Antietam National Cemetery, 1866 (Susan W. Trail Collection).

The trustees determined that the burial ground part of the cemetery should be set 130 feet inside the entrance gates, and that the intervening open space was to be "ornamented with trees and shrubbery." However, there was an obstacle to the design. While the trustees took great pains to grade and level the cemetery grounds, "Lee's Rock" remained. Lee's Rock was a limestone outcropping that the General supposedly climbed during the battle for a better view of the action. There was debate among the trustees about whether to keep or remove the rock during the initial grading of the cemetery grounds. The decision to move the cemetery 130 feet from the entrance, as well as retain Lee's Rock, led to

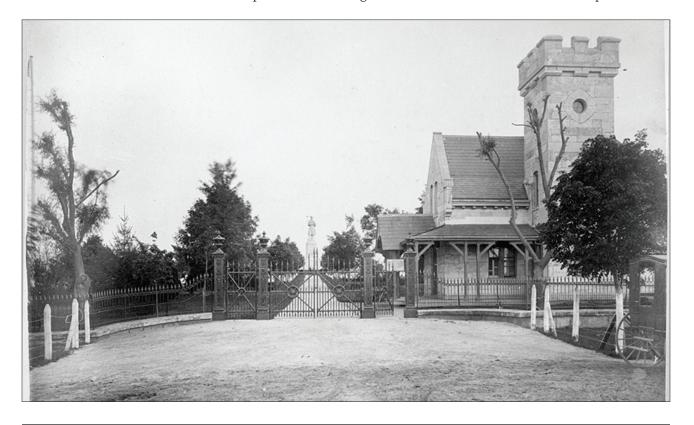
Figure 6. Entrance to Antietam National cemtery in the 1880s showing the Lodge and central path leading to the Soldiers Monument, along with the young specimen trees (Virginia Polytechnical College).

Unlike most lodges in post-Civil War national cemeteries that were built according to standardized plans designed by Quartermaster General Montgomery C. Meigs, the Superintendent's Lodge at Antietam was designed by noted architect Paul Pelz in 1867 (Figure 6. (Meigs designed only the rostrum for Antietam, built years later in 1879, after the War Department took control of the cemetery.)

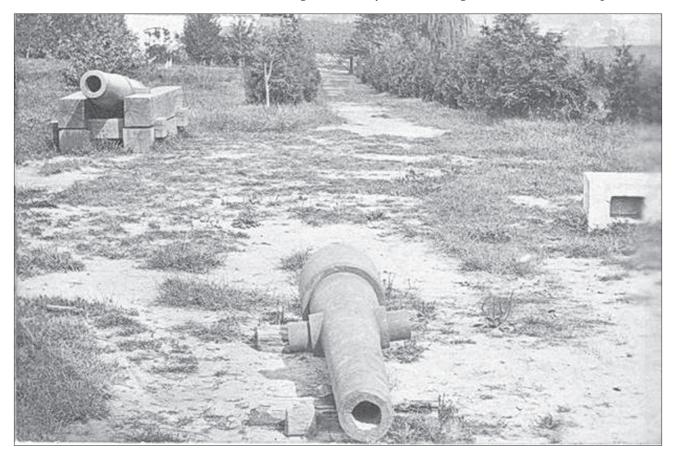
Figure 7. An 1877 image of the cemetery showing the unkempt condition of the cemetery. View looking north of the central path and lodge in the background (Personal Collection of Dr. Susan Winter Trail).

By 1877, the Trustees could not afford to pay the keeper and the maintenance of the cemetery suffered. In an April 18, 1877 report from Oliver Cox, CE QM Dept, to Col. A.F. Rockwell he writes, "Some sections [of the cemetery] are bordered with Box & the American Arbor Vitae, much of which is in bad condition. But few deciduous trees have been planted, while they with the evergreens give evidence of poor cultivation." <sup>16</sup> An 1877 stereo view of the cemetery shows the poor unkempt condition of the cemetery. The view, looking north, shows grass and weeds growing in the dirt driveways with the lodge house in the distance. A cannon barrel lies on the ground in the foreground, with another mounted on blocks nearby. Young evergreens line the driveway (Figure 7).

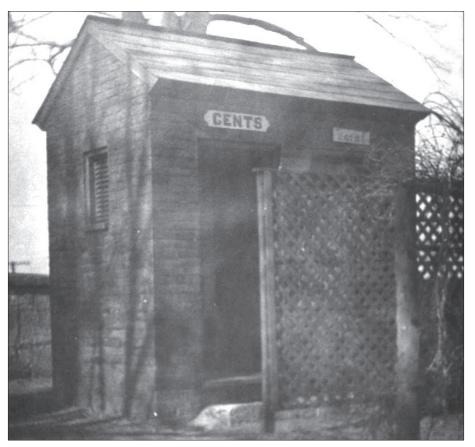
Figure 11. Image of the small brick privy, constructed in 1889 (Image from a report dated February 3, 1923, is held in the collection of the National Archives Record Group 79, stack area 150, Row 32 compartment 25).

In 1889, a small brick privy with slate roof was constructed on the cemetery grounds (Figure 11). The building was approximately 75 yards northwest of the lodge. Also at this time, it was noted that the circle avenue that was approximately 100 feet from the monument was lined with roses and the interior of the circle containing the monument was laid out in flower beds filled with beautiful flowers. <sup>25</sup> In 1891 the 4th regiment NY Volunteers requested permission from the Quartermaster General to place a monument in the cemetery. Permission was granted on the condition that there would be no expense to the US government and the design of the monument had to be approved by the Quartermaster

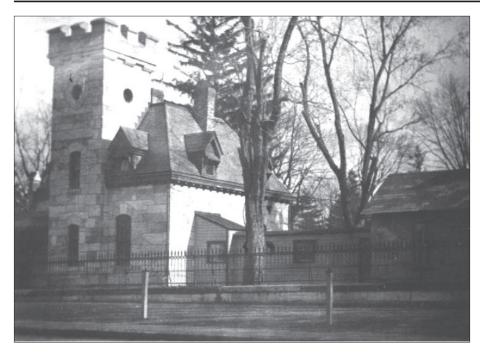
Figure 12. Image of the lodge with addition and connector, date unknown (Image from a report dated February 3, 1923, is also held in the collection of the National Archives Record Group 79, stack area 150, Row 32 compartment 25).

Along with the updating of the landscape, in 1898 the lodge was enlarged by the expansion of the stone tool house to accommodate a kitchen and dining room. These were attached to the east end of the tool house. In October of 1906, Capt. J.L. Pettus, Depot Quartermaster endorsed a recommendation that \$15.00 be spent to provide a wooden covering in the space between the rear of the lodge and the outbuilding that was used as a kitchen and dining room (Figure 12). The kitchen was twelve feet by twelve feet nine inches and the dining room the same size. A new 100-foot-high flagstaff was also erected. During fiscal year 1901 the slate roofed brick stable (mule barn) was constructed along the cemetery's west wall.<sup>27</sup> A gateway was opened in the wall to the north of the stable, leading out to the enclosed pasture lot owned by the United States immediately to the west of the west cemetery wall. The stable was 29 feet long, 18 feet wide and 12 feet high. The cemetery acquired its first horse in 1901. <sup>28</sup> In 1907, Landscape Gardener Rhodes inspected the site again and recommended that the wooden passageway be enclosed and new privy near the lodge be installed. Soon after, a new privy was constructed.

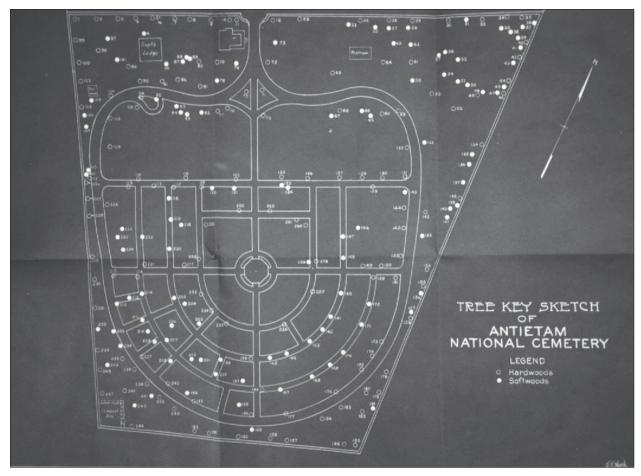
Figure 14. 1934 Inventory of the trees within the national cemetery (Antietam National Battlefield Archives).

One of the first things the National Park Service did upon acquiring the cemetery was to conduct a census of trees in 1934 to assess their condition and establish a numbering system. Part of this effort included a map with the location of trees, indicating which were deciduous and evergreens, and the placement of circular metal tags imprinted with an inventory number affixed to the trunks of the trees. From this inventory, the park service's branch of forestry came up with a planting plan for the future. The problem they encountered in 1934 was an aging population of trees, most of which were planted about the same time and were nearing the end of their life span. Something had to be done on a cyclical basis, otherwise the cemetery would be denuded of trees within a relatively short time. Further, many of the trees chosen for the initial planting were exotics, shallow rooted and short of life, exacerbating the problem.

The 1934 tree inventory tally was 262, most of them planted by the War Department between 1878 and 1933. Of those, the greatest number was silver maples (*Acer saccharinum*) at a count of 48. Next were Norway spruce (*Picea abies*) with 40, followed by Norway maple (*Acer platanoides*), 39. There were 23 sugar maples (*Acer saccharum*) and 22 hemlocks (*Tsuga canadensis*). Thirty one species of trees were listed (Figure 14).

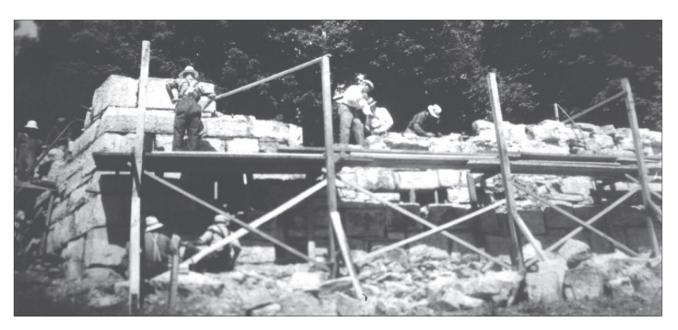
Figure 15. By 1934, CWA funds were used to complete extensive repairs to Antietam National Cemetery, including the reconstruction of the cemetery perimeter wall (Antietam National Battlefield Archives).

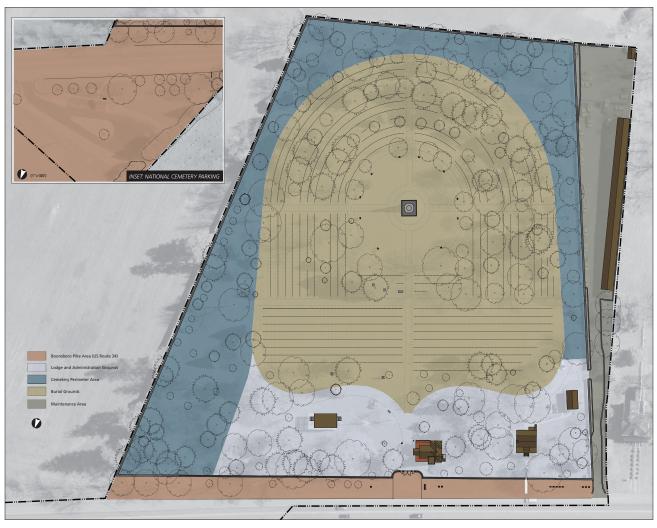
Figure 18. Management areas for Antietam National Cemetery (National Capital Region, 2014).

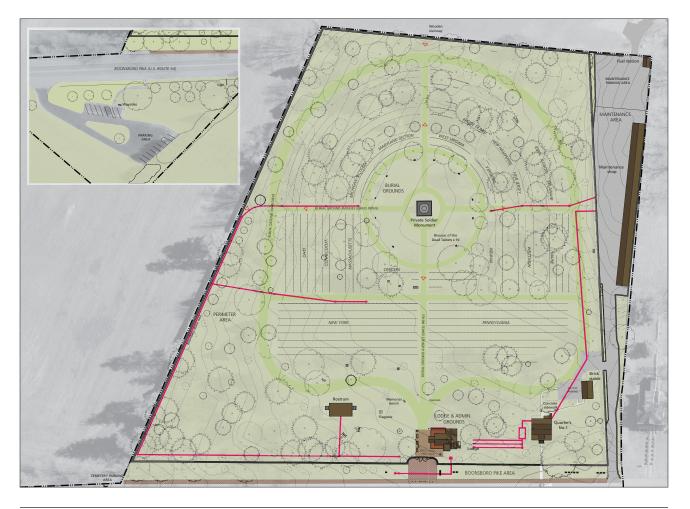
Figure 20. Map showing the existing below and above ground drainage and septic systems within Antietam National Cemetery (National Capital Region).

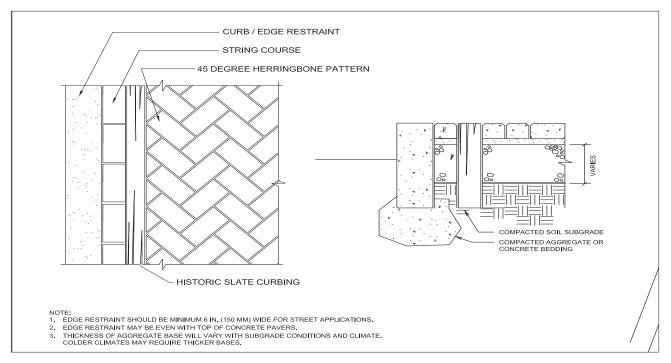
Figure 22. Detail of proposed protection for stone curbing (National Capital Region).

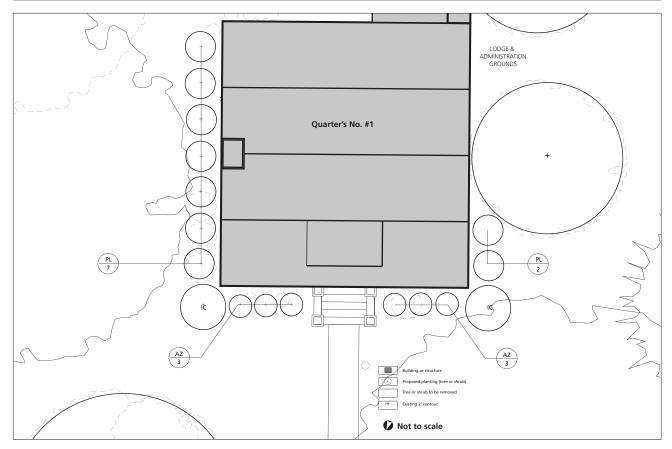
Figure 23. Recommended plantings for the Administrative building (Headquarters No.1) (National Capital Region).

By the 1930s, the use of shrubs to adorn bases of houses as foundation plantings became fashionable. Additionally, shrubs were placed throughout the landscape as specimen plants to highlight their unique habit, decorative fruit, or distinctive foliage or fall color. Such was the case following the construction of the administrative buildings as foundation and specimen plantings were scattered around the grounds and along the base of the building. Yet, the majority of these plants should be removed as they were not present at the end of the War Department's administration in 1933. However, following the future rehabilitation of the administrative building, the foundation plantings should be replanted to effectively screen the utilities near the building. In an effort to be compatible with the historic character of the cemetery, the planting arrangement should be understated and simple. Recommended plants include Chinese holly (*Ilex cornuta*, *'fineline'*), common cherrylaurel (*Prunus laurocerasus*, *Otto Luyken'*), and Azalea (*Rhododendron "Hinodegiri"*) (Figure 23).

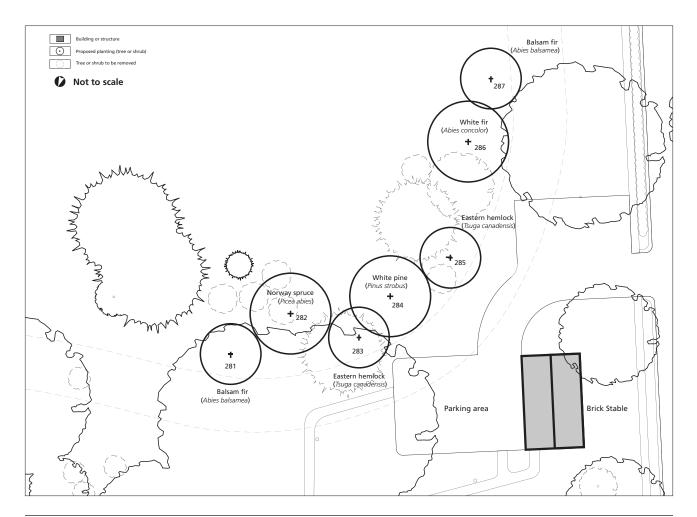
Figure 25. If reestablishing an orchard proves to be unfeasible, parking area should be screened with a combination of evergreen vegetation (NCR, 2014).

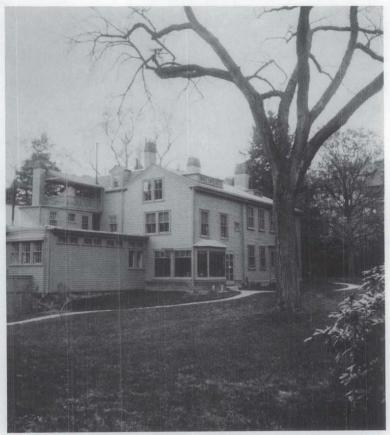
Figure 1. Historic plant materials can be retained while restoration of the historic structure is underway. The Wisteria and Actinidia vines that were historically used by Olmsted, were cut back during the restoration of Fairsted in 1988. Photo by Charles Pepper, courtesy of the Olmsted National Historic Site.

In 1980, The National Park Service began structural restoration of the house at Fairsted. To facilitate this work, the historic vines were removed from the facade and cut back to the ground. Since the vines were both historic plant material and an important feature of the property, complete removal was avoided. The vines were kept at ground level, but pruned frequently to prevent reattachment to the house. This situation resulted in weakened plant growth and an appearance quite different from

Olmsted's intention (see figure 1). Furthermore, long-term frequent pruning risked a higher incidence of pest-related problems to the plants and restricted their natural climbing habit. It was therefore important to the public site that a new trellis system be devised that would protect both the historic vegetation and the historic structure, while reestablishing the appearance of a "vine clad mansion."

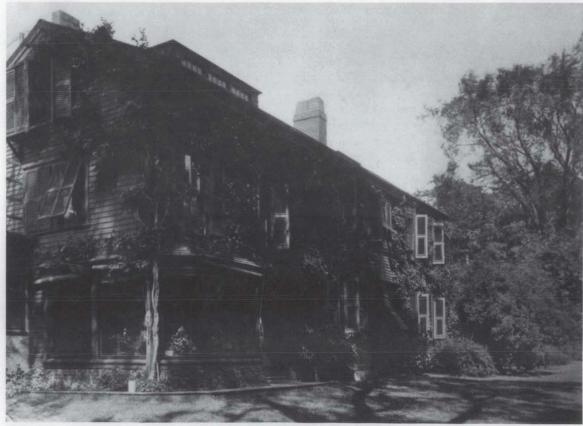
Figure 2. View of the west elevation at Fairsted which shows a steel strapping trellis system built as early as 1884. Photo courtesy of Olmsted National Historic Site.

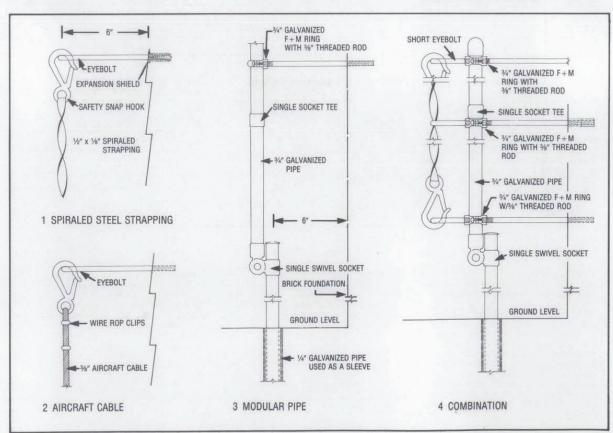
Figure 5. Details of the four experimental trellis systems. Drawings by Sharon Runner, National Park Service.

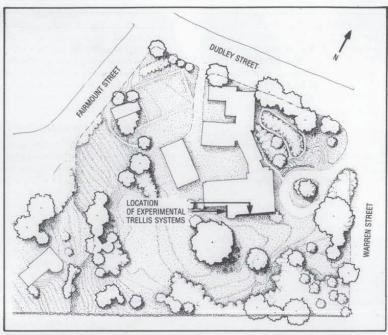
Figure 6. Site plan of Fairsted; the experimental trellis systems were installed on the south and west elevations. Drawing by Karen Day.
