Living Shoreline Design Guidelines for Shore Protection in Virginia's Estuarine Environments

**Virginia Institute of Marine Science
College of William & Mary
Gloucester Point, Virginia**

Version 1.2

Special Report in Applied Marine Science and Ocean Engineering No. 421

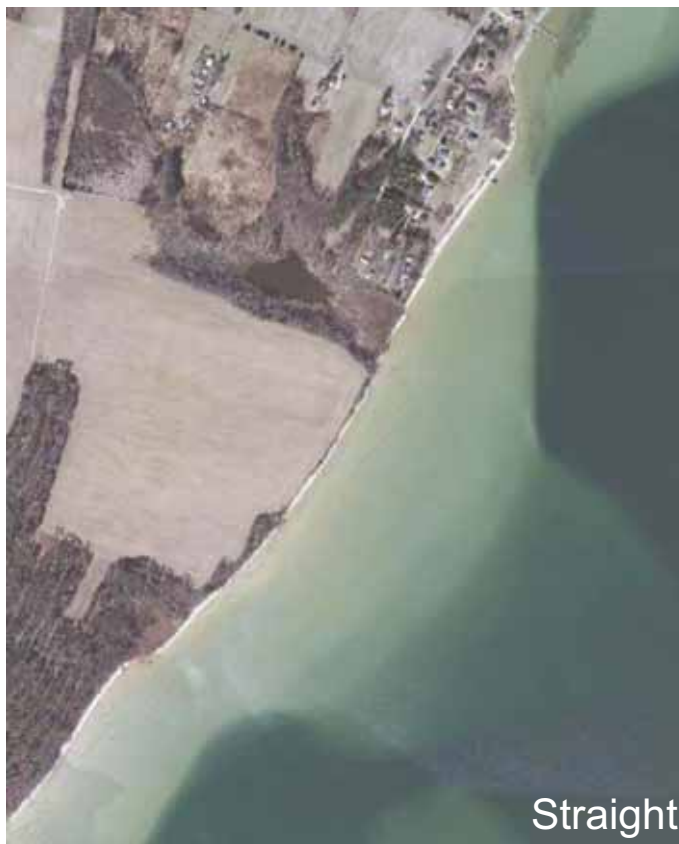
Figure 2-2. Photos illustrating four different types of shore morphology within Chesapeake Bay.

Shore morphology, or structure, can be a difficult parameter to assess because of the variation in types of shoreline throughout Chesapeake Bay. The essence of this parameter is to determine the level of protection from wave action. A pocket or embayed shoreline (Figure 2-2) tends to cause waves to diverge, spread wave energy out, and thus reduce erosion impacts (Figure 2-3). Open, linear shorelines and headlands tend to receive the full impact of the wave climate. The irregular shoreline, sometimes caused by scattered marsh patches or groins, tends to breakup wave crests along its length, reducing impacts.

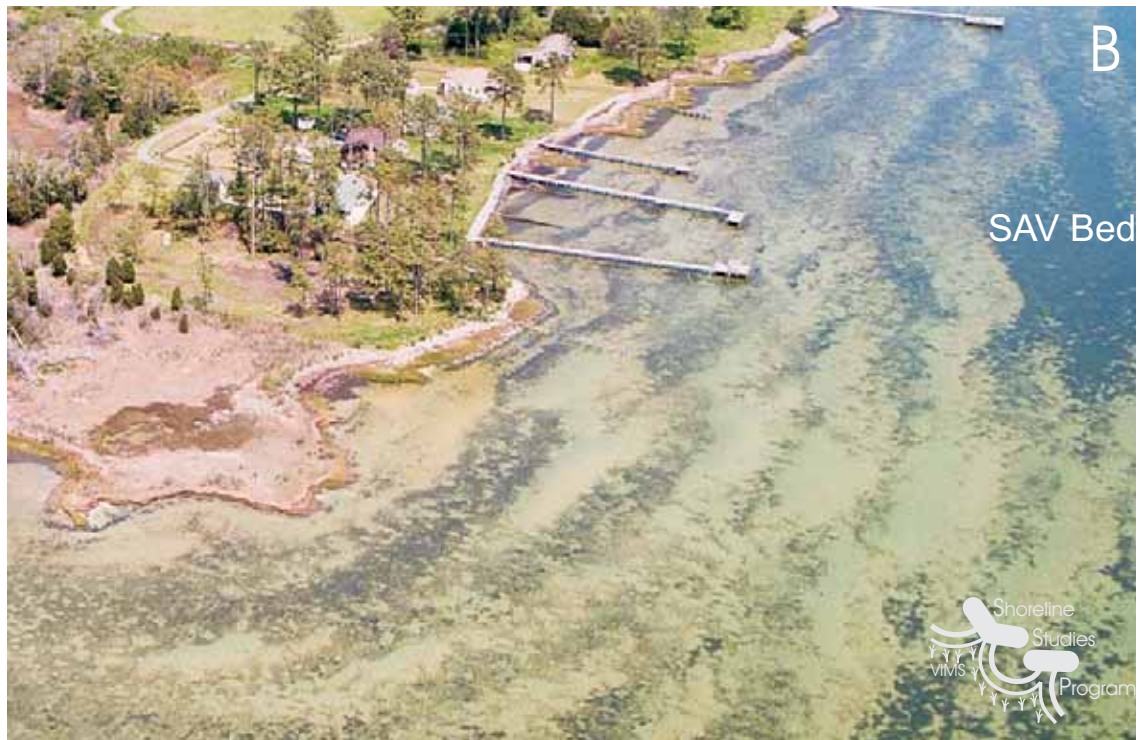
Figure 2-4. Photos showing nearshore bars and submerged aquatic vegetation. A) A VGIN 2009 photo shows the channel into Cranes Creek in Northumberland County, Virginia. Sand bars north of the channel will attenuate waves while the shoreline adjacent to the channel has no bars and will feel the full effect of the waves impacting the shoreline. B) A VIMS aerial photo of Pond Point on the East River in Mathews, Virginia (dated 21 April 2009) showing extensive SAV in the nearshore, as well as sand bars.

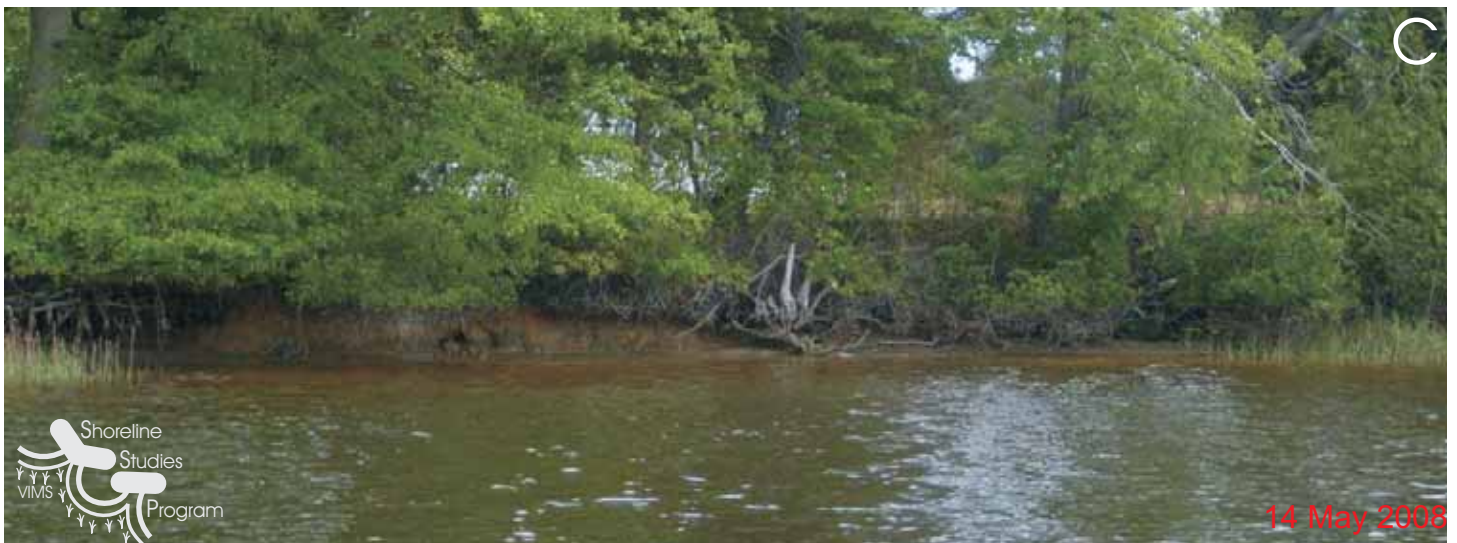
An undercut bank on the East River, Virginia.

Figure 2-8. Bank condition example photos.

The condition of the fastland bank is the best indication of how frequently wave action reaches the base of bank. Other factors, such as upland runoff, freeze/thaw and groundwater seepage, can make significant contributions, but storm waves are the main cause of most shore erosion in Chesapeake Bay. Stable banks are indicated by relatively gentle bank face slope with abundant vegetative cover and no undercutting along the base of bank (Figure 2-8A). The other extreme is the vertically exposed bank may be slumping and generally lacks stabilizing vegetation (Figure 2-8B). The intermediate case is a bank that is partially stable along much of its slope but has evidence of undercutting along the base of bank by wave and water action (Figure 2-8C). In fetches larger than 0.5 miles undercutting and exposed base of bank reveals potential long-term instability of the bank slope.

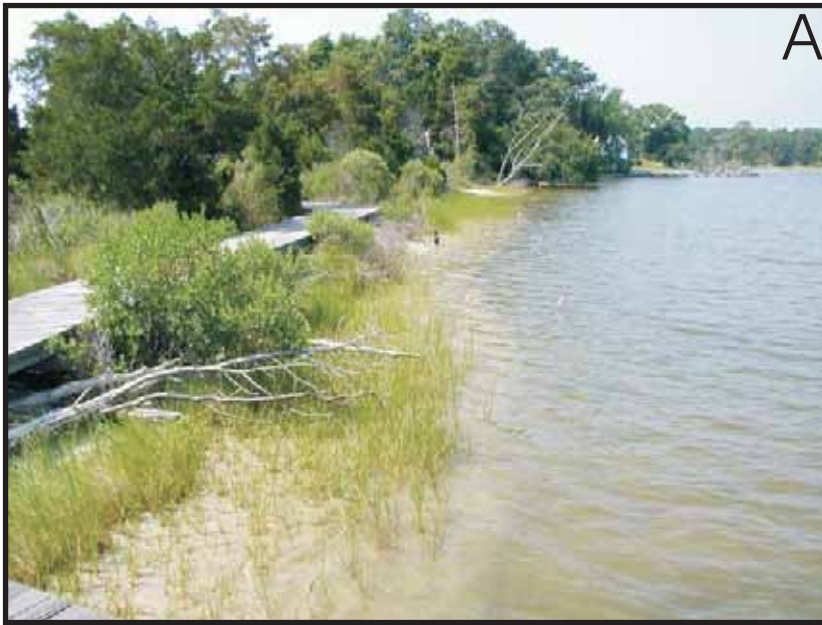
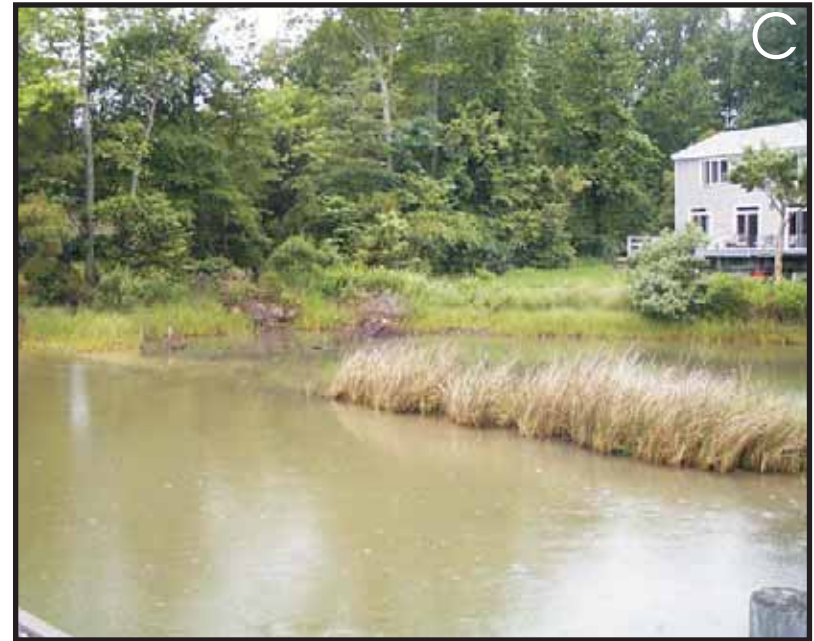
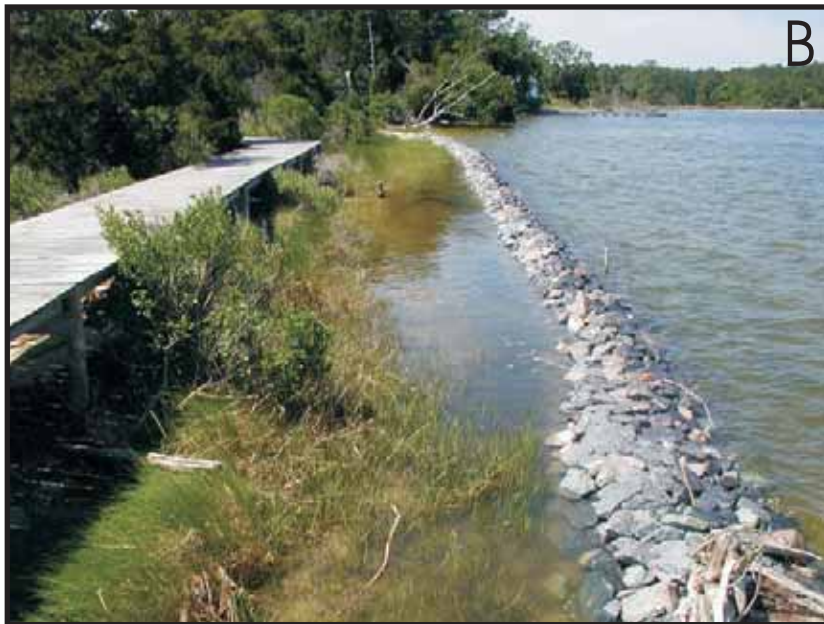
Figure 3-4. Photos showing marsh toe revetments A) before and B) after a project on Cranes Creek in Northumberland County and C) before and D) after a project on Mosquito Creek in Lancaster County, Virginia.

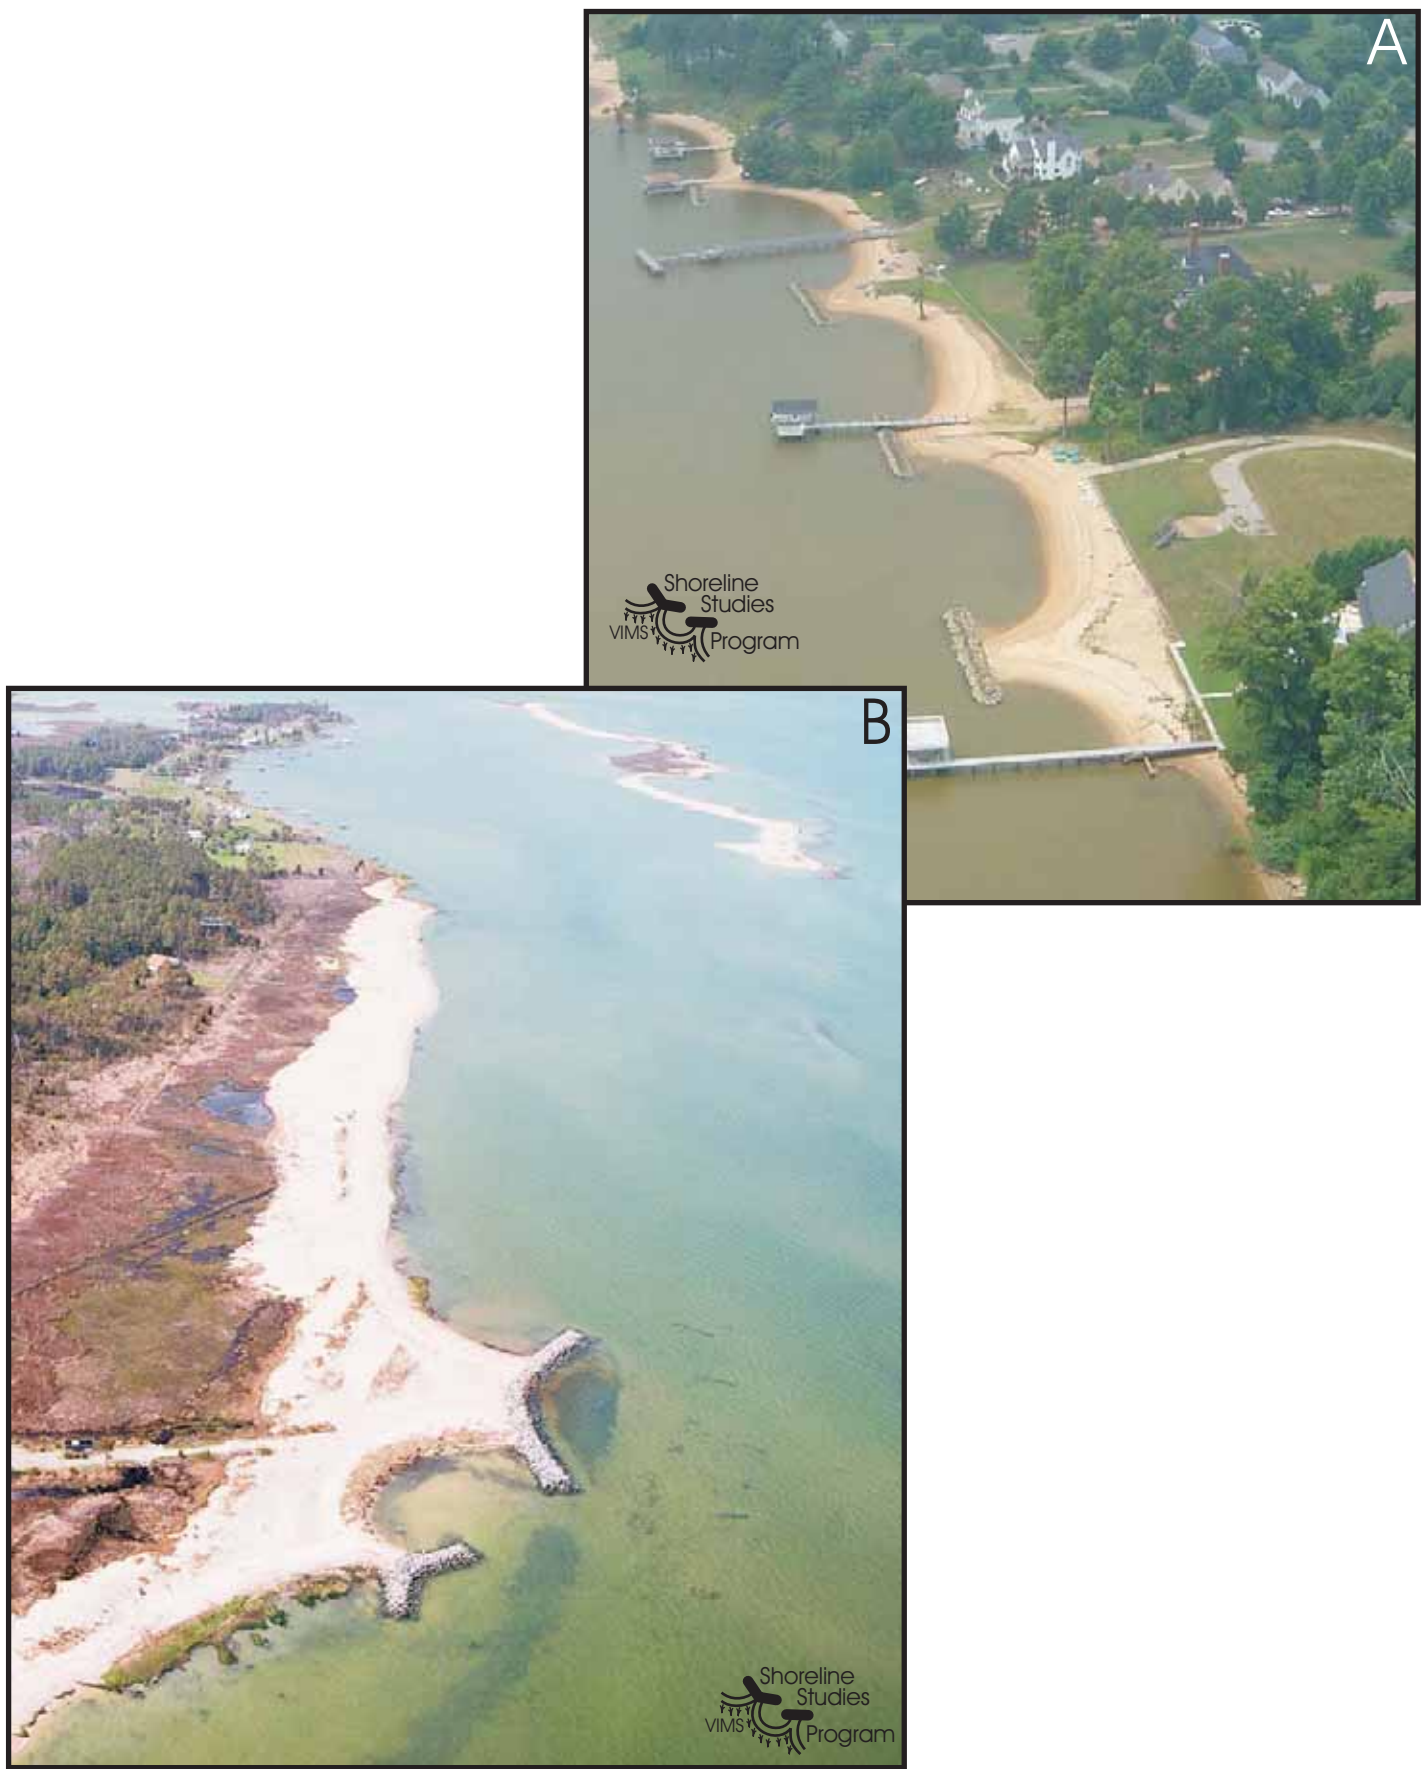
Figure 3-5. Aerial photos of A) Drummond Field breakwaters (June 30, 2005) on the James River, and B) Festival Beach on Chesapeake Bay (April 21, 2010). While the physical characteristics of each site differ, the goals are the same: protect the upland bank/marsh with a wide recreational beach.

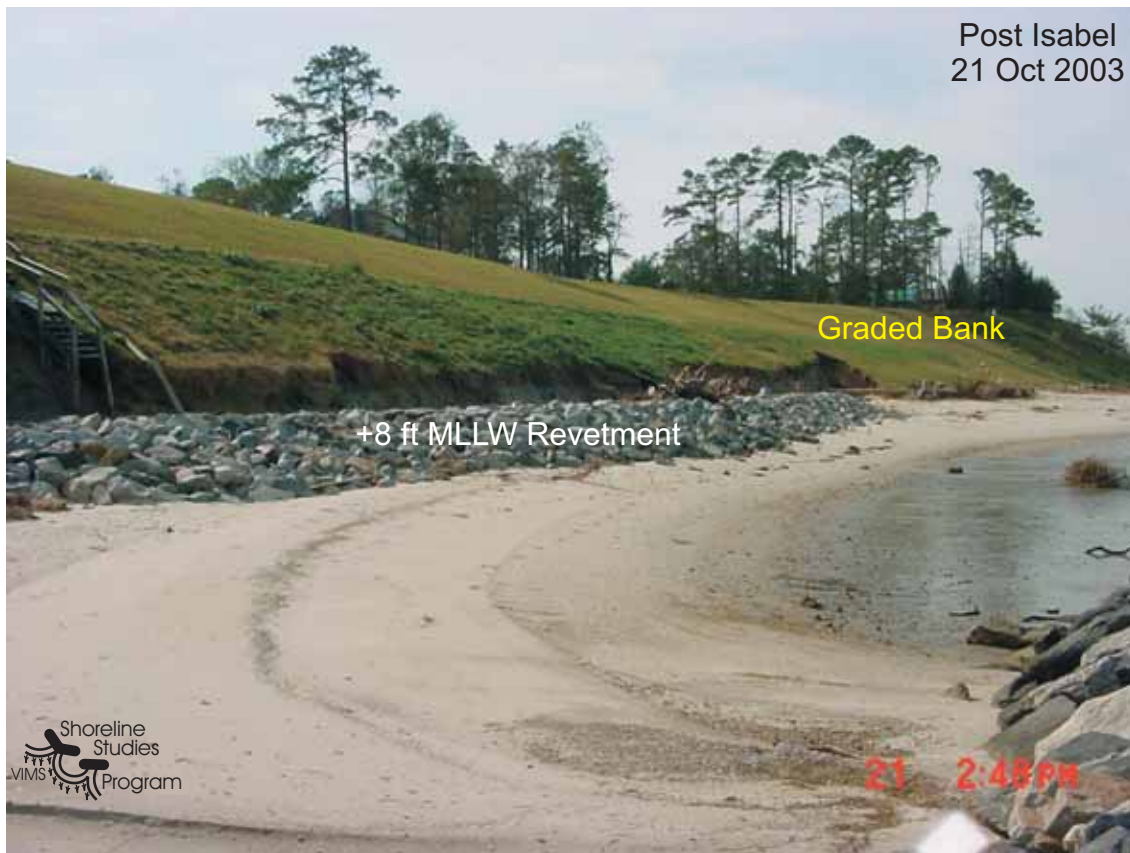
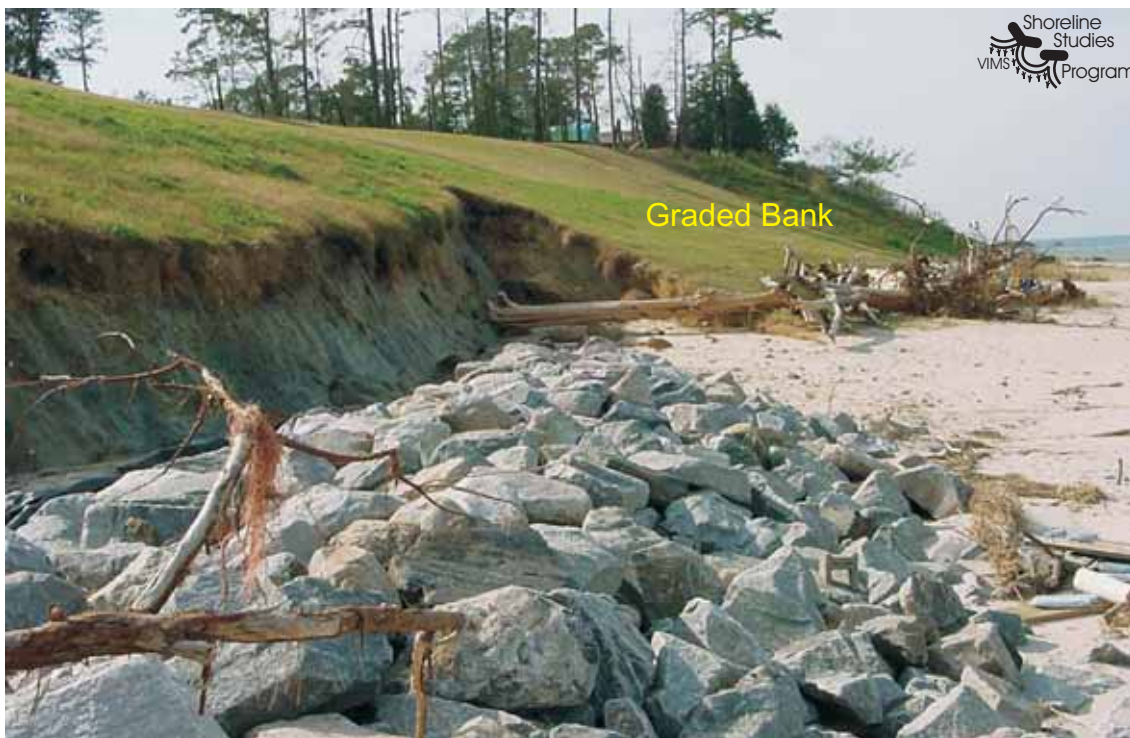
Figure 3-7. Revetment on the James River that was overtopped by storm surge and waves during Hurricane Isabel. Photo dates 21 October 2003.

When the design storm is exceeded, then so is the level of protection. Overtopping a revetment by surge and wave may only create a wave cut scarp across the adjacent bank or bluff (Figure 3-7) such as occurred along the James River during Hurricane Isabel. Has the level of protection been exceeded? The revetment is very much intact and as long as the stability of the bank face and consequently any infrastructure is not threatened, then probably not. If the structure itself fails, particularly early during the storm event, then a more serious problem will result. If the structure fails, the bank fails and the infrastructure are threatened or damaged. No erosion occurred of the graded bank just upriver from the revetment where the beach is wide behind a headland breakwater. The revetment crest elevation is +8 ft MLLW which was three feet less than water and wave heights in that area of the James River.

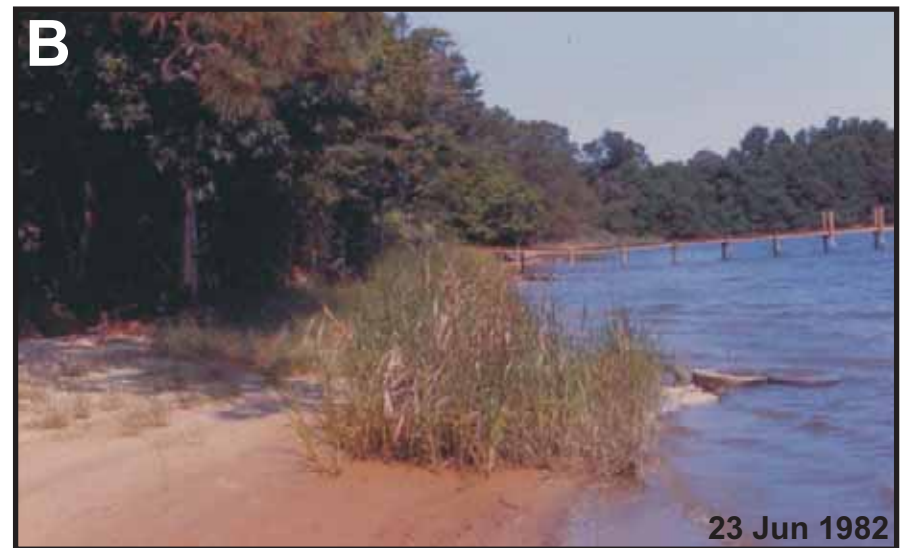
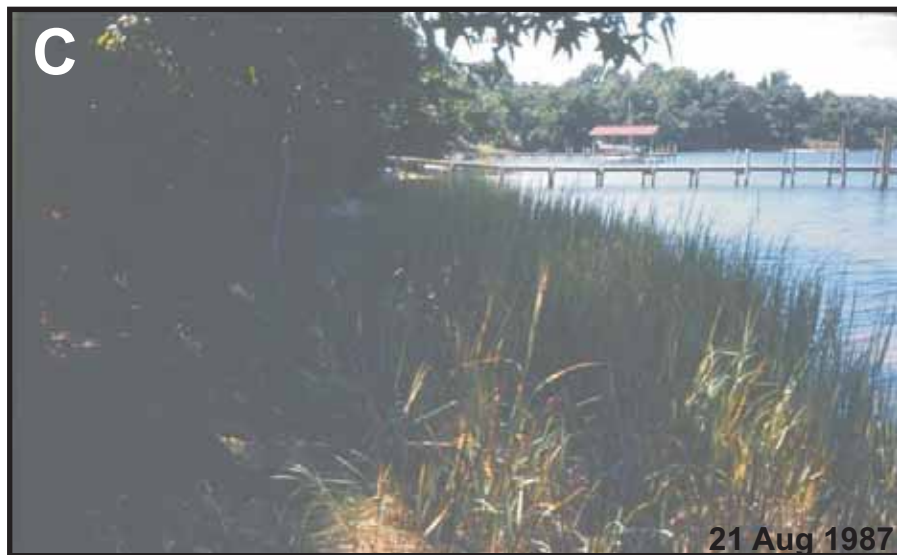
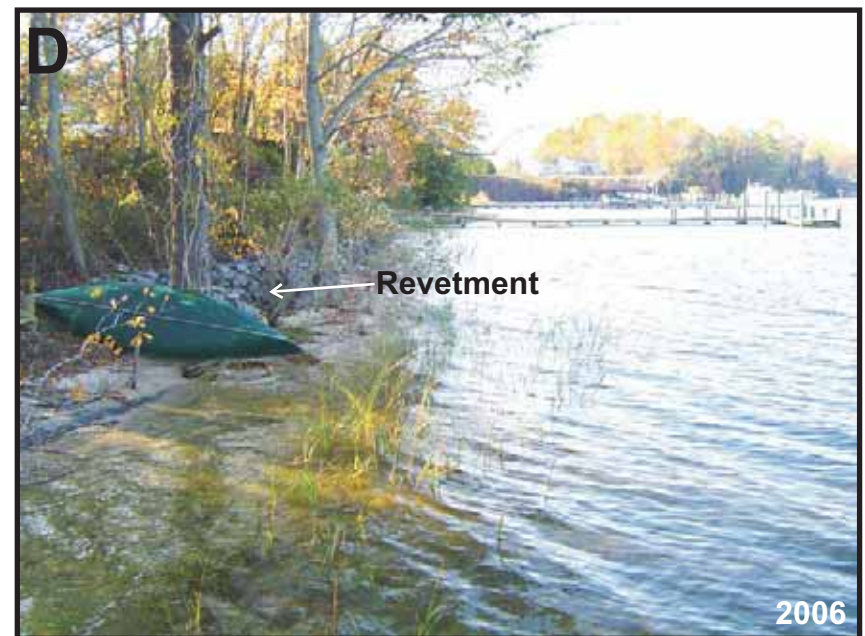
Figure 4-1. Lee marsh management site A) just after installation, B) a year later, C) six years after installation, and D) 25 years after construction.

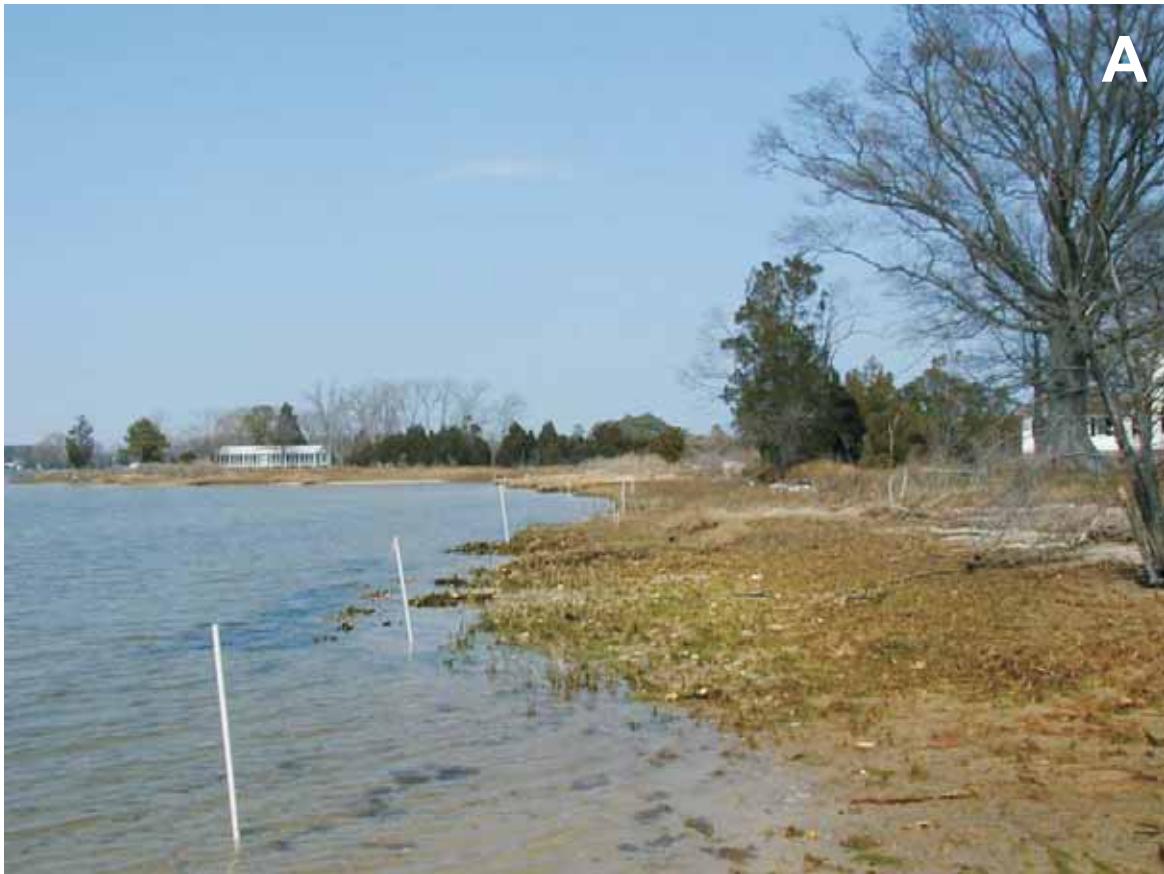
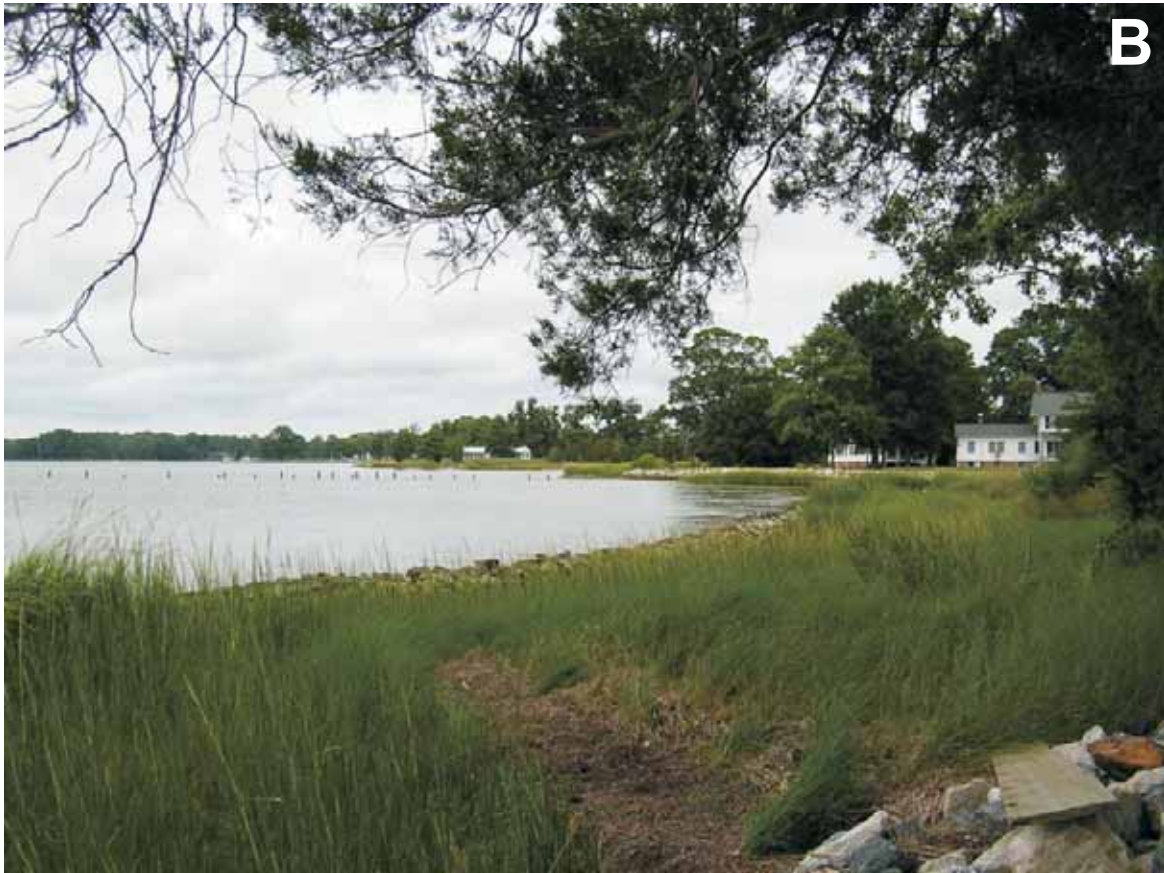
Figure 4-2. Hollerith marsh toe revetment/sill site A) before project with eroding fringing marsh in winter and B) after construction.

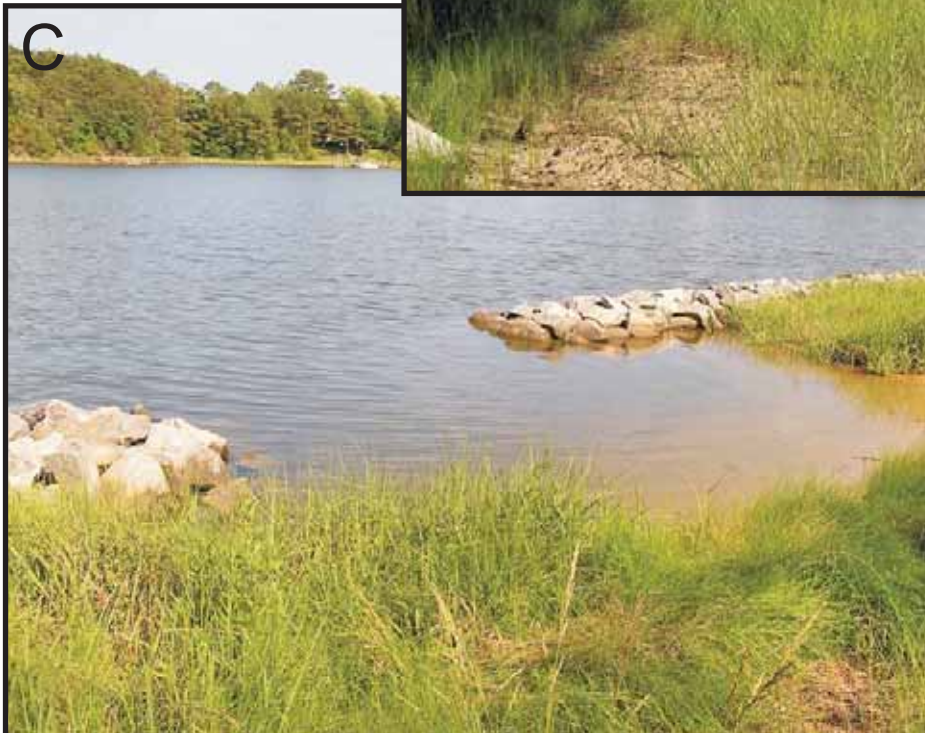
Figure 4-3. Foxx site photos. A) Before construction, the upland bank was undercut and only a small intermittent marsh fringe existed. B) After construction, a wide, marsh fringe and graded bank stabilized the site. C) Gaps in the sill allow waves in, reducing the width of the marsh there.

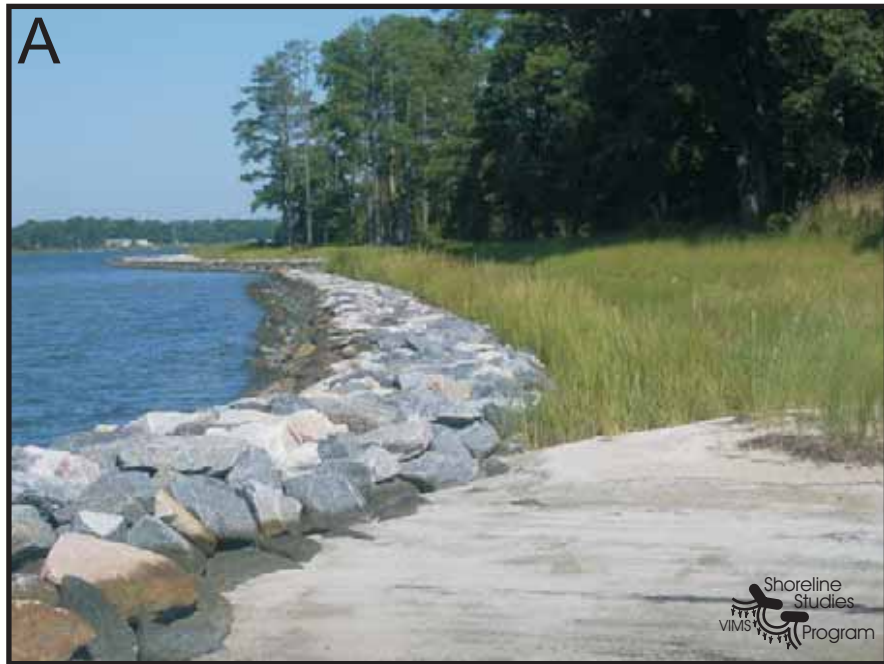
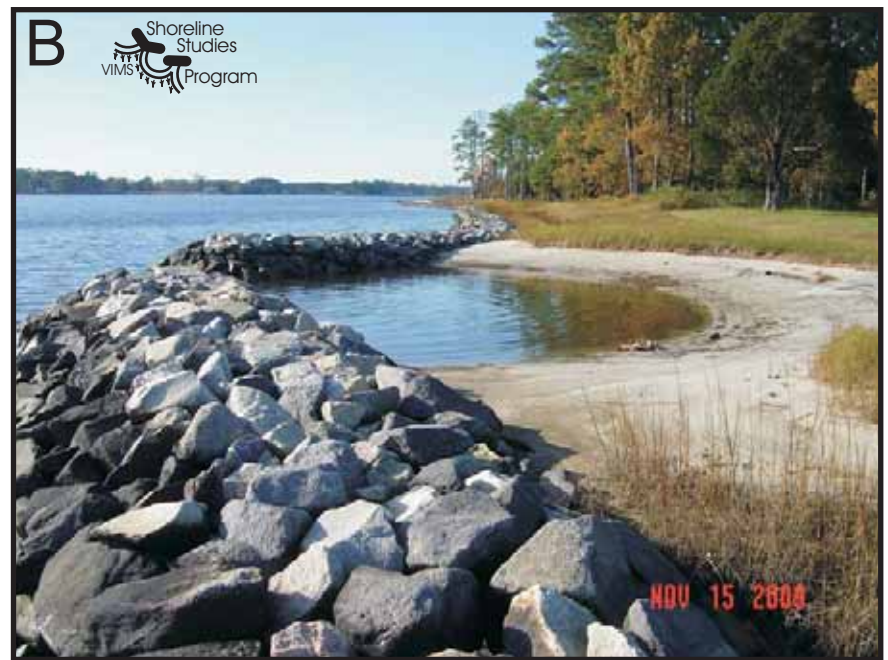
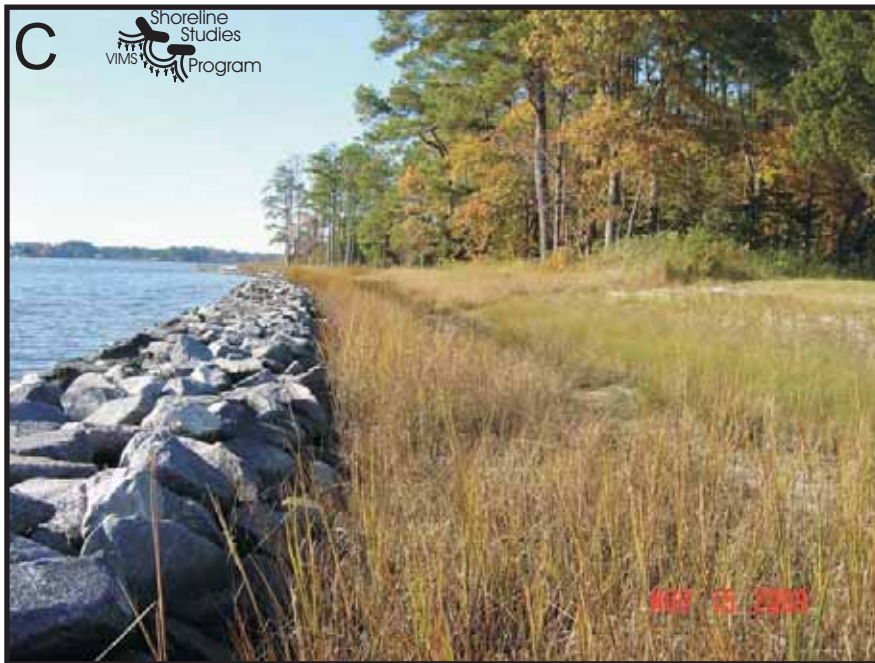
Figure 4-5. Sill system at Poplar Grove on the East River in Mathews County, Virginia six years after completion. A) The sill and marsh fringe provide a wide buffer between the water and the upland. B) The wide gap in the sill provides a pocket beach access area along the shoreline. C) The project zones are clearly visible: stone sill, *S. alterniflora*, *S. patens*, and upland/wooded. D) The old mill sits close to the shoreline. In this area, a revetment was chosen to protect the shoreline.

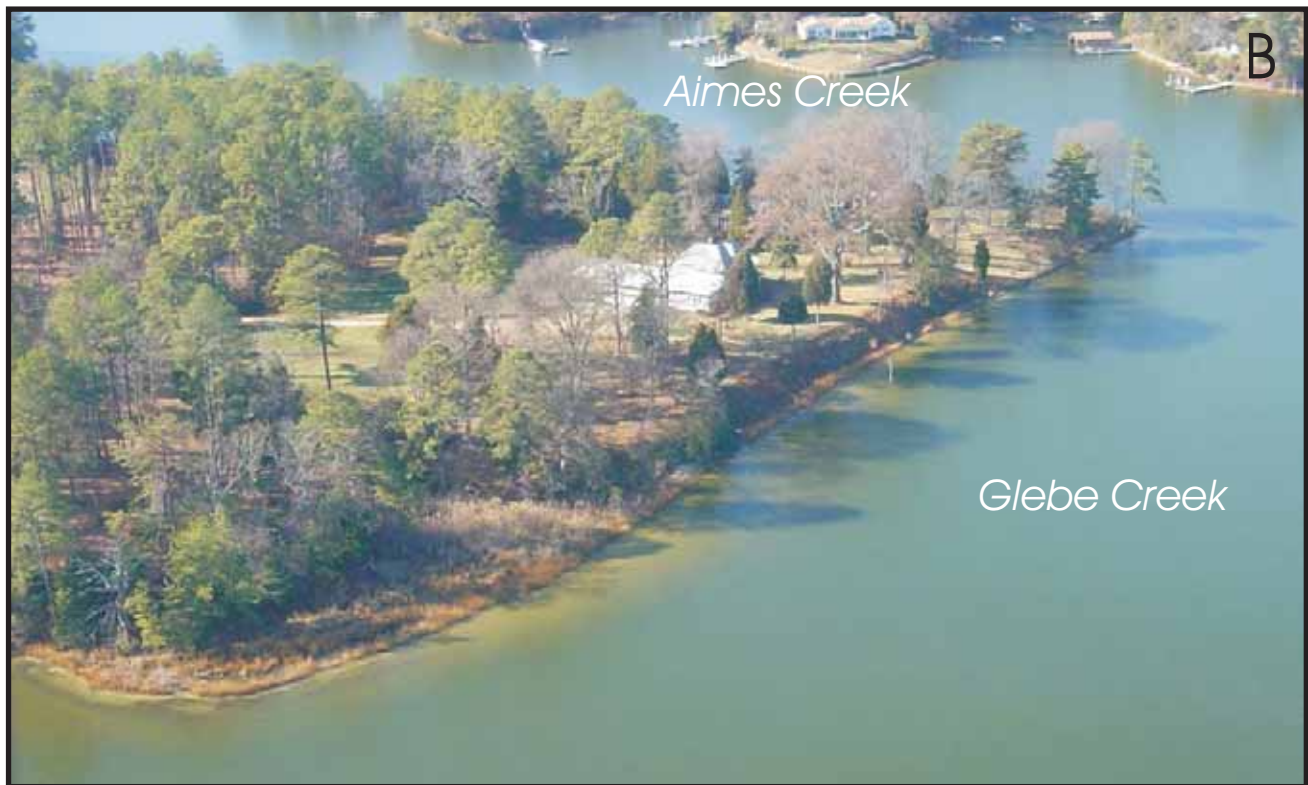
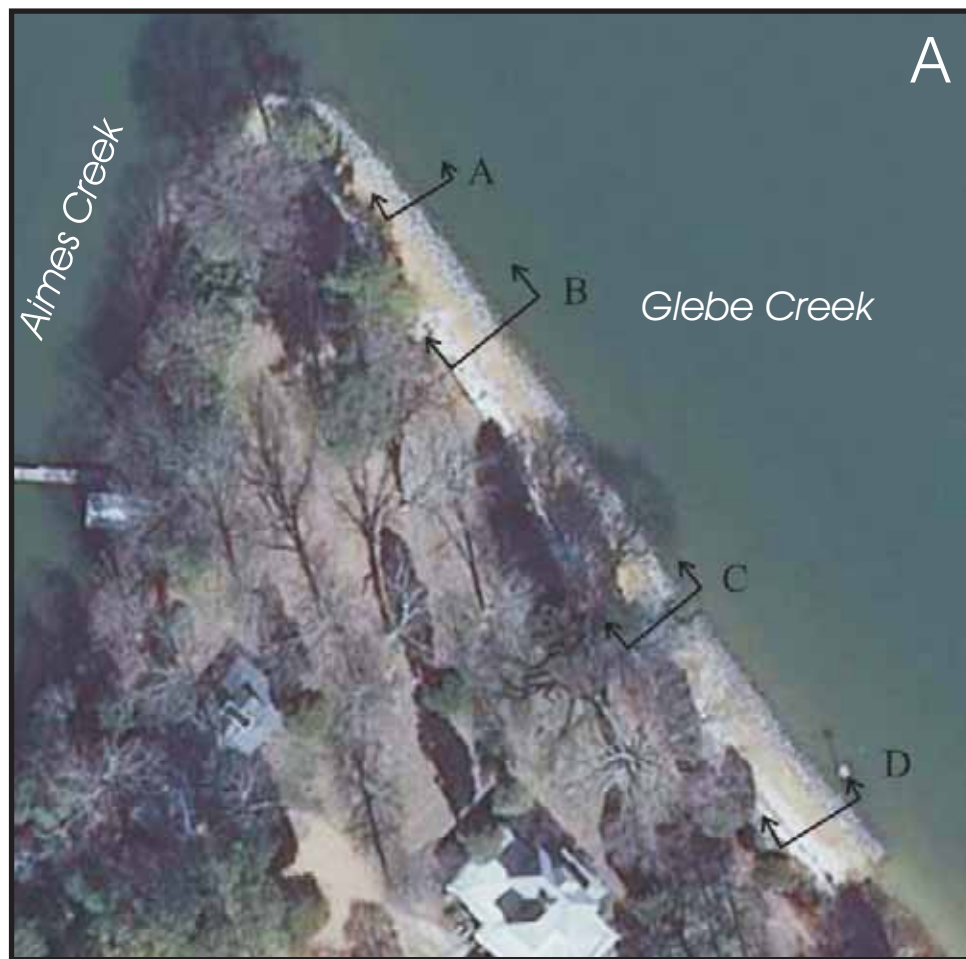
Figure 4-8. Longwood University's Hull Springs Farm on Glebe Creek. A) Before the shoreline project, the bank is eroding in front of the Manor House. B) After the project, the shore zone was widened with sand behind the sills.

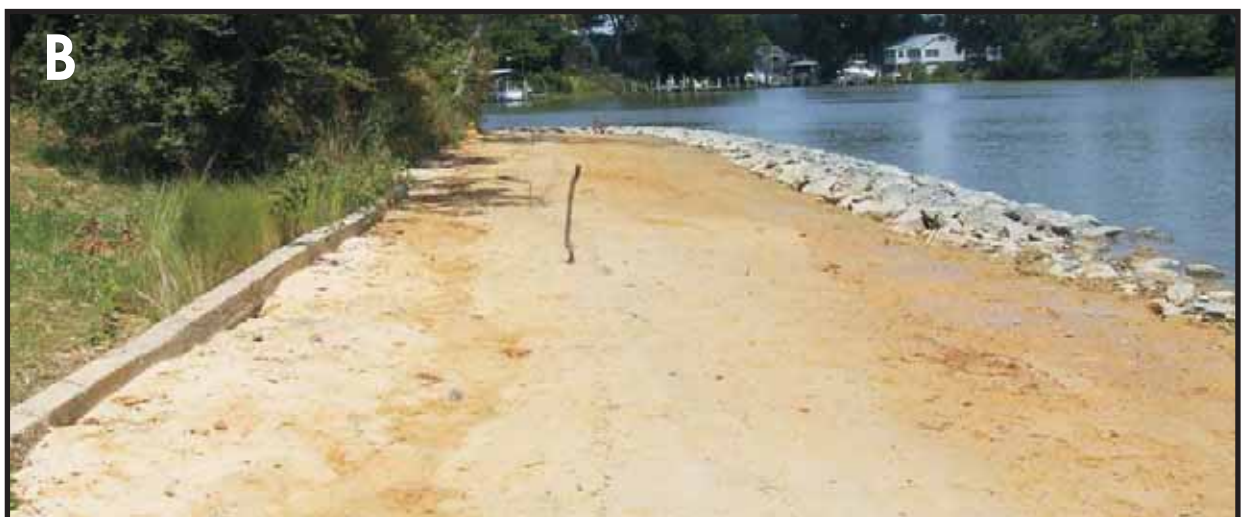
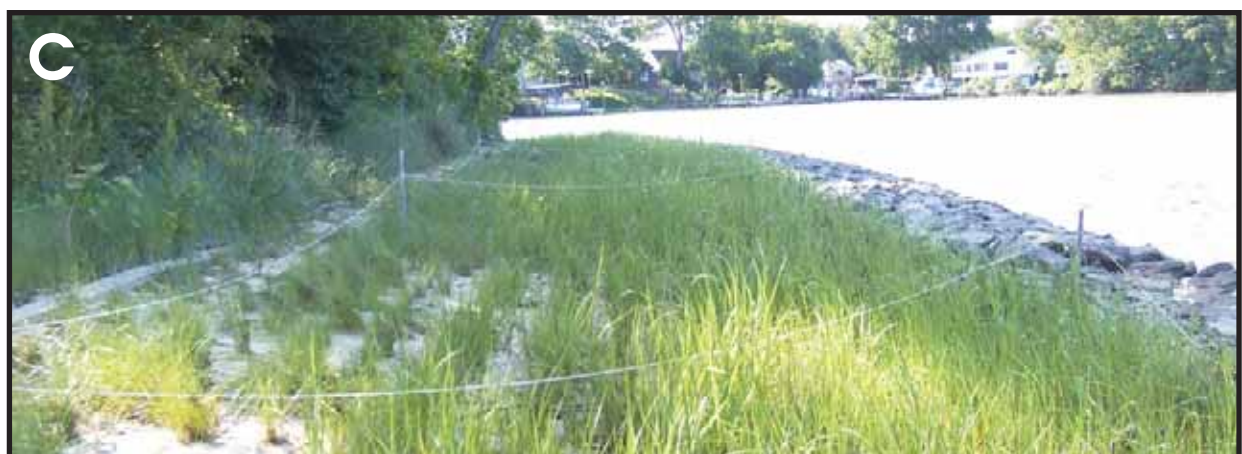
Figure 4-9. Hull Springs Farm shoreline A) before construction, B) after construction of the sill and placement of sand, and C) after planting.

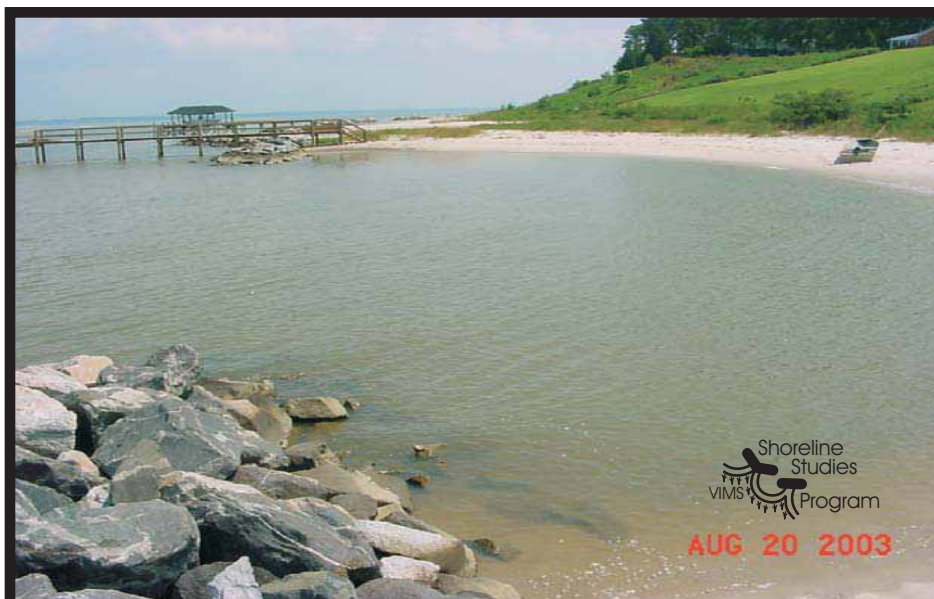
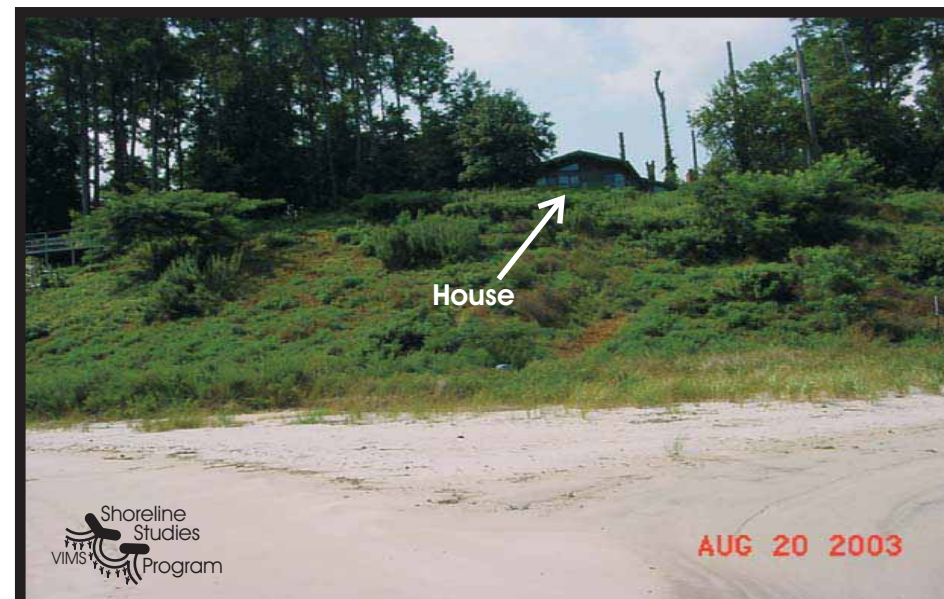
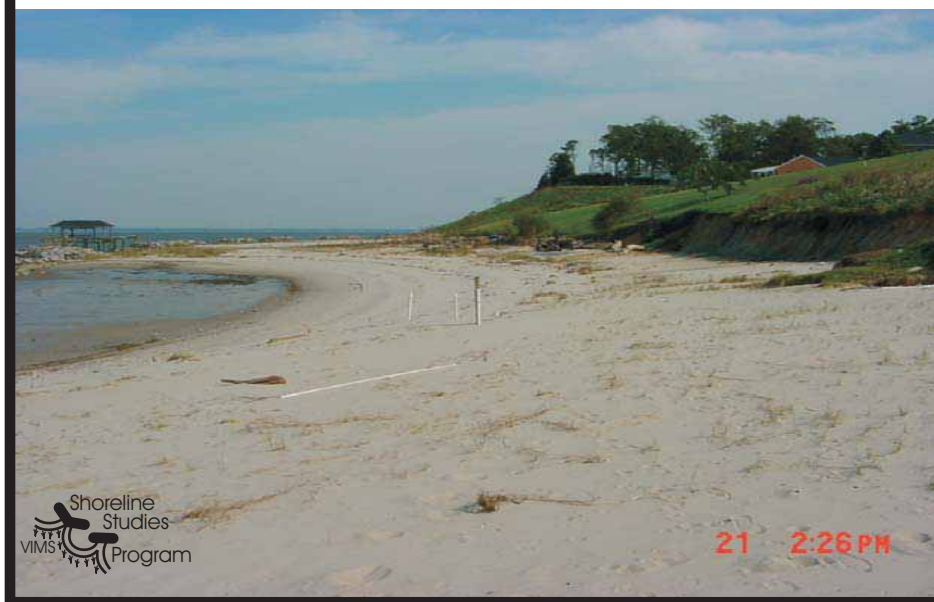
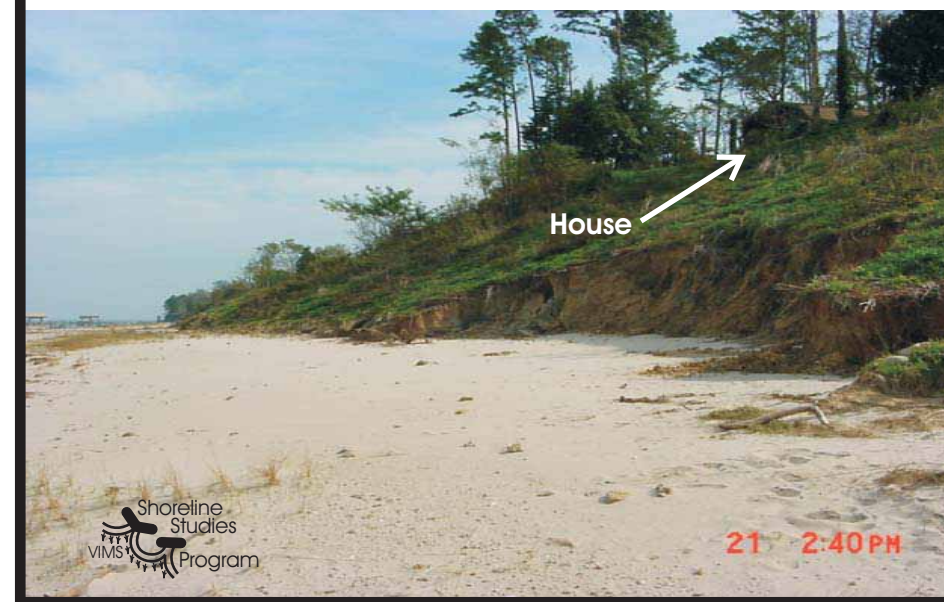
Figure 4-13. Van Dyke ground photos before and after Hurricane Isabel (from Hardaway *et al.*, 2005).

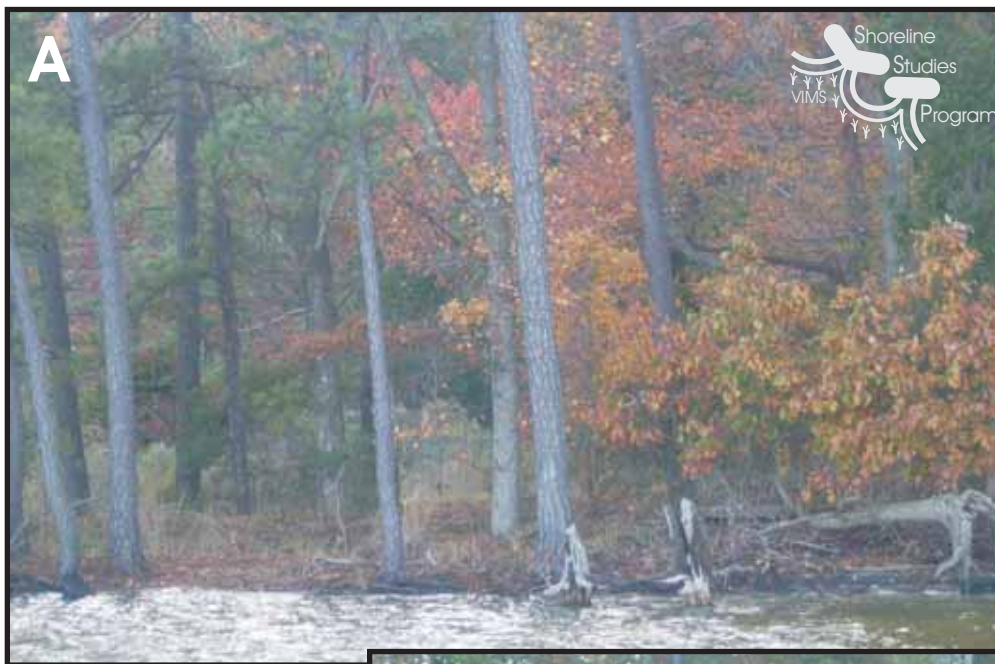
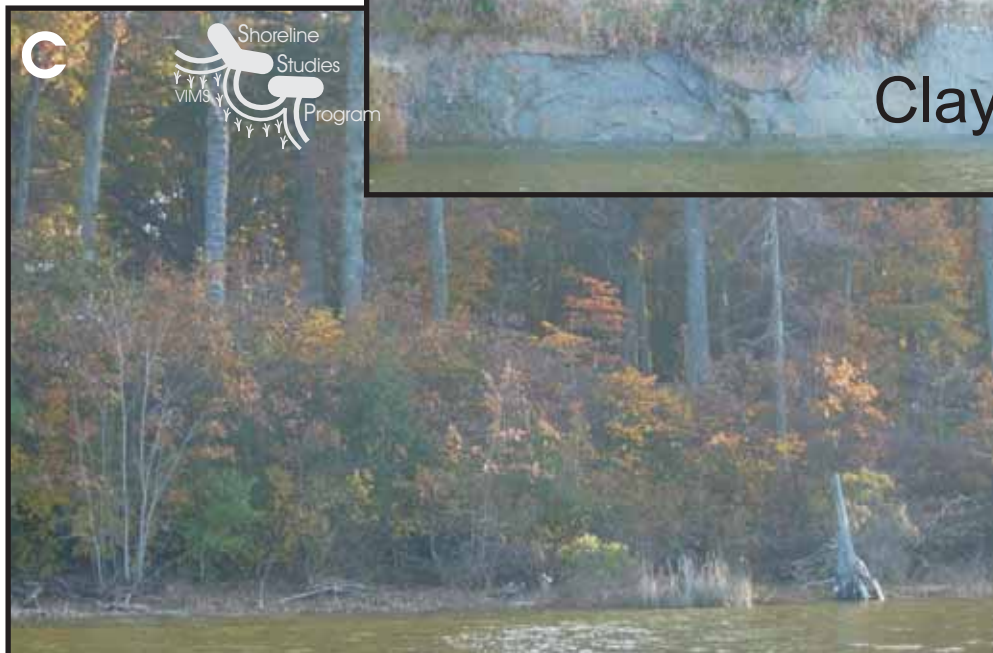
Figure 5-2. Site 349, as identified in the Mathews County Shoreline Management Plan, on the Piankatank River. A) The eastern end of the site is low, wooded and eroding. B) the high banks along the site are vertically-exposed and eroding. C) The western end of the site also is low, wooded and eroding.
