APPENDICES

Comprehensive Site Plan and
Environmental Assessment
THRO 258662

**Theodore Roosevelt National Park
Comprehensive Site Plan and Environmental Assessment
PMIS #258662**

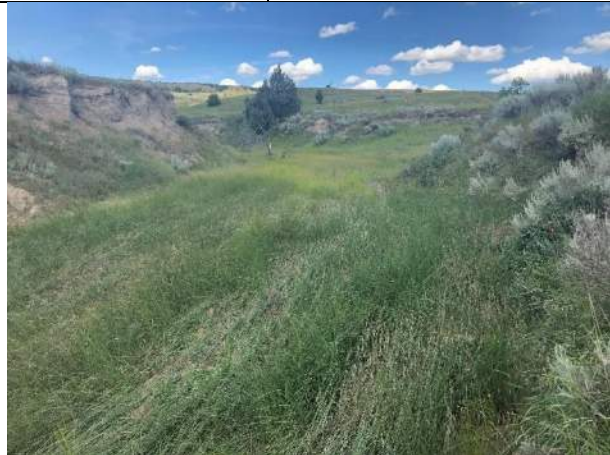
WETLAND 1A-1B-1C – INFORMATION SUMMARY			
Location:		Centrally located in the study area flowing north to south

Size (in study area)	>2.43 acres	
	FGDC Classification	PEM1A	
	HGM Classification	Slope	
	Wetland Data Sheet	DP5-North	
	Upland Data Sheet	DP6-North	
	Regulated under the CWA?	Yes, abuts tributary to TNW.	
	Delineation Rationale	Satisfies all three wetland criteria.	
Dominant Vegetation		Shoenoplectus pungens, Carex athrostachya, Distichlis spicata, Eleocharis palustris, Spartina pectinata, Shoenoplectus acutus	
Soils		Silty clay; 10YR 4/2 and 3/2 with redox features and depletions	
Hydrology		Surface water, High water table, Saturation.	
Primary Wetland Functions-Values Summary			
Water Quality		Sediment retention/stabilization, nutrient production and export.	
Hydrologic		Floodflow alteration, groundwater discharge.	
Habitat		Provides habitat diversity and migration corridors for a variety of wildlife.

Eight wetlands were delineated in the North Unit study area identified on Figure 6 in Appendix B as Wetlands 1A, 1B, 1C, 2, 3, 4, 5, and 6. Wetland 1 is a broad linear slope wetland in a confined drainage that is conveyed through culverts underneath Scenic Drive and Maintenance Way. Wetland 1 was subdivided into Wetland 1A, 1B, and 1C for mapping purposes in this report based on the hydrological breaks caused by the road crossings. Wetland 1 confluences with Tributary A just west of Maintenance Way near the employee housing complex. Wetland 1C transitions to riverine habitat (Tributary A) where the drainage narrows and the gradient increases closer to where it discharges to the Little Missouri River.

Wetland 1 is supported by groundwater springs and surface runoff following precipitation events. Wetland 1 had shallow surface water flowing in rivulets through dense herbaceous vegetation during the site visit, and contained multiple step-pools in which small pockets of water transitioned into vegetated wetlands where the drainage had aggraded over time. Evidence of flash floods were also observed including wrack lines and vegetative debris along the drainage walls approximately five feet above the wetlands and culvert inlets. The substrate was dominated by clay fines that had eroded from adjacent upland areas. Hydric soil indicators included depleted matrices with redoximorphic concentrations in the upper soil profile.

Habitat in Wetland 1 is classified as palustrine emergent persistent temporarily flooded (PEM1A). Vegetation in Wetland 1 was dominated by three-square (*Shoenoplectus pungens*, OBL), slender-beak sedge (*Carex athrostachya*, FACW), salt-grass (*Distichlis spicata*, FACW), spike-rush (*Eleocharis palustris*, OBL), and prairie cordgrass (*Spartina pectinata*, FACW). Hardstem bulrush (*Shoenoplectus acutus*, OBL) populated springs and ponded areas with extremely soft mud substrates (e.g. quicksand). Distinct topographic breaks marked transitions to the upland riparian community that generally consisted of longleaf sage (*Artemisia longifolia*, FACU), wolfberry (*Symphoricarpos occidentalis*, UPL), smooth brome (*Bromus inermis*, UPL), crested wheatgrass (*Agropyron cristatum*, NL/UPL), and sweet clover (*Melilotus officinalis*, FACU).

Primary functions provided by the linear slope Wetlands 1A, 1B, and 1C include moderation of groundwater flow, velocity reduction of surface water flow, retention of particulates, organic carbon export in the dry landscape, maintenance of plant community, habitat diversity and connectivity between wetlands, and maintaining distribution and abundance of vertebrates and invertebrates. Chorus frogs (*Pseudacris nigrita*) were observed throughout Wetland 1. Wetland 1 provides educational and scenic value due their rarity in the landscape and because they can be seen from Scenic Drive. Wetland 1 characteristics and functions are summarized in Table 3-2.

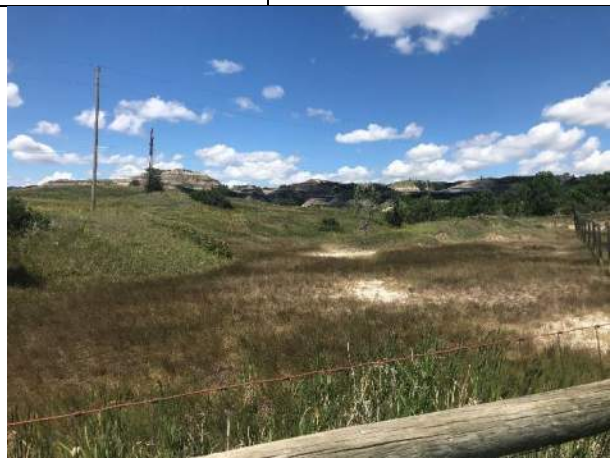
WETLAND 2 – INFORMATION SUMMARY			
Location:		Along the eastern property boundary south of Scenic Drive and entrance kiosk

Size (in study area)	0.57 acre	
	FGDC Classification	PEM1A	
	HGM Classification	Slope	
	Wetland Data Sheet	DP1-North	
	Upland Data Sheet	DP2-North	
	Regulated under the CWA?	Yes, abuts tributary to TNW.	
	Delineation Rationale	Satisfies all three wetland criteria.	
Dominant Vegetation	<i>Puccinellia nutalliana</i> , <i>Typha angustifolia</i> , <i>Cirsium arvense</i> , <i>Shoenoplectus pungens</i>		
Soils	Silty clay, 10YR 3/2 and 3/1 with redox features and depletions in the upper profile		
Hydrology	High water table, Saturation, Surface water, Salt crust		
Primary Wetland Functions-Values Summary			
Water Quality	Sediment retention/stabilization, nutrient production and export.		
Hydrologic	Floodflow alteration, groundwater discharge.		
Habitat	Provides habitat diversity and migration corridor for a variety of wildlife; food source for birds due to abundant insect population.

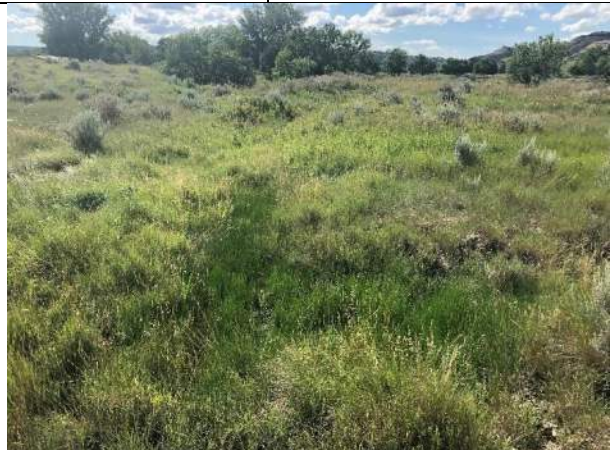
WETLAND 3 – INFORMATION SUMMARY			
Location:		East of Maintenance Way and south of Scenic Drive on hillside slope

Size (in study area)	0.01 acre	
	FGDC Classification	PEM1B	
	HGM Classification	Depressional	
	Wetland Data Sheet	DP3-North	
	Upland Data Sheet	DP4-North	
	Regulated under the CWA?	Yes, surface connection during storm events to Wetland 1C/Tributary A.	
	Delineation Rationale	Satisfies all three wetland criteria.	
Dominant Vegetation		<i>Elocharis palustris</i> , <i>Xanthium strumarium</i> , <i>Cirsium arvense</i>	
Soils		Clay, 10YR 3/2 with redox features and depletions in the upper soil profile	
Hydrology		High water table, Saturation, Surface water.	
Primary Wetland Functions-Values Summary			
Water Quality		Sediment and nutrient retention.	
Hydrologic		Groundwater recharge and discharge.	
Habitat		Low habitat functions due to livestock use.	
Values		Low value due to disturbance regime and isolation on the landscape.

Wetland 3 is a small depressional wetland supported by a shallow water groundwater seep. Livestock trampling has caused the side slopes of the linear feature to collapse, which causes water to temporarily pond and develop saturated soil conditions. It appears isolated from other surface waters and wetland habitats, but during snowmelt and large precipitation events it likely overflows into a wooded draw that connects to Wetland 1C approximately 300 feet downslope to the southwest.

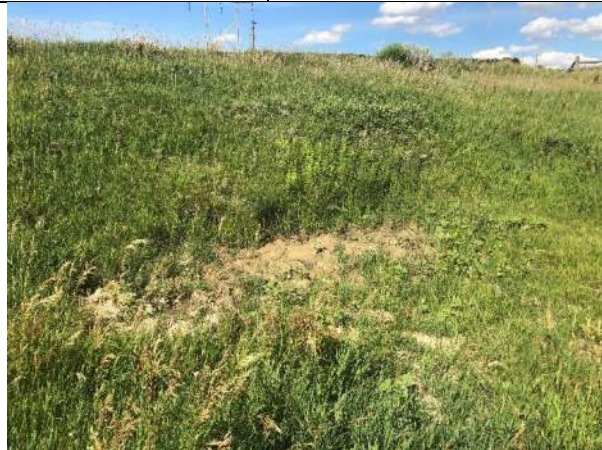
WETLAND 4 – INFORMATION SUMMARY		
Location:	South of Scenic Drive, east of entrance kiosk, at toe of road embankment

Size (in study area)	0.01 acre
	FGDC Classification	PEM1A
	HGM Classification	Depressional
	Wetland Data Sheet	DP3-North
	Upland Data Sheet	DP4-North
	Regulated under the CWA?	No, no surface connection to other regulated waters.
	Delineation Rationale	Satisfies all three wetland criteria.
Dominant Vegetation	<i>Xanthium strumarium</i> , <i>Carex athrostachya</i> , <i>Hordeum jubatum</i>	
Soils	Clay, 10YR 3/2 with redox features and depletions in the upper soil profile	
Hydrology	Saturation, Surface soil cracks	
Primary Wetland Functions-Values Summary		
Water Quality	Sediment and nutrient retention	
Hydrologic	Groundwater recharge	
Habitat	Low habitat functions due to proximity to road and flashy hydroperiod.	
Values	Low value due to proximity to road and low educational/scientific value.

Wetlands 4 and 5 are small (<0.01 acre) depressional wetlands located at the toe of the entrance road east of the kiosk, and are connected by a metal culvert through the road embankment. Wetland 5 is on the north side of the entrance road at the culvert inlet, and Wetland 4 is on the downslope side at the culvert outfall. Both wetlands are depressional pockets with clay pans and surface soil cracks that likely formed after the culvert was installed and the culvert concentrated stormwater flows from the surrounding uplands. Wetland vegetation was dominated by cocklebur, slender-beak sedge, and foxtail barley (*Hordeum jubatum*, FACW). Upland vegetation around the wetlands was dominated by longleaf sage, smooth brome, and crested wheatgrass. Habitat in Wetland 4 and 5 is classified as palustrine emergent persistent temporarily flooded (PEM1A). Primary functions provided by Wetlands 4 and 5 include water quality maintenance (e.g., sediment retention) and hydrologic (e.g., groundwater recharge). These wetlands have low value due to their proximity to the entrance road, low educational/scientific value, and low habitat functions. See Table 3-5 and Table 3-6 for summaries of Wetlands 4 and 5.

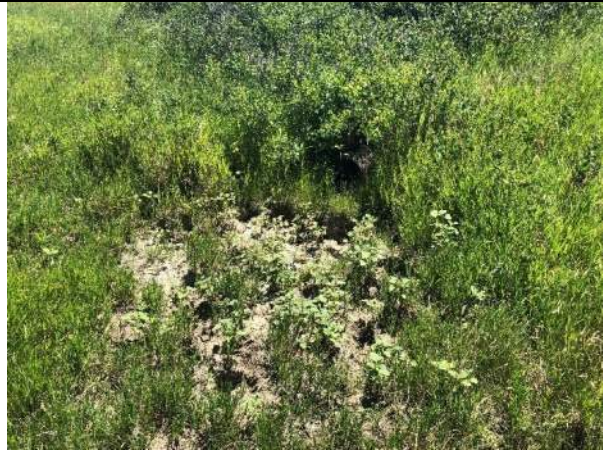
WETLAND 5 – INFORMATION SUMMARY			
Location:		North of Scenic Drive, east of entrance kiosk, at toe of road embankment

Size (in study area)	<0.01 acre	
	FGDC Classification	PEM1A	
	HGM Classification	Depressional	
	Wetland Data Sheet	DP3-North	
	Upland Data Sheet	DP4-North	
	Regulated under the CWA?	No, no surface connection to other regulated waters.	
	Delineation Rationale	Satisfies all three wetland criteria.	
Dominant Vegetation		<i>Xanthium strumarium</i> , <i>Hordeum jubatum</i> , <i>Bromus inermis</i>	
Soils		Clay, 10YR 3/2 with redox features and depletions in the upper soil profile	
Hydrology		Saturation, Surface soil cracks	
Primary Wetland Functions-Values Summary			
Water Quality		Sediment and nutrient retention	
Hydrologic		Groundwater recharge	
Habitat		Low habitat functions due to proximity to road and flashy hydroperiod.	
Values		Low value due to proximity to road and low educational/scientific value.

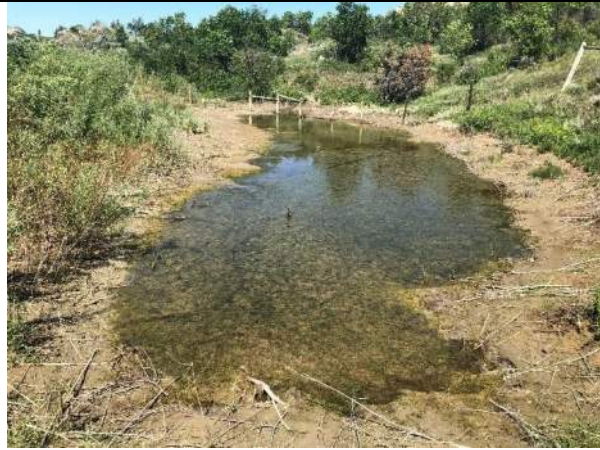
WETLAND 6 – INFORMATION SUMMARY			
Location:		Left bank of Little Missouri River along western study area boundary

Size (in study area)	0.17 acre	
	FGDC Classification	PAB3H	
	HGM Classification	Depressional	
	Wetland Data Sheet	DP7-North	
	Upland Data Sheet	DP8-North	
	Regulated under the CWA?	Yes, adjacent to TNW.	
	Delineation Rationale	Satisfies all three wetland criteria.	
Dominant Vegetation		<i>Elocharis palustris</i> , <i>Potamogeton pusillus</i> , <i>Typha angustifolia</i> , <i>Salix interior</i>	
Soils		Clay, 10YR 3/2 with redox features and depletions in the upper soil profile	
Hydrology		High water table, Saturation, Surface water.	
Primary Wetland Functions-Values Summary			
Water Quality		Sediment and nutrient retention, production export, sediment stabilization.	
Hydrologic		Groundwater recharge and discharge, floodflow alteration.	
Habitat		High habitat functions due to beaver presence.

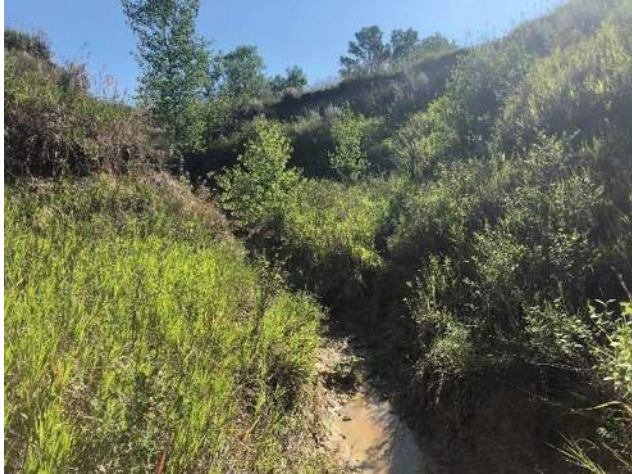
TRIBUTARY A - INFORMATION SUMMARY		
Location:	North-south alignment through the center of the study area

Stream Name	Unnamed (Tributary A)
	FGDC Classification	R4SBC
	USACE Classification	Tributary to TNW (Little Missouri River)
	Flow regime	Intermittent
	Fish Use	No
	Average Width	3-5'
	Comments	Tributary A flows in a deeply incised ravine. OHW estimated with offsets from top of bluff downstream of Wetland 1C (inaccessible).
Riparian Buffer Condition	Riparian buffer consists of shrub and grassland habitat in moderately good condition with limited evidence of browse and trampling by livestock. Buffer is impacted near road crossings and along the dirt access road near the maintenance facilities and storage yard in the southern portion of the study area.

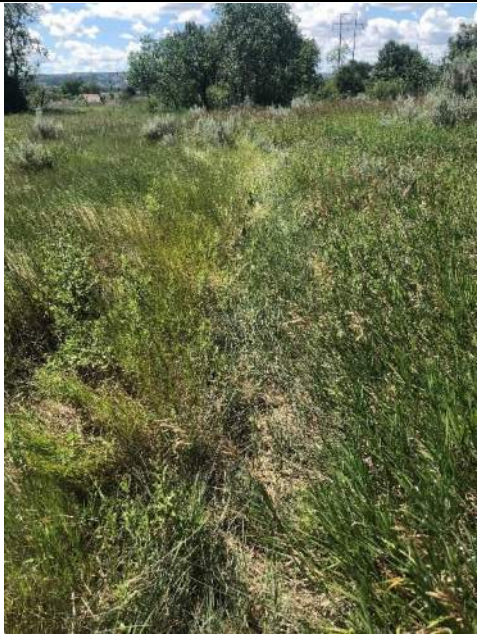
TRIBUTARY B - INFORMATION SUMMARY			
Location:		In the southern portion of the study area east of the maintenance buildings

Stream Name	Unnamed (Tributary B)
		FGDC Classification	R4SBCx
		USACE Classification	Tributary to TNW (Little Missouri River)
		Flow regime	Intermittent
		Fish Use	No
		Average Width	2'
		Comments	Tributary B conveys surface water from Wetland 2 to Wetland 1C/Tributary A during heavy precipitation events. Partially excavated with overhanging vegetation.
Riparian Buffer Condition	Riparian buffer consists of shrub and grassland habitat in good condition with limited evidence of browse and trampling by livestock. Wildlife movement is limited by a fence north of Tributary B.

Tributary B conveys surface water in an approximate 2-foot wide channel from Wetland 2 to Wetland 1C/Tributary A. The upper portion of Tributary B was excavated as evidenced by the raised berms that parallel it, and transitions to a steep, wooded drainage for approximately 250 feet before confluencing with Wetland 1C/Tributary A. Tributary B is incised with overhanging vegetation on both sides. Habitat in Tributary B is classified as riverine intermittent streambed seasonally flooded excavated (R4SBCx). Riparian habitat is in good condition, and wildlife movement is limited by a fence that parallels the north side of Tributary B. Tributary B characteristics are summarized in Table 3-9.

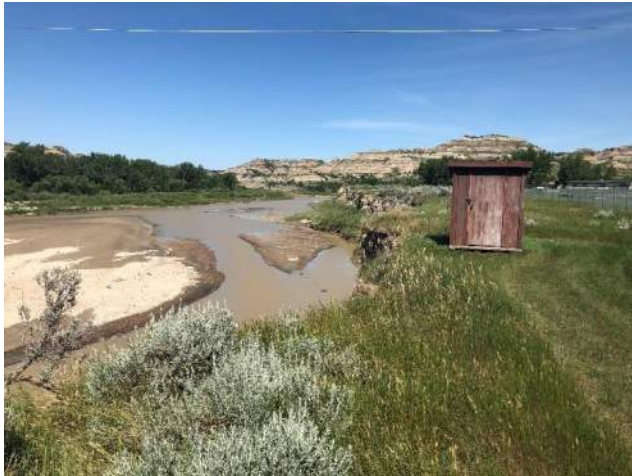
LITTLE MISSOURI RIVER - INFORMATION SUMMARY			
Location:		Along southwestern and southern study area boundary

Stream Name	Little Missouri River
		Cowardin Classification	R2USA, R2UBF
		USACE Classification	TNW
		Flow regime	Perennial
		Fish Use	Yes
		Average Width	200-400'
		Comments	OHW estimated using offsets from top of bluff south of the employee housing area.
Riparian Buffer Condition		Riparian buffer consists of forested, shrub, and grassland habitat in good condition. Buffer is partially impacted by sewage lagoons, material storage, and regular mowing at the top of the bluff. Slumping, sinkholes, and calving observed along the edge of the bluff.

The Little Missouri River parallels the south side of the study area. It is classified by the USACE as a Traditional Navigable Water (TNW), and habitat classes in the study area include riverine perennial unconsolidated shore temporarily flooded (R2USA) and riverine perennial unconsolidated bottom semipermanently flooded (R2UBF). Steep bluffs greater than 50 feet tall along the left bank near the sewage lagoons and employee housing transition to shorter bluffs and a broader floodplain further upstream to the northwest. Calving from erosion during high flows causes the bluff to occasionally collapse into large clay peds along the shoreline, and provides habitat for willows and other flood tolerant species to establish over time. Sinkholes and slumping were observed at the top of bluff from precipitation infiltrating through seams. Riparian buffer habitat along the bluff area is largely disconnected from the Little Missouri River due to the elevational differences, and vegetation communities are impacted by the sewage lagoons, materials storage, and routine mowing at the top of bluff. Riparian vegetation is in good condition north of the employee housing area and was not disturbed. Little Missouri River characteristics within the study area are summarized in Table 3-10

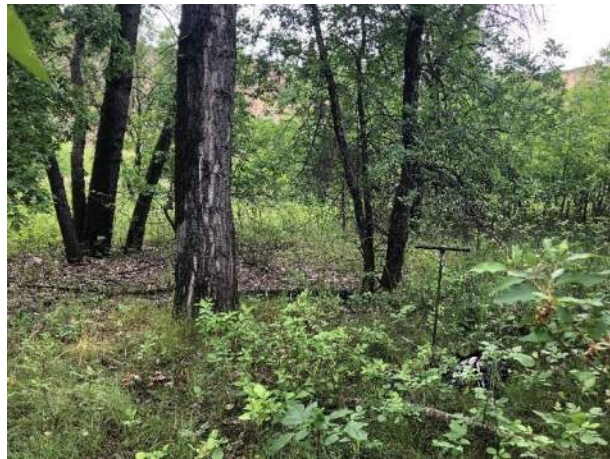
WETLAND 1 – INFORMATION SUMMARY			
Location:		North of Visitor Center and parking lot and east of Theodore Roosevelt's cabin

Size (in study area)	>0.11 acre
		FGDC Classification	PFO1A
		HGM Classification	Depressional
		Wetland Data Sheet	DP1-South
		Upland Data Sheet	DP2-South
		Regulated under the CWA?	No, in mapped floodplain of Little Missouri River but not inundated in a typical water year.
		Delineation Rationale	Satisfies all three wetland criteria.
Dominant Vegetation		Fraxinus pennsylvanica, Populus deltoides, Cornus sericea, Poa palustris, Carex sp.	
Soils		Clay; 10YR 3/2 and 4/2 with redox features and depletions	
Hydrology		Surface water, High water table, Saturation.	
Primary Wetland Functions-Values Summary			
Water Quality		Sediment and toxicant retention, nutrient removal.	
Hydrologic		Flood storage, groundwater recharge.	
Habitat		Provides habitat diversity and but limited by adjacent development.

Three wetlands were delineated in the South Unit study area identified on Figure 7 in Appendix B as Wetlands 1, 2, and 3. Wetland 1 is a depressional wetland located at the outlet of a stormwater pipe along the north side of the Visitor Center parking lot. Wetland 1 does not have a surface connection to any other wetlands or watercourses, and is located in the mapped 100-year floodplain of the Little Missouri River. Groundwater was observed at five inches below ground surface, and surface water was observed in the linear depression extending from the outfall that overflowed into a depressional pocket. Hydric soil indicators included depleted matrices below dark surfaces.

Habitat in Wetland 1 is classified as palustrine forested broad-leaved deciduous temporarily flooded (PFO1A). Dominant vegetation included eastern cottonwood and green ash (*Fraxinus pennsylvanica*, FAC) trees and saplings, red-twig dogwood (*Cornus sericea*, FACW), fowl bluegrass (*Poa palustris*, FACW), and an unidentified sedge (*Carex* sp., FACW or wetter). The sedge species was not identifiable in the field because a seed head was not found. It was assumed to be rated FACW or wetter due its establishment in saturated soil conditions and ponded areas. Upland vegetation also included eastern cottonwood and green ash trees and saplings, but also

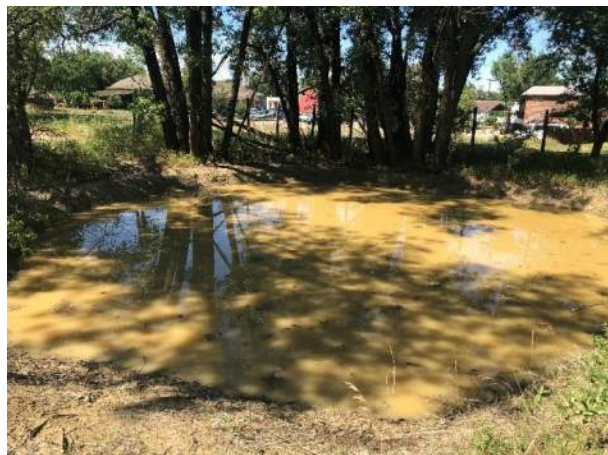
WETLAND 2 – INFORMATION SUMMARY			
Location:		East of town near the east end of Second Avenue

Size (in study area)	0.04 acre
		FGDC Classification	PUBJx
		HGM Classification	Depressional
		Wetland Data Sheet	-
		Upland Data Sheet	-
		Regulated under the CWA?	No, excavated wholly in uplands for the purpose of stormwater management.
		Delineation Rationale	Meets FGDC mapping standard.
Dominant Vegetation		Populus deltoides, Bromus inermis	
Soils		Mud	
Hydrology		Surface water	
Primary Wetland Functions-Values Summary			
Water Quality		Sediment retention.	
Hydrologic		Floodflow alteration.	
Habitat		Low habitat value due to periodic maintenance, fencing, and sediment-laden water.	
Values		Moderate societal value to minimize maintenance of concrete conveyance through town.

Wetland 2 is a ponded, depressional wetland excavated in uplands to capture and retain sediment from eroding hillsides and nearby draws. A low berm and excavated swale have been constructed to direct surface flows from heavy precipitation events into the pond. Wetland 2 functions as a sediment basin to capture the clay fines so they do not enter the concrete lined channel (Tributary B in this report) that flows through the City of Medina. Highly erodible soils were observed in the draw and drainage pathway but no OHW was observed that would make it a jurisdictional feature. The end of the swale is lined with concrete and buried under approximately two inches of sediment. Vegetation in the swale was dominated by upland plants such as smooth brome. Wetland 2 is surrounded by a stand of eastern cottonwood trees and is enclosed by fencing. Vegetation was not observed growing in the pond. Primary functions provided by Wetland 2 include sediment retention and flood storage

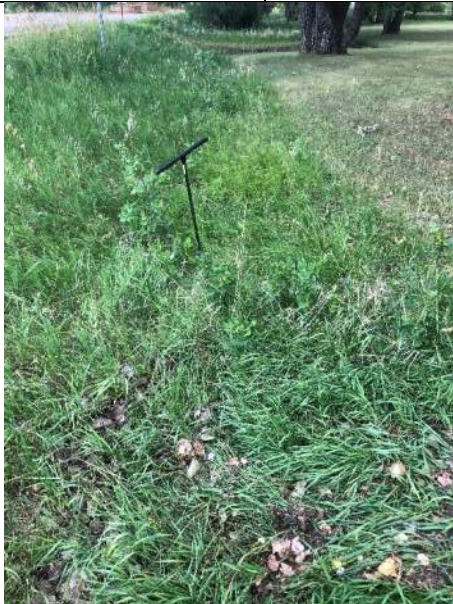
WETLAND 3 – INFORMATION SUMMARY				
Location:		At the northeast corner of the East River Road and 3 rd Avenue intersection

Size (in study area)	0.01 acre	
		FGDC Classification	PEM1A	
		HGM Classification	Slope	
		Wetland Data Sheet	-	
		Upland Data Sheet	-	
		Regulated under the CWA?	No, ditches constructed in uplands are not WOTUS.	
		Delineation Rationale	Presence of hydric soils and wetland hydrology with disturbed vegetation community.	
Dominant Vegetation		Fraxinus pennsylvanica, Poa pratensis		
Soils		Loam; 10YR 2/1 with redox features (10YR 5/6) and depletions (10YR 4/1)		
Hydrology		High water table, Saturation.		
Primary Wetland Functions-Values Summary				
Water Quality		Sediment and toxicant retention, and nutrient removal.		
Hydrologic		Floodflow alteration, groundwater recharge.		
Habitat		Low wildlife functions due to adjacent roads and regular vegetation maintenance.		
Values		Moderate societal value to treat stormwater runoff and improve water quality.

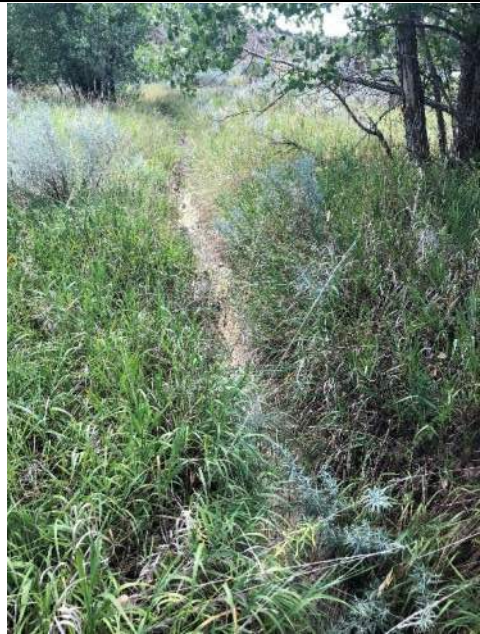
TRIBUTARY A - INFORMATION SUMMARY			
Location:		North-south alignment through the center of the study area

Stream Name	Unnamed (Tributary A)
		FGDC Classification	R4SBA
		USACE Classification	Not regulated, no surface connection to a WOTUS.
		Flow regime	Ephemeral
		Fish Use	No
		Average Width	2-3'
		Comments	Tributary A flows in an incised channel in response to precipitation events; substrate is dominated by eroded clay fines.
Riparian Buffer Condition	Riparian buffer consists of shrub and grassland habitat in moderately good condition. Buffer is impacted near the East River Road crossing and entrance drive to the maintenance facilities.

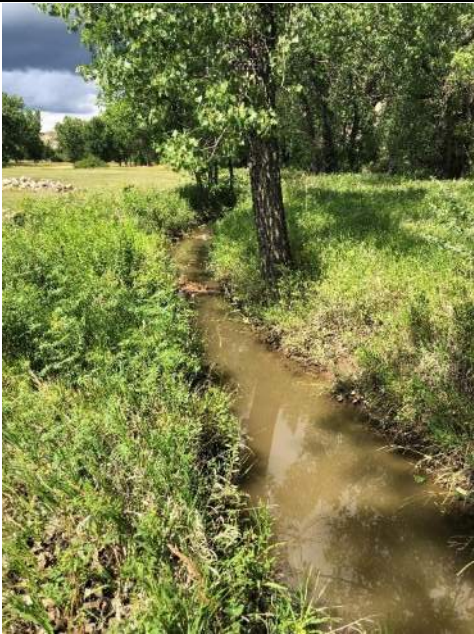
TRIBUTARY B - INFORMATION SUMMARY			
Location:	Center of town and west of East River Road

Stream Name	Unnamed (Tributary B)	
	FGDC Classification	R4SBCr, R4SBCx	
	USACE Classification	Tributary to TNW (Little Missouri River)	
	Flow regime	Intermittent	
	Fish Use	No	
	Average Width	3-6'	
	Comments	Tributary B flows in a concrete channel through town and then in a straightened channel around Chimney Park.	
Riparian Buffer Condition	Riparian buffer is minimal through town then transitions to a narrow forest corridor with adjacent maintained lawn areas around Chimney Park.

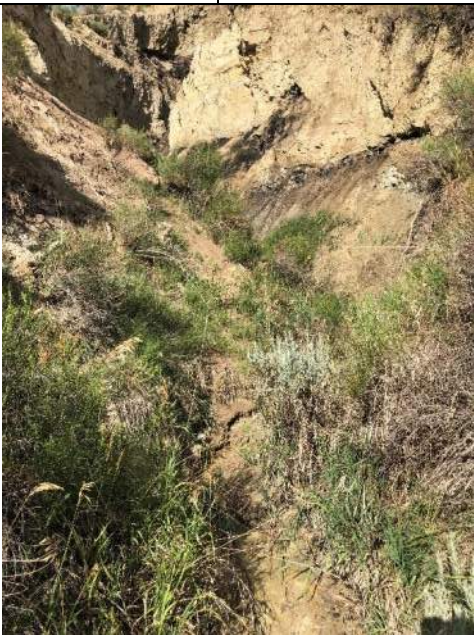
TRIBUTARY C - INFORMATION SUMMARY			
Location:		Northwest portion of study area between East River Road and the Little Missouri River

Stream Name	Unnamed (Tributary C)	
	FGDC Classification	R4SBA	
	USACE Classification	No, has an ephemeral flow regime with no surface water connection to other WOTUS.	
	Flow regime	Ephemeral	
	Fish Use	No	
	Average Width	1-2'	
	Comments	Tributary C flows in an incised ravine then dissipates on an alluvial fan of clay fines.	
Riparian Buffer Condition	Riparian buffer is limited by steep slopes within the ravine. Riparian shrub and herbaceous vegetation primarily functions to stabilize eroding soils.

Tributary C and Tributary D are ephemeral drainages in eroded bluffs that receive surface water runoff and groundwater seeps emanating from coal seams in incised ravines. Surface water in both tributaries disperses onto alluvial fans consisting of clay fines, and infiltrates east of the Little Missouri River. Both channels are approximately one-foot wide. The groundwater seeps cause the ravine sides to slump and erode over time. Riparian vegetation along the channels included big sagebrush, rabbitbrush (*Chrysothamnus nauseosus*, NL/UPL), saltgrass, and smooth brome. Habitat in Tributaries C and D is classified as riverine intermittent streambed temporarily flooded (R4SBA). Surface water was flowing at the time of the site visit. Tributary C and D characteristics are summarized in Table 4-7 and Table 4-8.

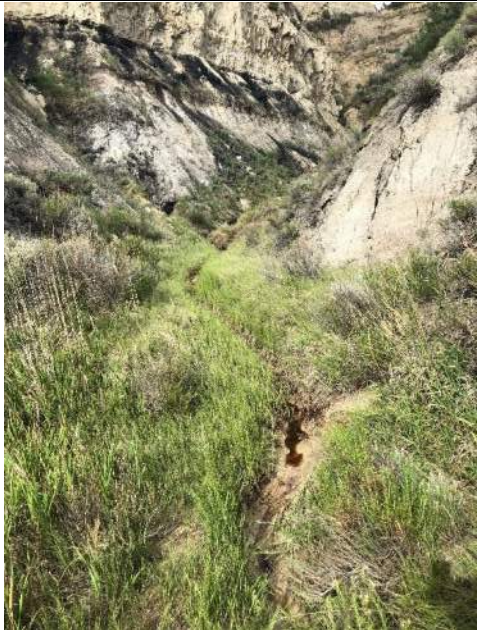
TRIBUTARY D - INFORMATION SUMMARY			
Location:		Northwest portion of study area between East River Road and the Little Missouri River

Stream Name	Unnamed (Tributary D)
		FGDC Classification	R4SBA
		USACE Classification	No, has an ephemeral flow regime with no surface water connection to other WOTUS.
		Flow regime	Ephemeral
		Fish Use	No
		Average Width	1-2'
		Comments	Tributary D flows in an incised ravine then dissipates on an alluvial fan of clay fines.
Riparian Buffer Condition	Riparian buffer is limited by steep slopes within the ravine. Riparian shrub and herbaceous vegetation primarily functions to stabilize eroding soils.

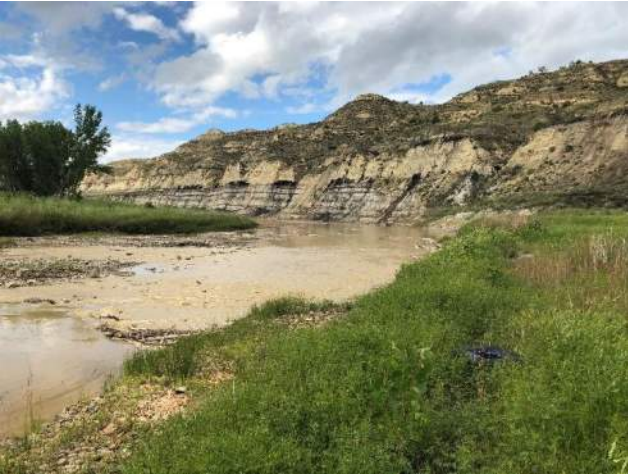
LITTLE MISSOURI RIVER - INFORMATION SUMMARY			
Location:		Northwestern edge of the study area

Stream Name		Little Missouri River
	FGDC Classification		R2USA, R2UBF
	USACE Classification		TNW
	Flow regime		Perennial
	Fish Use		Yes
	Average Width		100-150'
	Comments		Broad floodplain on right bank of river.
Riparian Buffer Condition		Riparian buffer consists of forested, shrub, and grassland habitat in good condition on the right bank within the study area and is engaged during flood events.

The Little Missouri River parallels the northwestern edge of the study area for approximately 1,350 feet. It is classified by the USACE as a TNW, and habitat classes in the study area include riverine perennial unconsolidated shore temporarily flooded (R2USA) and riverine perennial unconsolidated bottom semipermanently flooded (R2UBF). The OHWM was based on evidence of scour, bed and banks, gravel sorting, and the presence of floodplain terraces along the right bank that supported plants tolerant of saturated soil conditions versus upland plants. Herbaceous plants below the OHWM included prairie cordgrass, three-square, and spike-rush, and plants above the OHWM included wild licorice (*Glycyrrhiza lepidota*, FACU), sweet clover, showy milkweed (*Asclepias speciosa*, FAC), leafy spurge, and smooth brome. Soil profiles on the floodplain terraces above the OHWM had bright matrices (10YR 3/3 and 4/3) and sandy texture. Riparian vegetation also included a row of eastern cottonwood trees that paralleled the river approximately 100 to 150 feet to the east. Evidence of recent beaver browse was also observed. Little Missouri River characteristics within the study area are summarized in Table 4-9.

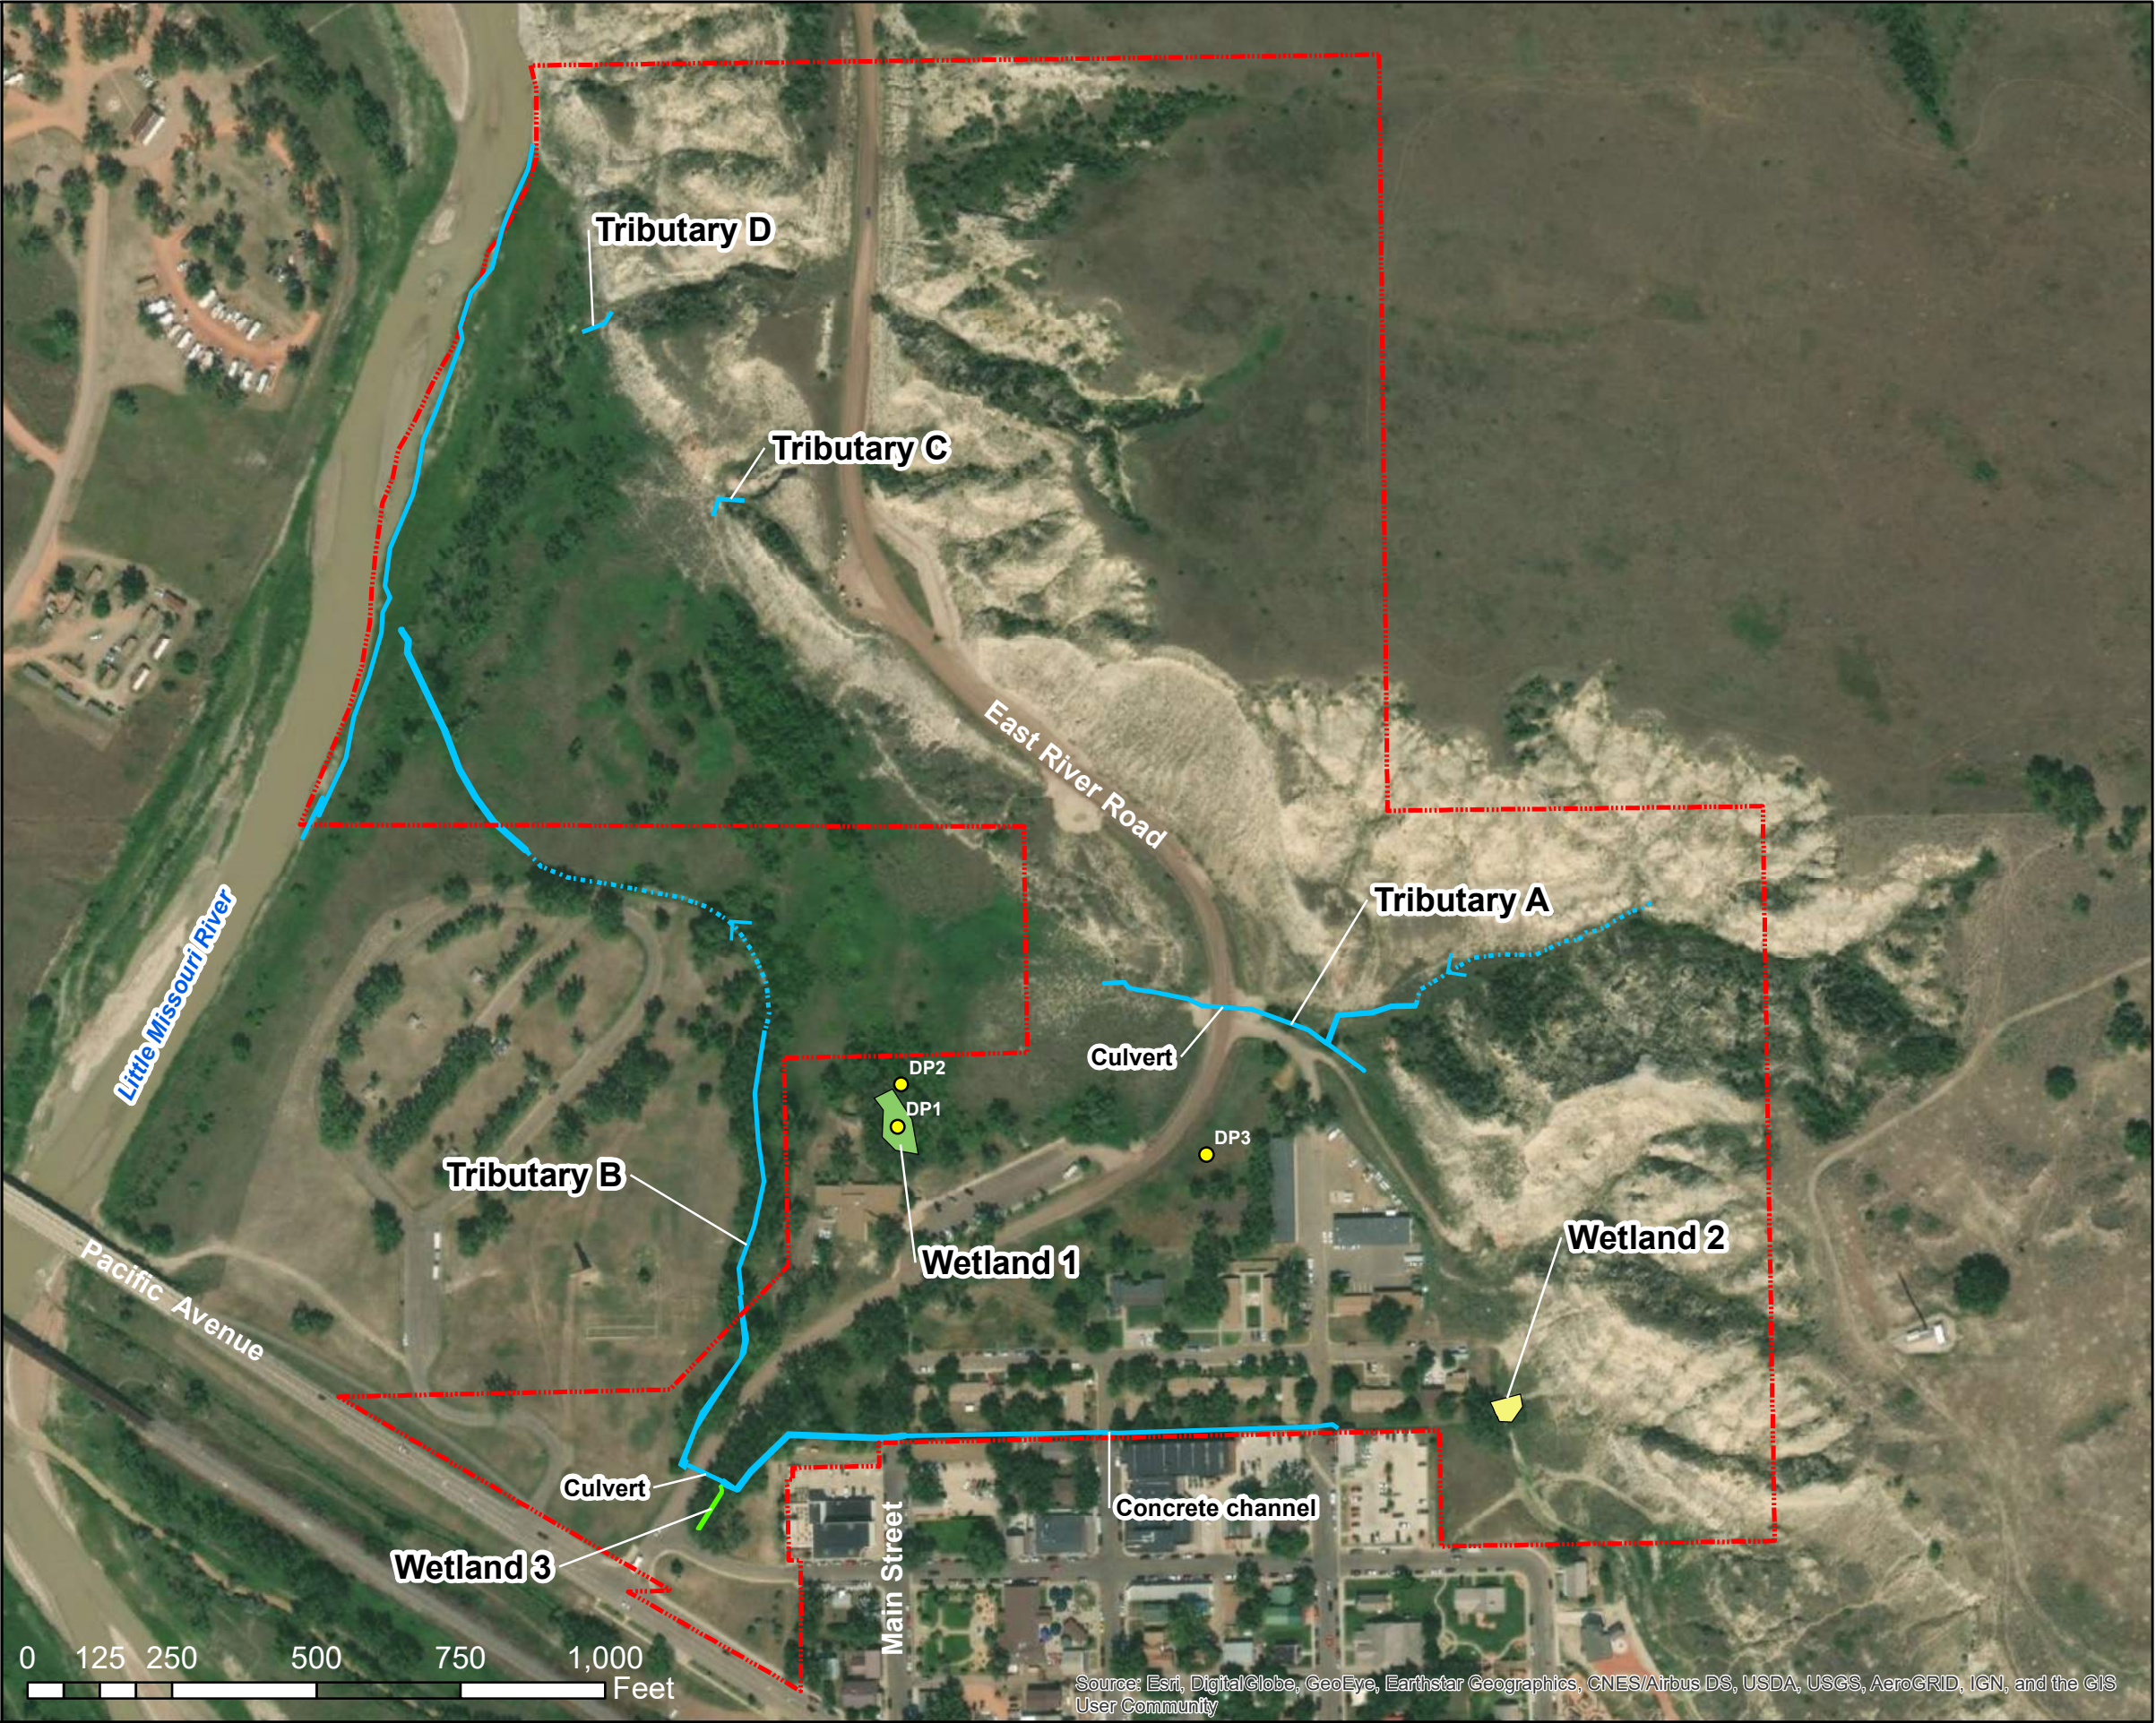
FIGURE 6
NORTH UNIT
WETLANDS AND STREAMS

Eight wetlands and three watercourses were identified and delineated in the North Unit study area as shown on Figure 6 in Appendix B. Wetland determination data forms are provided in Appendix C. Wetlands and streams characteristics are summarized in Tables 3-1 to 3-10.

Three watercourses were delineated in the study area, identified in this report and on Figure 6 in Appendix B as Tributary A, Tributary B, and the Little Missouri River. Tributary A flows from north to south through the center of the study area, and confluences with Wetland 1 west of Maintenance Way and north of the employee housing area. It flows through culverts underneath Scenic Drive and Maintenance Way, and backwatering during flood events at the culvert inlets was evidenced by wrack lines approximately five feet above the culvert inlet elevations. Upstream of Maintenance Way, habitat in Tributary A is classified as riverine intermittent streambed seasonally flooded (R4SBC) and flows in a three to five-foot wide low flow channel within a steep-sided ravine. Downstream of Maintenance Way the channel broadens and water velocities decrease, which allows the tributary to aggrade and support the development of wetland vegetation and a step-pool system with intermittent vegetated and ponded areas (Wetland 1C). Wetland 1C transitions back to a fluvial environment and R4SBC habitat as Tributary A flows in a deep ravine with higher velocities towards its confluence with the Little Missouri River. Riparian habitat includes shrub and grasslands in good to moderate condition. Riparian functions are limited by the gravel roads to the well house and maintenance facilities, and Maintenance Way and Scenic Way which are paved. Common woody riparian vegetation included American elm, cottonwood (*Populus deltoides*, FAC), common juniper, wolfberry, and wood's rose, and grasslands commonly included smooth brome, wheatgrass species, bluegrass, and various forbs. Characteristics of Tributary A are summarized in table 3-8.

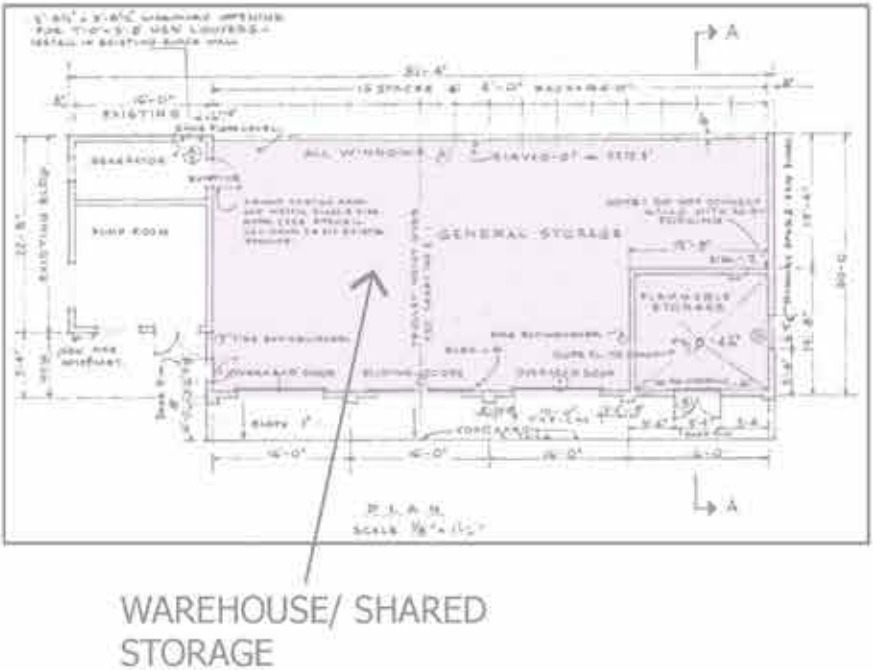
- South Unit Maint. Area Needs:
- Galley/Break/Meeting Room
 - Workspaces (3)
 - Heated Bays (2)
 - Larger LE Bay
 - Dedicated Fire Bay
 - Additional Unheated Space
 - Vehicle Maintenance Bay not large enough for snow plow maintenance
 - ABAAS Restroom/Shower/Lockers
 - Moe Publication Storage to VC
 - Task oriented storage with vehicle storage
 - Vehicle Wash Bay
