Fredericksburg & Spotsylvania NMP proposes to address water infiltration issues and inadequate attic ventilation at Old Salem Church. Staff from the National Park Service's Historic Preservation Training Center recently repaired and replaced interior plaster that was compromised due to water infiltration through the brick walls. The park proposes to mitigate this issue by adding gutters and downspouts to the structure. In addition, the park proposes to add a wooden gable end vent on the western façade of the building to facilitate ventilation in the attic.

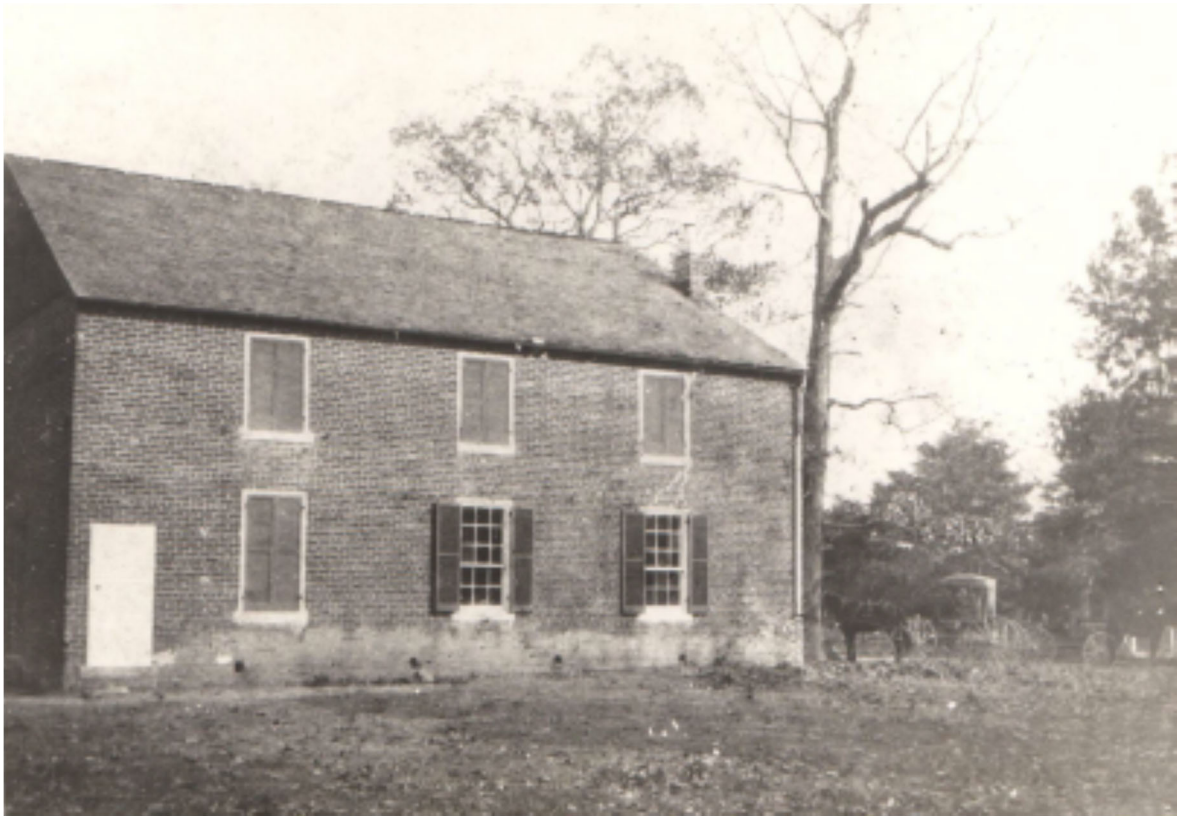
Old Salem Church 1890s – note downspout along southeast corner of the church

Historic images from the early 20th century indicate that gutters and downspouts have been used on the church in the past. Other historic photos show a semi-circular gable vent in the structure's western façade. Following the completion of the 1968 Historic Structure Report, the gutters, downspouts, and gable vent were subsequently removed. The park proposes to reinstall 6" half-round gutters and 4" round downspouts. Downspouts will be located on the northwest and southwest corners of the building. A semi-circular wooden gable end vent will also be reinstalled in the church's western façade so that excess heat can escape from the building's attic.

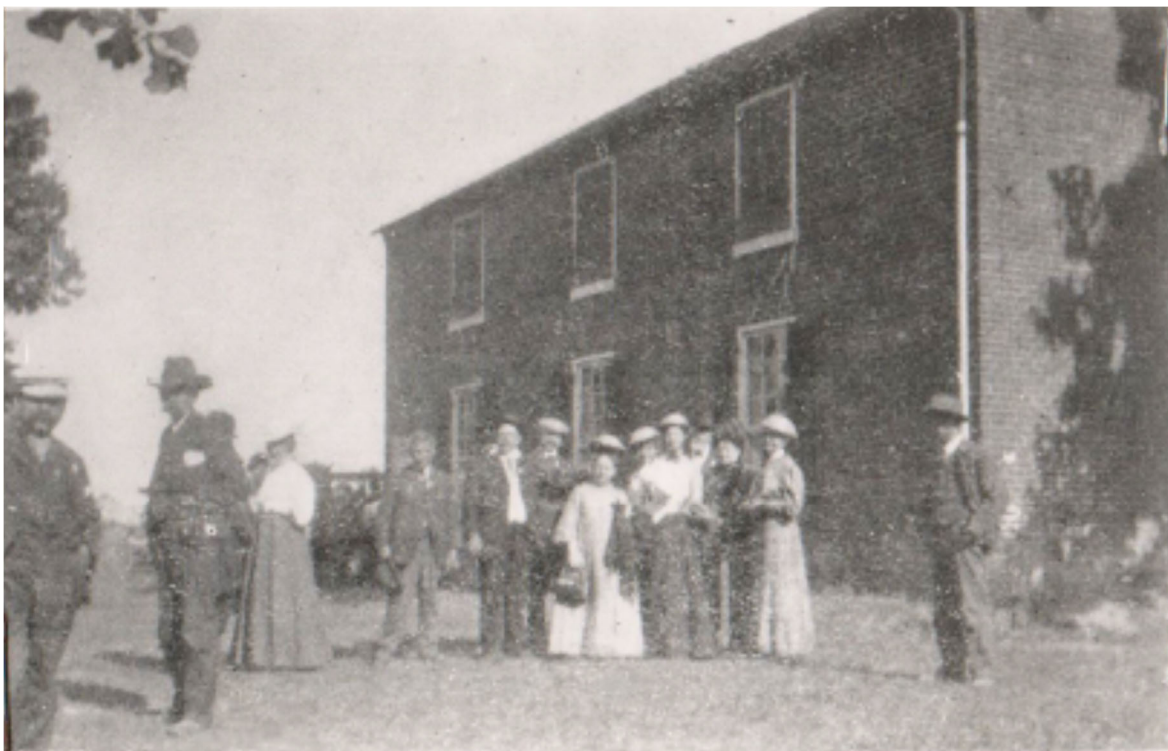
Old Salem Church 1908 – note downspout along southeast corner of the church

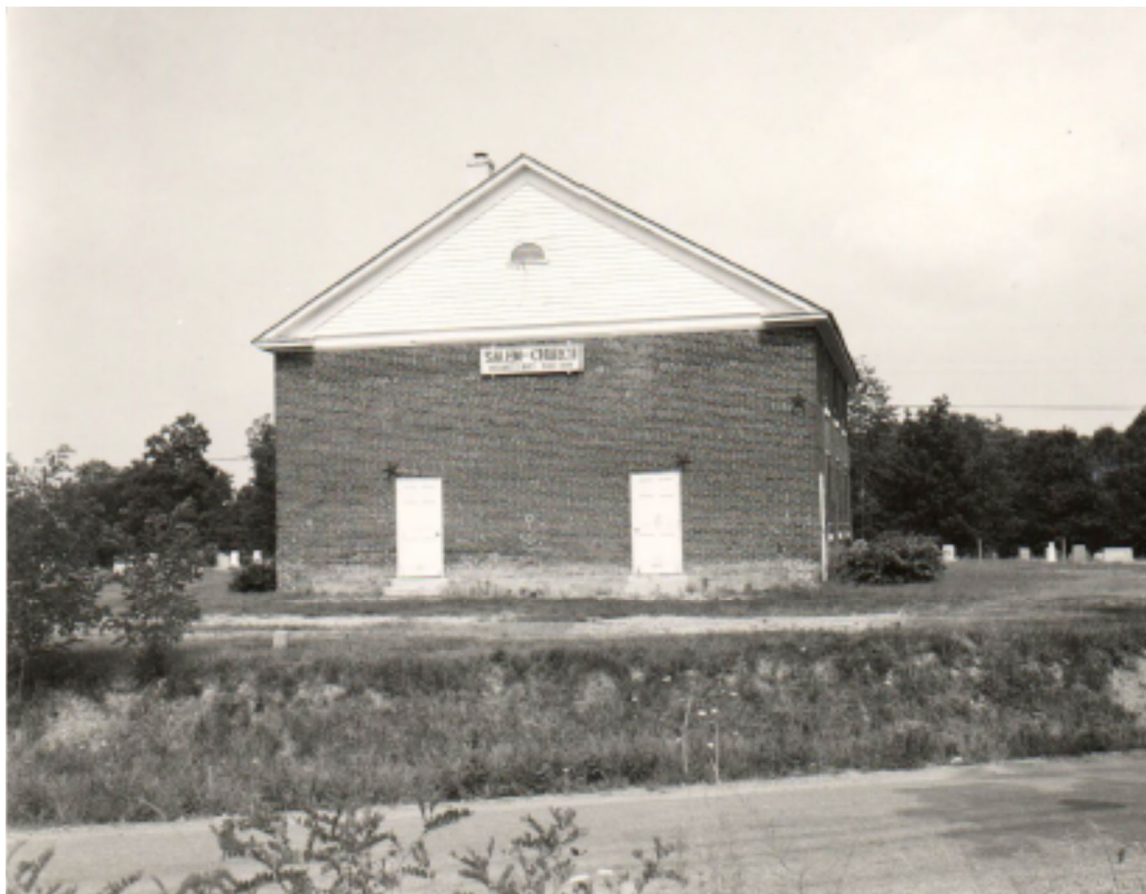
Salem Church 1960s – note attic vent on western gable end of the church

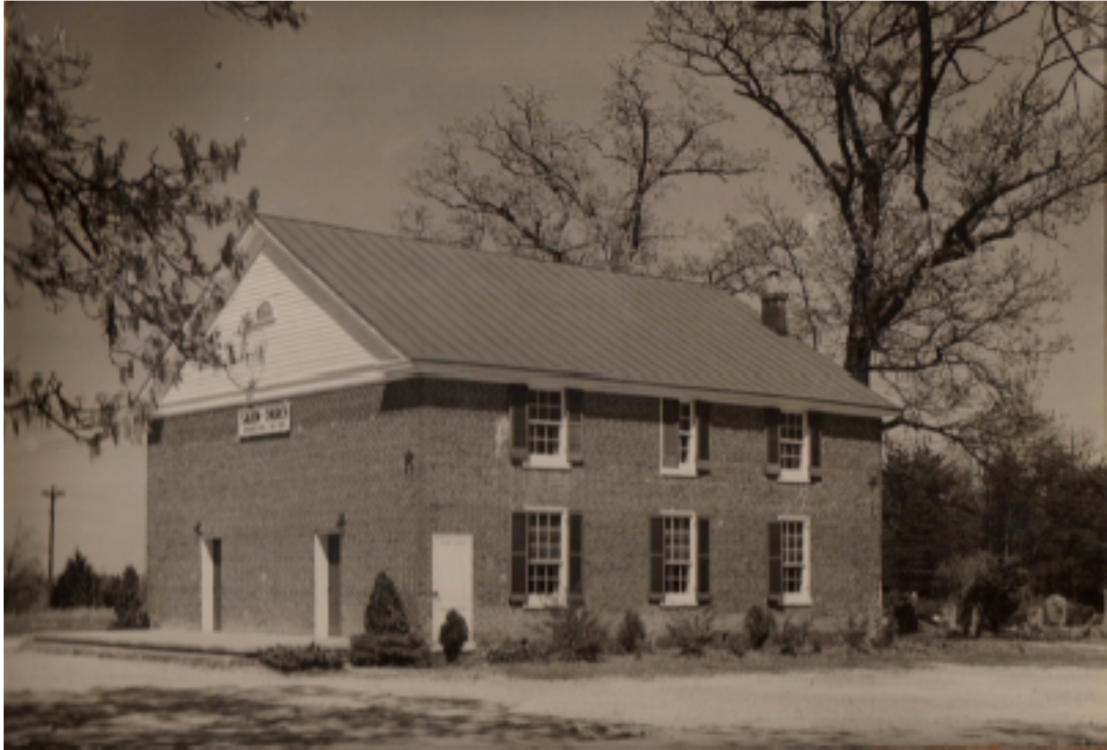
Salem Church 1960s – note attic vent on western gable end of the church

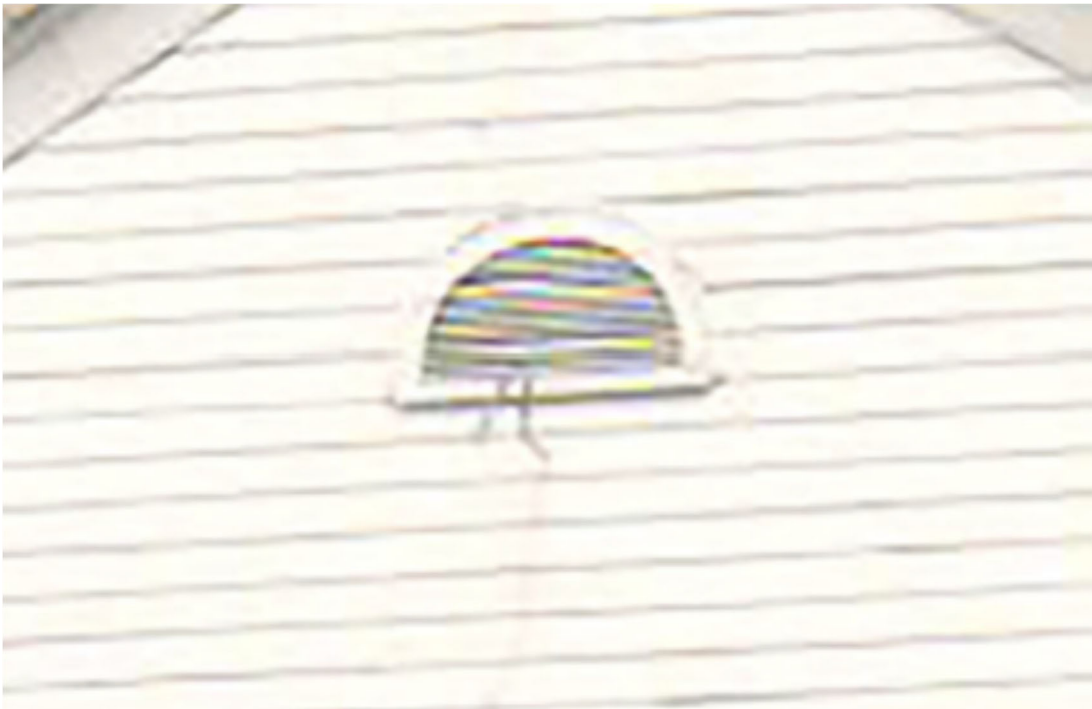
Closeup of attic vent 1960s
