REHABILITATE TIDAL BASIN AND WEST POTOMAC PARK SEAWALL

National Park Service, National Mall and Memorial Parks

Consulting Party Meeting #2

December 15, 2022

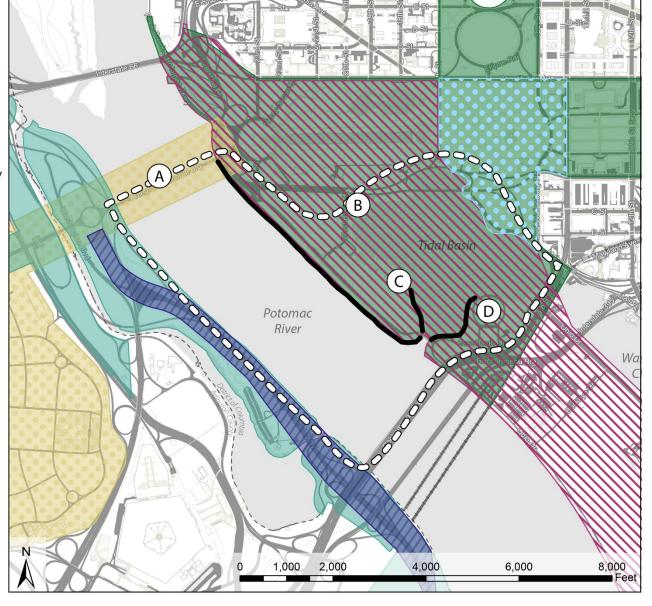
AREA OF POTENTIAL EFFECTS

Poposed extent of seawall project

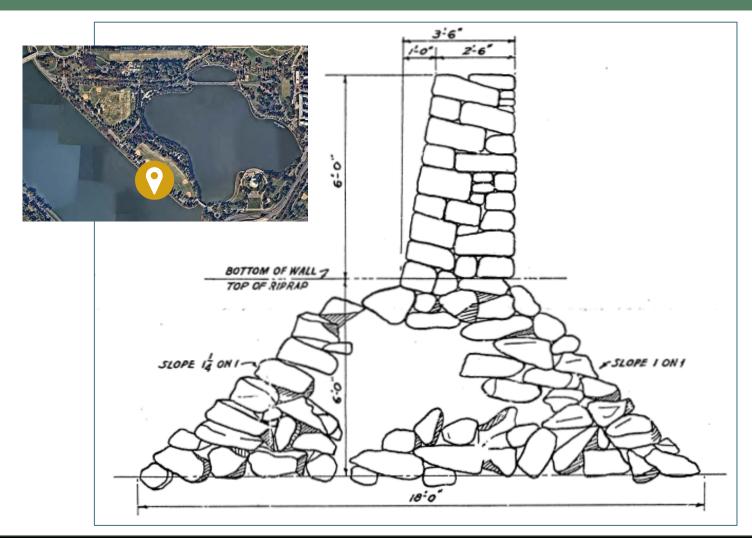
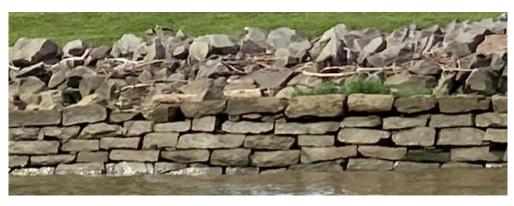
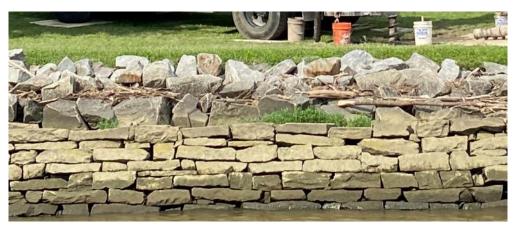
DRY STACKED STONE, SPLIT FACE – 1893 - 1896 HISTORIC DESIGN AND EXISTING CONDITION PHOTOS

West Potomac Park South - Looking Northeast

West Potomac Park South – Looking Northeast

WEST POTOMAC PARK SOUTH

- MOSTLY-RECTANGULAR STONES RATIO 1:1 6:1
- UNIFORM COLOR
- MINOR PINNING/CHINKING SMALL STONES PLACED INTO VOIDS TO HOLD LARGER STONES
- GOOD COURSING CONTINOUS HORIZONTAL JOINTS
- ROUGH & SMOOTH EXPOSED FACES
- POSSIBLE TOOLED/CHISELED SIDES (CUT) SOME ROUGH OR SPLIT FACES
- SMALL TO MEDIUM HEIGHT ~ 4" 6" (AVG)
- NO MORTAR STONES WELL DEFINED

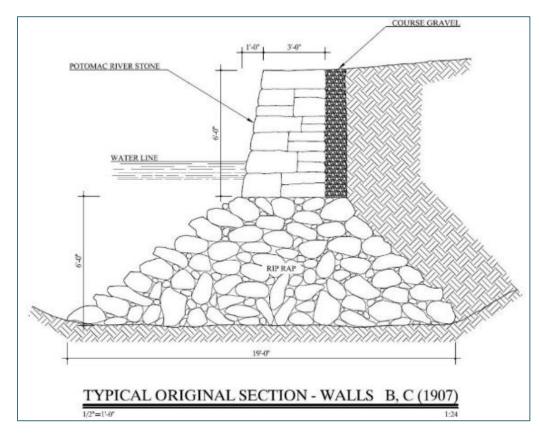
MORTARED UPPER STONES – 1896+ HISTORIC DESIGN AND EXISTING CONDITION PHOTOS

Original 1907 Design Cross Section (NPS Cultural Landscape Report, June 2020)

EXISTING CONDITIONS
(Original 1907 Tidal Basin West Seawall section)

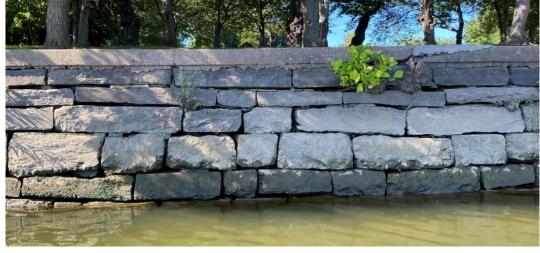
Tidal Basin West (NIC) – Looking North

Tidal Basin West

- Mostly-rectangular stones ratio 1:1 4:1
- Uniform color?
- Minor pinning/chinking
- Good coursing continuous horizontal joints

- Rough & smooth exposed face
- Tooled/chiseled sides (cut)
- Medium to large height ~ 6" 10" (avg)
- Aged mortar to face of stone medium sized joints (<1")

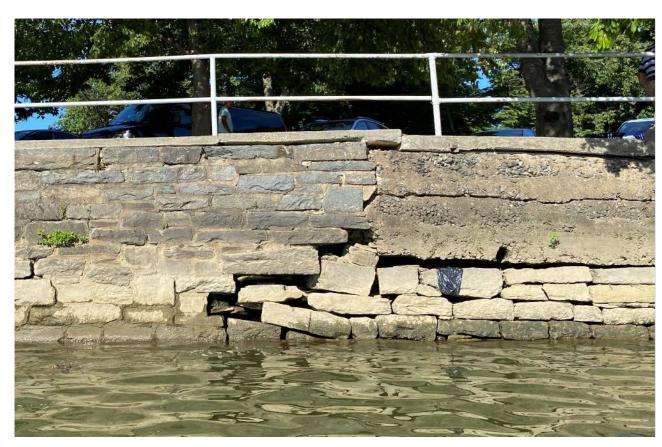
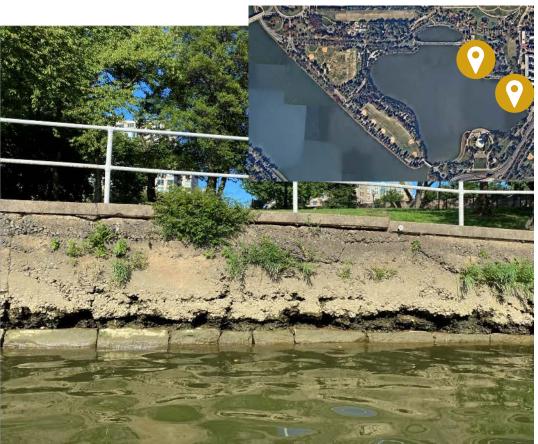
3FT PORTLAND CEMENT CONCRETE – 1902 EXISTING CONDITION PHOTOS

Tidal Basin North (NIC) – Looking East

Tidal Basin North (NIC) – Looking North

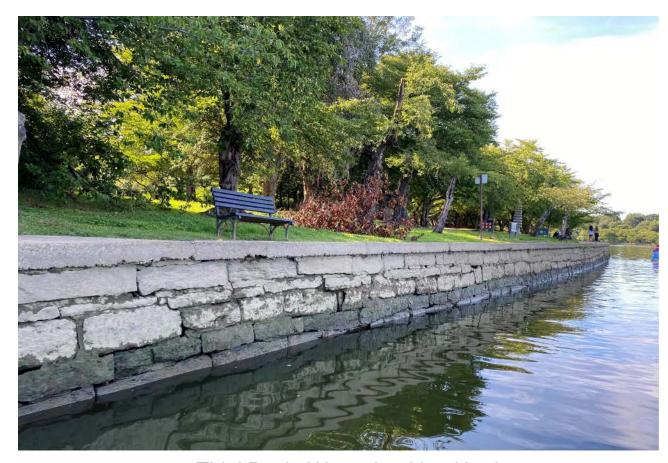
CONCRETE PAVING – 1915 EXISTING CONDITION PHOTOS

Tidal Basin West– Looking North

Tidal Basin West (NIC) – Looking Northwest

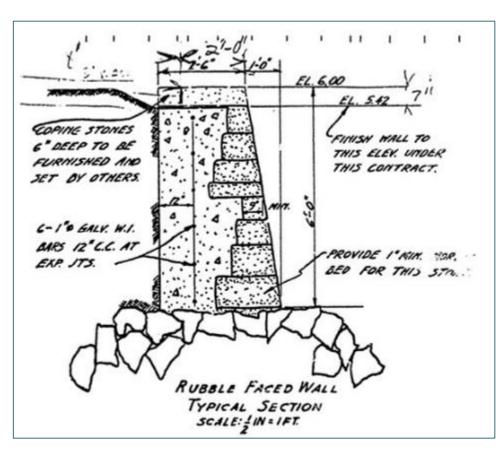
JFM CONCRETE BACKED WALL - 1941 HISTORIC DESIGN AND EXISTING CONDITION PHOTOS

Typical 1940s Tidal Basin East Seawall section

EXISTING CONDITIONS
(Typical 1940s Tidal Basin East Seawall section)

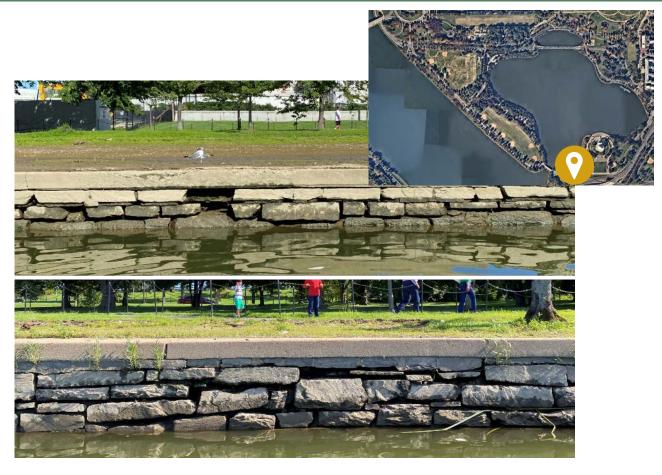
Tidal Basin East – Looking East

Tidal Basin East

- Rectangular stones ratio 1:1 8:1
- Uniform color
- Minor to moderate pinning/chinking
- Minor to good coursing continuous horizontal joints

- Very rough & smooth exposed face
- Some tooled/chiseled sides (cut) some rough sides
- Small to large height ~ 3" 10"
- Aged/degraded mortar leaves large gaps around veneer stones (>1")

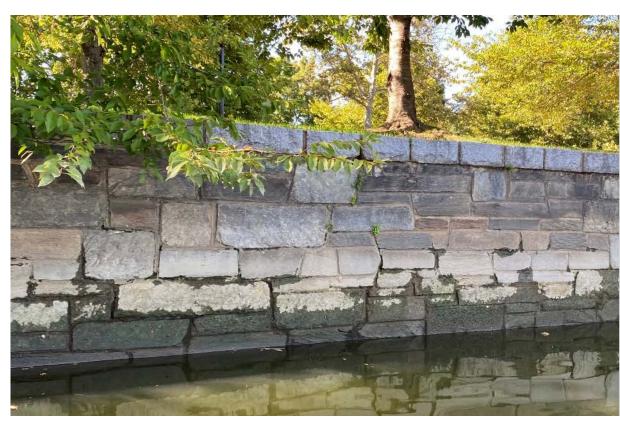
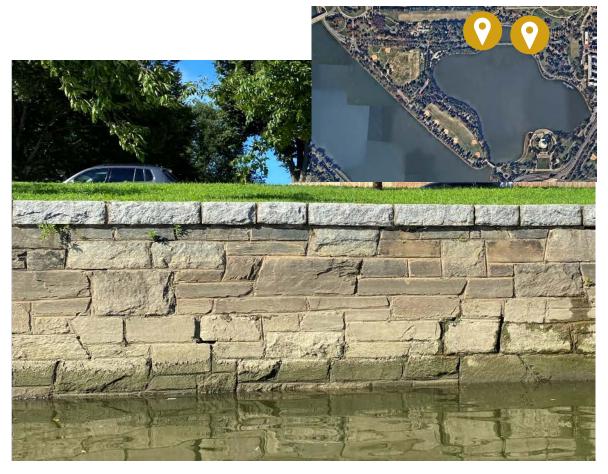
NON-RECTANGULAR, DRESSED, COLORED STONE – 1943 EXISTING CONDITION PHOTOS

Tidal Basin Lagoon (NIC) – Looking East

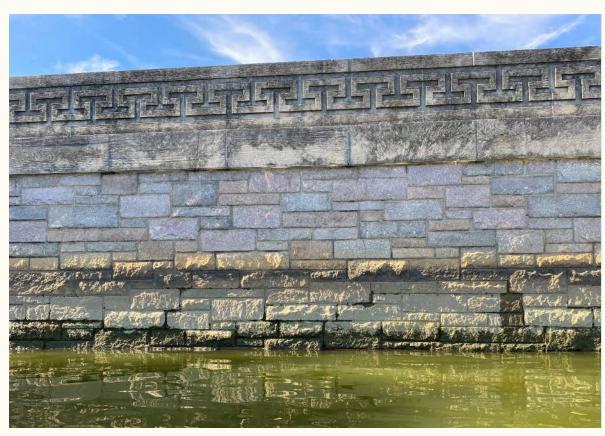
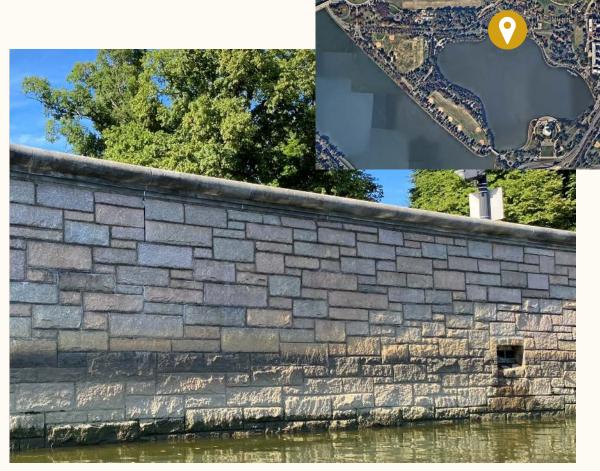
CONCRETE STONE VENEER – 1943 EXISTING CONDITION PHOTOS

Kutz Bridge (NIC) – Looking North

Independence Ave SW (NIC) – Looking North

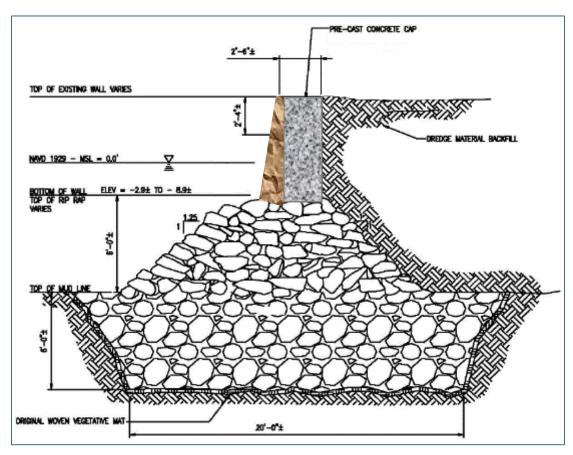
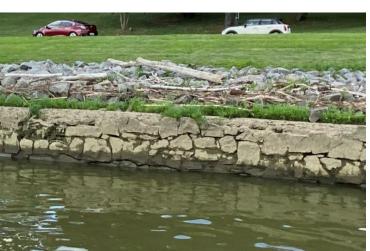
WPP-N CIP CONCRETE, STONE VENEER – 1958 HISTORIC DESIGN AND EXISTING CONDITION PHOTOS

Assumed Concrete Repair (Dewberry 2011)

West Potomac Park North – Looking North

EXISTING
CONDITIONS
(Assumed
Concrete
Repair: WPP
North)

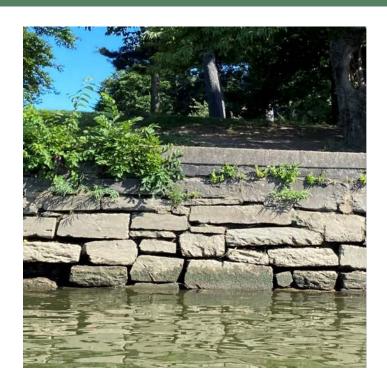
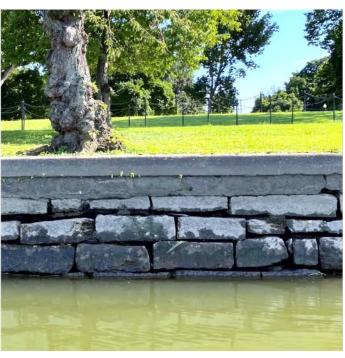
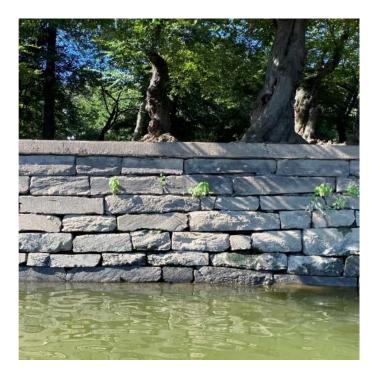
ACCEPTABLE SEAWALL CHARACTER

- Rectangular Stone Shape
- Reuse as much Historic Stone as Possible
 - Large Stone Variability
 - Moderate Pinning/Chinking

- Good Horizontal Coursing
- Less than 1" Joint Gaps Around Stones with Recessed Mortar
- Uniform Color
- Rough & Smooth Stone Faces

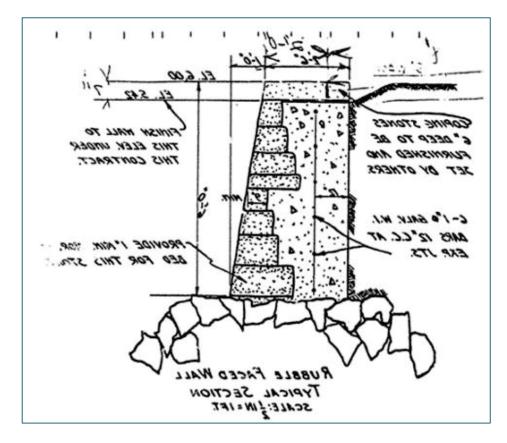
TIDAL BASIN EAST – PROPOSED

MHHW = Mean Higher High Water MLLW = Mean Lower Low Water Impacted Trees to be Replaced as Required (species and size vary) Transition to Existing Grade (occurs past the extent of this detail) Proposed Walkway - 1 Proposed Wall - Height 4.75' Existing Wall Heights Vary from 0.4' to 2.5' 5 Year Return Period Level: 5.2' (20% Chance/Yr) 6 Month Interval: 4.0' 1 Month Interval: 3.3' MHHW Level: 1.77 MLLW Level: -1.4' EXISTING GRADE ALL ELEVATIONS REFERENCE TO NAVD88

SCALE: 1/8" = 1'-0" SECTION 2

PROPOSED CONDITIONS (TYPICAL)
Tidal Basin - East

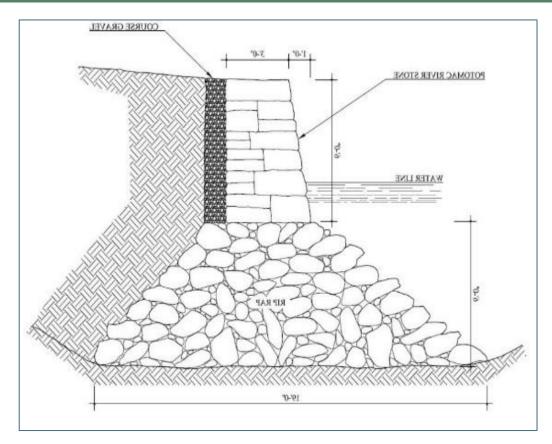
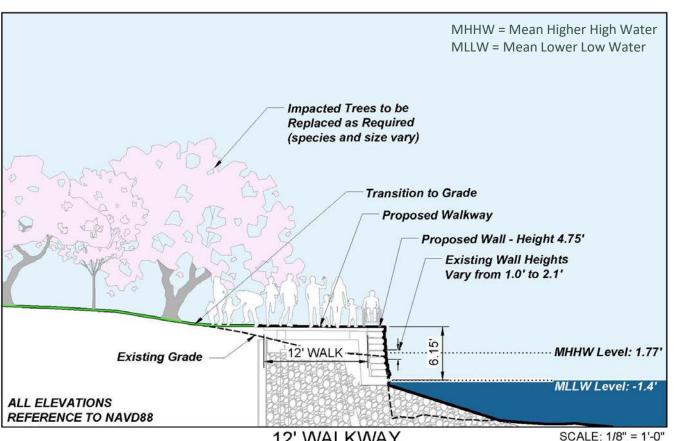
TIDAL BASIN WEST - PROPOSED

12' WALKWAY
PROPOSED CONDITIONS (TYPICAL)
Tidal Basin - West

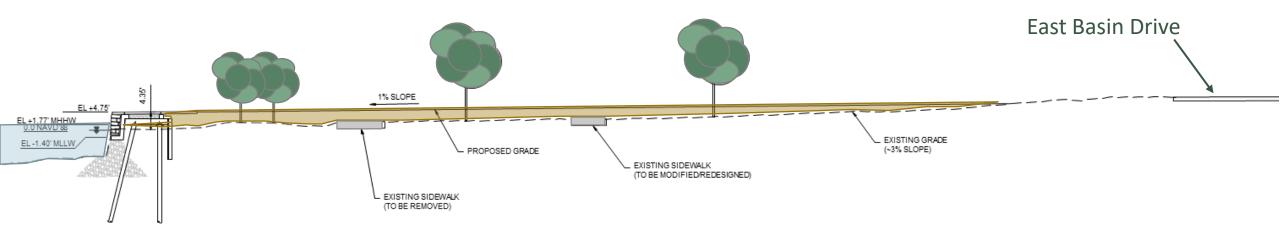
TIDAL BASIN EAST — INLAND GRADING*

*Cross sectional view of grading/fill to maintain 1% slope to top of wall

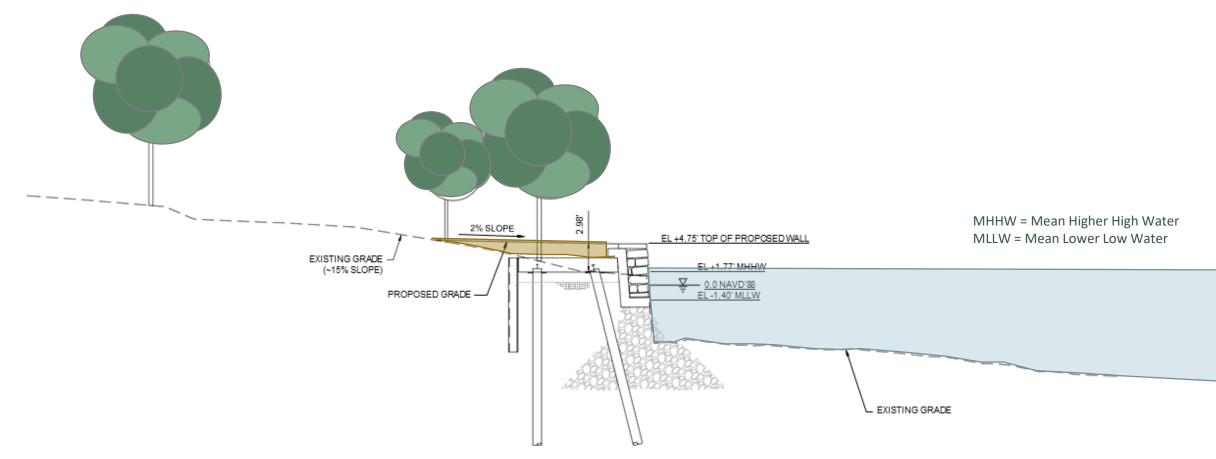
TIDAL BASIN WEST – INLAND GRADING*

*Cross sectional view of grading/fill to maintain 2% slope to top of wall

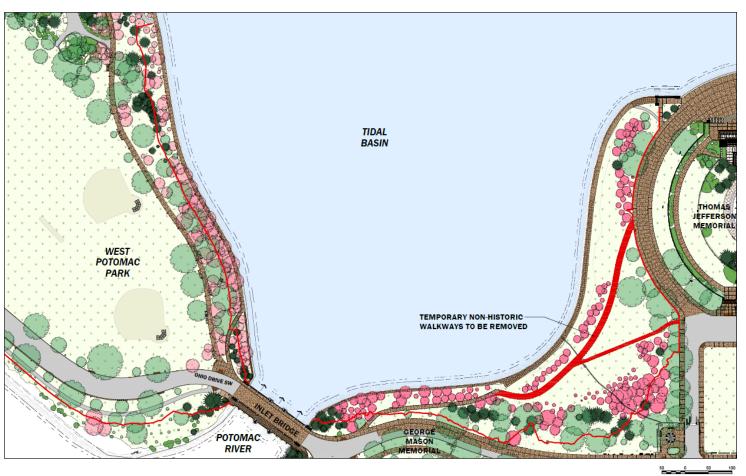
EXISTING VEGETATION PLAN – TIDAL BASIN

ESTIMATED # OF TREES TO BE REMOVED

Section	Cherry	Deciduous	Evergreen	Unknown	Total
TB - East	108	29	26	5	168
TB - West	49	3	12	2	66
TOTAL	157	32	38	7	234

EXISTING CONDITIONS
CULTURAL LANDSCAPE REPORT TIDAL BASIN JUNE 2020

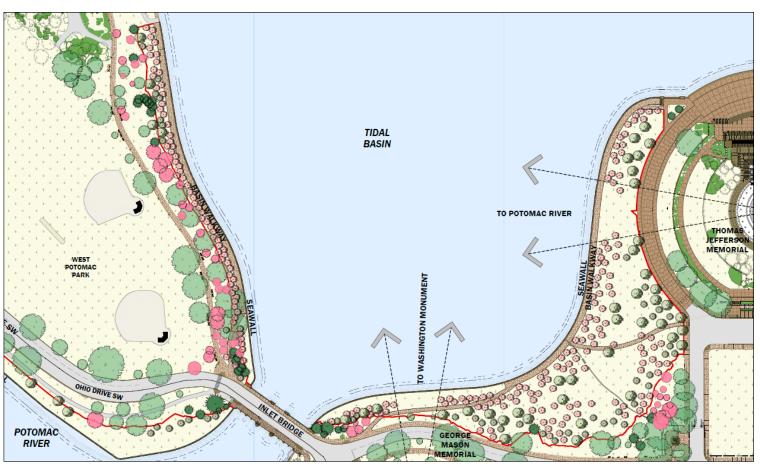
PROPOSED PLANTING PLAN – TIDAL BASIN

ESTIMATED # OF TREES TO BE PLANTED

Section	Cherry	Deciduous	Evergreen	Unknown	Total
TB - East	145	45	35	0	225
TB - West	64	6	16	0	86
TOTAL	209	51	51	0	311

*Concept will develop further, and full tree assessment will be conducted by project team and NPS arborist

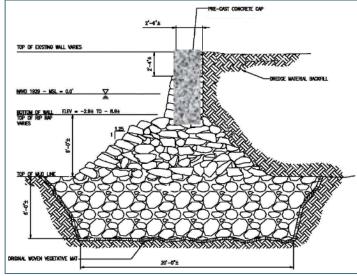
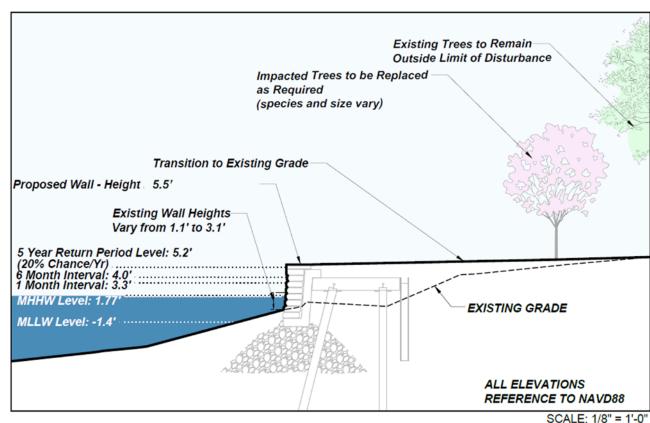
WEST POTOMAC PARK - PROPOSED

EXISTING
CONDITIONS
(Original Section:
WPP South)

SCALE: 1/8" = 1'-0" SECTION 8

PROPOSED CONDITIONS (TYPICAL)
West Potomac Park
