Re-pointing Brickwork at the Fredericksburg National Cemetery - Phase 3 (PEPC 113424)

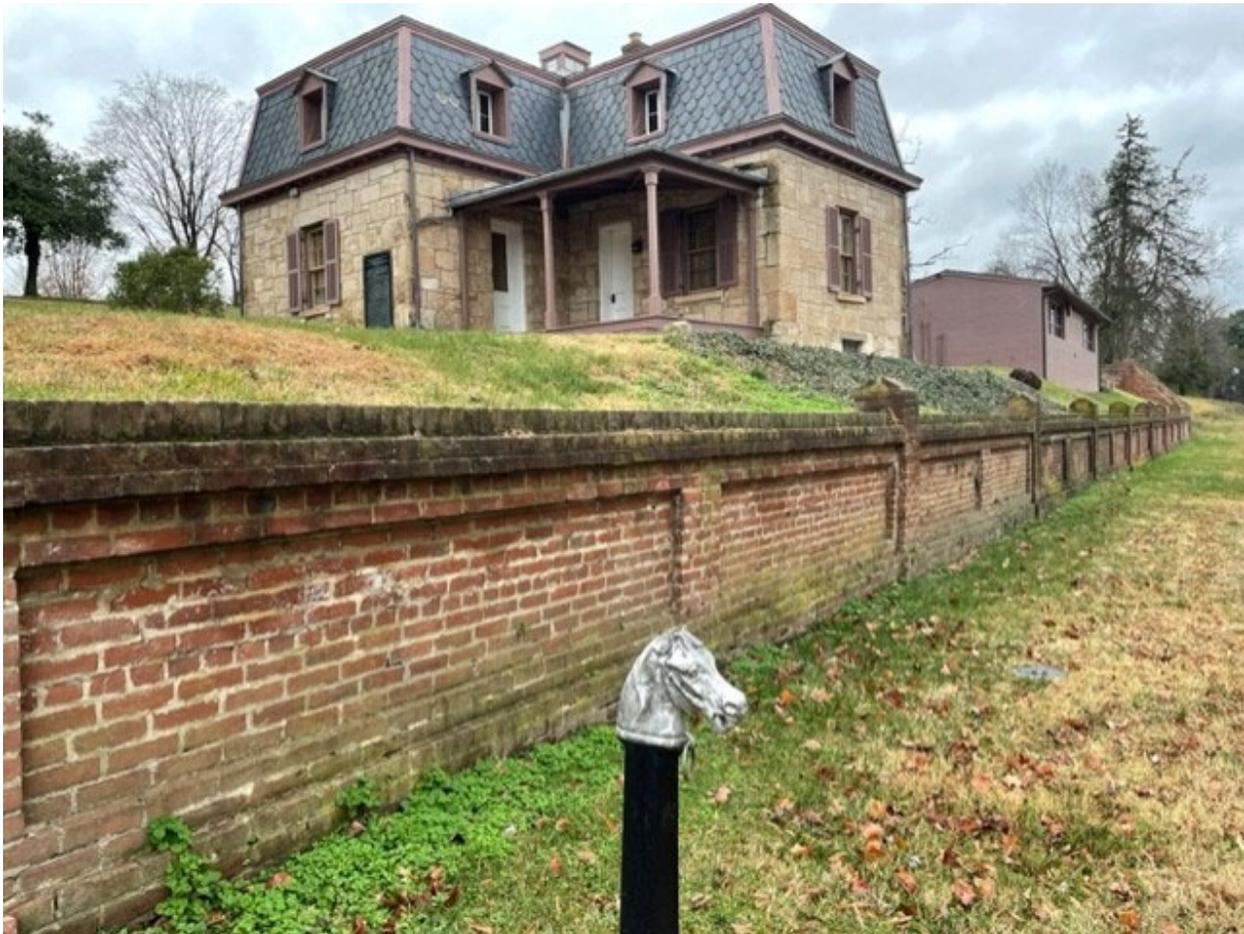
Photos of panels 142-145 which serve as a retaining wall along Sunken Road and are proposed for complete reconstruction. Proposed work may include "excavation, temporary shoring, and backfill." In addition, tree stumps and/or roots may need to be removed.

There are no known graves in the area behind panels 142-145, rather these panels are situated directly below the Fredericksburg National Cemetery Lodge. Looking northwest.

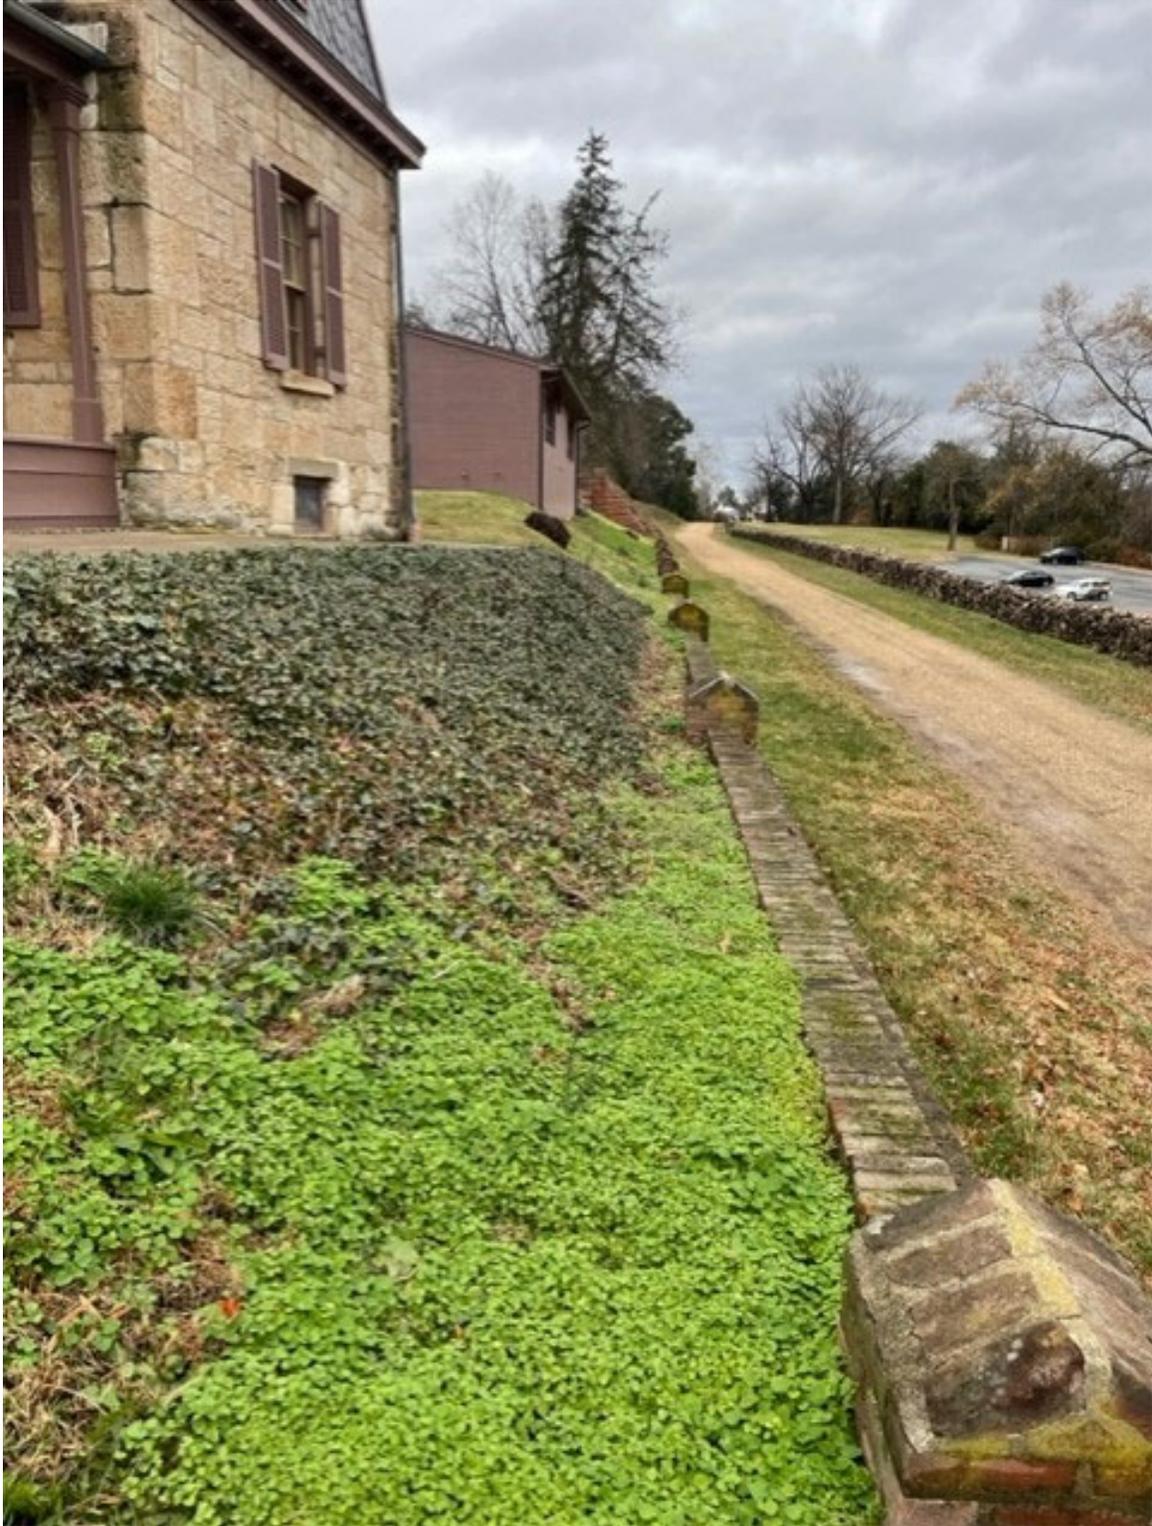
View of the steep escarpment adjacent to the cemetery's eastern wall and panels 142-145. This area will be excavated, and temporary shoring provided while the panels are reconstructed. Looking north up Sunken Road.

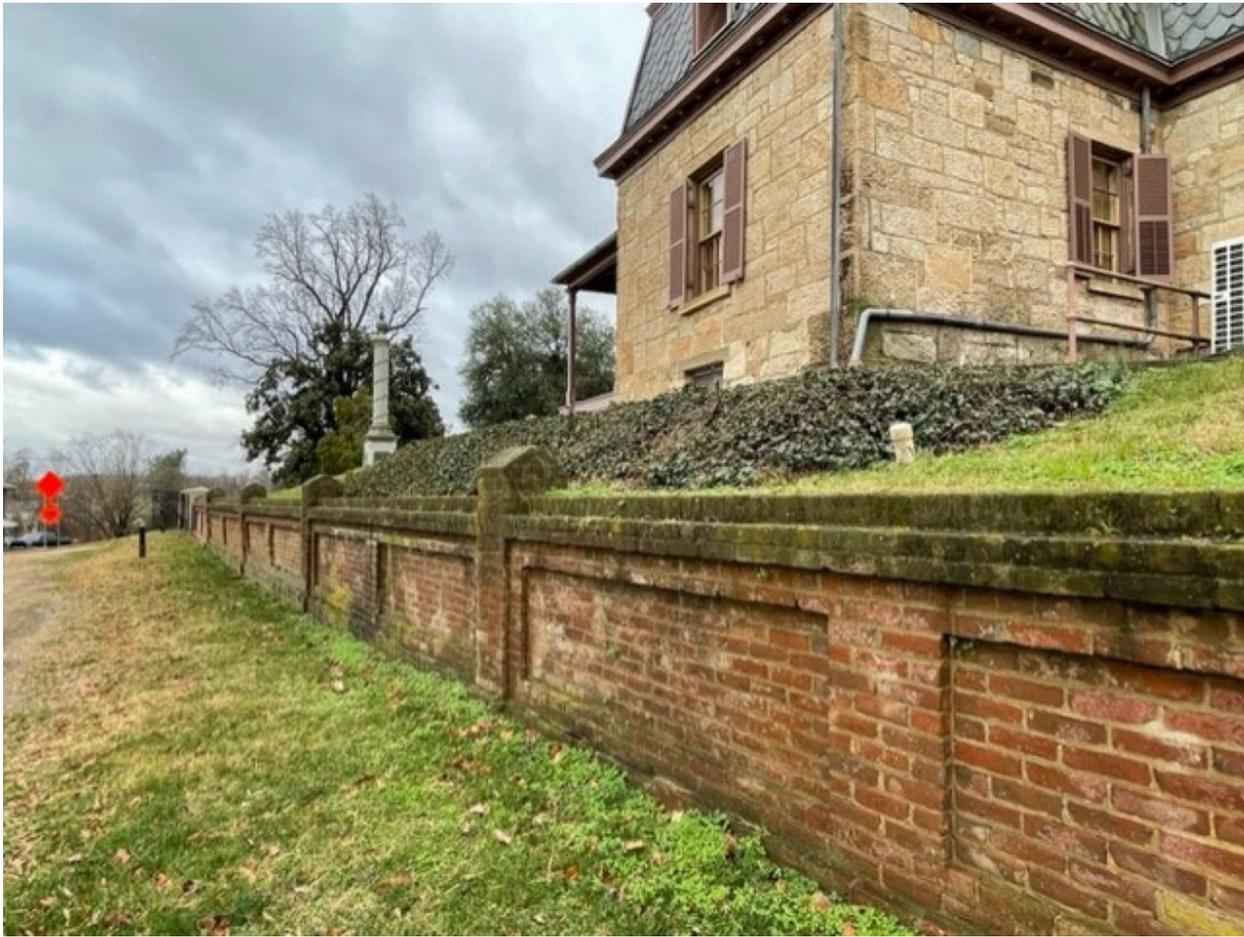
Panels 142 – 145 of the eastern cemetery wall are to be dismantled to grade and reconstructed. During the archeological monitoring of a waterline replacement to the cemetery lodge in 2019, an intact section of a circa 1875 circular brick drain adjacent to the eastern cemetery wall was encountered, identified, and documented. This feature runs roughly north-south and parallel with the brick cemetery wall, within the grassy area immediately west of the Sunken Road (shown above). The centerline of the drain is approximately 3.0 feet from the east face of the retaining wall, and the top of the drain is approximately 1.8 feet below the current ground surface. The circular drain is constructed of roughly mortared bricks aligned lengthwise and is approximately 1.5 feet (18 inches) in diameter. As no work is proposed below grade, this feature is not expected to be impacted.
