**STATEMENT OF FINDINGS
FOR
EXECUTIVE ORDER 11990 (PROTECTION OF WETLANDS)**

**MILE CREEK ROAD RE-ROUTE AND BRIDGE CONSTRUCTION
COOK COUNTY HIGHWAY DEPARTMENT &
GRAND PORTAGE BAND OF LAKE SUPERIOR CHIPPEWA
MILE CREEK ROAD/COUNTY STATE AID HIGHWAY 17 (CSAH 17)
GRAND PORTAGE NATIONAL MONUMENT
GRAND PORTAGE, MINNESOTA**

**Grand Portage National Monument
February 2023**

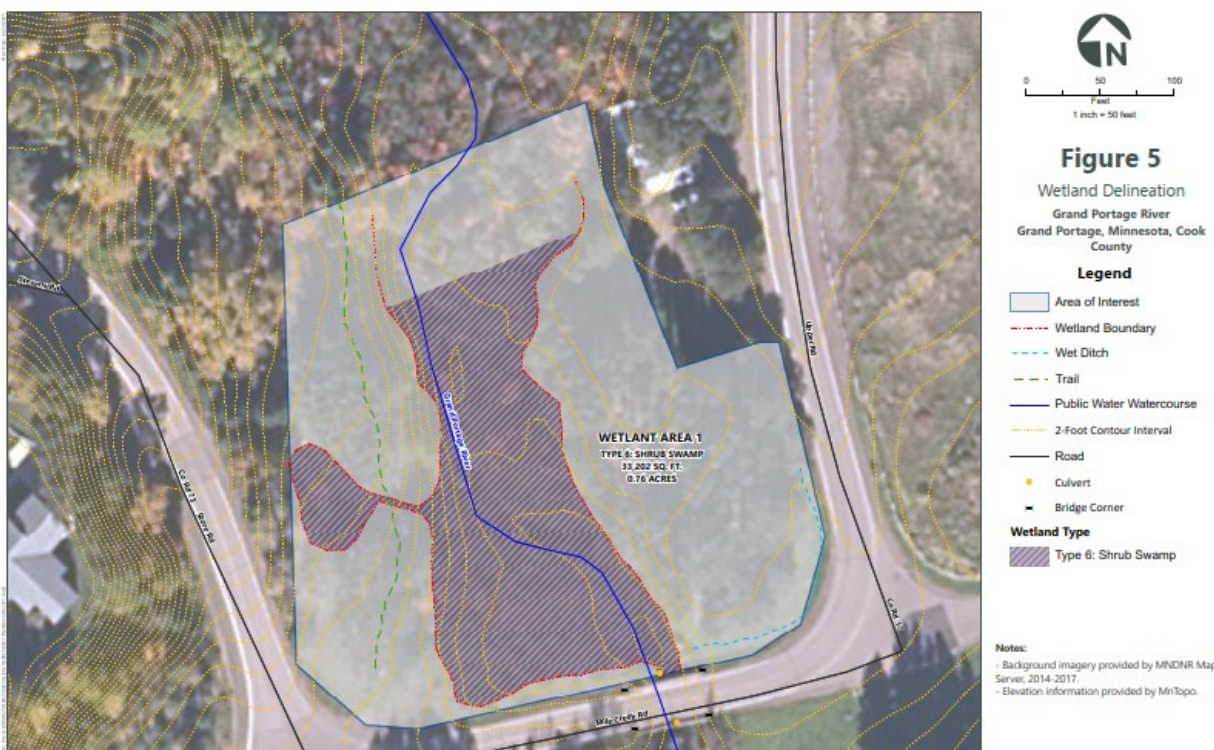
Figure 5: Wetland Delineation Map.

The wetland delineation performed by MSA identified a palustrine scrub shrub and forested wetland area on either side of the Grand Portage Creek riverine wetland just to the north of Mile Creek Road (Wetland Area 1). Wetland Area 1 has primary characteristics of a palustrine scrub/shrub wetland which is associated with the Grand Portage Creek riverine and palustrine wetland flood plain (**Figure 5**).
