Repairs to Fort Jefferson Counterscarp and Dredging of Selected Areas

Environmental Assessment

March 2023

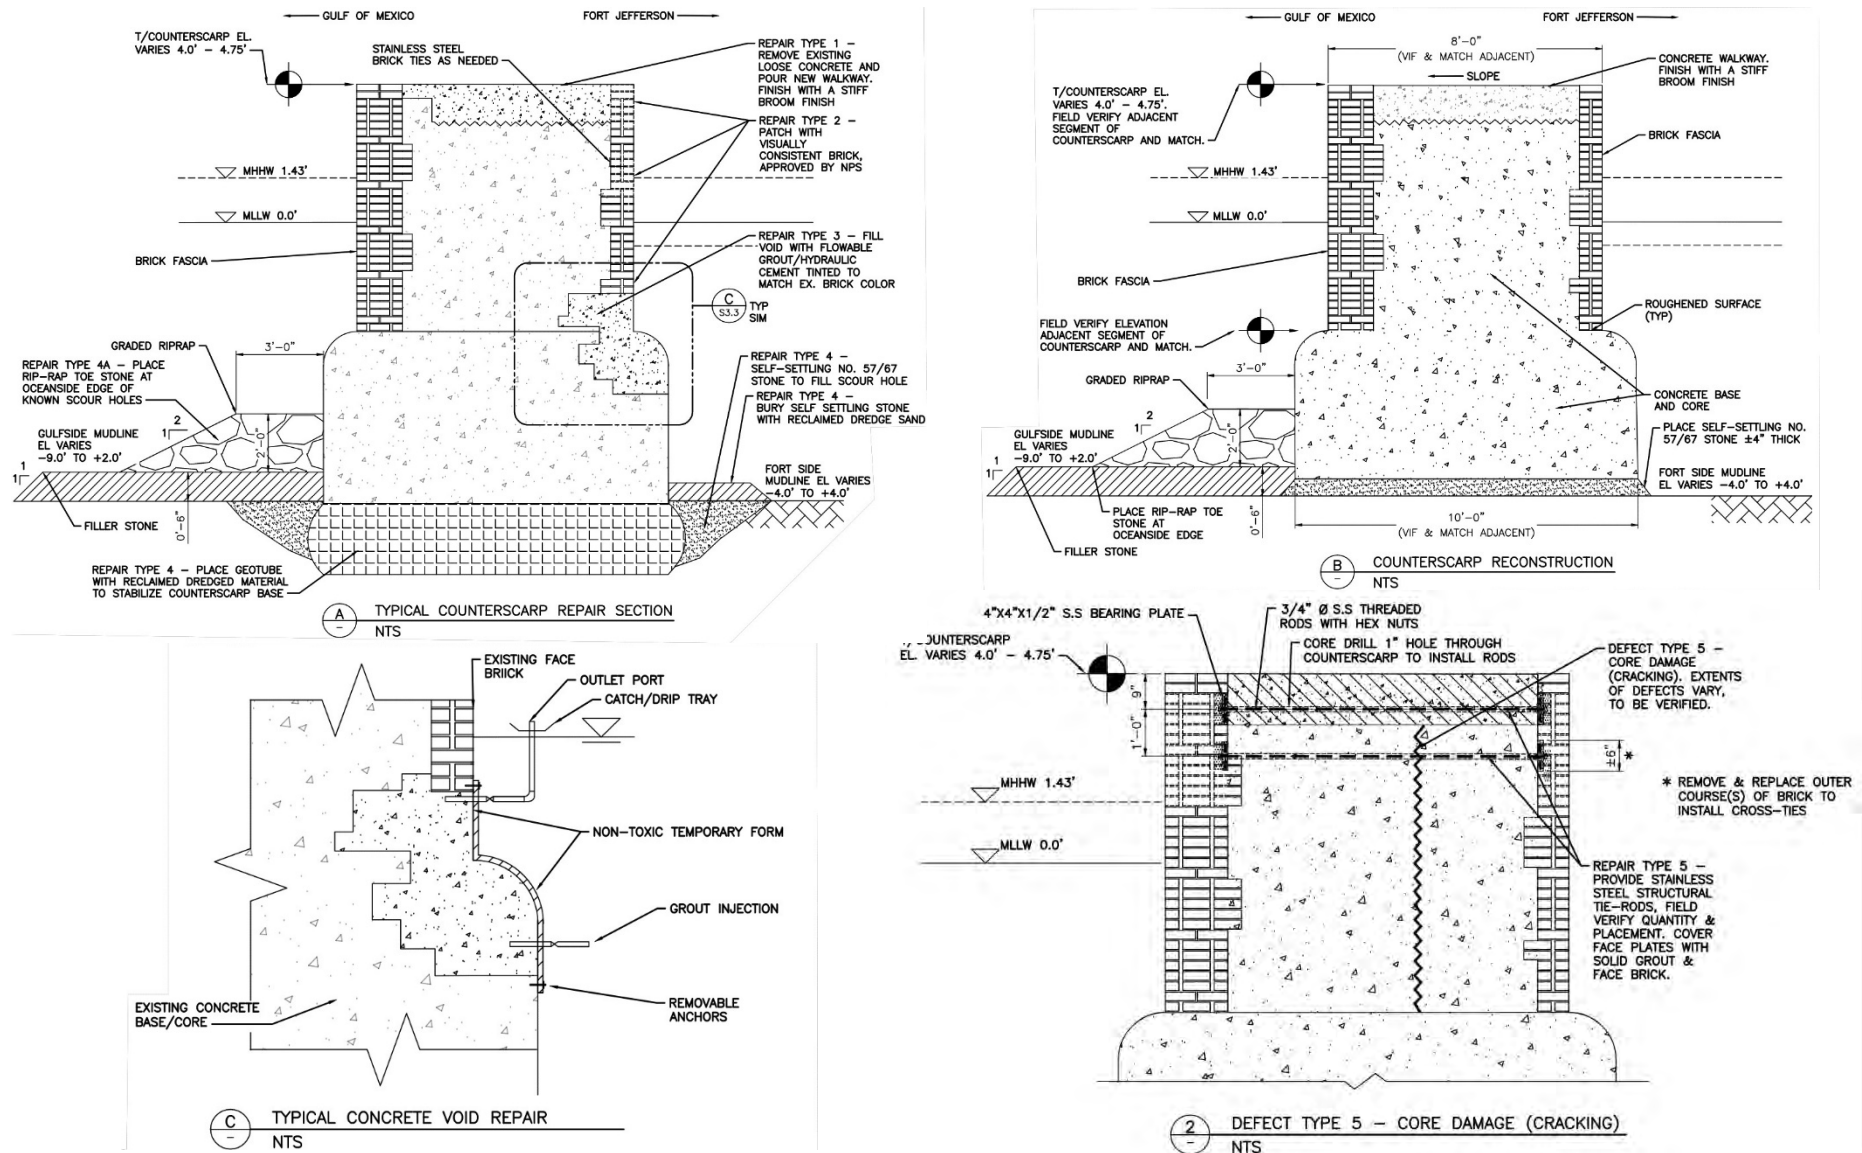
Figure 3. Counterscarp Repair Design

Counterscarp repair would consist of rebuilding approximately 60 ft of the western face of the counterscarp that is currently collapsed and replacement of approximately 46 ft of missing cement walkway along the northwest face of the counterscarp. The scoured/undermined sections of the counterscarp would be repaired by filling below-water voids with woven, non-toxic geotextile “bags” to restore stability to the counterscarp. The two core failures on the northeast face of the counterscarp would be repaired, which may include stainless steel and/or epoxy anchors, preformed bracing rods, along with other concrete/masonry repair strategies. The brick fascia that is missing would be repaired on both sides of the northeast, northwest, west and southwest counterscarp walls. New materials that match the historic fabric of the counterscarp would be used for the repairs and rehabilitation to achieve a more durable structure. The non-historic concrete that broke free from the counterscarp and fell into the moat would be removed. The brick that has broken free from the counterscarp and fallen into the moat would be removed and moved to the existing rubble pile on the eastern side of the fort. Dredge spoil material would be used for concrete and/or mortar repair on the counterscarp. Where possible, masonry defects would be patched utilizing existing materials and new materials that are both aesthetically and chemically consistent to match the historic character of the fort. Once repaired, approximately 150 ft of rip-rap revetment, consisting of locally-sourced limestone boulders, would be placed at the oceanside base of the counterscarp; approximately 60 ft would be placed at the southwest face of the counterscarp and approximately 90 ft would be placed on the western face of the counterscarp, equivalent to 150 cubic yards (cy), to aid in hardening and prolonging the counterscarp’s life against future ocean energy, wave action, and scour. The rip-rap revetment extent would be approximately 4 – 6 ft. See **Figure 3** for the design of the counterscarp repairs, and for more details refer to the draft permitting drawings in **Appendix A**.

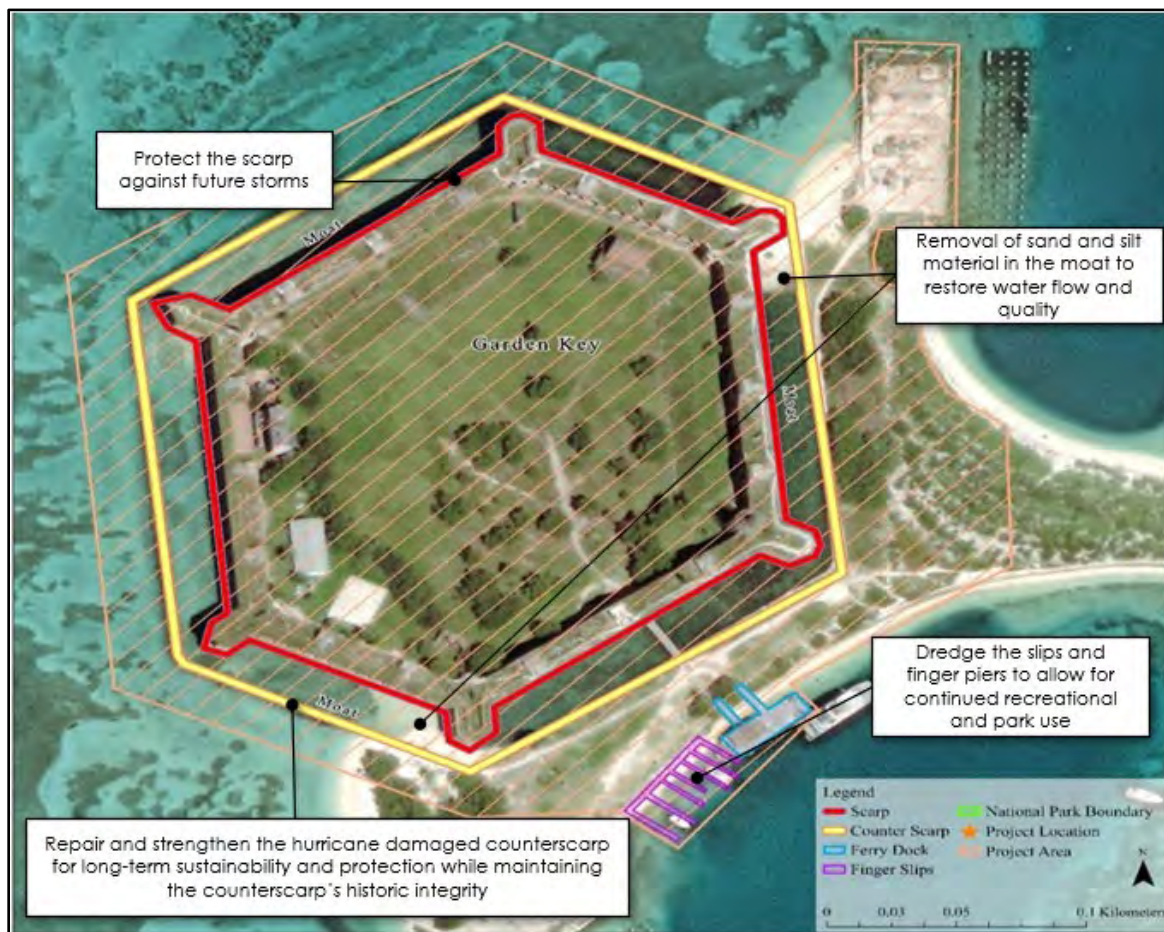
Figure 4. Alternative B Overview

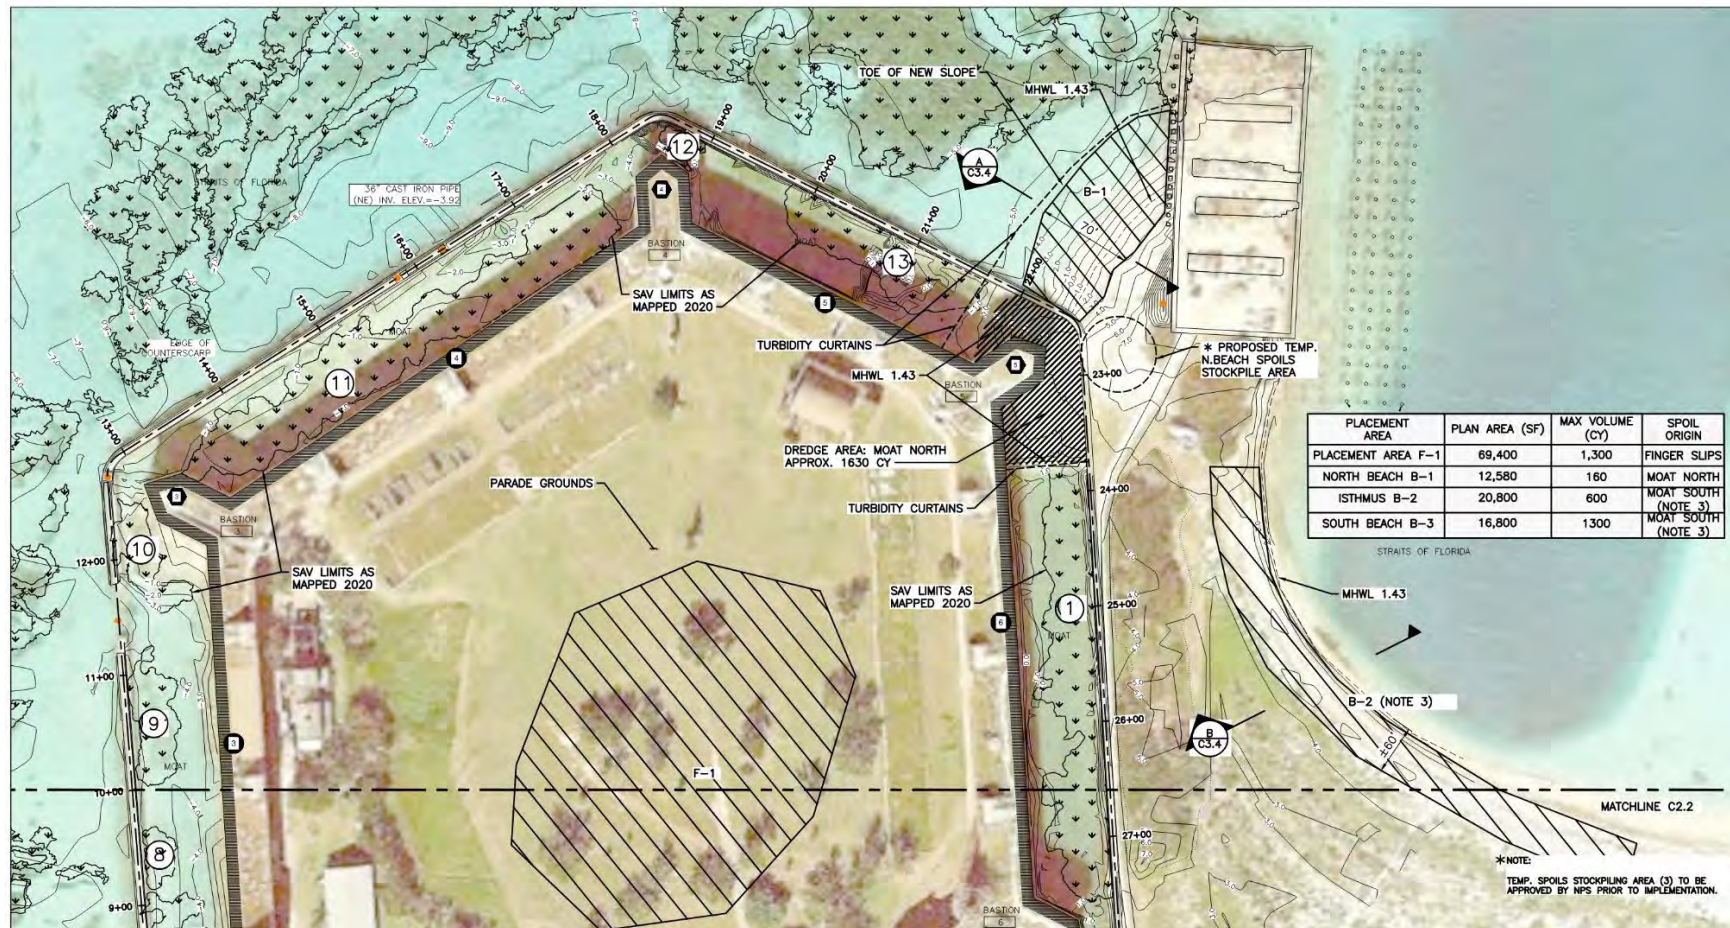
Figure 5. Dredge Spoil Placement (1 of 2) – Alternative B

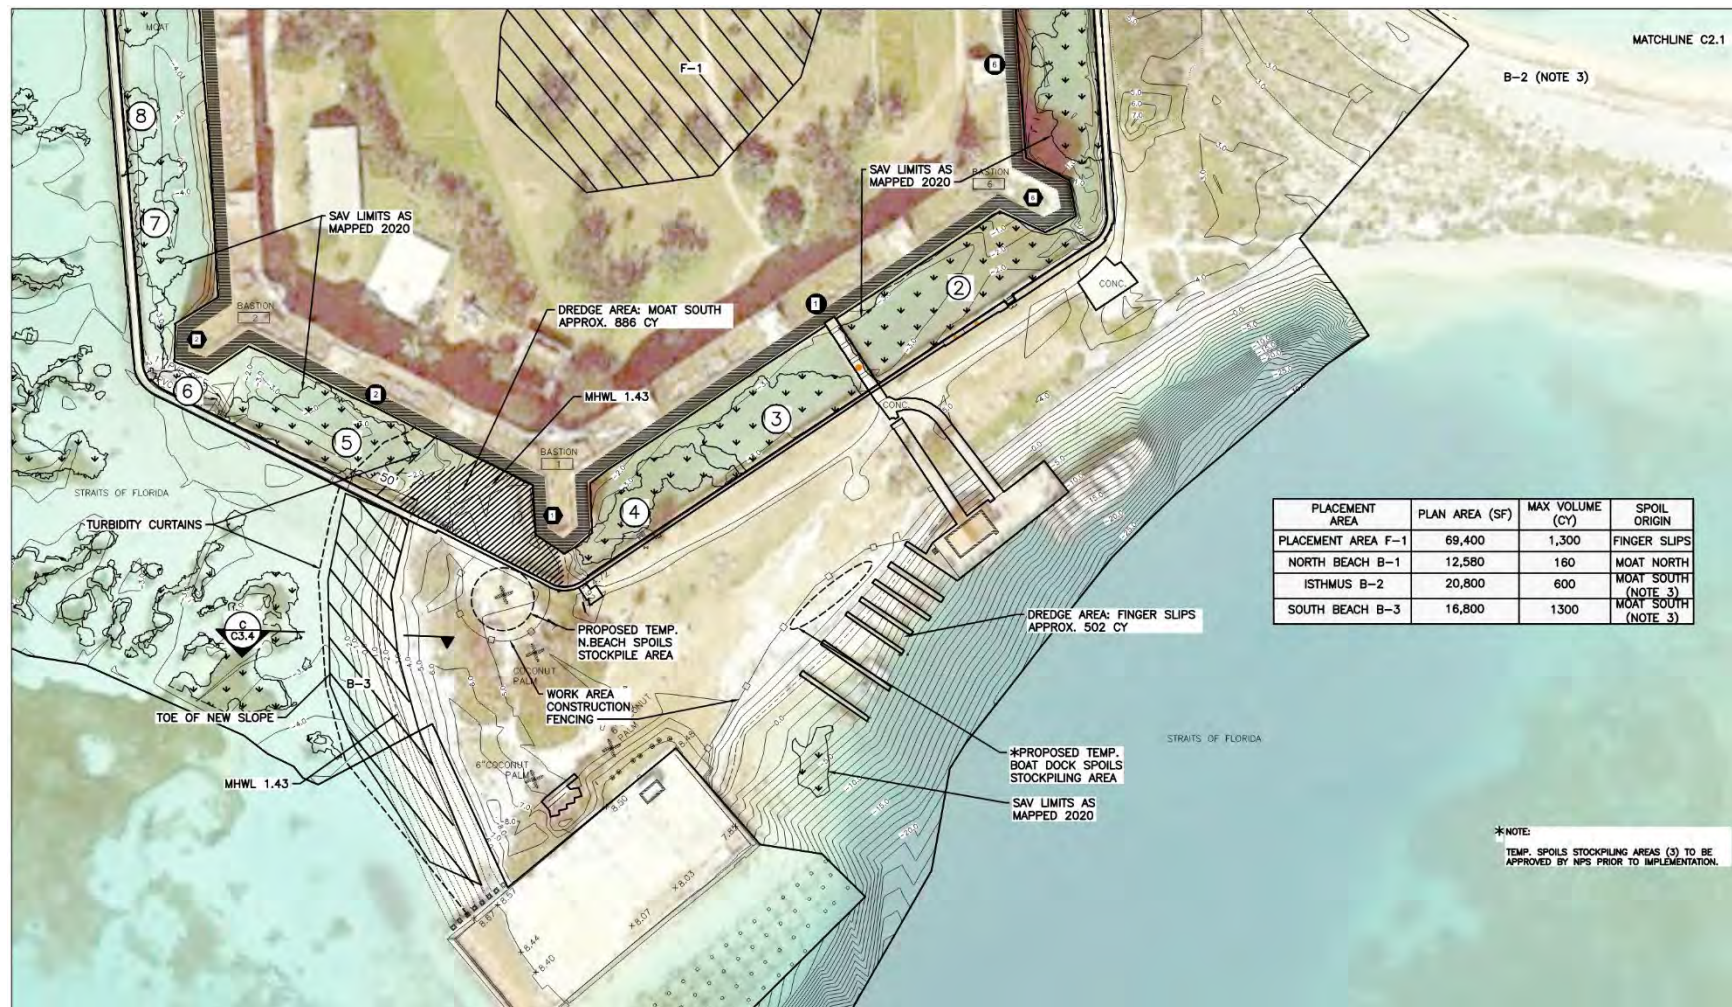
Figure 6. Dredge Spoil Placement (2 of 2) – Alternative B

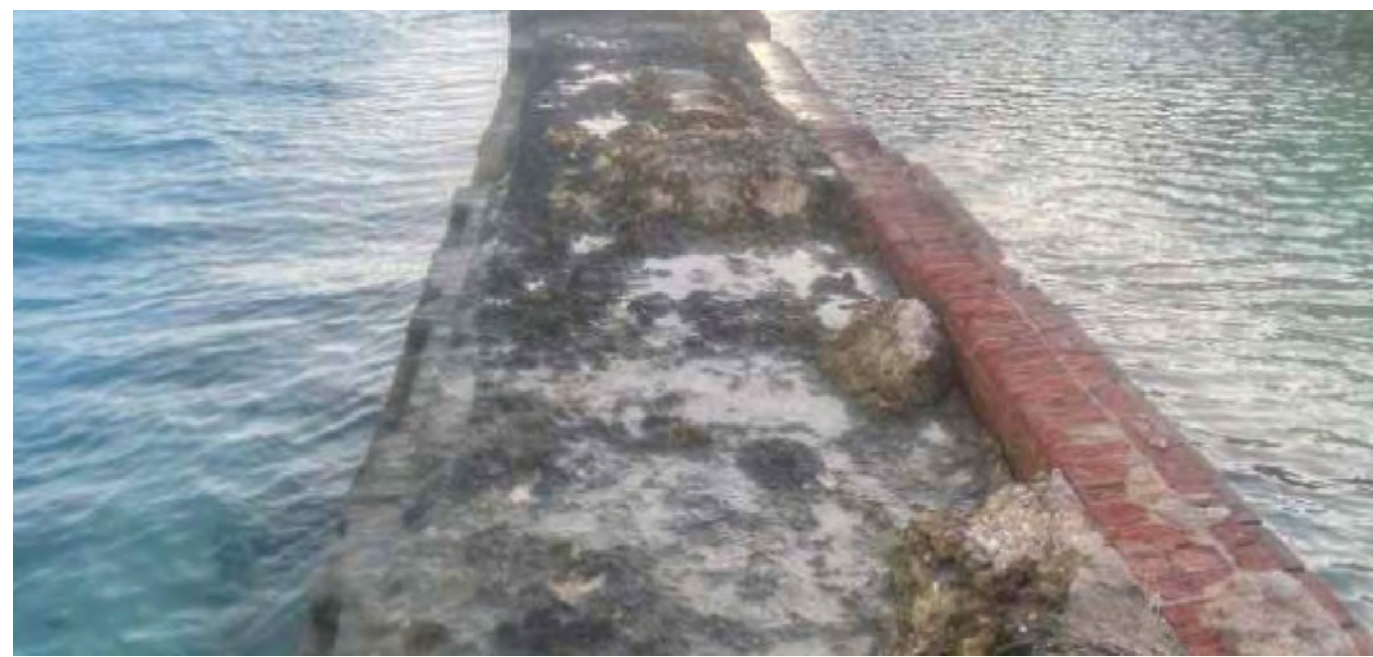
1 DEFECT TYPE 1 – LOSS OF WALKWAY CONCRETE
NTS

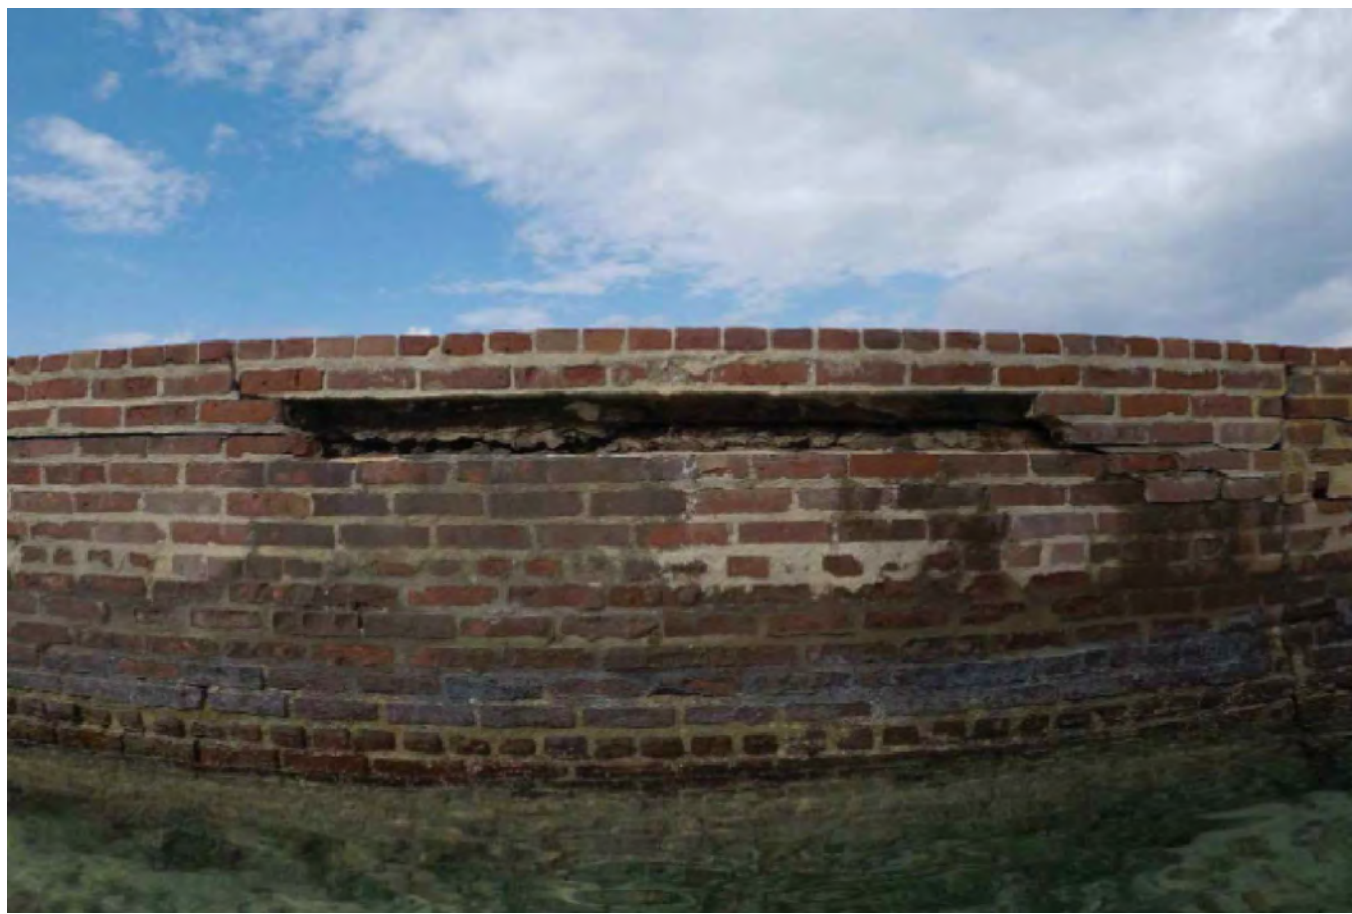
2 DEFECT TYPE 2 – ABOVE WATER LOSS OF BRICK/MORTAR
NTS

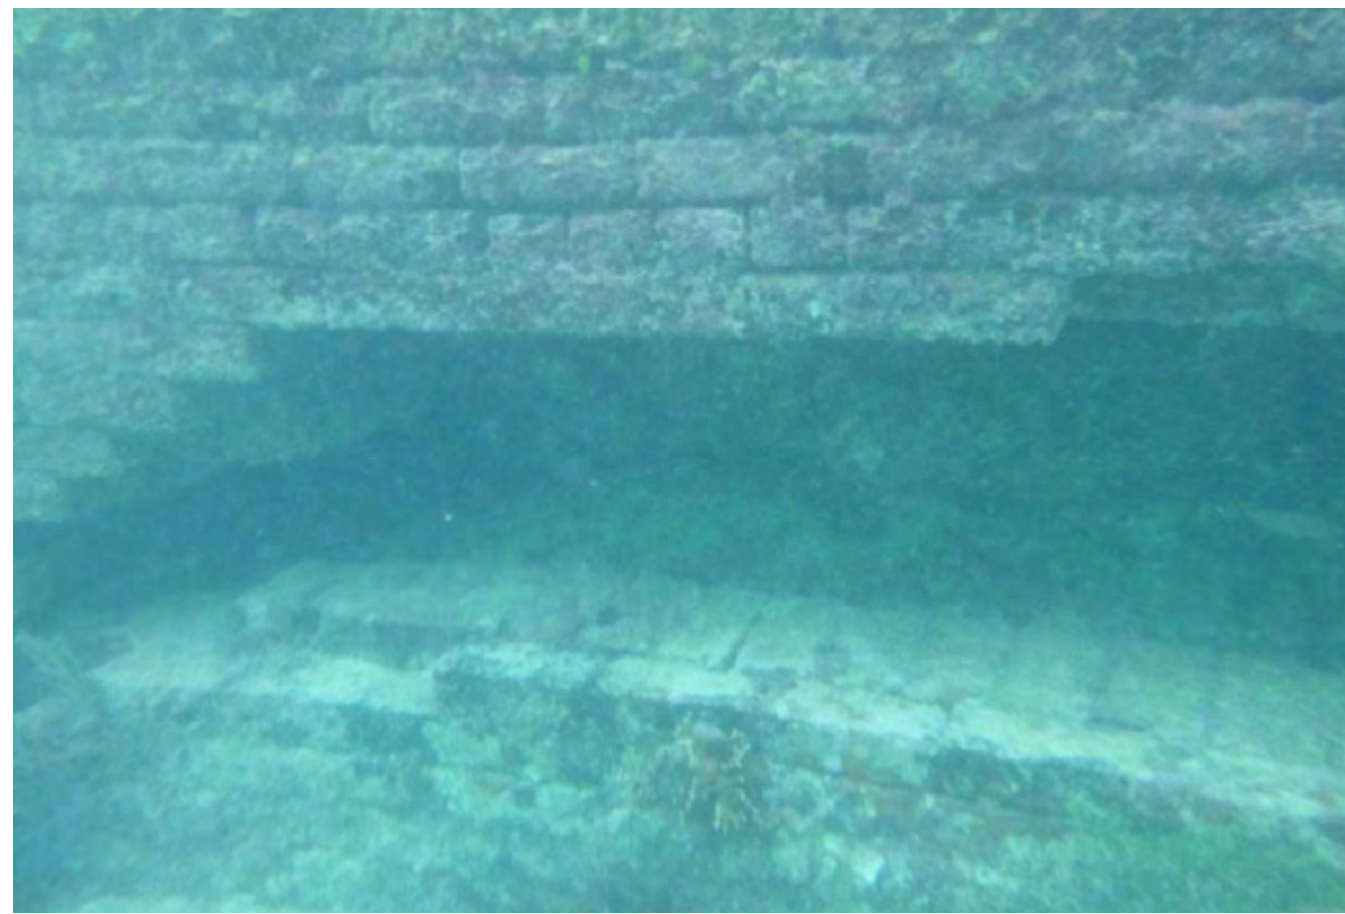
3 DEFECT TYPE 3 – BELOW WATER LOSS OF BRICK/CONCRETE
NTS

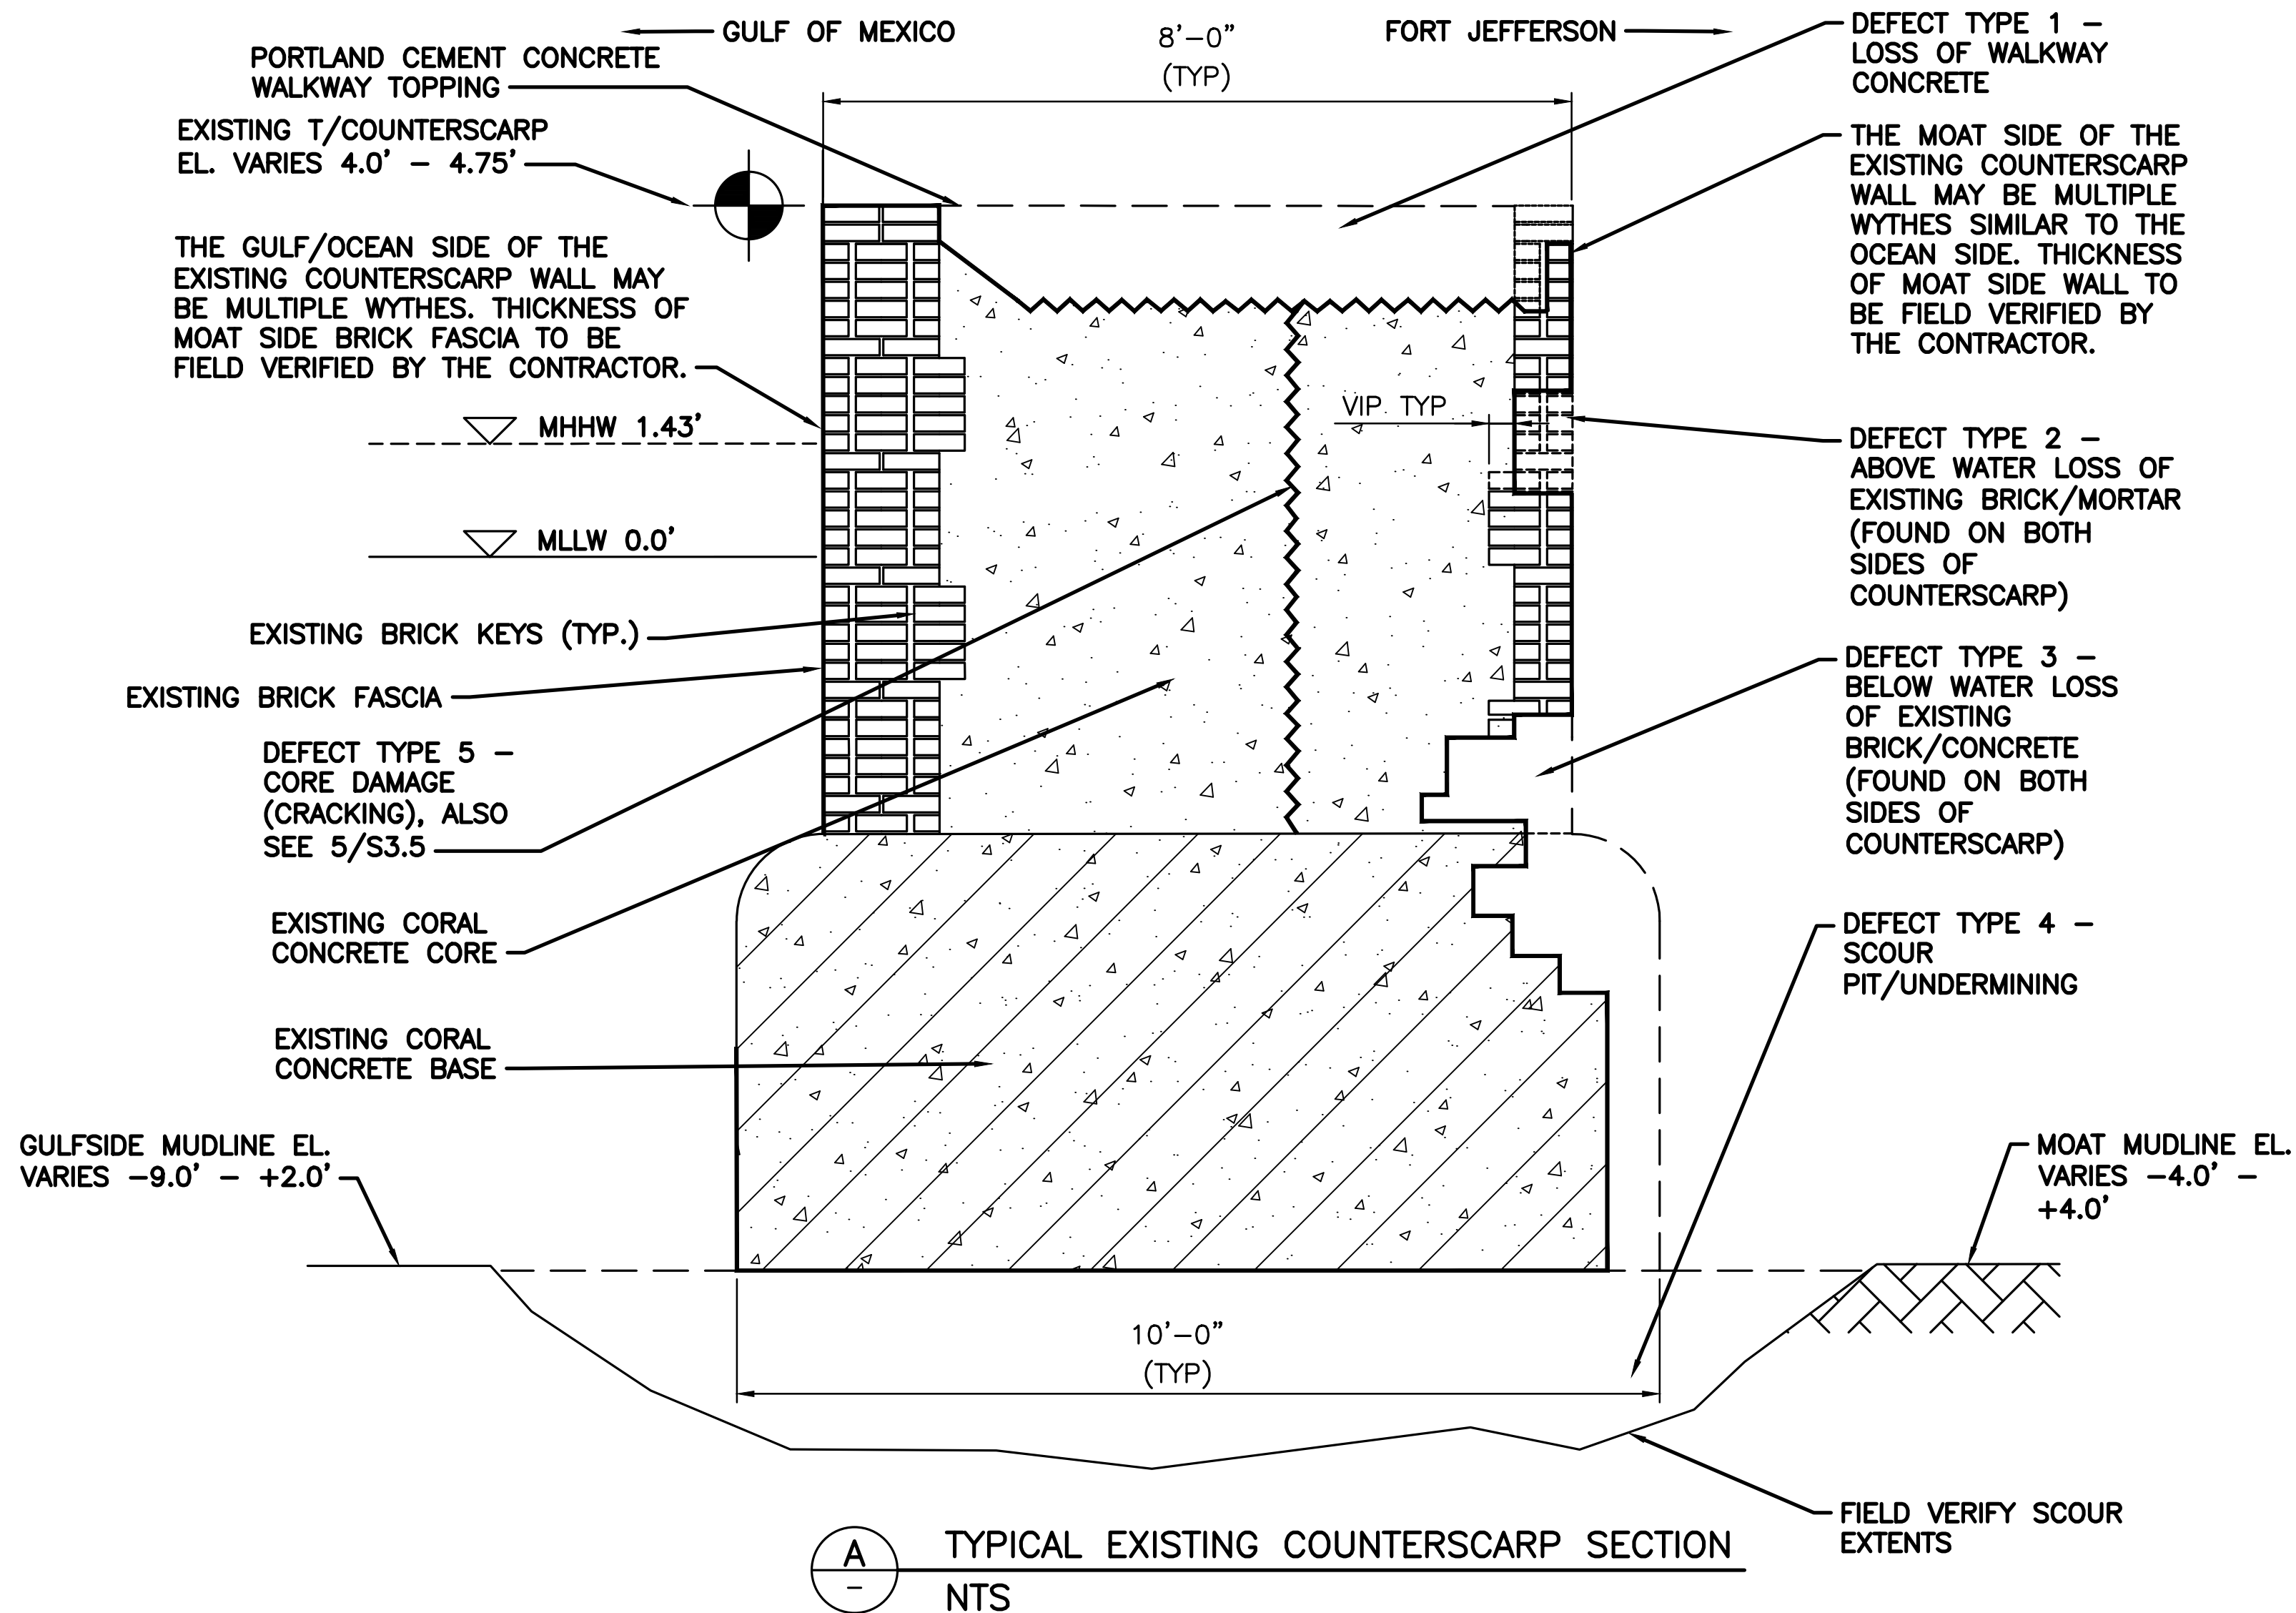
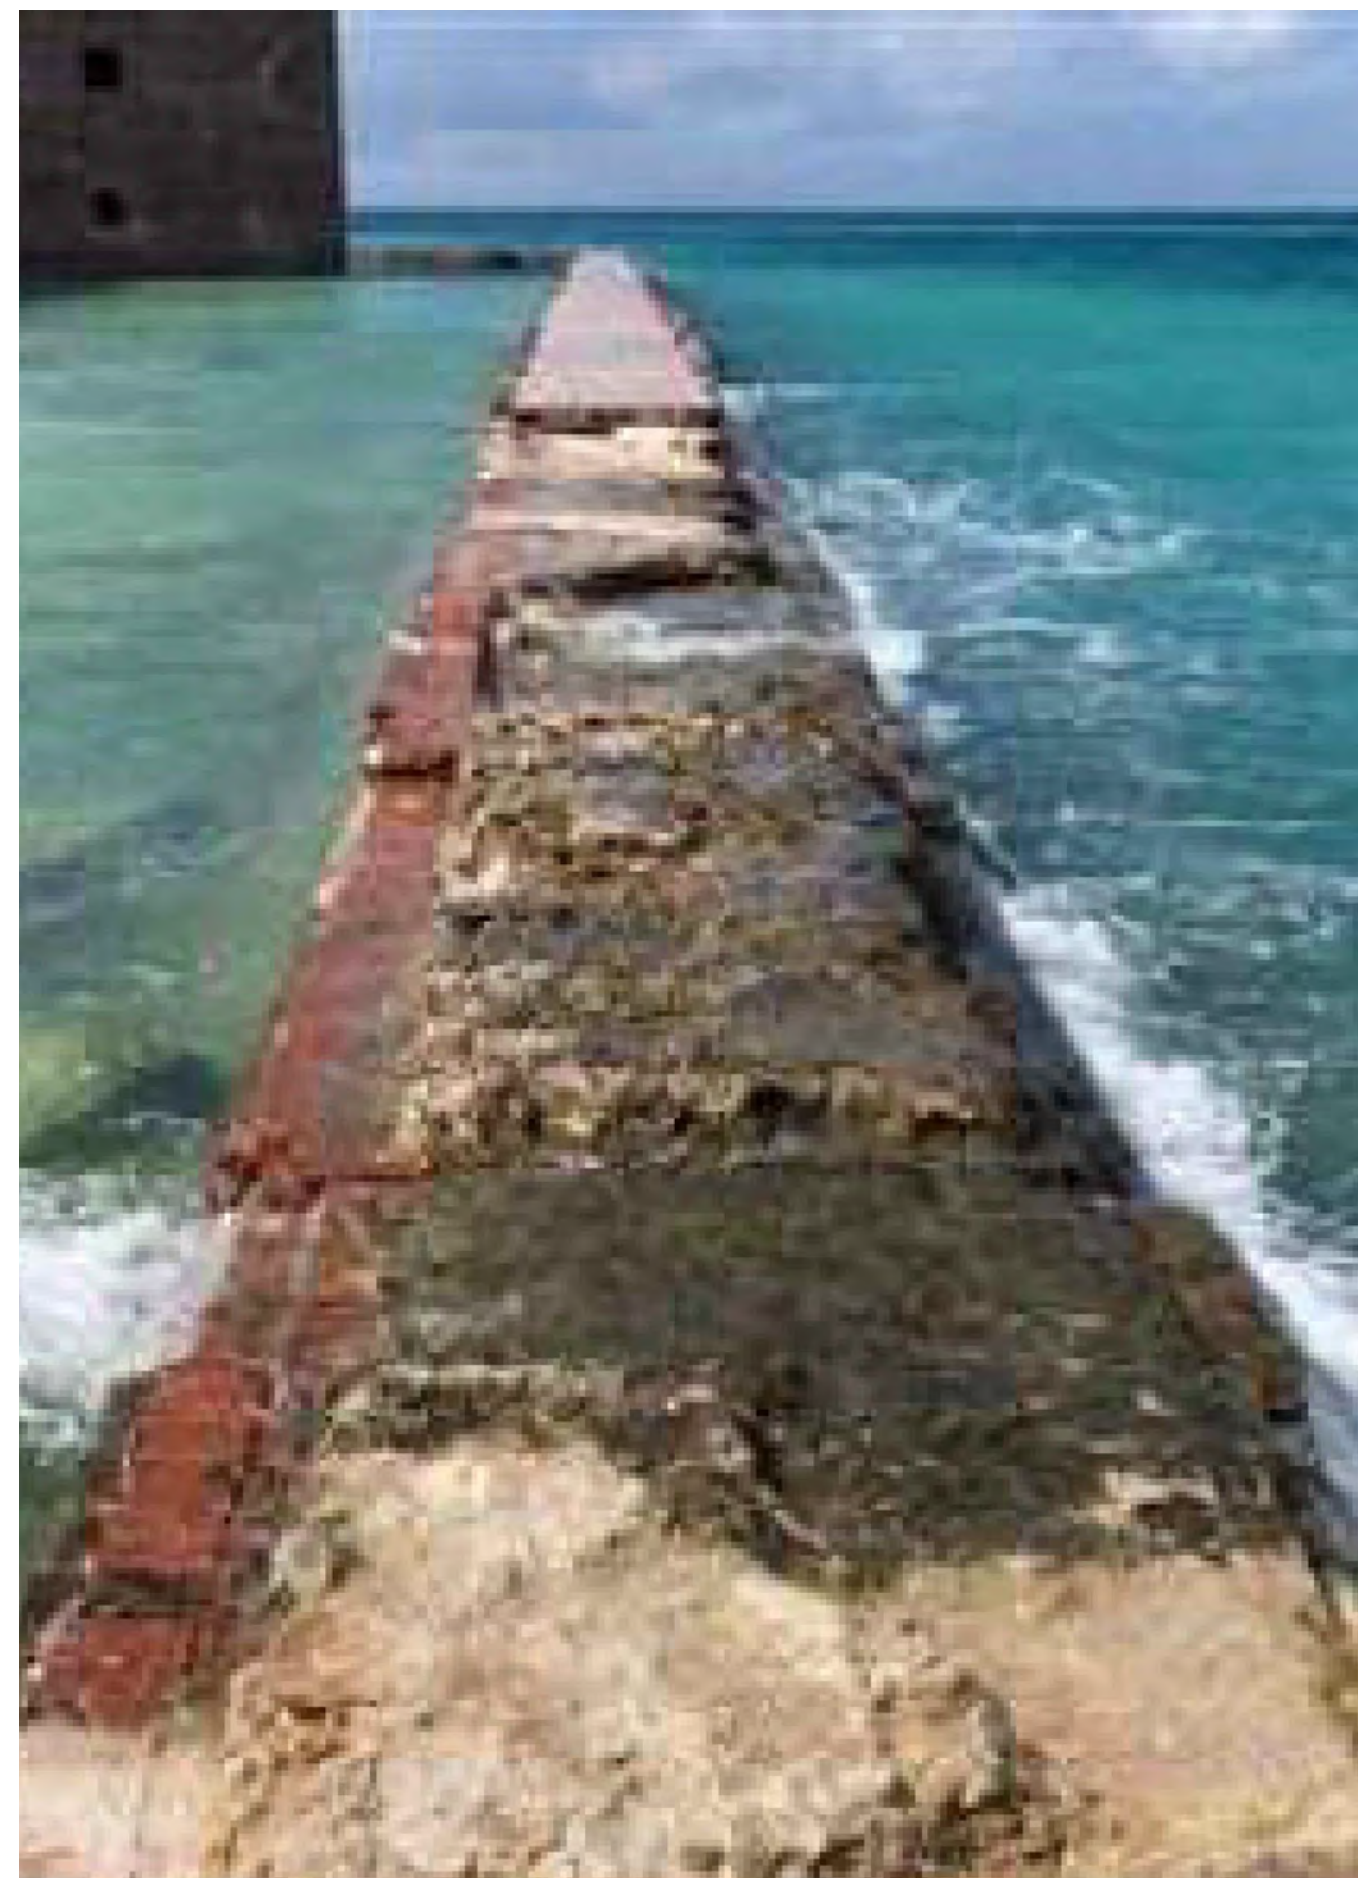
5 DEFECT TYPE 5 – CORE DAMAGE (CRACKING)
NTS

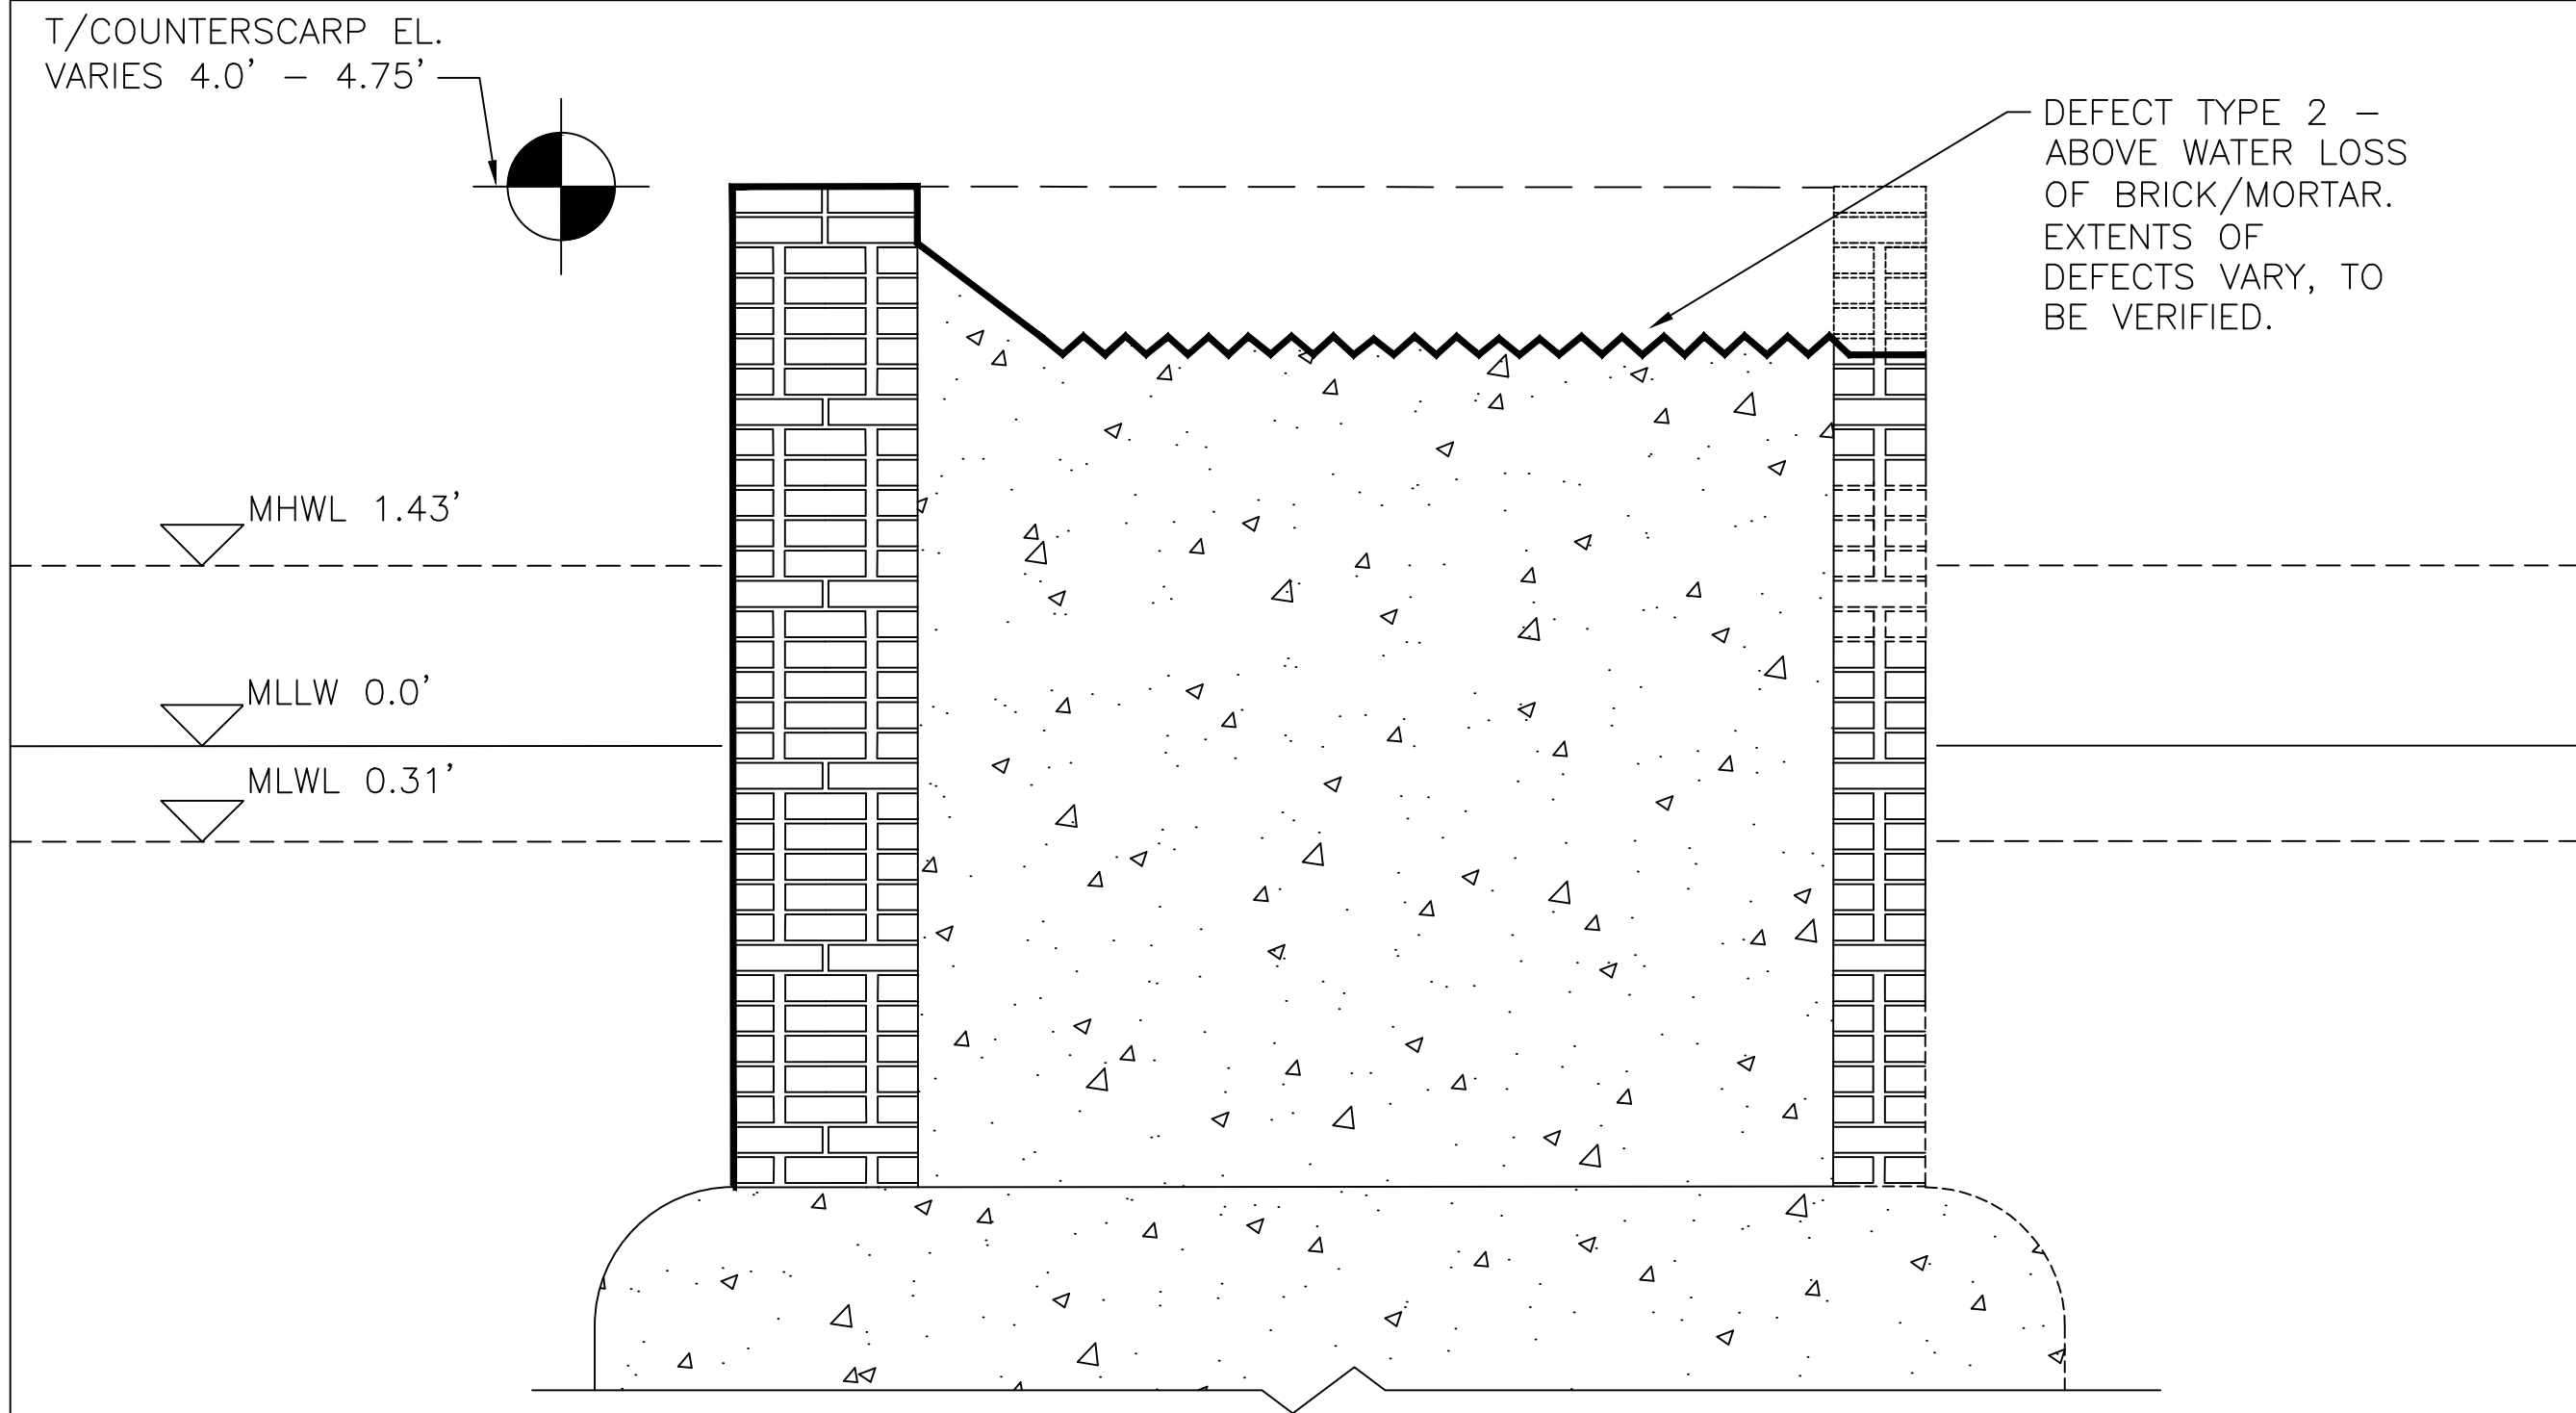
1
- DEFECT TYPE 1 - LOSS OF WALKWAY CONCRETE
NTS
