Repairs to Fort Jefferson Counterscarp and Dredging of Selected Areas

Environmental Assessment

March 2023

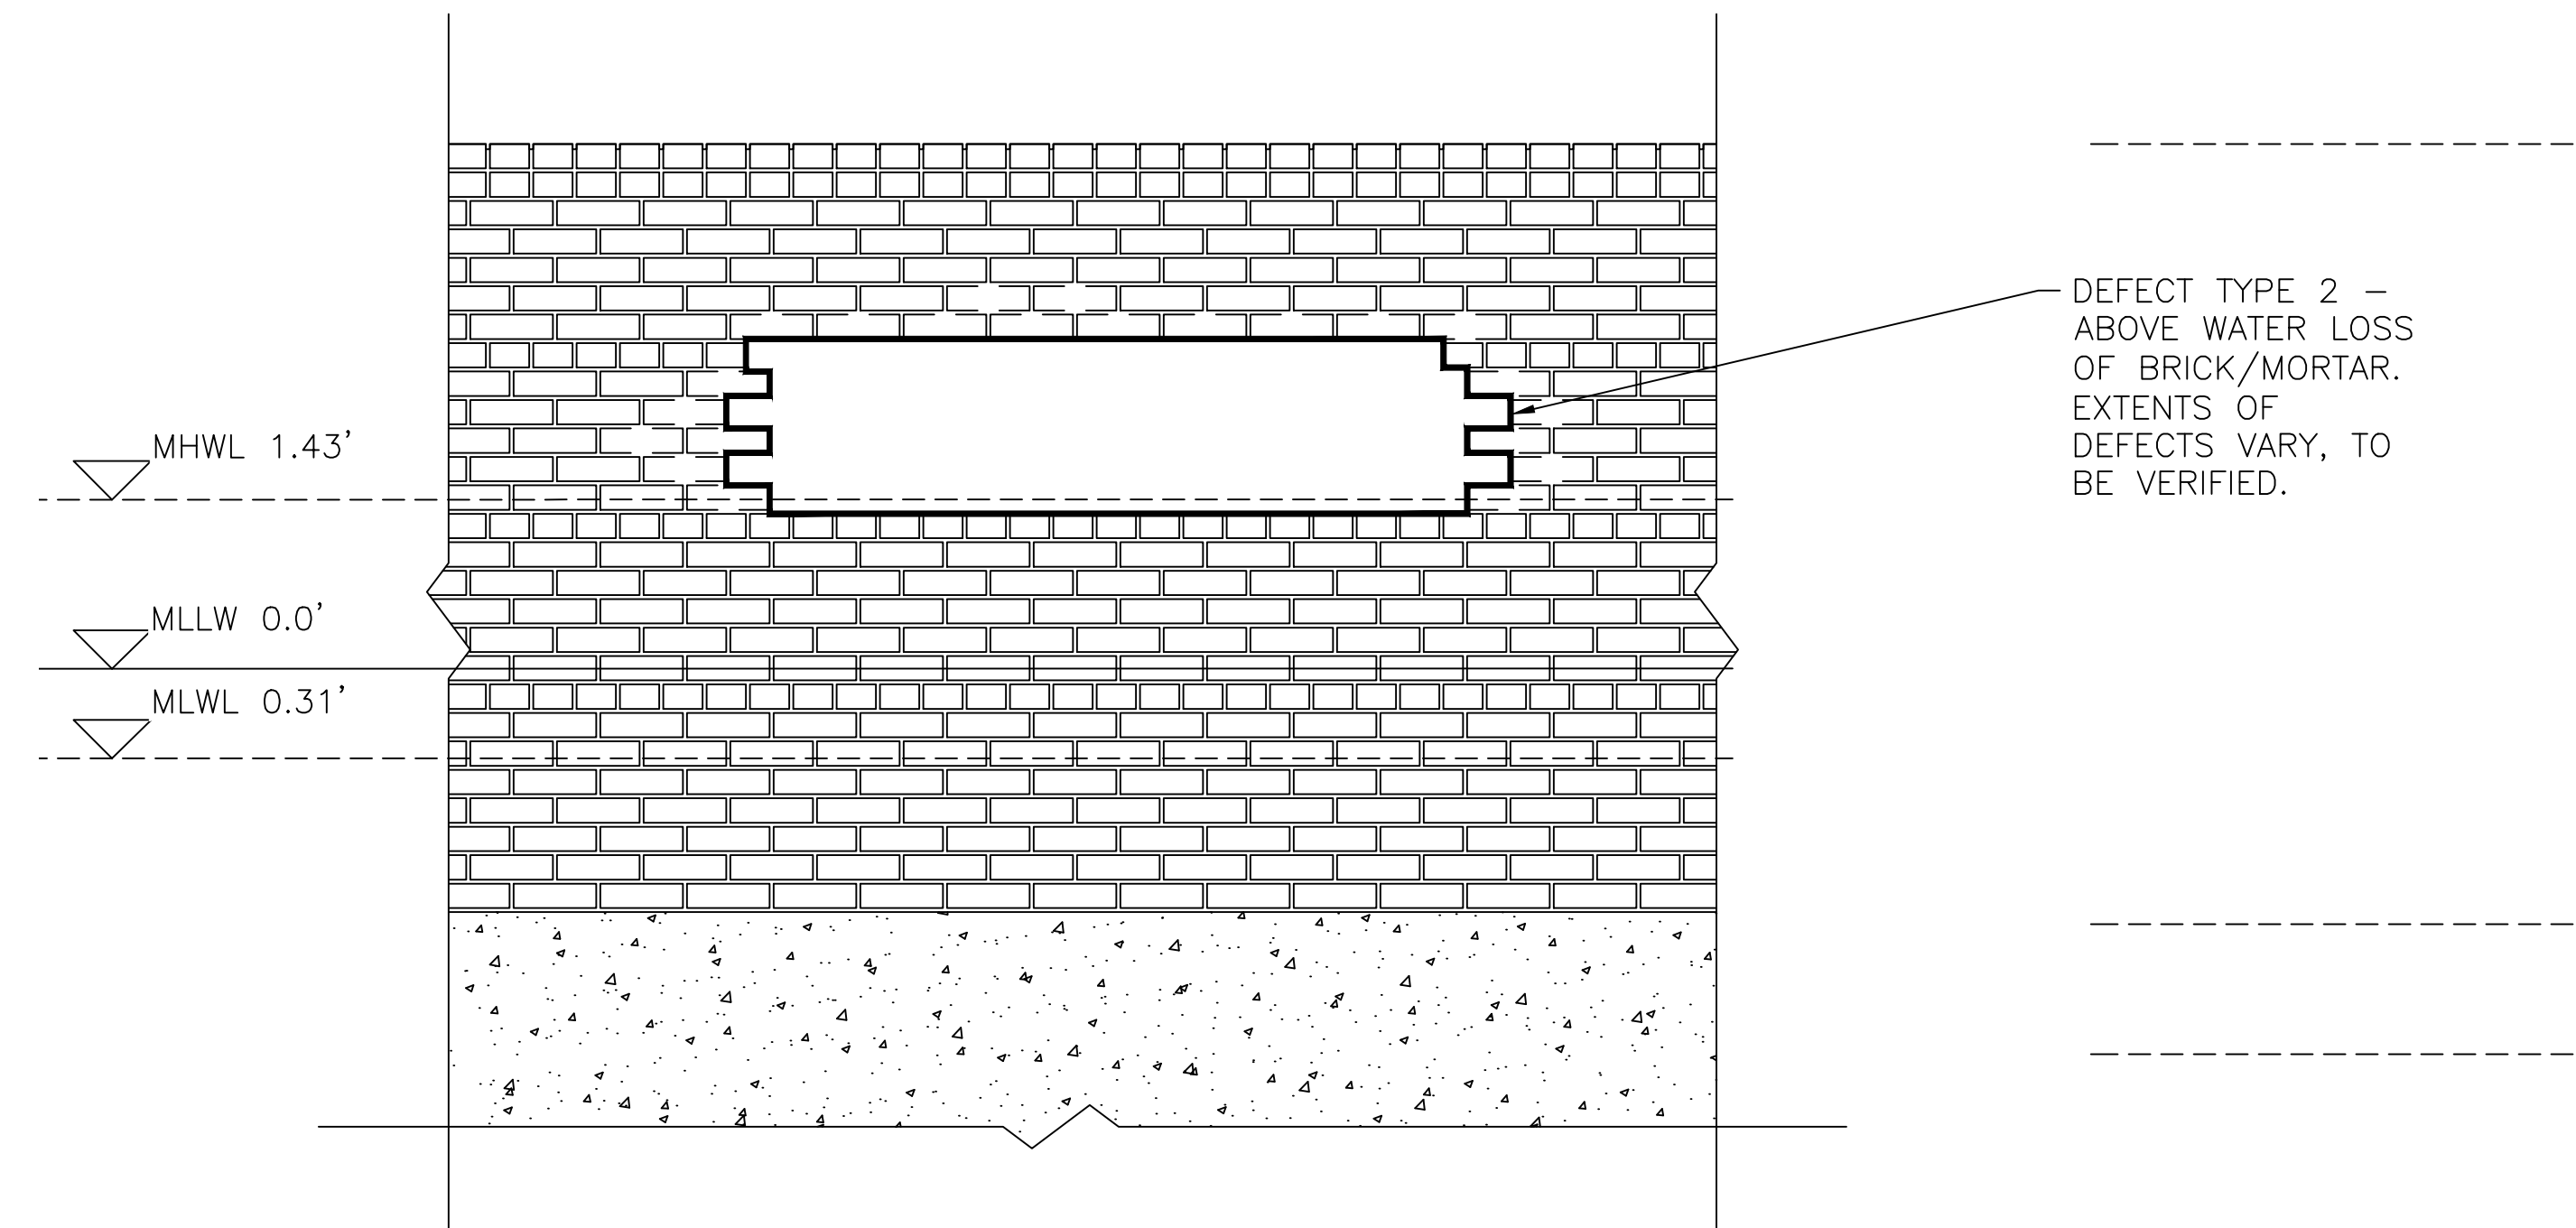
2
- DEFECT TYPE 2 - ABOVE WATER LOSS OF BRICK/MORTAR
NTS

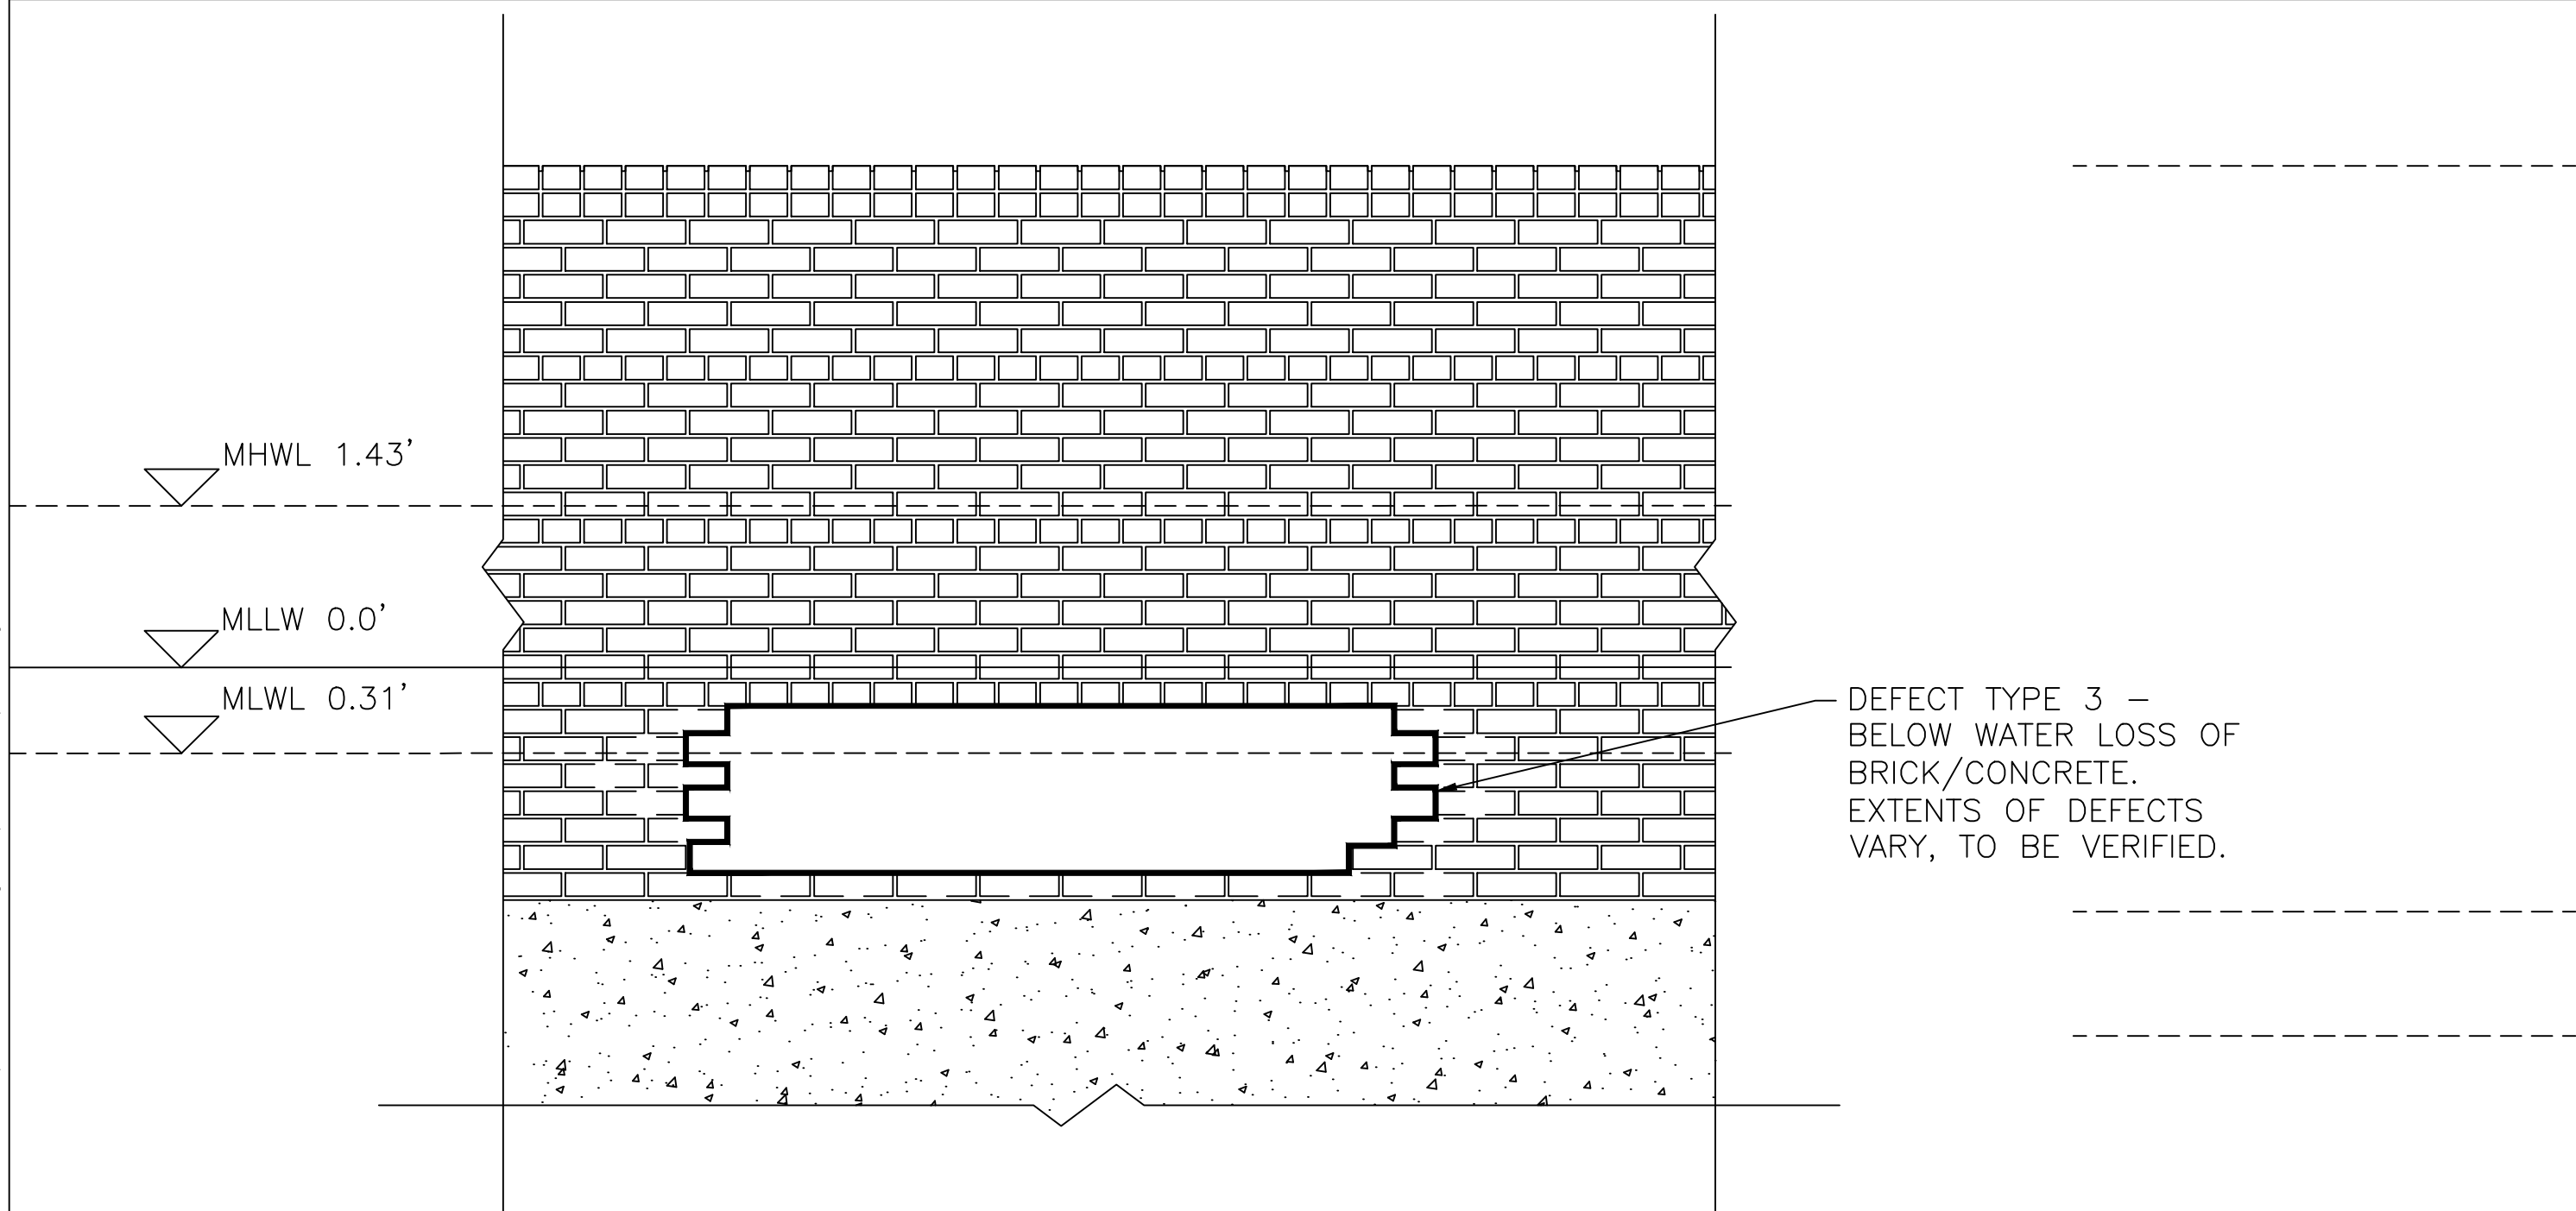
3
- DEFECT TYPE 3 - BELOW WATER LOSS OF BRICK/CONCRETE
NTS

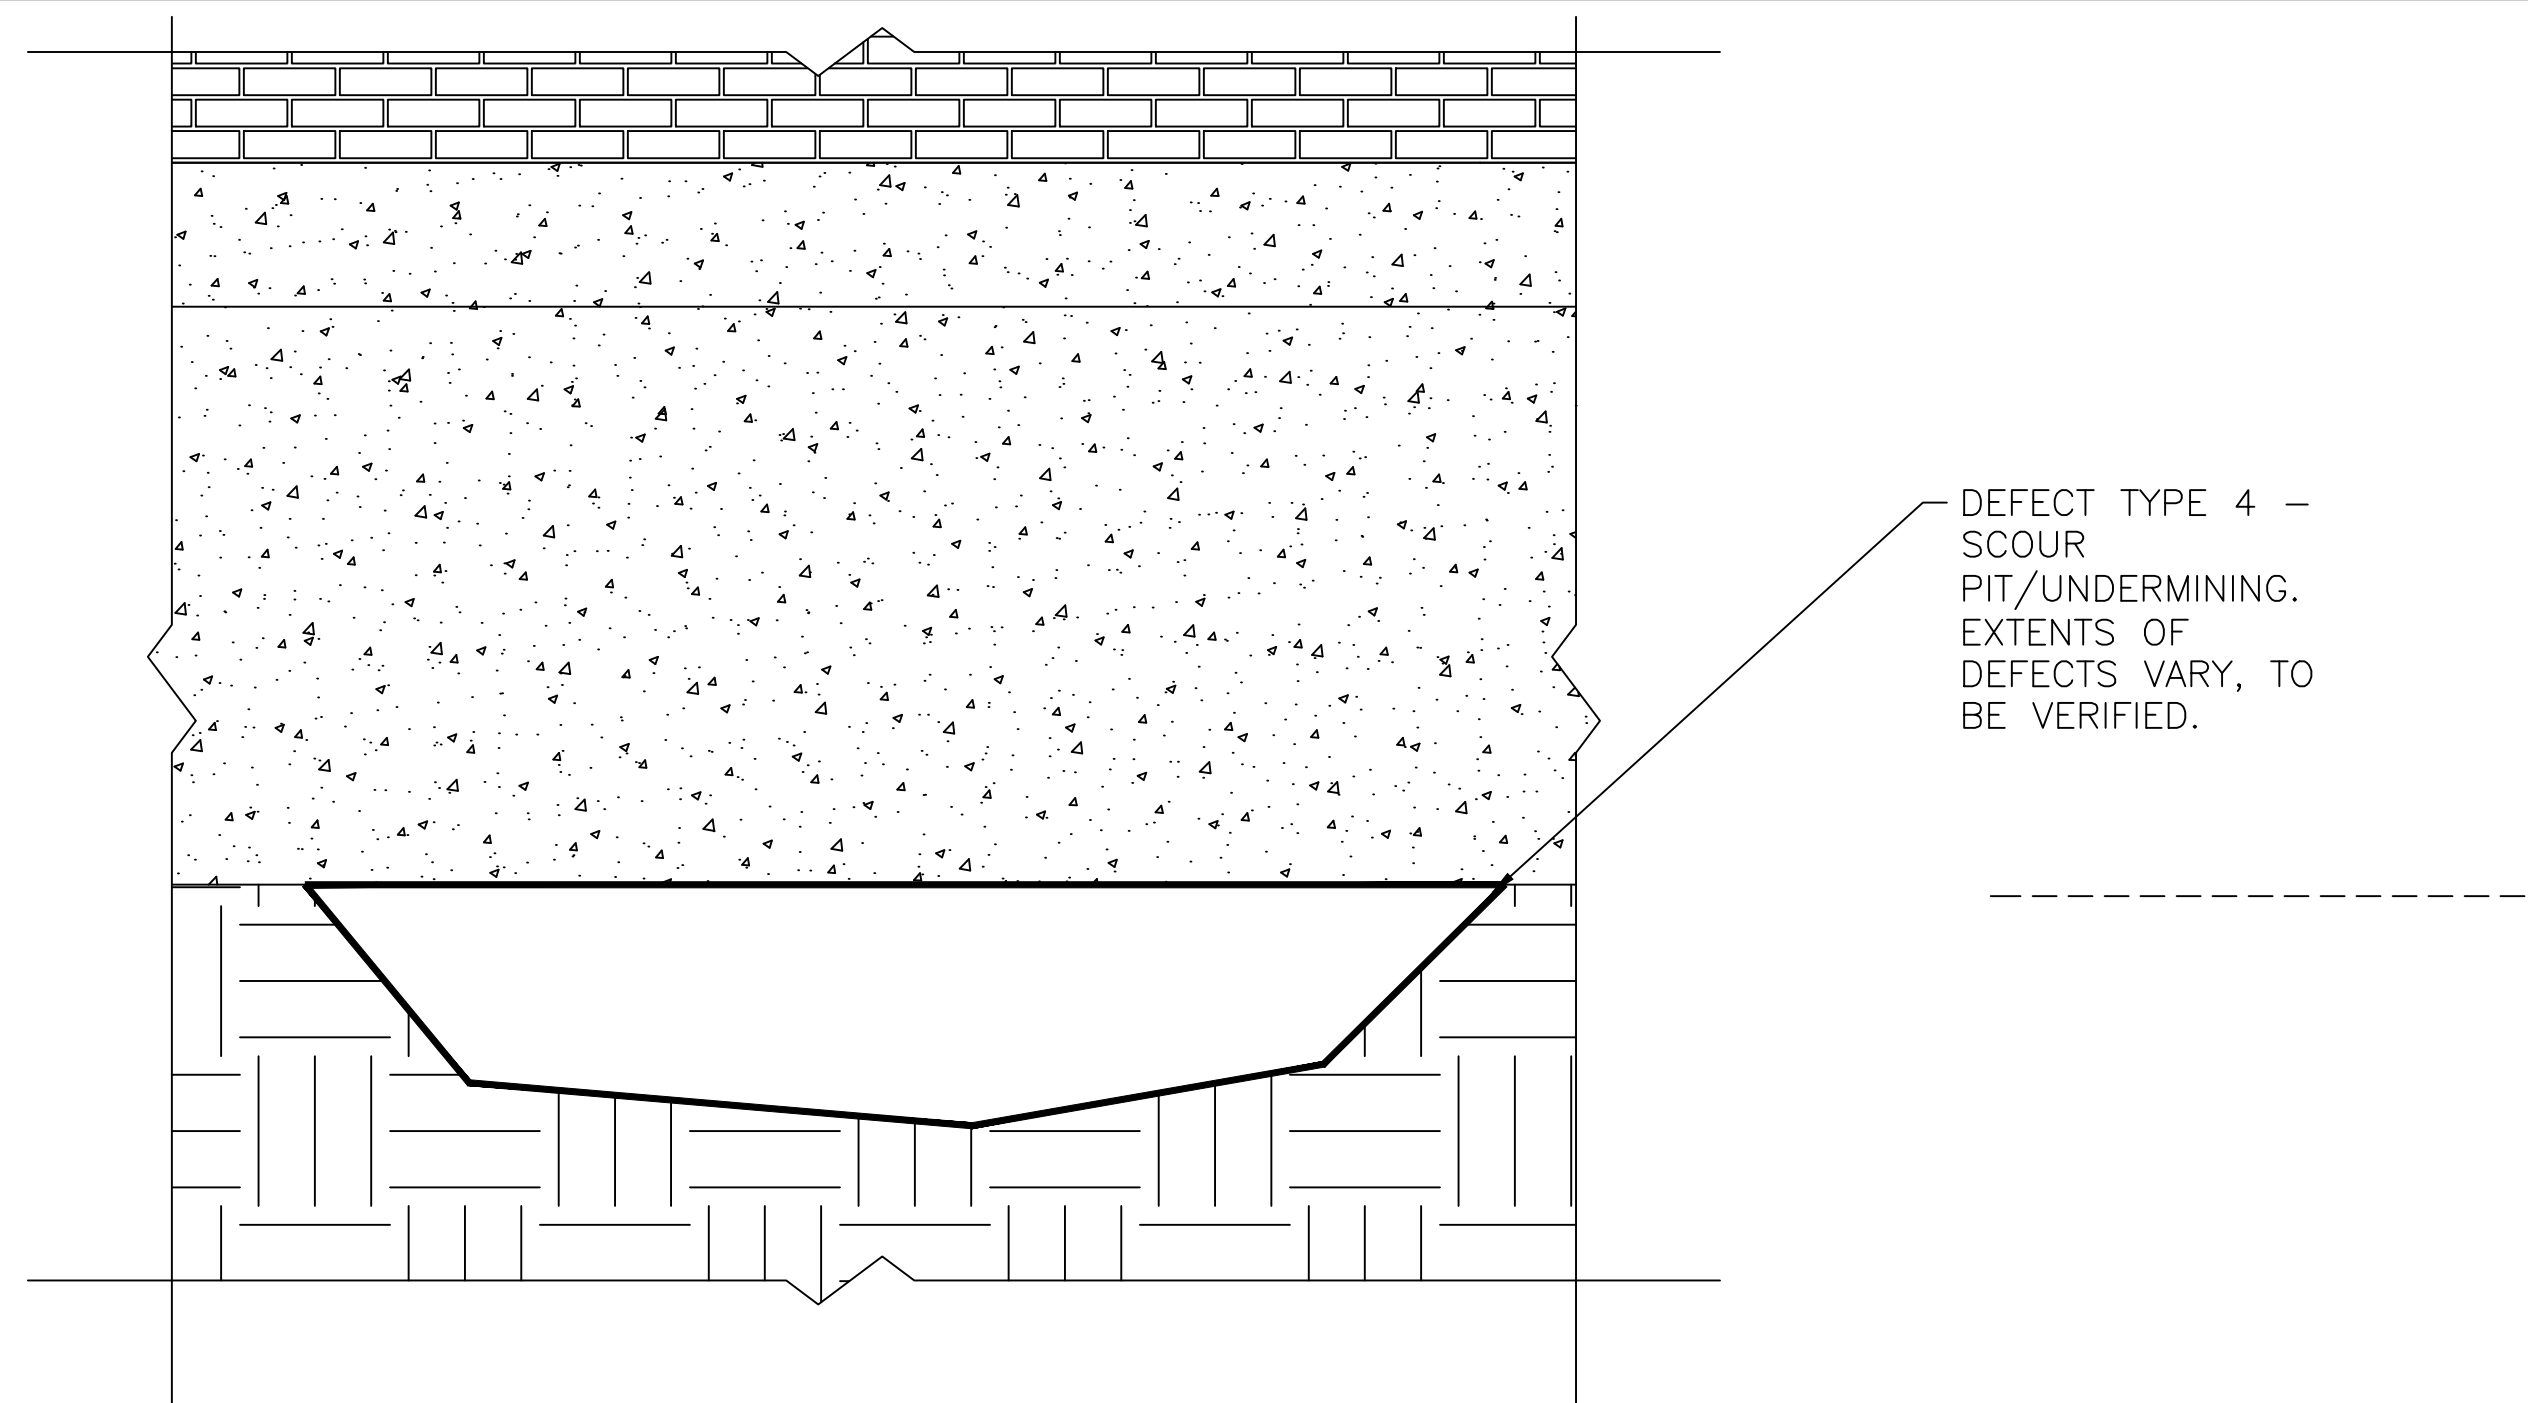
4
- DEFECT TYPE 4 - SCOUR PIT/UNDERMINING
NTS

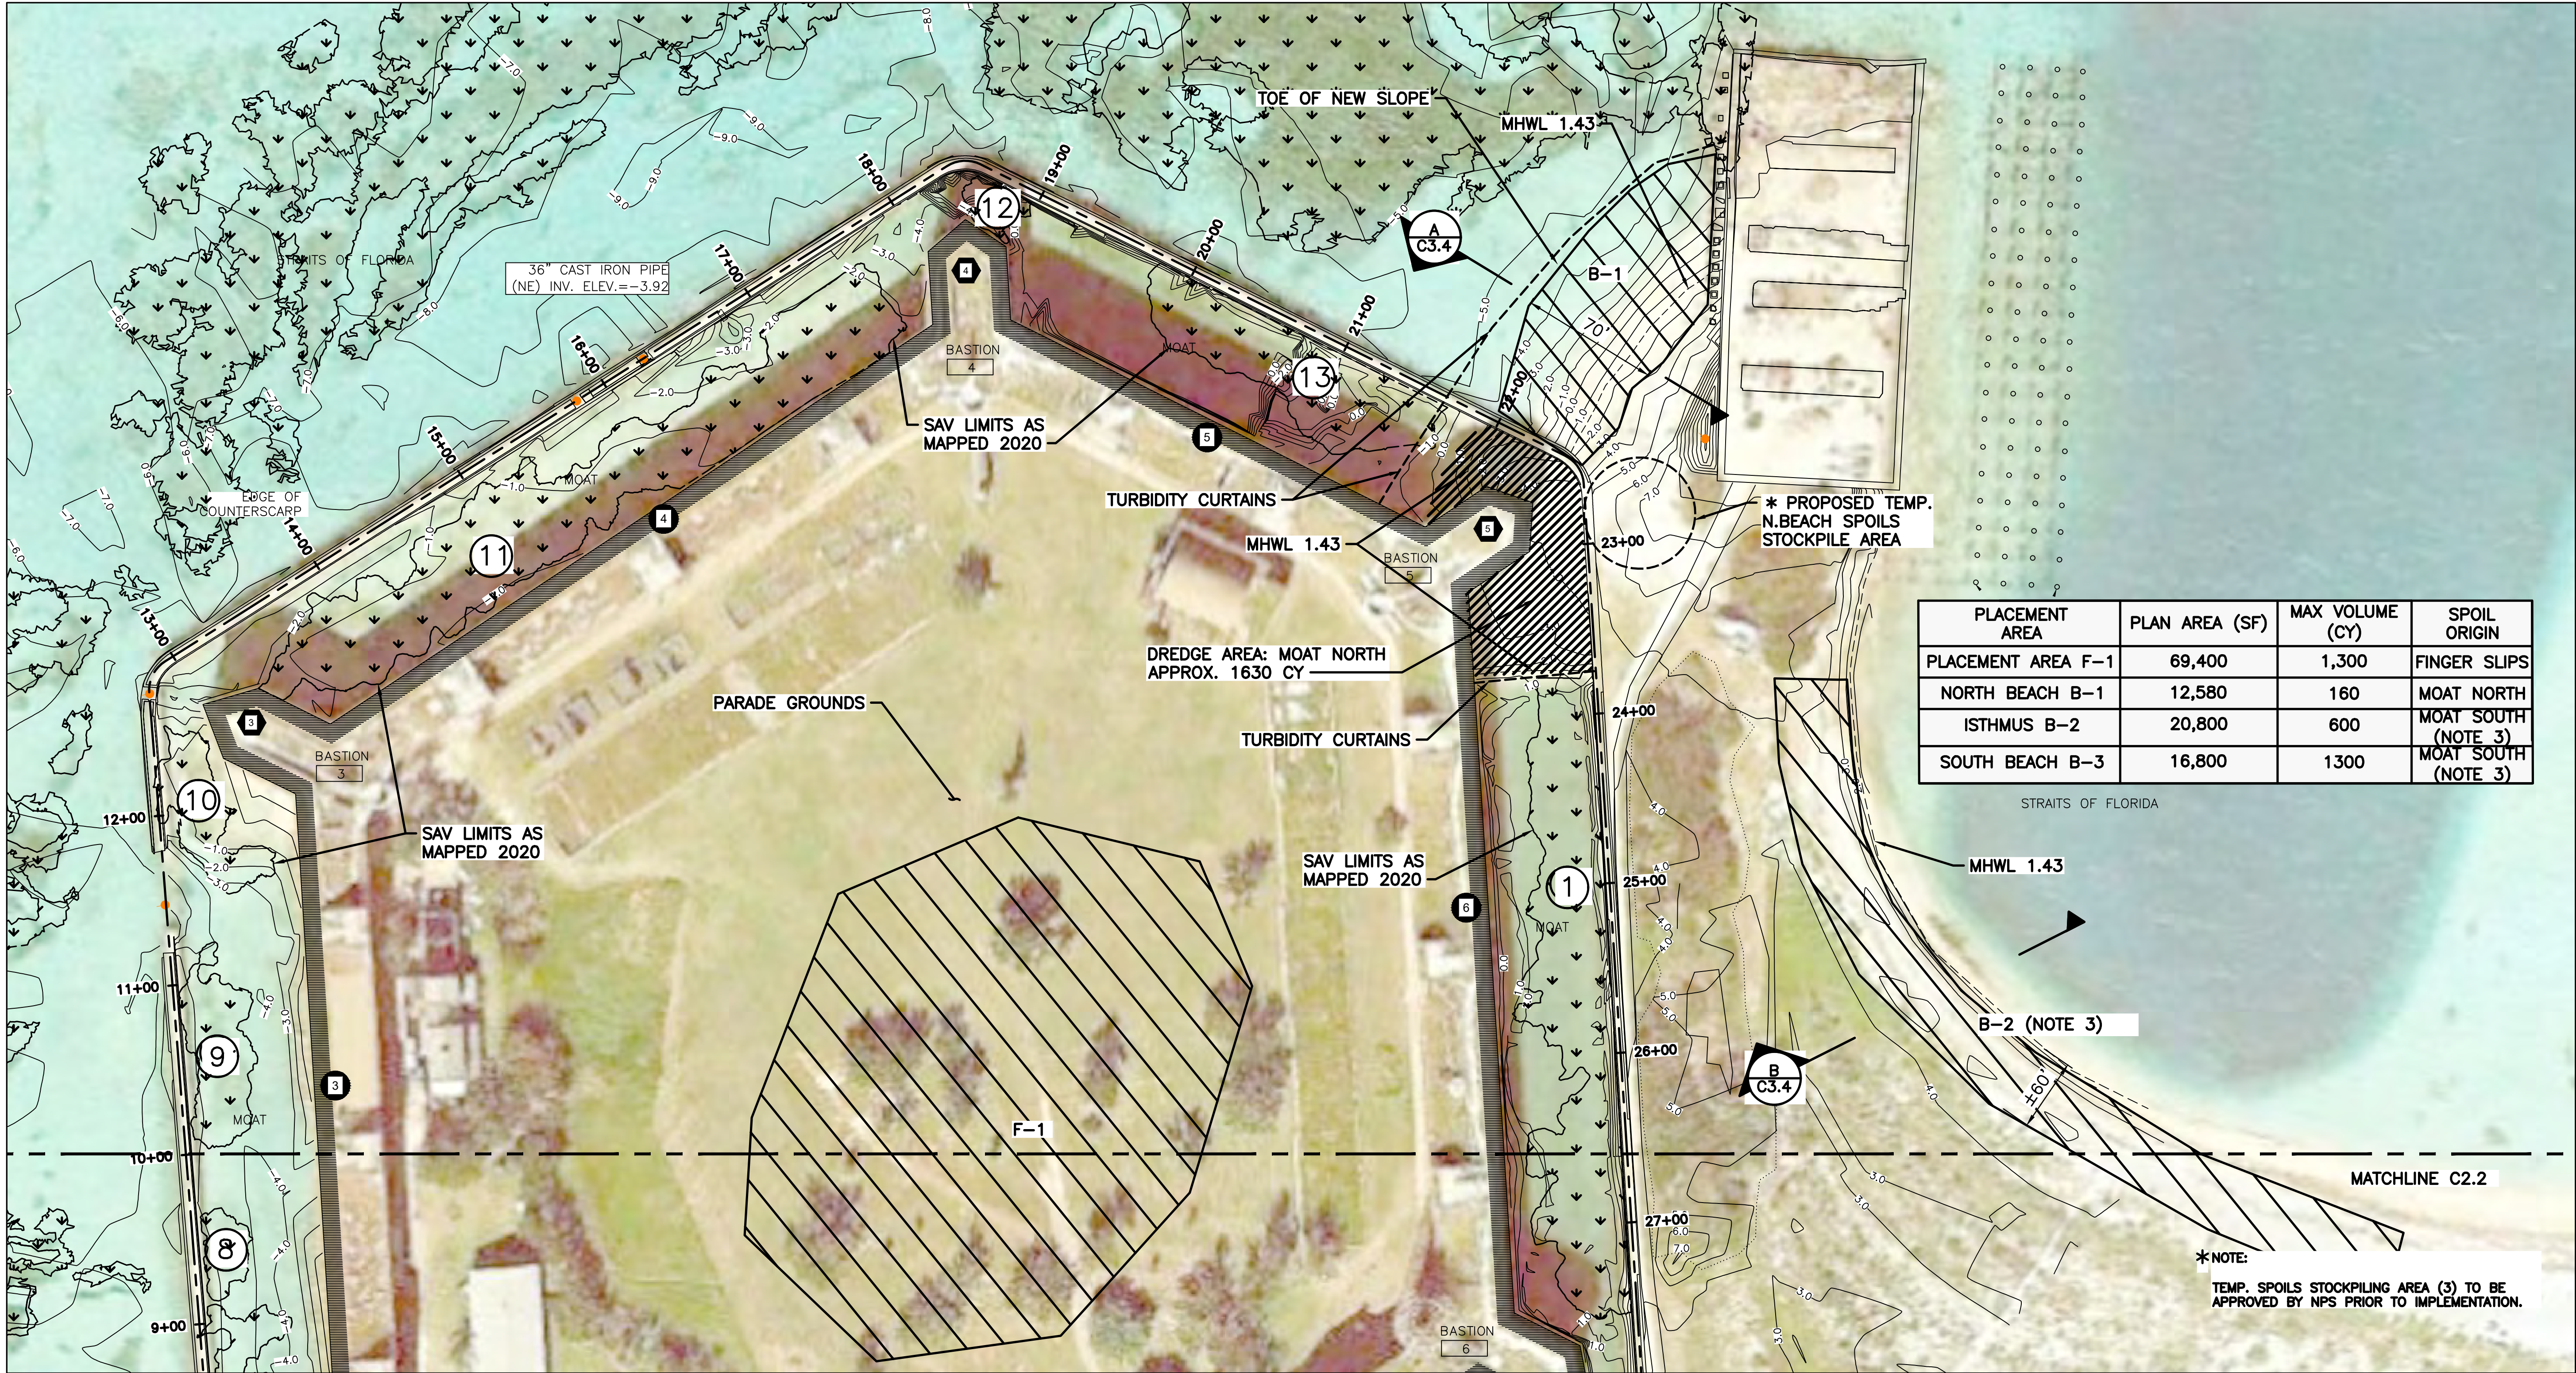
PLACEMENT AREA	PLAN AREA (SF)	MAX VOLUME (CY)	SPOIL ORIGIN
PLACEMENT AREA F-1	69,400	1,300	FINGER SLIPS
NORTH BEACH B-1	12,580	160	MOAT NORTH
ISTHMUS B-2	20,800	600	MOAT SOUTH (NOTE 3)
SOUTH BEACH B-3	16,800	1300	MOAT SOUTH (NOTE 3)

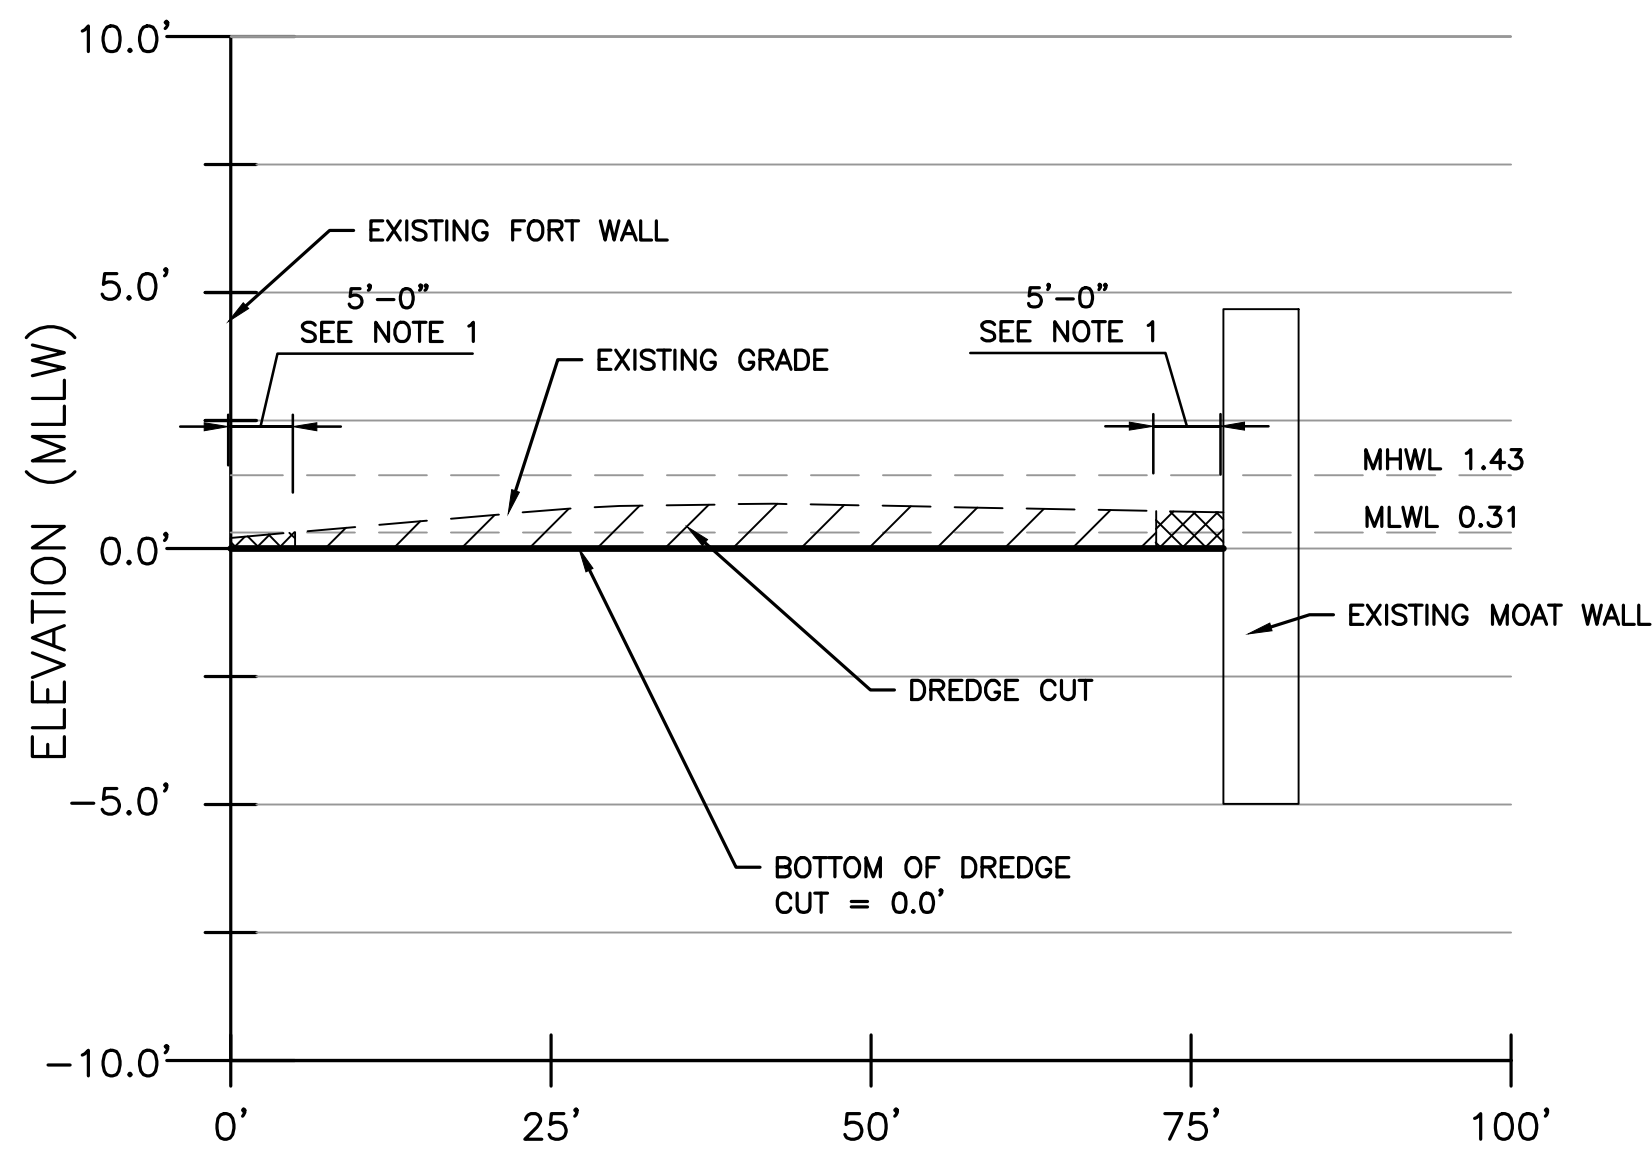
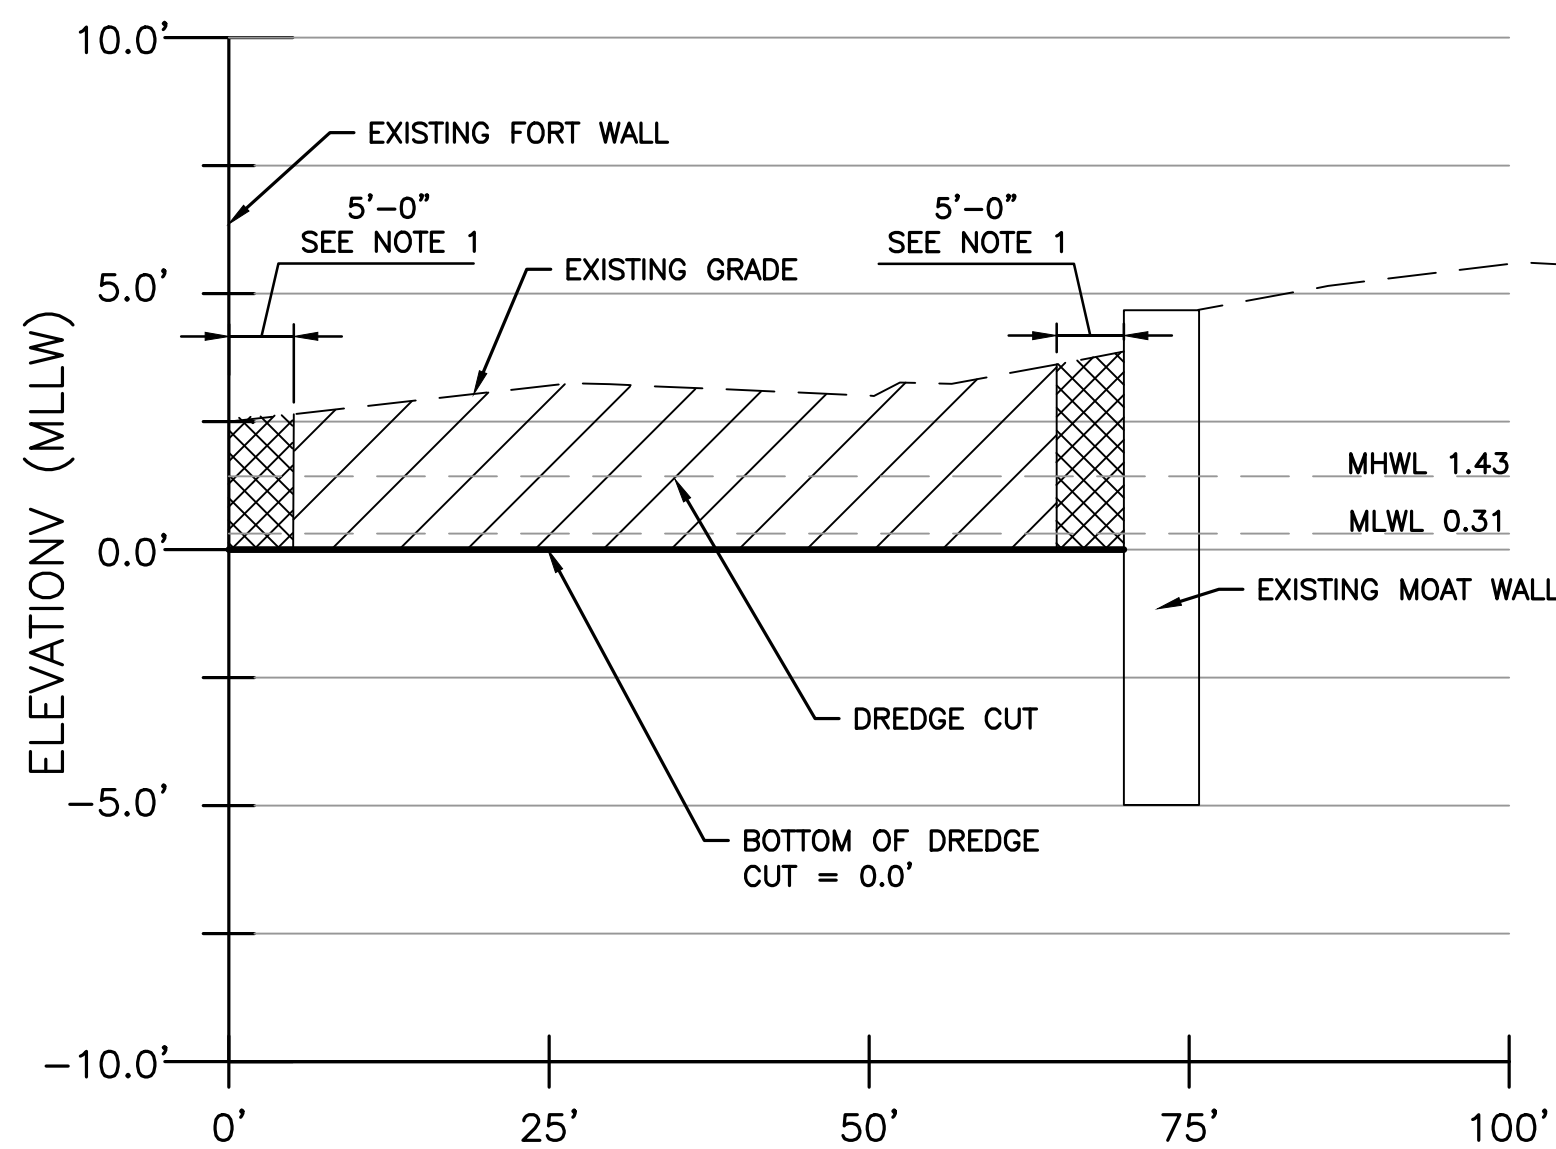
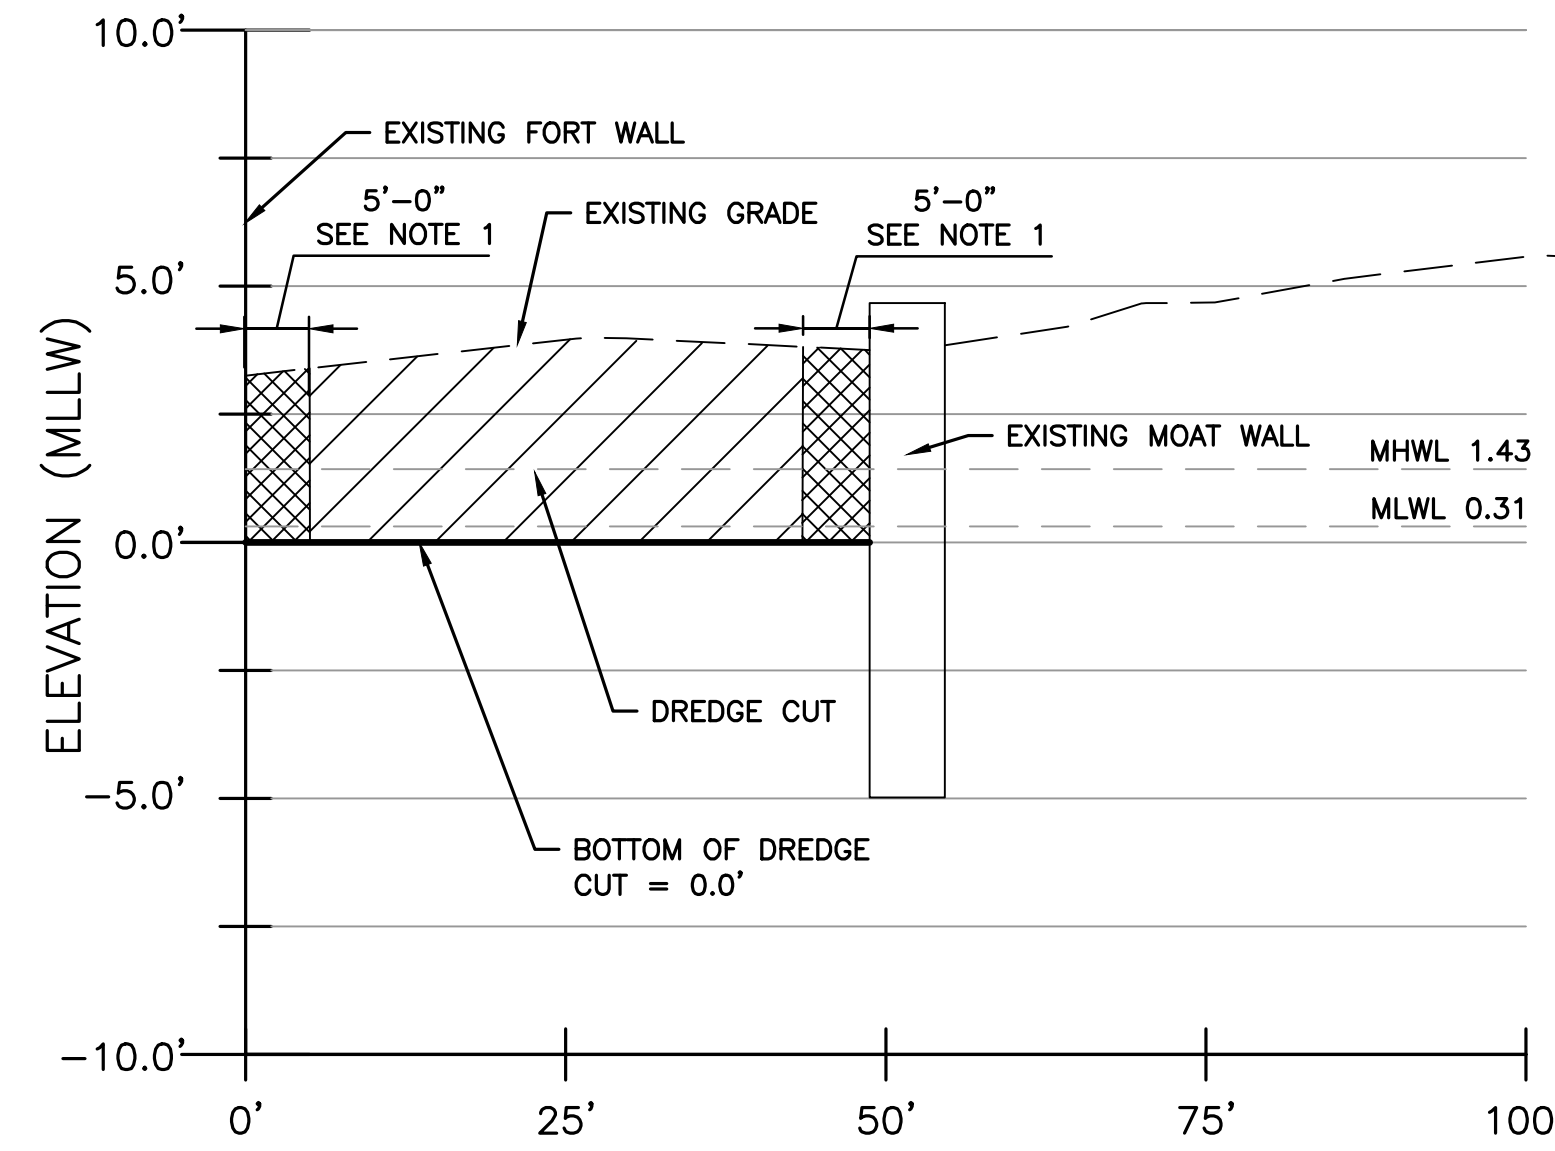
A1 TYPICAL SECTION
HORIZONTAL SCALE 1"=15'; VERTICAL SCALE: 1" = 5'

A3 TYPICAL SECTION
HORIZONTAL SCALE 1"=15'; VERTICAL SCALE: 1" = 5'

1. PROTECTIVE WORK BUFFER – DREDGE WITH HAND / SUCTION METHODS TO PREVENT DAMAGE TO MASONRY.
2. DREDGING TO DAYLIGHT AT EXISTING ELEVATION 0.0'

A2 TYPICAL SECTION
HORIZONTAL SCALE 1"=15'; VERTICAL SCALE: 1" = 5'
