Repairs to Fort Jefferson Counterscarp and Dredging of Selected Areas

Environmental Assessment

March 2023

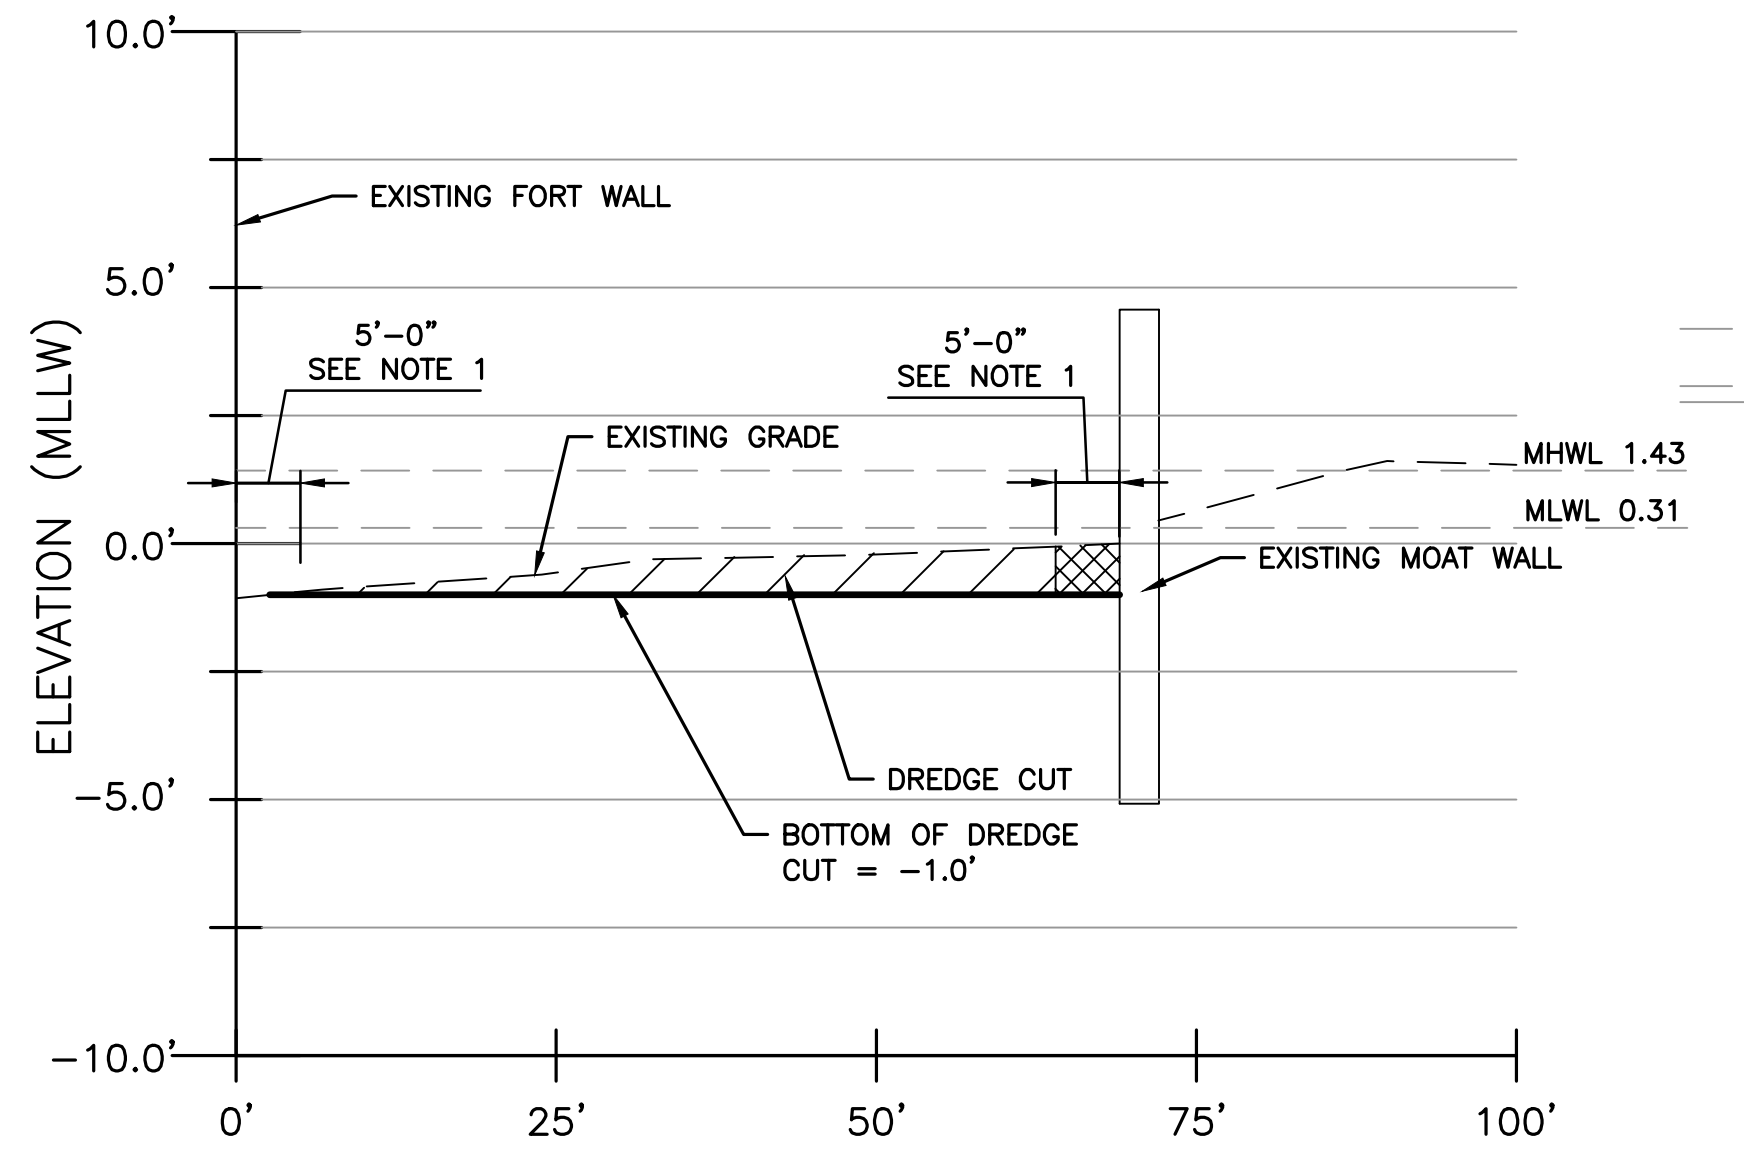
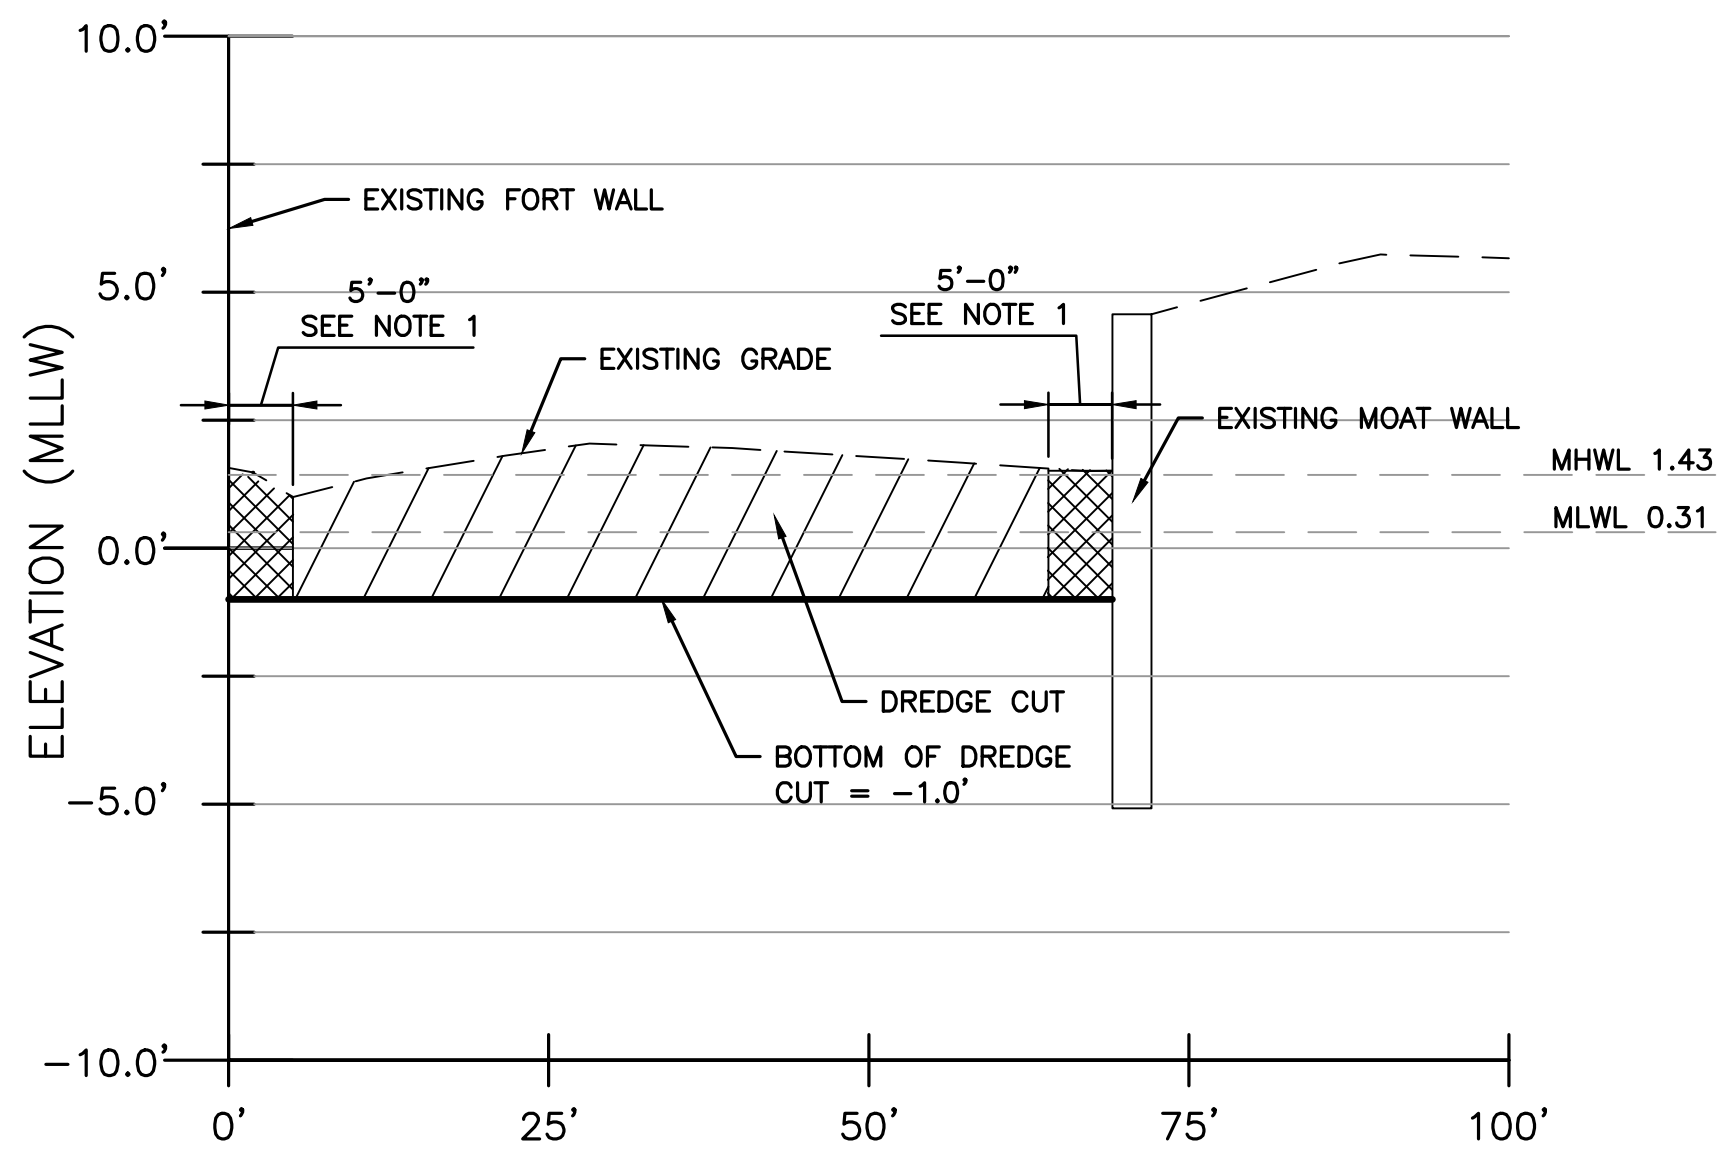
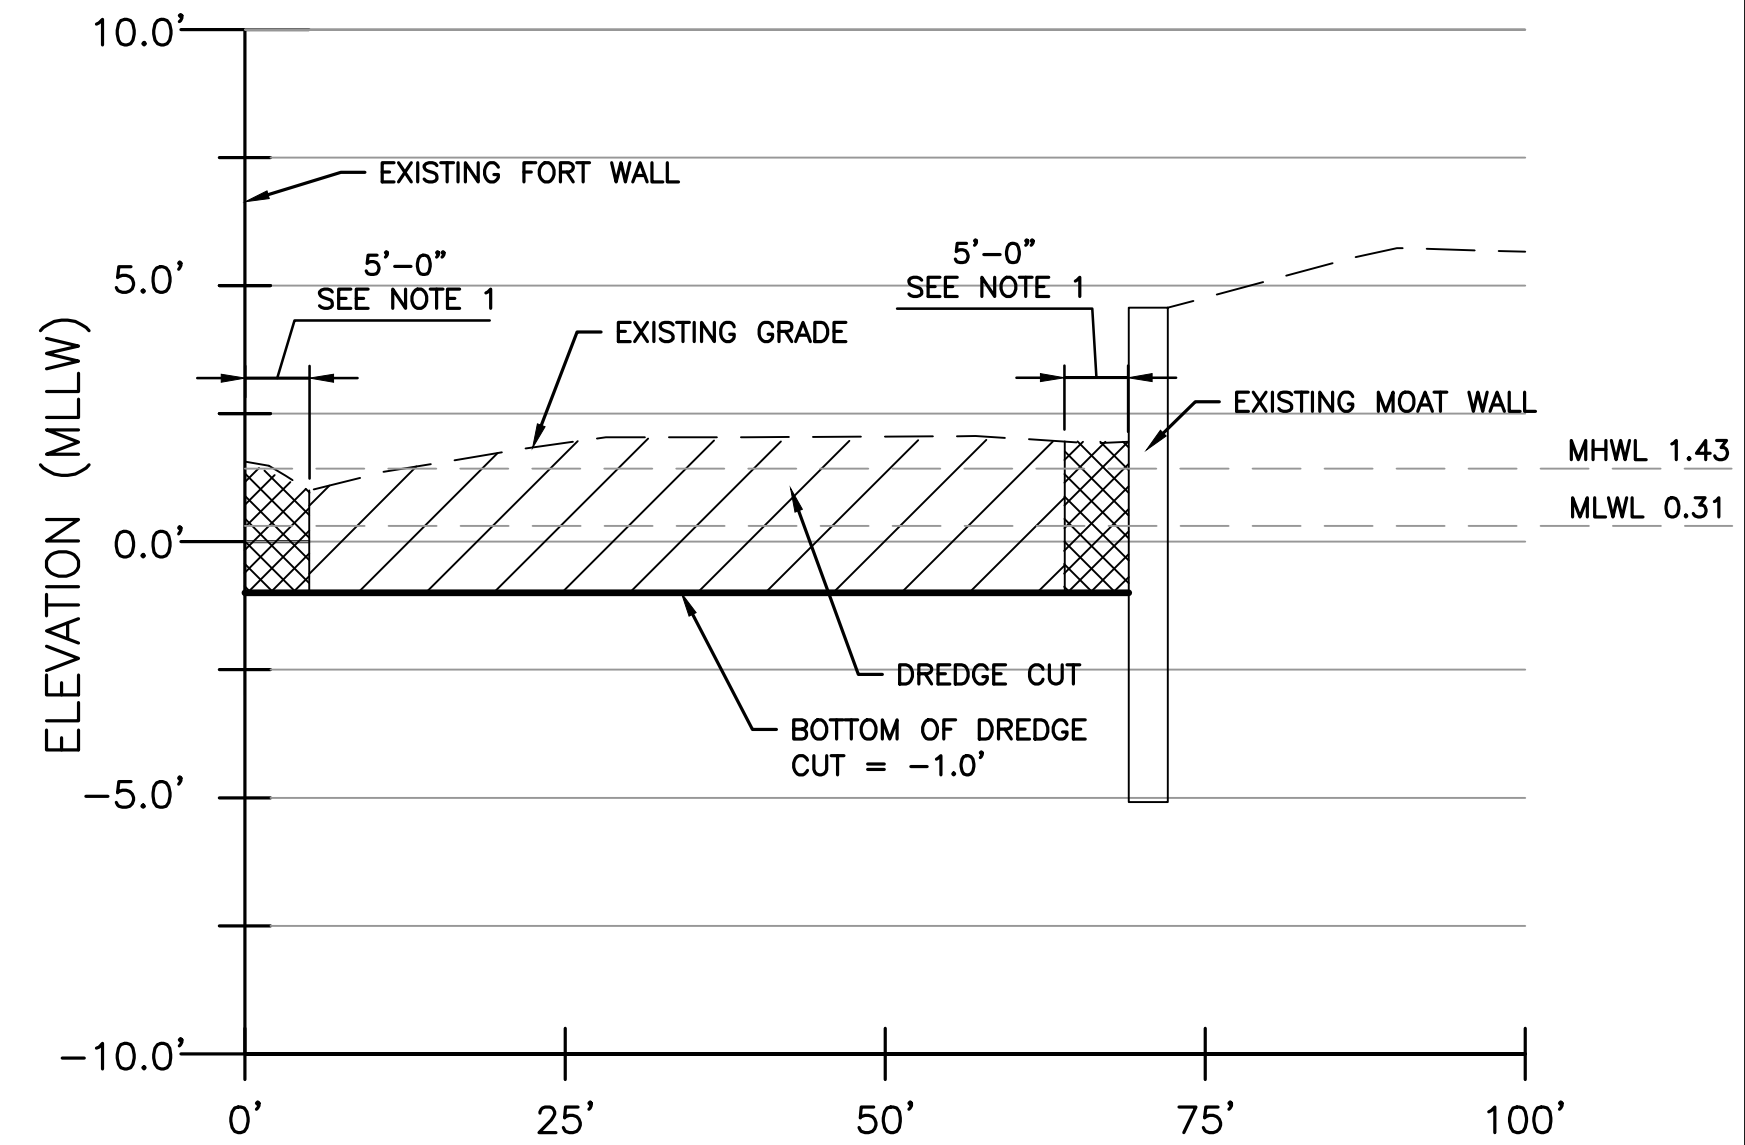
B1 TYPICAL SECTION
HORIZONATAL SCALE 1"=15'; VERTICAL SCALE: 1" = 5'

B3 TYPICAL SECTION
HORIZONATAL SCALE 1"=15'; VERTICAL SCALE: 1" = 5'

1. PROTECTIVE WORK BUFFER – DREDGE WITH HAND / SUCTION METHODS TO PREVENT DAMAGE TO MASONRY..
2. DREDGING TO DAYLIGHT AT EXISTING ELEVATION 0.0'

B2 TYPICAL SECTION
HORIZONATAL SCALE 1"=15'; VERTICAL SCALE: 1" = 5'

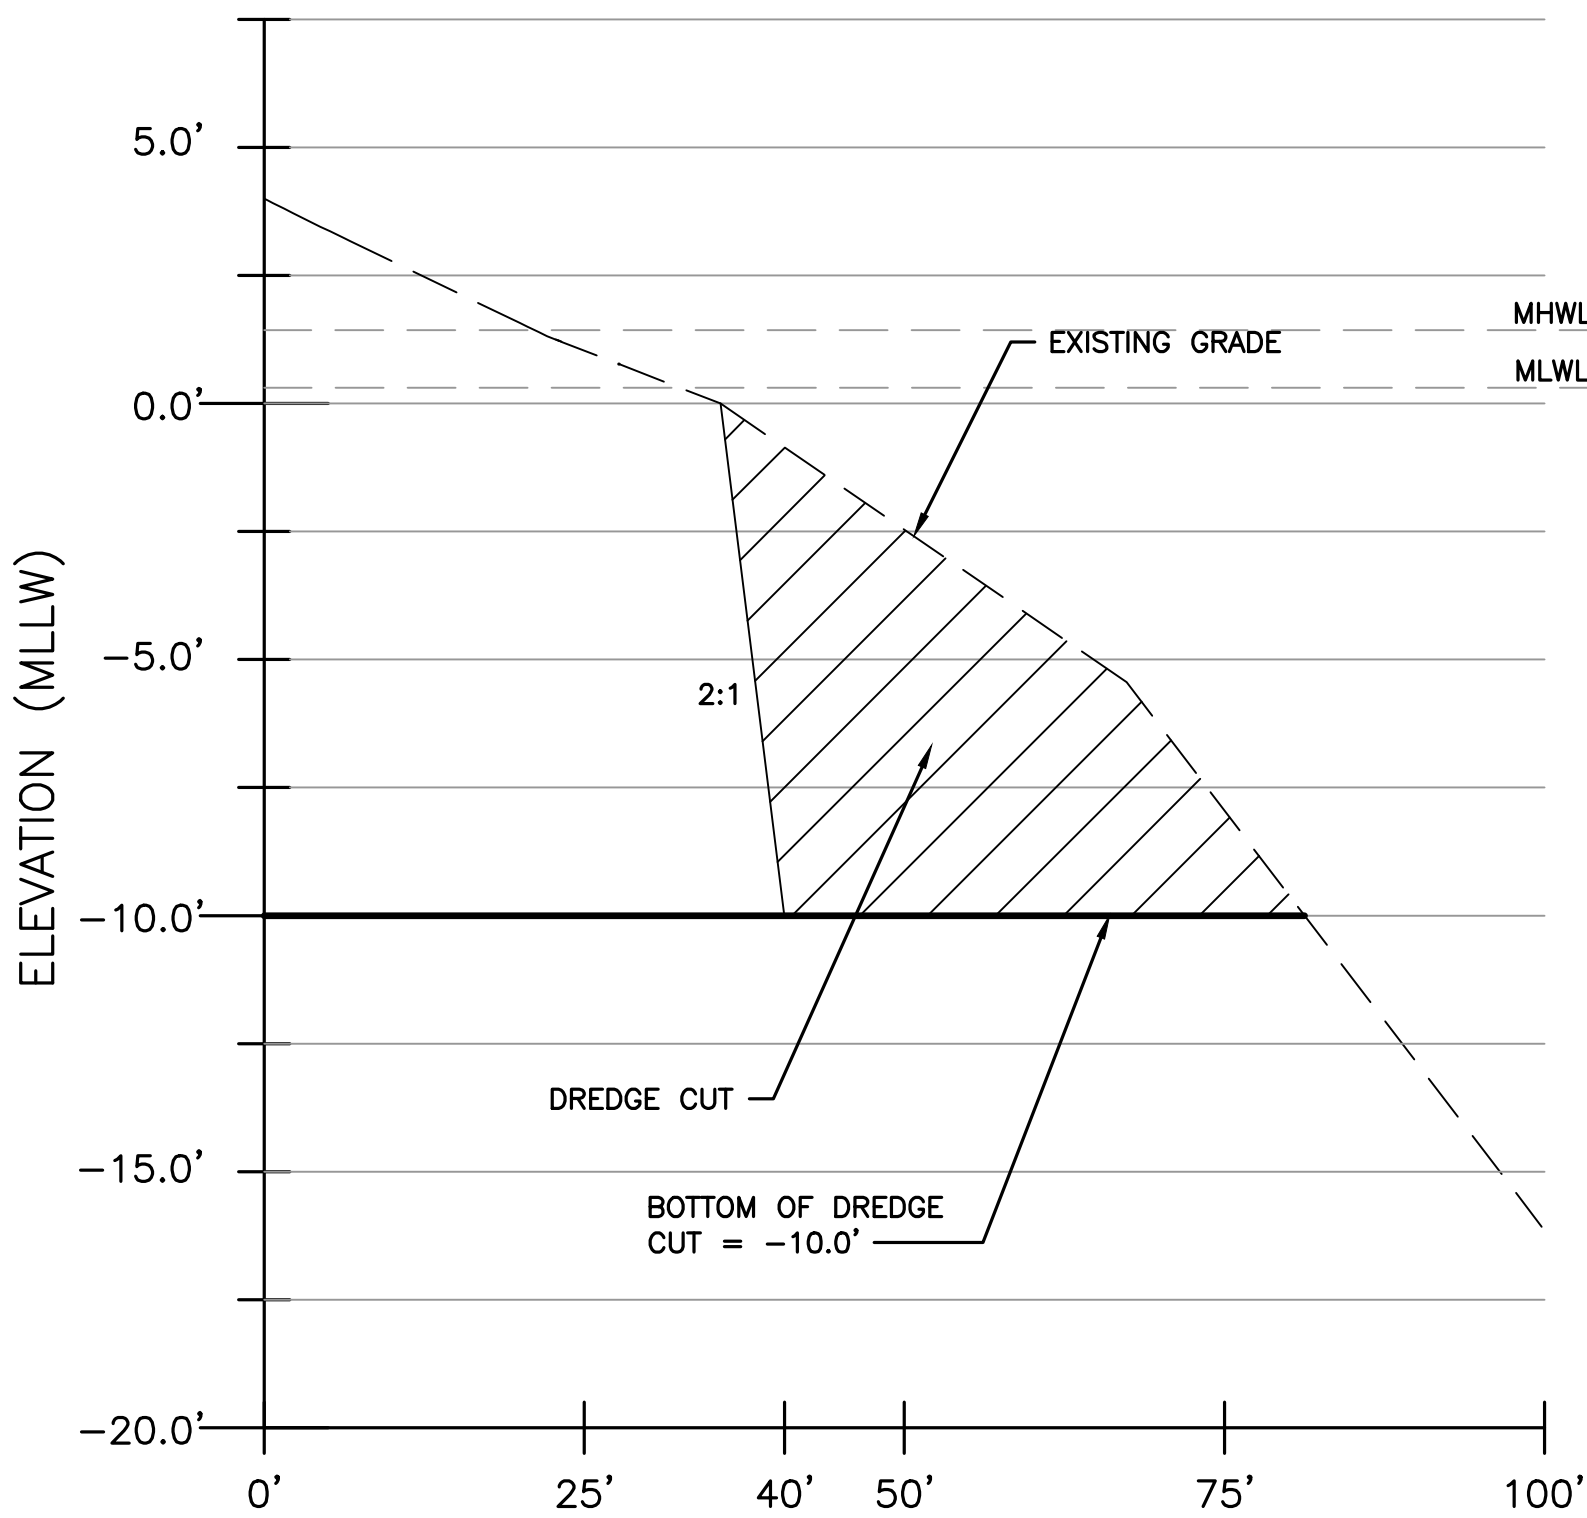
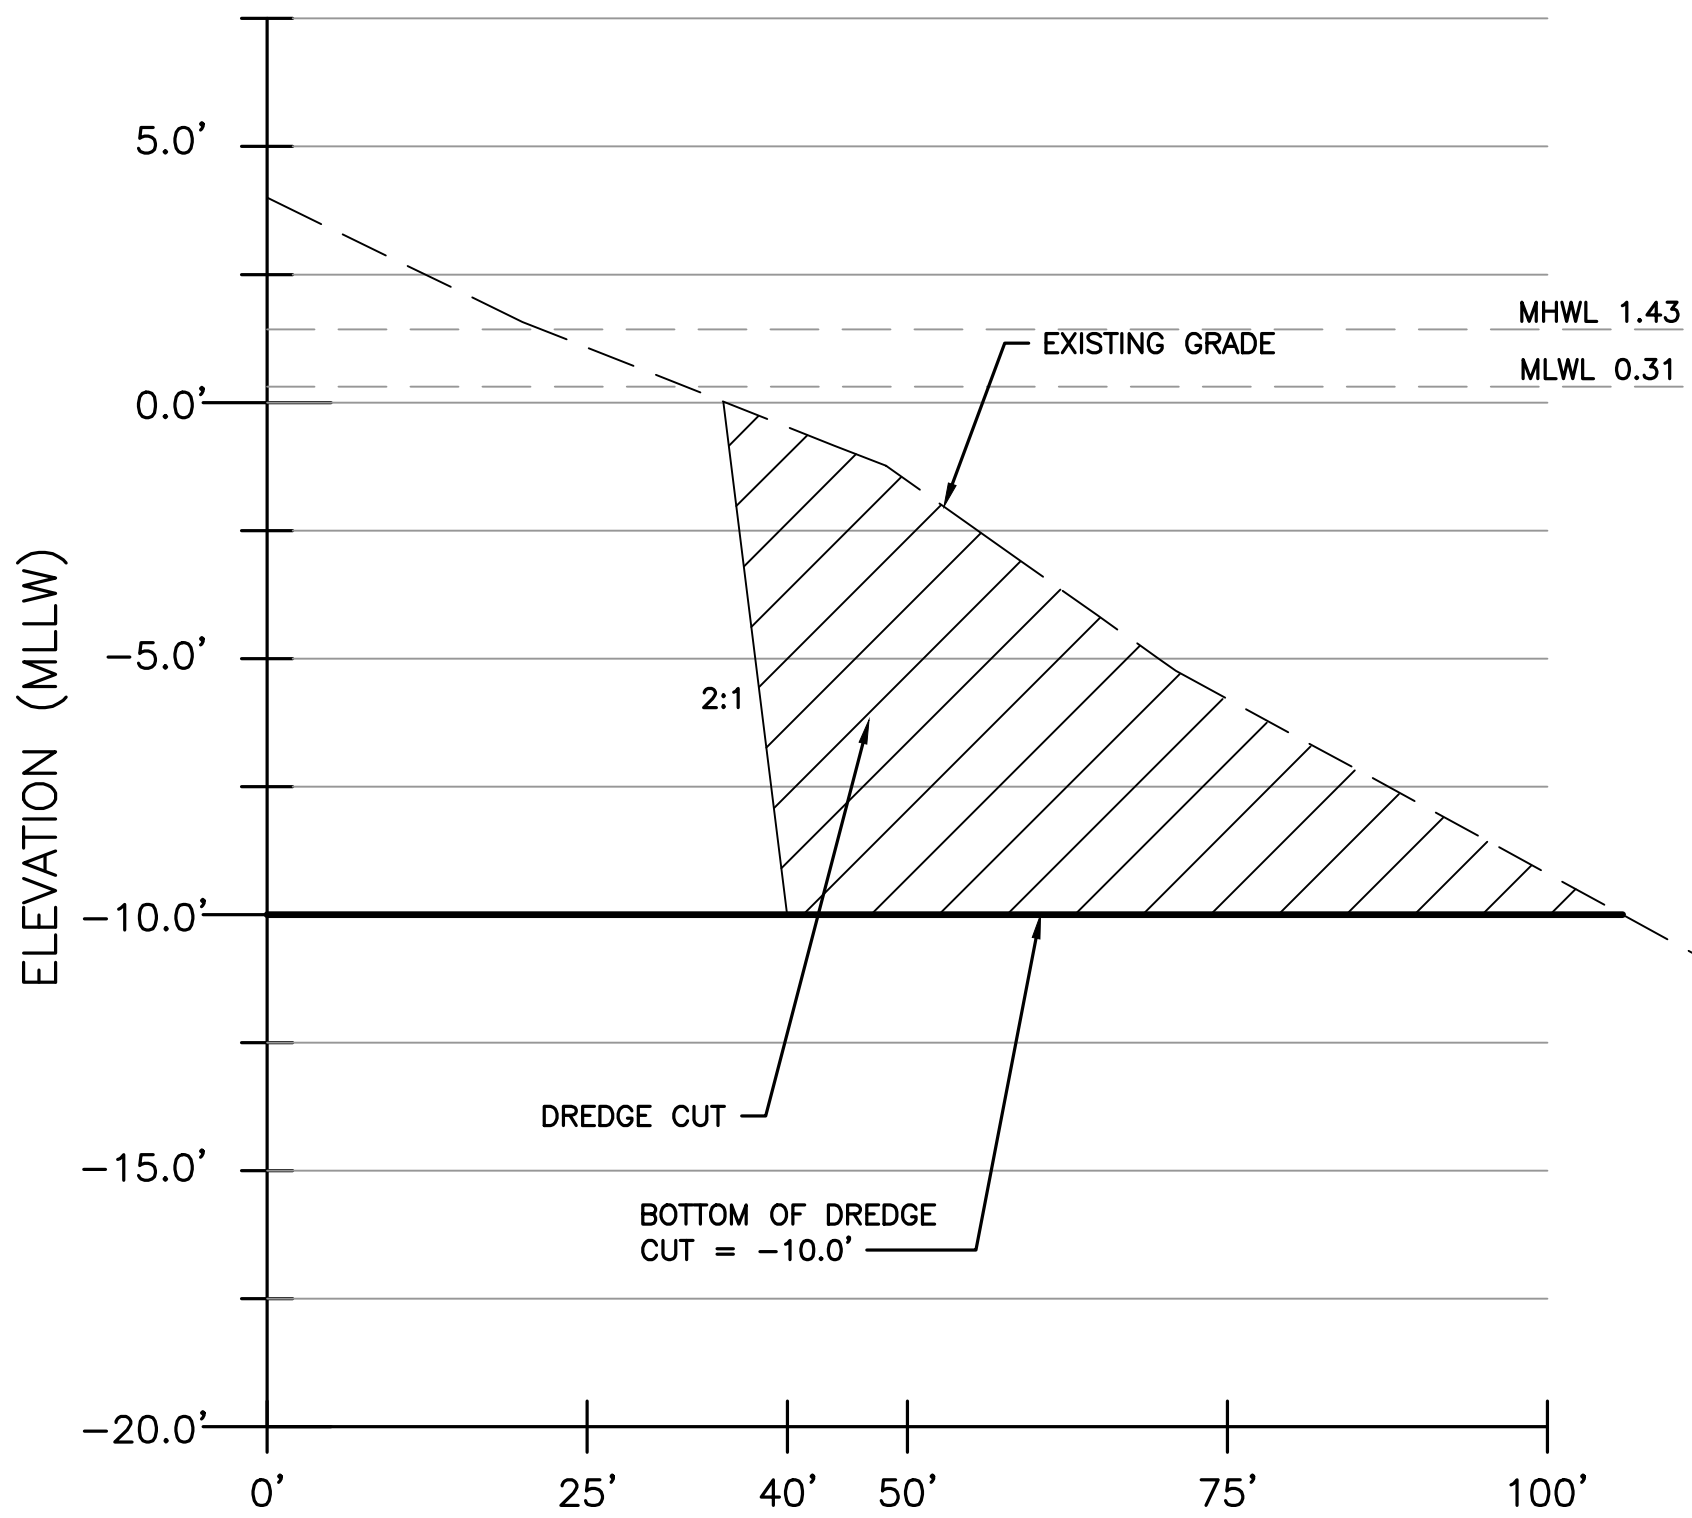
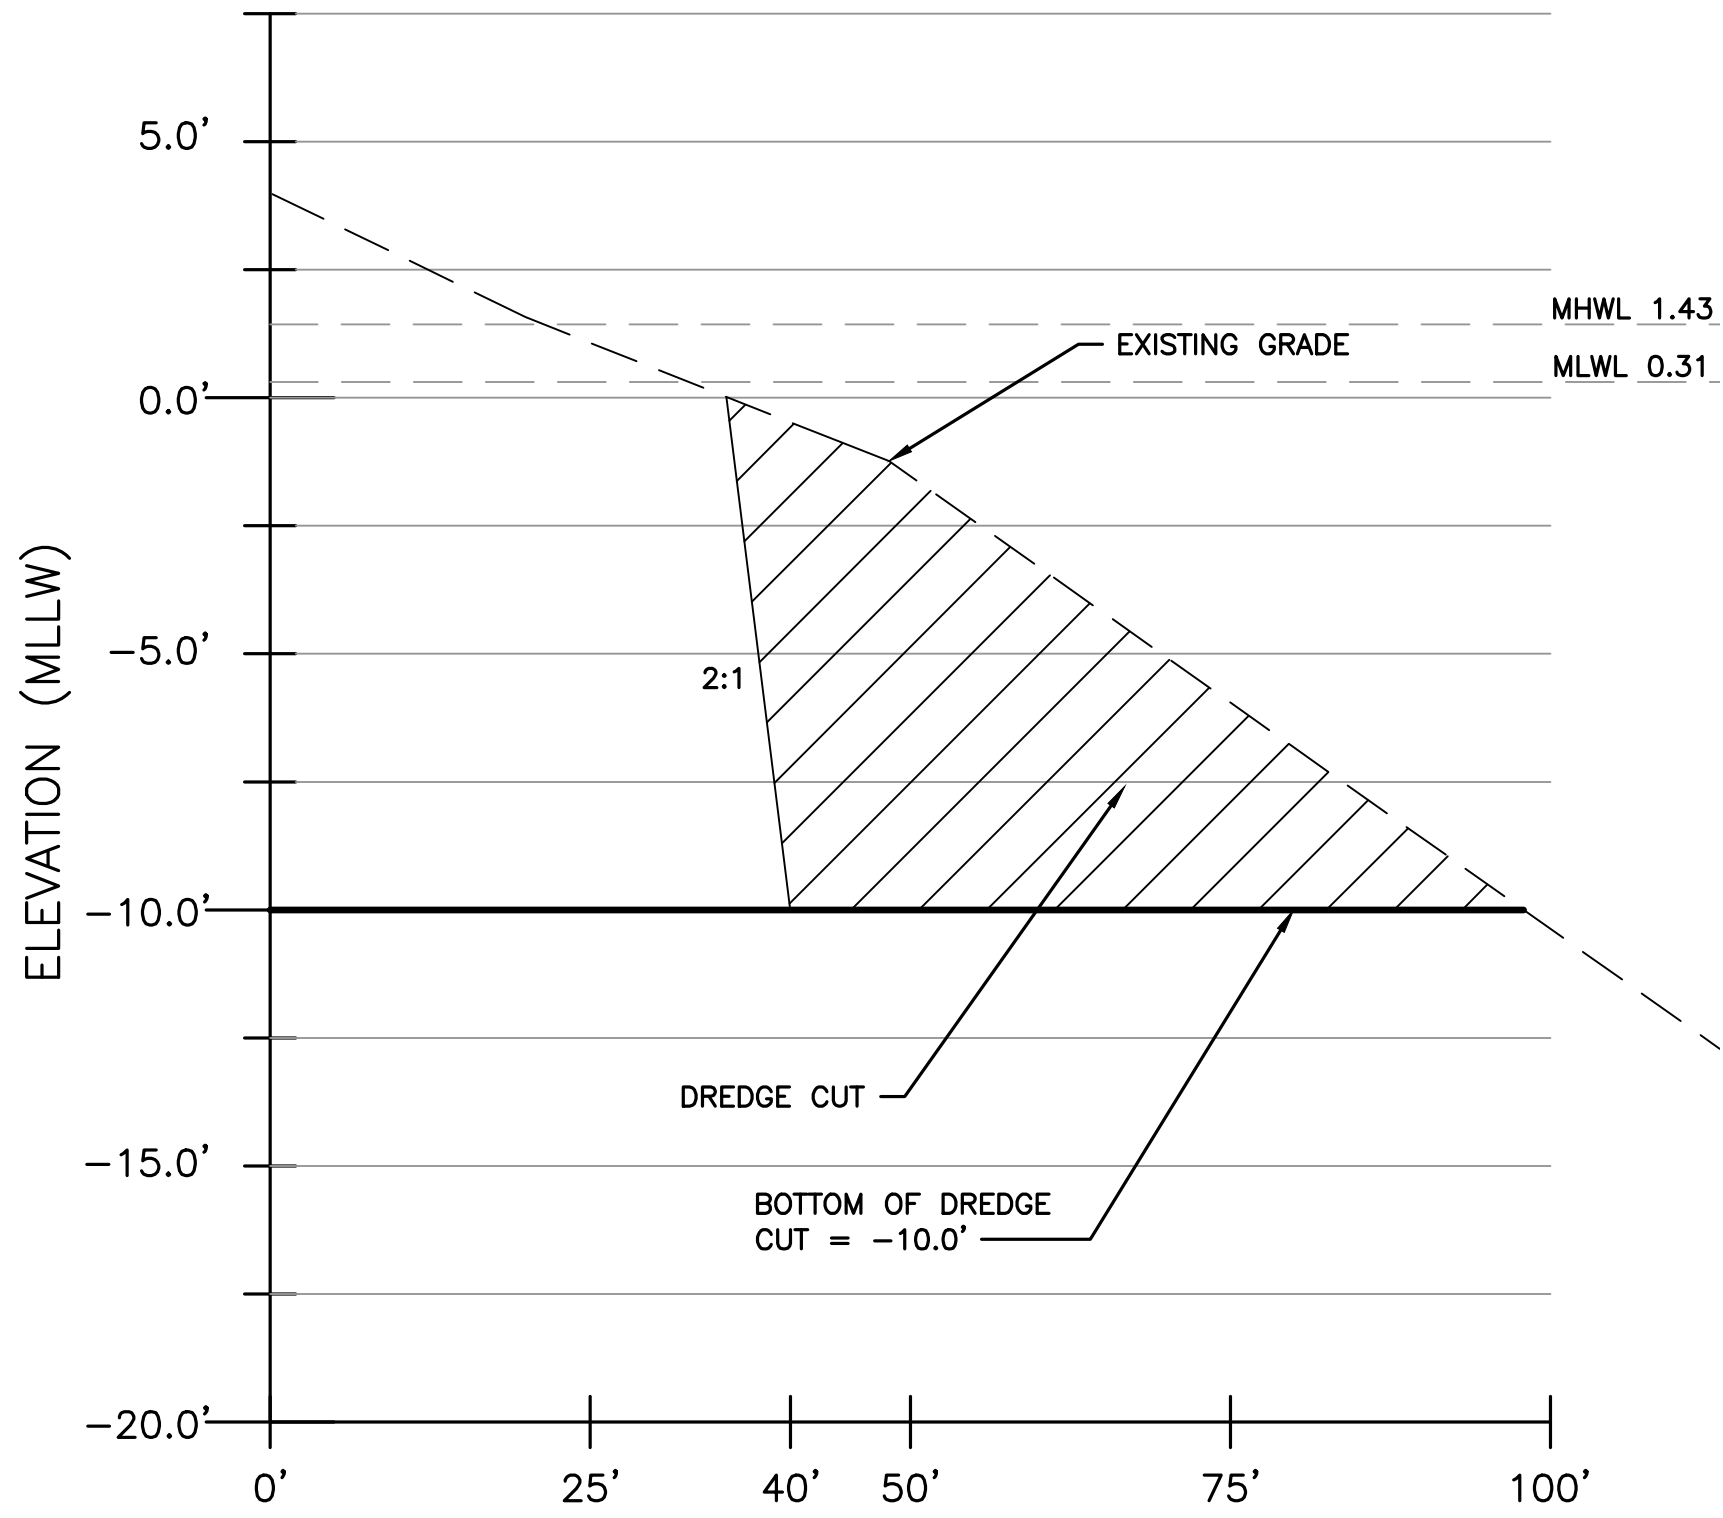
- ALL SPOILS FROM FINGER PIER DREDGING WILL BE STOCKPILED AND UTILIZED AT FORT.
- NO BEACH PLACEMENT IS PROPOSED FOR FINGER SLIP MATERIAL.

C1 TYPICAL SECTION
HORIZONATAL SCALE 1"=15'; VERTICAL SCALE: 1" = 5'

C2 TYPICAL SECTION
HORIZONATAL SCALE 1"=15'; VERTICAL SCALE: 1" = 5'

C3 TYPICAL SECTION
HORIZONATAL SCALE 1"=15'; VERTICAL SCALE: 1" = 5'
