North Rim Water System Improvements Pre-NEPA

Civic Engagement, June-July 2023

Grand Canyon National Park

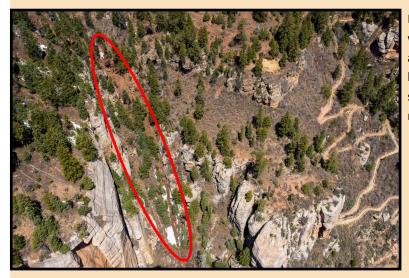
Right: Close-up view of broken North Rim waterline resulting from heavy snow in Winter 2022-23. (NPS Photo)

Left: Overhead view of a section of the North Rim waterline that was destroyed by rockslides resulting from high snow accumulation in Winter 2022-23. Several hundred feet of pipe was lost, requiring costly repairs in a hazardous environment. This section of waterline is surface mounted, and with the improvements would be placed in a borehole. (NPS Photo)

- The North Rim waterline is largely surface mounted in steep and rugged terrain, with only a few short sections installed underground.
- The waterline has exceeded its 50-year design life and requires an average of five repairs per year due to pipe failures such as failing joints, damage from falling rocks, and freezing.

- The North Rim waterline is susceptible to freezing because it is surface mounted and exposed; as such, the waterline is drained prior to winter to prevent freezing, and water is not pumped to the North Rim from approximately December-March. During this time, the North Rim must rely on water stored in the North Rim water tanks.

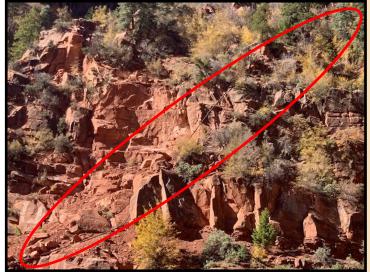
Left: Example of the North Rim waterline surface installed in steep, rugged terrain near Supai Tunnel. (NPS Photo)

Right: Example of the North Rim waterline surface installed in rugged, vertical terrain. (NPS Photo)
