# Replace Obsolete Seasonal Housing with Multiplex Housing and Amenities Environmental Assessment

October 2023

**US Department of the Interior  
National Park Service  
Mammoth Cave National Park**

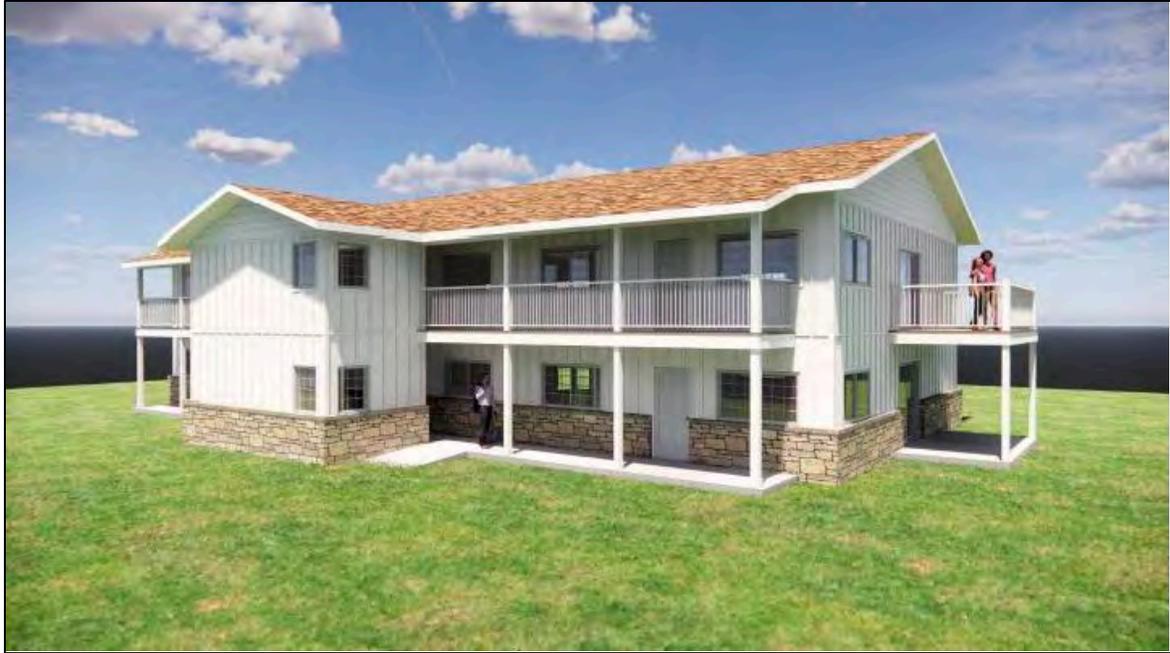
Figure 4. NPS Prototype #7 for seasonal housing unit replacement project.

The two proposed replacement units are based on NPS prototype #7, which is a two-story building with 12 bedrooms/baths for a total of 24 beds, solar panels on the roof of each building, an indoor gathering space, outdoor pavilion/gathering space, personal storage, and sufficient employee parking (Figures 4 and 5). The two-story building configuration, with 12 bedrooms/baths each, is equal to and more efficient than, the current level of seasonal housing and does not constitute an increase in bed count. All new lighting would be consistent and in compliance with maintaining the park's International Dark Sky certification.

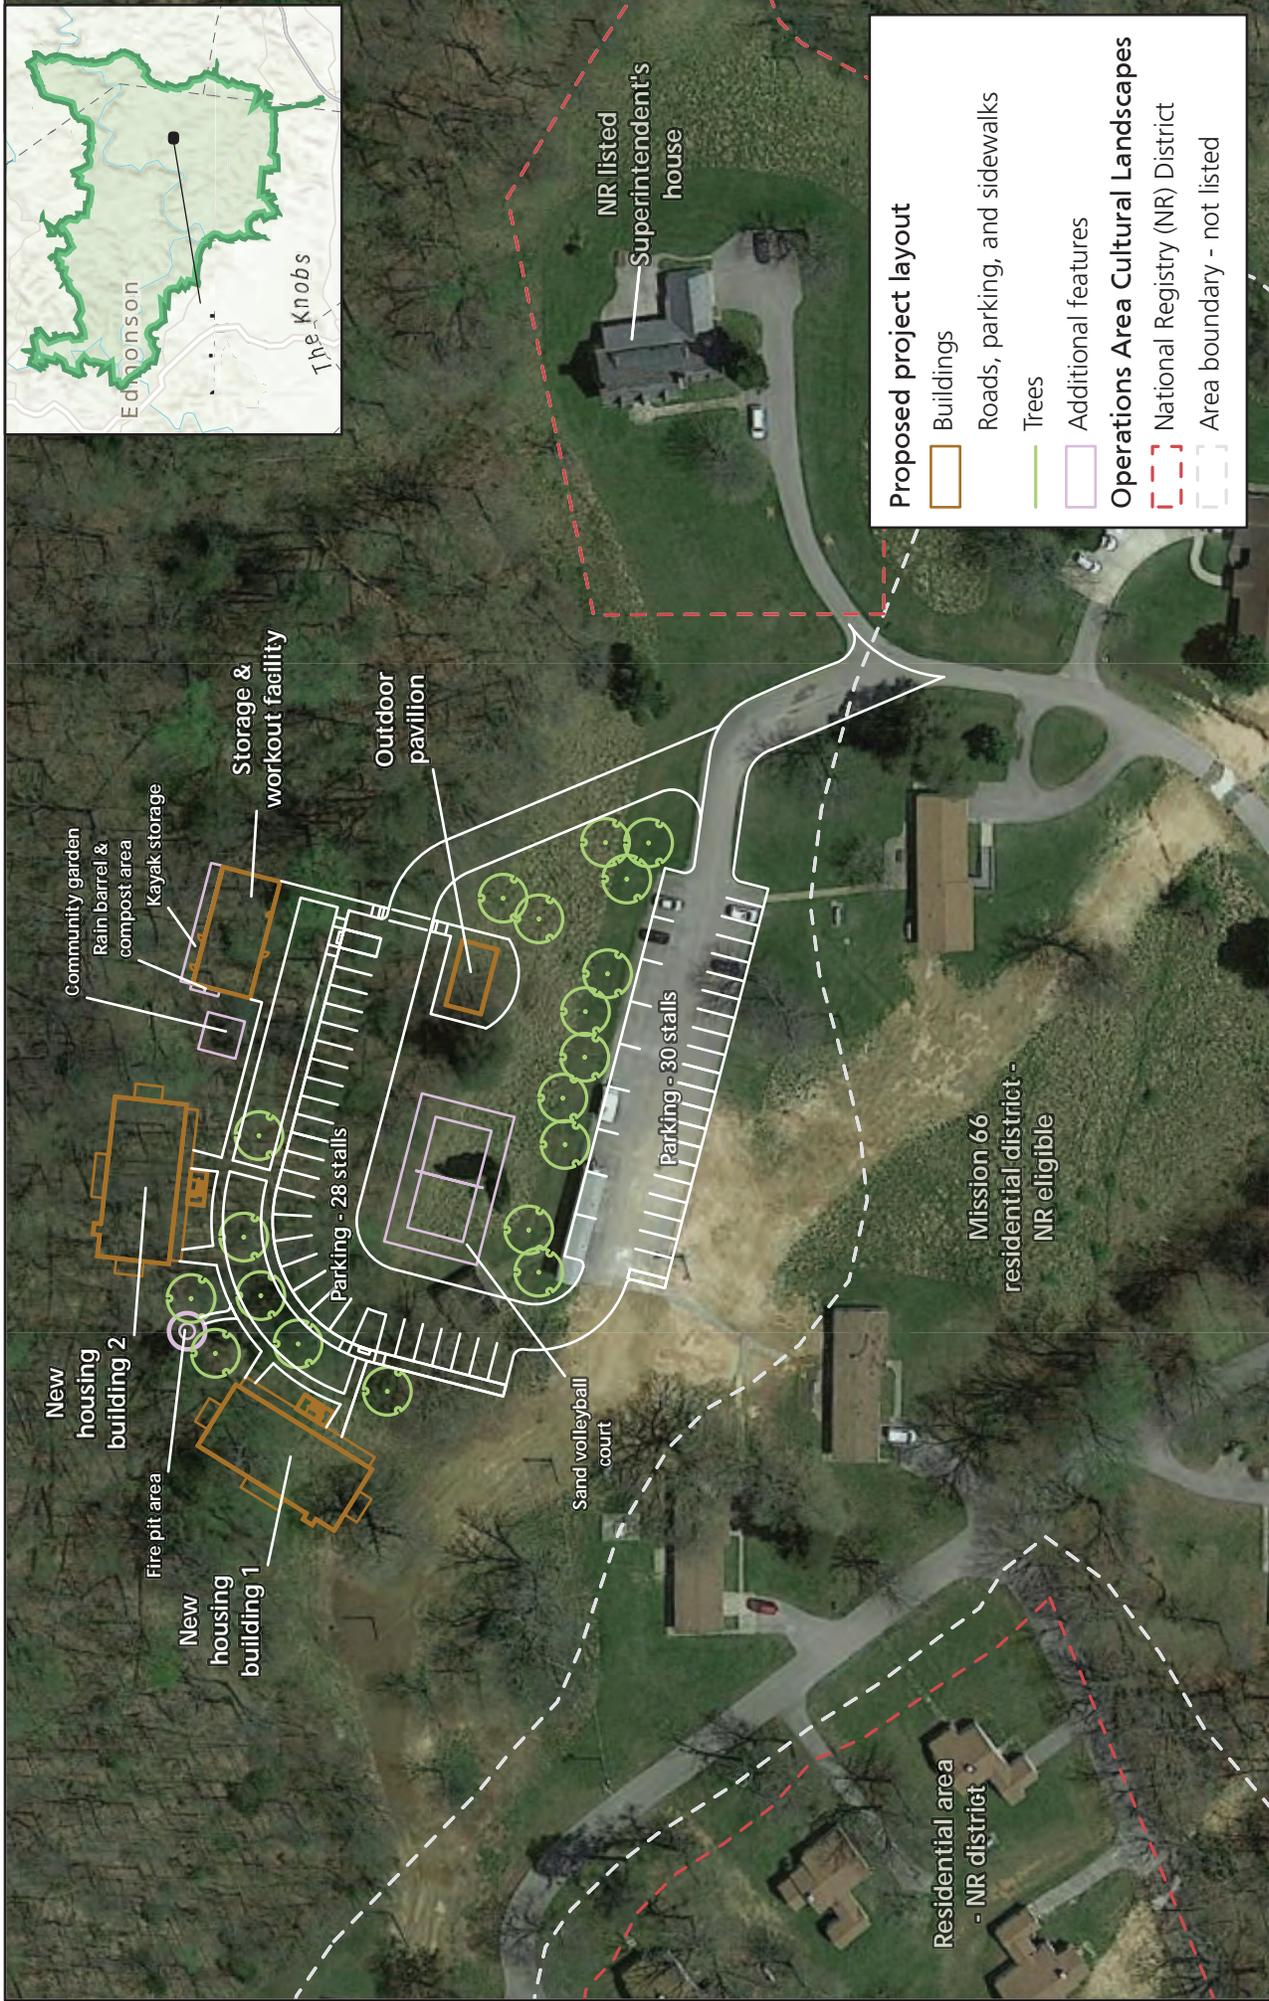
FIGURE 5: Spatial layout of proposed seasonal housing, loop road, and parking'

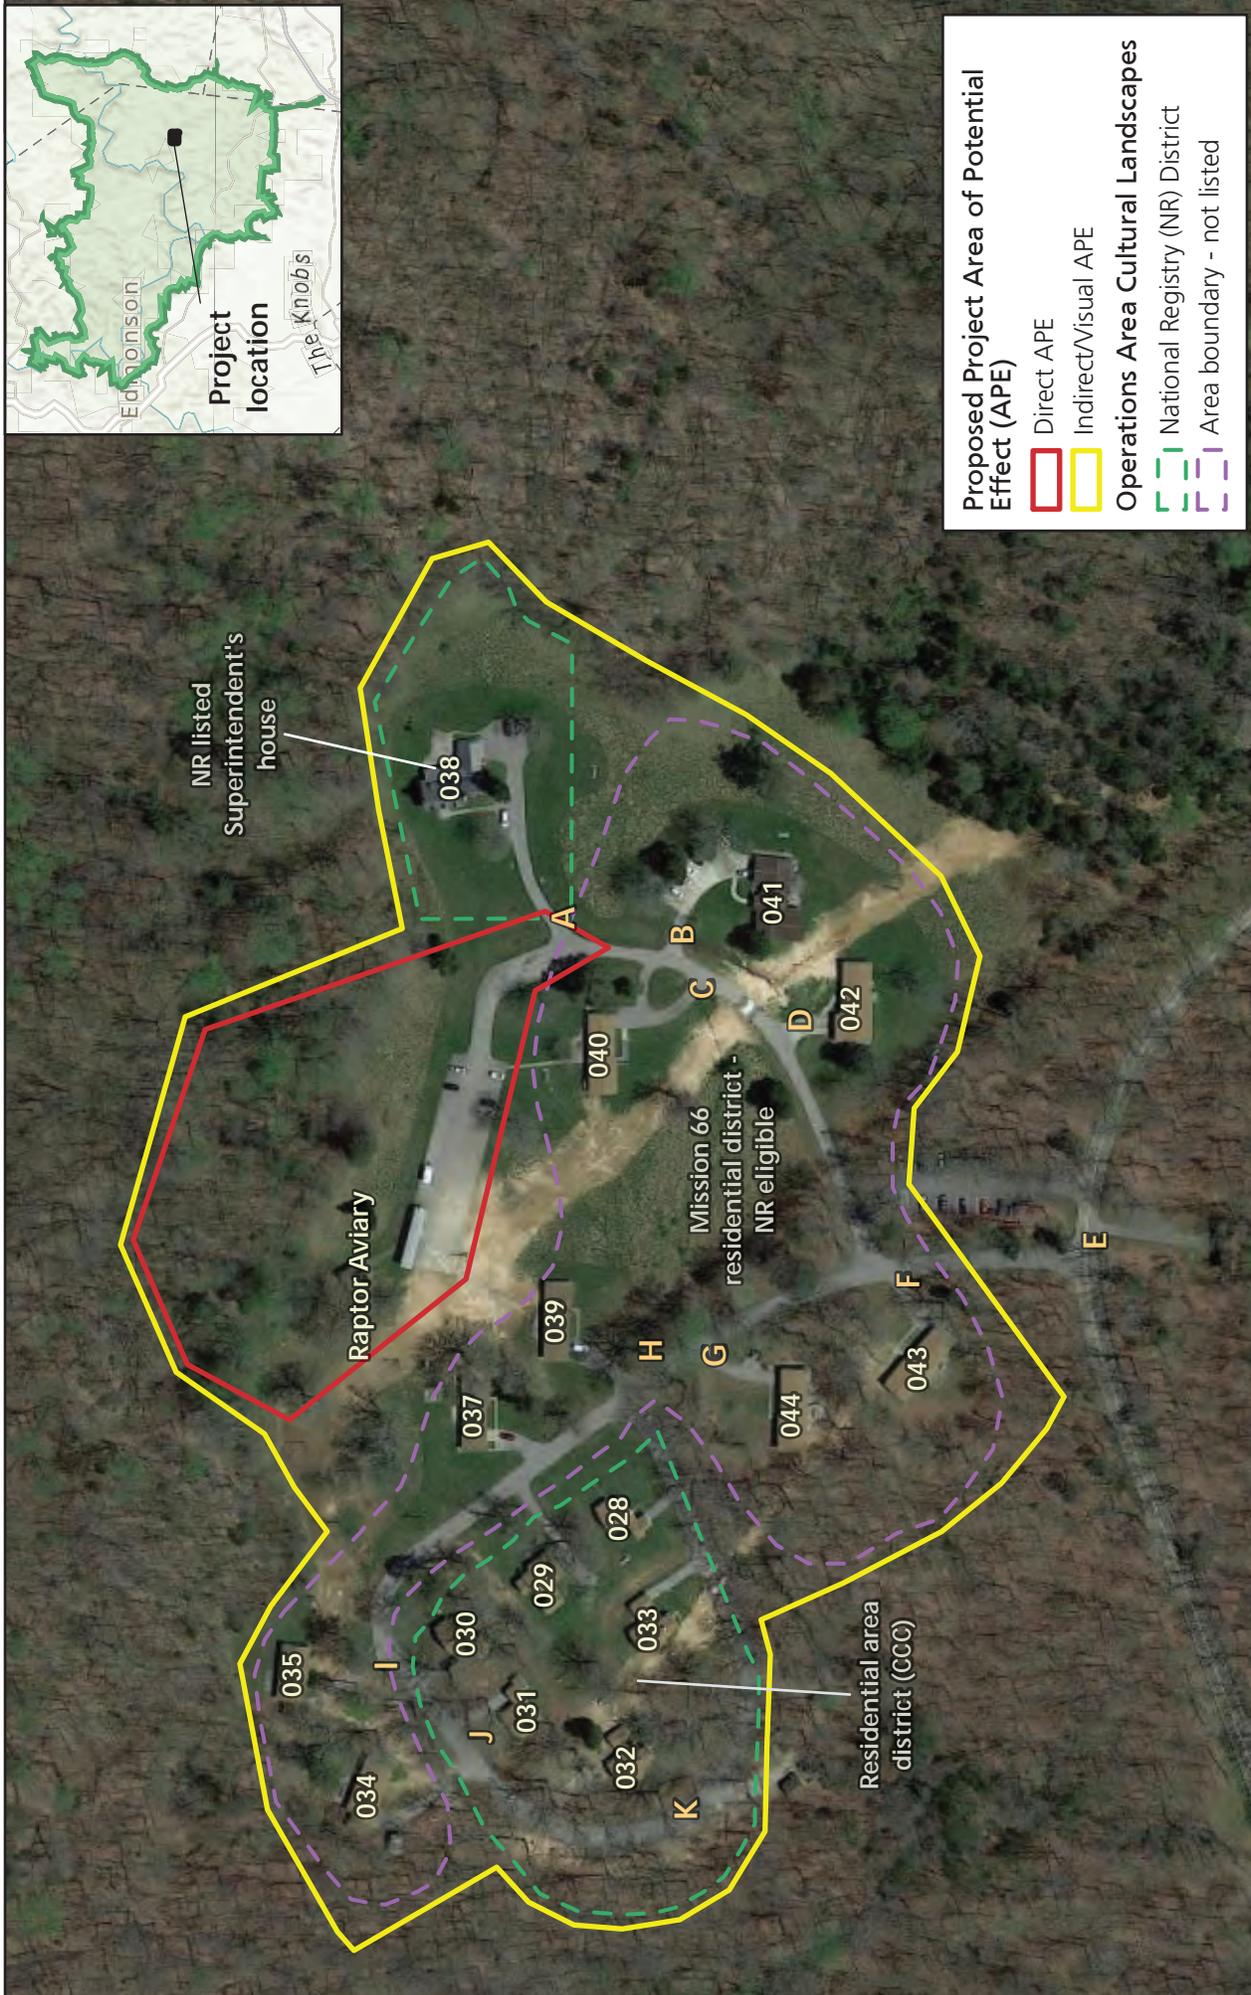
**Proposed Project Area of Potential Effect (APE)**

- Direct APE
- Indirect/Visual APE

**Archeological Resources.** Some ground disturbance would be required for the proposed action, therefore potential archeological resources were considered within the direct APE (Figure 6). A 2002 archaeological survey covered much of the area to the south of the proposed location (Loughlin, 2002). For the 2002 survey, a 25-acre parcel used for park housing was systematically investigated. No sites were identified, and no further work was recommended. A review of the records with the Kentucky Heritage Council State Historic Preservation Office (KYSHPO) and from Mammoth Cave did not identify any other previously recorded sites within the proposed footprint.

residential area and is inclusive to the area of potential ground disturbance (Figure 6). The visual or indirect APE also includes the larger living quarter’s district, which is a mix of Mission 66-era and CCC-era residential houses, along with the CCC era Superintendent’s House (Figure 6). With regards to the built environment, there remains one temporary structure within the APE (aviary) that will be removed. In addition, 16 buildings that comprise the Administration and Housing component of the Operations Area cultural landscape are found within the indirect or visual APE (Figure 6). Six of these are contributing to the CCC-constructed Residential Area, which is on the NRHP. The Superintendent’s House is individually listed on the NRHP.

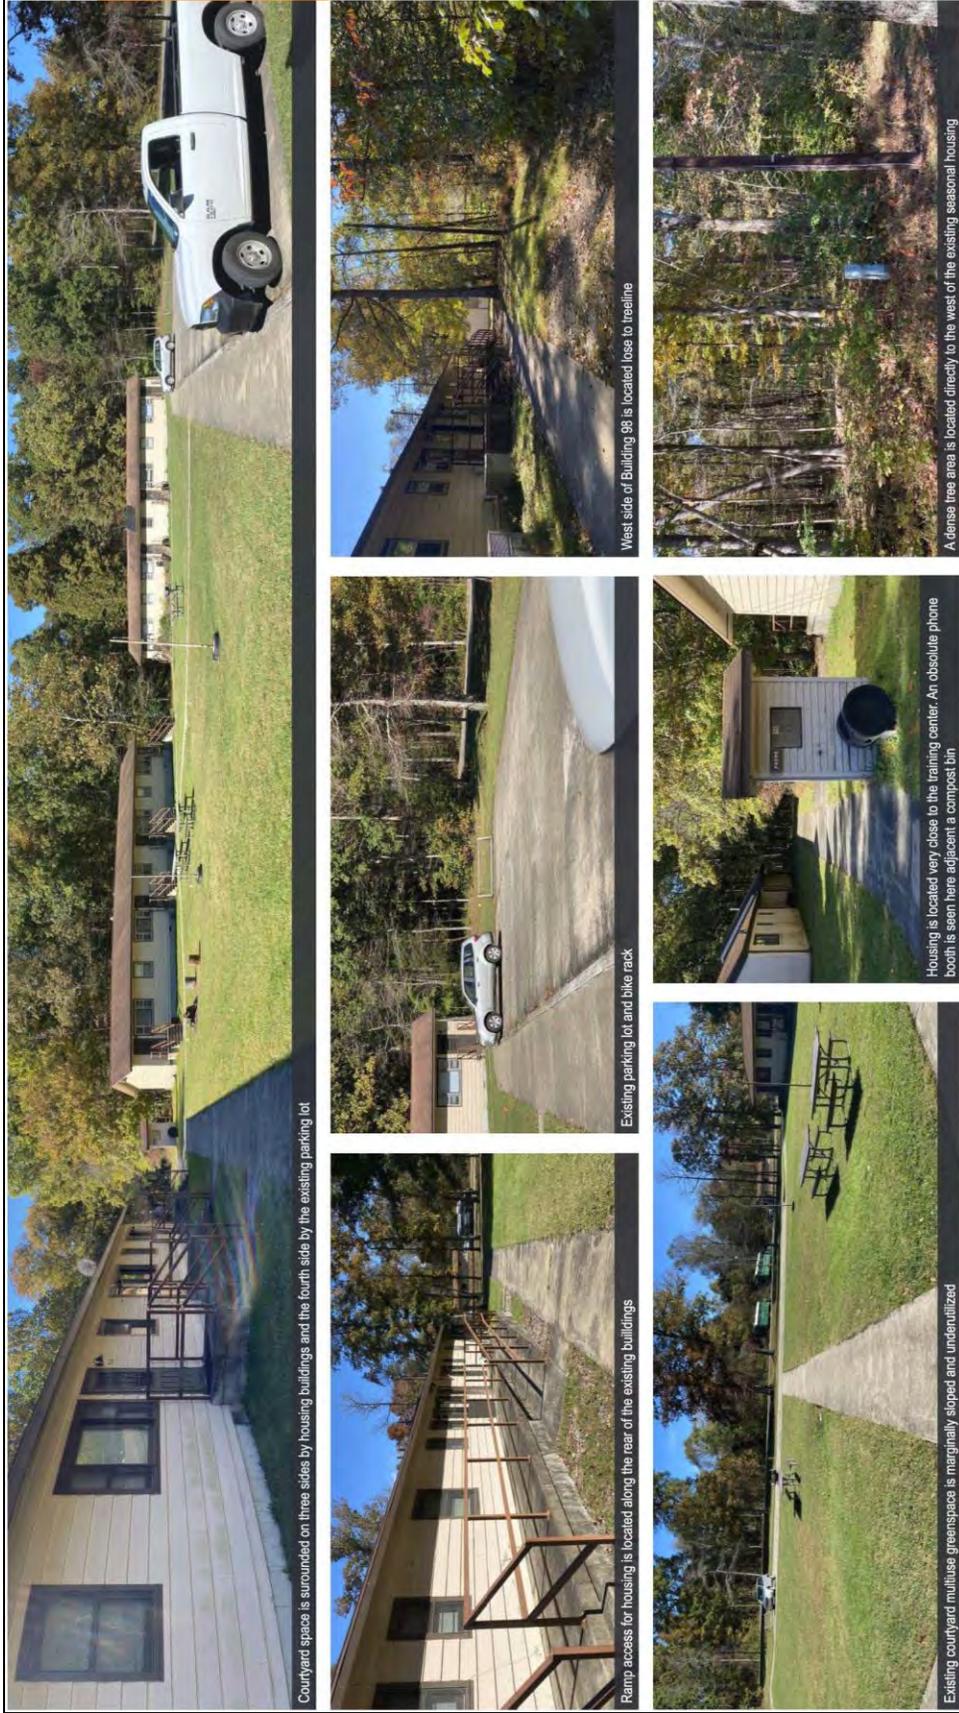
Figure 8. Character of existing seasonal housing area (No Action Alternative).

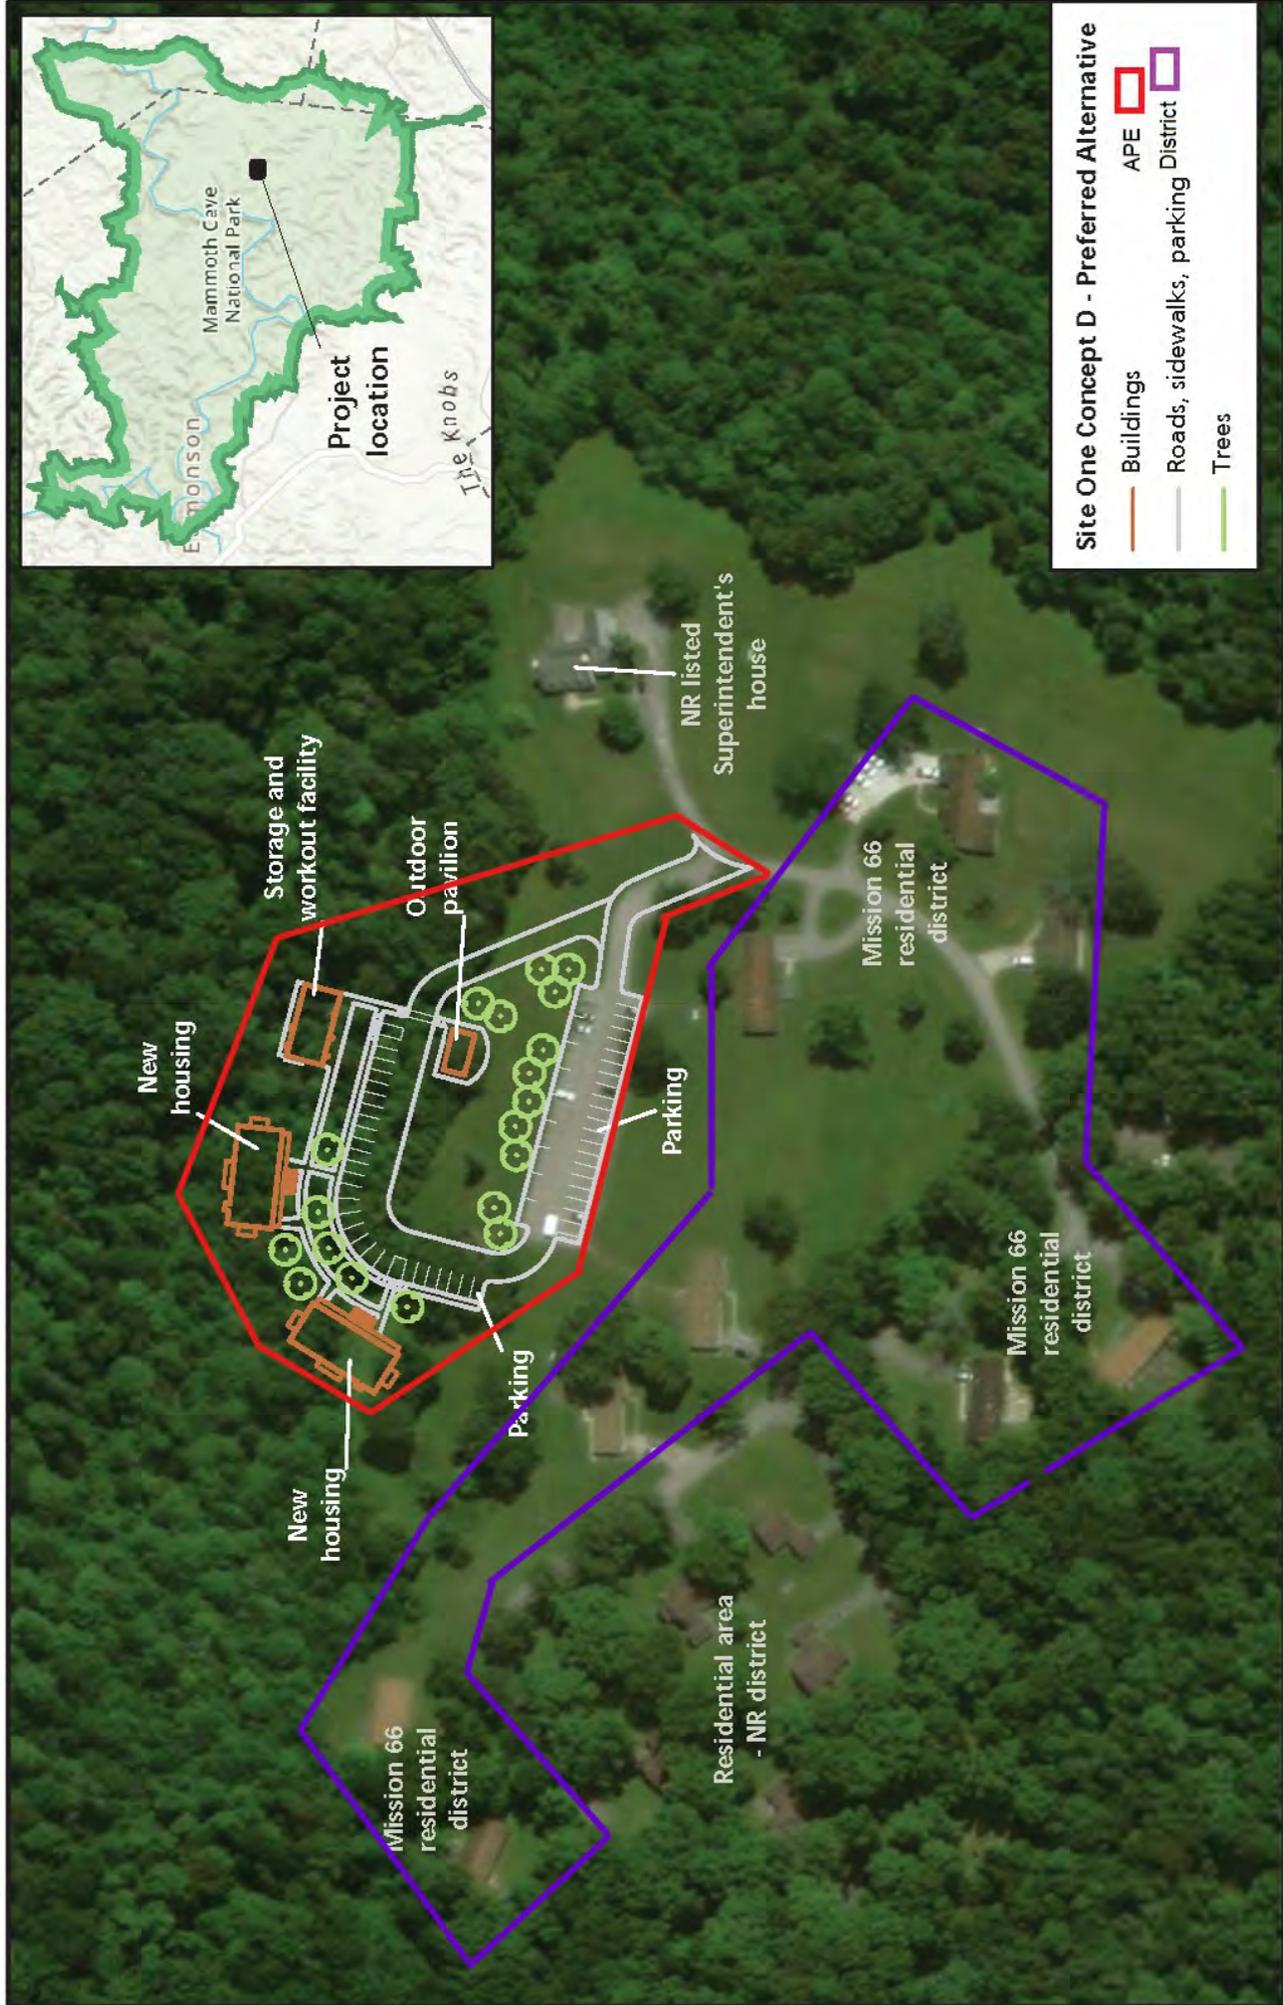
Figure 3. Seasonal Housing Unit Replacement Environmental Assessment/Assessment of Effects  
 Project Layout and Area of Potential Effect

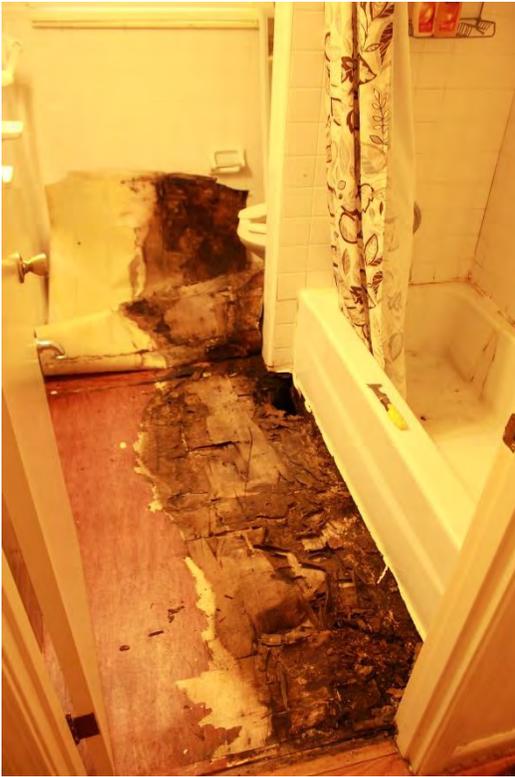
**Caption: ED 217\_7, Building 34, bathroom floor is close to complete deterioration and unsafe**

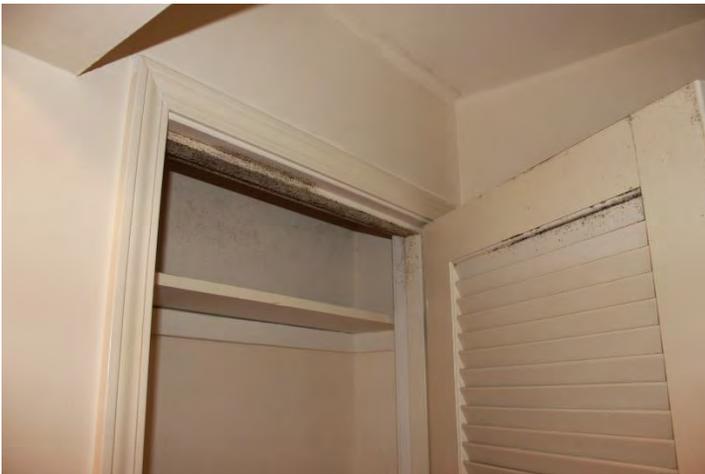
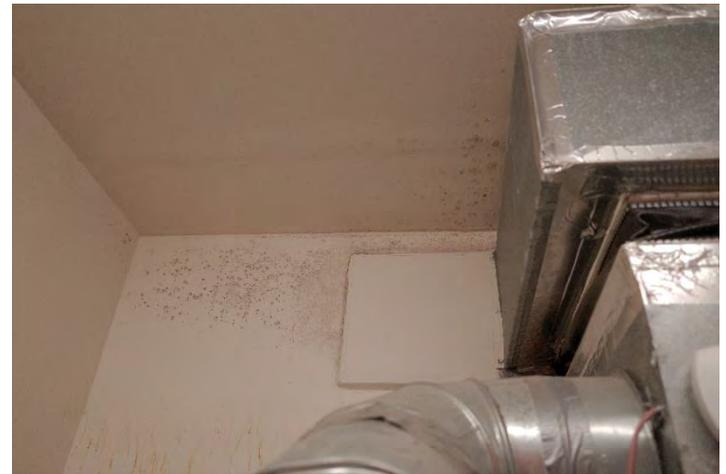
**Caption: ED 217\_8, Building 34, mold is present in nearly every room and in closets and storage areas**

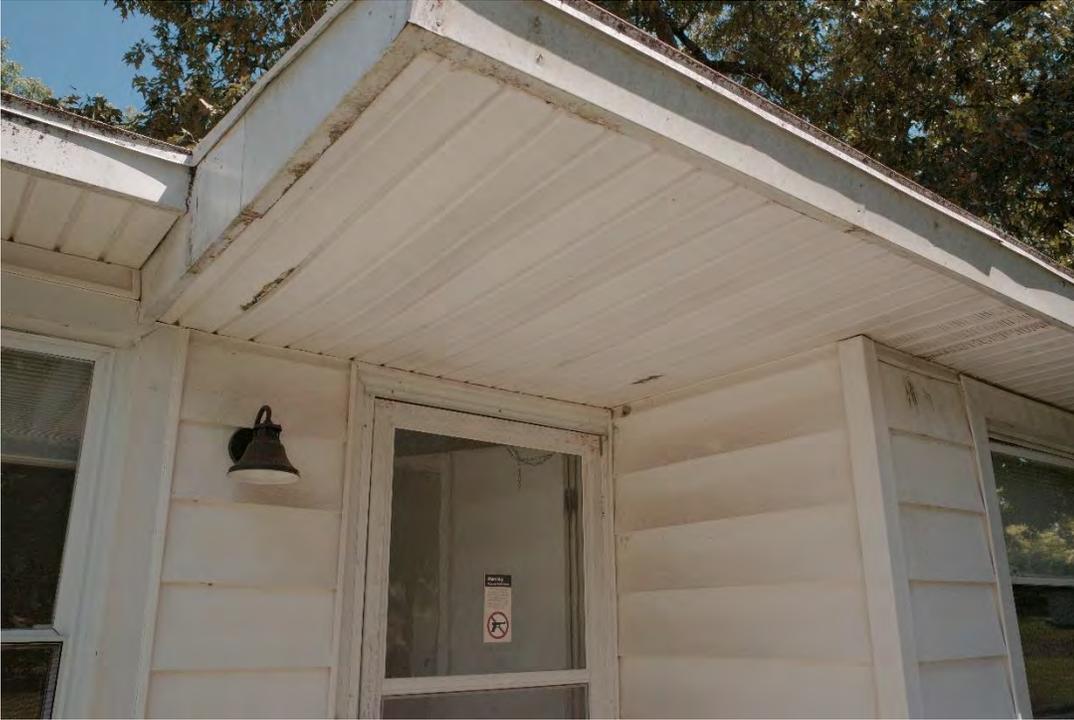
**Caption: ED 219\_5, Building 37, Doorway awning is deteriorated and sagging**

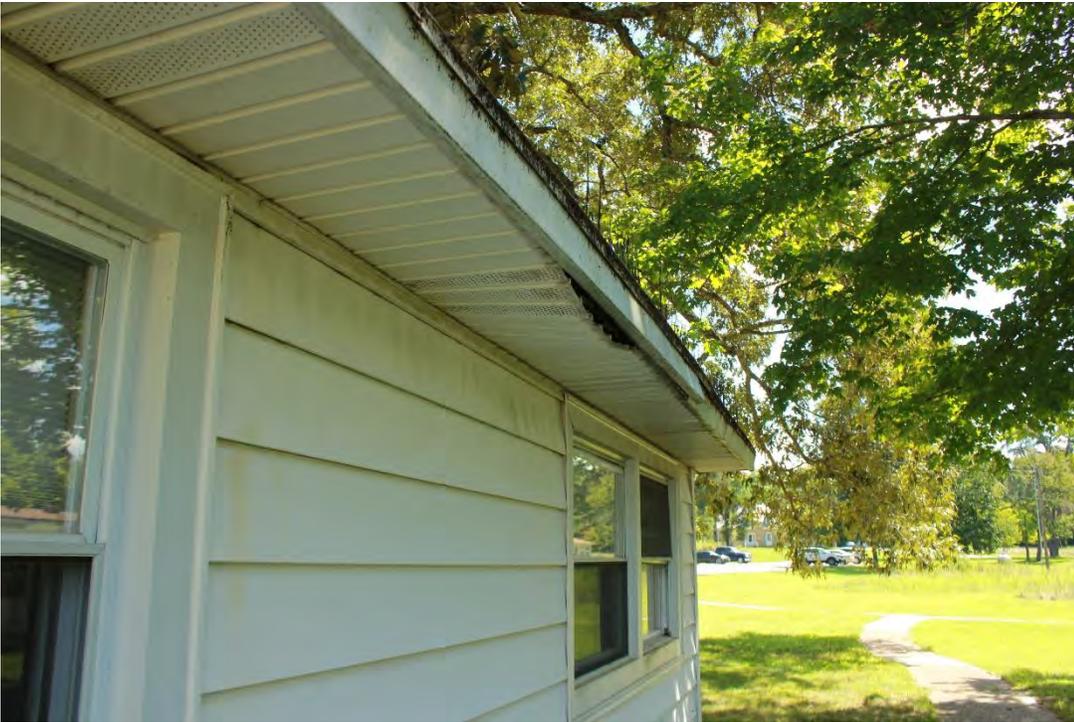
**Caption: ED 219\_4, Building 37, Soffits are collapsing in multiple places from the eaves and fascia is deteriorated**

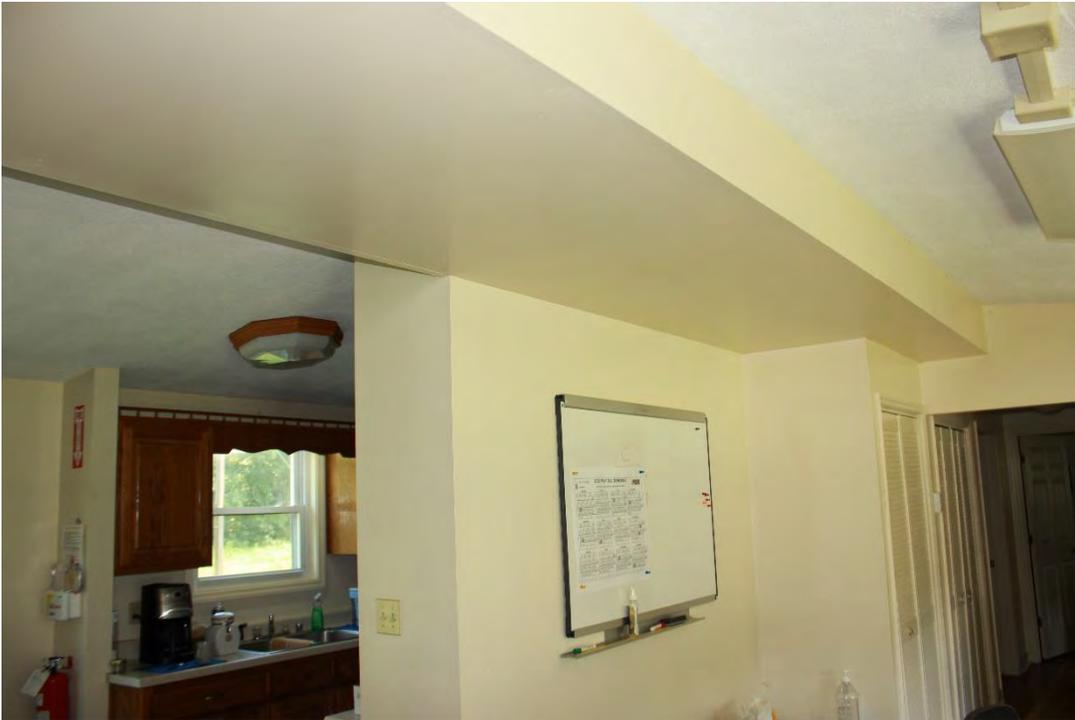
Caption: ED 219\_7, Building 37, Central rafter beam is covered and ceiling dropped to house ductwork

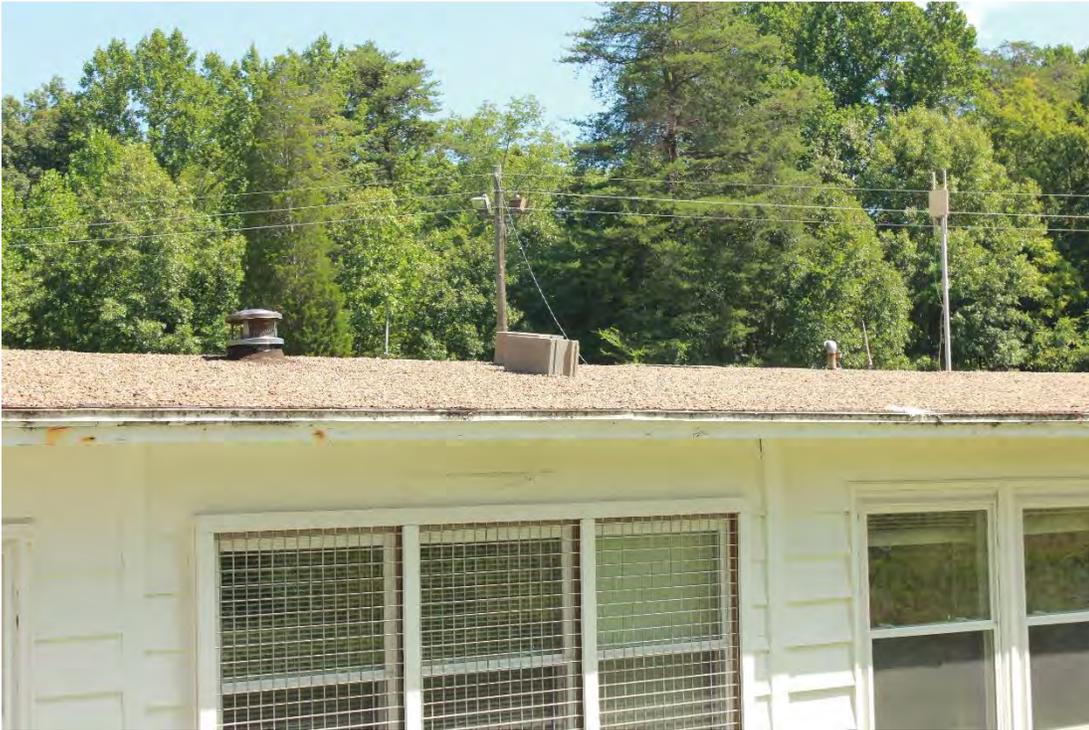
**Caption: ED 220\_5, Building 39, Built up roof, showing signs of failure and blocks holding down loose tar paper**

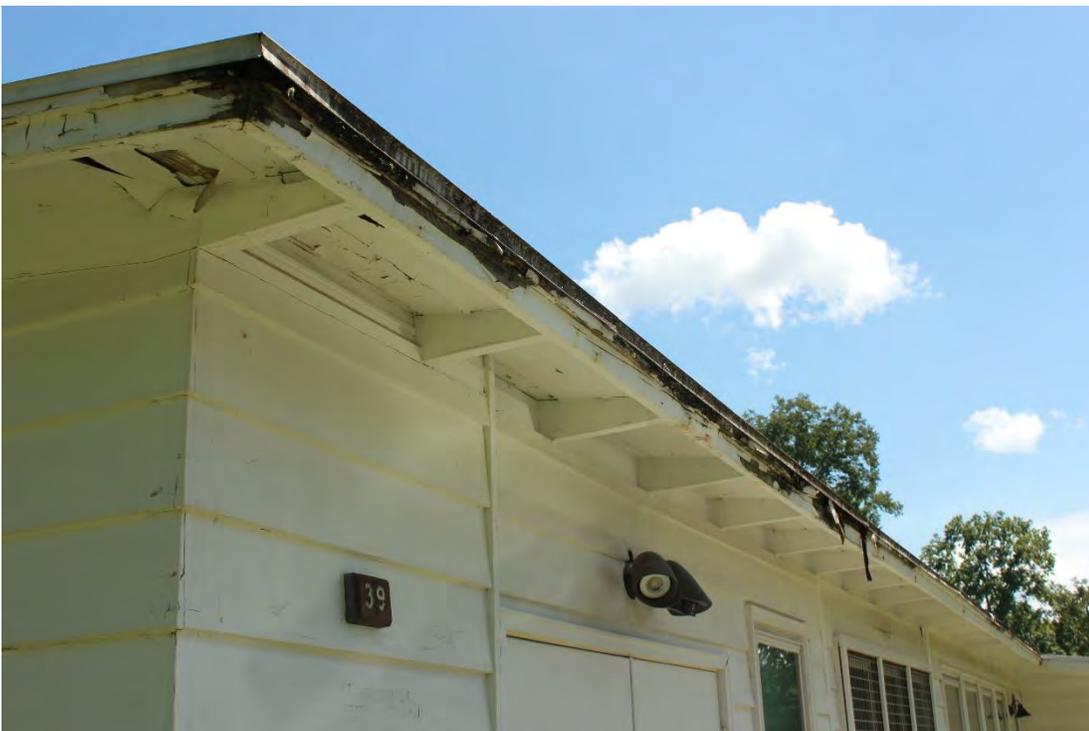
**Caption: ED 220\_6, Building 39, Fascia boards, showing severe deterioration due to no gutters in original design**

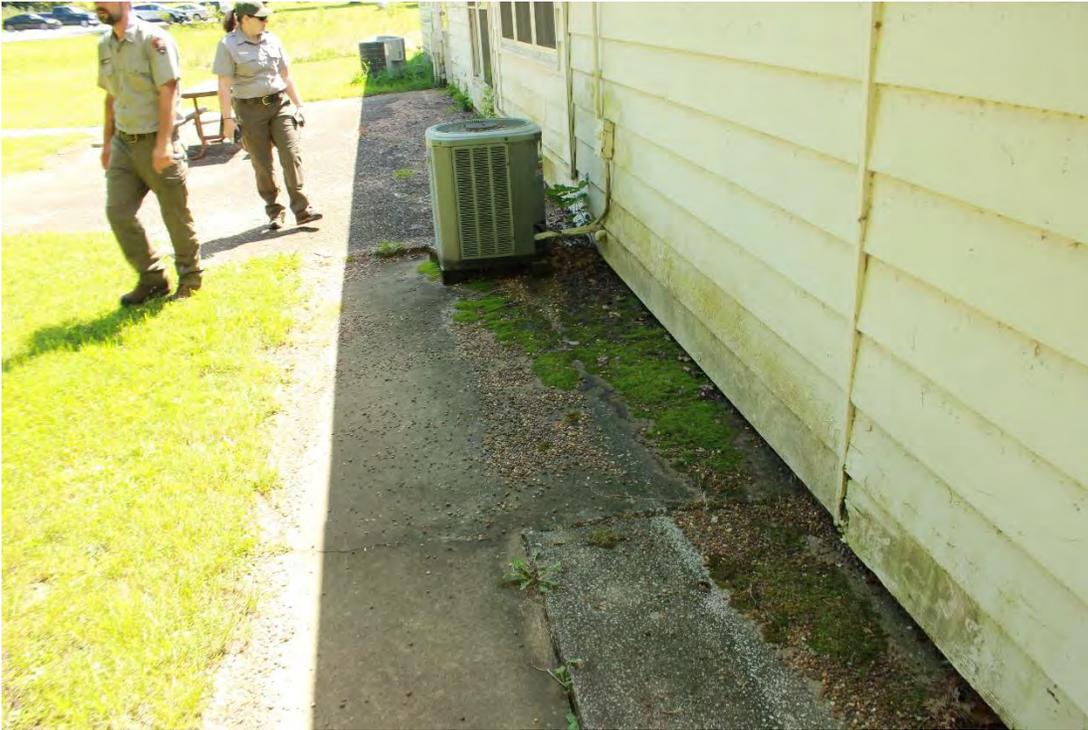
Caption: ED 220\_7, Building 39, Washed out gravel accumulating below eaves of built up roof

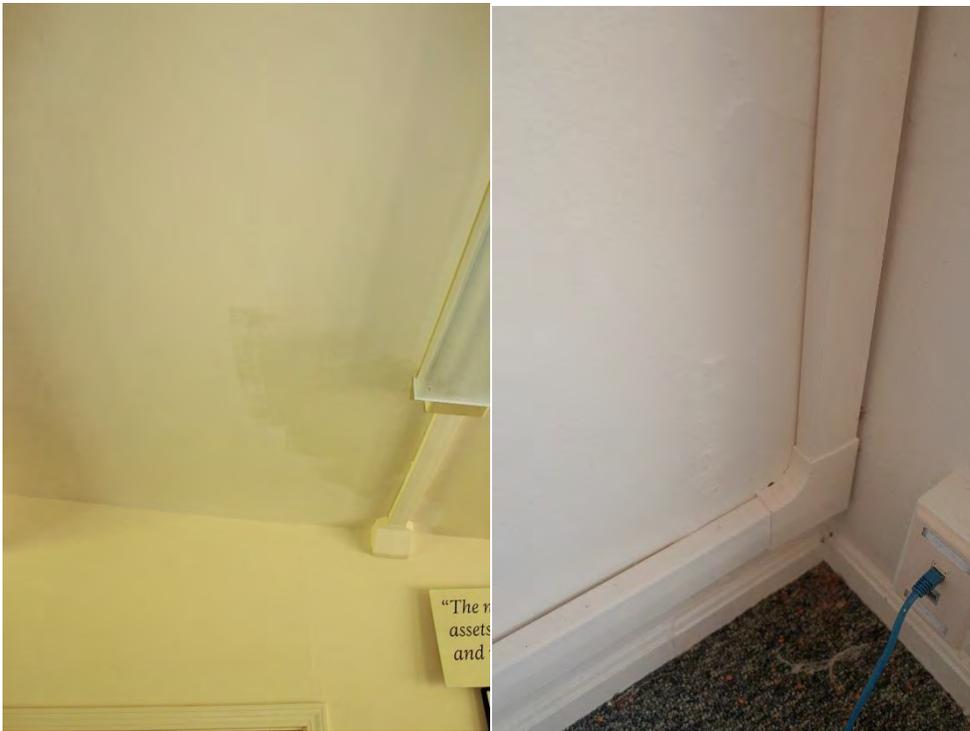
Caption: ED 220\_8, Building 39, Samples of water damage on the ceiling and walls, evident in over 12 locations in the building

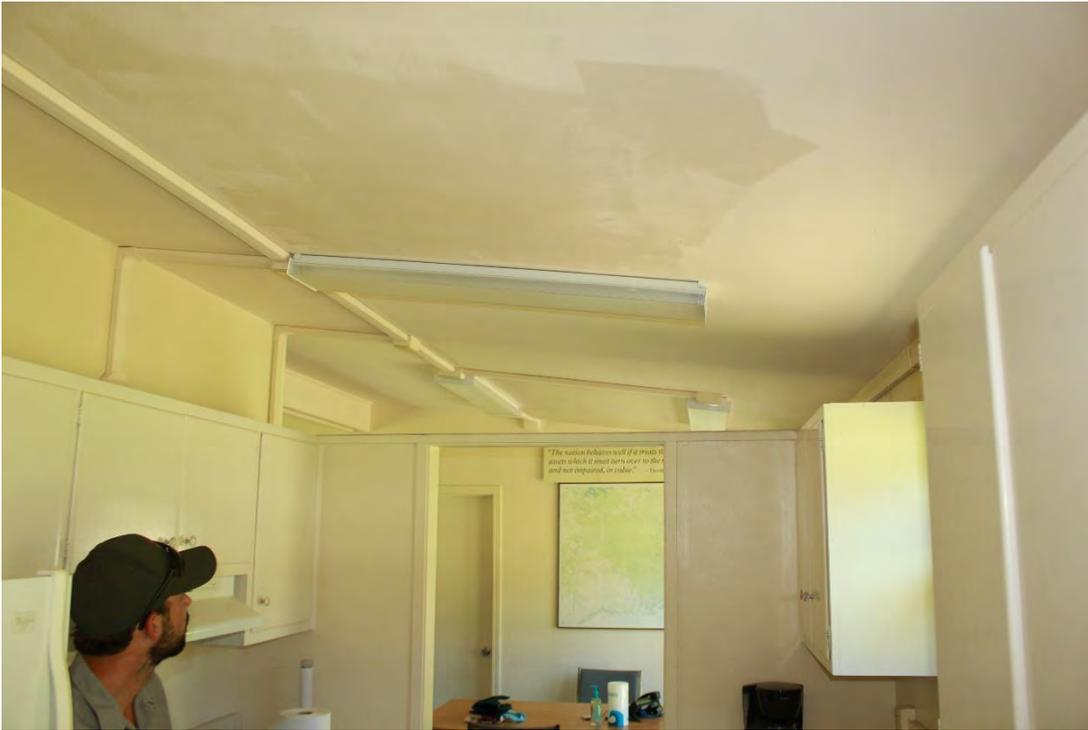
Caption: ED 220\_9, Building 39, Water damage in the ceiling, repaired and continuing to fail

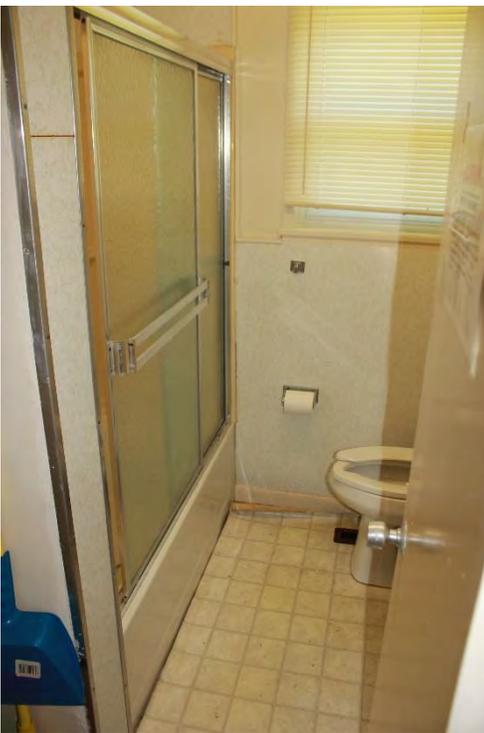
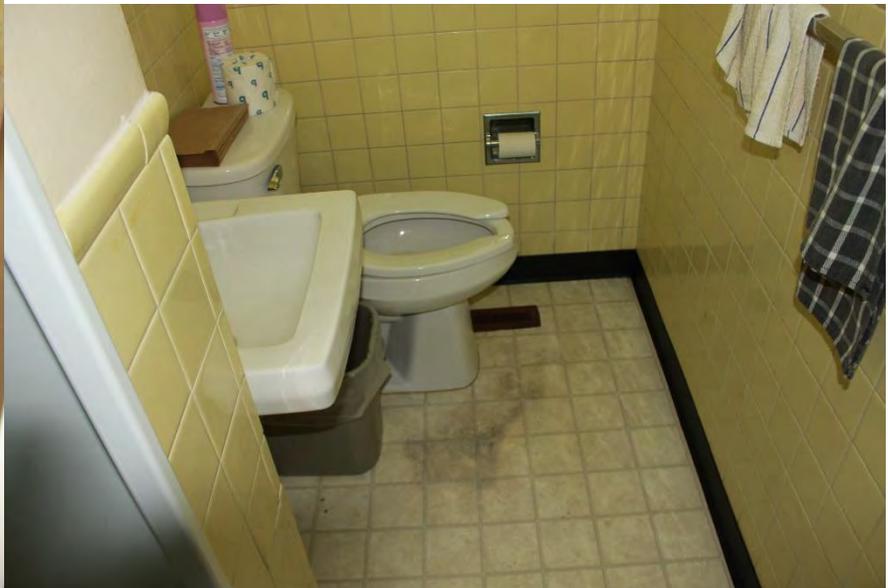
Caption: ED 220\_10, Building 39, Bathroom floors that are rotted and creating mold conditions

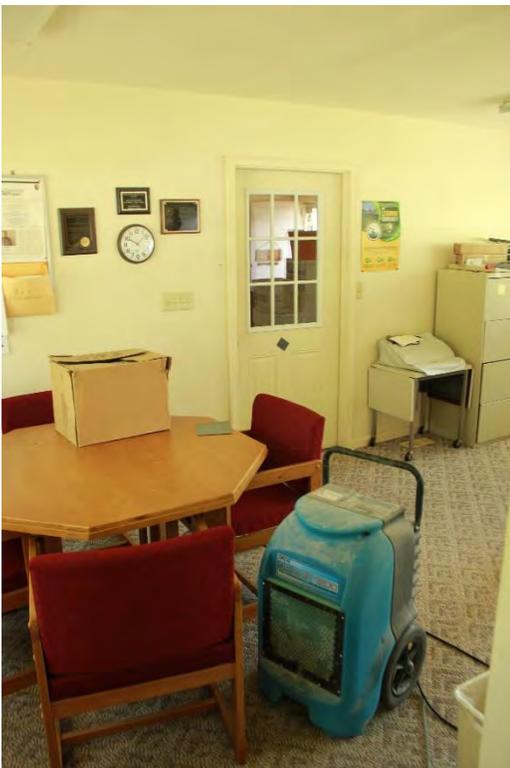
Caption: ED 221\_8, Building 40, Interior showing dehumidifier running perpetually in the building

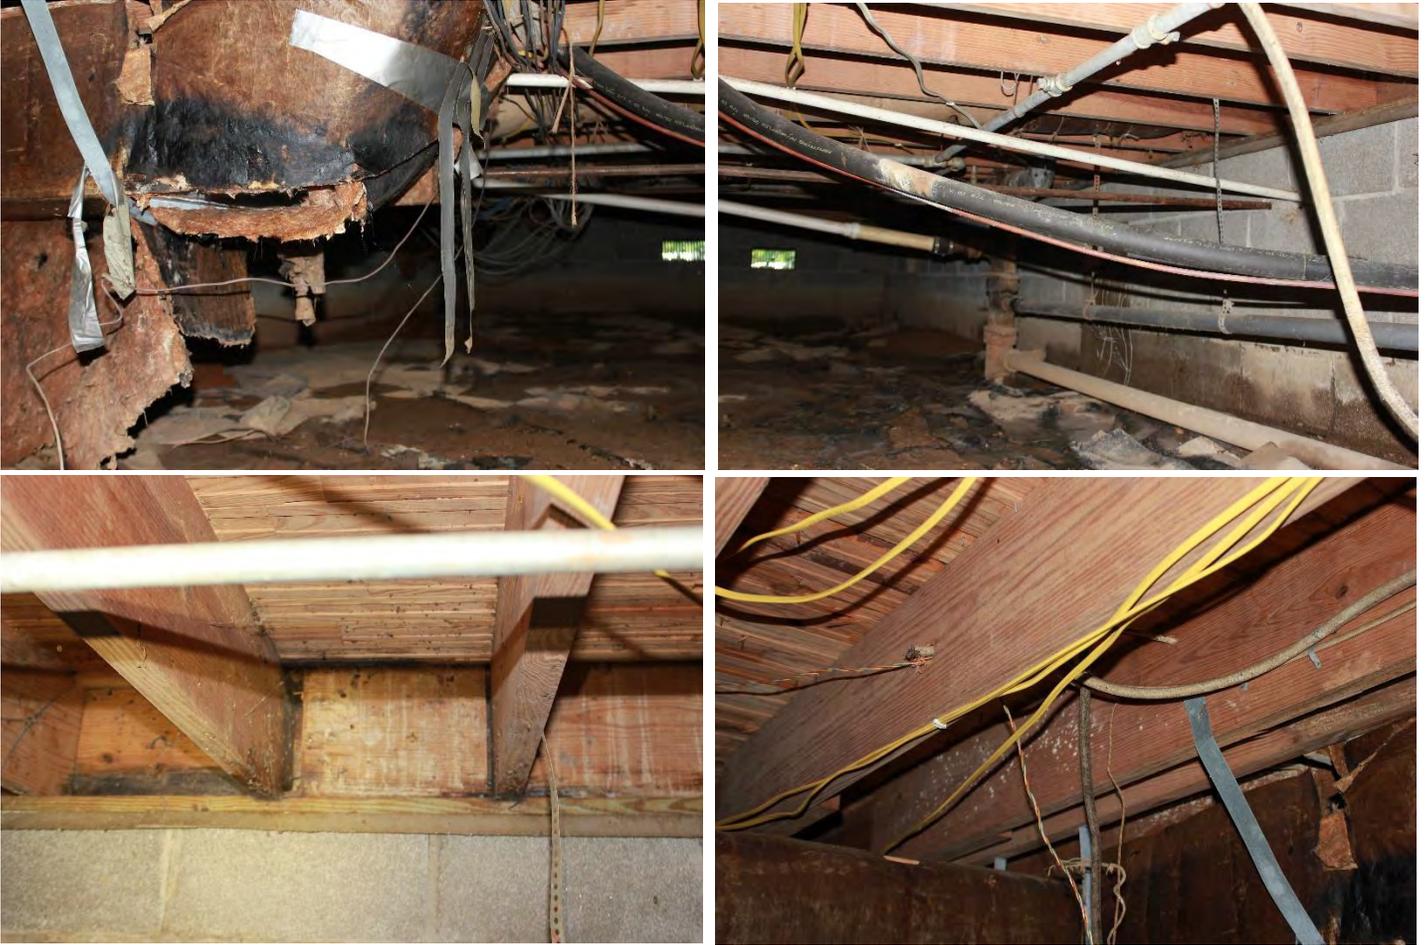
Caption: ED 221\_9, Building 40, Collage of images from the crawl space, showing mold and moisture damage throughout

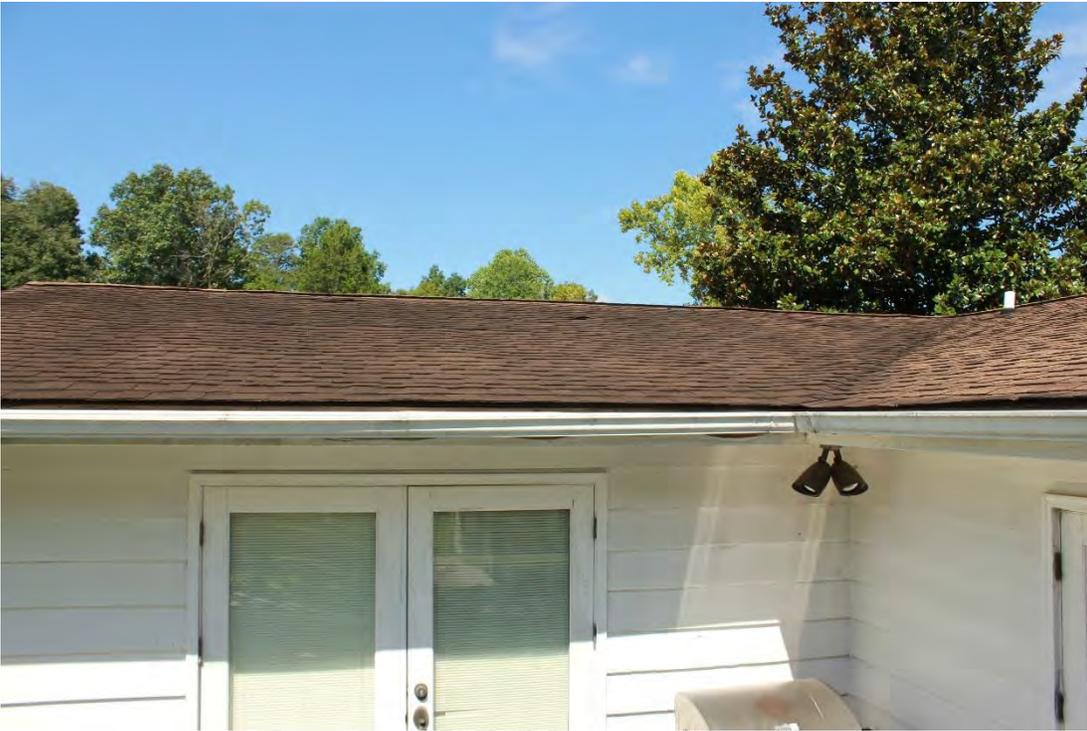
Caption: ED 222\_5, Building 41, Roof line above addition, showing uneven and wavy surface with shingles coming loose.

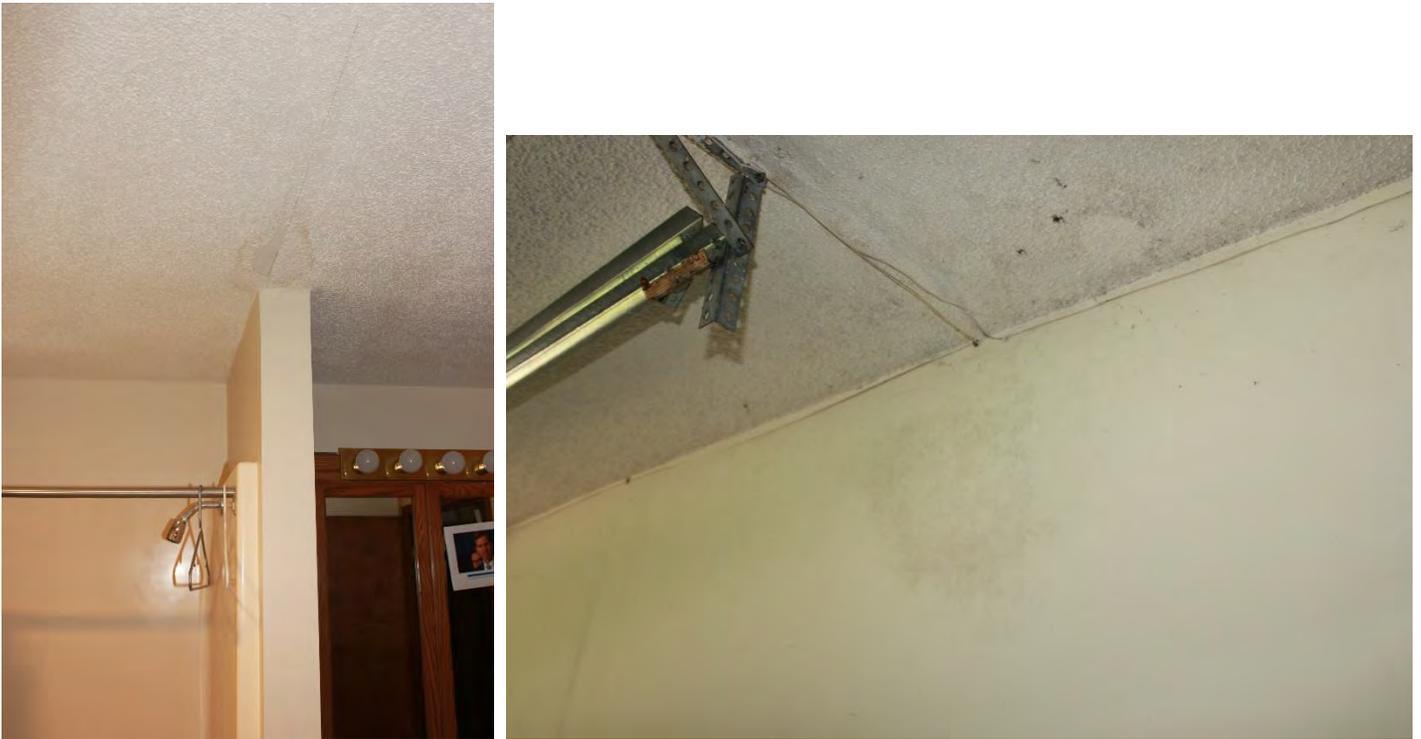
**Caption: Ed 223\_5, Building 42, Water damage and cracking in the ceiling and wall**
