# Replace Obsolete Seasonal Housing with Multiplex Housing and Amenities Environmental Assessment

October 2023

**US Department of the Interior  
National Park Service  
Mammoth Cave National Park**

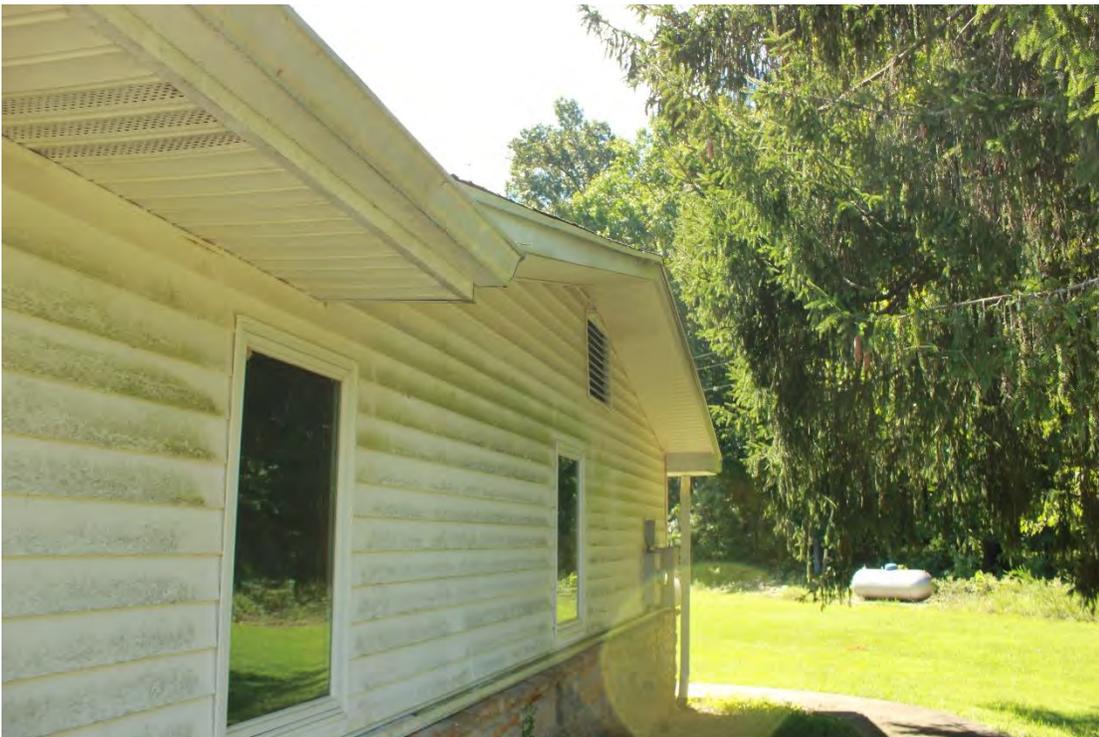
**Caption: Ed 223\_6, Building 42, Roof line sagging, showing signs of severe deterioration from moisture**

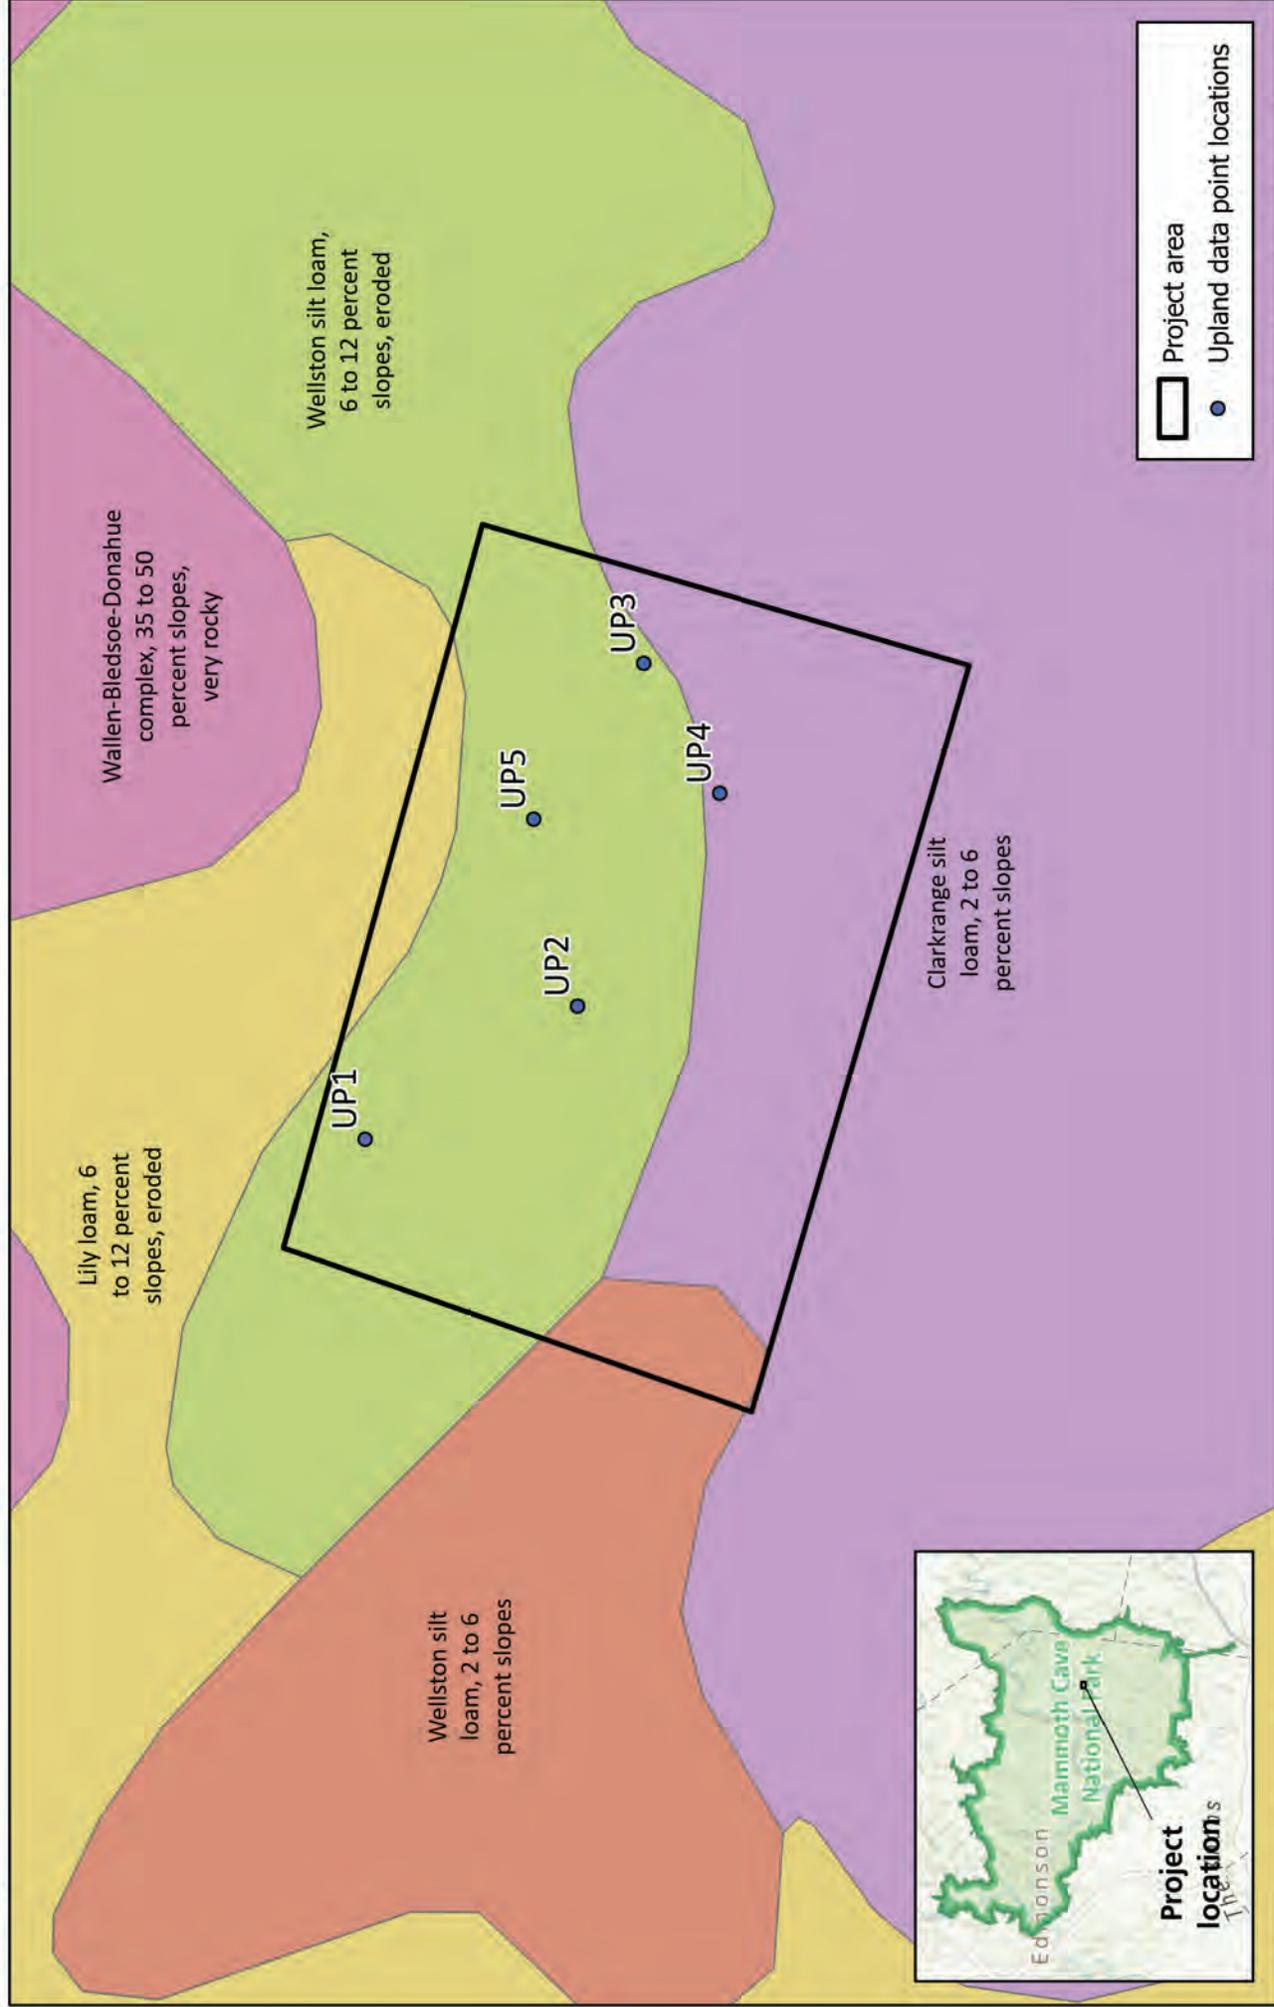
FIGURE 4: NRCS soil map, Mammoth Cave Area of Investigation for proposed new seasonal housing unit.
