# **Wetland Delineation Report: Blackstone Minerals B-2 Re-Entry Project**

December 31, 2008  
Revised May 28, 2009

Endeavor Natural Gas, LP

Project No. 0092408

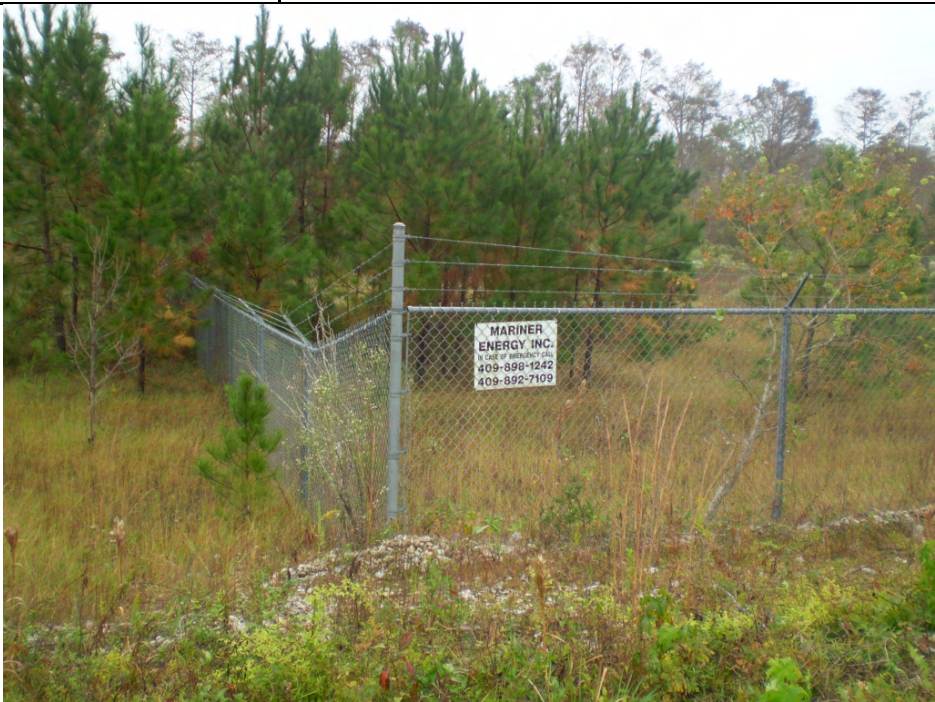
<b>Client:</b>	<b>Endeavor</b>	<b>Project Number:</b>	<b>0092408</b>
<b>Project Name:</b>	<b>B-2 Well Re-entry</b>	<b>Location:</b>	<b>Hardin County, Texas</b>
<b>Photograph ID:</b> PB130001

<b>Feature:</b> Upland Site			
<b>Date:</b> 11/13/2008			
<b>Comments:</b> Northeast corner of the fence surrounding the Site. Photo taken facing south into Site.			
<b>Photograph ID:</b> PB130002

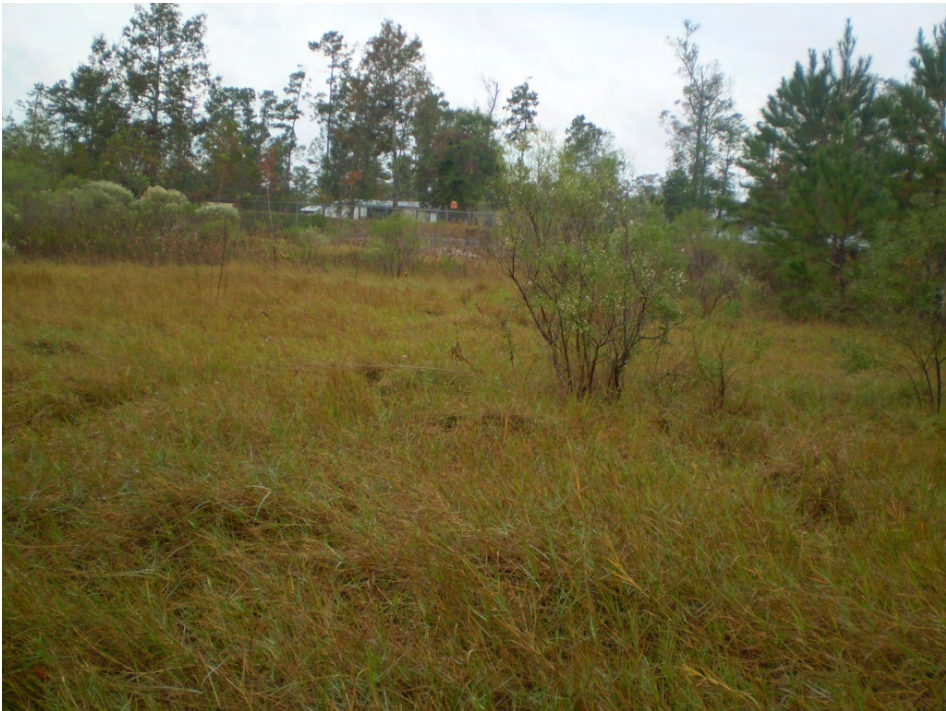
<b>Feature:</b> Upland Site			
<b>Date:</b> 11/13/2008			
<b>Comments:</b> Photo taken from the southeast corner of the Site facing north into the Site.

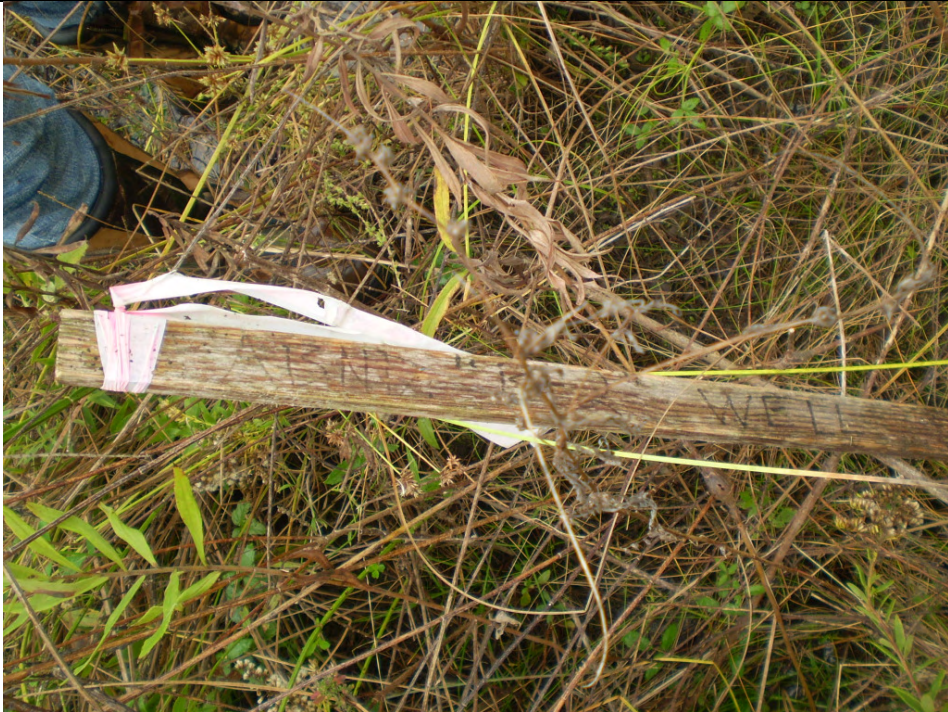
<b>Feature:</b> Stake 1			
<b>Date:</b> 11/13/2008			
<b>Comments:</b> Picture of a knocked over stake within the Site. Stake has "ABND B-2 WELL" written on it.			
<b>Photograph ID:</b> PB130004

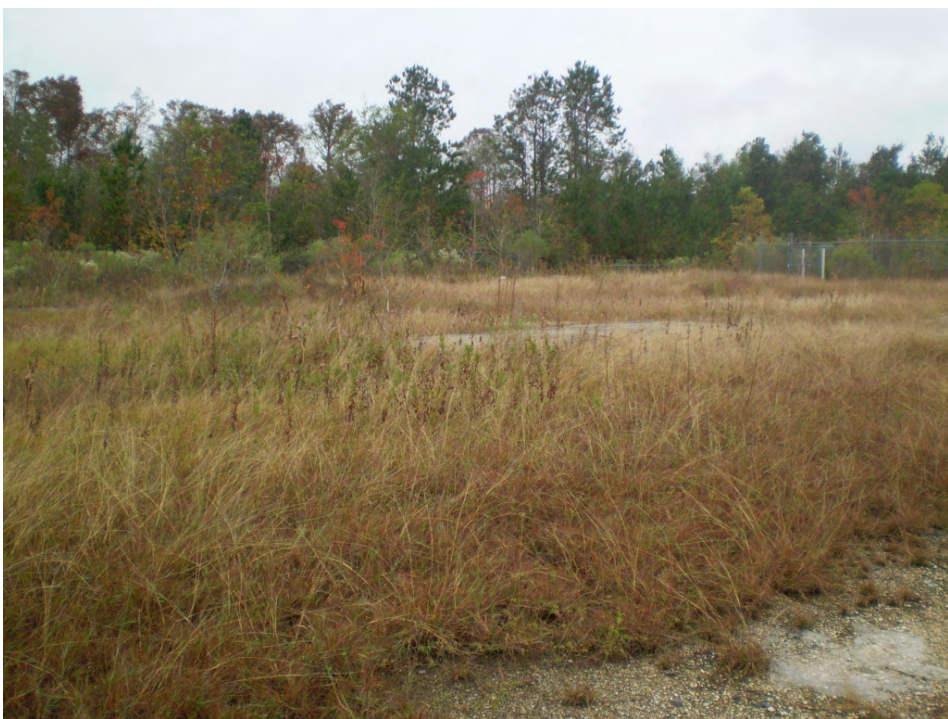
<b>Feature:</b> Upland Site			
<b>Date:</b> 11/13/2008			
<b>Comments:</b> Photo showing the general condition of the Site. Photo taken facing southwest.

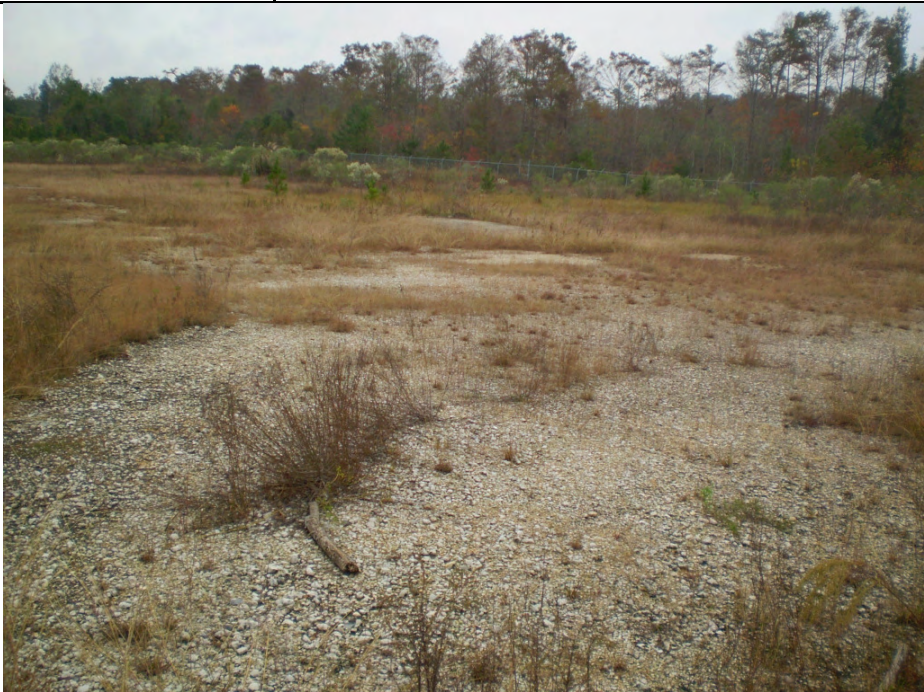
<b>Client:</b>	Endeavor	<b>Project Number:</b>	0092408
<b>Project Name:</b>	B-2 Well Re-entry	<b>Location:</b>	Hardin County, Texas
<b>Photograph ID:</b> PB130005

<b>Feature:</b> Upland Site			
<b>Date:</b> 11/13/2008			
<b>Comments:</b> Photo taken from the northwest corner of the Site facing southeast into the Site.			
<b>Photograph ID:</b> PB130006

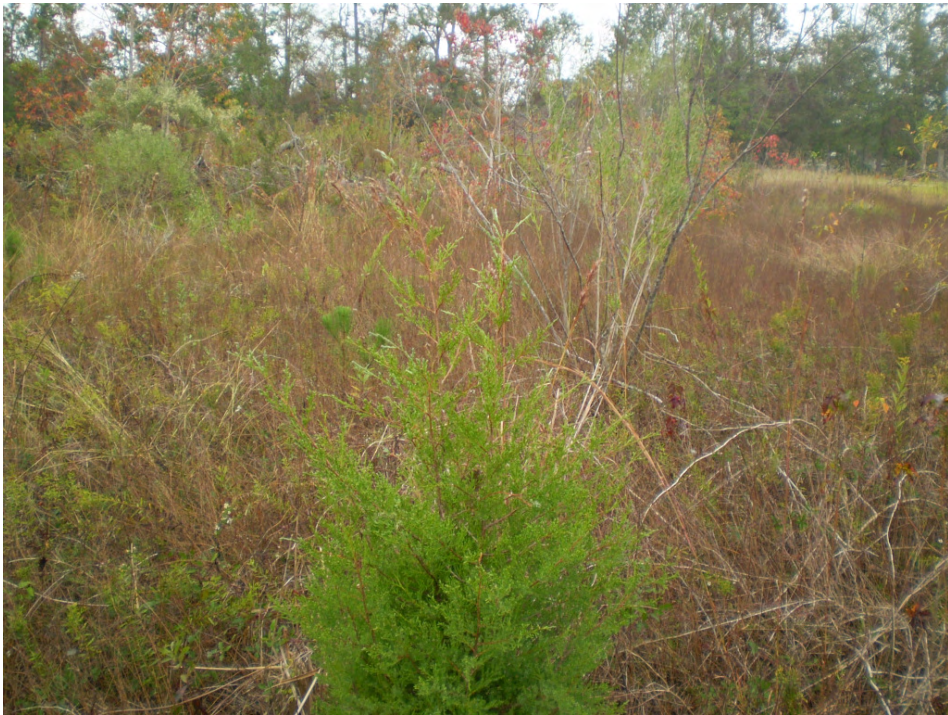
<b>Feature:</b> Upland Site			
<b>Date:</b> 11/13/2008			
<b>Comments:</b> Photo of the vegetation located to the west of the Site. Photo taken facing northwest outside of the Site to the adjacent habitat.

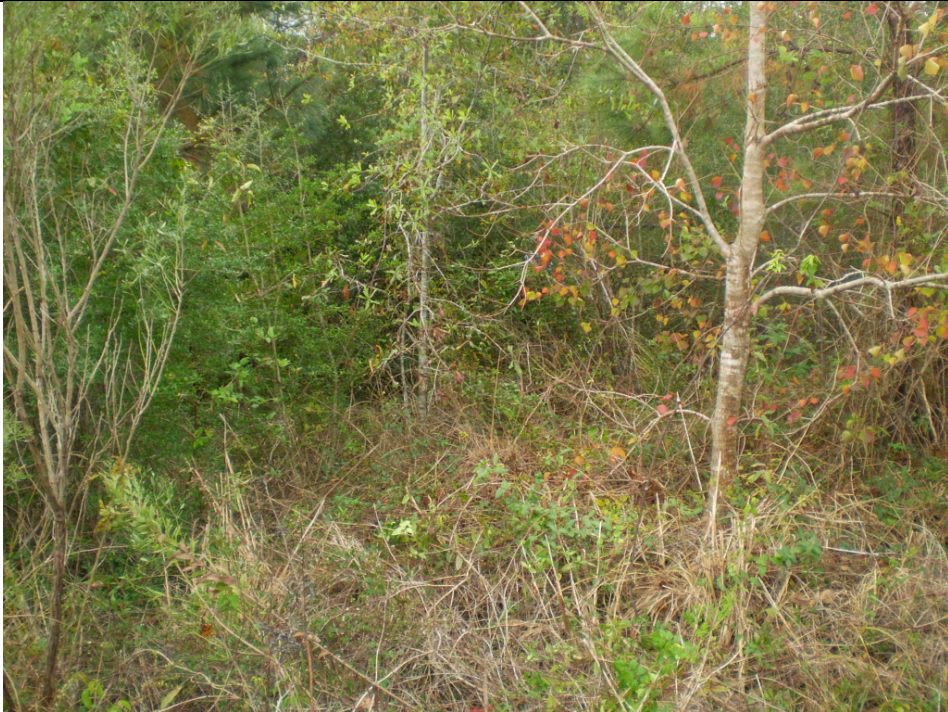
<b>Client:</b>	Endeavor	<b>Project Number:</b>	0092408
<b>Project Name:</b>	B-2 Well Re-entry	<b>Location:</b>	Hardin County, Texas
<b>Photograph ID:</b> PB130007

<b>Feature:</b> Upland Site			
<b>Date:</b> 11/13/2008			
<b>Comments:</b> Photo of the vegetation located to the western portion of the Site. Photo taken facing southwest outside of the Site to adjacent habitat.			
<b>Photograph ID:</b> PB130008

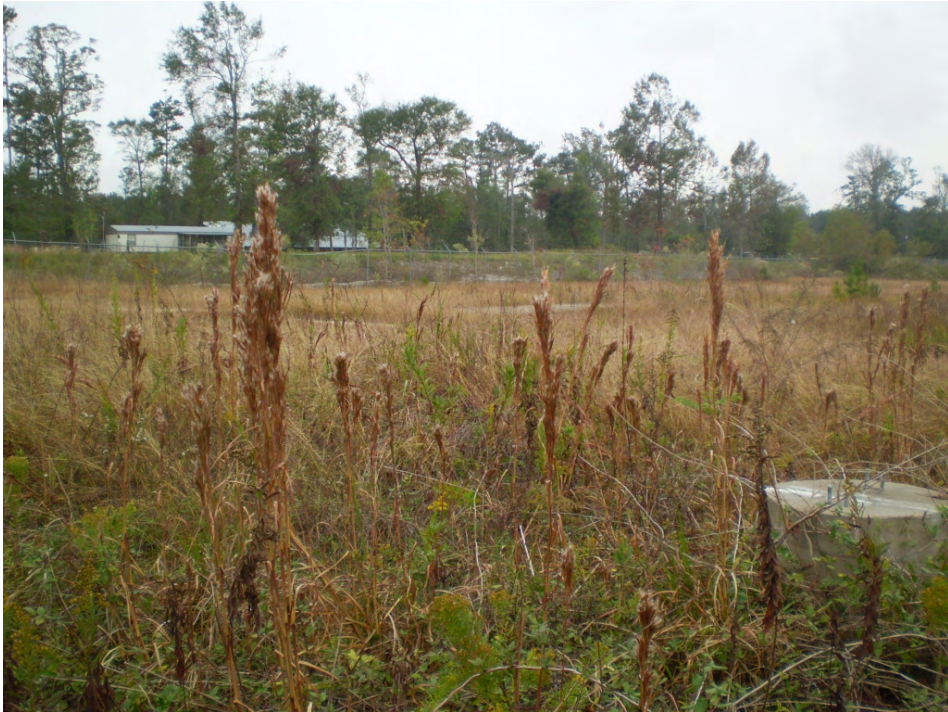
<b>Feature:</b> Upland Site			
<b>Date:</b> 11/13/2008			
<b>Comments:</b> Photo of the southwest corner of the Site. Photo taken facing northeast into the Site.

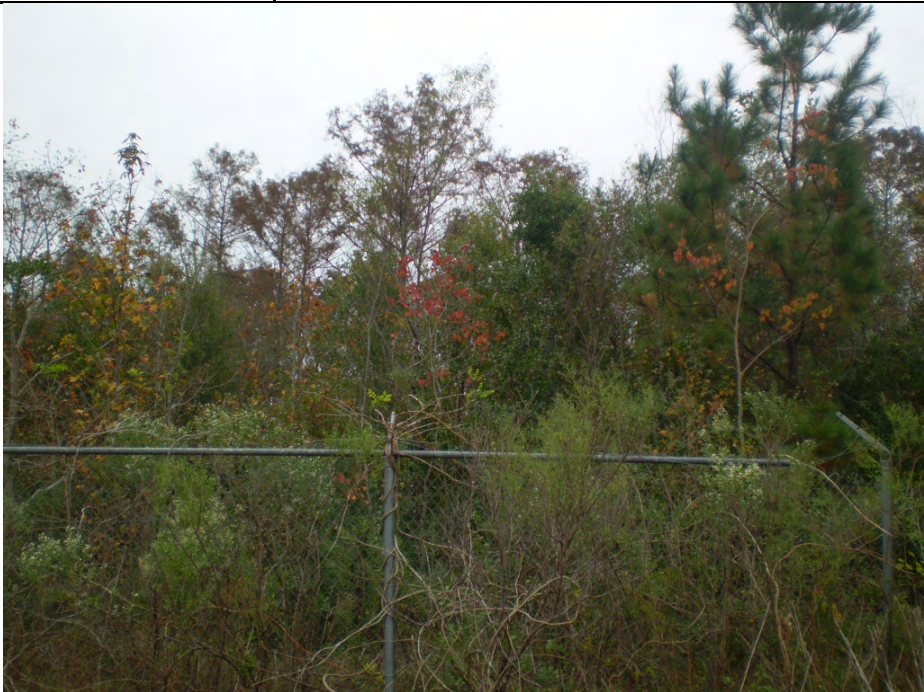
<b>Client:</b>	Endeavor	<b>Project Number:</b>	0092408
<b>Project Name:</b>	B-2 Well Re-entry	<b>Location:</b>	Hardin County, Texas
<b>Photograph ID:</b> PB130009

<b>Feature:</b> Adjacent Area			
<b>Date:</b> 11/13/2008			
<b>Comments:</b> Photo of the vegetation located south of the Site. Photo taken facing south towards the adjacent habitat outside Site.			
<b>Photograph ID:</b> PB130010

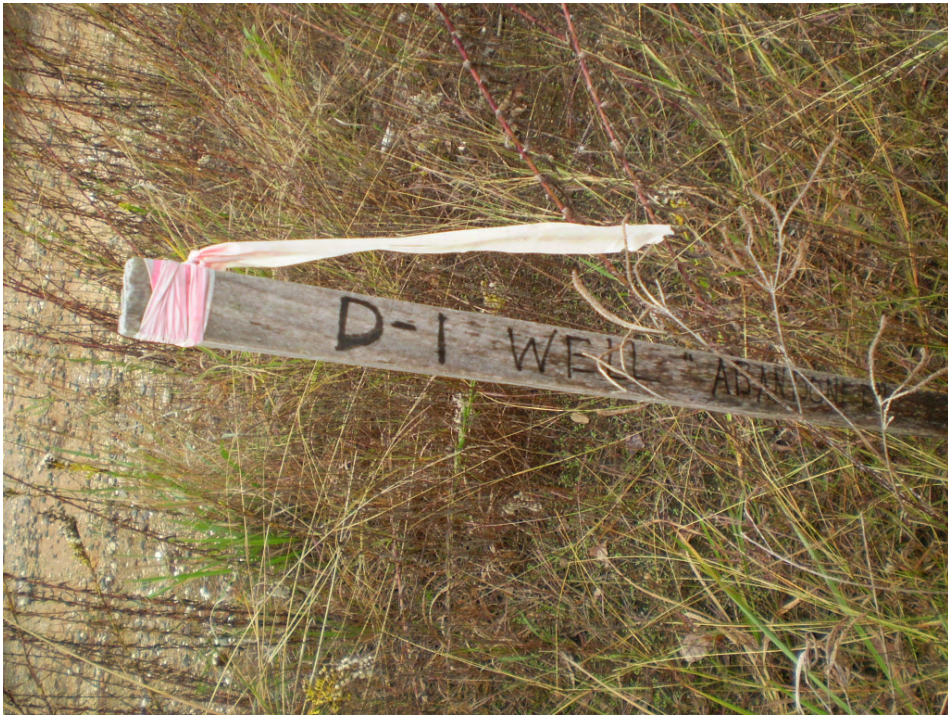
<b>Feature:</b> Stake 2			
<b>Date:</b> 11/13/2008			
<b>Comments:</b> Photo of a stake located south of the center of the Site. Stake has "D-1 WELL Abandoned" written on it.

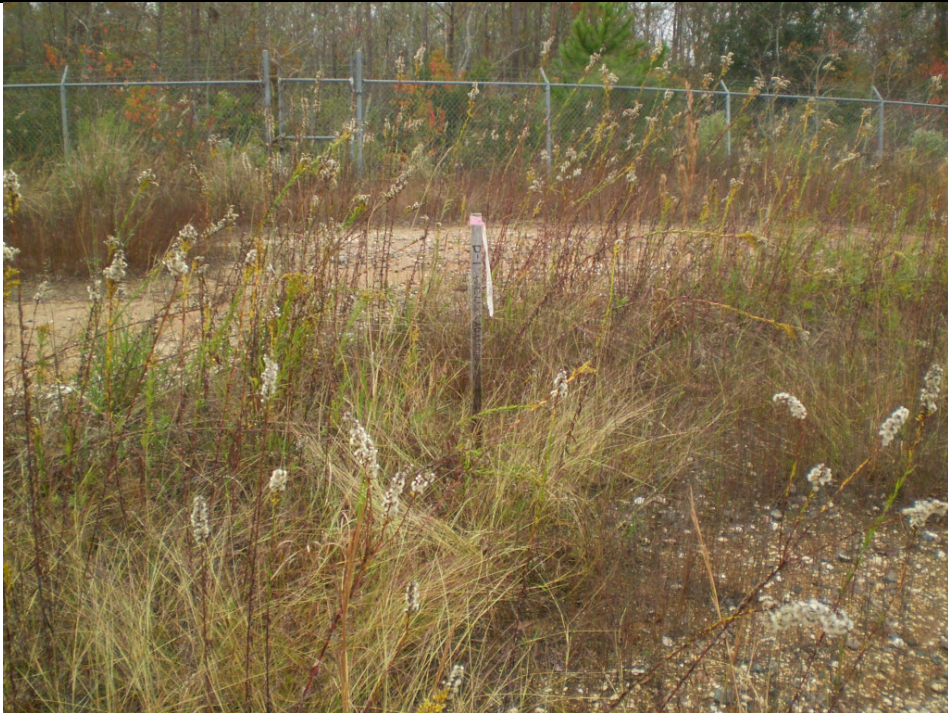
<b>Client:</b>	Endeavor	<b>Project Number:</b>	0092408
<b>Project Name:</b>	B-2 Well Re-entry	<b>Location:</b>	Hardin County, Texas
<b>Photograph ID:</b> PB130011

<b>Feature:</b> Stake 2			
<b>Date:</b> 11/13/2008			
<b>Comments:</b> Photo of D-1 Well stake. Photo taken facing south.			
<b>Photograph ID:</b> PB130012

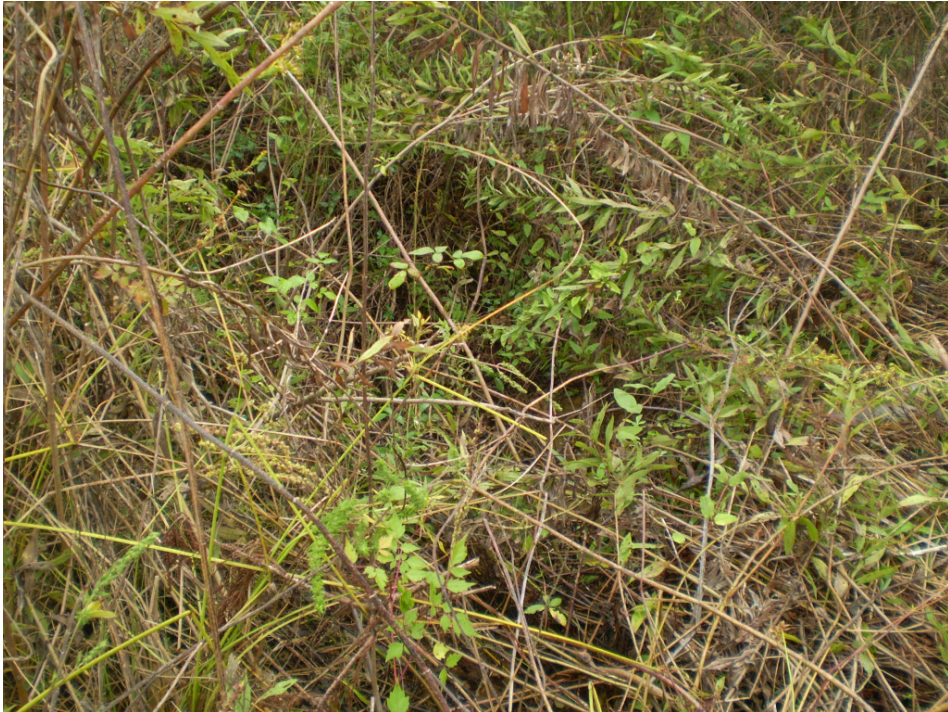
<b>Feature:</b> SAHA001			
<b>Date:</b> 11/13/2008			
<b>Comments:</b> Photo showing water flowing from the swale SAHA001 in the Site into a large mixed bottomland hardwood-cypress forest located to the south of the Site. Photo taken facing south outside of site.

As mentioned above, SAHA001 is fed by an apparent ephemeral swale that drains from the agricultural property north of the Site, through a culvert, and into the swale. The swale drains south of the Site into an observed mixed bottomland hardwood-cypress forest. A direct connection between the swale and an observed wetland located south of the Site was observed during the field survey. ERM did not delineate or verify the extent of the observed wetland south of the Site. However, through the use of NWI and topographic mapping, it was determined that the wetland south of the Site is adjacent to the LNVA canal. Accordingly, a minor, indirect connection could exist between the Site swale and the LNVA canal, but only immediately following rain events (during which the Site swale collects storm water from the surrounding uplands).

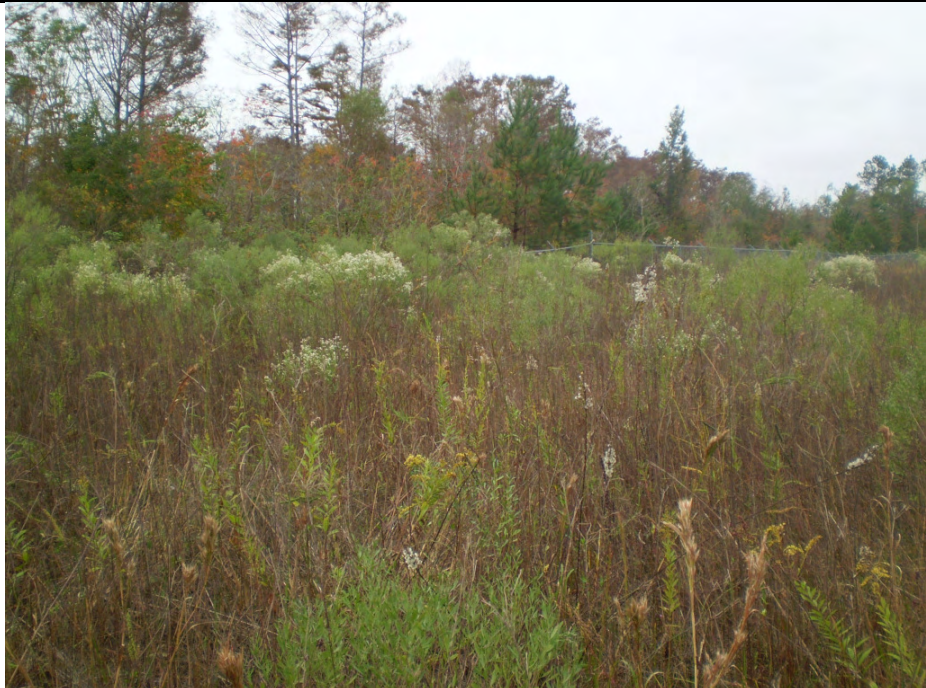
<b>Feature:</b> SAHA001			
<b>Date:</b> 11/13/2008			
<b>Comments:</b> Photo of vegetation located inside the swale, SAHA001. Photo taken facing southwest			
<b>Photograph ID:</b> PB130014

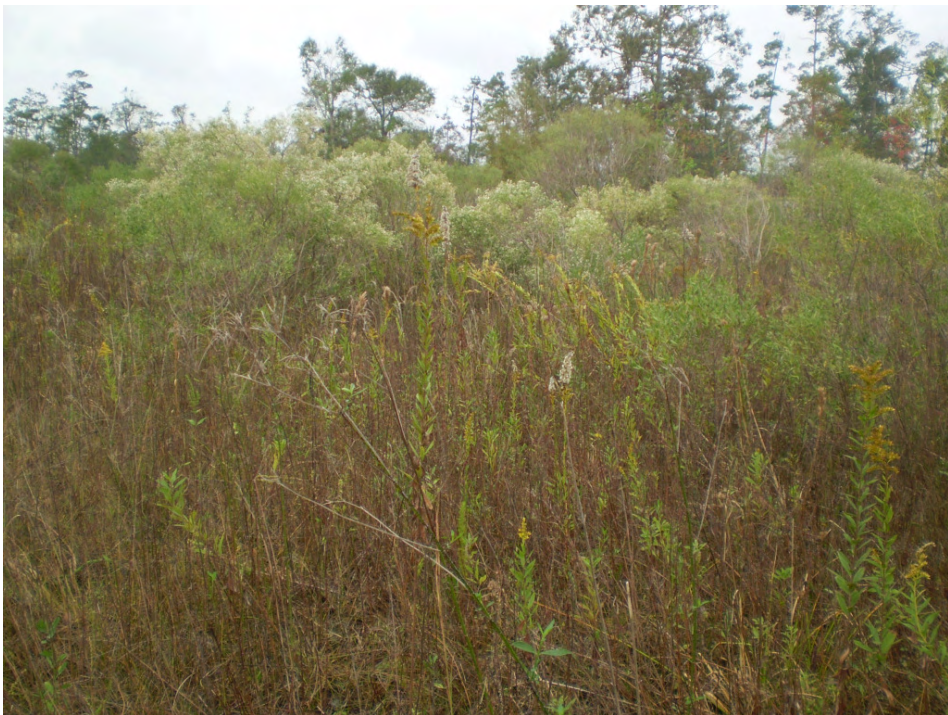
<b>Feature:</b> SAHA001			
<b>Date:</b> 11/13/2008			
<b>Comments:</b> Photo the swale, SAHA001. Photo taken facing northwest.			
<b>Client:</b>	Endeavor	<b>Project Number:</b>	0092408

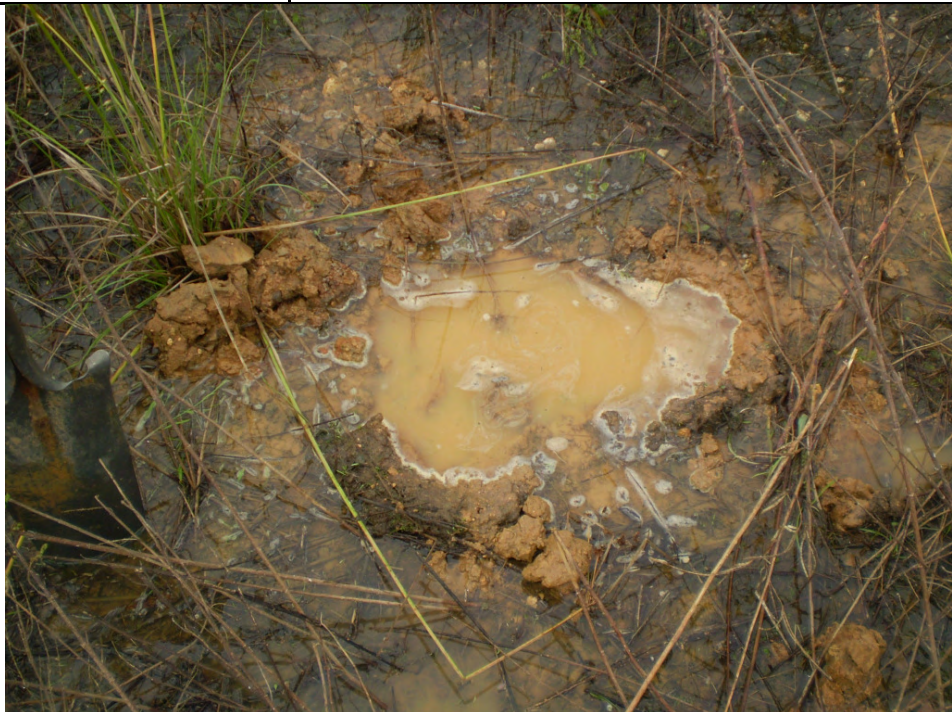
<b>Feature:</b> Soil Pit			
<b>Date:</b> 11/13/2008			
<b>Comments:</b> Photo of the soil pit dug in the swale, SAHA001.			
<b>Photograph ID:</b> PB130016

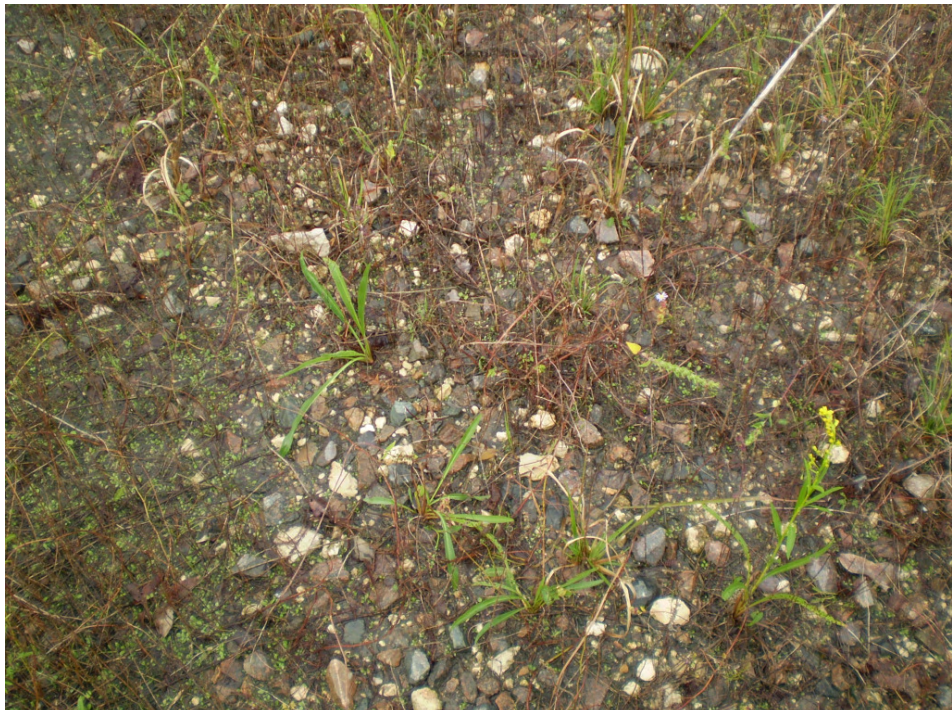
<b>Feature:</b>			
<b>Date:</b> 11/13/2008			
<b>Comments:</b> Photo of gravel covered ground adjacent to the swale, SAHA001.

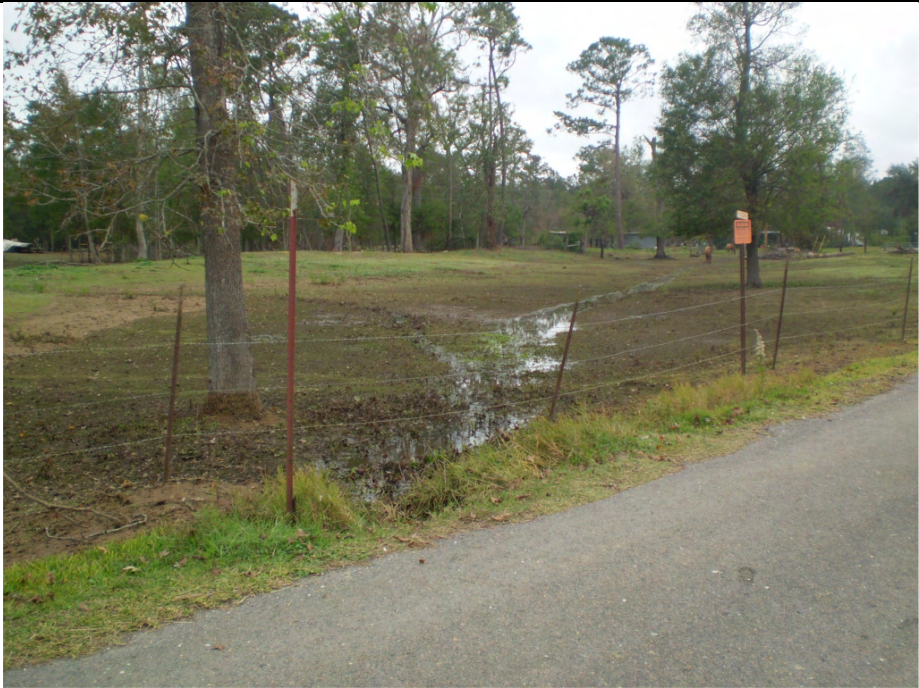
<b>Feature:</b>			
<b>Date:</b> 11/13/2008			
<b>Comments:</b> Ephemeral swale on the property located to the north of the Site. Photo taken facing northeast across Burge Road.			
<b>Photograph ID:</b> PB130018

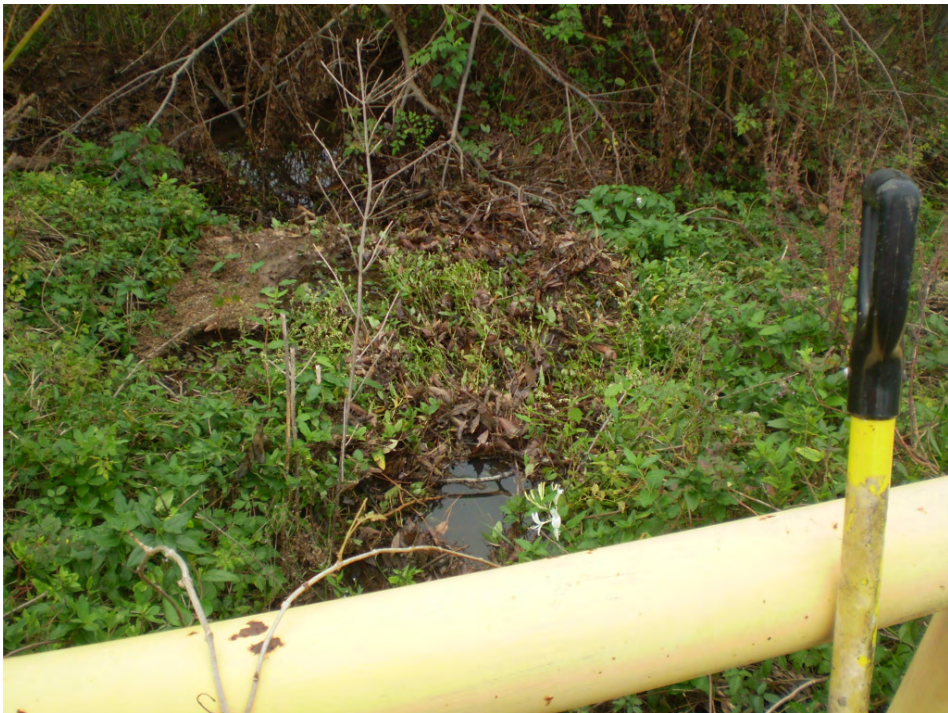
<b>Feature:</b>			
<b>Date:</b> 11/13/2008			
<b>Comments:</b> Culvert carrying water under Burge Road into Site. Photo taken facing south towards site boundary.			
<b>Client:</b>	Endeavor	<b>Project Number:</b>	0092408

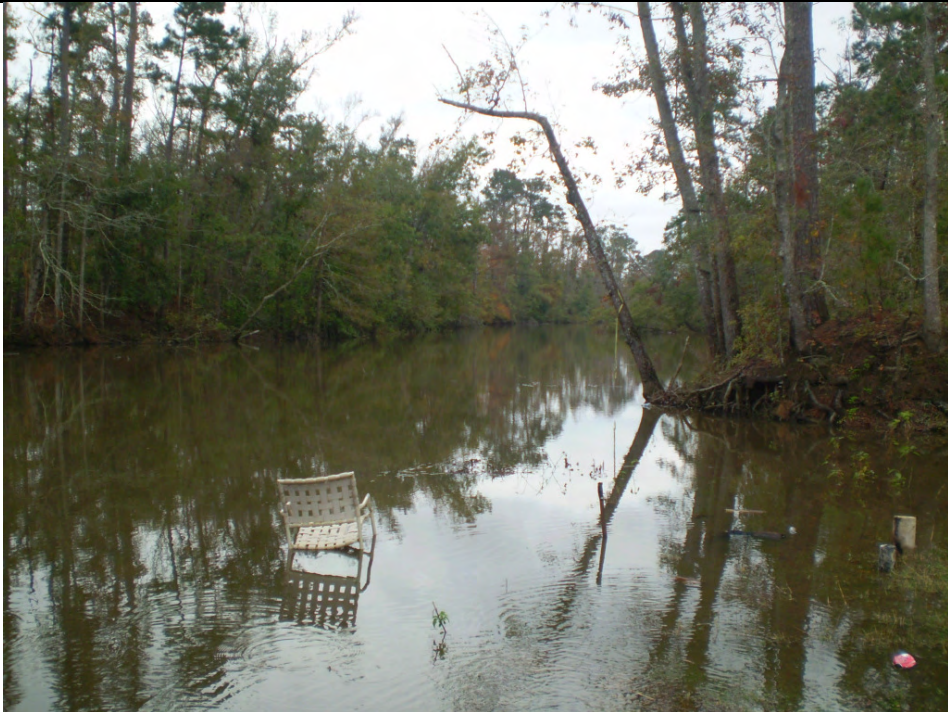
<b>Feature:</b> LNVA Canal		
<b>Date:</b> 11/13/2008		
<b>Comments:</b> LNVA Canal located 1,250 feet south of the Site. Photo taken facing southwest.		
<b>Photograph ID:</b> PB130020

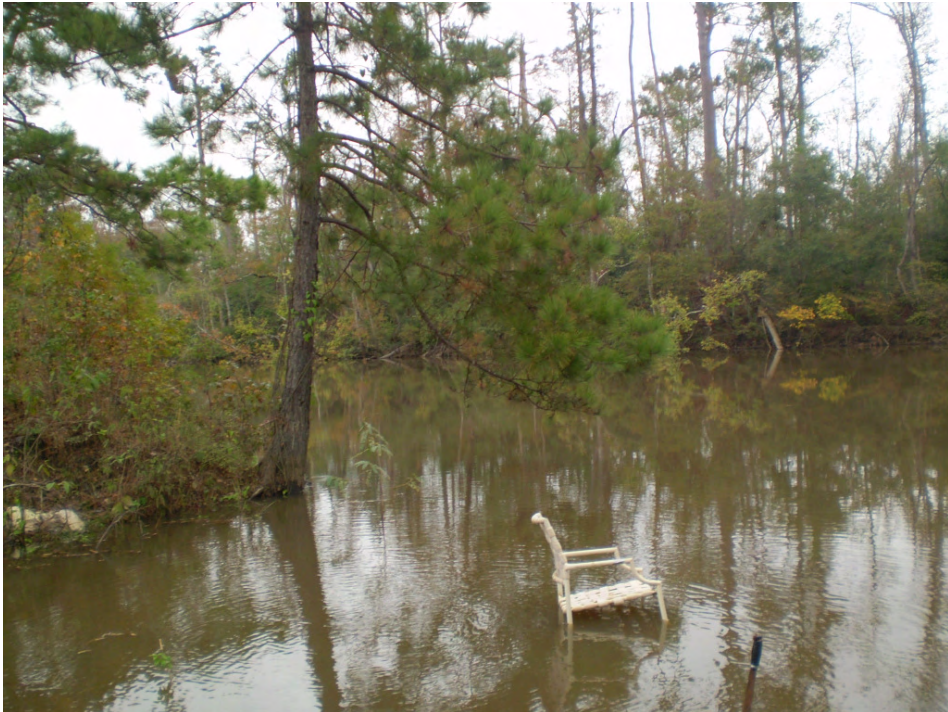
<b>Feature:</b> LNVA Canal		
<b>Date:</b> 11/13/2008		
<b>Comments:</b> LNVA Canal located 1,250 feet south of the site. Photo taken facing northwest.
