**WETLAND STATEMENT OF FINDINGS FOR
DIRECTOR'S ORDER #77-1: WETLAND PROTECTION**

**Stabilize Riverbank at Towpath Buckeye along the Cuyahoga River
Cuyahoga Valley National Park Peninsula, Ohio**

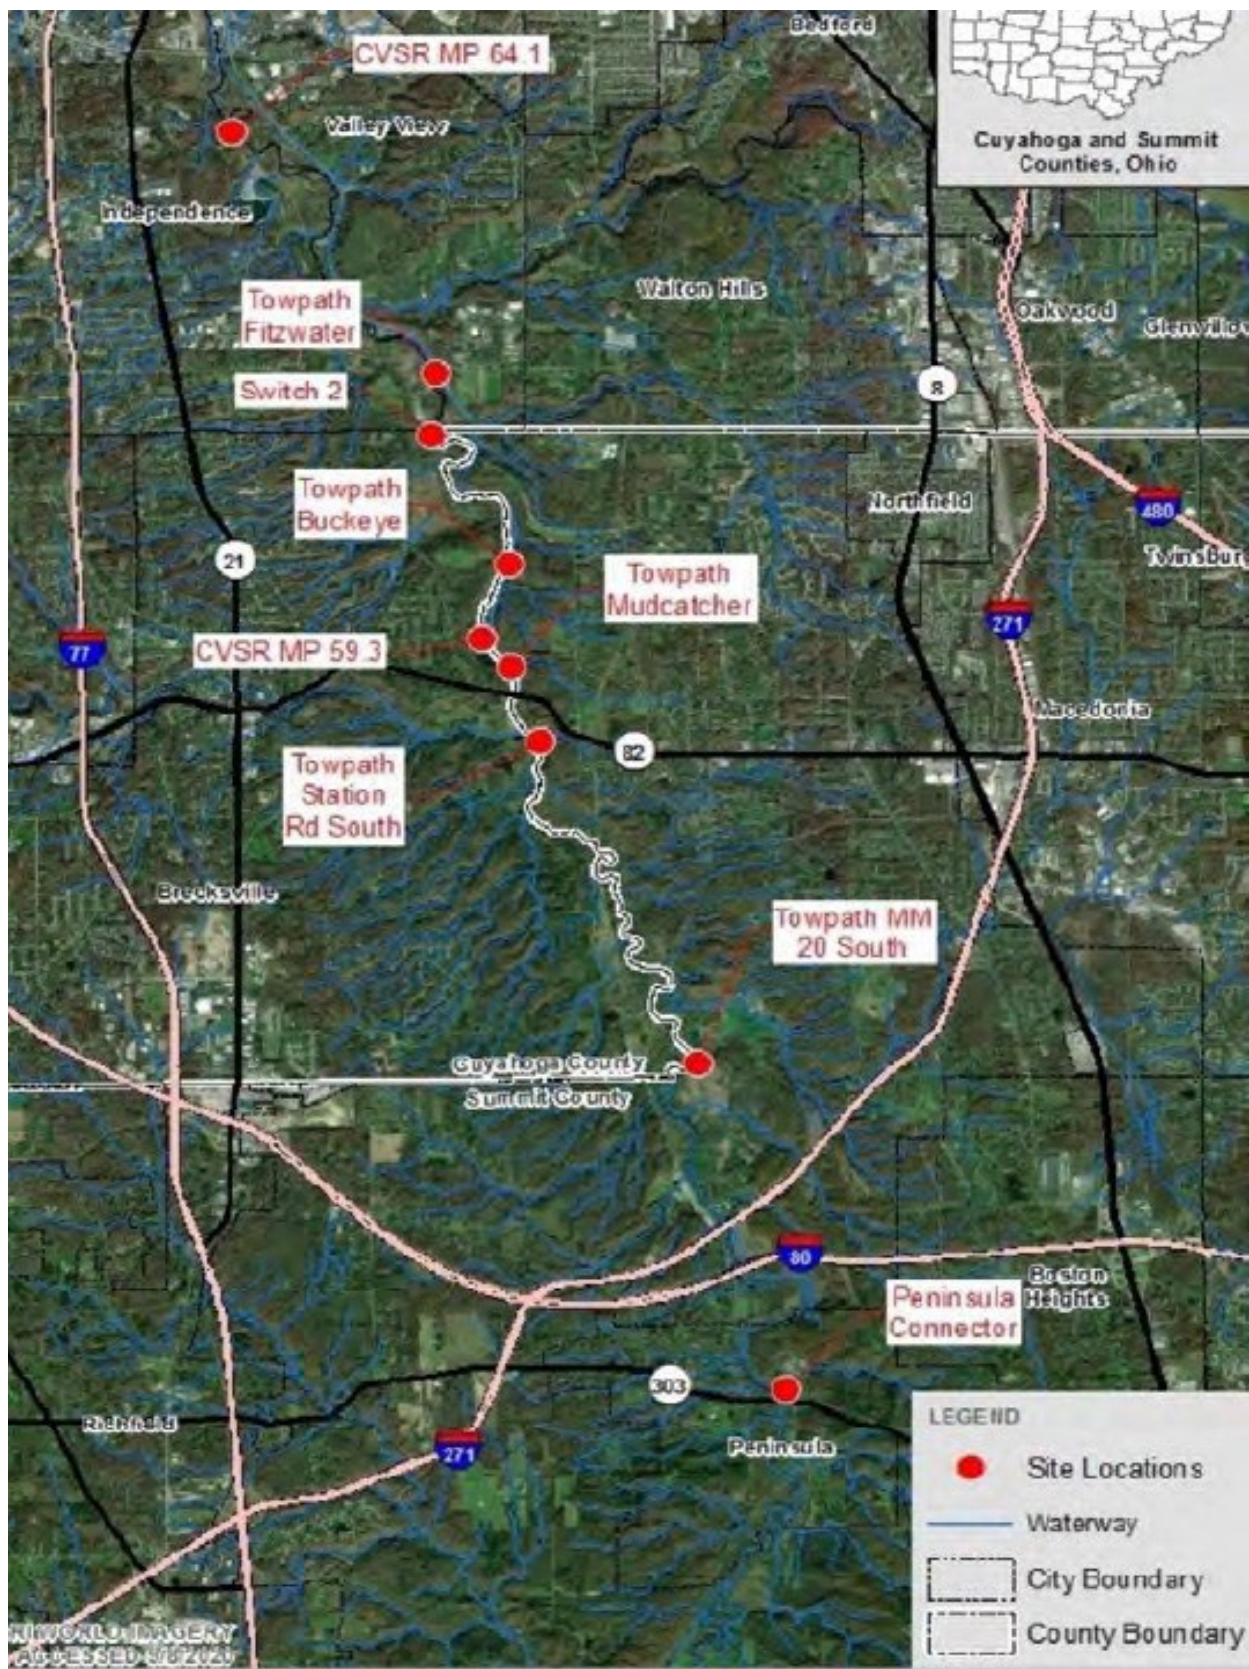
Figure 1. All nine shoreline project locations along the Cuyahoga River including Towpath Buckeye

The NPS proposes to implement riverbank stabilization measures at the Towpath Buckeye shoreline along the Cuyahoga River. The Buckeye project site is located 1.14 miles north of the Brecksville-Northfield Bridge, on the left bank (east bank) of the river (Figure 1).

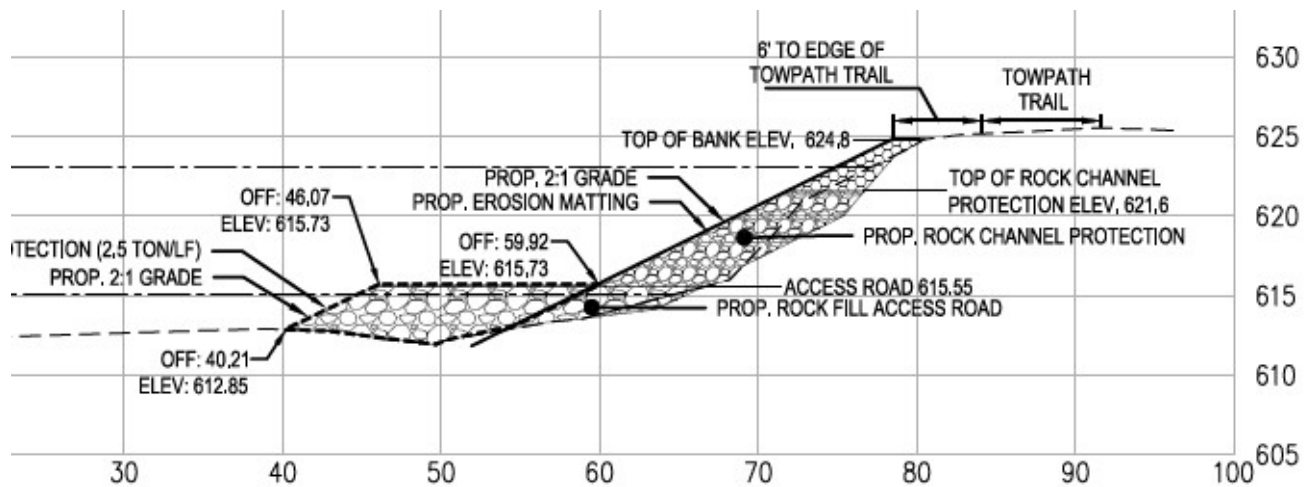
Figure 3. Buckeye Towpath Armoring, selected alternative, typical construction-drawing section of the proposed armoring treatment. Note that 3.4 feet of fill above the top of the rock channel protection elevation 621.6 will be planted and is considered the bioengineering section of the armoring. The armoring extends 40 feet from the top-of-bank out into the river.

The NPS proposes to implement riverbank stabilization measures at Towpath Buckeye along the Cuyahoga River. A riprap solution that includes live plant staking and seeding along the top of the rock fill was chosen as the preferred alternative concept in the Value Analysis Workshop. Alternative solutions for bank stabilization were analyzed during the Value Analysis Workshop in June 2021 and memorialized in the final Value Analysis Report from October 2021. Structural and bioengineering (planting strip 10-feet wide at the top of the bank armoring) measures were considered in the design of bank stabilization at Towpath Buckeye (Figure 3) shows the final detailed cross section of the preferred alternative.

The design for Towpath Buckeye armoring was developed as a bank infill (adding rock material and some soil to an eroded bank) project to restore appropriate bank slope for stability and re-establish a 6' minimum width shoulder along the Towpath trail. Currently, sections of the project area come within 6 ft of the towpath (Figure 3). Based on the Slope Stability analysis the infill shall be sloped no steeper than 2H:1V to the proposed toe of slope along the channel bed.
