National Park Service  
U.S. Department of the Interior  
Zion National Park  
Springdale, Utah

## Environmental Assessment Zion Canyon South Entrance Redesign (PEPC 104914)

March 2024

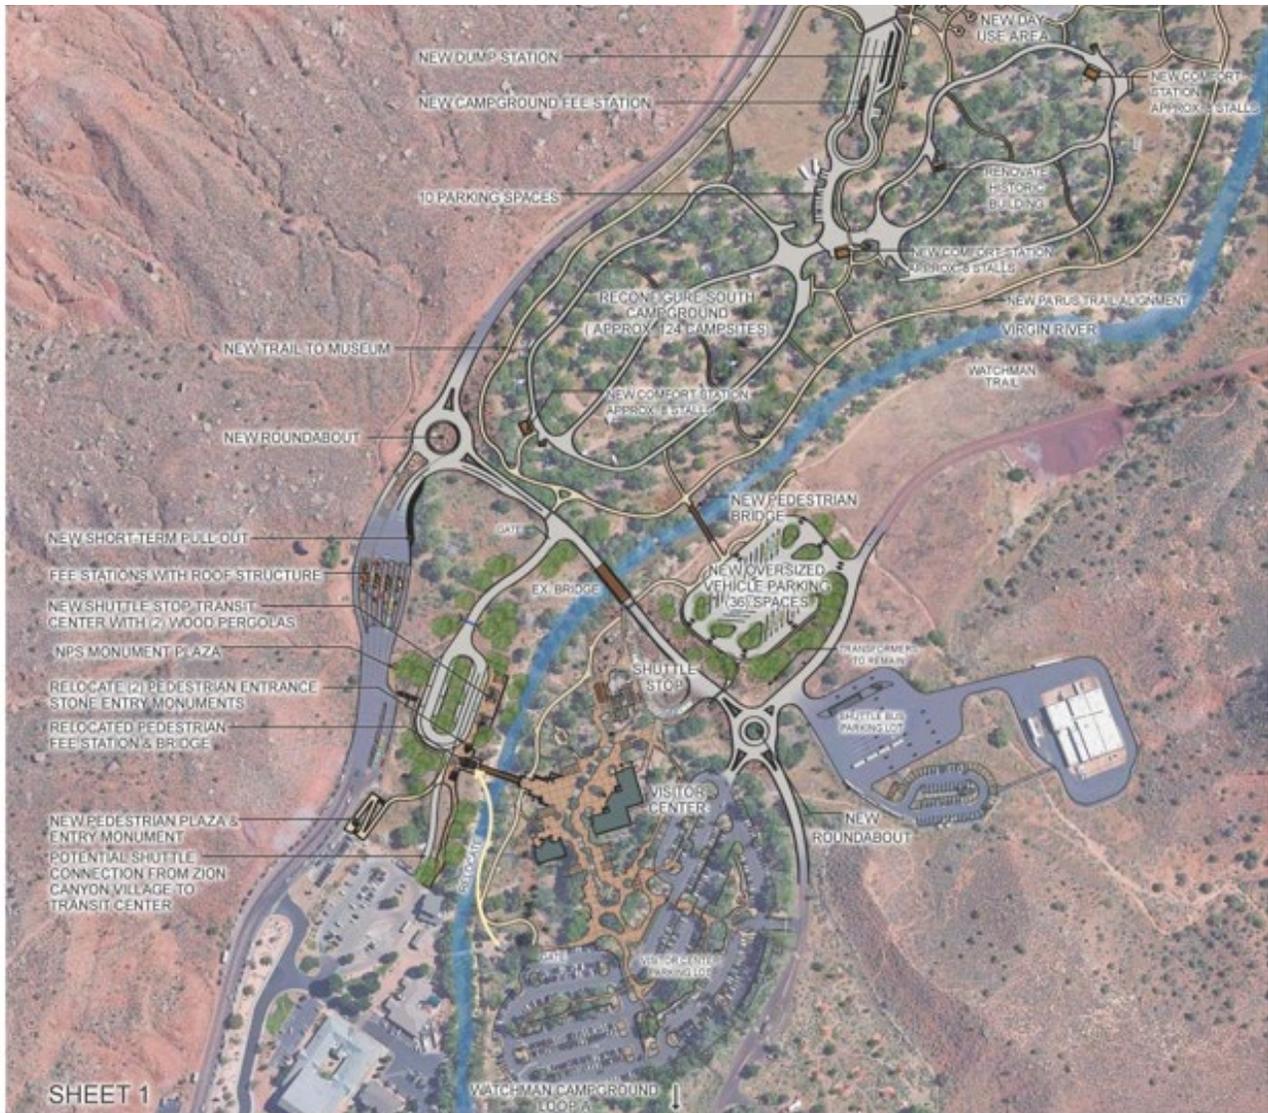
Value Analysis Study Alternative B (Considered and Dismissed)

Alternatives/Proposal	Reason for Dismissal
<p><b>Continued Use of Existing Bridge:</b></p> <ul style="list-style-type: none"> <li>• Different roundabout layout</li> <li>• New pedestrian bridge</li> <li>• No new vehicular bridge</li> </ul>	<p>Alternatives with a different circulation pattern and continued use of the existing bridge were considered during the design process, including Alternative B from the Value Analysis Study (NPS 2021c) and Option D from the Transportation Study (NPS 2015). These alternatives would feature a different circulation pattern and roundabout layout from Alternative B as described in the EA and would continue use of the current two-lane vehicular bridge. Continued use of the existing bridge would not meet the purpose and need for the proposal because issues with safety and vehicular, bicycle, and pedestrian circulation would remain unaddressed; as a result, these alternatives were dismissed because they would not meet the purpose and need for the proposal. Retaining only one vehicle access over the narrow existing bridge would not reduce the current vehicular congestion at the Zion Canyon South Entrance. In addition, continued use of the existing bridge would limit options for egress in the event of flooding or other emergencies.</p>

<p><b>Shift New Bridge East to Bisect Campground:</b></p> <ul style="list-style-type: none"> <li>• Construct new vehicle and pedestrian bridge</li> <li>• Shift bridge east to span 100-year floodplain</li> <li>• Construct pedestrian underpass under new vehicle bridge</li> <li>• Reconfigure South Campground</li> </ul>	<p>An alternative was considered during design that would construct a new vehicle and pedestrian bridge further north, reconfiguring South Campground (Transportation Study Option B [NPS 2015]). This alternative featured a vehicle circulation pattern that would relocate the primary alignment of the Zion–Mt. Carmel Highway to bisect South Campground before crossing the North Fork of the Virgin River via a new vehicle and pedestrian bridge. The South Campground access road would be reconfigured to accommodate large increases in vehicular traffic. Bisecting the campground with the most popular entry into ZION would shift all the traffic to an overnight use area and may increase unintended pedestrian-vehicle interactions as well as lengthen the estimated drive time to the Zion Canyon Visitor Center or under an evacuation. This alternative would also reduce the number of campsites in South Campground. In this location, the bridge would span the 100-year floodplain; however, the existing bridge would continue to restrict the floodplain. This alternative was dismissed because it would not meet the purpose and need for the proposal because it would contribute to unsafe conditions for campers, and it would not reduce interaction on roads between shuttle vehicles and visitor vehicles.</p>
