Special Use Construction Permit Submittal

TEXAS EASTERN TRANSMISSION SYSTEM
UCHC - CLIN, MP 307 & MP 307.9
NATCHEZ TRACE REVETMENT PROJECT
HINDS COUNTY, MISSISSIPPI
2023

Wetland Delineation and Waterbody Survey Report

Environmental Survey Photographs
SE-19-10722 Natchez Trace Revetment Project
Hinds County, Mississippi
October 15, 2019

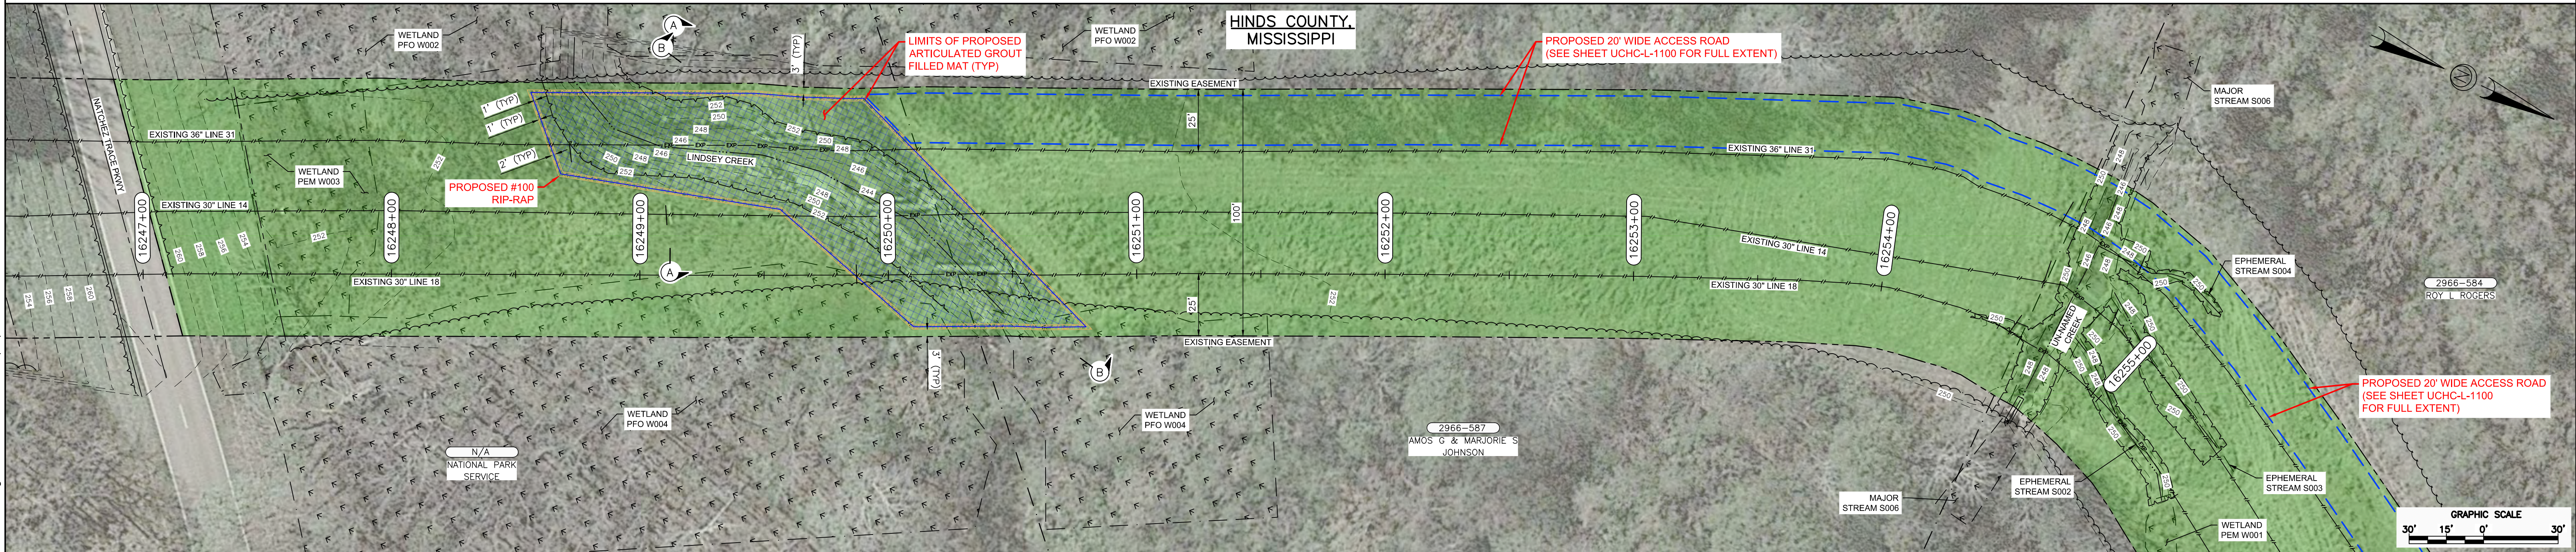
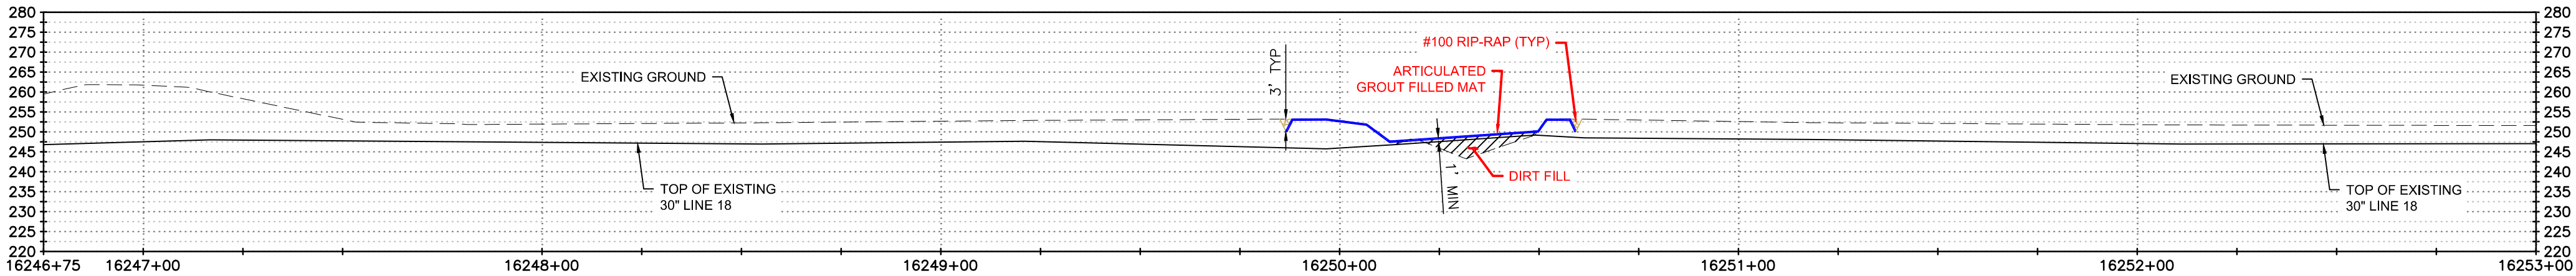
PROFILE VIEW - REVETMENT OVER EXISTING 30" LINE 18
STA. 16246+75 TO STA. 16256+00
SCALE: 1"=30'H, 1"=30'V

Texas Eastern has three existing pipelines (Lines 14, 18, and 31) below Lindsey Creek which is subject to erosion as a result of the stream channel. Exposed pipe is a safety concern for the following reasons: 1) the pipe may be struck by debris during high water conditions and become damaged, increasing the risk for rupture; 2) the pipe may cause debris to accumulate and create a dam, causing upstream flooding; and 3) the protective coating on exposed pipe may be damaged or disbanded, leading to corrosion, thus weakening the pipe wall.

Texas Eastern proposed to complete the maintenance work by first sandblasting and recoating an approximately 45-foot-long segment of the existing pipe. All excavation associated with the replacement and lowering of the pipe will be completed within the existing 100-foot-wide permanent ROW. Following sandblasting and recoating of the pipe segment, a rock shield will be installed on the pipelines and the stream bed and banks will be graded and re-contoured. Additionally, a concrete articulating grout mat will be installed within Lindsey Creek.

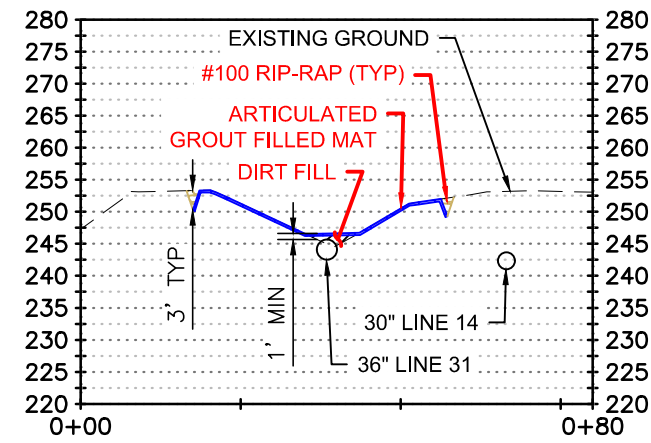
SECTION A
LOOKING UP STATION
SCALE: 1"=30'H, 1"=30'V

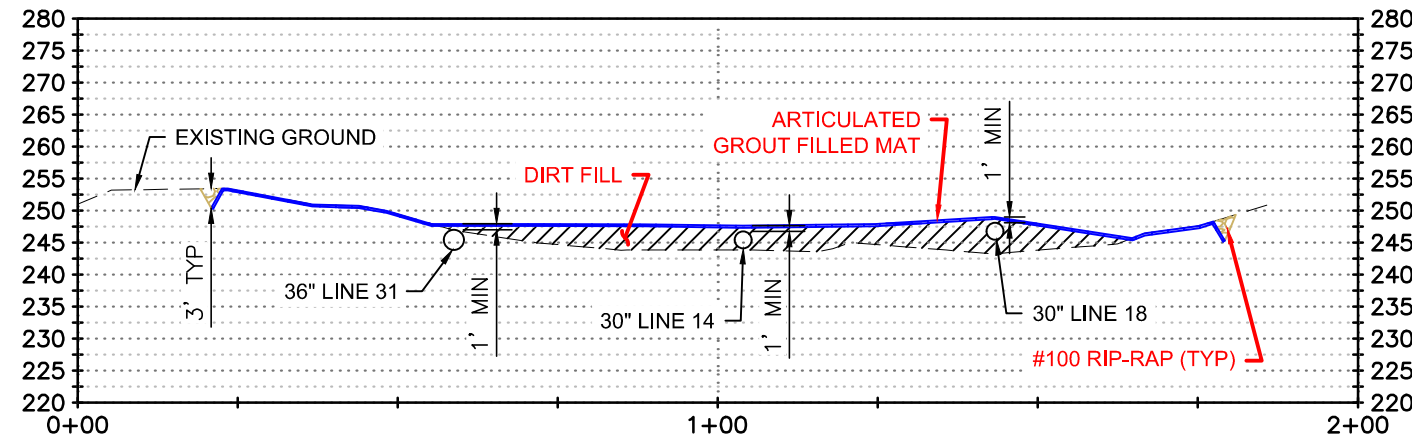
SECTION B
LOOKING UP STATION
SCALE: 1"=30'H, 1"=30'V

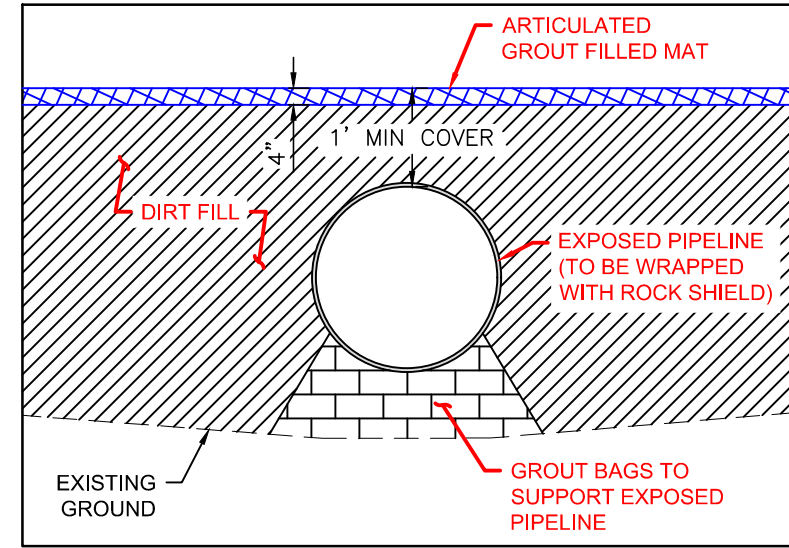
TYPICAL SECTION SHOWING
ARTICULATED GROUT FILLED MAT AND COVER
SCALE: NTS

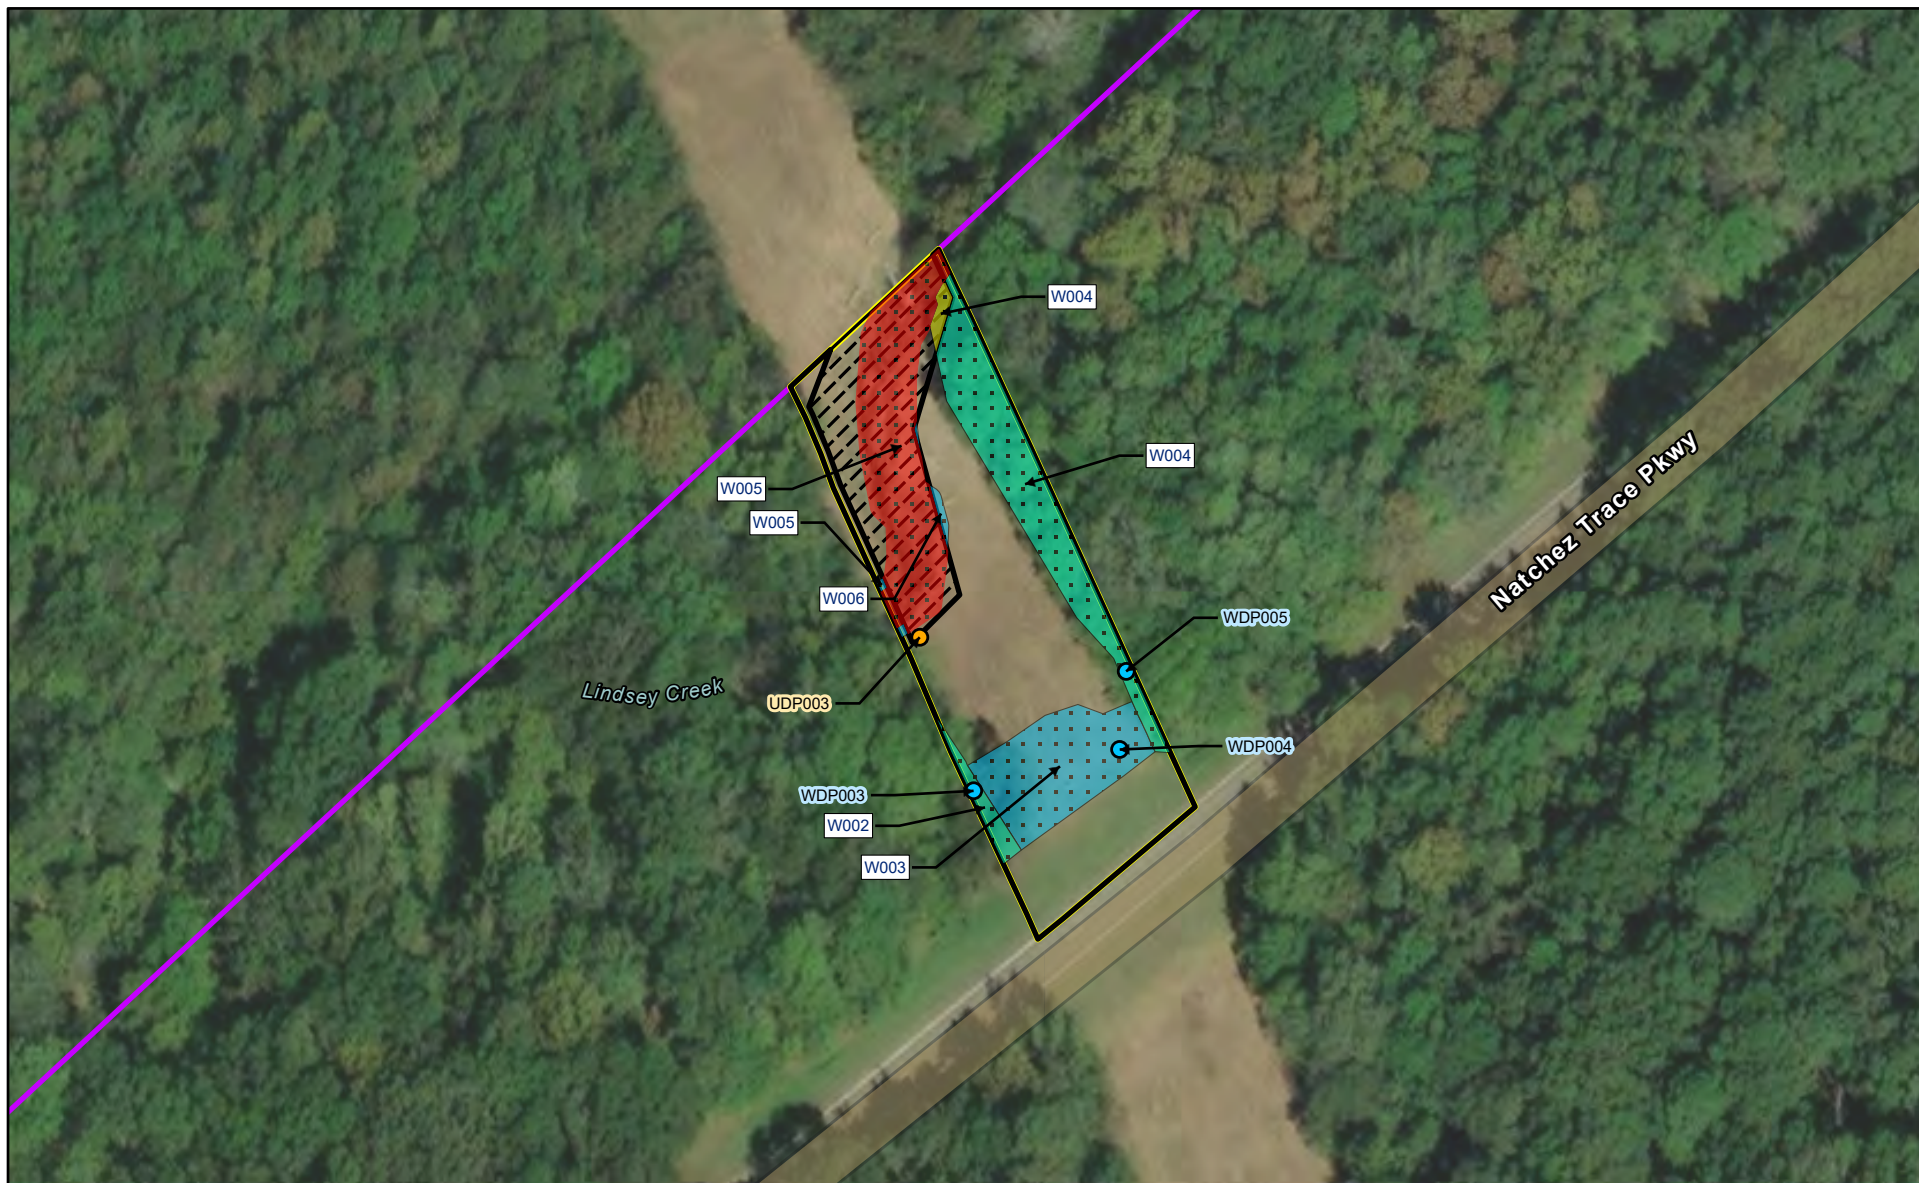
FIGURE 3:
FIELD SURVEY AND IMPACTS MAP

Legend	
●	Wetland Data Point
●	Upland Data Point
 	Permanent PEM Impacts (0.130-ac.)
 	Permanent PFO Impacts (0.005-ac.)
 	Temporary PEM Impacts (0.096-ac.)
 	Temporary PFO Impacts (0.120-ac.)
 	Permanent Workspace
 	Temporary Workspace
 	Survey Area
	Lindsey Creek Natchez Trace Boundary
—	Existing Pipeline

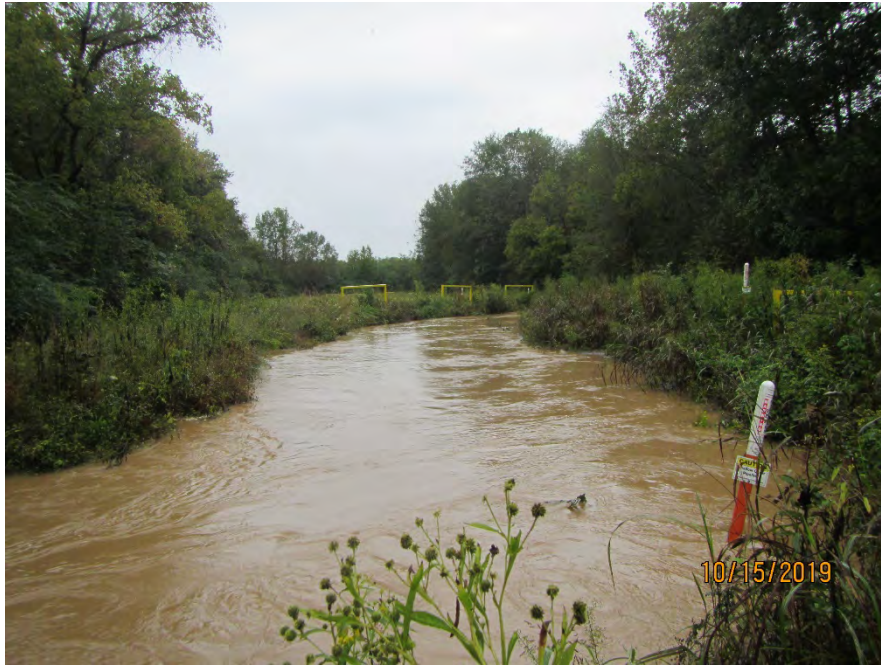
Photograph #1 – Representative view of Lindsey Creek, located within the pipeline right-of-way, facing north.

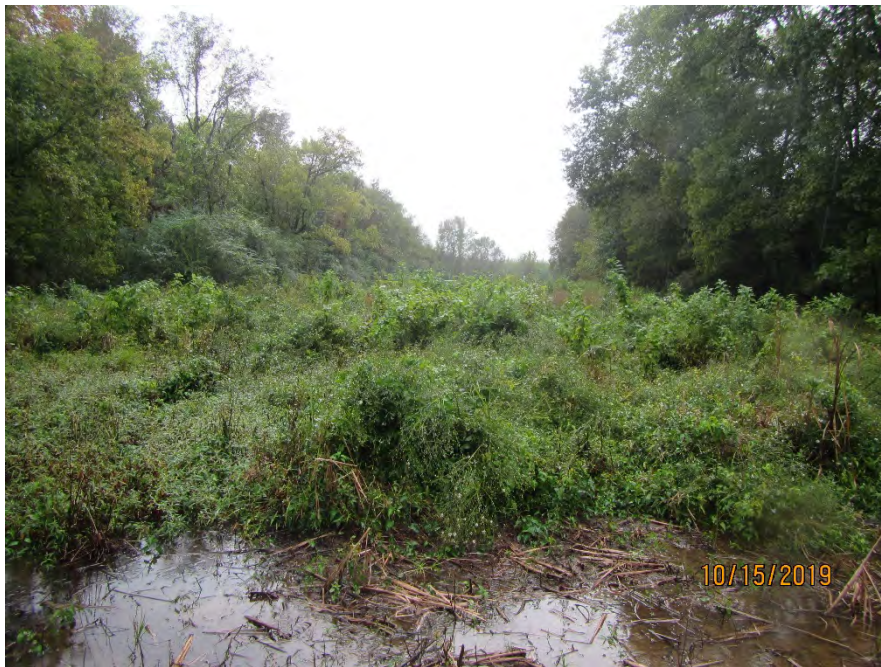
Photograph #2 – Representative view of the Palustrine Emergent Wetland (W003), facing northwest.

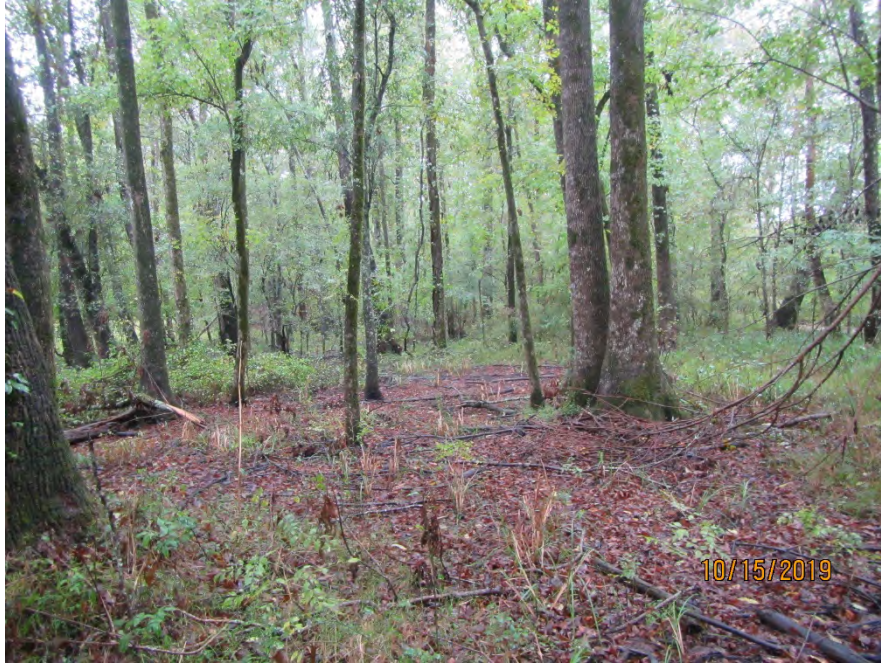
Photograph #3 – Representative view of the Palustrine Forested Wetland (W002), facing west.

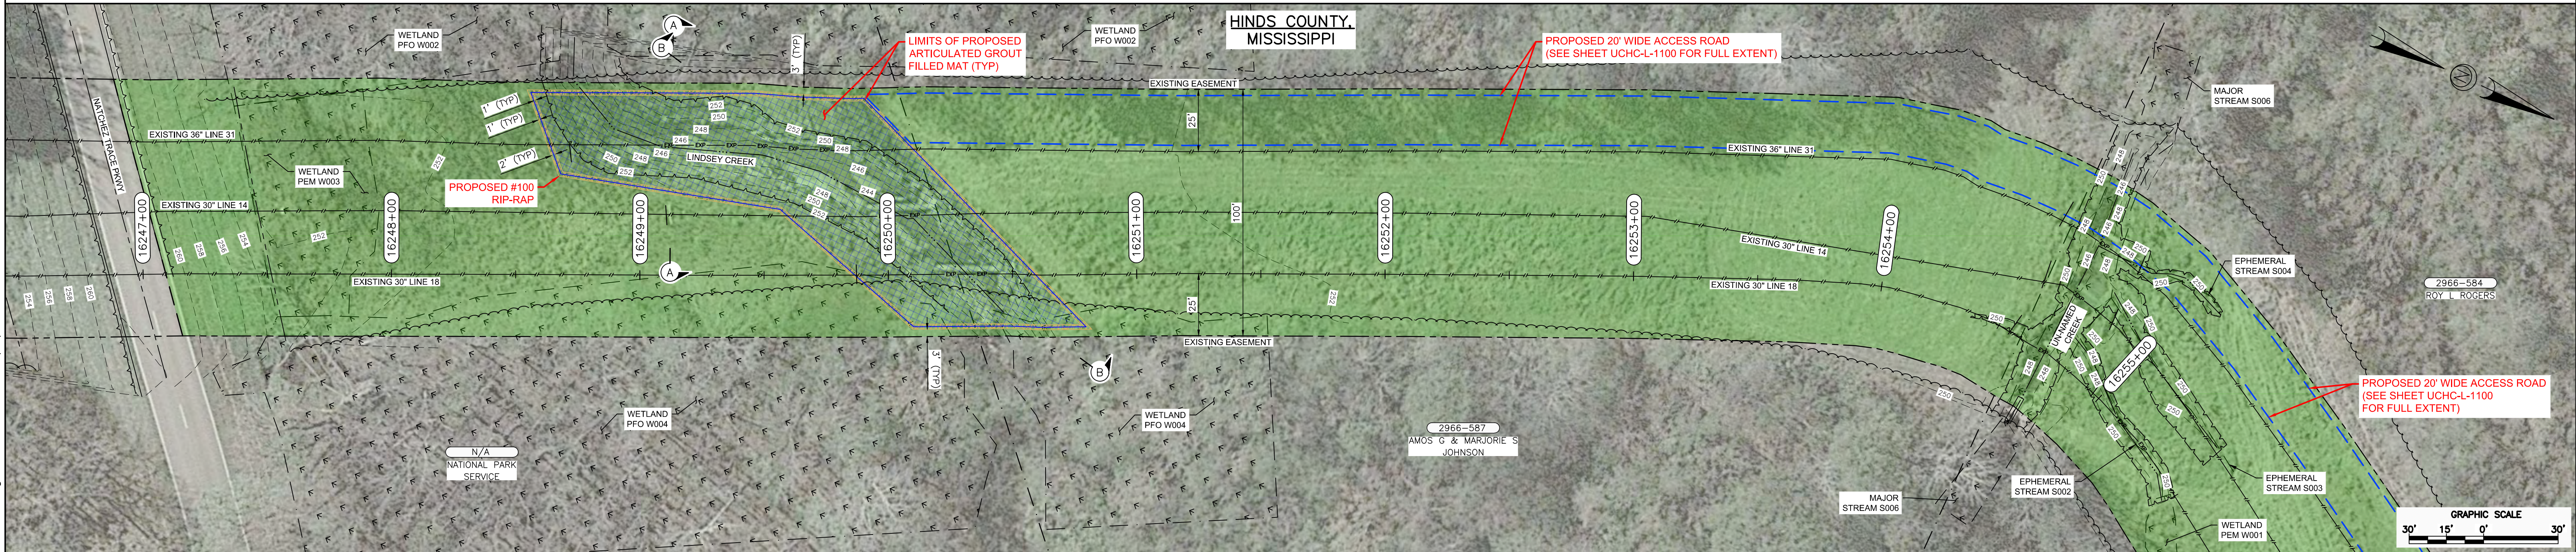
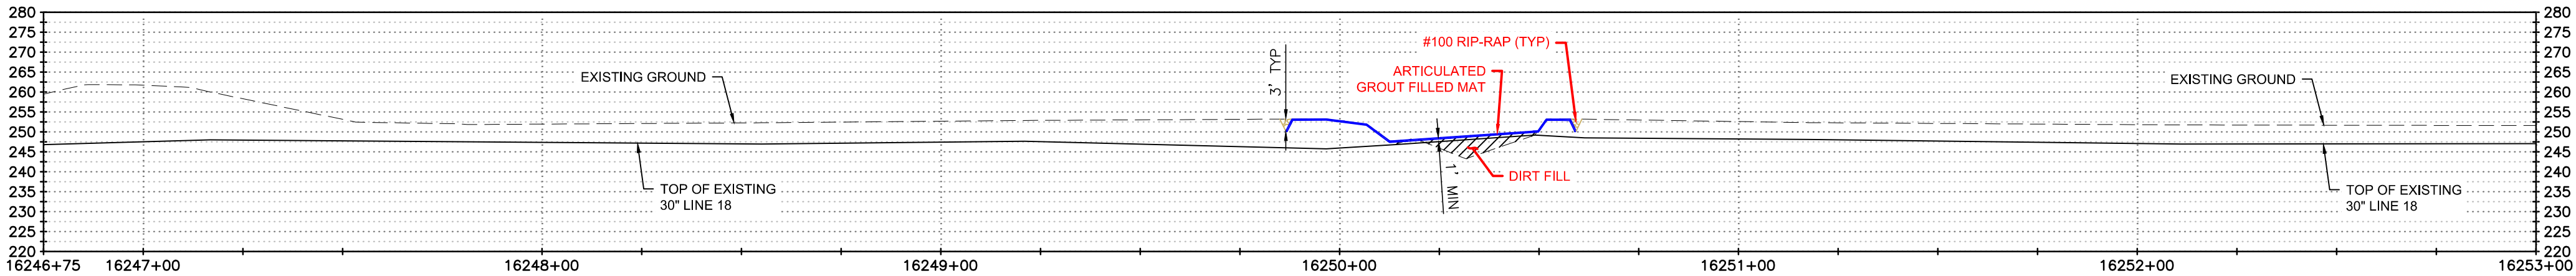
PROFILE VIEW - REVETMENT OVER EXISTING 30" LINE 18
STA. 16246+75 TO STA. 16256+00
SCALE: 1"=30'H, 1"=30'V

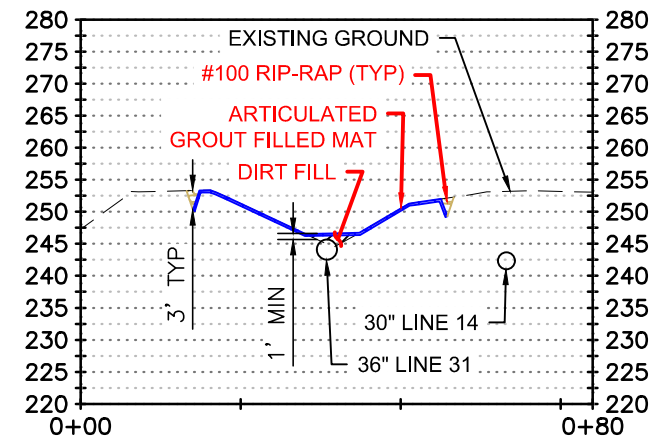
SECTION A
LOOKING UP STATION
SCALE: 1"=30'H, 1"=30'V

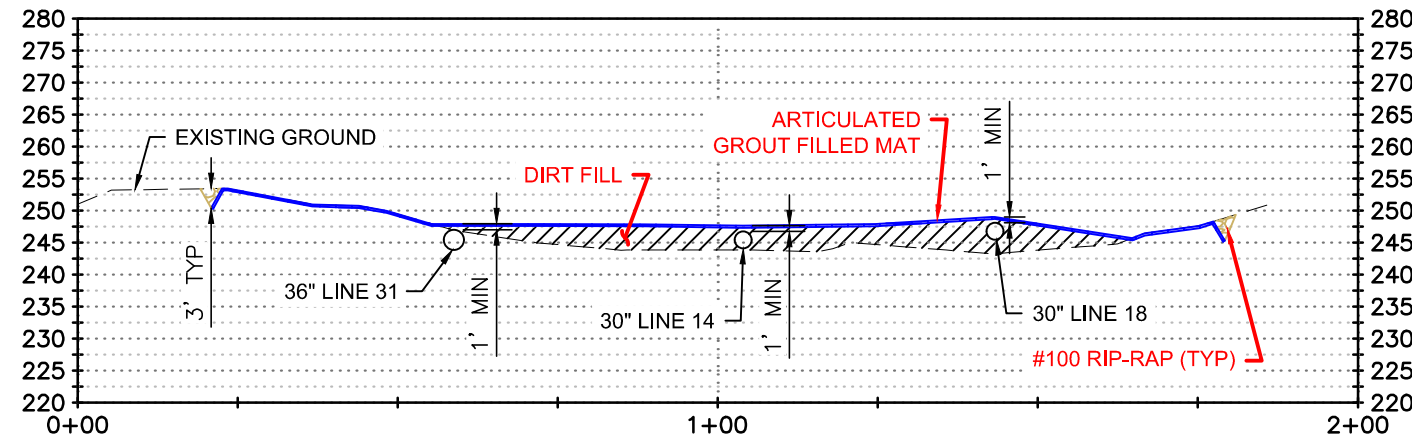
SECTION B
LOOKING UP STATION
SCALE: 1"=30'H, 1"=30'V

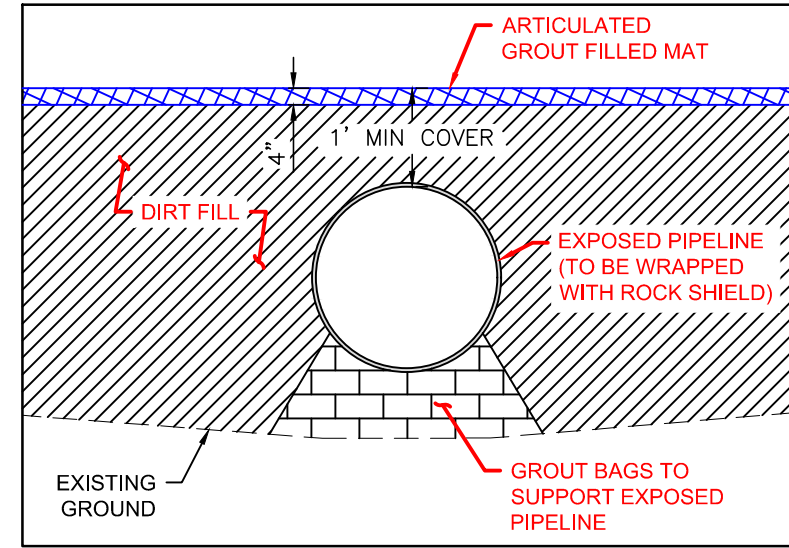
TYPICAL SECTION SHOWING
ARTICULATED GROUT FILLED MAT AND COVER
SCALE: NTS
