# National Park Service Cultural Landscapes Inventory 2024

**Denali Park Road Patrol Cabins**

**Denali National Park and Preserve**

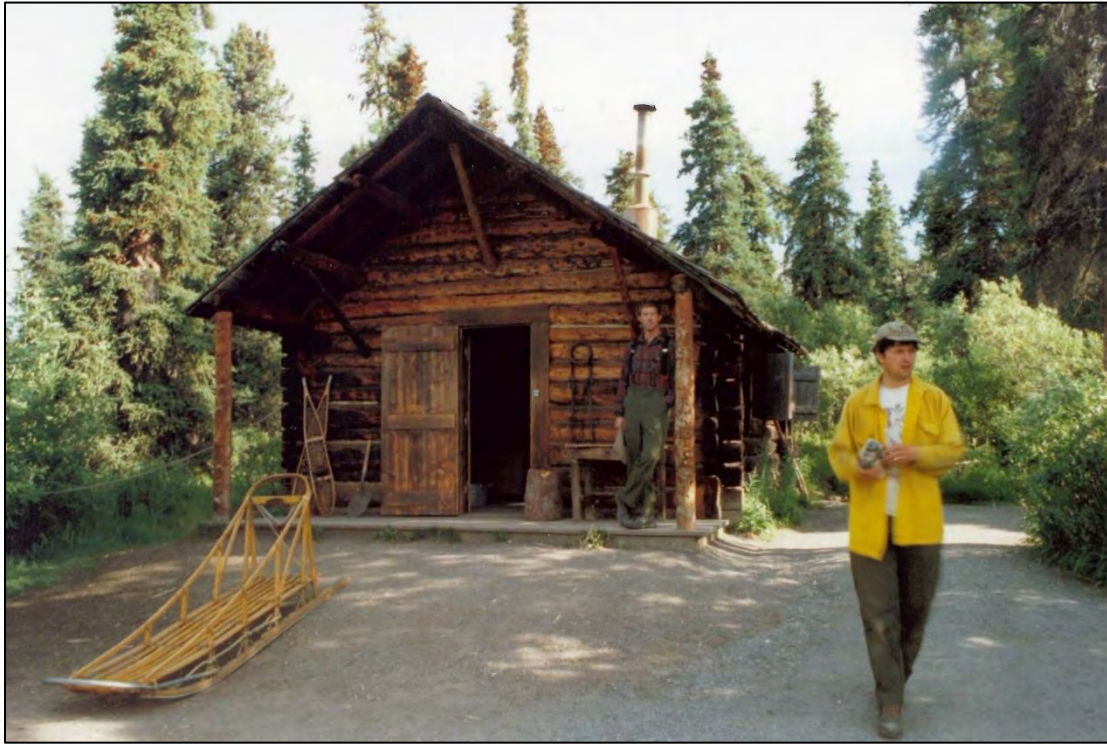
Fig 2.13. Front view of separated Upper Savage Cabin, 1999 National Park Service, Denali National Park and Preserve.

together. Starting in 1986, the cabin underwent a thorough restoration. Foam was sprayed in the larger holes and wood chips/strips were used to fill gaps (NPS, Compendium of Work). In 1988, the rehabilitation was completed when a pressure treated timber foundation was installed (Rees & Weddle, 1999; NPS, LCS, 1995). The cabin was surveyed again in 1994 (Leeper & Partlow, 1994). Moisture damage was documented on the roof and a corner missing chinking was identified as a possible entry for rodents (NPS, Compendium of Work). In 1999, water was observed leaking in and around the stove pipe (Rees & Weddle, 1999). The pipe was later repaired.

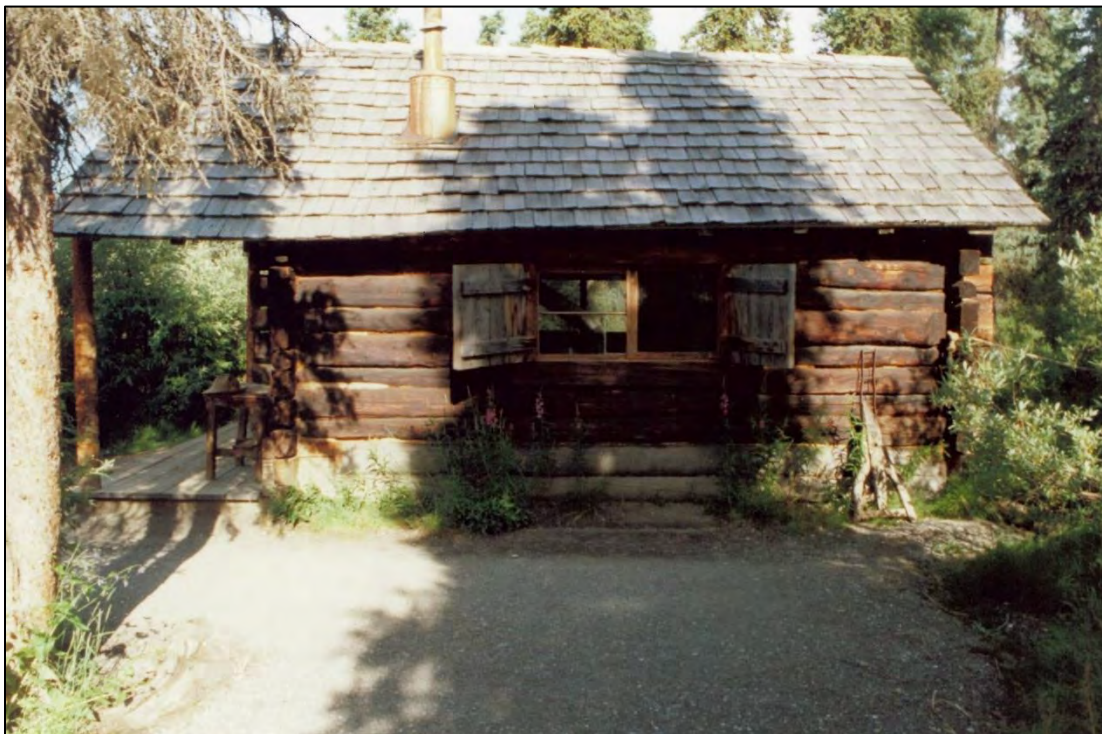
Fig 2.14. Side view of separated Upper Savage Cabin, 1999 National Park Service, Denali National Park and Preserve.

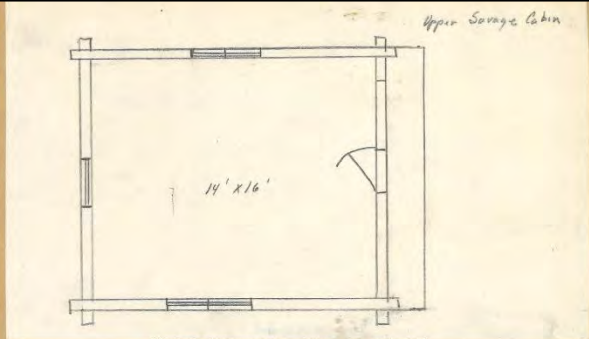
<p>Upper Savage Cabin</p> <p>14' x 16'</p>
YEAR BUILT <u>1924</u> REMODELED <u>1940</u> DRAWING NO. <u>None</u> OCCUPANCY <u>Occasional</u> ORIGINAL COST, \$ <u>2500</u> Present value, \$ <u>"</u> NUMBER STORIES <u>1</u> NUMBER ROOMS <u>1</u> Sq. Ft. <u>2000</u> Sq. Ft., Basement <u>224</u> 1st floor <u>"</u> 2d floor <u>"</u> Other <u>"</u>		
INSTRUCTION TYPE <u>LOG</u> Walls, exterior <u>LOG</u> Walls, interior <u>LOG</u> Floors <u>Plank</u> Roof <u>Roofing Paper</u>		REMARKS: This cabin was built out in the open at 13 mile on the highway with two cabins and covered runway between. They were moved to their present position in 1940 and only one cabin is now usable. The other is still on the moving skids. In the summer of 1949 a bear kept entering the cabin and it needs repair work and cleaning. A small cache is needed for food storage.

EXTERIOR FINISH: Walls <u>Log</u> Floors <u>Plank</u> Ceilings <u>Celex</u>		
UTILITIES: Water <u>None</u> Electric <u>None</u> Sewer <u>None</u> Phone <u>None</u>		
MECHANICAL EQUIPMENT: Sanitary <u>None</u> Heating <u>1 small stove</u> Fuel <u>Wood and coal</u> Electric <u>None</u> H. W. <u>None</u>		
EXISTING CONDITION OF BUILDING: Structural <u>Good</u> Mechanical <u>Good</u>		
FIRE PROTECTION: Hydrant size <u>None</u> Distance <u>"</u> Sprinklers <u>None</u> Extinguishing apparatus <u>None</u>		
PREPARED BY <u>Mr. J. N. MacGuffey, Park Ranger</u> APPROVED <u>"</u> Photos prepared by <u>George M. Peters, Park Ranger</u>

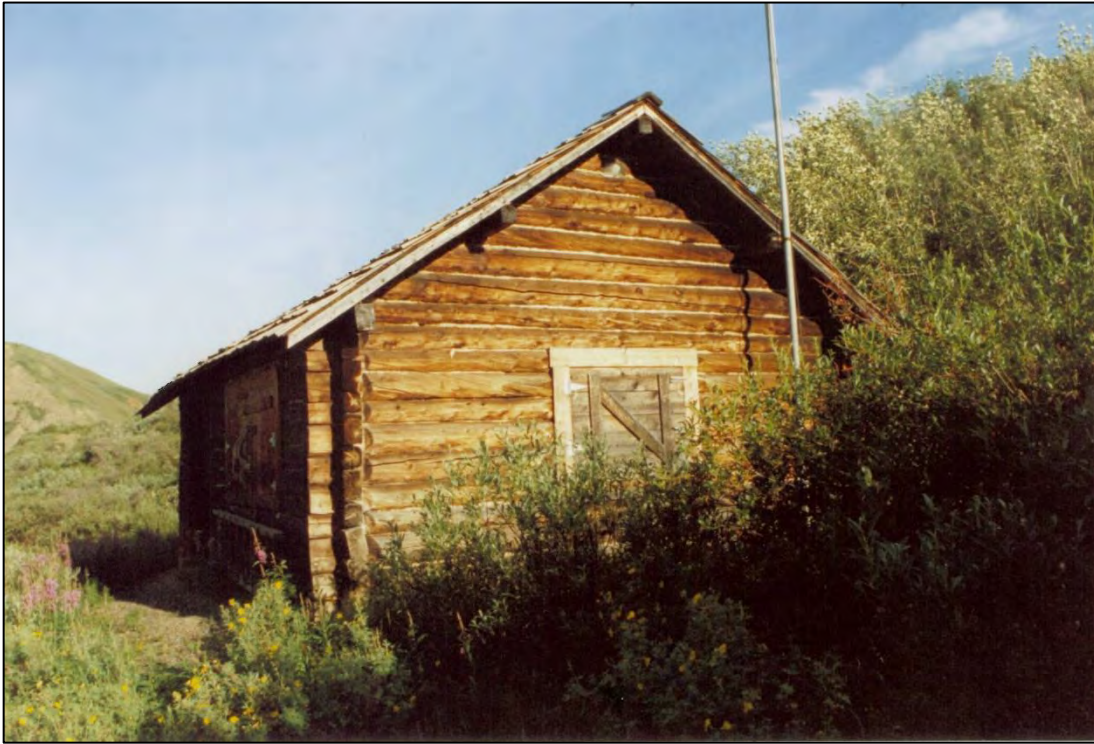
Fig 2.76. Back of the East Fork Cabin, 1999. National Park Service, Denali National Park and Preserve.

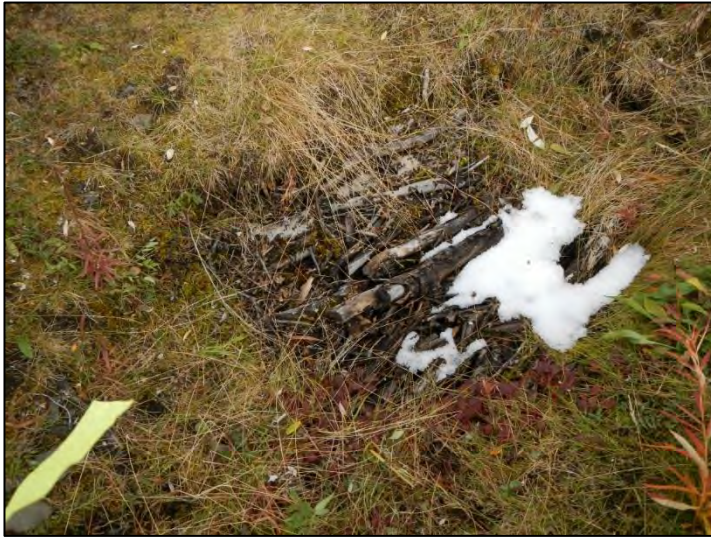
*Fig 3.56. East Fork Undetermined Pit 1 (NPS, 2015).*
