U.S. Department of the Interior  
National Park Service

# Lincoln Memorial Reflecting Pool & Grounds Rehabilitation

18 March 2010

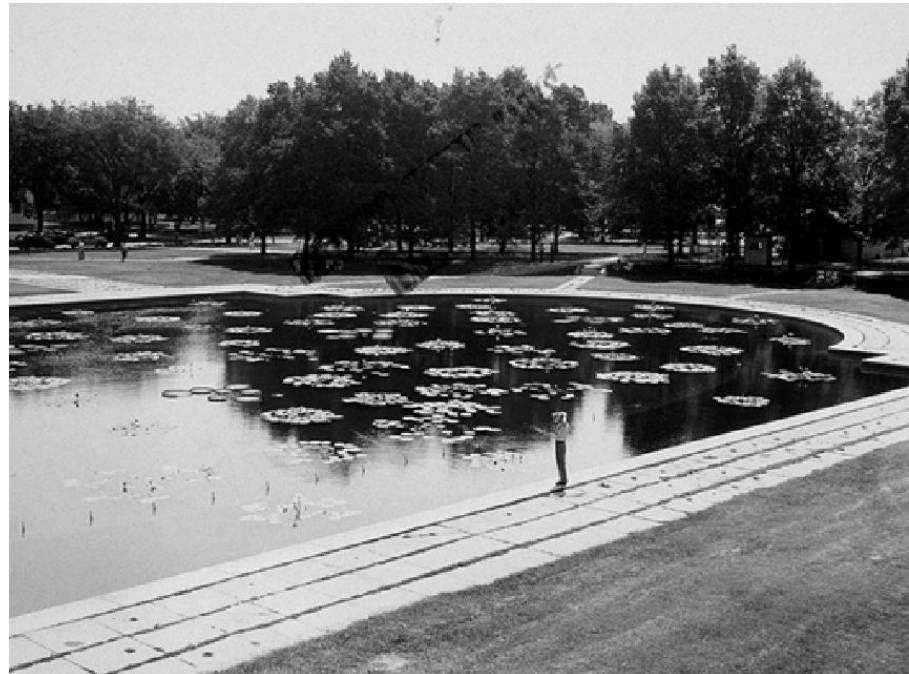
Historic Image of Rainbow Pool with Adjoining Concrete Walk

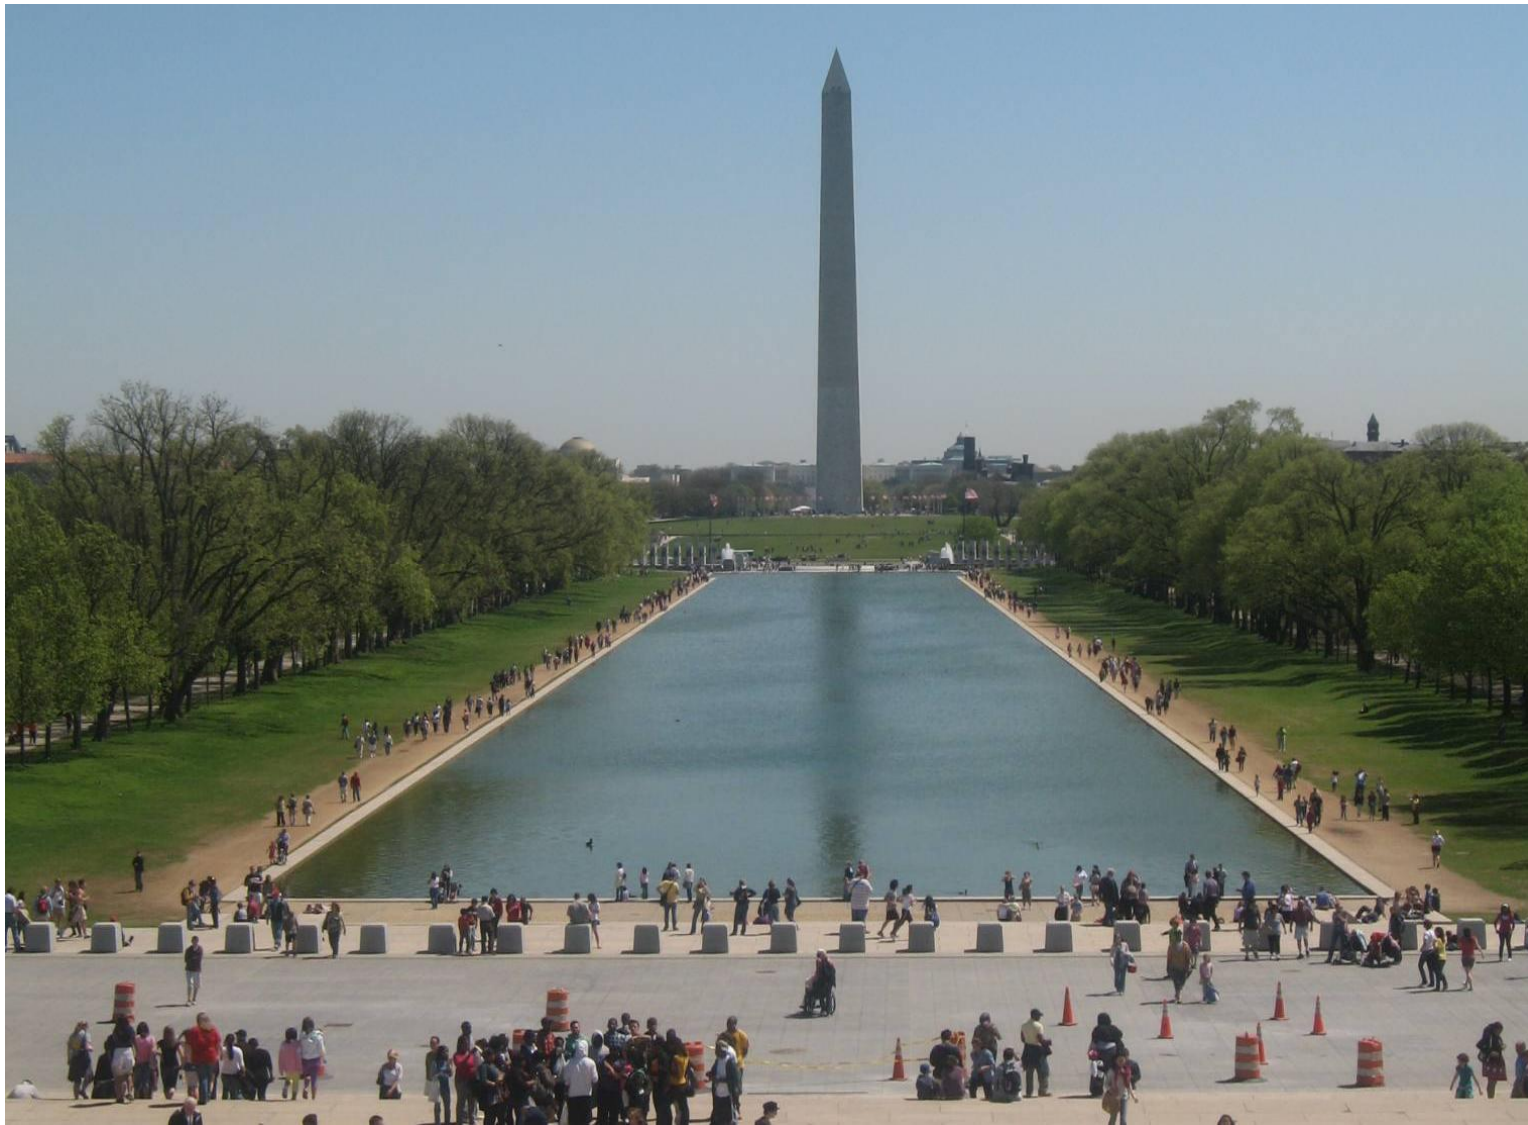
Existing Conditions with 15-16' Wide Social Trails - April 2009

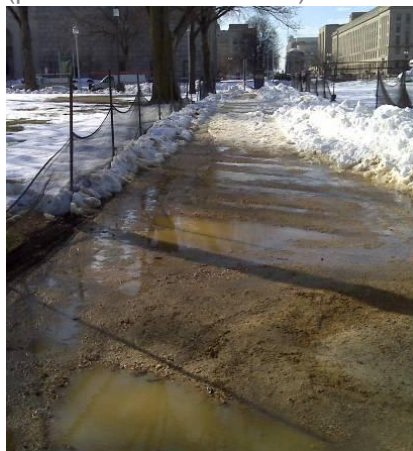
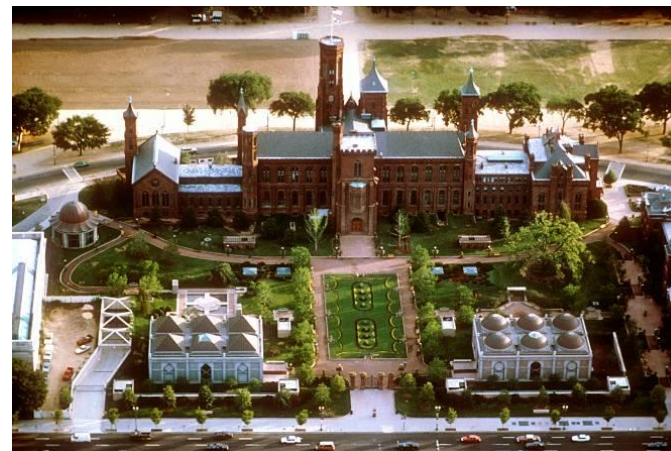
National Sculpture Garden uses granite paving for primary paths. Stone dust used for secondary pathways (photo from 2010-02-23)

Existing stone dust path at National Mall after recent snowfall, showing drainage issues and difficulty of snow removal (photo from 2010-02-26)

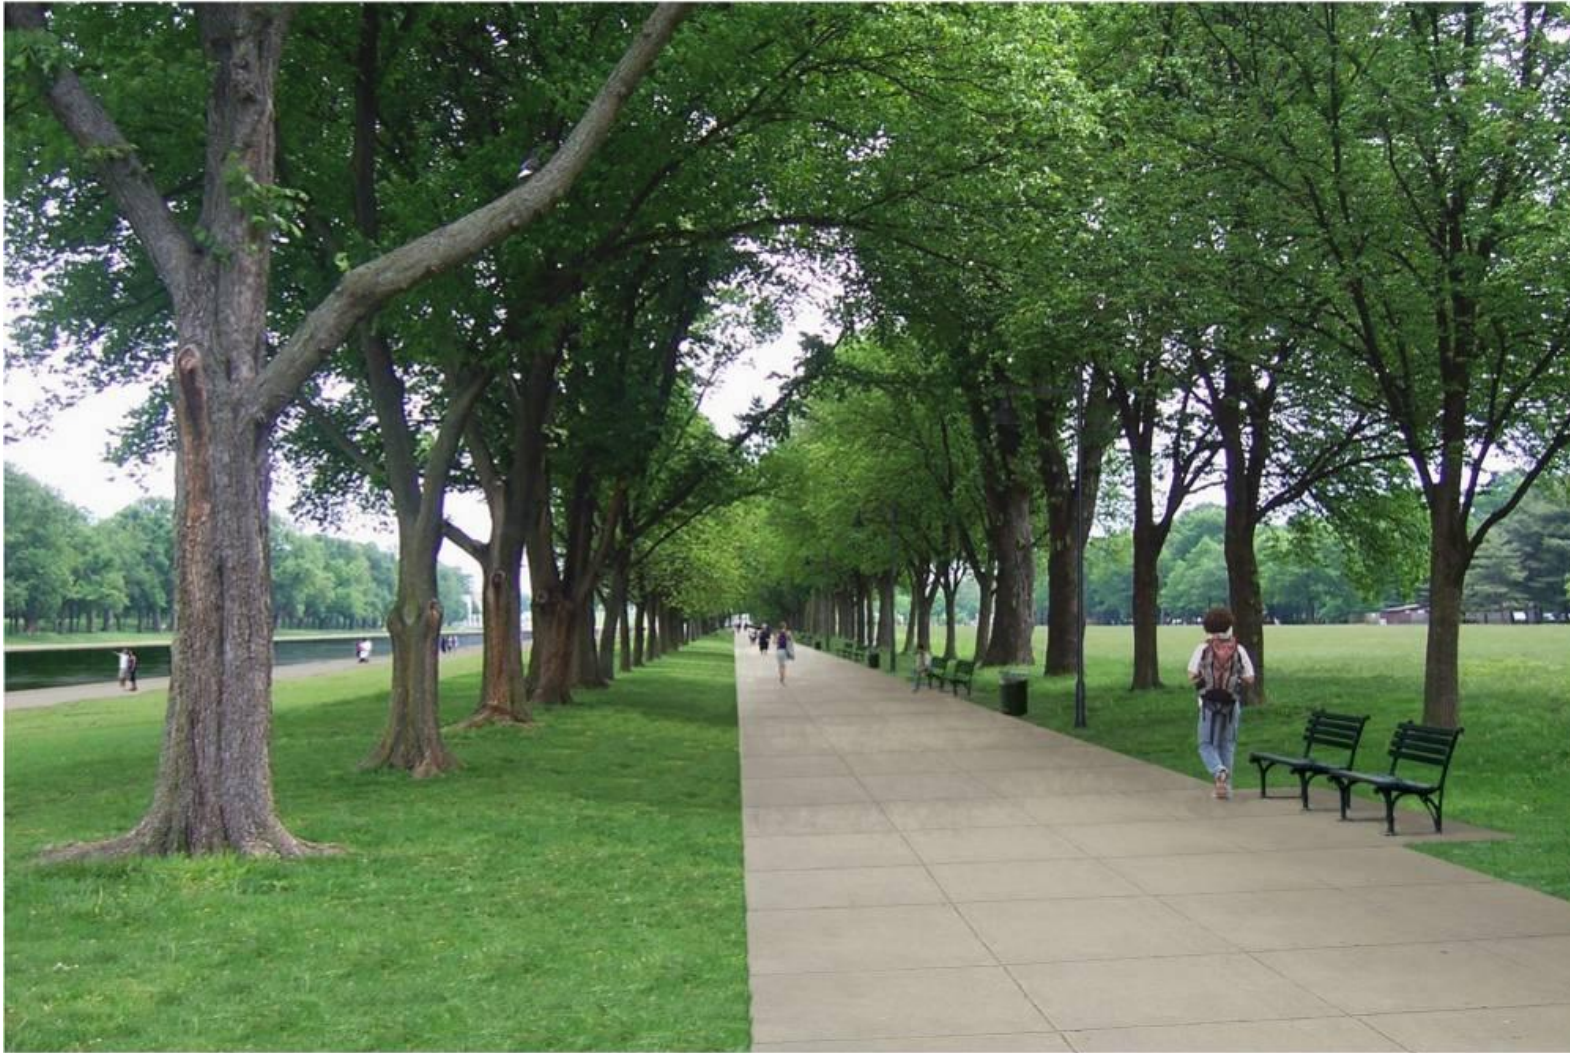
Surface Material - Concrete Option

15' P.I.P. Concrete Path  
(Historic Paving Pattern to  
Match Adjoining)

New Benches  
(to Match Existing and New  
Arrangement)

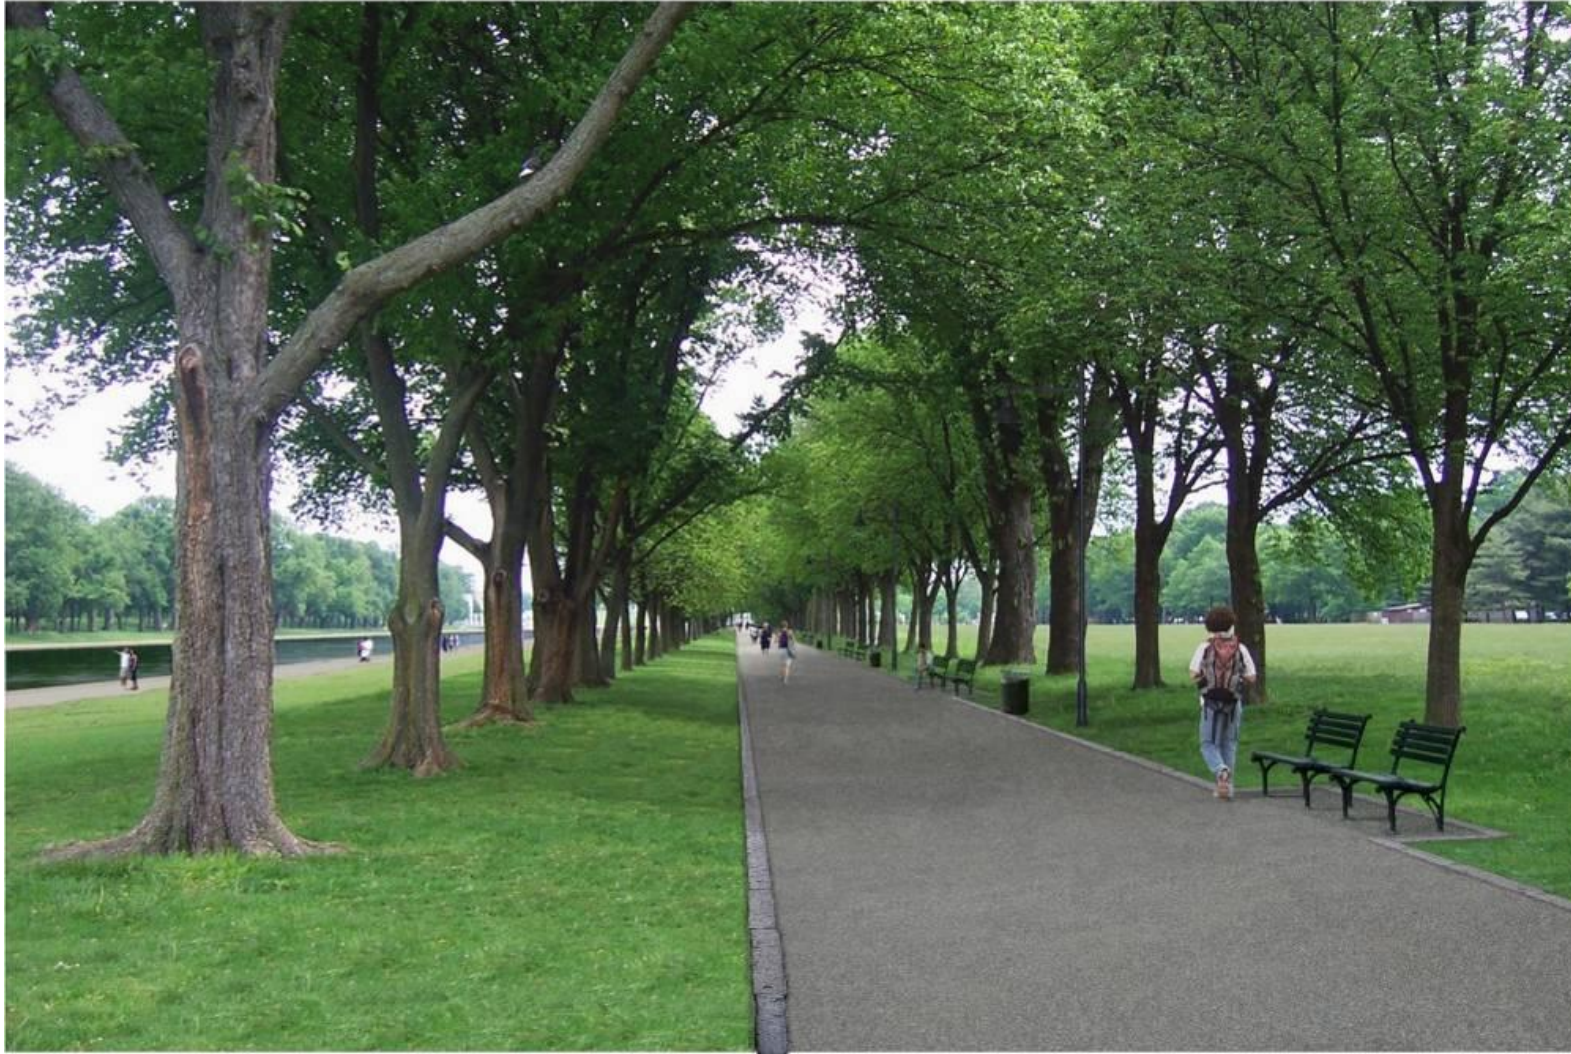
Surface Material – Asphalt – Recommended Option

15' Asphalt Walk

Flush 6" Granite Edging

New Benches  
(to Match Existing and New  
Arrangement)

Asphalt is the recommended option for the Elm Walks due to National Park Service positive experience with the material. Since the bicentennial, NPS has found asphalt easy to maintain and durable at this location. Asphalt is flexible pavement that responds well to both pedestrians and occasional vehicular traffic. Additionally, traditional material for park pathways and blends with the landscape better than concrete.
