## Appendix 5: Draft Cultural Landscape Inventory (CLI) (detached)

National Park Service  
Cultural Landscapes Inventory  
2006

Carbon River Road  
Mount Rainier National Park

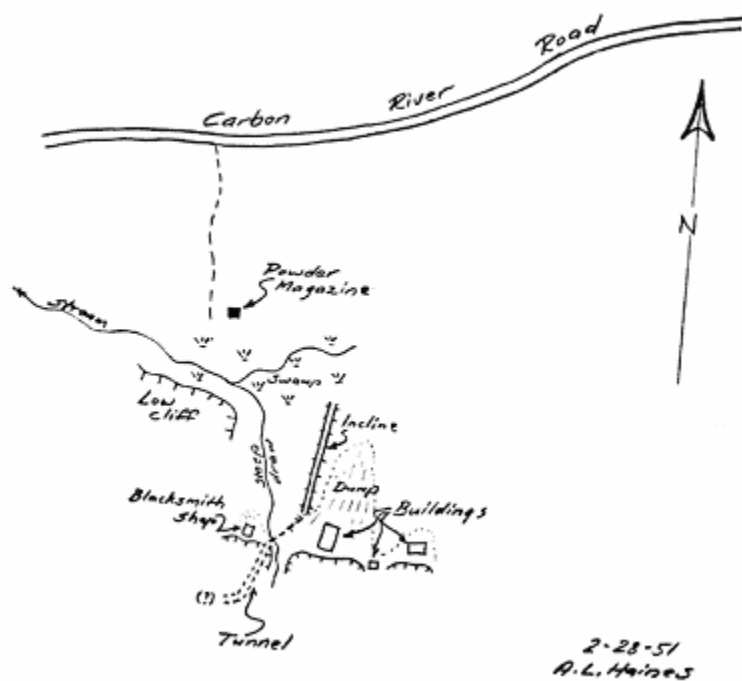
*History #1: Drawing illustrating the location of an abandoned mine along the south side of the Carbon River Road, approximately one mile east of the entrance, 1951 (MORA Archives).*

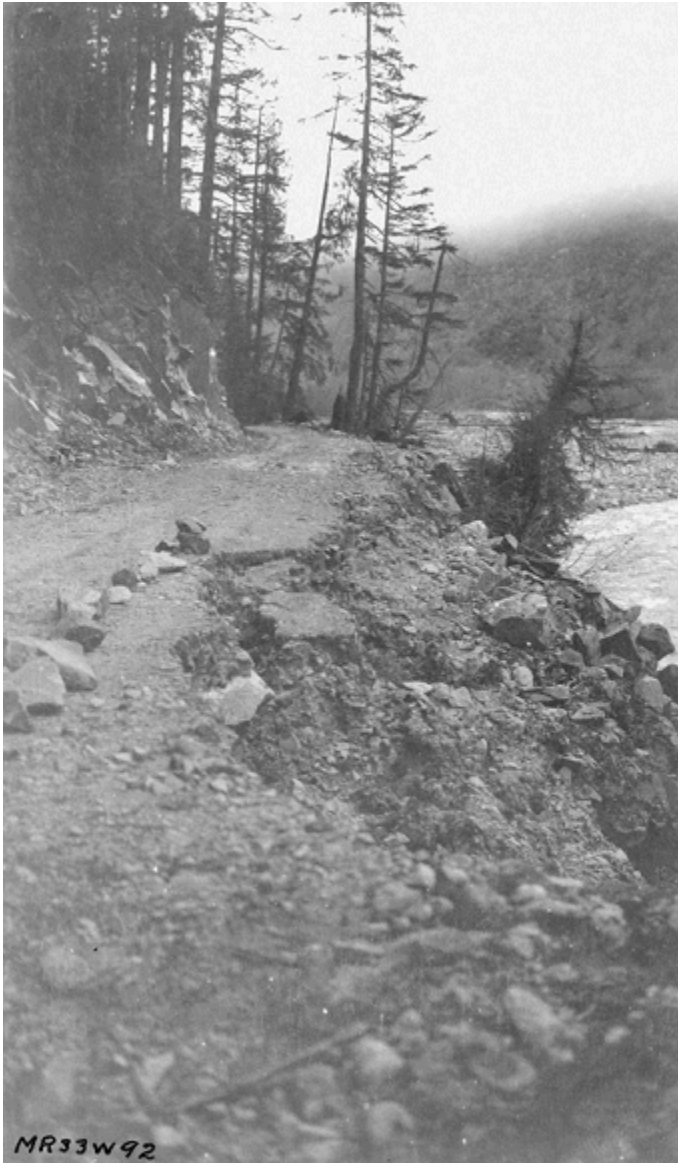
*History #5: Historic photograph, looking west, showing flood damage on the Carbon River Road, n.d. (Photo Number: e77, MORA Archives).*

Not only did Peters commend the design quality of the Carbon River Road, but he also continued to embrace the “Around the Mountain Road” idea. Despite Peters’ optimism, the last section of the Carbon River Road was not completed in 1922. As construction resumed in the spring of 1923, extra time and money was needed to repair portions of the road that had been damaged by winter flooding. Chief Engineer Goodwin and the new park Superintendent C.L. Nelson discussed the need for river revetments to protect the road (Goodwin to Nelson: February 14, 1923). By the summer of 1924, emergency roadwork had commenced because of additional flood damage to the Carbon River Road. At this time, funds had been allotted for revetments, which included the construction of cribbing. In a pedantic letter from Director Mather to yet another new park Superintendent Owen A. Tomlinson, Mather urged the park to finish the repair and revetment work in order to “save further damage to Government property, namely the Carbon River Road,” revealing his frustration with the project (Mather to O.A. Tomlinson: July 25, 1924). At the time, Mather could not know that Tomlinson would remain the park Superintendent for a record 17 years, and would provide the staying power behind much of Mather’s vision for the park. (see photos, history #5 and history #6)

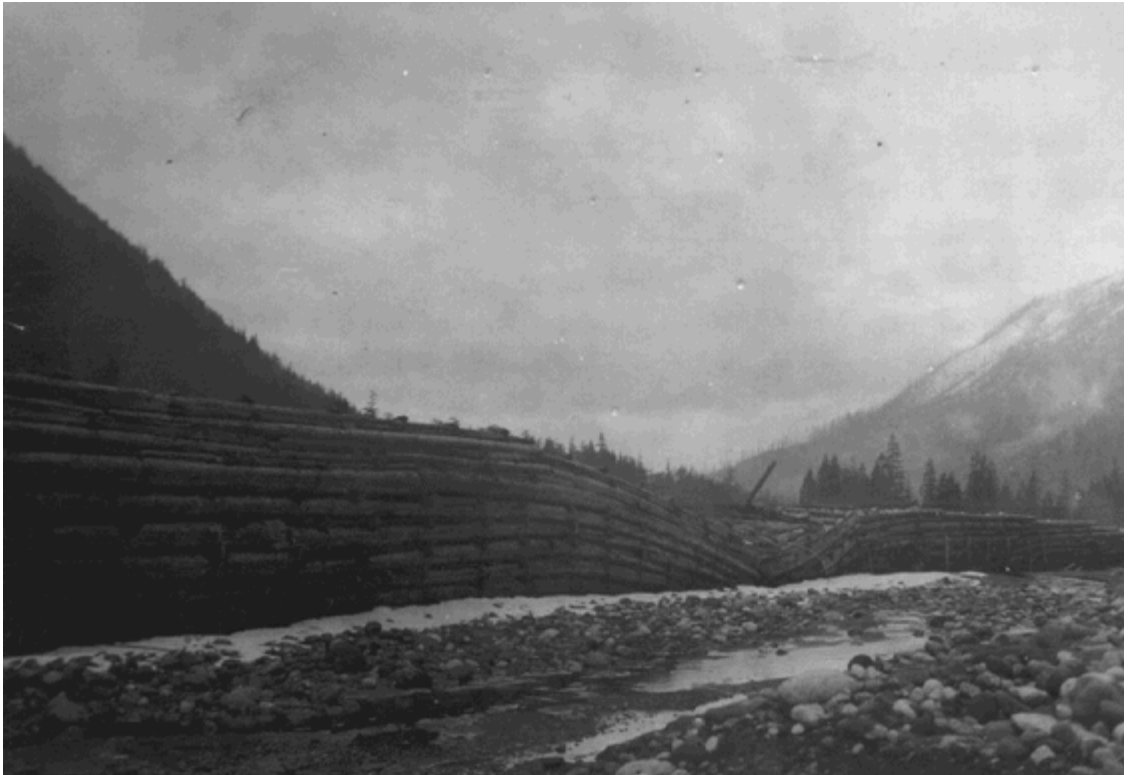
*History #6: Log cribbing constructed along the Carbon River, c. 1925 (Photo Number: twc586, MORA Archives).*

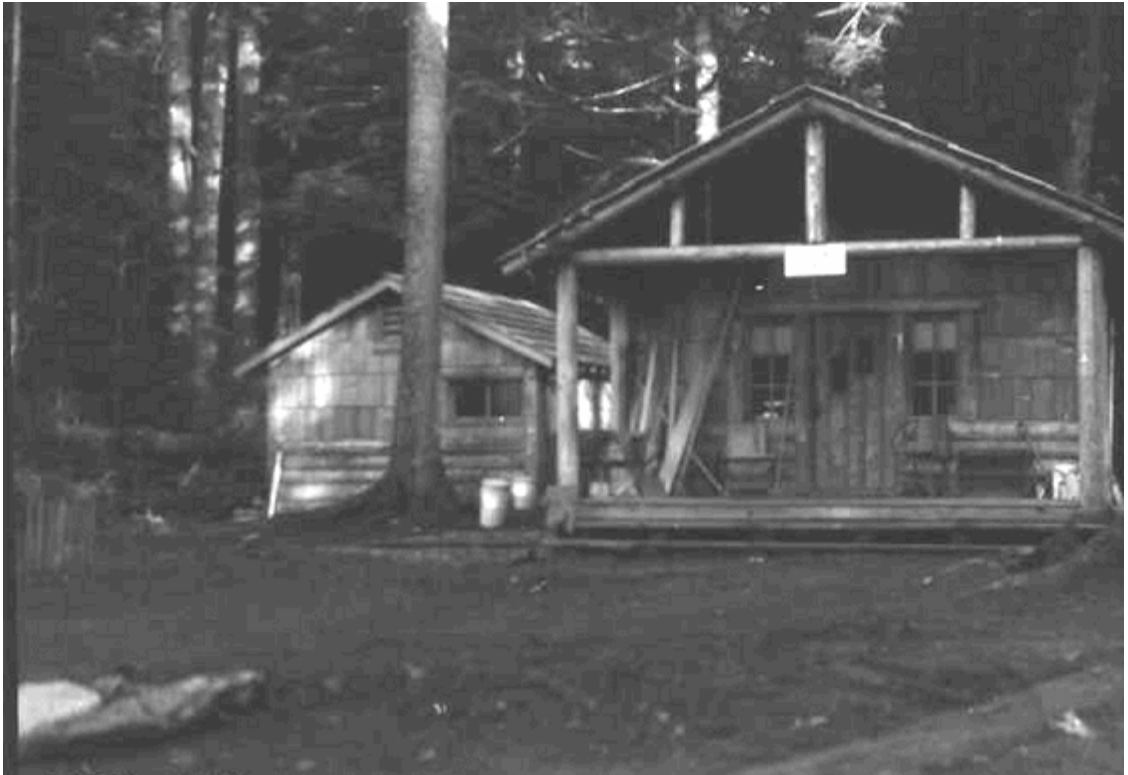
*History #7: Historic photograph showing the Carbon River Ranger Station at the Carbon River Entrance and an associated woodshed, 1931 (Photo Number: n4036, MORA Archives).*

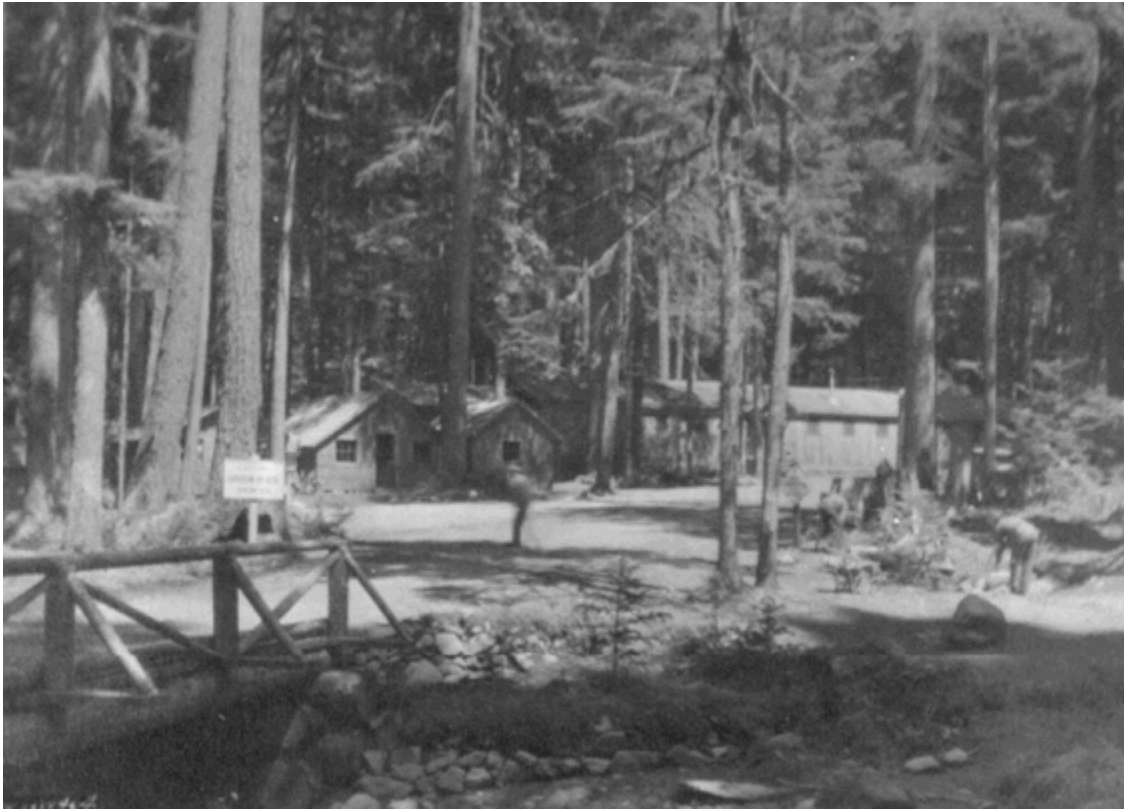
*History #8: Historic photograph, looking northeast, showing temporary CCC buildings at Camp No. 3, located in the Ipsut Creek Campground, c. 1939. Note the Ipsut Creek Bridge in the foreground (Photo Number: is1141, MORA Archives).*

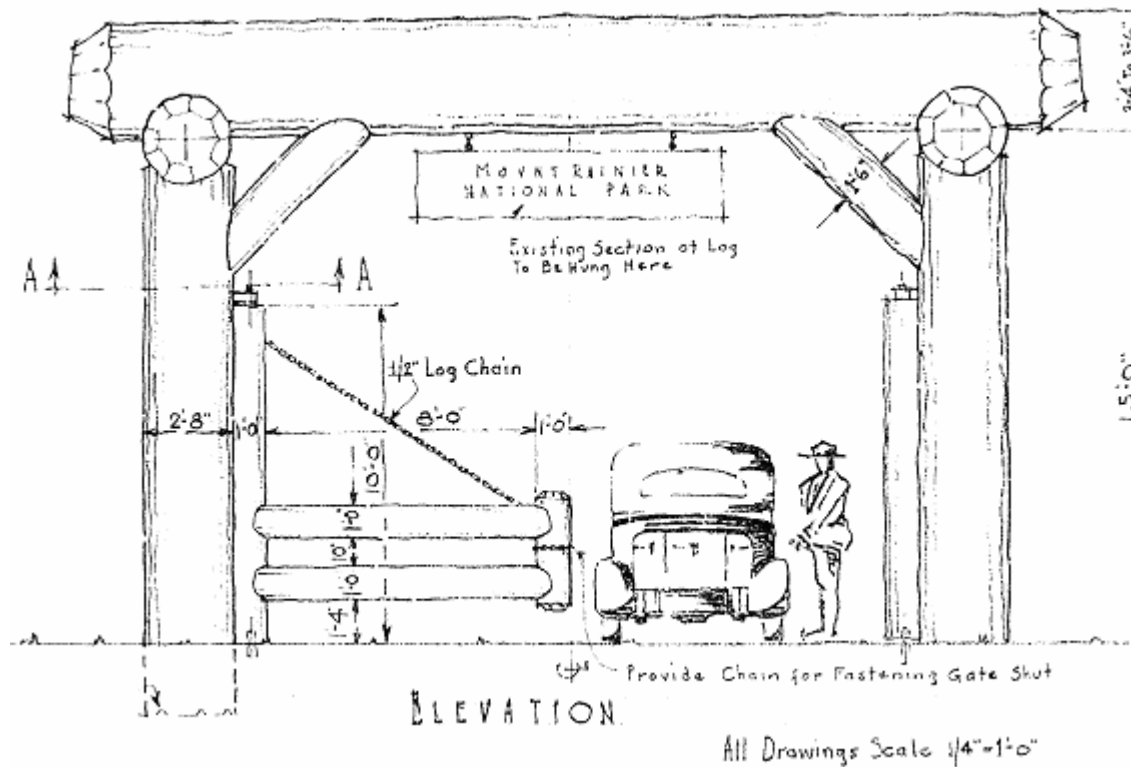
*History #9: Historic drawing illustrating the construction plan for the Carbon River Entrance Arch, 1933 (Microfiche etc: 8403, MORA Archives).*

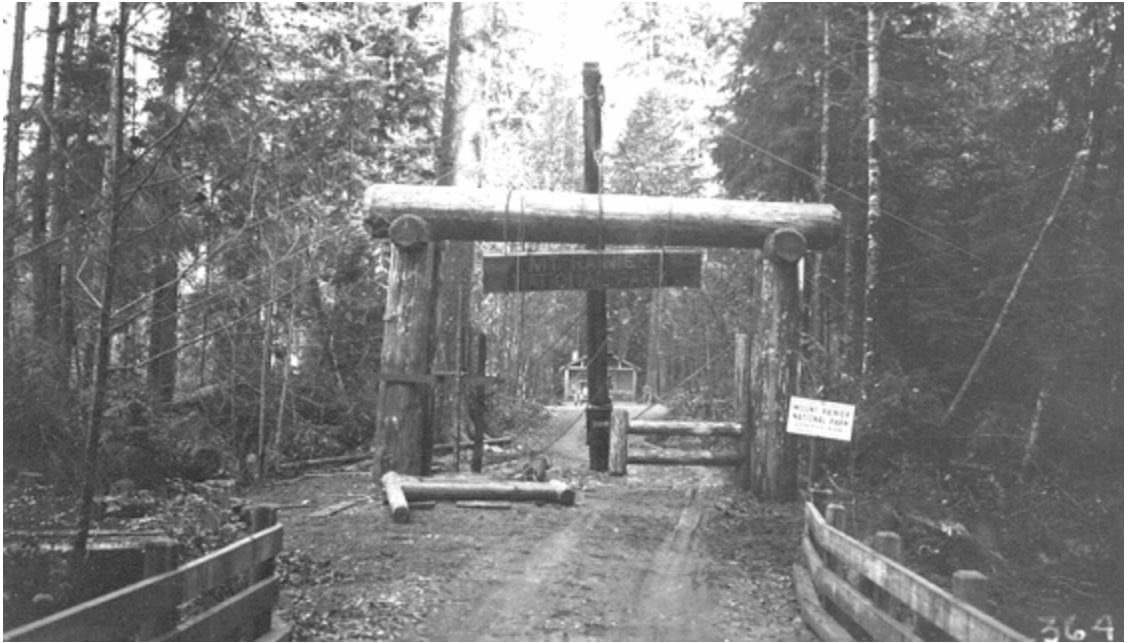
*History #10: Historic photograph, looking east, showing the Carbon River Arch under construction, c. 1933 (Photo Number: ps3649, MORA Archives).*

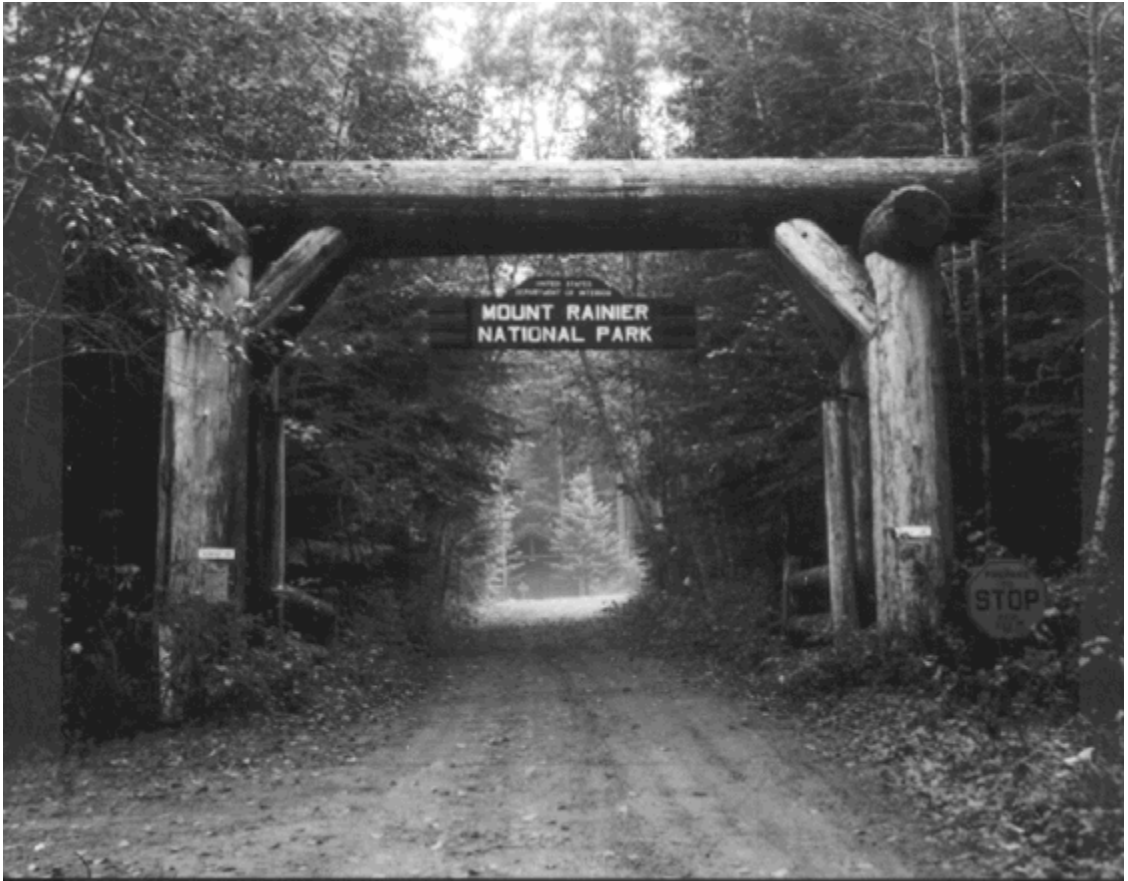
*History #11: Historic photograph, looking east, showing the Carbon River Arch. Note the Carbon River Ranger Cabin in the background, 1953 (Photo Number: is1953, MORA Archives).*

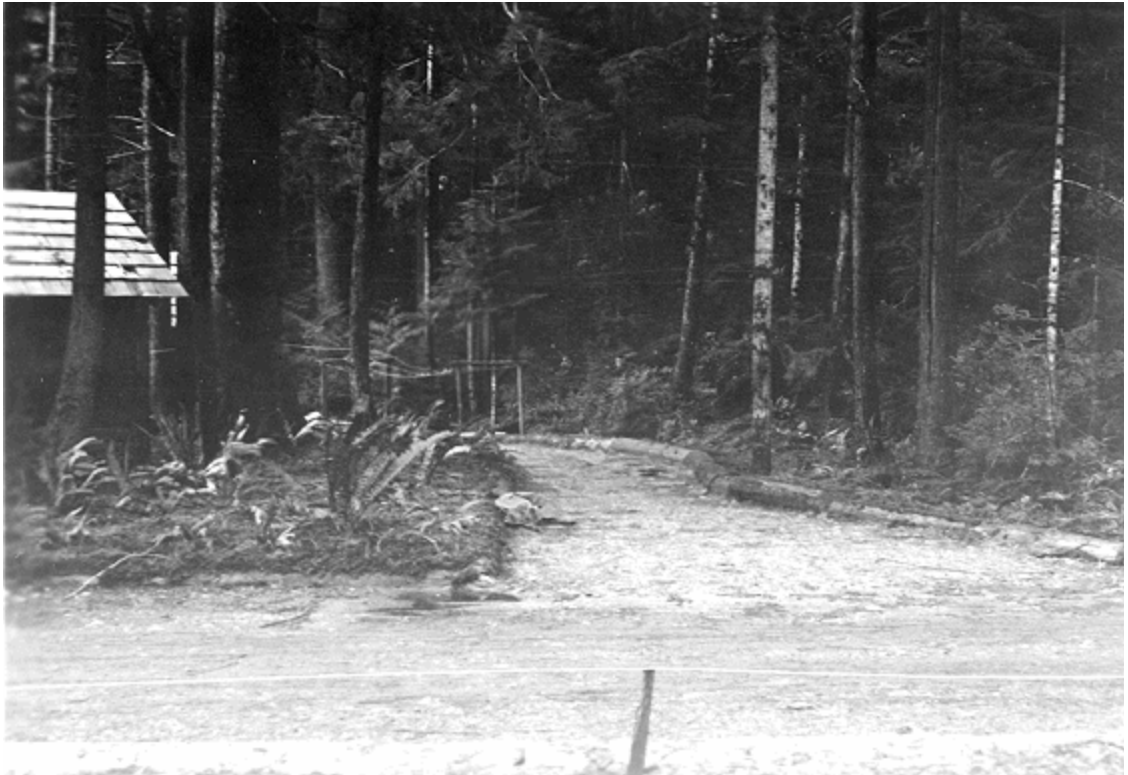
*History #12: Historic photograph, looking north, showing the service drive behind the Carbon River Ranger Station, located at the Carbon River Entrance, n.d. (Photo Number: twc587, MORA Archives).*

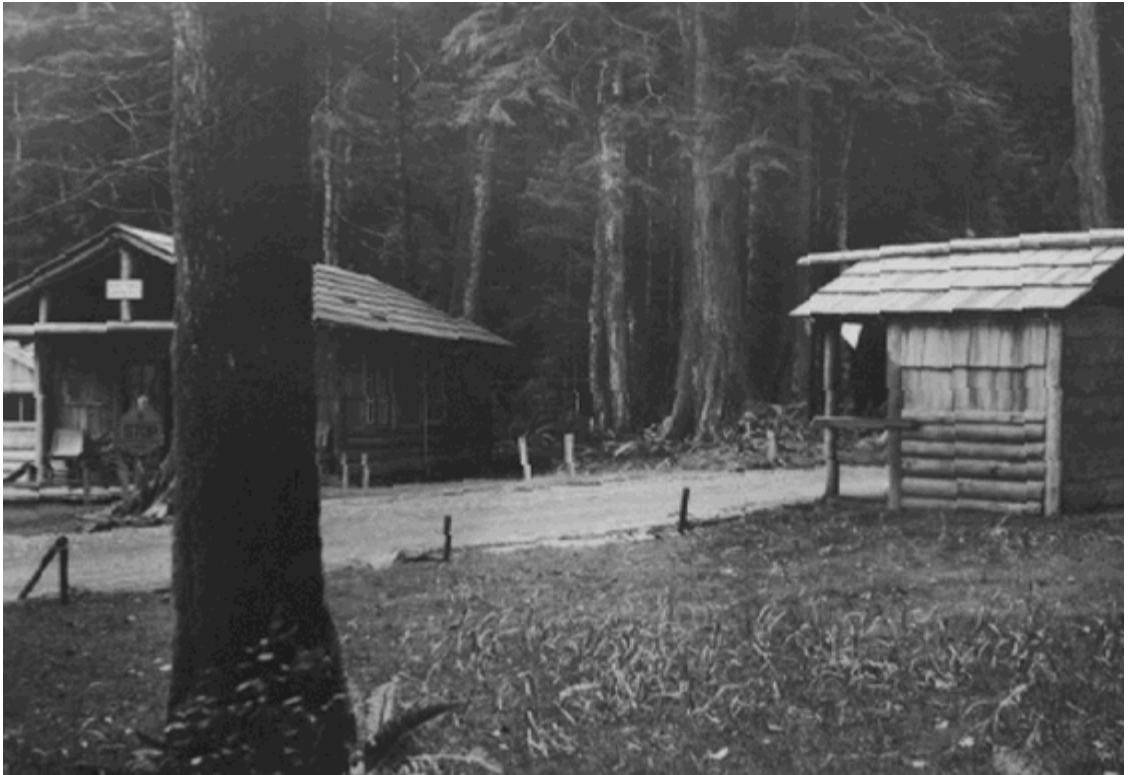
*History #13: Historic photograph, looking northeast, depicting the Carbon River Entrance area. Note the orientation of the road in relationship to the Registration Booth and the Ranger Cabin, n.d. (Photo Number: twc588, MORA Archives).*

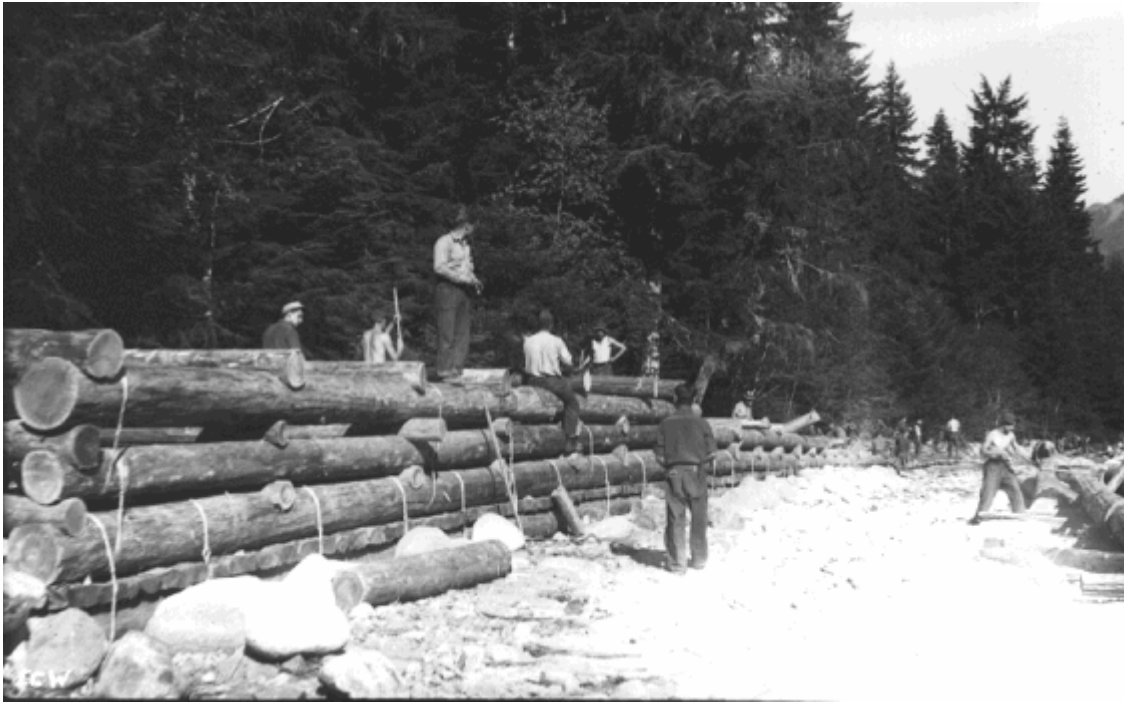
*History #14: Historic photograph depicting CCC crews constructing log cribbing along the Carbon River, c. 1934 (Photo Number: n4502, MORA Archives).*

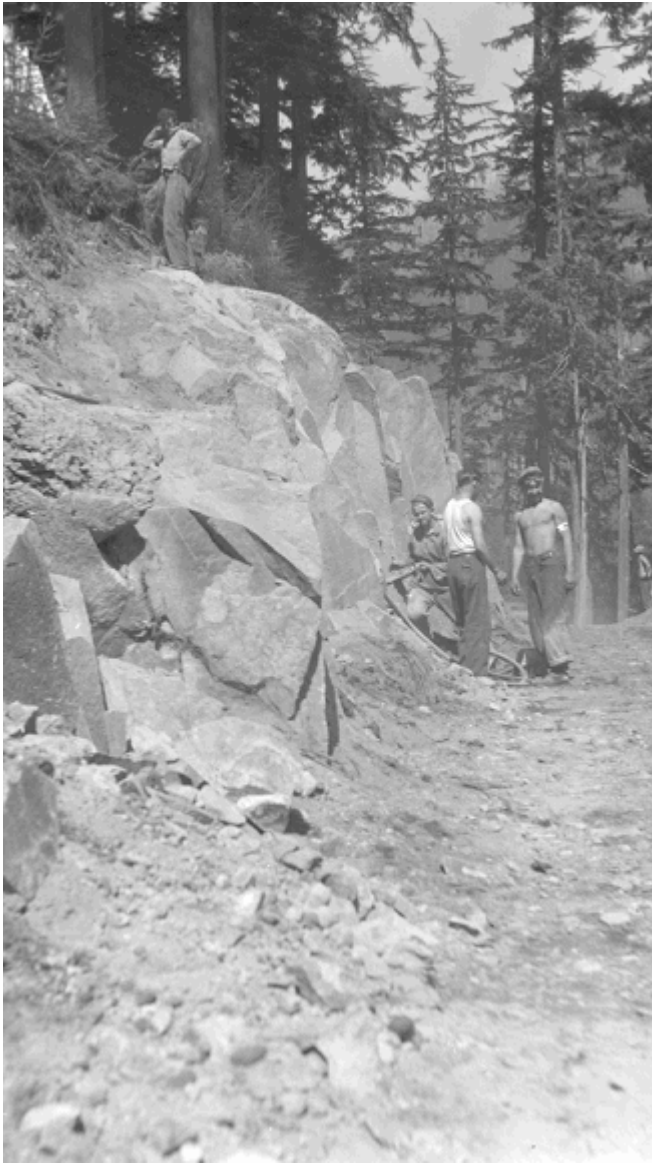
*History #15: Historic photograph, looking west, showing CCC crews drilling rocks in an effort to widen the Carbon River Road, c. 1935 (Photo Number: n4500, MORA Archives).*

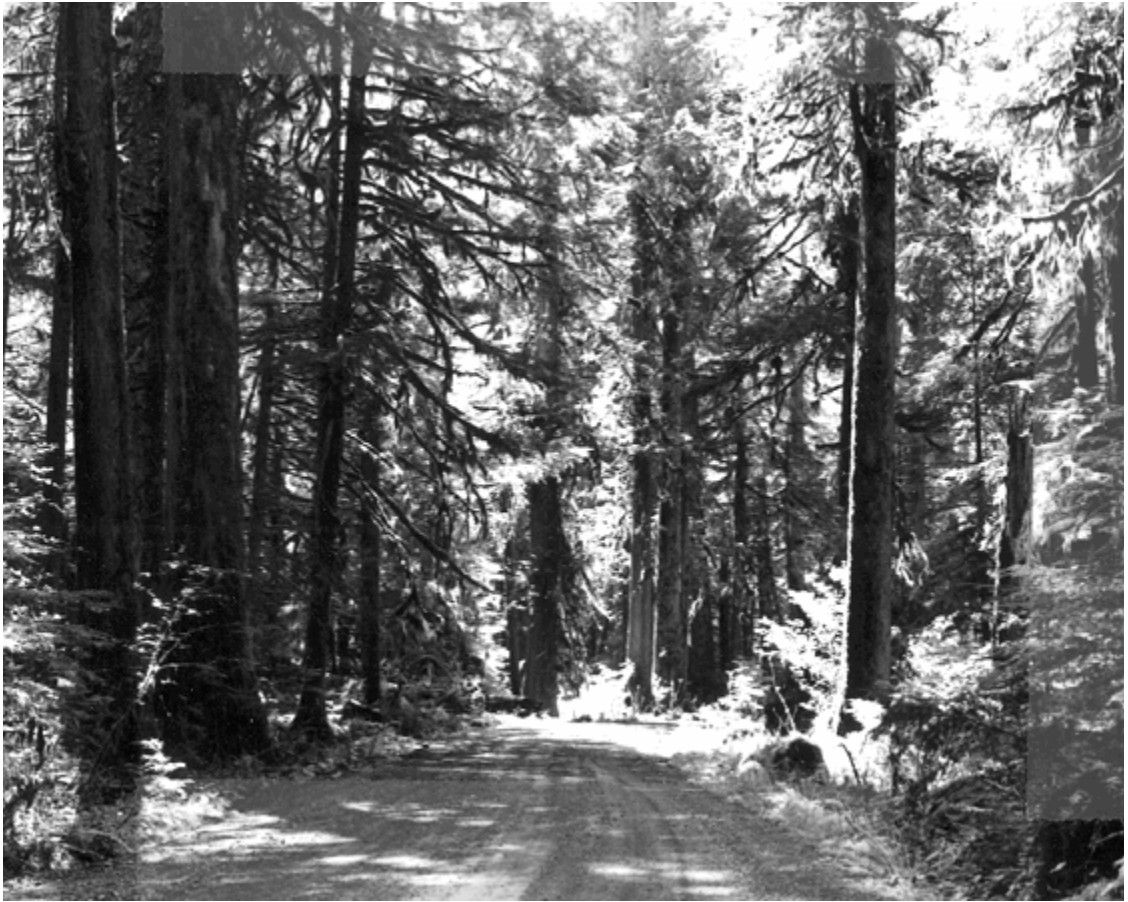
*History #17: Historic photograph of the Carbon River Road, 1961 (Photo Number: is1681, MORA Archives).*

As the 1960s began, park officials continued to maintain and improve the Carbon River District while following the objectives of the Mission 66 Plan. In 1961, the road was re gravelled and graded by a local company from Fairfax (Chief Ranger's Report, July 1961). (see photo, history #16) In 1960, the park's trail crew constructed a corral in the utility area, for the storage of trail pack horses (Chief Ranger's Report, July 1960). In the following year, the ranger station and wood shed at the Carbon River Entrance received new concrete slab footings and the buildings were slightly realigned (Chief Ranger's Report, September 1961). Unfortunatously, just one year later the ranger station and wood shed burned down, due to an unattended wood stove. This left the Carbon River rangers having to live in a trailer for two seasons (Thompson 1981, 186). To provide better accommodations, a "transa-house" was installed at the entrance in 1965 on poured concrete footings (Carbon River Sub-District Manual, General Description-Introduction, Chapter 1 Section 2, Page 3, 1967).

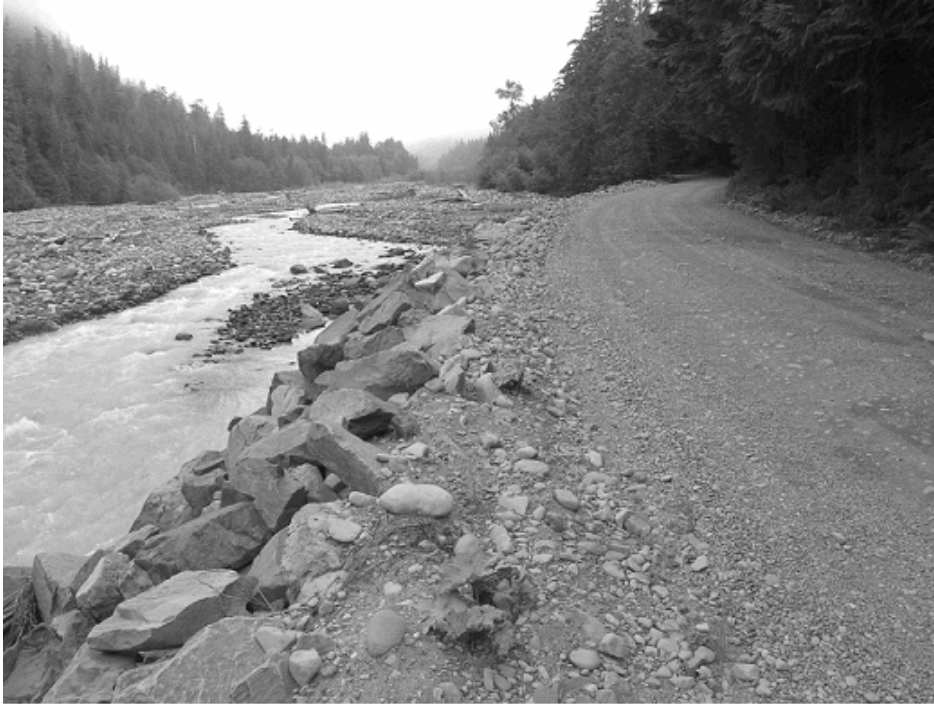
*Natural Systems and Features #1: Contemporary photograph showing the location of the Carbon River in relationship to the road. Note the non-contributing riprap along the riverbank, which serves to protect the road from high waters (MORA, 2006).*

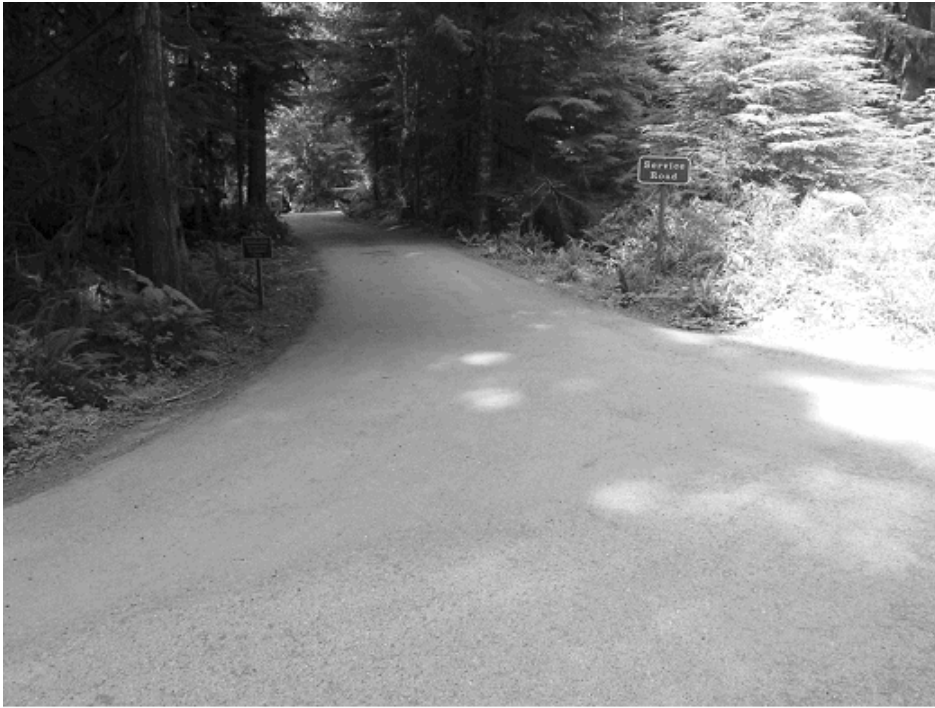
*Spatial Organization #3: Contemporary photograph, looking north, showing the contributing service road that is associated with the utility area (MORA, 2006).*

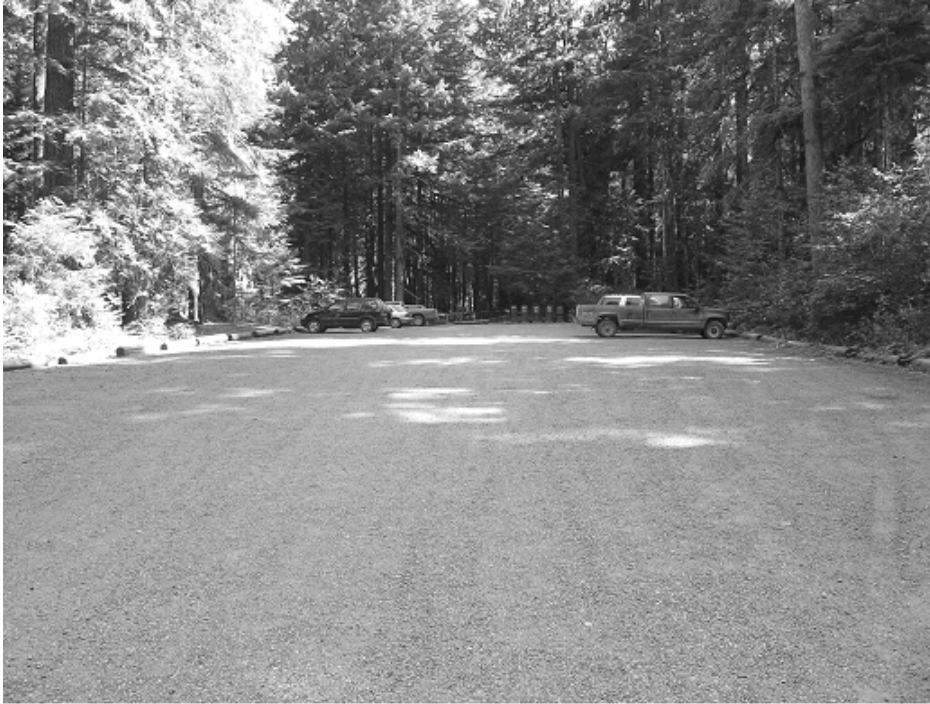
*Spatial Organization #4: Contemporary photograph, looking east, showing the Wonderland Trailhead parking area. Today, the Carbon River Road terminates at this location; however, historically the road extended three miles further (MORA, 2006).*

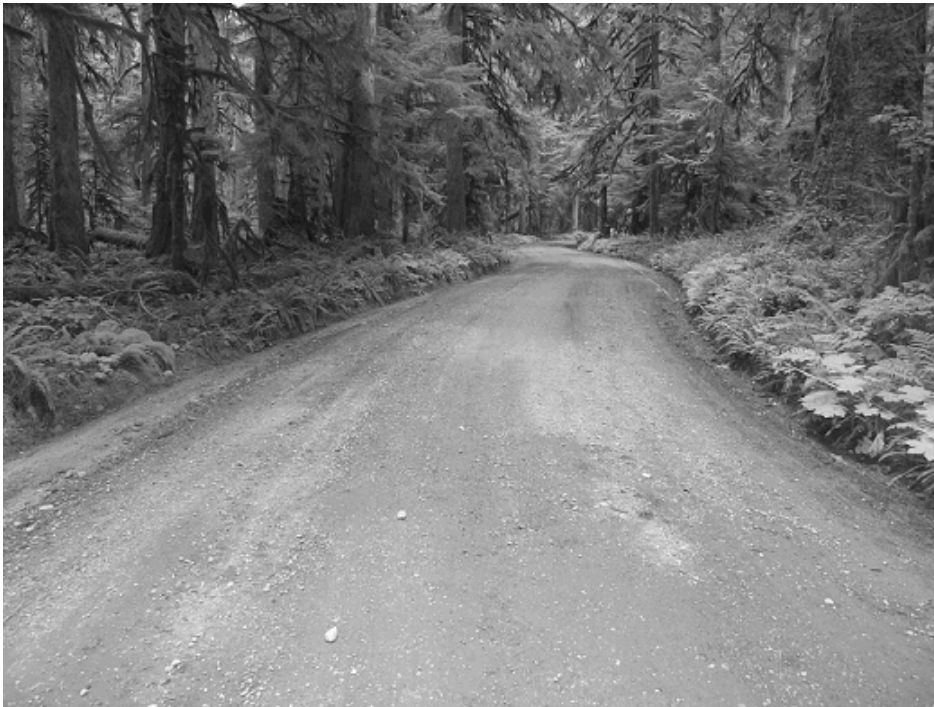
*Circulation #1: Contemporary photograph showing the prism of the Carbon River Road. This photograph is representative of a large proportion of the road, which is defined by a crowned double ditch construction (MORA, 2006).*

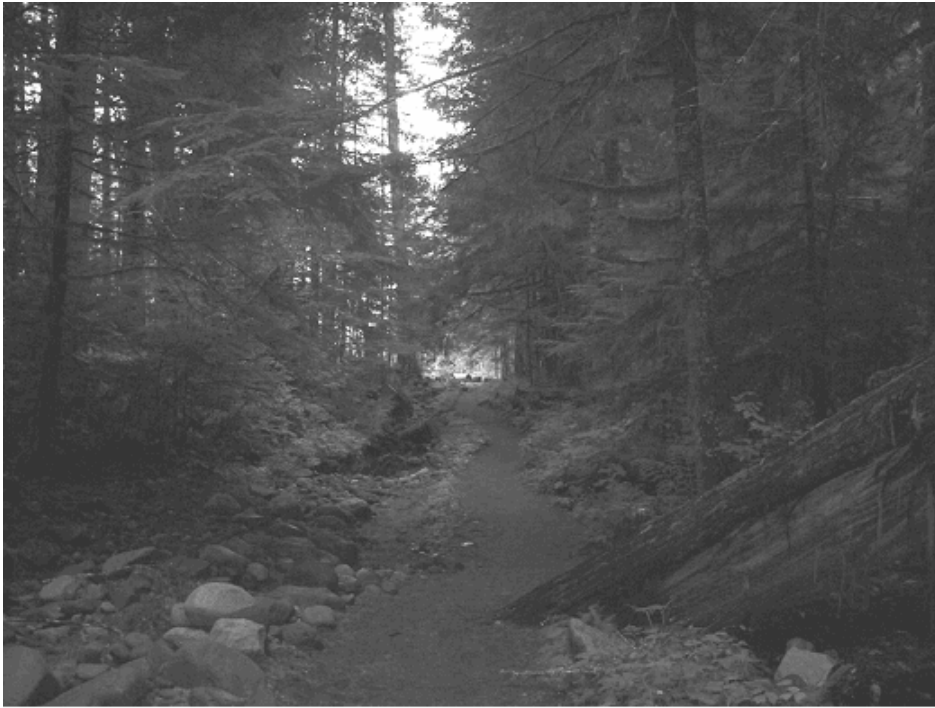
*Circulation #2: Contemporary photograph showing a portion of the Wonderland Trail, located east of the Ipsut Creek Campground. Portions of this trail are situated in the historic location of the Carbon River Road (MORA, 2006).*

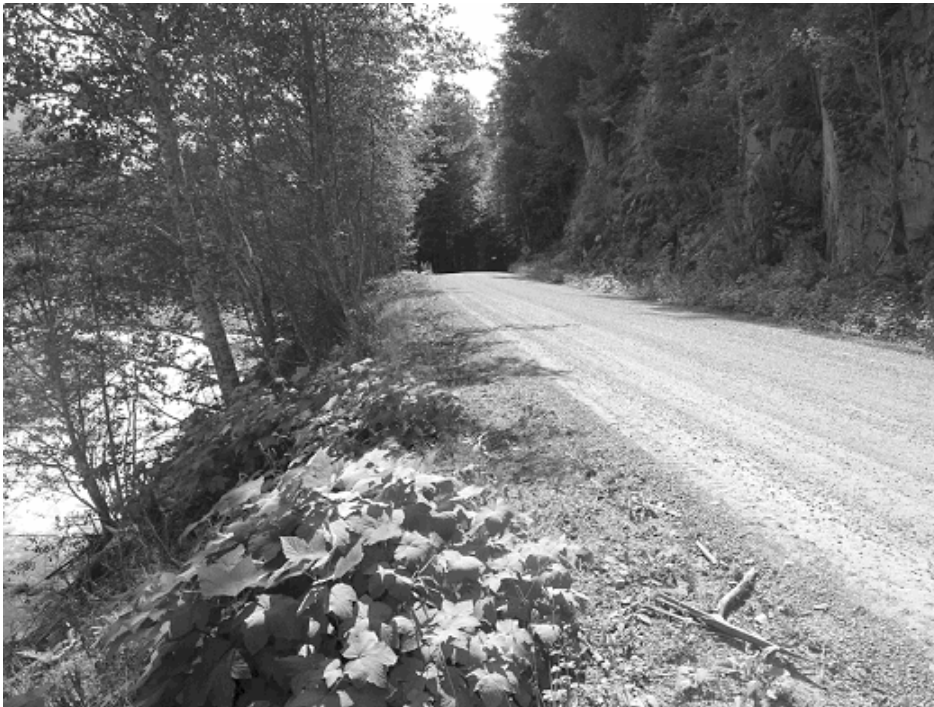
*Topography #1: Contemporary photograph, looking east, illustrating the rock cut bench cross section of the Carbon River Road near Ranger Creek. Note the close proximity of the Carbon River on the northern side of the road (MORA, 2006).*

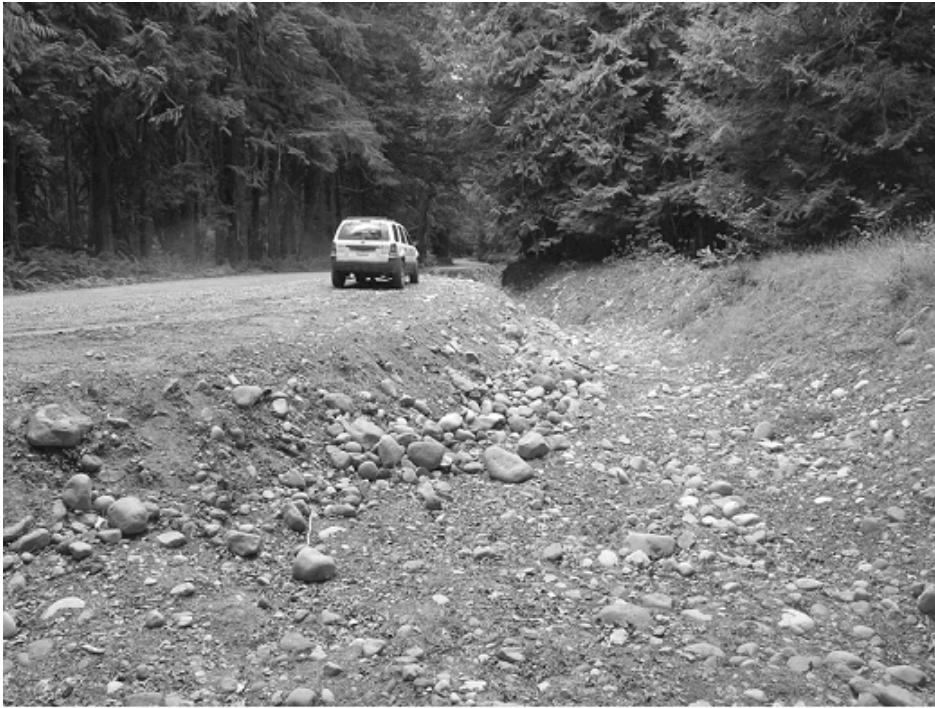
*Topography #2: Contemporary photograph showing flood damage associated with the Carbon River Road near the Evans Cabin site (MORA, 2006).*

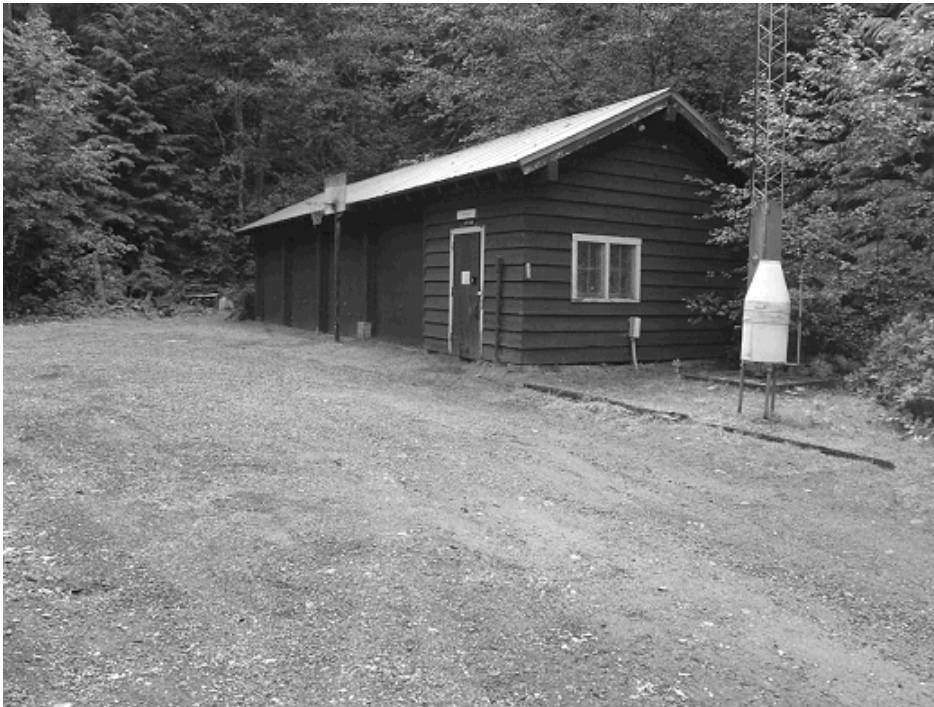
*Buildings and Structures #1: Contemporary photograph showing the utility building, located near the park entrance. Today, this building serves as a contributing landscape feature due to its association with the CCC in the Carbon District (MORA, 2006).*

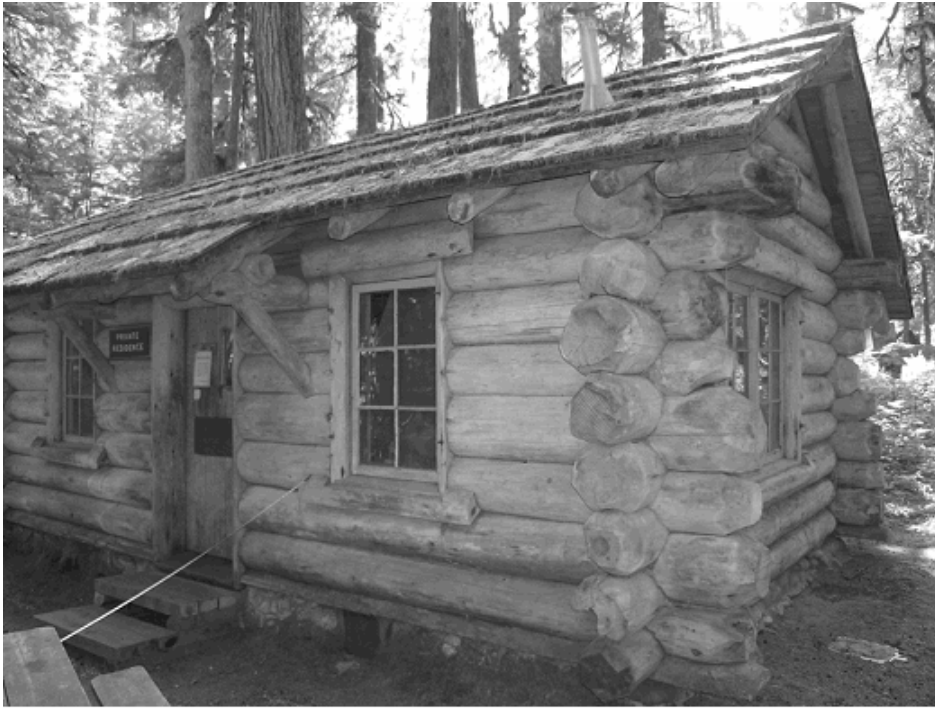
*Buildings and Structures #3: Contemporary photograph, looking south, showing the Ipsut Creek Patrol Cabin. Constructed in the 1930s as a result of CCC efforts, this building is a contributing landscape feature (MORA, 2006).*

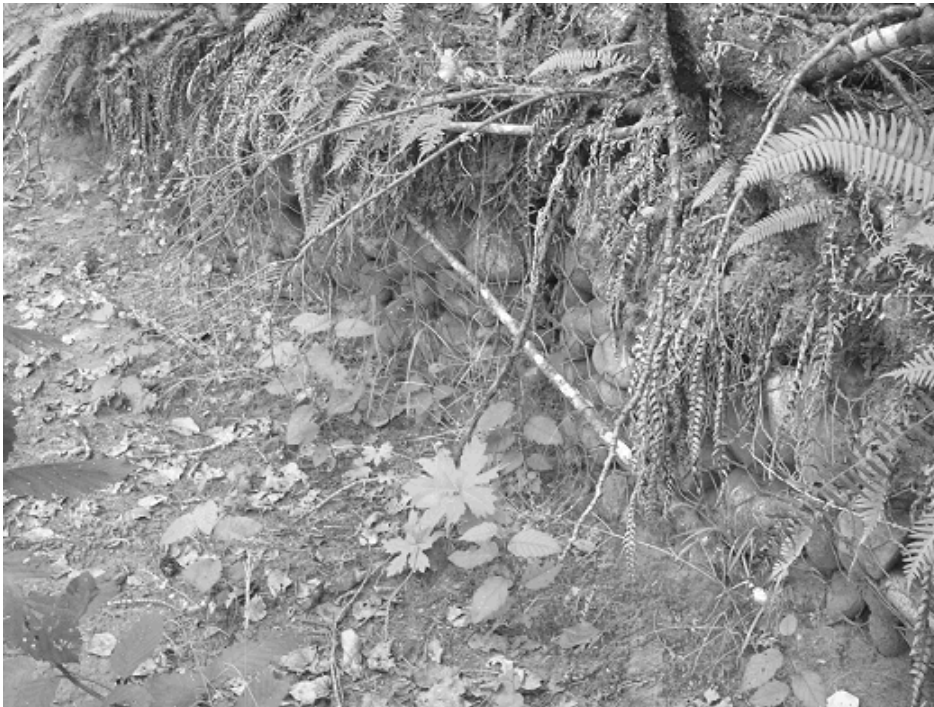
*Small Scale Features #1: Contemporary photograph illustrating a rock gabion, which serves as a non-contributing flood control device (MORA, 2006).*

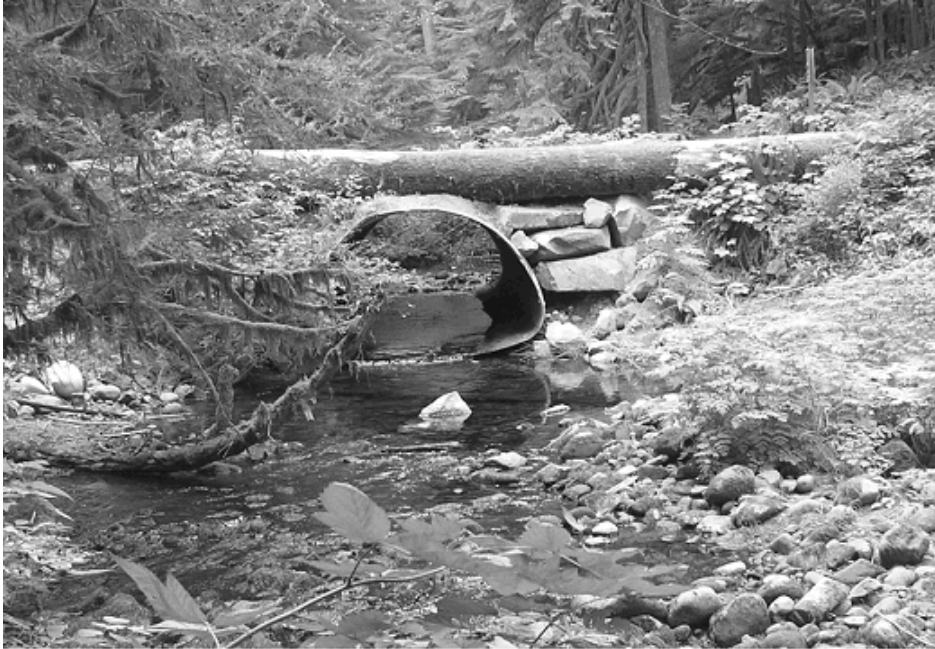
*Small Scale Features #2: Contemporary photograph showing a non-contributing culvert at Ranger Creek, near the Green Lake Trailhead (MORA, 2006).*

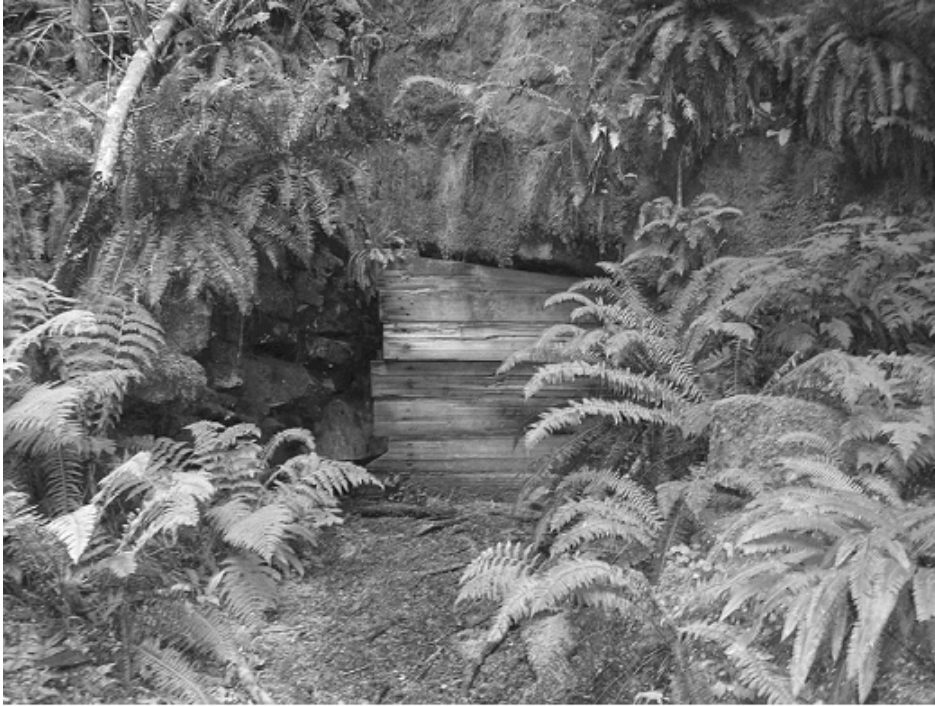
*Archaeological Sites #2: Contemporary photograph showing the boarded entrance of a historic mine, located on the southern side of the Carbon River Road. This contributing archaeological site is located one mile from the park entrance (MORA, 2006).*

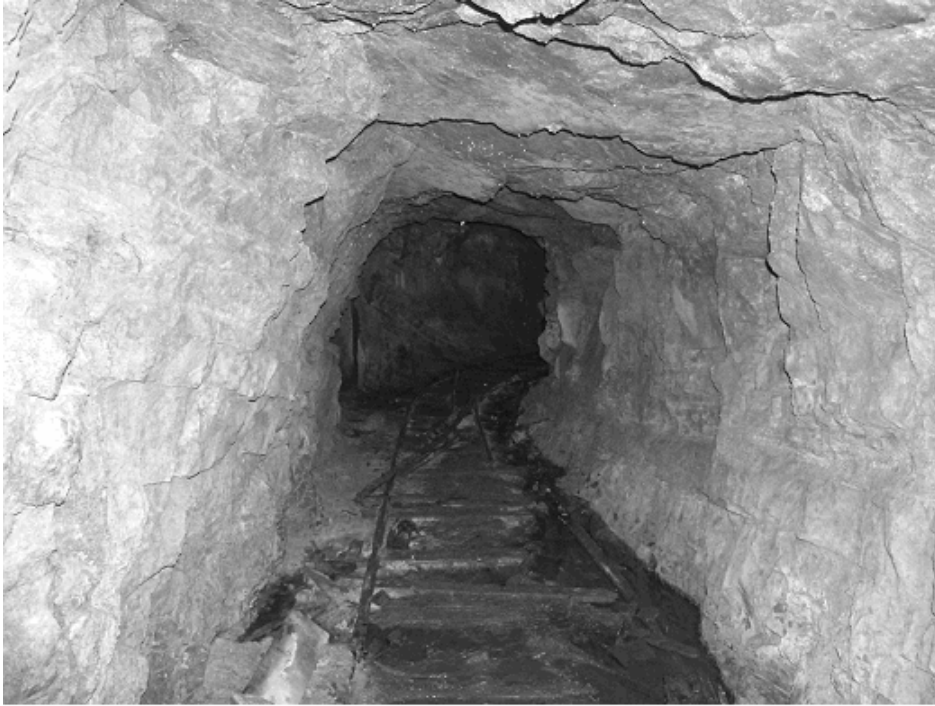
*Archaeological Sites #3: Contemporary photograph showing the interior of the mine entrance shown above. Note the extant tracks from an incline railway, which historically transported the mined mineral ore to the river bottom below (MORA, 2006).*

"The notable feature of the mine was supposed to be an incline railway by which the ore was lowered from the tunnel to the river bottom 300 feet below. With these meager facts in mind I looked for the mine several times during the late summer without results. Again on February 23rd I made a try. While following the foot of the hill, at a point just behind the district powder magazine, I saw some cut stumps on the slope. An old, overgrown clearing led up to what appeared to be a rock slide below a small cliff. Actually it was a spoils dump of blasted rock, with here and there rusty cans, pieces of scrap and boards mixed in. At the top was a bench with remains of a snow-crushed pole-and-shake building on it. The collapse of the structure
