MOUNT RAINIER NATIONAL PARK CARBON RIVER ACCESS MANAGEMENT

BIOLOGICAL ASSESSMENT and ESSENTIAL FISH HABITAT ASSESSMENT

June 2010

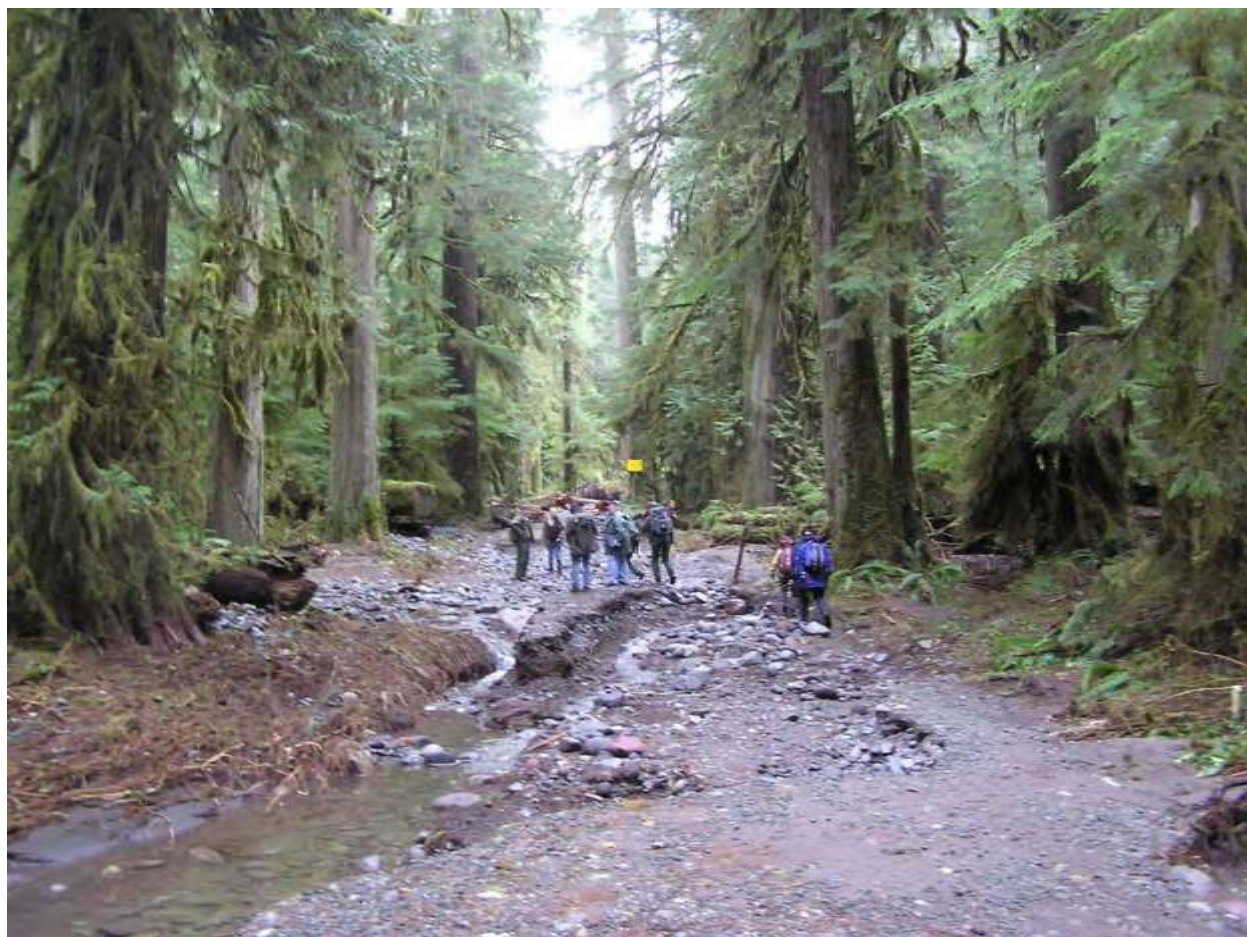
Flood damage along the Carbon River Road – February 2007.

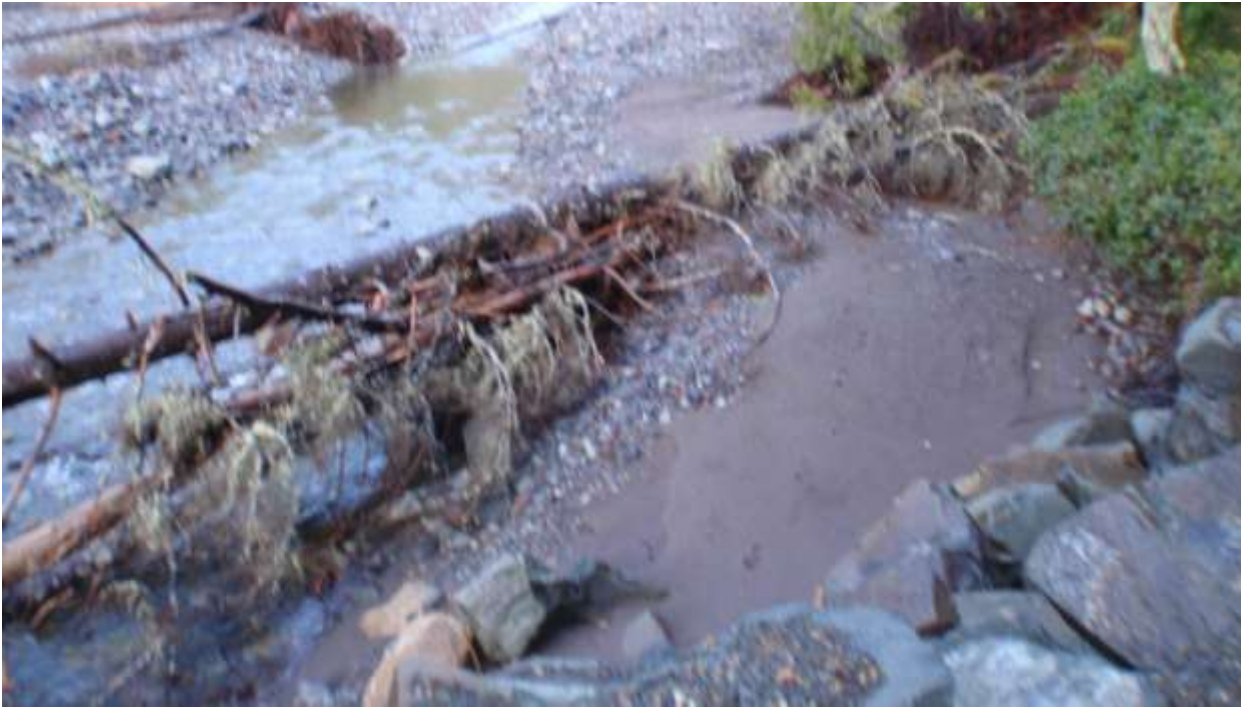
Site #1: Park boundary**Figure 3:** View of bank at toe of rip rap about 40 feet from Carbon River Road

Risk: Bank Erosion threatening Carbon River Road.

Proposed flood protections: Augmentation of existing natural log jam.

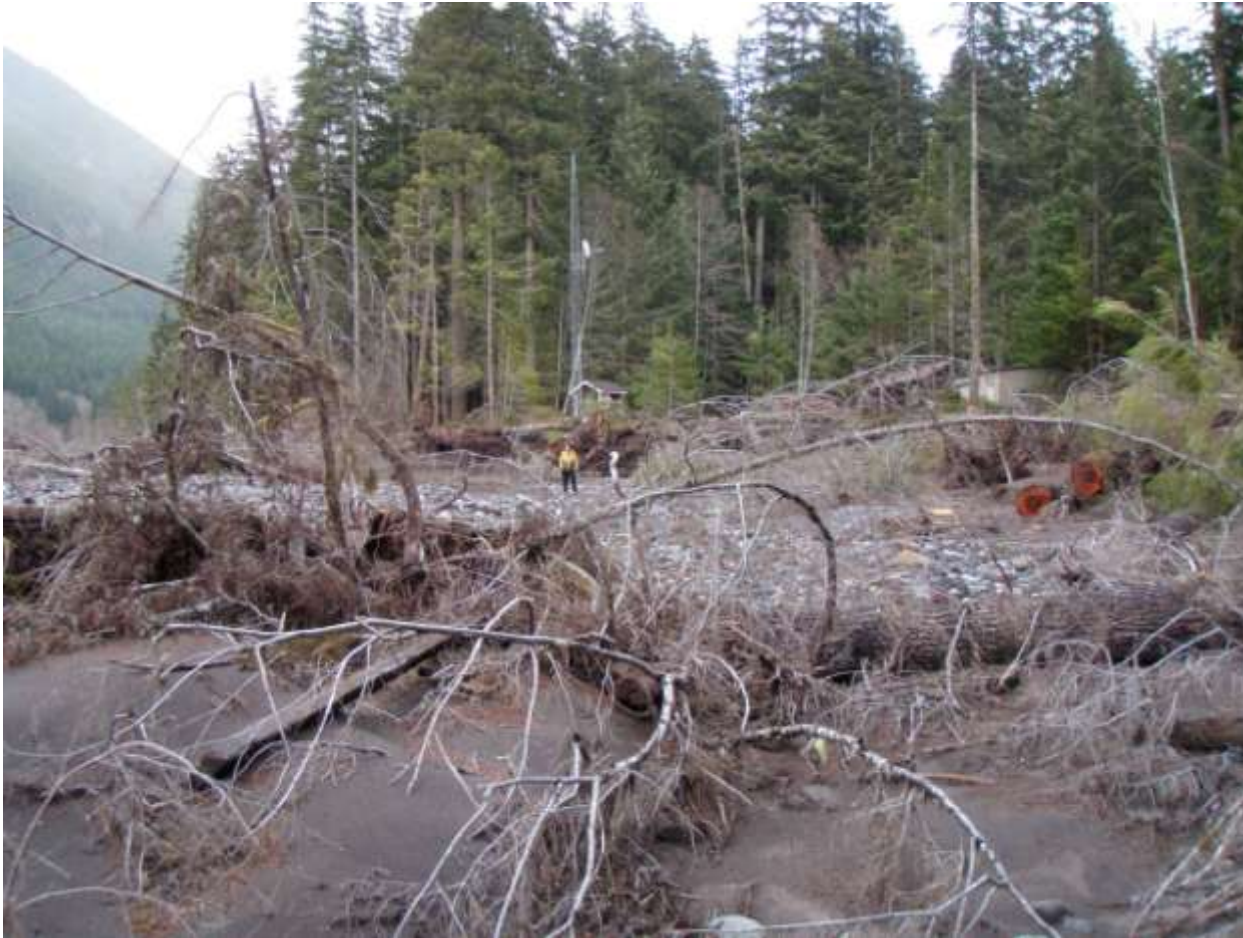
Figure 4: View of bank looking upstream from river bed towards Maintenance Area

Risk: Bank Erosion threatening Carbon River entrance area, road and parking area.

Proposed flood protections: Flow Deflection Engineered Log Jams (ELJ's) (Figure 5).

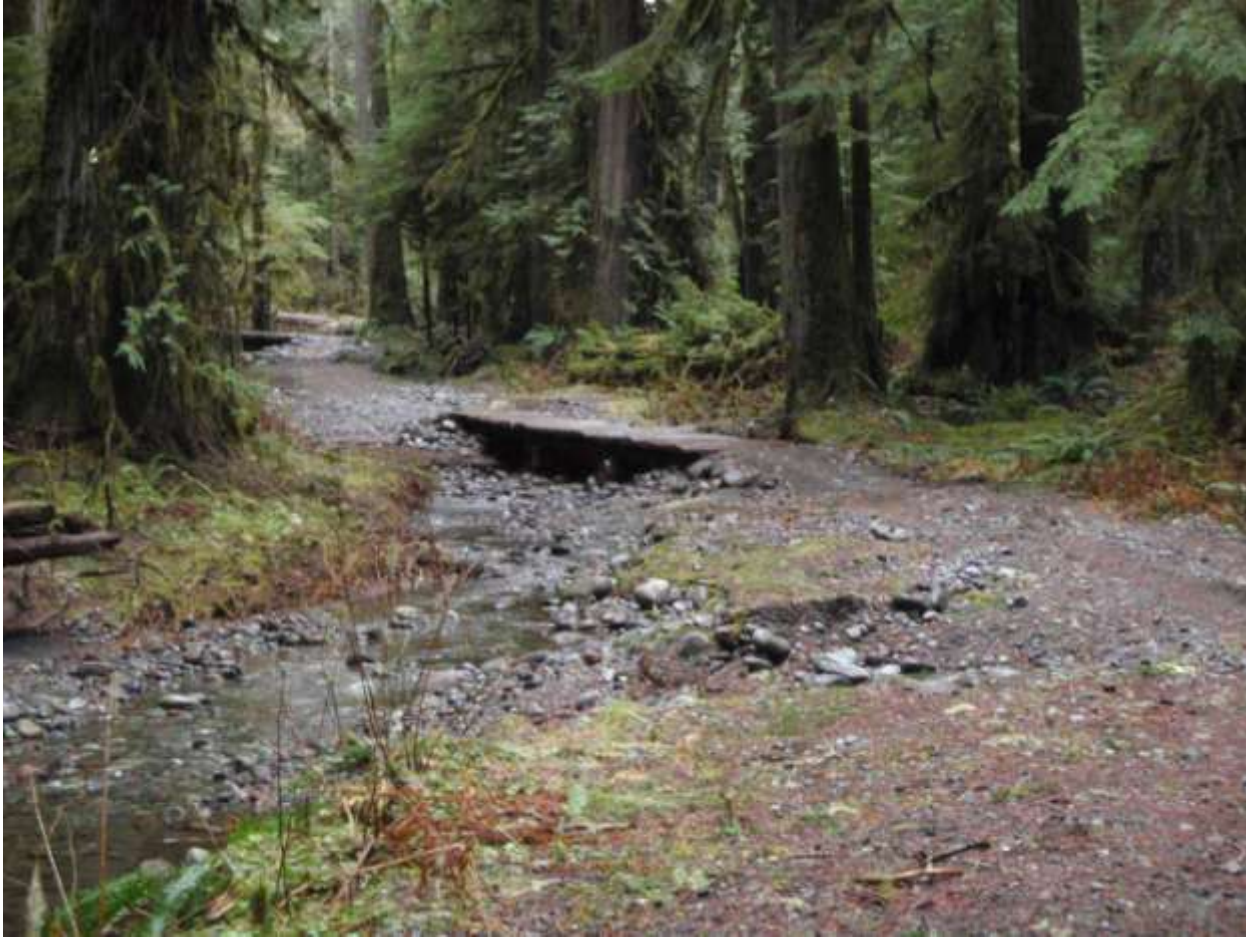
Figure 6: Tributary crossing road/trail in the Falls Creek Fan Area.

Risk: Falls Creek tributary migration and road capture of stream. This area will be repaired remain open to vehicle traffic.

Proposed flood protections: Rock -cored log cribs with pilings, rock-cored cribs no pilings, rock-cored road hump with large rock, gravel covered log hump. Check dams would be installed in woods at tributaries flowing across road with sufficient size to allow fish passage in tributaries.

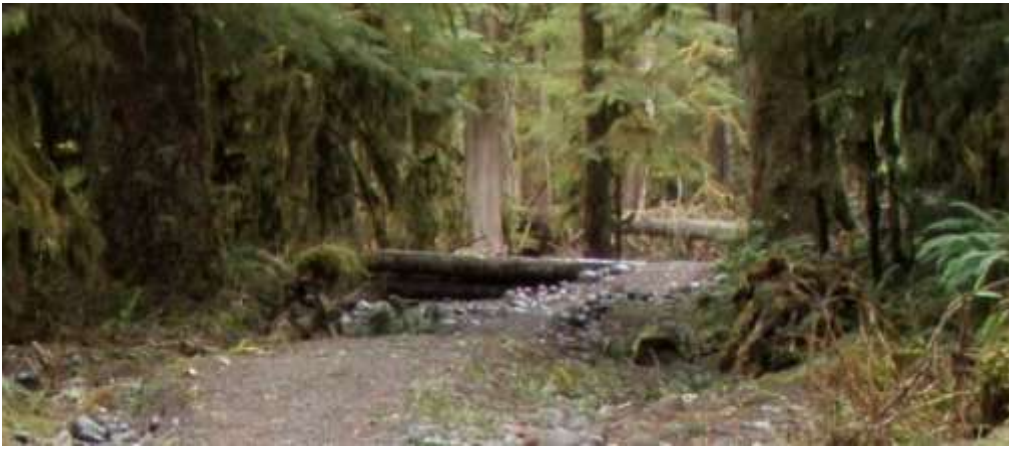
Figure 10: Gravel covered log hump

Size of structure: 5 to 9 structures 12 to 15 feet long , exact length and width would be determined by A&E.

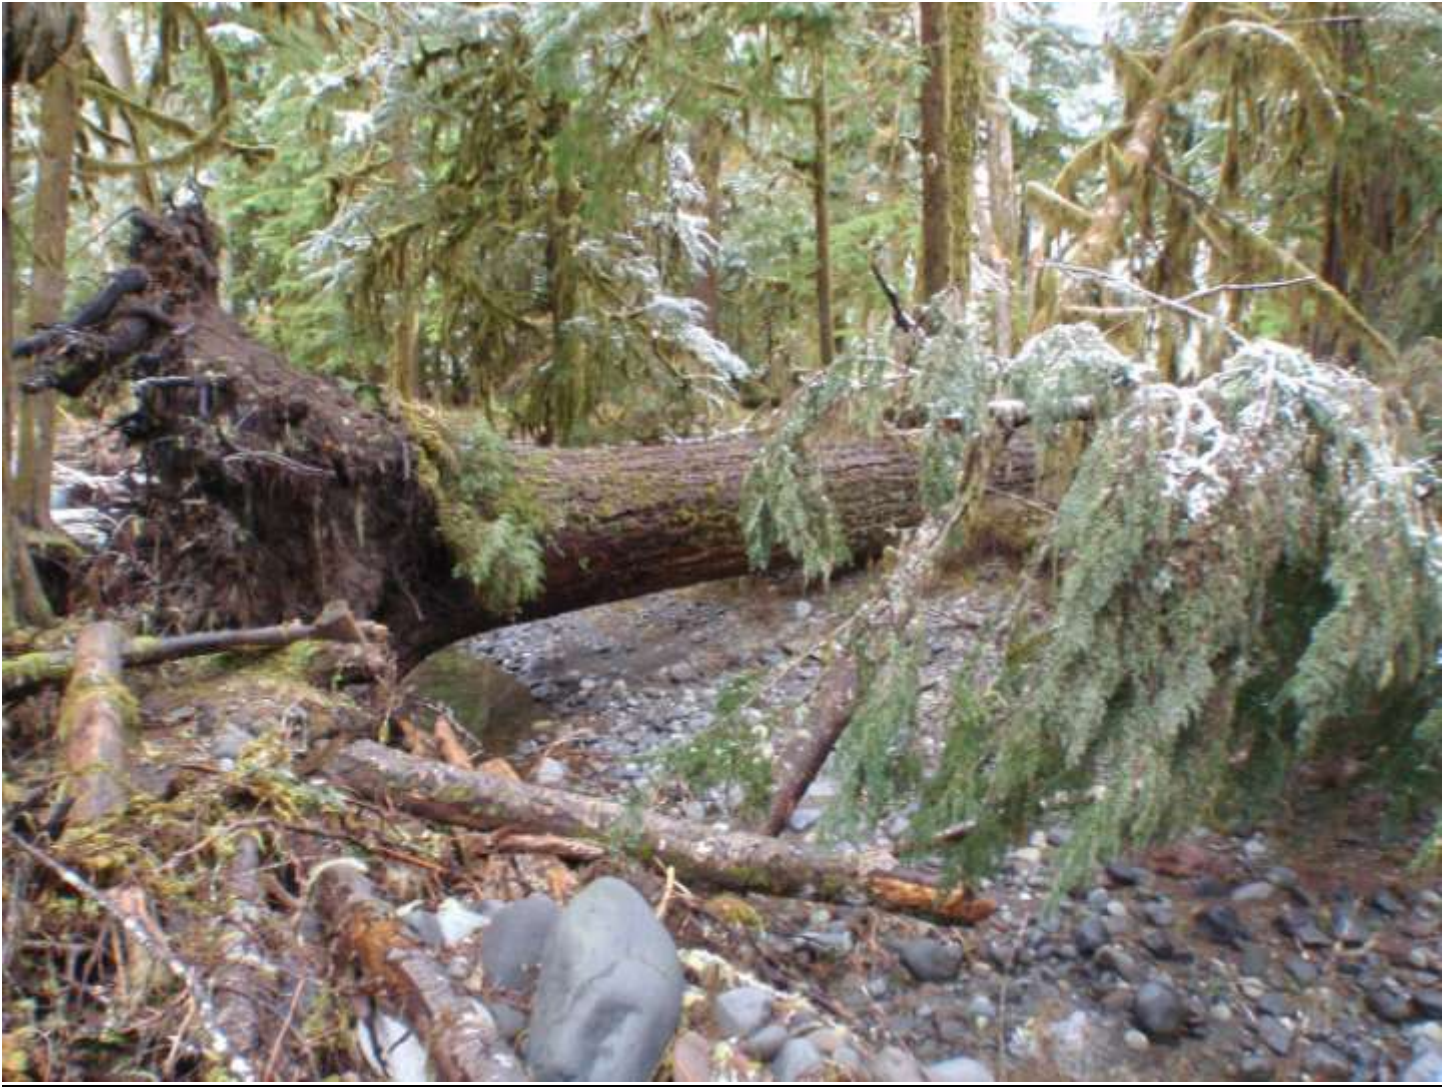
Figure 11: Developing side channel of the Carbon River in the former Carbon River Road Prism. Current hiking trail is not shown but out of frame to the left of the photo.

Risk: Carbon River migration and road capture and bank erosion. Leakage across vegetated island between Carbon River and new channel is pervasive along length of island.

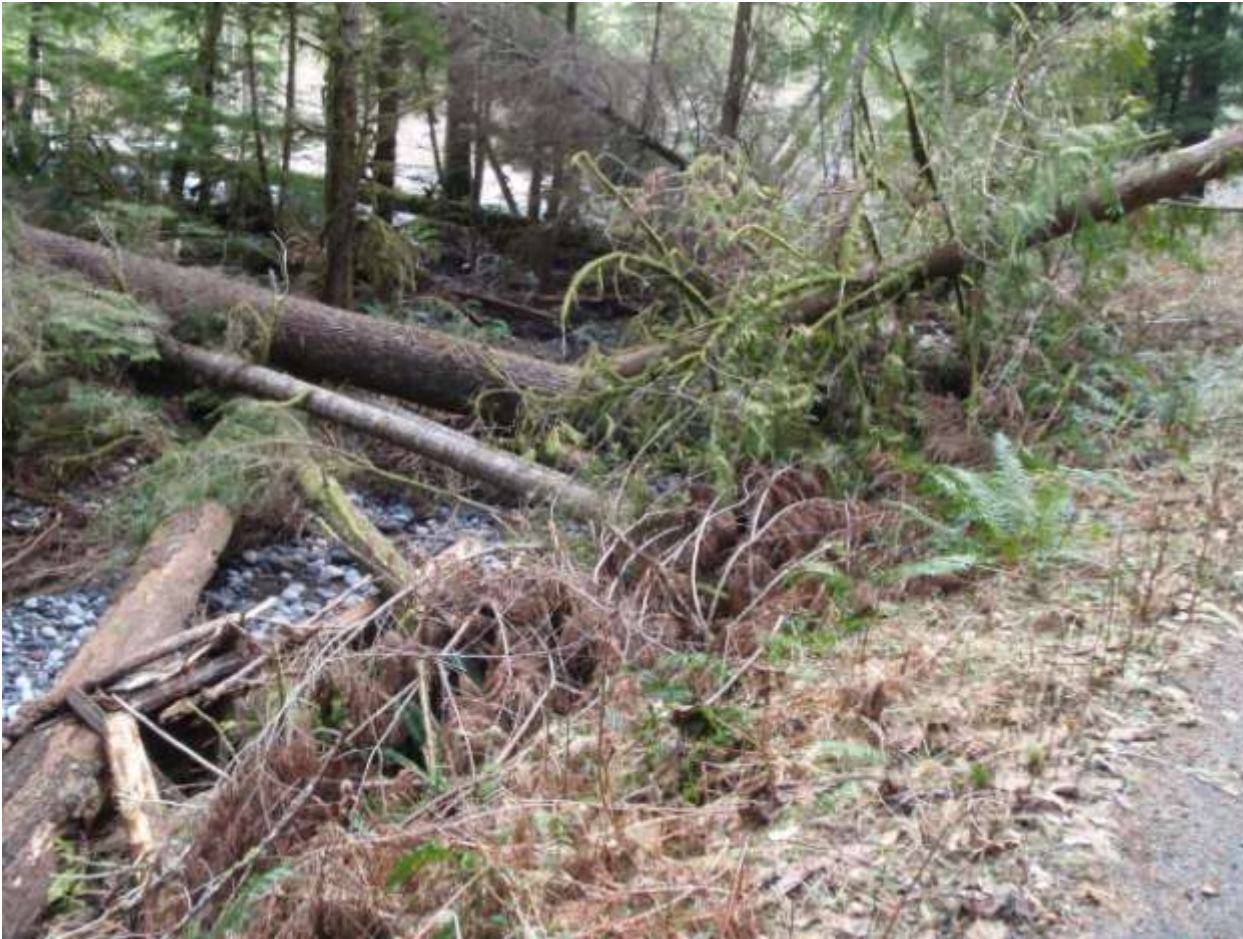
Figure 16: Expanding channel near road edge. Carbon River mainstem is visible through woods.

Risk: Carbon River migration, road capture of stream, and bank erosion.

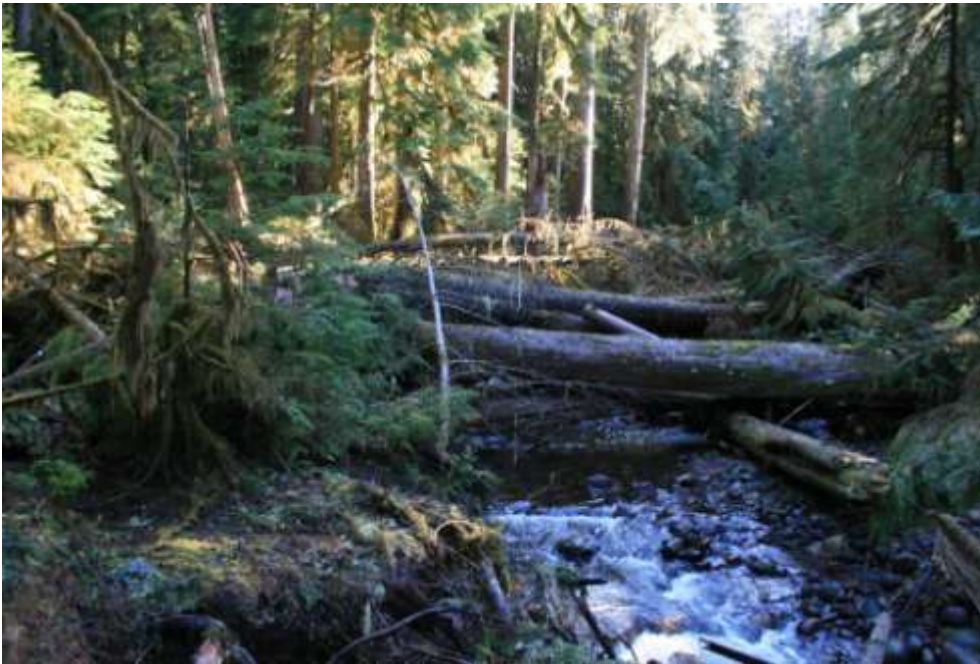
Figure 18: “Magirl channel” near the Carbon River Road.

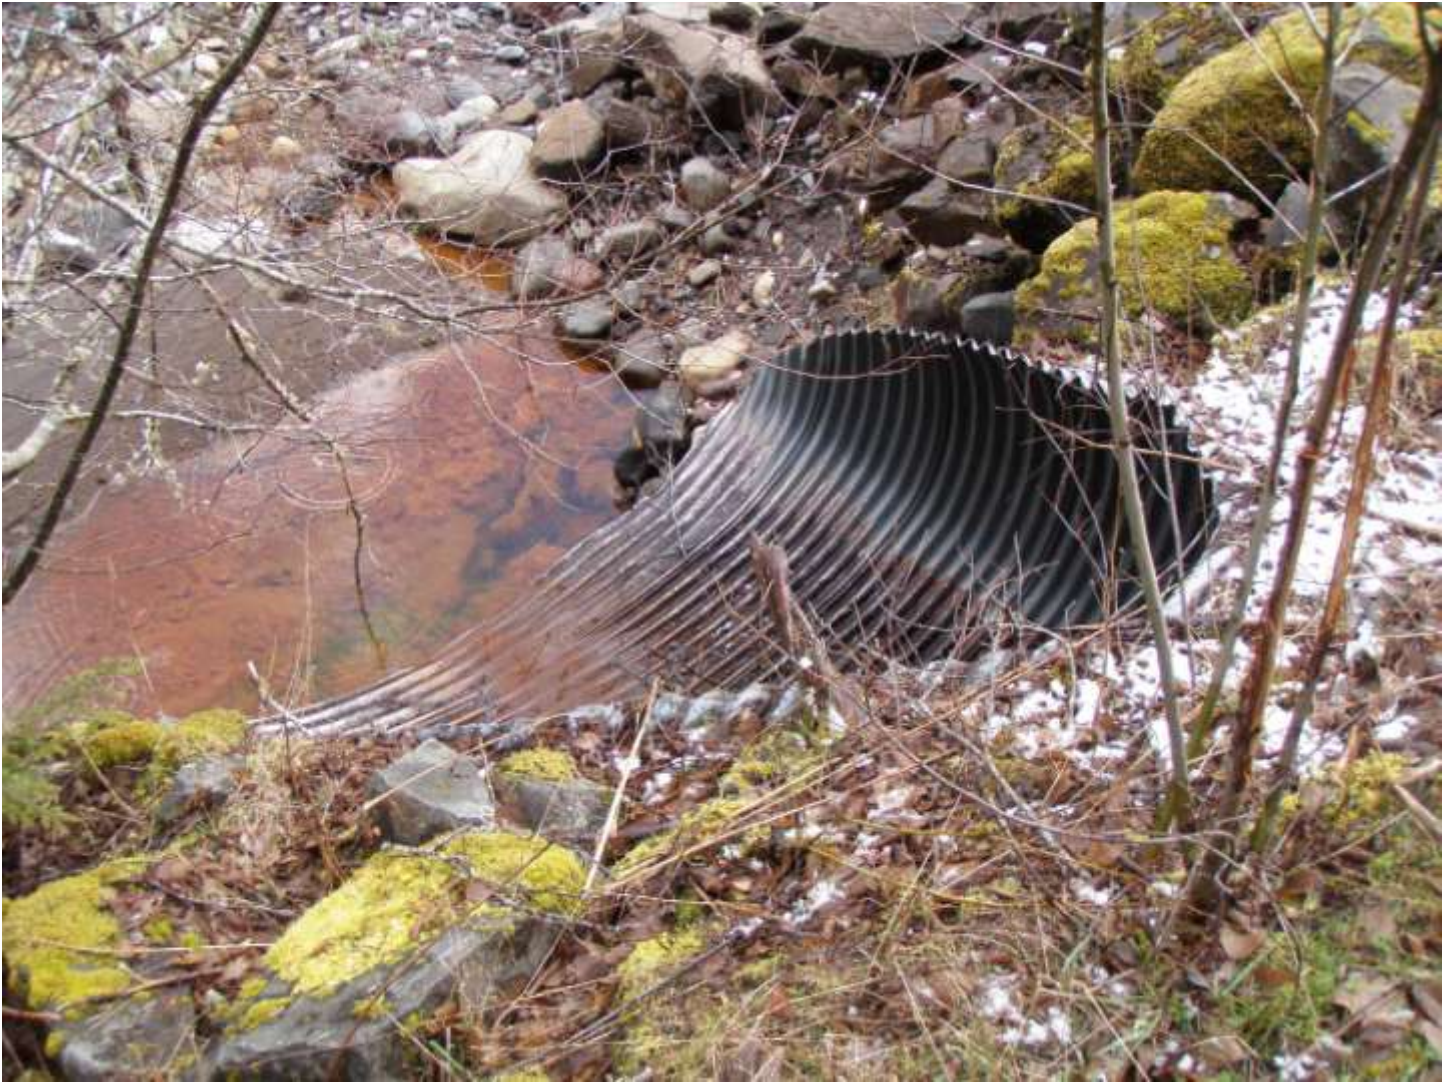
Figure 20: Hanging culvert near “Magirl channel”

Risk: The "Magirl Channel" flows to a hanging culvert that is approximately 6 ft off of the bed of the Carbon River. This presents a serious fish passage concern and the culvert is scheduled to be removed. When this occurs, a large sediment bulge which has been accumulating behind the culvert will be head cut and mobilized downstream (Figure 21) unless check dams are installed. An analysis of the longitudinal profile shows that there is approximately 650 cubic yards of material that could be supplied to the river if the channel is allowed to headcut without grade control structures.

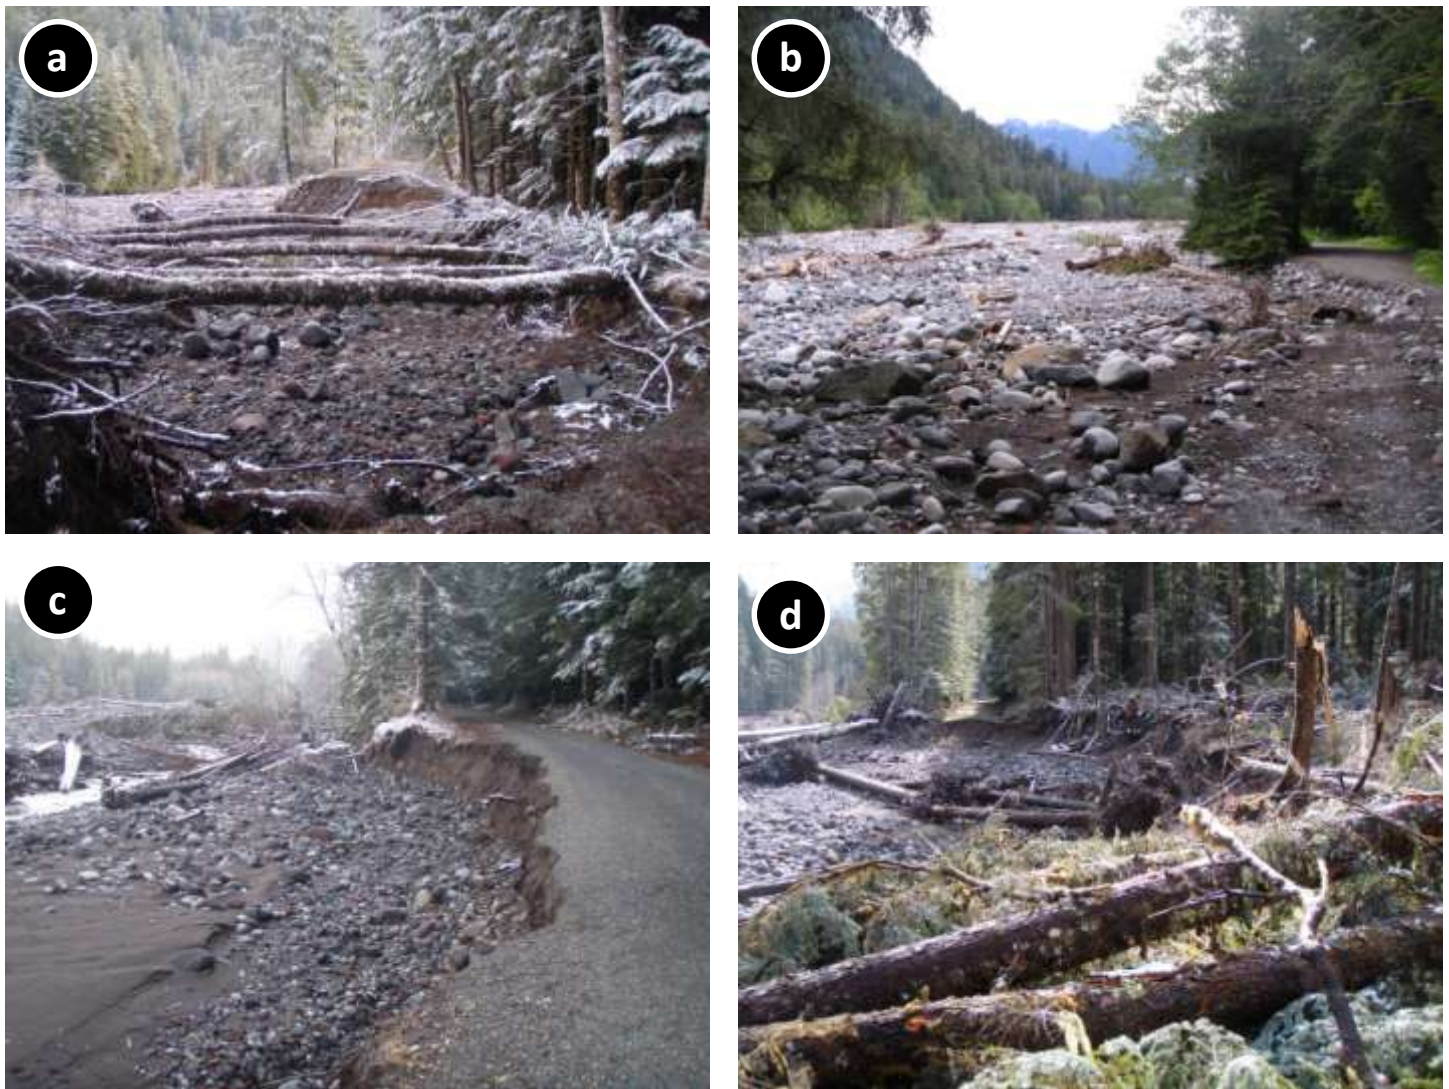
Figure 22: Bank erosion sites. (a) Site 8, MP 3.5; (b) Site 11, MP 3.8; (b) Site 12, MP 3.9; (c) Site 13, MP 4.5.

Risk: Continued bank erosion, heavy aggradation in river next to cut pushing river into bank during flooding. In order to determine the relative risk for the "bite" sites, bank erosion rates were calculated. See Appendix C for maps showing the bank erosion at each washout site. Aerial photos from 2002 and 2007 and LiDAR data from 2008 were analyzed to determine the bank position during each time frame. The area of bank loss was determined in ArcGIS and shown in Table 2. Overall, bank erosion is a serious concern at each site, averaging 5-15 ft per year during the analysis period. It is likely that the most erosion occurred in the 2006 flood; however, bank erosion did occur between 2007 and 2008 which indicates the erosive forces of small to moderate floods are actively eroding banks at and in the vicinity of the bite sites. The risk for future bank erosion has been previously calculated (in the Risk Analysis) and is listed as "Extreme." It is anticipated that without further protection, bank erosion and damage to the extant portions of the Carbon River Road will continue.

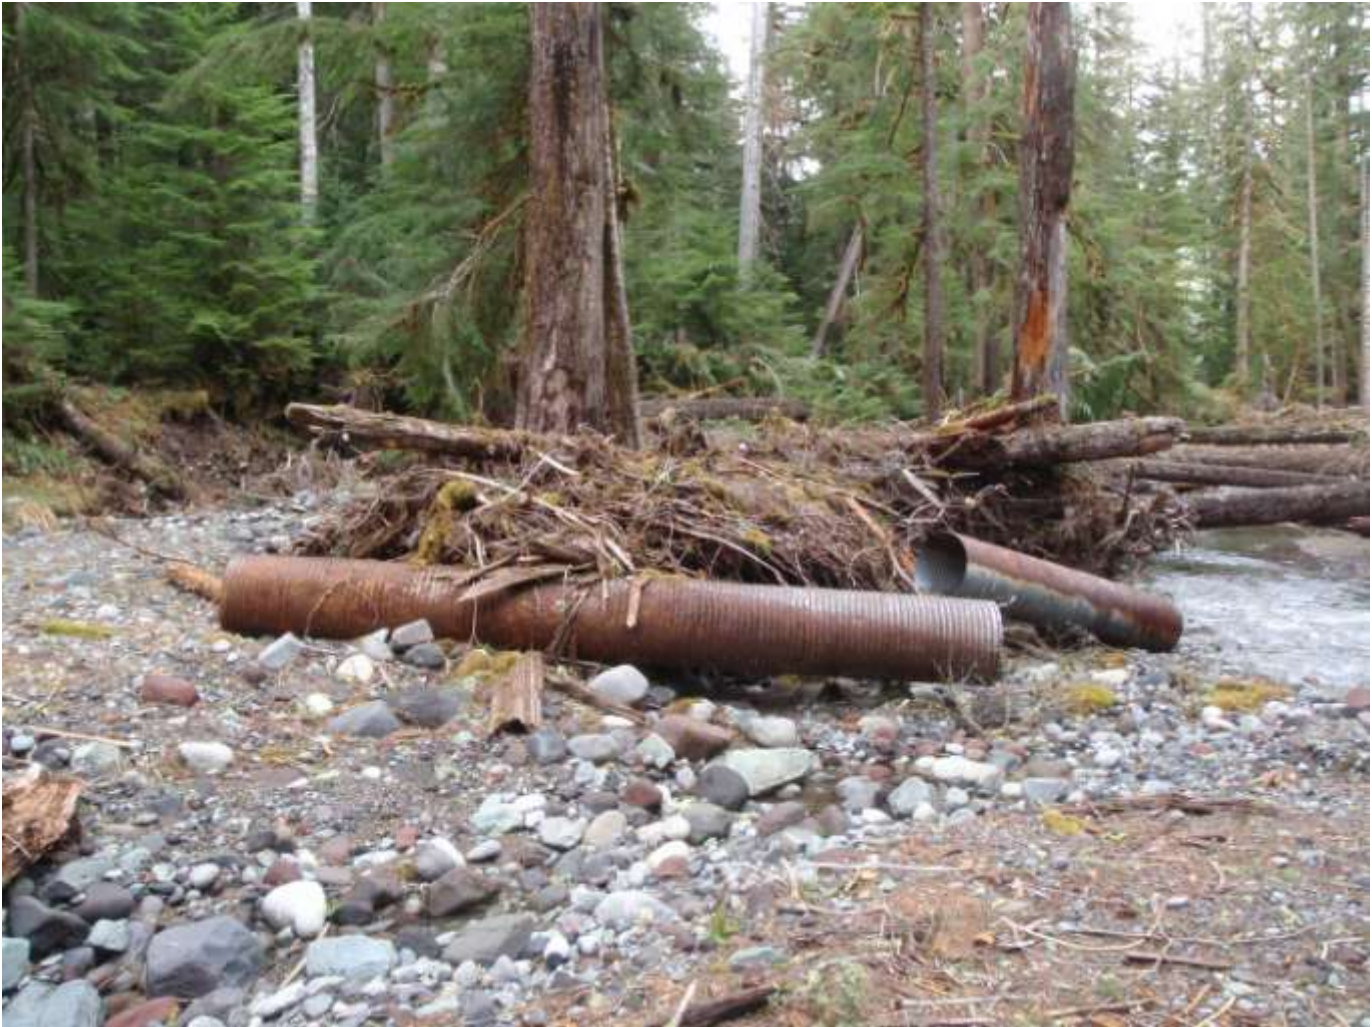
Figure 23: New Channel Ipsut Road at Campground Entrance Looking Down Stream

Risk: The Carbon augmented Ipsut creek, locally known as Ca-put creek, is about 40 feet average (20 to 60 feet) from the current trail. Because of this relatively large vegetation buffer, erosion risk to most of the trail is not considered high. There is a 20 ft section of trail (Figure 24) Check dams are no longer being considered.
