Scotts Bluff National Monument
Oregon Trail Ruts Landscape Study
and Environmental Assessment ■ 100% Report

Character Area D1

699 **Character Area D2**

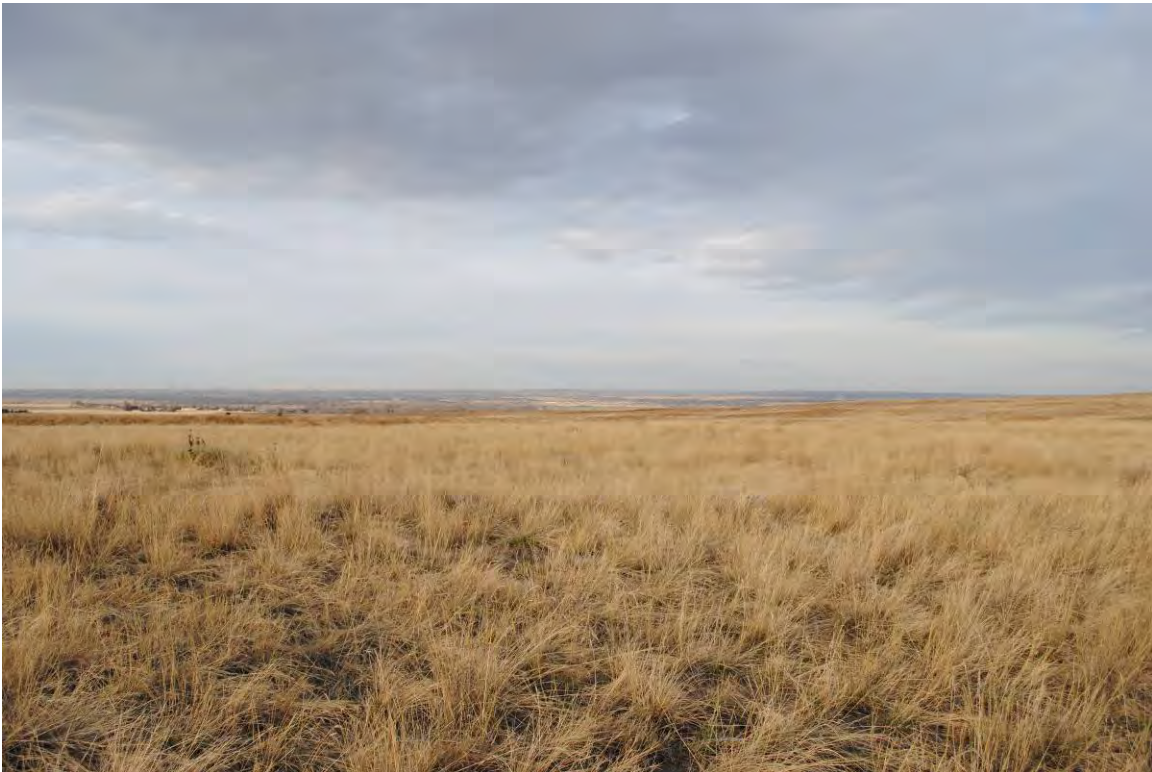
Figure 3 - 45. Character Area D1 looking west (2009) (MBD DSC_0111.JPG)

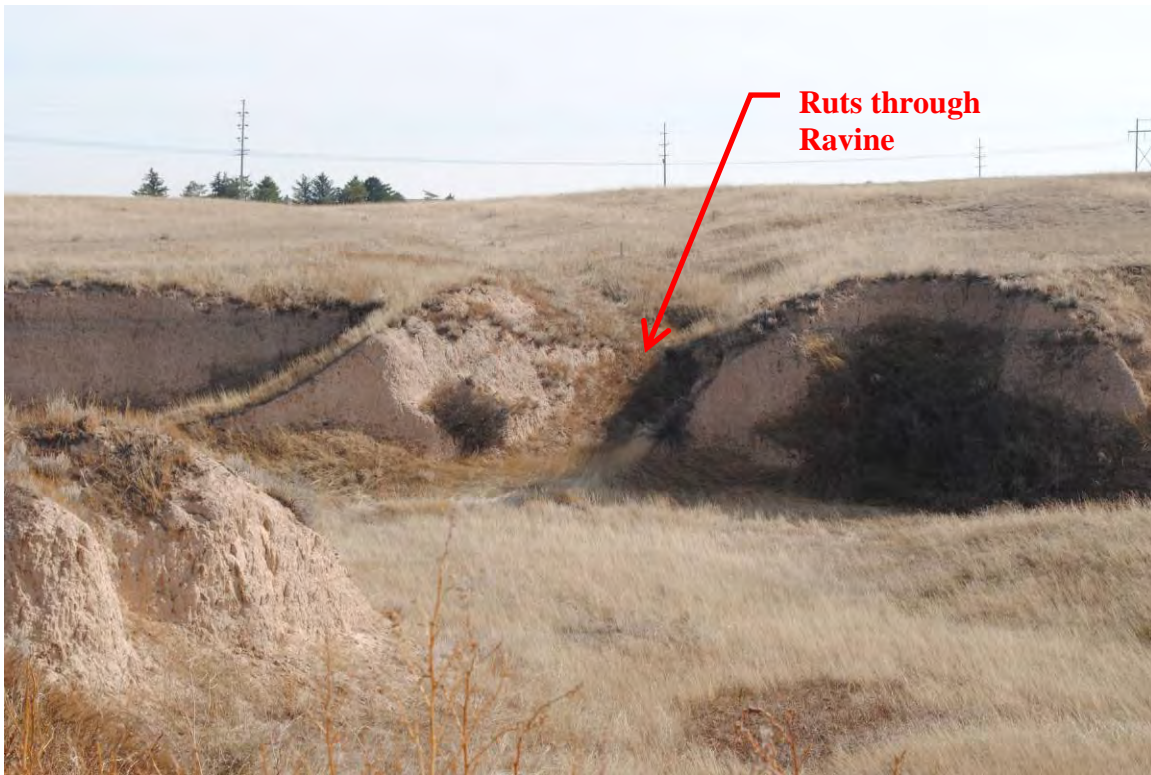
- 721 ▪ The sections of the trail that cross the ravine are Class 1 (unaltered original trail) and
722 are easily discernable.
- 723 ▪ Figure 3-47 shows an overhead electric line in the background. The presence of
724 these lines in the area of the trail ruts diminishes the original views experienced by
725 the emigrants as they approached Mitchell Pass from the east.

Figure 3 - 47. Ruts through ravine at the east end of Character Area D2 (2009)
(MBD DSC_0062.JPG)

- The most prominent features visible to visitors are the ruts through the ravine as seen in Figure 3-47 and Figure 3-48.
- Visitors who visit this area have an opportunity to experience the approach of Mitchell Pass and the views Scotts Bluff and South Bluff in much the same way emigrants did.
- This area receives little foot traffic and visitation is primarily limited to the interpretive wayside.

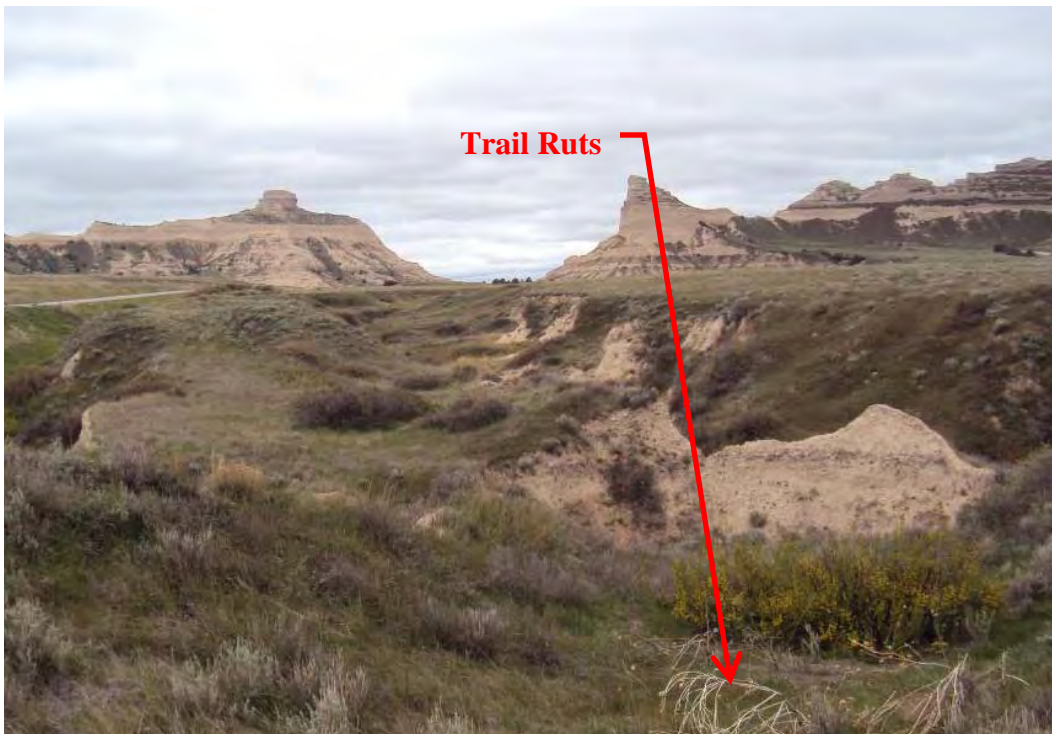
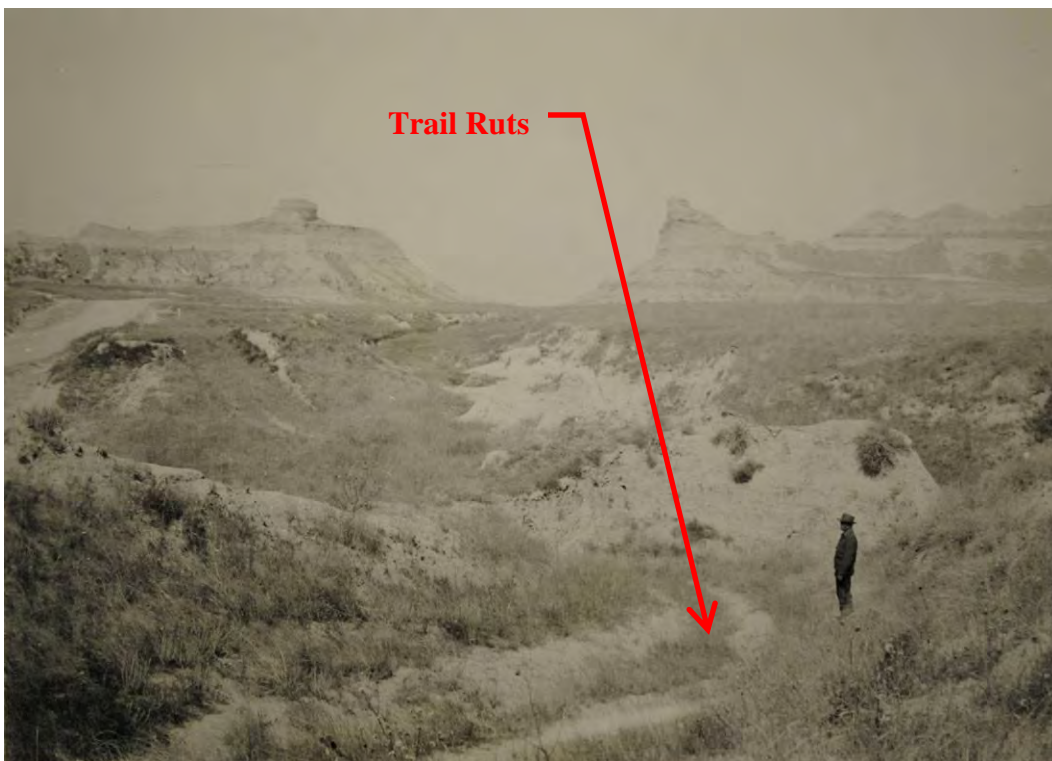
Figure 3 - 48. Character Area D2 looking west (2010) (MBD DSC_00161.JPG)
Below - Oregon Trail around ravine (c. 1941) (DSC_0210.jpg) (source: SCBL archives)

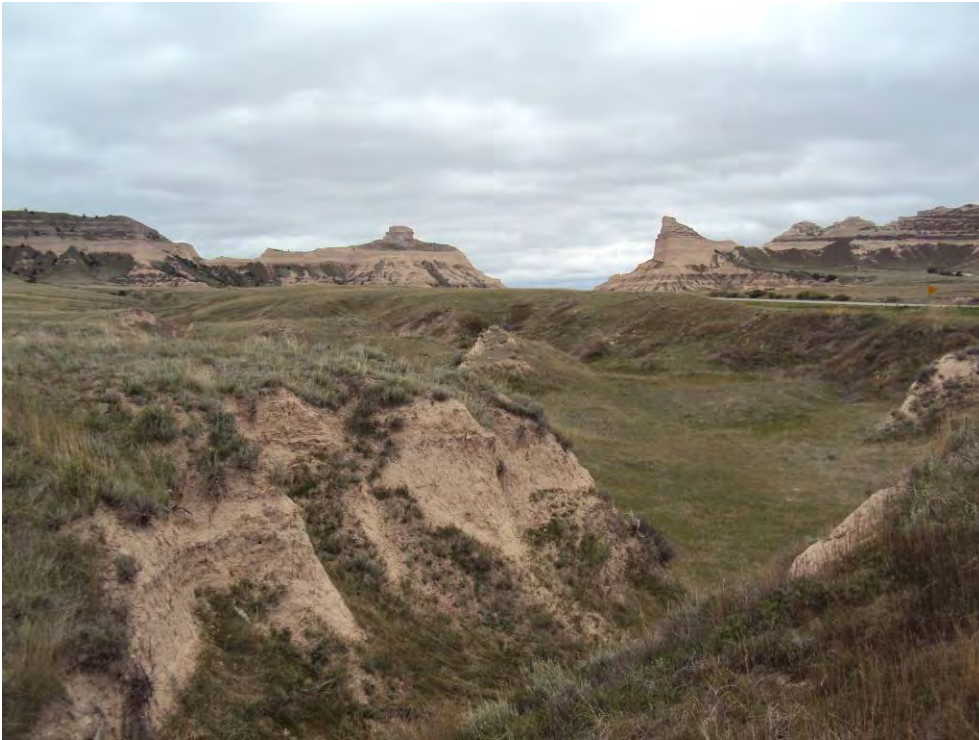
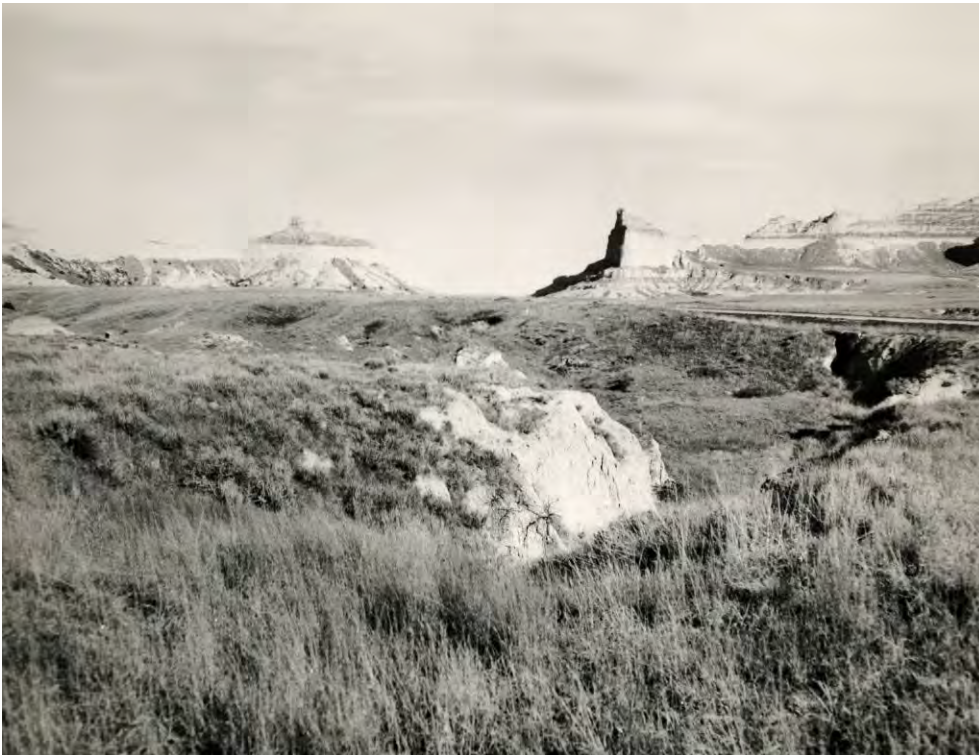
Figure 3 - 49. Character Area D2 *Above* – Oregon Trail ruts remnant – east monument boundary (2010) (MBD DSC00158.JPG); *Below* - Oregon Trail ruts and Mitchell Pass – east boundary (c. 1956) (DSC_0244.jpg) (source: SCBL archives)

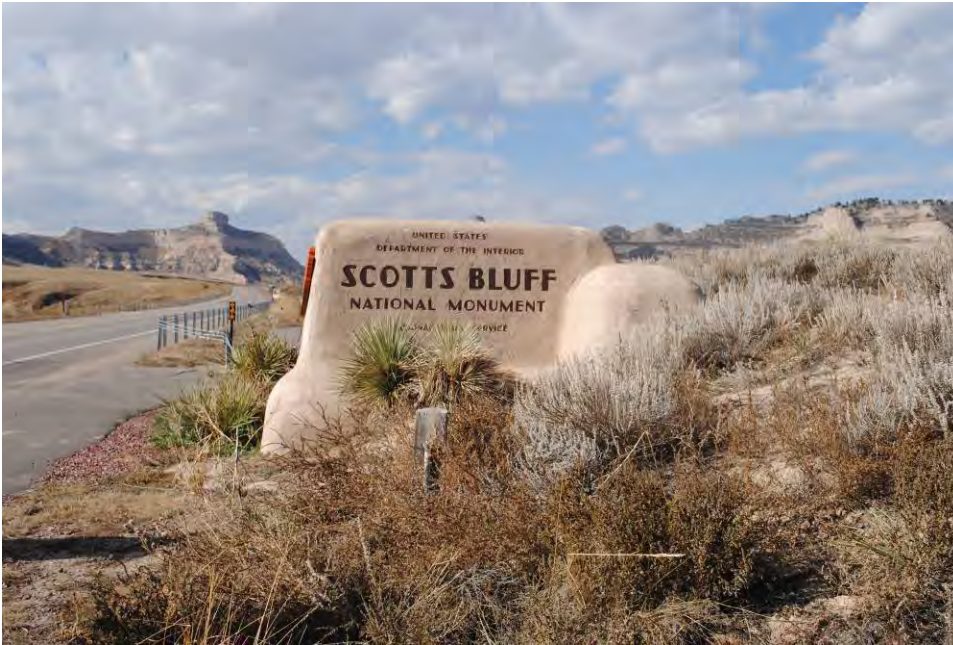
Figure 3 - 50. Monument entrance sign at east entry in Character Area D2 (2009)
(MBD DSC_0064.JPG)
