Cane River Creole National Historical Park  
Natchitoches, Louisiana

## ENVIRONMENTAL ASSESSMENT

### Emergency Stabilization / Erosion Control on the Bank of Cane River Lake, Oakland Plantation

December 2010

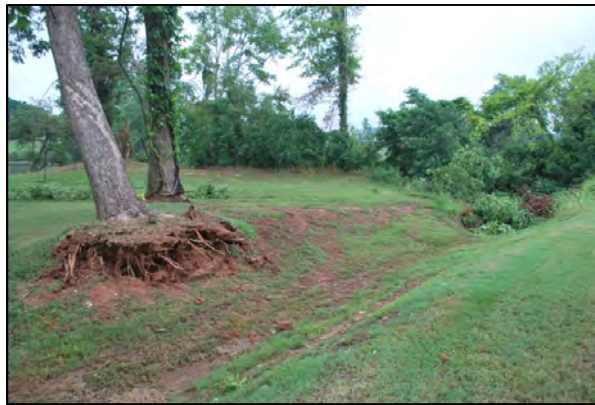
**Figure 1-4. Erosion in roadside swale**

The highly eroded areas are located at or near the existing storm water discharge points to the Cane River Lake. At the north end of the project site, severe erosion due to the high velocity of storm water discharge exiting the cross drain pipes caused a large portion of the lake bank to washout. Similarly, a small washout occurred south of the plantation store near a discharge area of an existing cross drain pipe. The erosion of the bank along Cane River Lake has reduced the top of the bank to as narrow as approximately 10 feet from the edge of the roadway pavement.

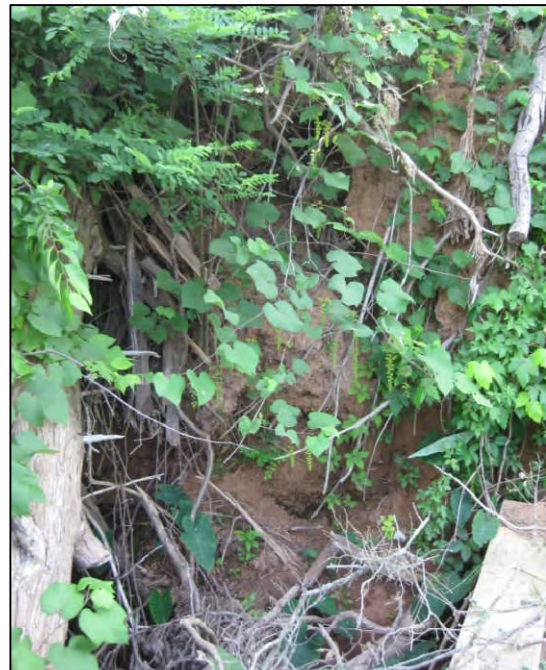
**Figure 1-5. Erosion along the lake bank**

In addition to the erosion caused by the storm water runoff, erosion problems are occurring near the top and side of the bank. Although the lake does not have a substantial current flow, local boat traffic that travels along the lake creates wake that contributes to the erosion of the toe of the lake bank. Wave action bouncing off of the newly constructed seawalls along portions of the Cane River Lake has contributed to the erosion of the bank, particularly along the toe of the bank.

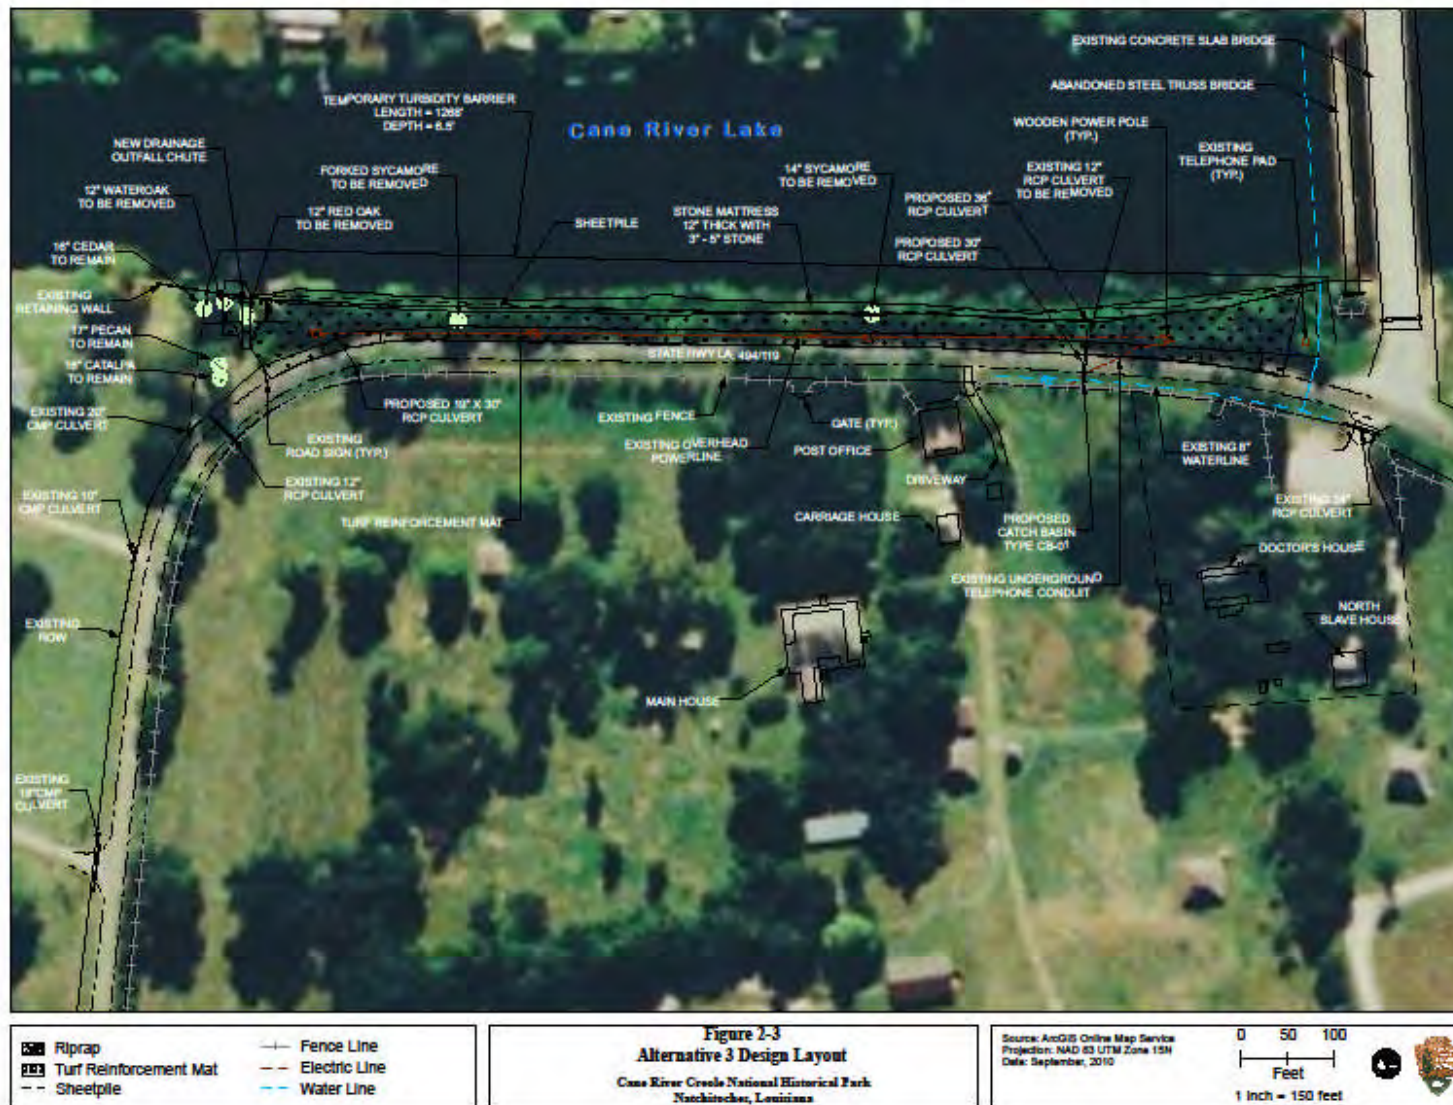
Figure 2-3. Alternative 3 Design Layout

Proposed drainage improvements under Alternative 3 would be the same as the Preferred Alternative, including re-grading the drainage ditches on both sides of the roadway, installing culvert crossings, installing a new culvert outfall into the lake, and constructing a drainage outfall chute into the lake at the north end of the project site (Figure 2-3).

Under Alternative 3, to limit impacts to water quality in the lake water from sediment and silt, a temporary turbidity barrier would be required during the clearing and grubbing phase and until new grass can be established along the new lake bank. In addition, due to the steep condition of the existing lake bank, a barge would be required in order to perform construction near the water edge. An additional staging area would be located on park property. The initial earthwork activities along State Highway LA 494/119 may require temporary closures on the northbound lane of the highway and temporary relocation of existing utilities.

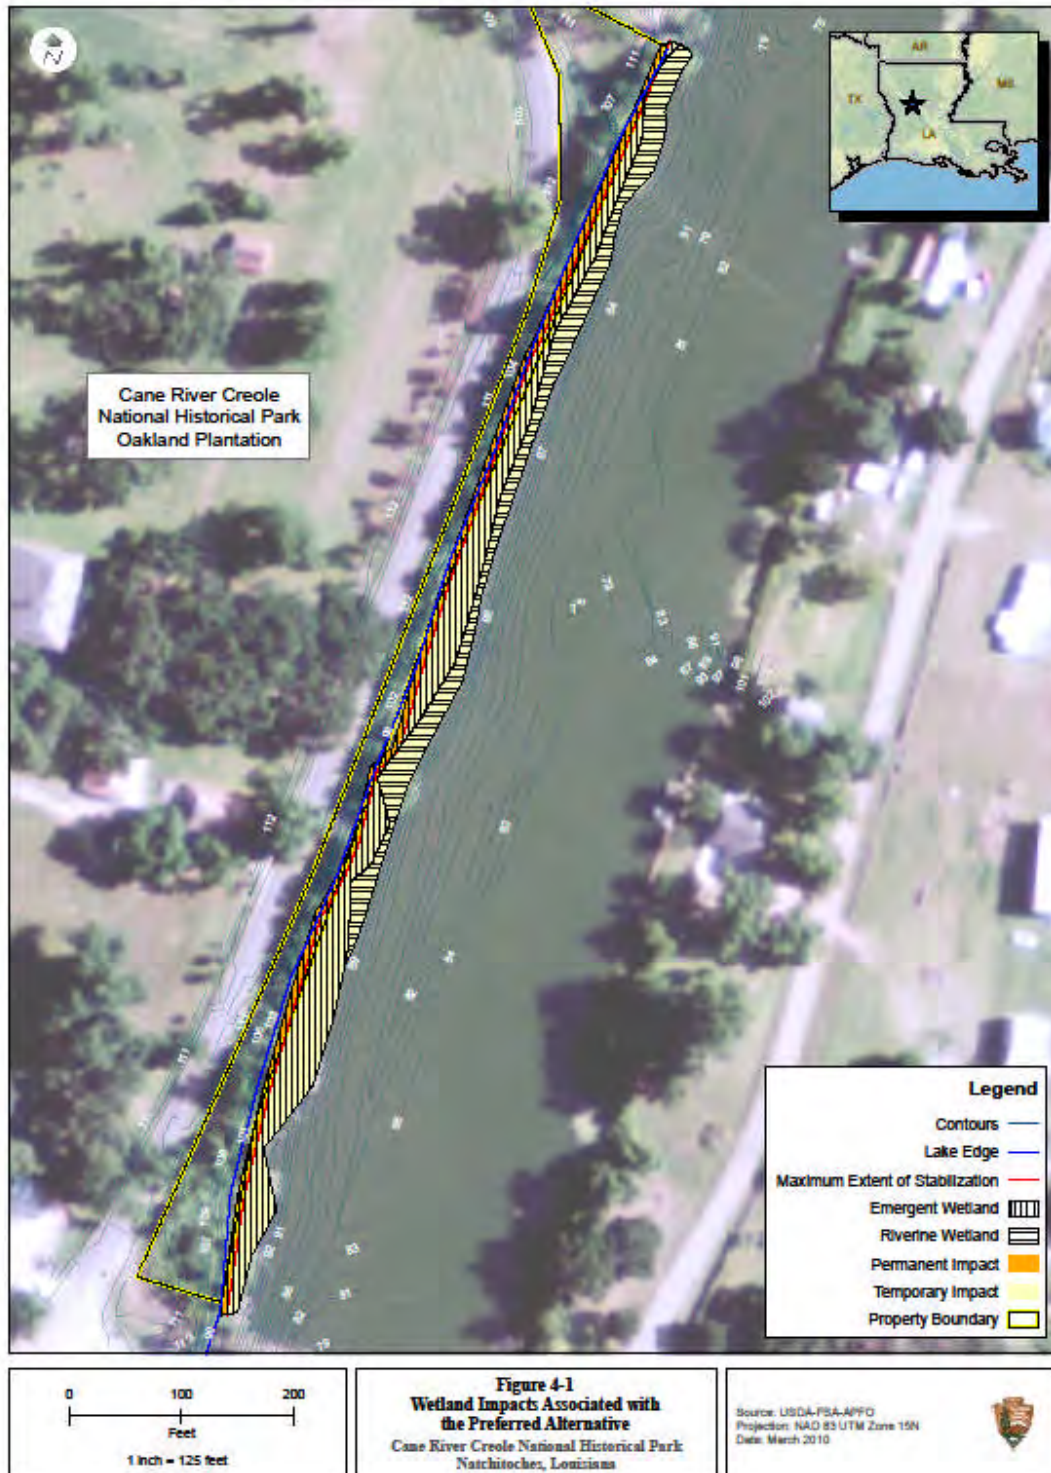
**Figure 4-1. Wetland Impacts Associated with the Preferred Alternative**

**Common to Alternatives 1 and 3** – Long-term, minor, adverse, impacts to wetlands are anticipated as a result of Alternatives 1 and 3 due to the extent of the embankment footprint into the lake. Although Alternative 1 includes an extent of the embankment footprint 5.6 ft into the Lake and Alternative 3 includes an extent of the embankment footprint only 5 ft into the Lake, the impact acreage is the same. As a result of Alternatives 1 and 3, it is estimated that approximately 0.17 acres of fill material along the bank classified as palustrine, emergent, persistent/non-persistent permanently flooded wetland (PEM1/2H) would be required and would permanently impact this wetland and 0.001 acres along the bank classified as riverine, lower perennial, open water, permanently flooded wetland (R2OWH) would be permanently impacted. The PEM1/2H wetland beyond the extent of bank stabilization would be temporarily and adversely affected during the construction period. As a result, a maximum of approximately 0.47 acres beyond the bank stabilization classified as palustrine, emergent, persistent/non-persistent permanently flooded wetland (PEM1/2H) and 0.26 acres of riverine, lower perennial, open water, permanently flooded wetland (R2OWH) would temporarily impact these wetland areas during barge activities while the stabilization is being constructed and placed along the shoreline. Therefore, a total of approximately 0.171 acres of PEM1/2H and R2OWH wetlands will be permanently affected by Alternatives 1 and 3 along the bank of the Cane River Lake at the plantation.

The yellow pond lily is the dominant plant species that will be temporarily impacted beyond the bank stabilization because it is the only emergent rooted vascular plant at the site at depths beyond 5 ft. Yellow pond-lily is an aquatic perennial plant with spongy rhizomes that anchor the plant into the muddy bottom of a waterbody (USDA/NRCS 2004). Although this plant is not considered invasive, it is very difficult to eradicate when not grown in containers because any section of rhizome left behind may sprout new growth; this plant may become weedy in some regions or habitats and may displace desirable vegetation if not properly managed (USDA/NRCS 2004). Due to the hardiness and resilience of yellow pond lily rhizomes, it is expected that this plant species will recover in many areas from temporary construction that occur beyond the areas of bank stabilization following the completion of water-based construction activities. Although long-term, minor, adverse impacts to wetlands would occur as a result of Alternatives 1 and 3, beneficial impacts are associated with stabilizing the bank and replanting with wetland vegetation to reduce future erosion and the ultimate loss of land would offset the adverse impacts to wetlands. In addition to the impact along the bank of Cane River Lake, proposed drainage improvements will also occur in the vicinity of a disturbed area investigated during the wetland delineation in the northeast corner of the site. Specifically, a drainage outfall chute into Cane River Lake at the north end of the project site is proposed that will also be naturally re-vegetated following construction activities. The drainage chute design details include a smooth transition to the existing Cane River Lake bank slope. Therefore, Alternatives 1 and 3 should reduce the secondary or offsite effects that currently occur at the site, including drainage and flooding that have exacerbated the bank erosion and have affected the existing wetlands along the shoreline of the site.

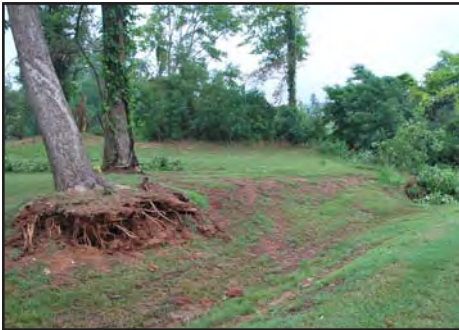
Damage caused by the storms in 2007.

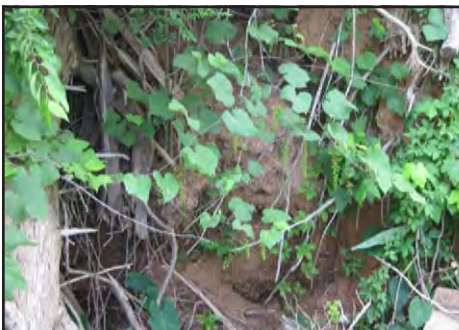
Erosion along the affected area.

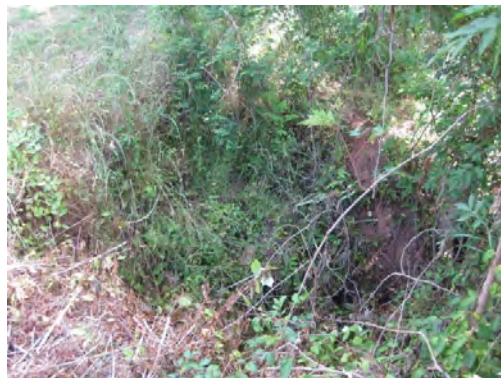
Photo 4 – Erosion scour hole
