VICKSBURG NATIONAL MILITARY PARK  
**PEMBERTON'S HEADQUARTERS**  
(WILLIS-COWAN HOUSE)

# HISTORIC STRUCTURE REPORT

2005

For  
**Cultural Resources, Southeast Region**  
**National Park Service**

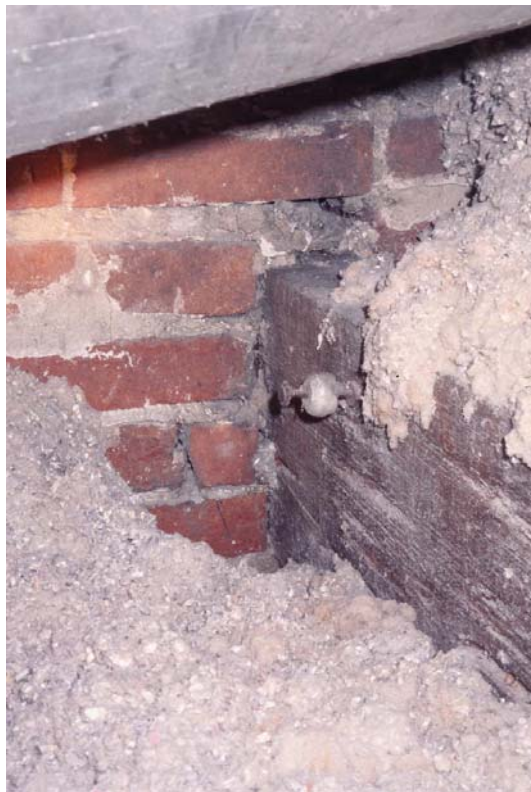
*Figure B - 3* Ceiling joists above the original L-shaped porch are resting in formed joist pockets in the brick wall, indicating they are an original feature

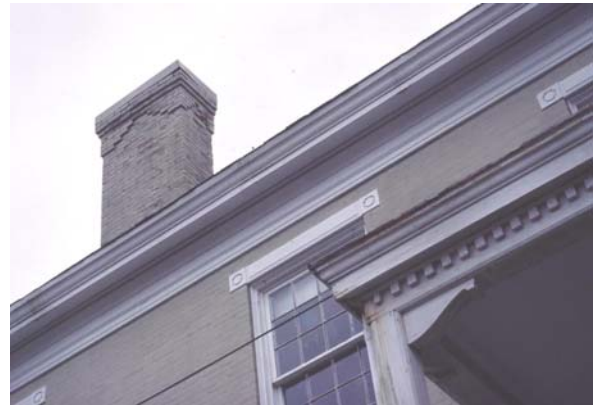
*Figure C – 6 Cornice of west porch and original house, and corbelled chimney*

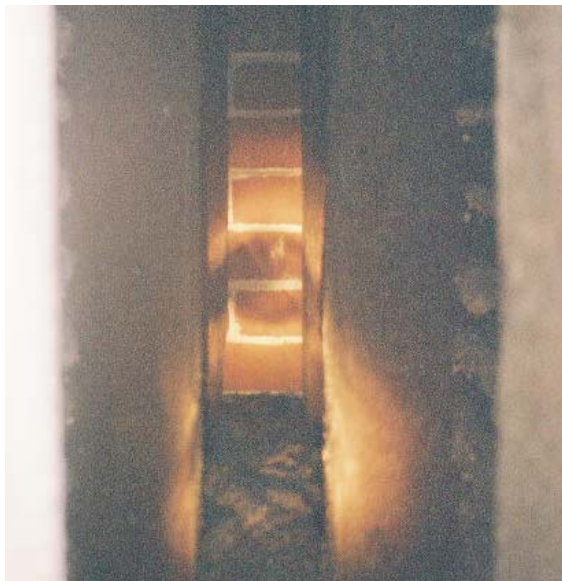
*Figure C – 7* Pencilled brickwork visible in pocket door opening to Room 206A

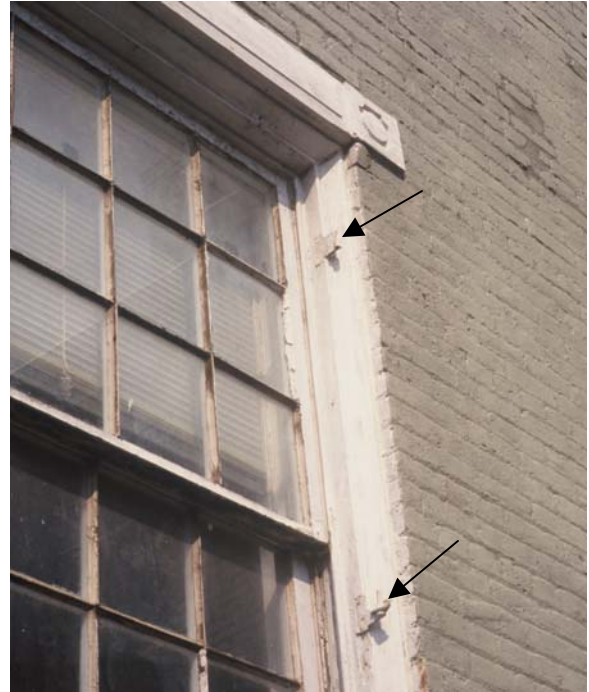
*Figure C – 10 Shutter hinges; the upper hinge dating from the second quarter of the nineteenth century, the lower dating from the third or fourth quarter or the nineteenth century*

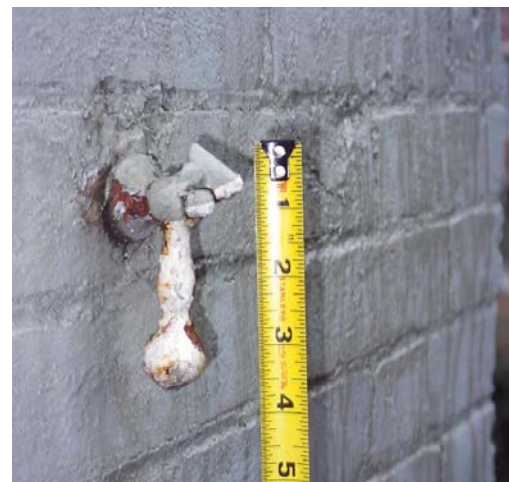
Also in the masonry flanking the windows of the north, east, and west elevations of the 1835-36 house, are remnants and ghost marks of a shutter dog design popular in the second and third quarters of the nineteenth century.

*Figure C – 11 Shutter dog*

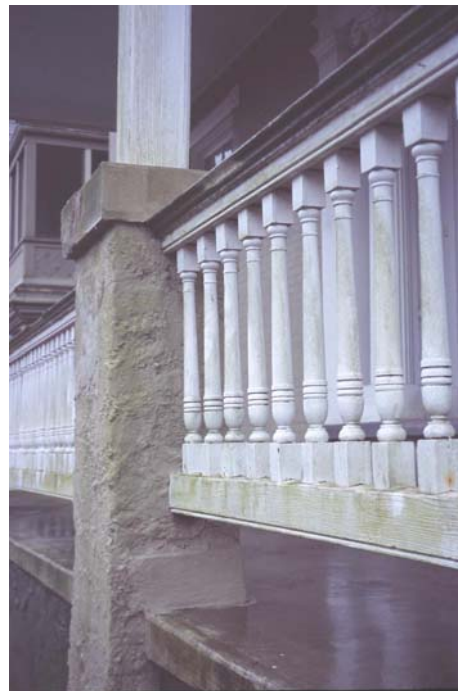
*Figure C – 13 Front porch balustrade*

handrail, and beaded bottom rail match. The side porch now has a modern, 1½" x 1½," replacement balustrade; the remnants of the original are in storage in Room 001. Both porches were likely constructed to complement one another during the same 1850-51 construction campaign.

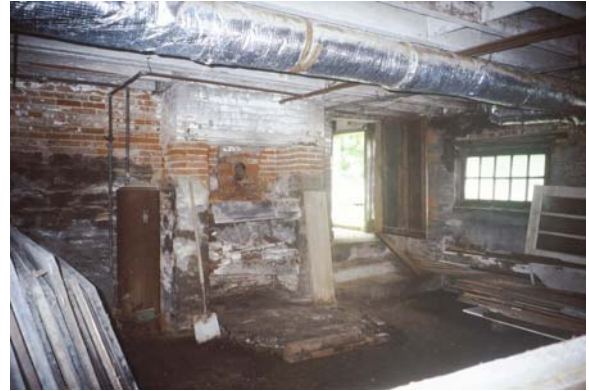
*Figure C – 15 Room 001*

- **Flooring:** Hand-made brick dry laid in a sand bed in a staggered stretcher course pattern. An additional layer of brick, partially intact, is laid on top of the floor between the supports for fireplace of Room 105 and extends about 4'-0" into the room; the platform was probably installed for a heating or cooking device when the flue was added in the late nineteenth or early twentieth century.

- **Walls:** Until the late twentieth century, the brickwork of the walls was exposed. Then a Portland cement-rich stucco was applied on the interior surfaces of all interior walls to a height of about 5'-0," probably in an attempt to stem ground-water infiltration. The 12" above this stucco is eroded from rising damp, and is damp to the touch. The remaining distance up to the ceiling joists retains evidence of whitewash.

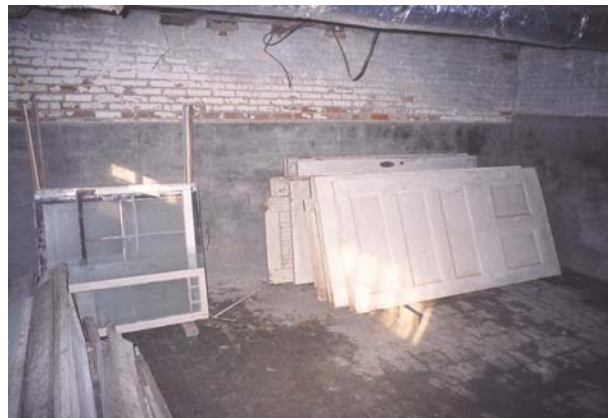
*Figure C - 16* Original doors in storage in Room 001

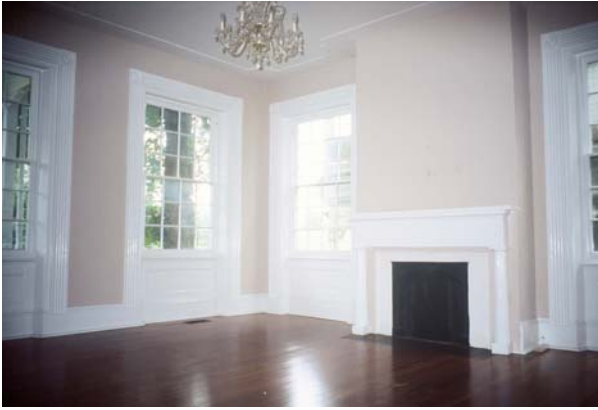
*Figure C – 17 Room 101*

- *Flooring:* The 1919 era, tongue-and-groove, 3¼” pine flooring is laid east-to-west on top of the original random width flooring.
- *Walls:* Early lime plaster, perhaps original, was patched in 1997-99.

- *Doors:* The original five-panel door is now missing and presumably is among the doors stored in Room 001. The doorway retains its 1835-36 vintage, Greek Revival style, paneled jambs and head, and fluted casing with corner blocks.

- *Windows:* Four, 1835-36 vintage, floor-to-lintel window units have splayed paneled jambs and heads, fluted floor to lintel casings, recessed panels, and 12-over-12 light, double-hung, window sash. All sash are the original 1835-36 Type A. Three of the sashes, however, and the muntins of the lower sash of the two north windows and the lower of the southeast window, have been replaced with Type C muntins, probably a Civil War era repair.

- *Other Features:* A plexiglass panel in the ceiling provides a view to a shattered joist reportedly damaged during the Siege of Vicksburg. A built-in bookcase was installed in a door opening in the south wall in 1997-99. According to the owner who made the change, Andrew Johnson, the Victorian 4-panel door and flat board door casing matched that of the doorway that leads from Room 108 to Room 110, as well as the doorways of the Kitchen, Room 109.

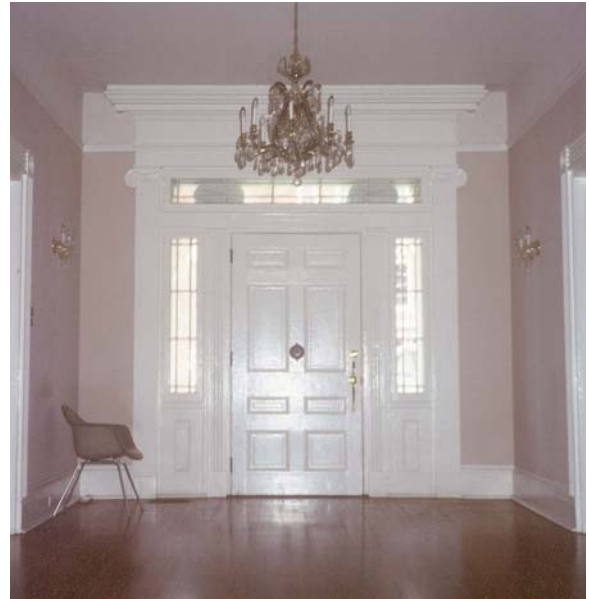
*Figure C – 18 Room 102*

- *Flooring:* The 1919 era, tongue-and-groove, 3¼” pine flooring was laid north-to-south on top of the original random width flooring.
- *Walls:* The early lime plaster, perhaps original, was patched in the late 1990s.
- *Doors:* The house’s main entrance doorway, located at the north end of the room and probably original to the 1835-36 construction, is a spectacular example of Greek Revival style design and craftsmanship. The original eight-panel door is attached with three, 5-knuckle, 4½,” iron, butt hinges with the manufacturer’s stamp: PERKS. The original and early rim locks are missing.

Immediately opposite, a complimentary composition of fluted pilasters, architrave, and transom frame a double doorway with paneled jambs and head and fluted surrounds; here the doors are missing but are presumed to be among those stored in Room 001. The doorways to the two Parlors, Rooms 101 and 103, opposite each other to the east and west, retain their 1835-36 vintage, Greek Revival style, paneled jambs and head, fluted surrounds and trim.

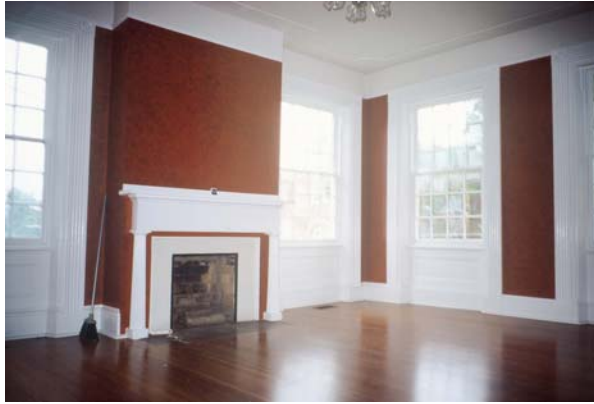
*Figure C - 19 Room 103*

- *Flooring:* The 1919 era, tongue-and-groove, 3¼" pine flooring is laid east-to-west on top of the original random width flooring.
- *Walls:* Early lime plaster, perhaps original, was patched in the late 1990s.

- *Doors:* The original five-panel doors to the Entrance Hall, Room 102, and the Stair Hall, Room 104, are now missing and presumably are among the doors stored in Room 002. Both doorways retain their 1835-36 vintage, Greek Revival style, paneled jambs and heads, fluted surrounds and trim.

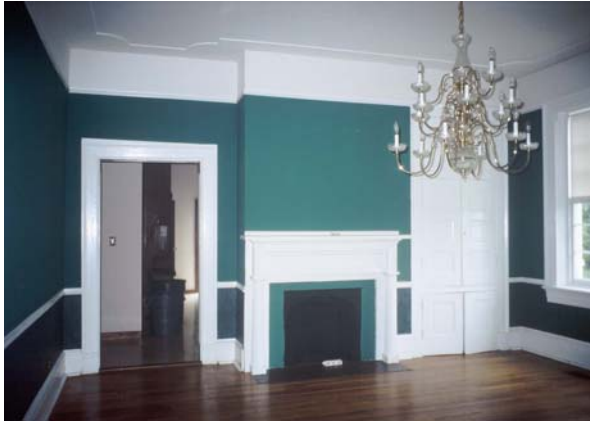
*Figure C – 23 Room 105*

*Room 105:* In the early nineteenth century, this room, the Dining Room, was a less public room. The architectural elements of the original 1835-36 construction period reflect this secondary importance. The windows, for example, while still splayed to display craftsmanship and flood the room with natural light, do not extend all the way to the floor as they do in the two, more public rooms that also have windows, the parlors. The door surrounds are not fluted as they are in the public rooms, nor are the window surrounds fluted as they are in the two parlors. In 1850-51, a portion of the original porch was enclosed and the east exterior wall of the Dining Room was demolished, thus creating an enlarged dining area of the combined Rooms 105 and 106. By the late 1990s, pronounced structural problems had resulted from the diminished support and the wall was partially rebuilt.

- *Flooring:* The 1970s, tongue-and-groove, 2¼” red oak flooring was laid east-to-west here and in Room 106 into which this room opened.
- *Walls:* Early lime plaster, perhaps original, was patched in the late 1990s.
- *Doors:* The doorway to the Stair Hall, Room 104, dates to 1835-36; the original five-panel door is now absent but presumably is among the doors stored in Room 001. The doorway to the Kitchen, Room 109A, was added, probably in 1850-51, when enclosing the east side porch would have necessitated another route to the Kitchen Building. The door, probably a reused 1835-36 era, five-panel door or a 1850-51 reproduction, is now absent but presumably is among the doors stored in Room 001. It is noteworthy that the Greek Revival style casing of this doorway, while appearing to be identical to the other 1835-36 and 1850-51 door

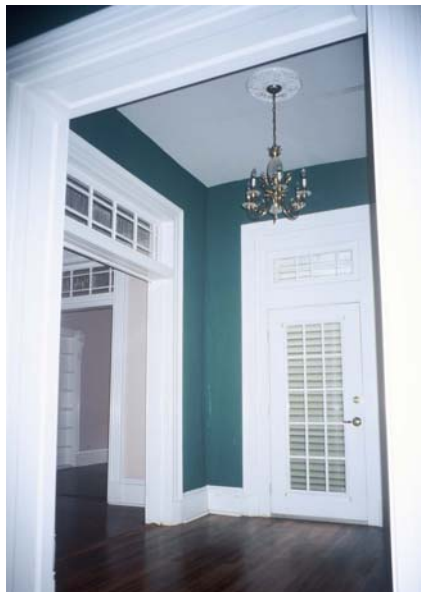
*Figure C – 26* Room 106A

- *Flooring:* The 1970s, tongue-and-groove, 2¼” red oak flooring was laid east-to-west here and in Room 105 into which Room 106 opened. By the 1990s, there was termite damage throughout the red oak flooring of Rooms 105 and 106. During the remodeling of 1997-99, the perimeter of the original Dining Room, Room 105, was re-established, and the Dining Room Extension, Room 106, was subdivided. Red oak flooring was salvaged from the area that became Room Section 106B, and used to patch the flooring of 106A and 105. In its place, a plywood subfloor with carpet was installed in the resultant bathroom of Room 106B.

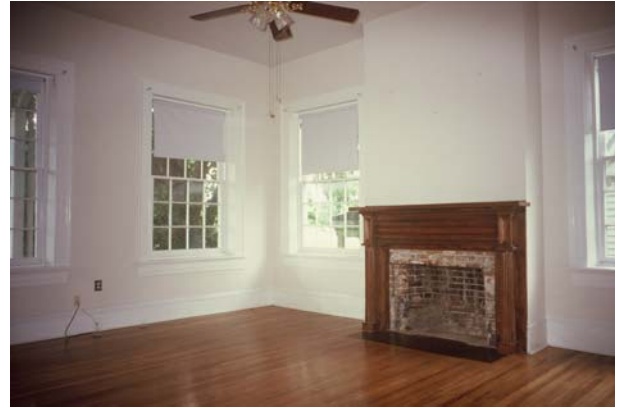
*Figure C – 29 Room 201*

*Room 201:* This, the Northeast Bedroom, is one of two bedrooms on the second level of the 1835-36 house that are larger and more finely detailed. These bedrooms feature the most intricate mantel friezes in the house, and the more complex window sash.

- *Flooring:* The 1970s, tongue-and-groove, 2¼” red oak flooring is laid east-to-west on top of the original random width flooring.
- *Walls:* Early lime plaster, probably original, was patched during the 1997-99 remodeling.

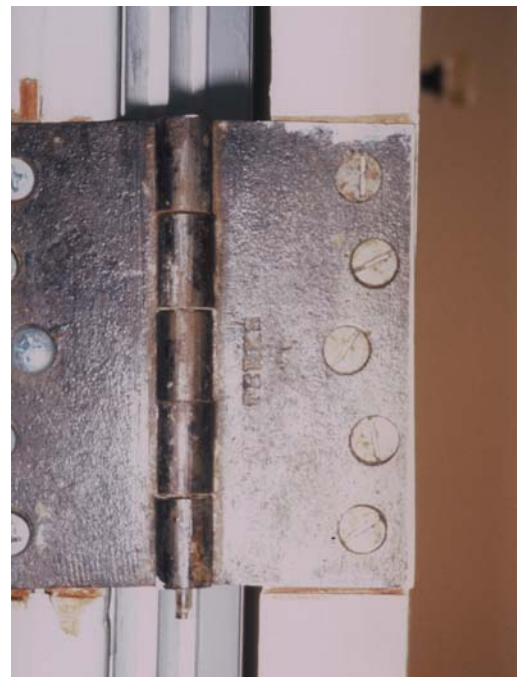
*Figure C – 30 “PERKS” Hinge*

- *Doors:* In the doorway to the Hall, Room 202, an original five-panel door is hung with two early, 4½", 5-knuckle, iron butt hinges with the fabricator's mark: "PERKS;" a modern, 5-knuckle hinge has been added at mid-section of the door. This doorway retains its original 1835-36 vintage, Greek Revival style, paneled jambs and head, and door casing. A second doorway, also with paneled jambs and header, opens to Room 208, a section of the original open porch that was enclosed to be a secondary space in 1850-51. The door is a five-panel door hung with two modern 5-knuckle butt hinges. This doorway has Greek Revival style trim, probably dating to 1850-51, mimicking the 1835-36 trim found elsewhere.

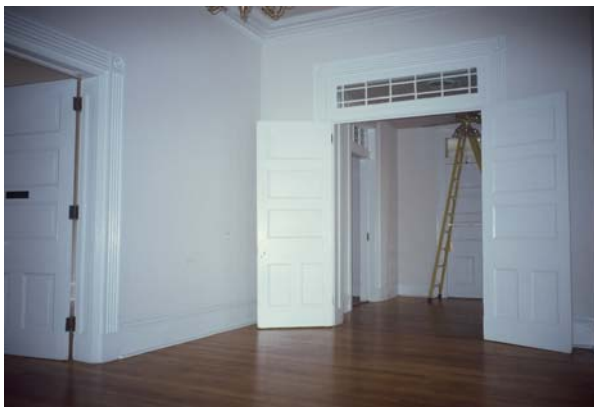
*Figure C – 31 Room 202*

- *Flooring:* The 1970s, tongue-and-groove, 2¼," red oak flooring was laid east-west on top of the original random width flooring.
- *Walls:* The early lime plaster, probably original, was patched during the late 1997-99 repairs.

- *Doors:* The doorway to the upper level of the front entrance porch is located at the north end of the room and is probably original, dating to the 1835-36 construction period. Like its match at first level, it is a spectacular example of Greek Revival style design and craftsmanship.

The original eight-panel door is secured with three 5-knuckle, 4½," iron, butt hinges. The original and early rim locks are missing. Immediately opposite, a complimentary composition of fluted pilasters, architrave, and transom frame a double doorway; here there is a pair of five-panel doors, each with two, 5-knuckle, 4" iron butt hinges labeled "PERKS." The doorways to the two large bedrooms, Rooms 201 and 203, opposite each other to the east and west, retain their 1835-36 vintage, Greek Revival style, paneled jambs and head, and fluted casing.

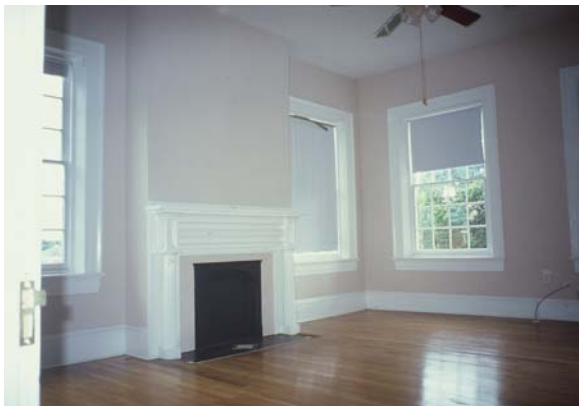
*Figure C – 32 Room 203*

- *Flooring:* The 1970s, tongue-and-groove, 2¼” red oak flooring was laid east-to-west on top of the original random width flooring.
- *Walls:* Early lime plaster, probably original, was patched in the 1997-99 repairs.
- *Doors:* The doorway to the Entrance Hall, Room 202, and the one to the Stair Hall,

- *Windows:* Four 1835-36 window units contain 12-over-12 light, double-hung, window sash. All sashes but one are Type A; one sash is Type B.
- *Ceiling:* The flat plaster ceiling was replaced in the 1997-99 repairs with gypsum board.

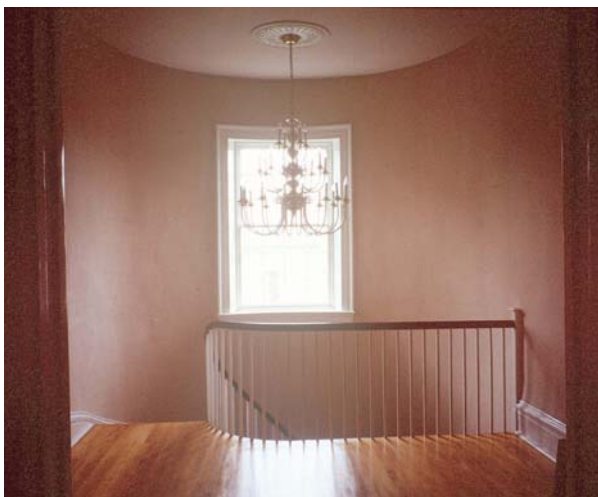
*Figure C – 33 Room 204*

- *Walls:* Early lime plaster, probably original, was patched in the 1997-99 repair effort.
  - *Doors:* A double doorway with a transom matching that of the Hall, Room 202, opens to the west; the doors are now missing but presumably are among those stored in Room 001. A doorway for a single-leaf door leads to the Northwest Bedroom, Room 203, and another to the Southwest Bedroom, Room 205. All three doorways have 1835-36 vintage, Greek Revival style, paneled jambs and heads, and fluted door casing.

- *Windows:* A single window unit with double-hung, 12-over-12 light sash is centered on the west wall. One sash is 1835-36 era Type B and the other is Type C and a Civil War era repair.

- *Ceiling:* The flat plaster ceiling was replaced with gypsum board in 1997-99.
  - *Baseboards:* The tall, 1835-36 vintage, Greek Revival style baseboards with beveled cap are intact.

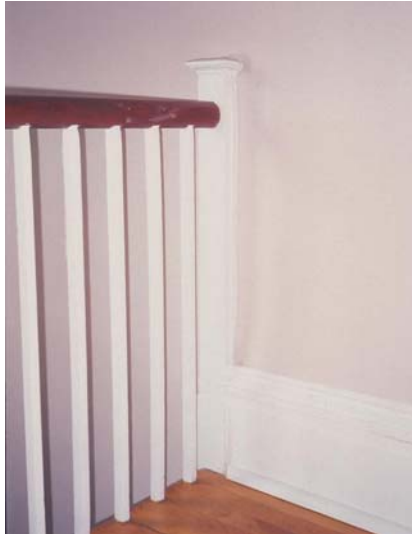
*Figure C – 34 Top stair post*

- *Fireplace & Mantel:* None are present.
  - *Staircase:* An elegant, curving, Greek Revival style staircase to the first floor level is positioned along the west wall. The handrail height is now, with added flooring, 3'-0½" above the floor at second level where it terminates into a 3¼" wide square cut pilaster with simple cap.

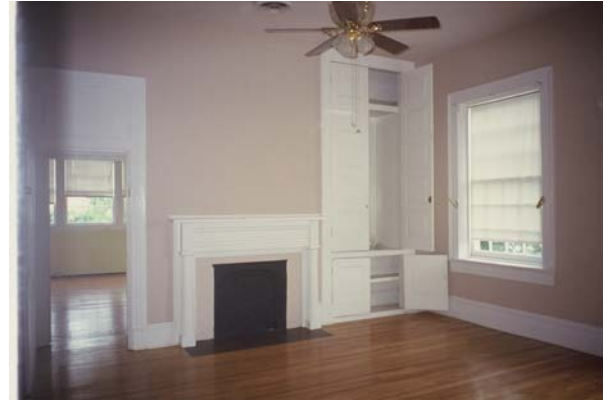
*Figure C – 35 Room 205*

- *Flooring:* The 1970s, tongue-and-groove, 2¼” red oak flooring was laid east-to-west.
- *Walls:* Early lime plaster, perhaps original, was patched in the 1997-99 repairs.
- *Doors:* The doorway to the Stair Hall, Room 204, dates to 1835-36, and has Greek Revival style paneled jambs and head and trim. An original five-panel door is hung on two, 4½” iron, butt hinges stamped “GREENWOOD CIN O”. The doorway to the Sleeping Porch, Room 209, was installed in an original window opening, probably when the second level was added in 1919; the four-panel door and three-light transom are of early twentieth century design. A third doorway was installed in an original 1835-36 window opening on the east wall and leads, now, to a modern bathroom in Room 206A installed in 1997-99. This

doorway has a three-light transom matching the one leading to the Sleeping Porch, suggesting that the doorway may date to 1919; the door surround was reworked, and a resin door cast in an historical six-panel design was installed in 1997-99.

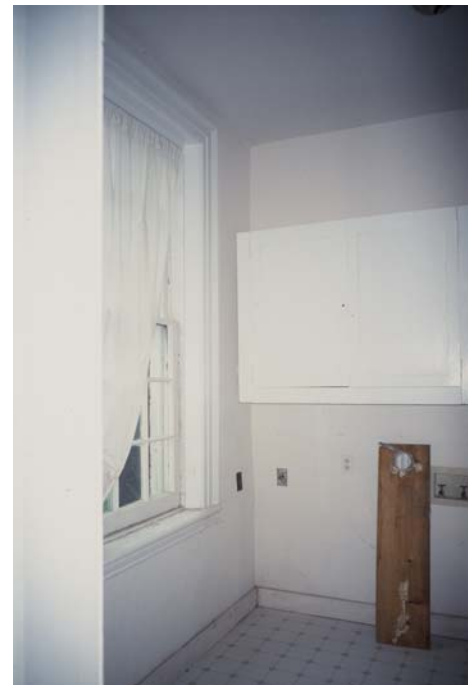
*Figure C - 37* Room 206A

- *Walls:* In 1997-99, the early lime plaster, perhaps the original dating to 1850-51, of the north, east, and west walls was patched. The south wall, containing the remnants of a small firebox added in 1850-51, was furred out with gypsum board to create a plumbing chase. A new gypsum board on stud, cross wall running east-west, was constructed to divide the room into two sections.

- *Ceiling:* The early lime plaster ceiling, probably original, was replaced with gypsum board in 1997-99.
  - *Baseboards:* The room was stripped of most early baseboard elements in 1997-99. A few elements were reused in the Bathroom, Room 206B, but none in the Laundry Room, Room 206A.

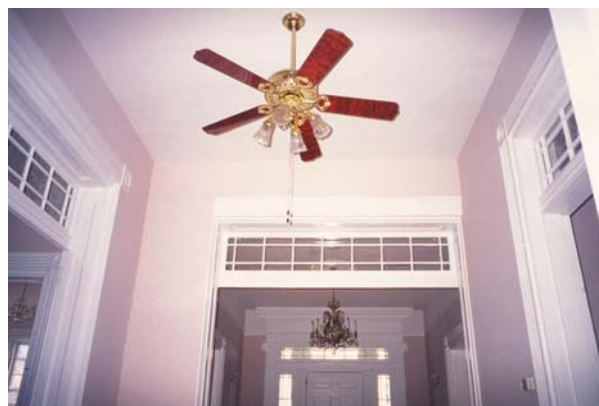
*Figure C – 38 Room 207, looking into Room 202*

- *Flooring:* The 1970s, 2¼" tongue-and-groove, red oak flooring was laid east-west on top of the 1850-51 flooring.
  - *Walls:* In 1997-99, the early lime plaster, presumably the original dating to 1850-51, was patched.

- *Doors:* The openings to the Hall, Room 202, and the Upper Stair Hall, Room 204, apparently date to 1835-36 as indicated by the decorative lintel panels. Either opening could have been a doorway or a window, originally. After 1850-51, both were doorways with transom. Both have paneled jambs and heads, and no trim on this side of the openings, except for the original paneled lintel. The doorway to Room 206 was constructed in 1850-51. It was constructed for a pocket door with transom; the transom is missing and a five-panel door of 1835-36 design is now hung as a swinging door with early, 5¾" iron butt hinges. The door trim is Greek Revival style dating to 1850-51. The doorway with transom to Room 208 was constructed as a pocket door in 1850-51, and the pocket door is still in place. The door trim is Greek Revival style dating to 1850-51.

- *Windows:* None are present.
  - *Ceiling:* The lime plaster ceiling, probably original, patched in 1997-99.
  - *Baseboards:* The tall, 1850-51 vintage, Greek Revival style baseboards with flush caps, mimicking the 1835-36 designs found in the earliest portions of the house, are intact.

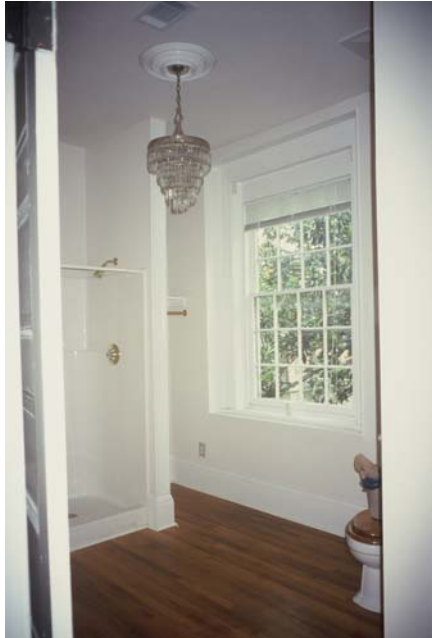
*Figure C – 39 Room 208A*

- *Flooring:* The 1970s, 2¼” tongue-and-groove, red oak flooring was laid east-west on top of the 1850-51 flooring.
- *Walls:* In 1997-99, the early lime plaster, presumably the original dating to 1850-51, of the north and west walls was patched; the east and south walls were furred out with gypsum board for plumbing chases. At the same time, a gypsum board on stud cross wall was constructed to subdivide the room into two bathrooms.
- *Doors:* The doorways to the Hall Extension, Room 207, and to the Northeast Bedroom, Room 201, retain 1850-51 vintage, Greek Revival style trim.
- *Windows:* There are two window openings for double-hung window units, both in Room 208A. Both conform to the

1835-36 design features found in the earliest part of the house. They were moved to their current locations during the 1850-51 remodeling. Their places of origin are not known, but they would likely be along the south wall of the Northeast Bedroom, Room 201. The window unit now on the east wall is blocked in. The window unit now on the south wall has two Type A sashes. A third double-hung window unit was removed from the south wall of Room 208B during the 1997-99 remodeling.

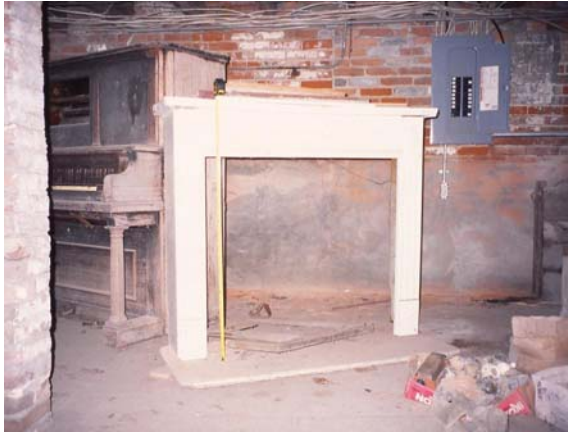
*Figure C – 40 Room 208 mantel*

- *Ceiling:* The early lime plaster ceiling was replaced with gypsum board in 1997-99.
- *Baseboards:* The baseboards of both 208A and 208B are modern, dating to the 1997-99 remodeling.
- *Fireplace & Mantel:* A small, corner fireplace was installed in 1850-51. In 1997-99, the firebox was blocked off and the mantel placed in storage in Room 002. The mantel is made of painted wood. Its most distinctive feature is the decorated frieze containing a classical urn at the center flanked by a garland on either side.

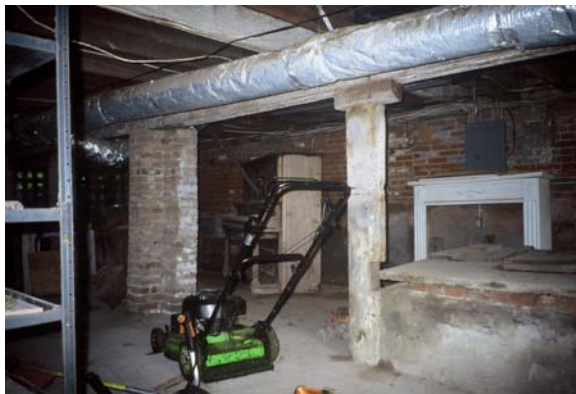
*Figure C - 41 Room 002*

- *Flooring:* Poured cement, set at grade, forms the flooring. This cement was poured after the brick piers were constructed. An earlier flooring of brick or even dirt may be below the current cement flooring.
- *Walls:* The 1835-36 south foundation wall of the house ell and porch forms the north wall of this space. The east one-half of the south wall is the remnant wall of the Kitchen Building, now demolished; the

west one-half of this wall was constructed in 1919. From grade up to a height of about 3'-3", the brickwork has been parged with a Portland cement-rich stucco, undoubtedly an attempt to stem rising damp. The east and west ends are enclosed with lattice work also dating, probably, to 1919.

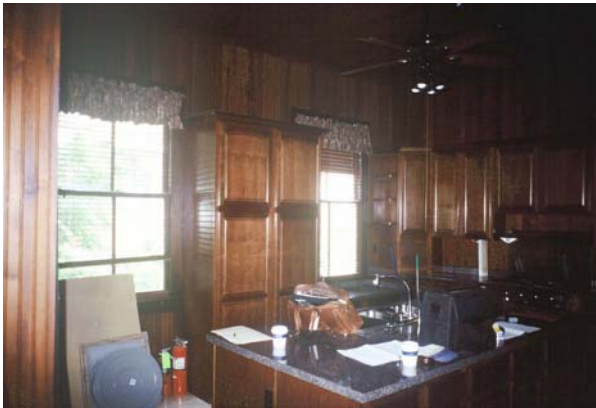
*Figure C - 43 Room 109A*

*Room 109 A & B:* The first level is subdivided into a roughly equal space by a north-south partition wall. The west room, Room 109A, contains a modern residential kitchen installed in 1997-99 with cabinets along the north, west, and south walls, a large center island, gas stove, and electric refrigerator. A straight run of stairs along the south walls leads to the second level. The east room, Room 109B, became a bedroom in the 1997-99 remodeling; the space below the stairs is a closet.

- *Flooring:* The flooring of the Kitchen (Room 109A) is 1997-99 vintage sheet vinyl, while that of the Bedroom (Room 109B) is similar vintage carpet.

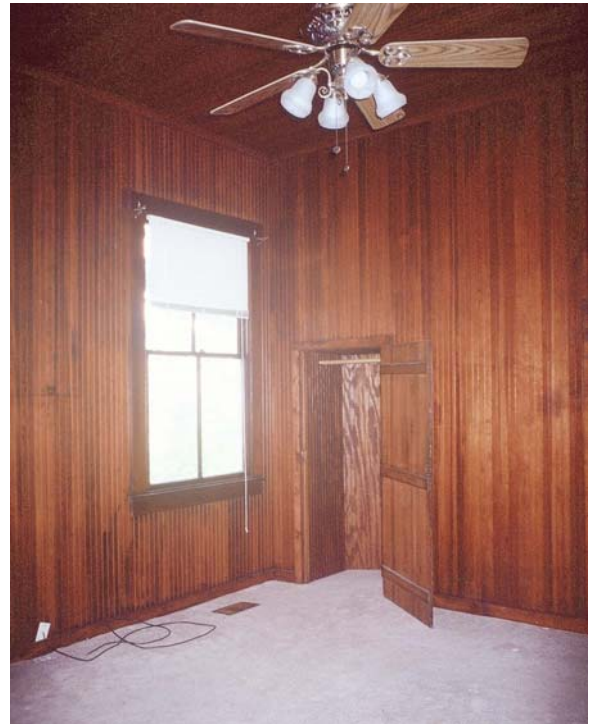
*Figure C - 44 Room 109B*

- *Walls:* Except for the gypsum board on studs partition wall installed in 1997-99 to subdivide the room, the walls retain their 1919 vintage 3¼" beaded boards applied on the vertical.

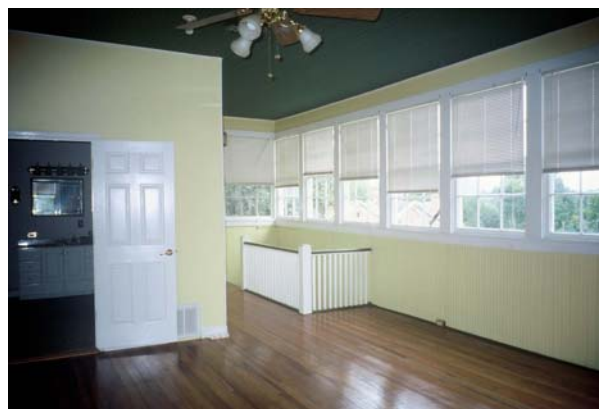
*Figure C - 45 Room 209A*

*Room 209 A & B:* A large, open second level room was constructed in 1919 by the Sisters of Mercy to be their Sleeping Porch. It remained that way until the 1997-99 remodeling when partition walls of gypsum board on studs were constructed to create a Bathroom with closet (Room 209B) in the northeast corner. The remaining L-shaped space is Room 209A.

- *Flooring:* The tongue-and-groove, 3/4" pine flooring, running east-to-west, remains from the original construction of 1919. This flooring is exposed in Room

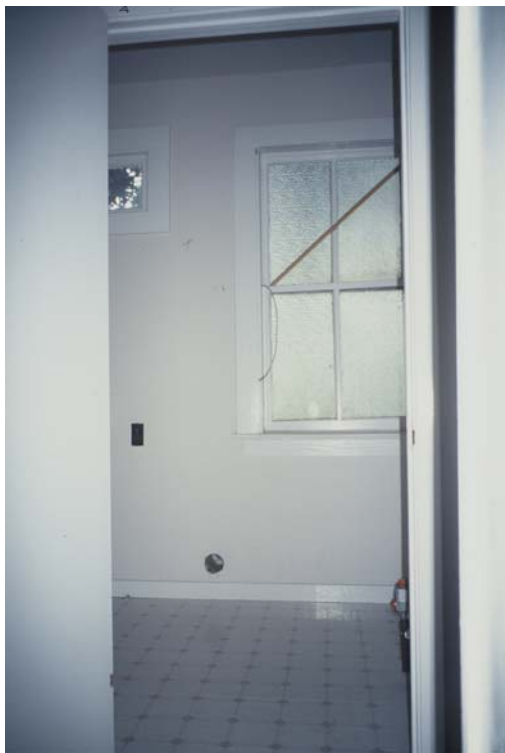
*Figure C – 46*      *Room 110B*

- *Flooring:* Sheet vinyl flooring was installed throughout during the repairs of 1997-99.
- *Walls:* Gypsum board was installed on the walls during the repairs of 1997-99.

- *Ceilings:* Gypsum board was installed during the 1997-99 repairs.
- *Baseboards:* Modern baseboards of nominal 1" x 4" plank boards were installed in the 1997-99 repairs.

- *Fireplaces & Mantels:* None are present.
- *Finishes:* All wood trim and gypsum board surfaces are painted.
- *Mechanical & Electrical Systems:* A modern, electric ceiling light was installed in each room section during the 1997-99 repairs. In addition, new copper water pipes, a water heater, and washer/dryer hook-ups were installed.

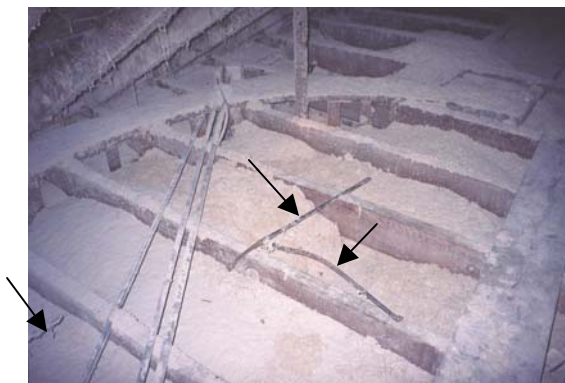
Figure C – 48 Early gas lines in the attic

In the attic, part of the pipe has been disconnected when HVAC ductwork was installed and perhaps with other work too, but the remaining sections indicate gas lights were present on the second floor in the stair hall, both principal bedrooms (Rooms 201 and 203) and the interconnecting hall (Room 202.) No gas lighting fixtures were found on site, however. An abandoned, early twentieth-century gas water heater remains in basement Room 001 and a furnace is in a ground level crawl space.

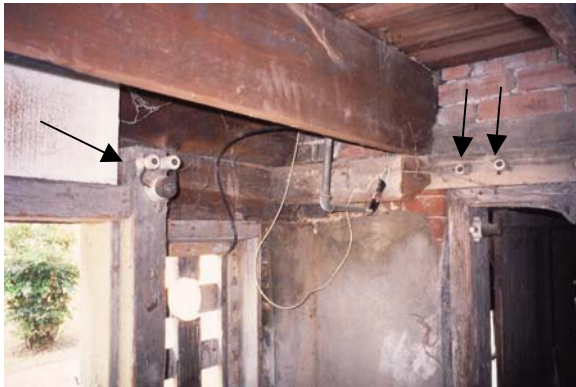
Electricity came to Vicksburg in 1886. The earliest evidence of electricity in the house is the late-nineteenth century/early-twentieth century ceramic insulators found in the

basement, Room 002, of the frame addition and in the attic of the original house. The previous owner reported that the house was largely rewired in the 1970s and completed in 1997-99 when the current lighting fixtures were installed. Nothing was observed to contradict those statements.

*Figure C – 50 Knob and tubing*
