Chapter 3: Existing Conditions / Affected Environment

The *Secretary of the Interior's Standards for the Treatment of Historic Properties* require a comprehensive understanding of the current conditions to provide a baseline for the development of treatment recommendations. This chapter provides a thorough inventory of the existing conditions of the environmental context, cultural resources (including cultural landscapes, buildings, and archeological sites), wildlife, socioeconomics, visitor experience, and park operations related to the Delta-01 and Delta-09 sites.

Minuteman Missile National Historic Site
Historic Structures Report/Cultural Landscape Report/Environmental Assessment

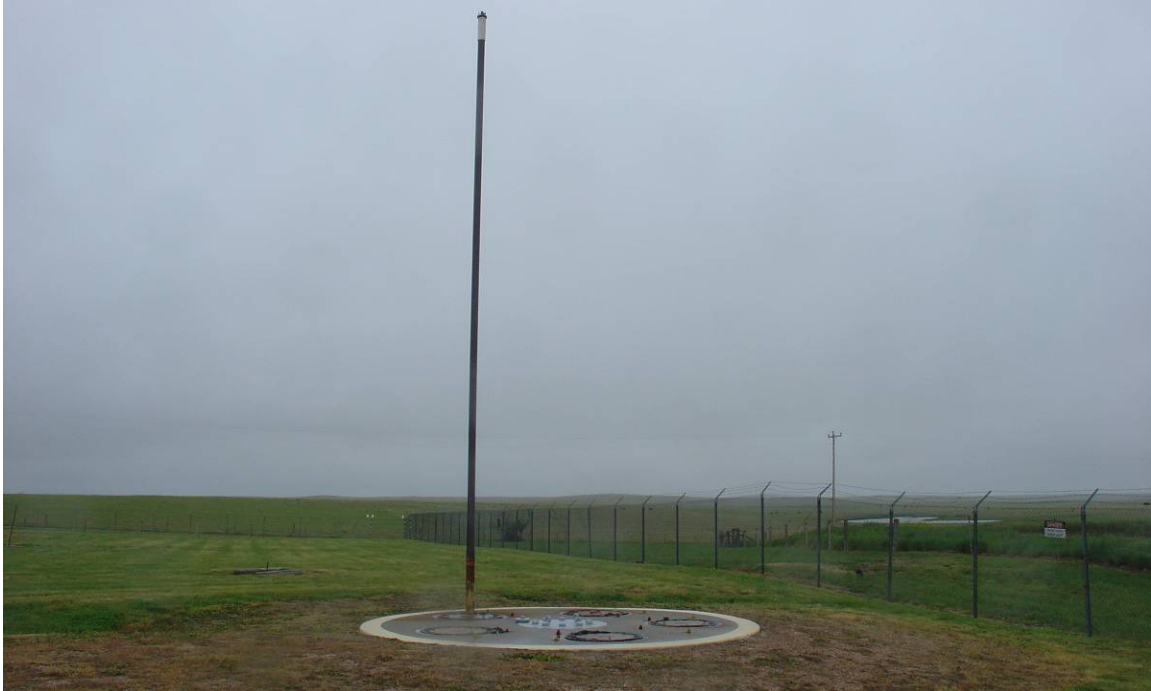
Figure 3- 11: Hardened High Frequency Receive Antenna at Delta-01, facing southeast, June 2009
(source: QEA 3385)

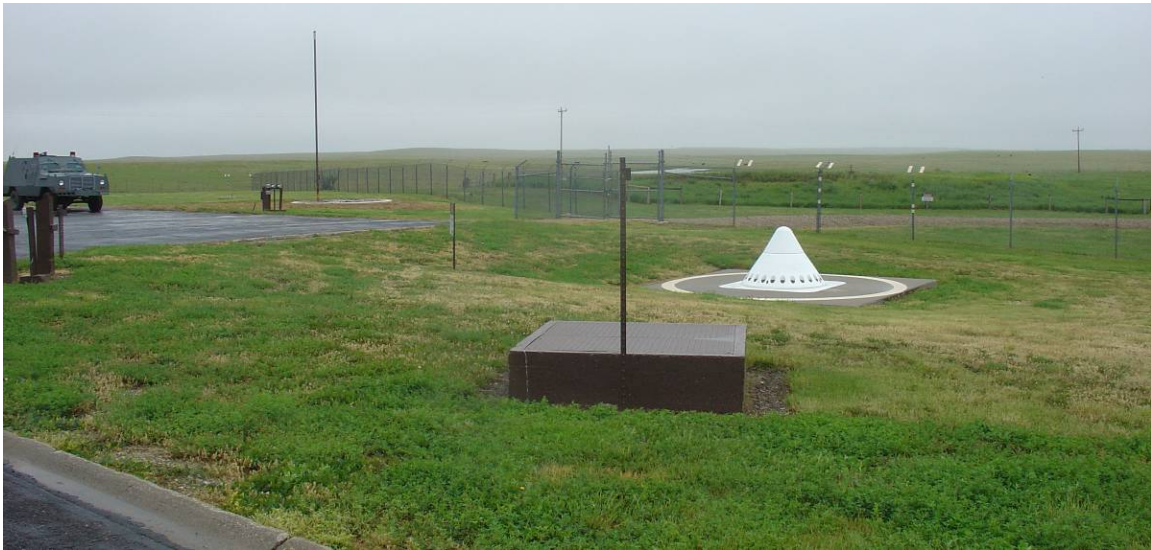
Hardened ultra-high frequency antenna (HS 106, IDLCS 100483)	<i>The hardened UHF antenna is located near the southwest corner of the LCF support building. It consists of a massive, cast-steel frustum, bolted to a thick, reinforced-concrete slab sixteen feet square. A conical, white fiberglass weather dome surmounts the frustum. The antenna was installed in 1976. The antenna is in good condition.</i>	3-12
Survivable low frequency communication system antenna (HS 107, IDLCS 100484)	<i>Installed in 1968, the SLFCS antenna is buried in the ground about 140 feet east of the LCF support building and is not visible from the surface. The antenna is in good condition.</i>	Not visible on surface, see map for location.
Cathodic protection rectifier (HS 110, IDLCS 100485)	<i>Electronic device installed in 1982 to protect underground features from corrosion. Located outside the security fence on the north side of the access road. The aboveground portion includes a white-painted steel electrical box mounted on a wood pole. The below ground portion is a well approximately 220 feet deep, containing eleven graphite anodes. The rectifier is in poor condition.</i>	3-13

Figure 3- 12: Well cap (brown box) and Hardened Ultra High Frequency Antenna (white cone), facing southwest, June 2009
(source: QEA 3354)

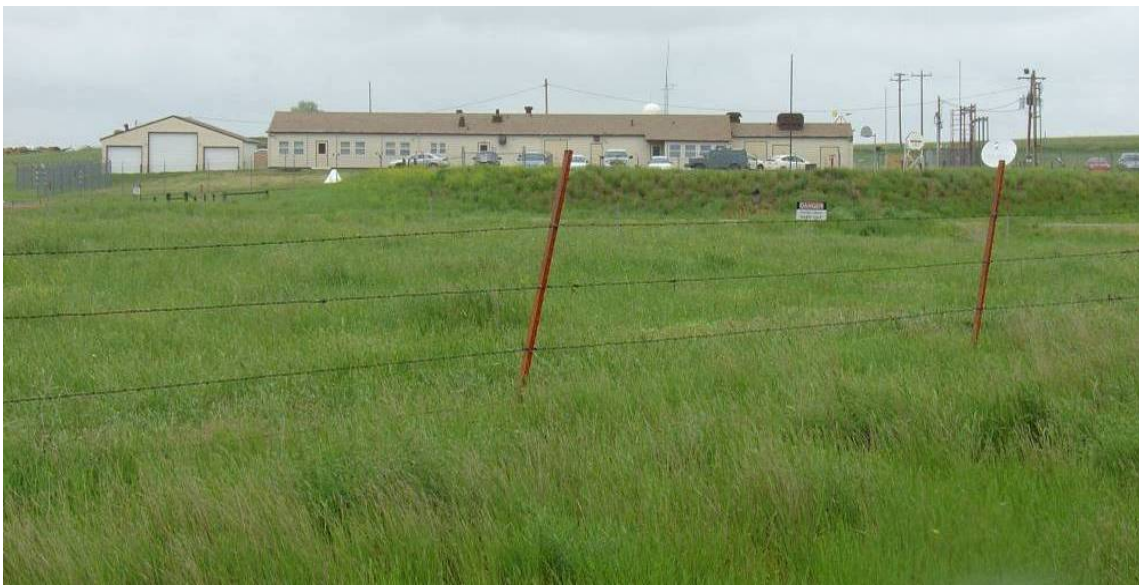
Small Scale Features, cont.	Description/Condition	Figure #
Two sewage lagoons (HS 108, IDLCS 100486)	<i>Northern lagoon is the primary structure which is roughly square with sides oriented at approximately a 30 degree angle from north/south. The southern lagoon is the secondary structure and is an odd shape, wrapping around the southeast corner of the primary lagoon. Both structures have earthen berms surrounding their sides to detain settlement materials. The lagoons are in good condition.</i>	3-14
Helicopter pad (HS 109, IDLCS 100485)	<i>Square concrete pad outside security fence on raised platform. Access is by graded gravel route from the Launch Control Center parking area. There is an asphalt perimeter around the helipad. The helipad is in good condition.</i>	3-15
ICBM super-high frequency satellite terminal antenna (ISST) (HS 126, IDLCS 754345)	<i>Installed circa 1992, the antenna is located at the rear of the LCF support building. The antenna was installed when the missile sites were being deactivated in Ellsworth's 67th Strategic Missile Squadron. The antenna is in good condition.</i>	3-16

Figure 3- 14: Livestock fence with embankment of secondary sewage lagoon behind and Delta-01 buildings in background, facing northwest, June 2009 (source: QEA 3649)

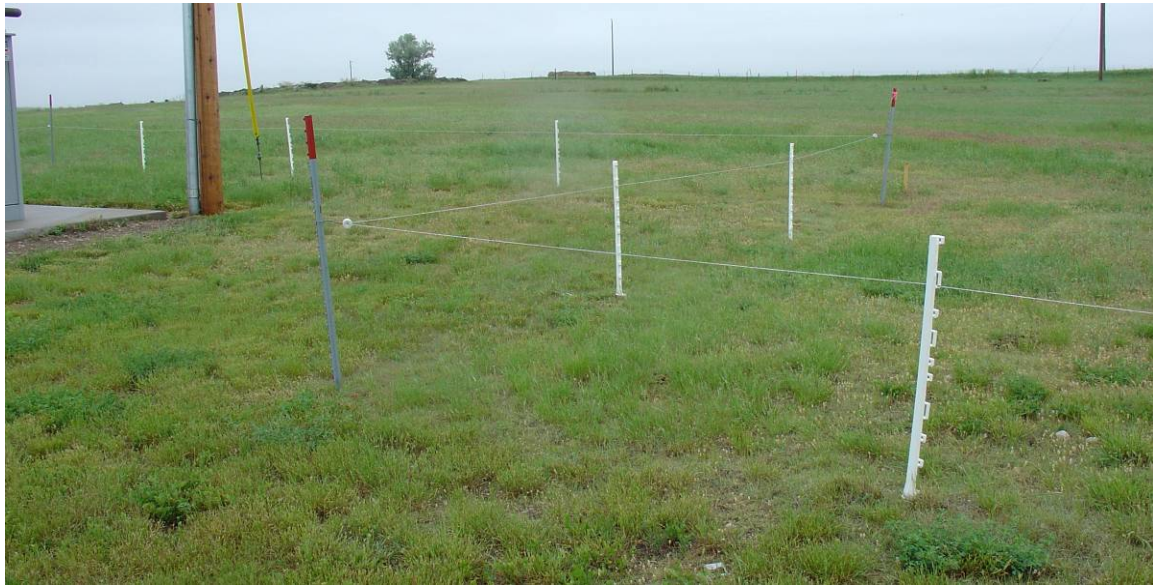
Electric fence	<i>Gray t-posts painted red on top and white plastic posts with a single low voltage electrical wire at about two-feet off the ground. Erected by the National Park Service to prevent livestock from damaging vehicles on the entrance drive. The electric fence is in good condition.</i>	3-19
Historic signage (HS 117, IDLCS 354856)	<i>Brown metal signs with white lettering hung on the security fence, warning signs, and no smoking signs. The signs are in good condition.</i>	3-20

Figure 3- 19: Electric fence north of access drive, facing northwest, June 2009 (source: QEA 3453)

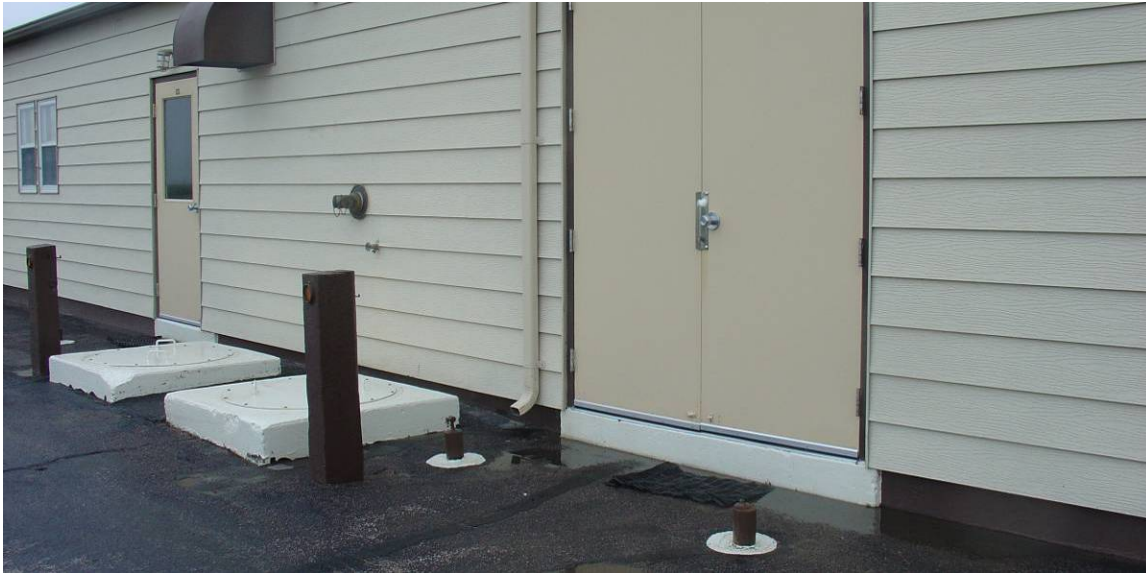
Small Scale Features, cont.	Description/Condition	Figure #
Protective bollards (HS 116, IDLCS 354857)	<i>Wood and concrete bollards painted brown located near the buildings and other features to prevent damage from large vehicles. The bollards are in good condition.</i>	3-21
Access road and parking area (HS 119, IDLCS 390289)	<i>Asphalt drive and parking area. The pavement is in fair condition.</i>	3-22, 3-23
Well and water tanks (HS 118, IDLCS 354851)	<i>Brown metal box approximately four foot square and one foot tall is visible above ground. The portion of the well and water tanks that is visible is in good condition. The condition of the underground features is unknown.(verify)</i>	3-12
Flagpole (HS 120, IDLCS 398270)	<i>Metal pole. The flagpole is in good condition.</i>	3-23
Basketball goal (HS 112, IDLCS 287625)	<i>Metal basketball post with goal. The basketball goal is in good condition.</i>	3-23

Figure 3- 21: Wood bollards at Launch Control Facility, facing northwest, June 2009
(source: QEA 3376)

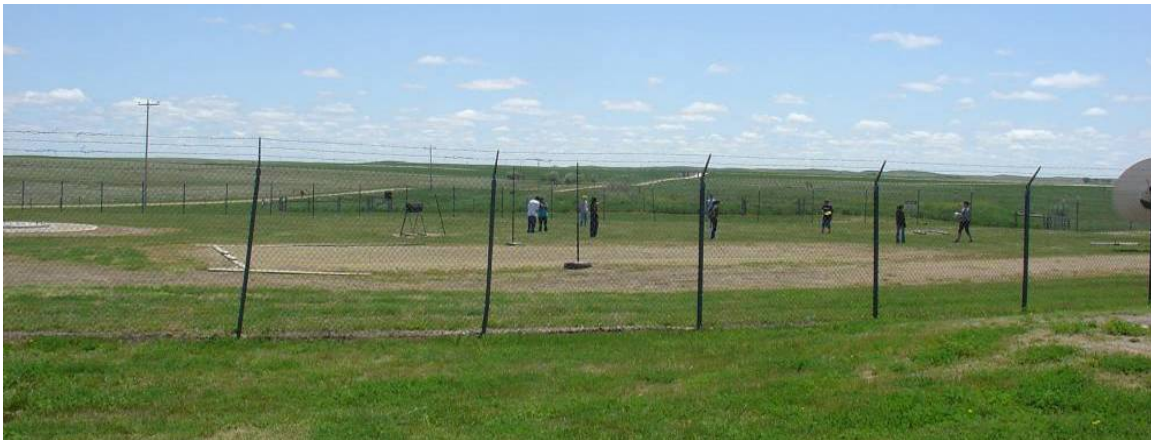
Volleyball court (HS 115, IDLCS 287266)	<i>Sand/dirt court with net supported by metal posts. The volleyball court is in fair condition. There are weeds encroaching into the sand.</i>	3-24
Horseshoe court (HS 114, IDLCS 287261)	<i>Two u-shaped wood pits with stakes aligned with each other. Grass is growing between the dirt pits. The horseshoe pits are in fair condition.</i>	3-25
Code burner (HS 111, IDLCS 287264)	<i>Small concrete square flush at the ground is visible. The code burner is in good condition.</i>	3-26
Interpretive wayside	<i>NPS wayside with historic photographs and text describing the "invisible warriors." Fiberglass panel mounted on aluminum posts. The wayside is in good condition.</i>	3-20
Portable toilet	<i>Tan plastic portable toilet building. The portable toilet is in good condition.</i>	3-16
Concrete pad, transfer switch, and generator	<i>Concrete slab and electrical transfer switch, and generator the generator is yellow. The pad, generator and switch are in good condition.</i>	3-27

Figure 3- 24: Security fence and volleyball court, facing south, June 2009 (source: QEA 3159)

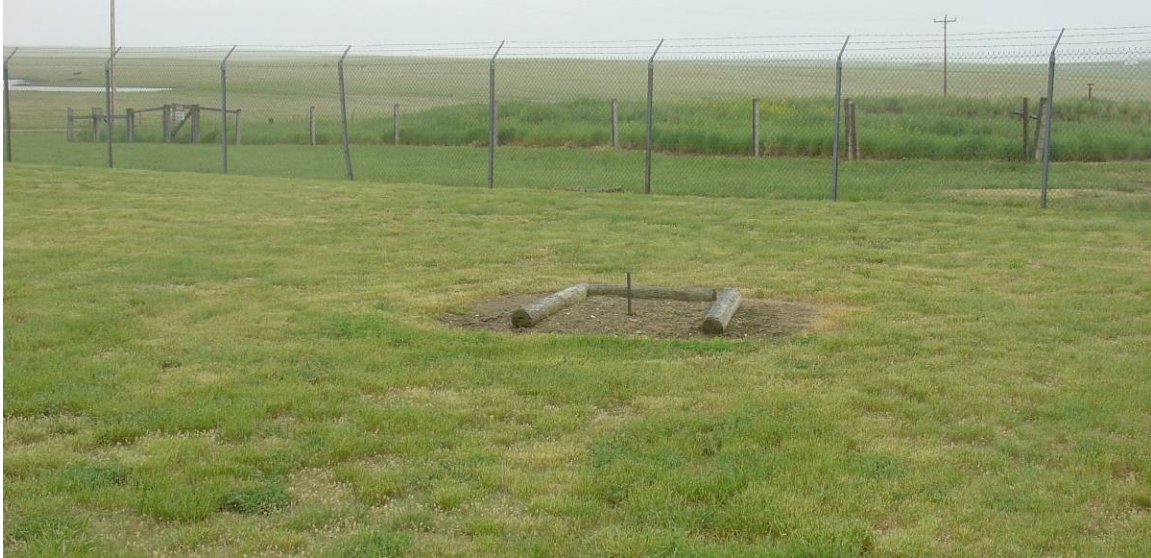
Figure 3- 25: South end of horseshoe court, facing south, June 2009 (source: QEA 3412)

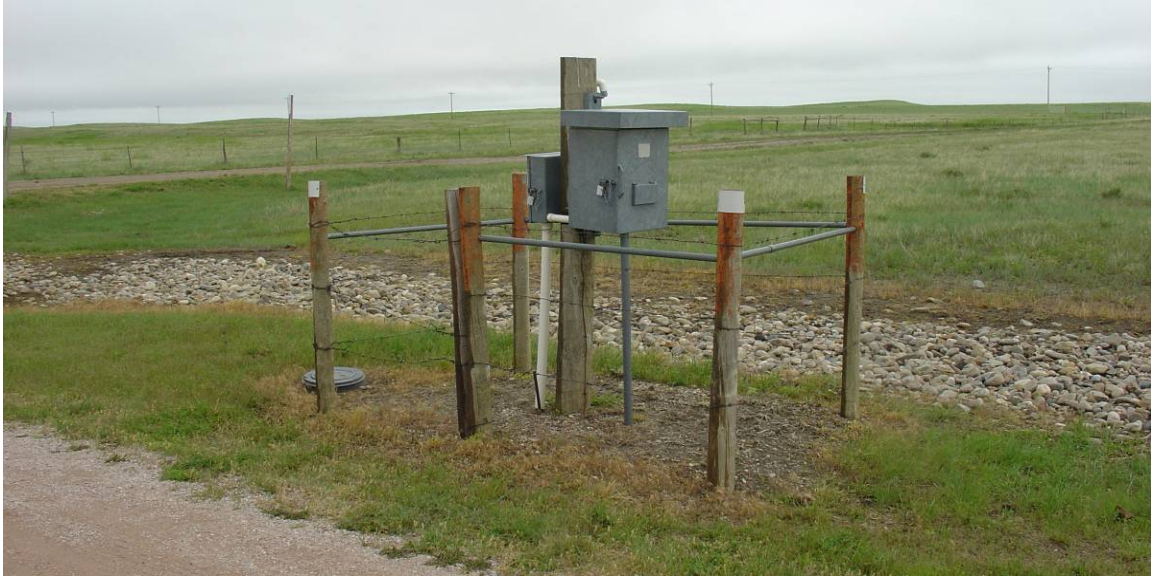
Cathodic protection rectifier (HS 912, IDLCS 390310)	<i>Installed 1982-83. Located on the south side of the access drive, approximately 160 feet east of the security fence. The below ground portion consists of a well approximately 220 feet deep that contains eleven graphite anodes. The system is not operational. It is in poor condition.</i>	3-35
Two azimuth markers (HS 905, IDLCS 100492)	<i>Used in conjunction with the autocollimator to align the Minuteman guidance system. They are located approximately one thousand feet from the launcher—one to the north-northwest and one to the north-northeast. Each marker consists of a cylindrical concrete pylon, three feet in diameter and eight feet deep, set vertically into the ground. The visible (above-ground) portion of each pylon is approximately eighteen inches in diameter and four feet high. A disc-shaped aluminum alloy survey plate is set into the top of each pylon. The azimuth markers are in good condition.</i>	3-36

Figure 3- 35: Cathodic protection rectifier, facing southeast, June 2009 (source: QEA 3521)

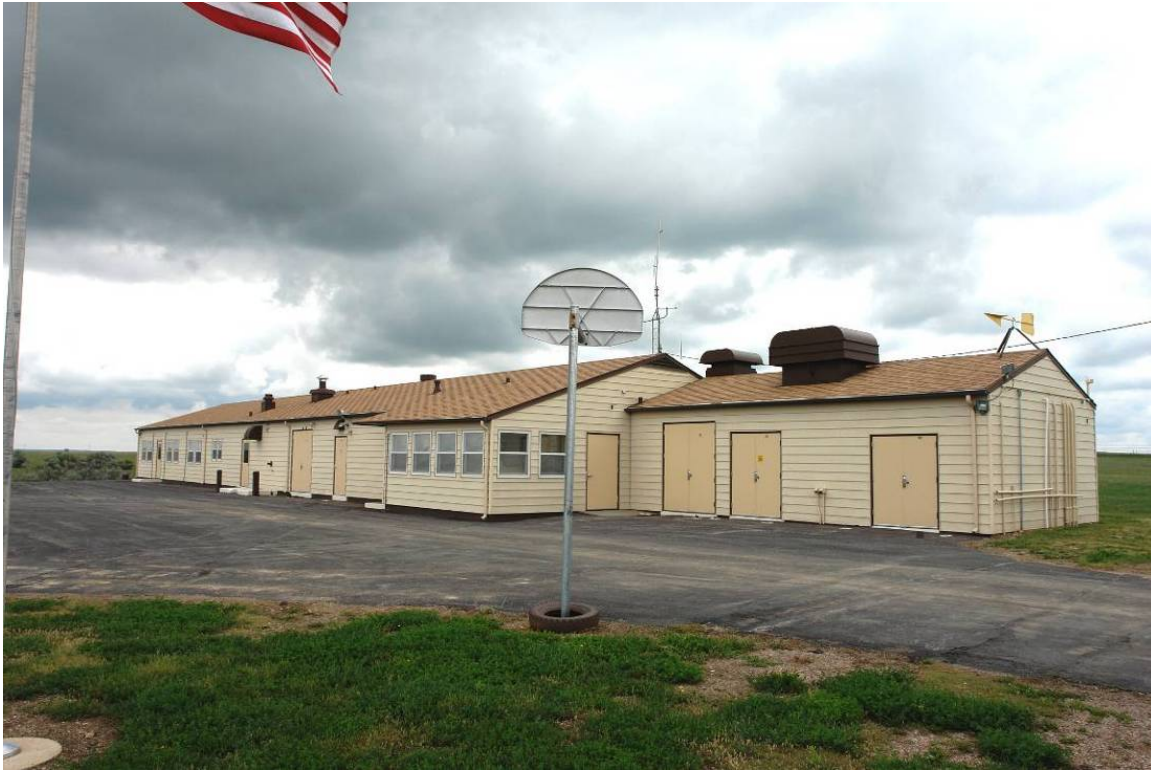
Figure 3- 45: Delta-01 Launch Control Support Building (source: QEA 8394)

Siding: The pre-finished tan colored, wood grain embossed, prefabricated steel siding (8" exposure), which replaced the original asbestos cement shingle siding in the mid-80s, is in good condition with several dings, gouges, and dents throughout the four elevations (figures 3-45, 3-47, 3-48, 3-49). There is some staining below the hose bib on the south elevation caused by dripping water from the bib. The exterior and interior corner trim and window surrounds are also in good condition. There are no indications that the siding is not functioning as expected for its age and condition.

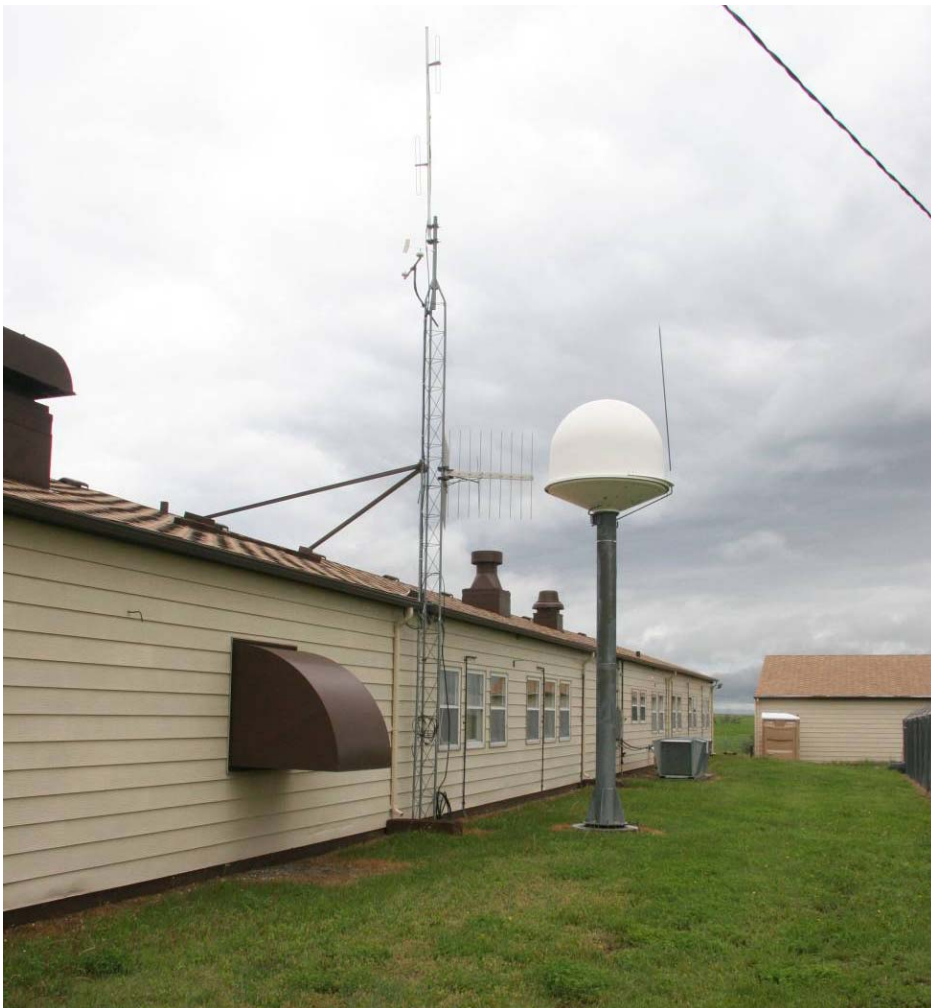
Figure 3- 47: North elevation looking west (source: QEA 0041)

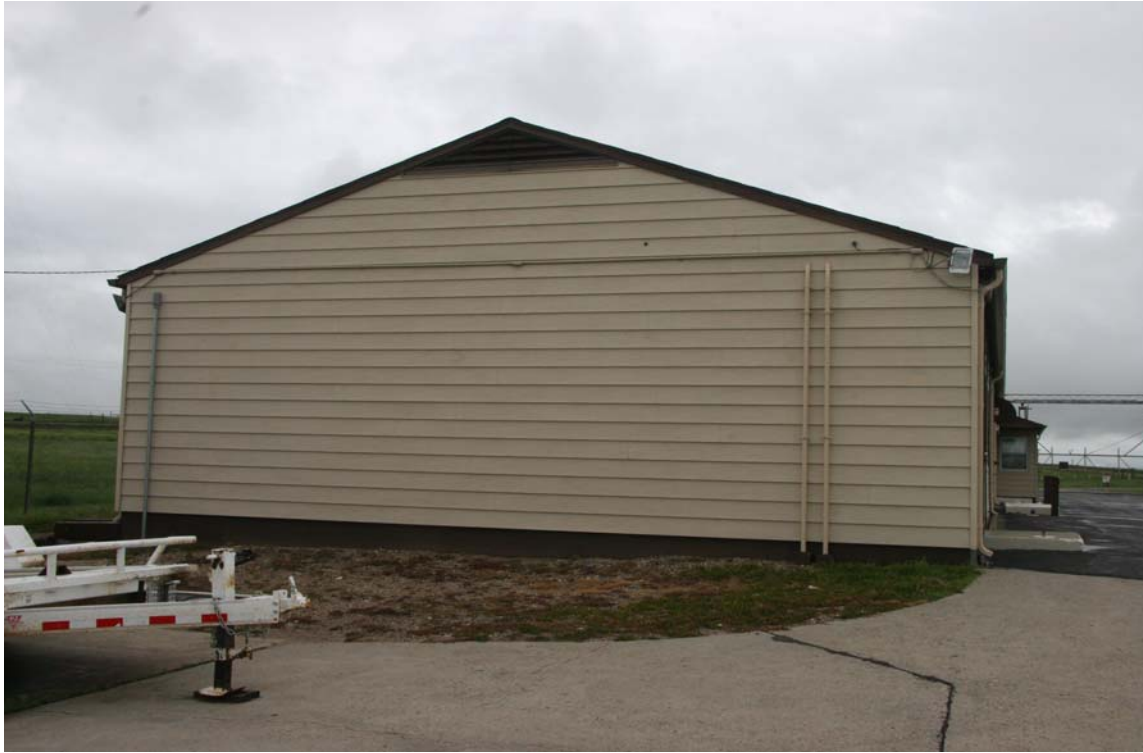
- Miscellaneous horizontal and vertical metal conduit, both painted and unpainted, are in good condition.
- There is one location in the south half of the gable where a previous penetration of electrical wire through the siding has been abandoned.
- The metal louver at the top of the gable is painted the dark brown trim color and is in good condition.

Figure 3- 48: Launch Control Support Building, west elevation (source: QEA 0018)

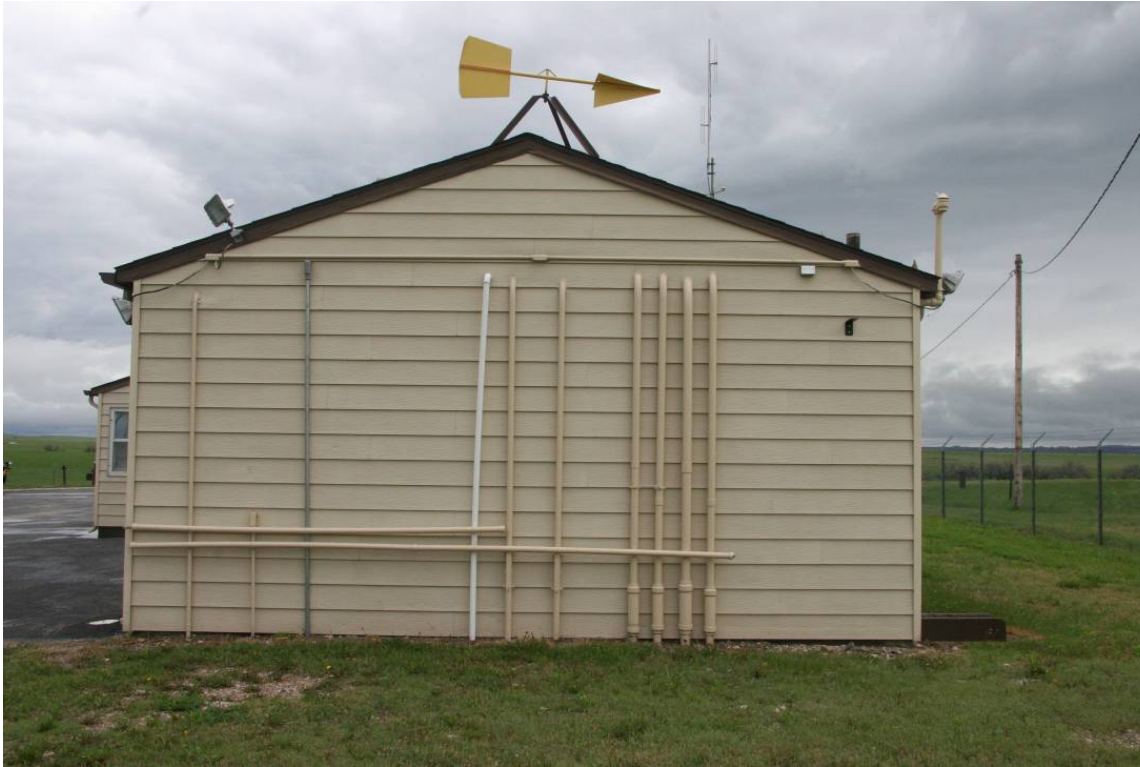
Figure 3- 49: Launch Control Support Building, east elevation (source: QEA 0045)

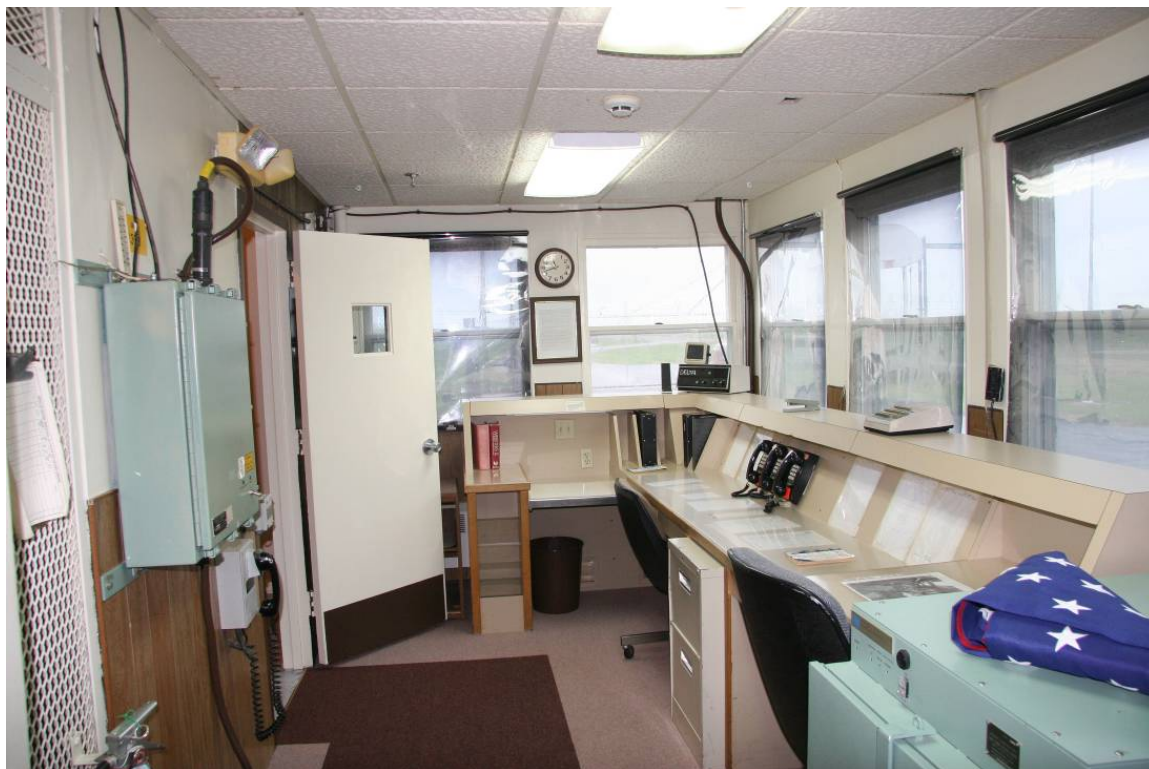
Security Console: The extant security console was installed circa 1983 and is in good condition (*figure 3-51*). The console was installed over the original carpet with the circa 1990 carpet scribed to the console. The original carpet remains exposed between the console and the east and south walls.

Figure 3- 51: Security Office looking east, 2009 (source: QEA 0117)

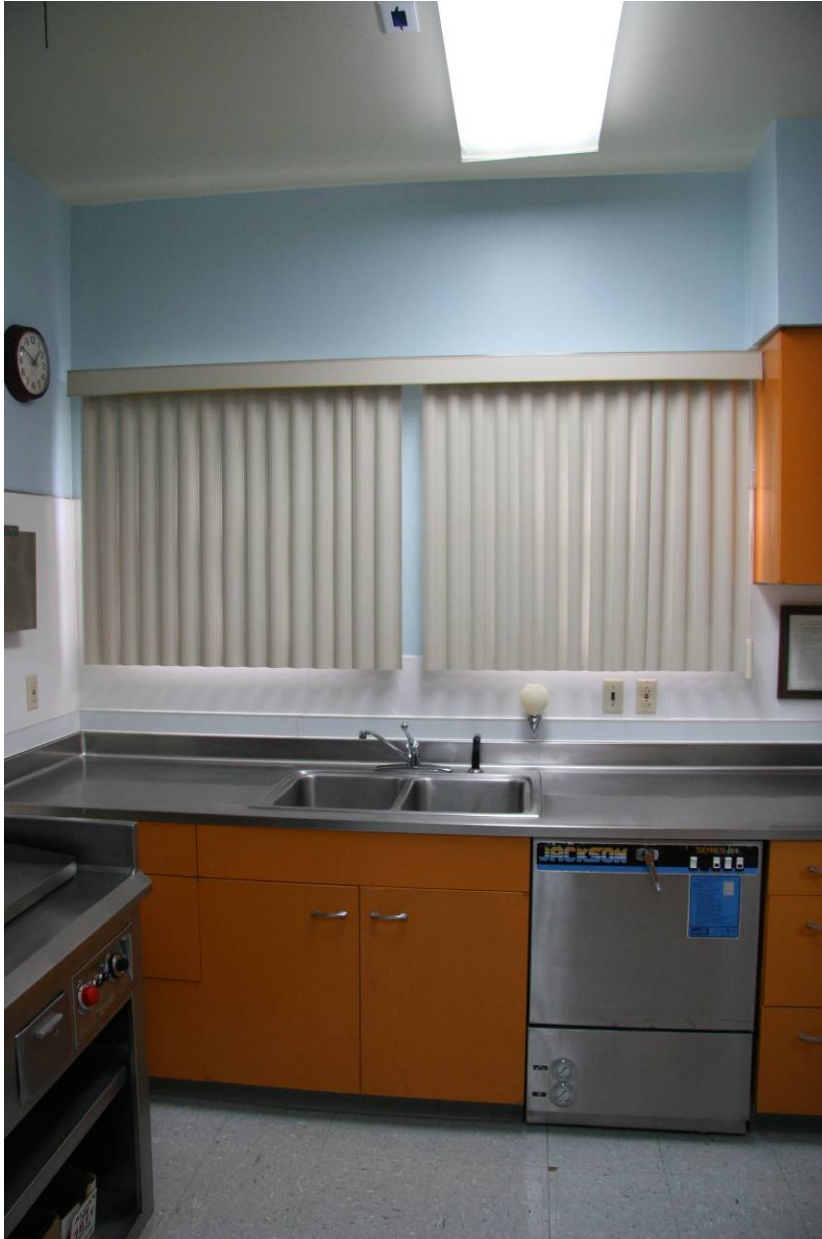
- The exhaust hood, base cabinets, food warmer, and griddle all appear to be original equipment and in good condition (figure 3-57).
- The original range (4 burner) with oven appears to have been replaced with a commercial oven unit, between 1980 and 1983, which is in good condition.
- The original deep fat fryer appears to have been replaced with a two burner cook top unit, between 1980 and 1983, which is in good condition.
- Refrigerator, unknown date, is in good condition.
- Dishwasher: The original dishwasher was relocated on the north wall to the east, circa 1980, and is in good condition (figure 3-54). It is unknown if this unit is still the original.

Figure 3- 54: Kitchen, looking north (source: QEA 0012)

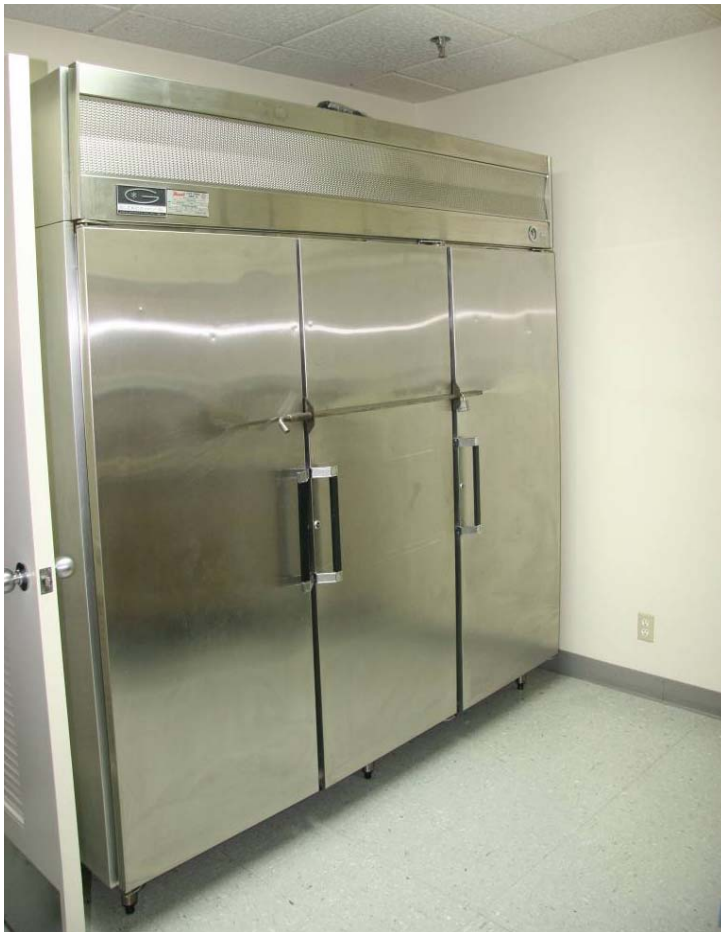
- Two stand alone upright freezers are against the north wall, one relocated from the kitchen; both in good condition.
- A three unit commercial freezer unit stands along the east wall and is in good condition (figure 3-59).

Figure 3-58: Commercial freezer unit on east wall of serving room (source: QEA 0077)

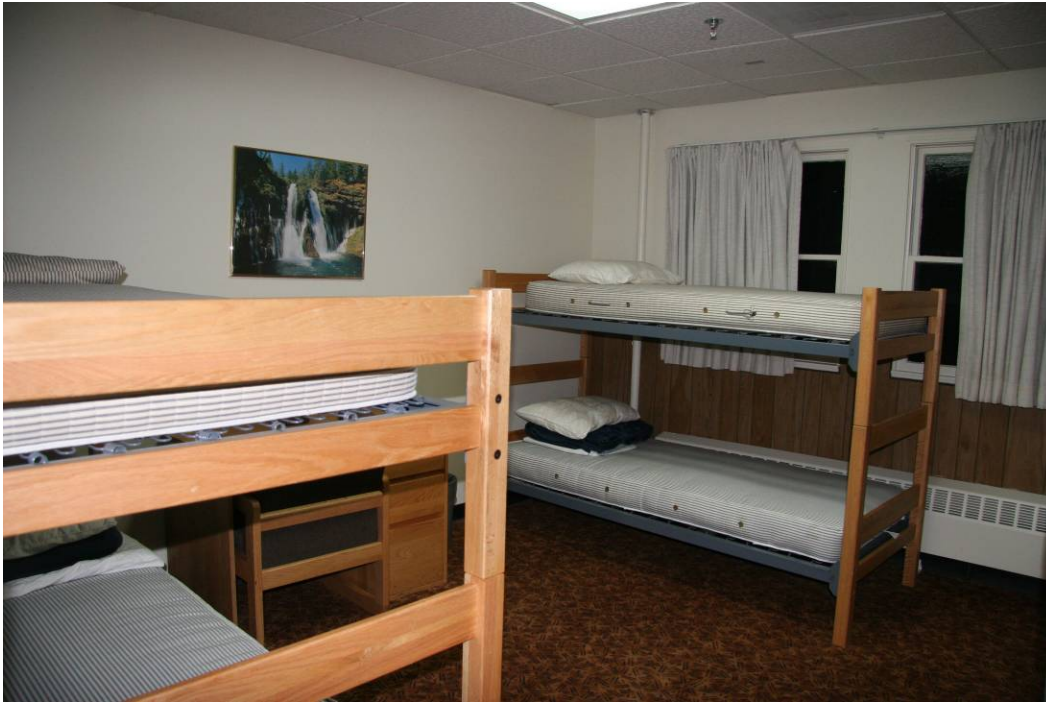
Window Treatments: Vertical fabric curtains on a retractable rod in good condition. Window glass in Bedrooms 118 and 120 has been painted black.

Figure 3- 59: Typical bedroom (118) looking northwest (source: QEA 0063)

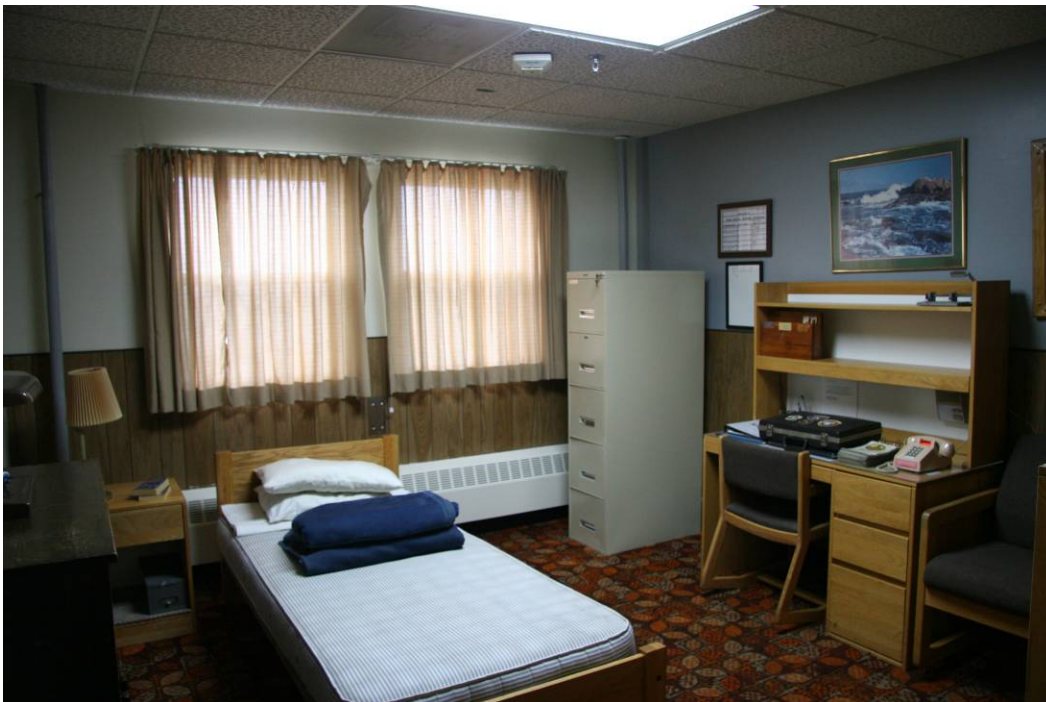
Figure 3- 60: Typical bedroom (123) looking south (source: QEA 0058)

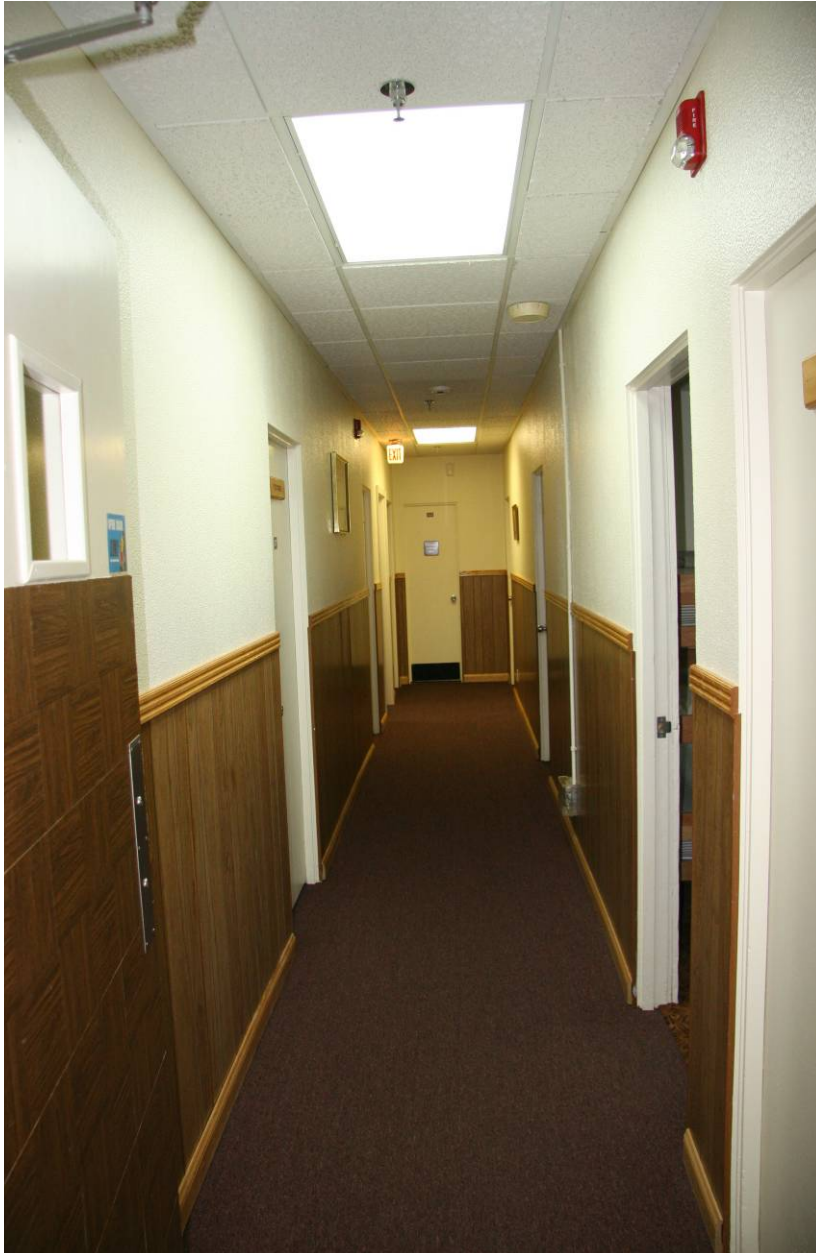
Ceiling: Suspended 2' x 2' tegular acoustic tile ceiling with recessed fluorescent light fixtures in good condition (figure 3-61).

Figure 3- 61: Corridor, looking west (source: QEA 0012)

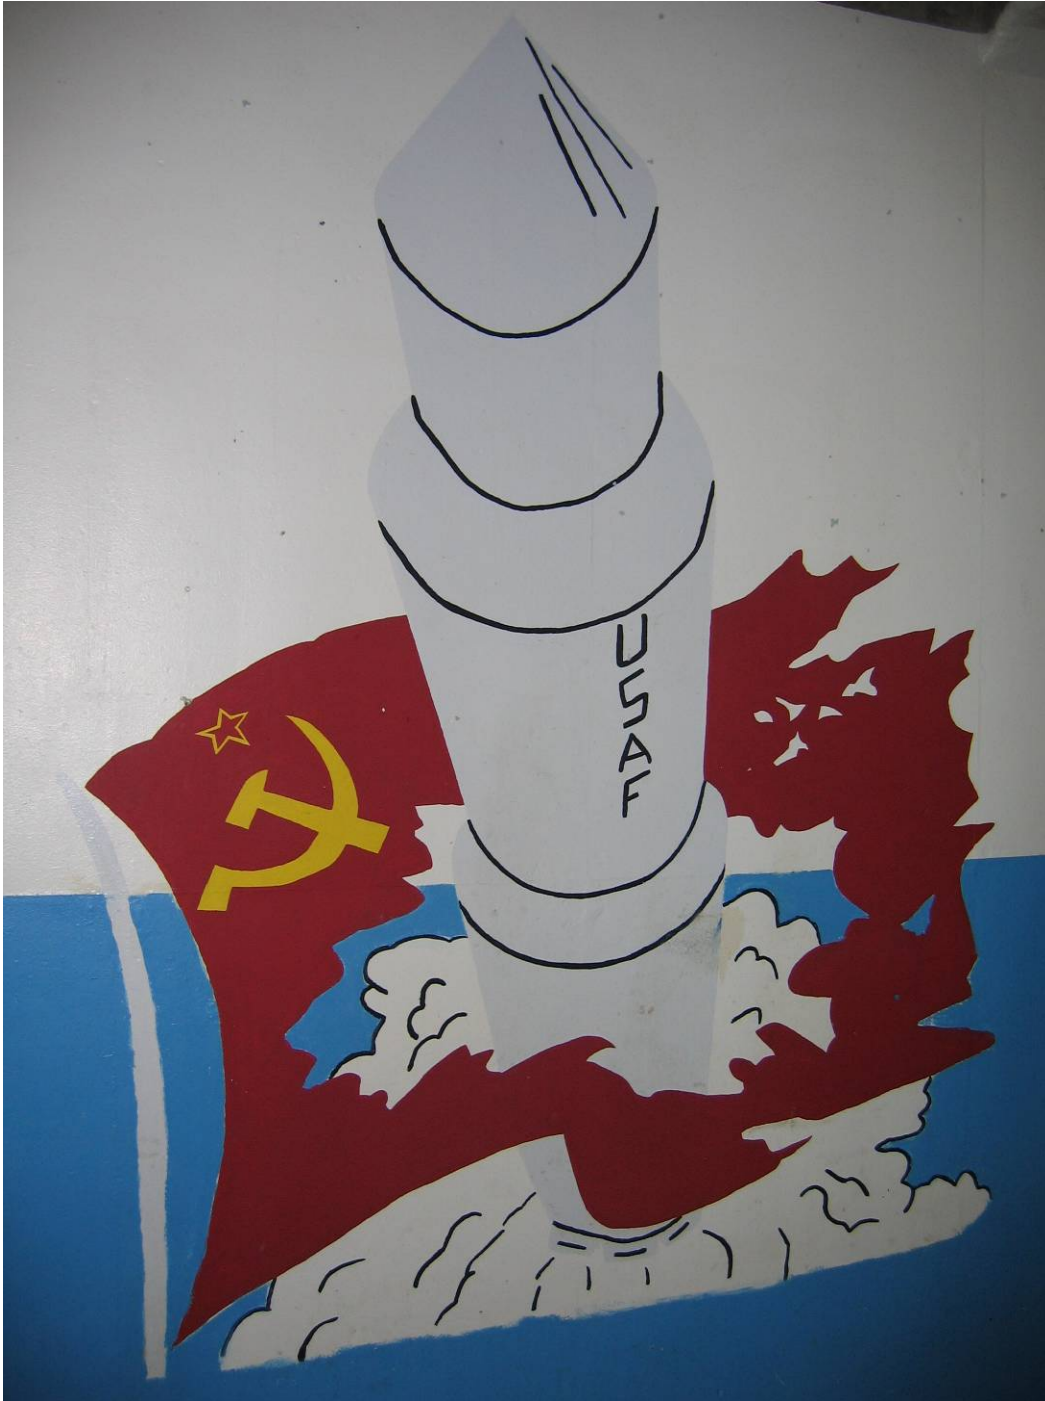
Blast Door and Door Stop: The original 8-ton, blast-proof, steel and concrete door is painted light grey and in good condition (figure 3-62 and 3-63). See Part 1-A Historical Background for discussion on decorative paintings on the face of this door. The steel door stop is bolted to the concrete wall 3'-5" high to the center and painted bright yellow with a rubber or neoprene bumper pad attached to the end. The door stop is in good condition.

Figure 3- 63: Launch control center vestibule artwork (source: QEA 7017)

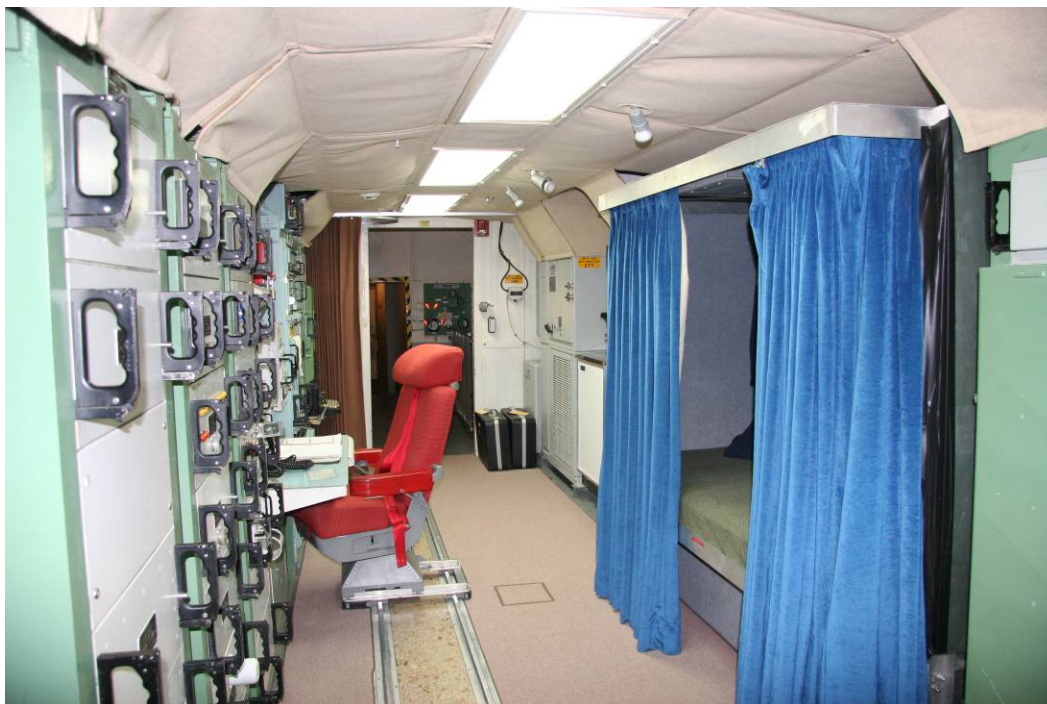
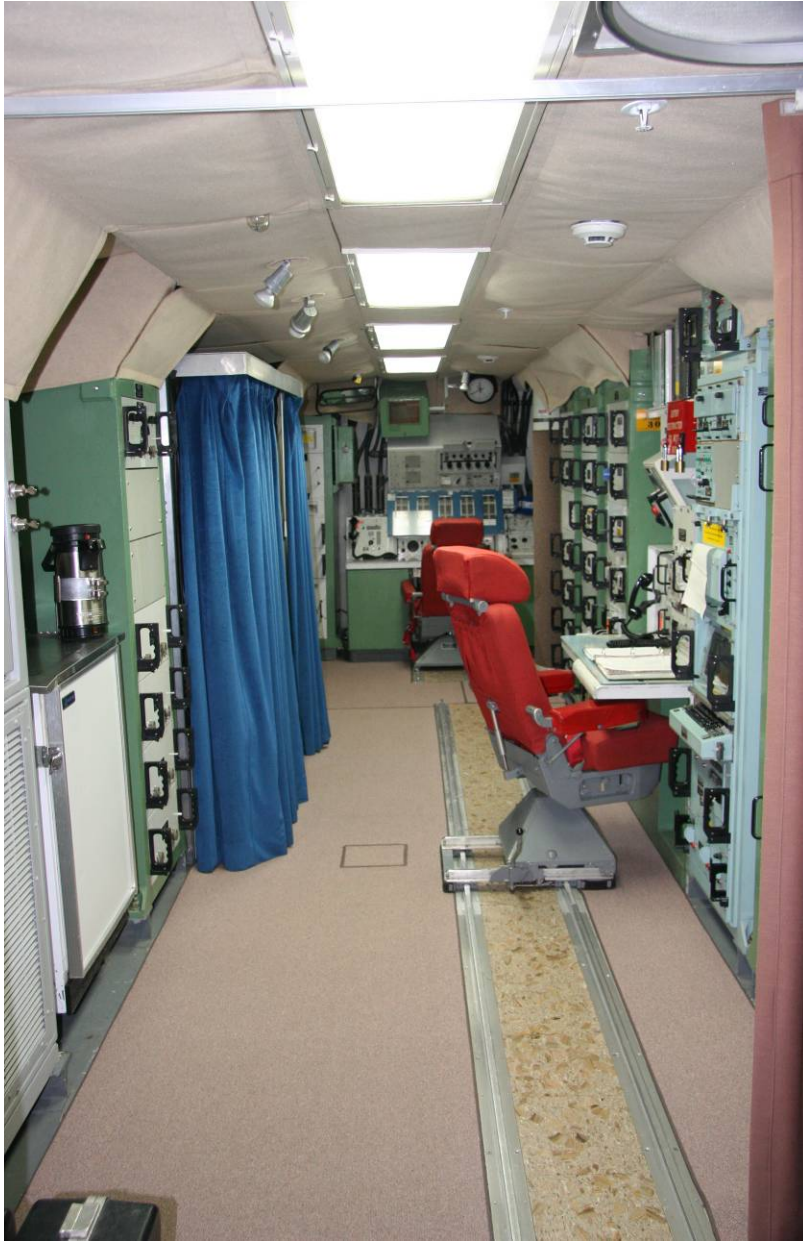
Walls: Solid and perforated metal acoustic panels, painted, in good condition. Sound absorption fabric panels were installed between 1982 and 1990 on the walls and ceiling to deaden the noise in the Center (figures 3-64 and 3-65). These beige colored panels are in good condition with the exception that the hook and loop fasteners are coming loose from the racks due to the contact cement releasing from the attachment point.

Figure 3- 64: Launch Control Center, looking west (source: QEA 0110)

Figure 3- 65: Launch Control Center, looking east (source: QEA 0113)

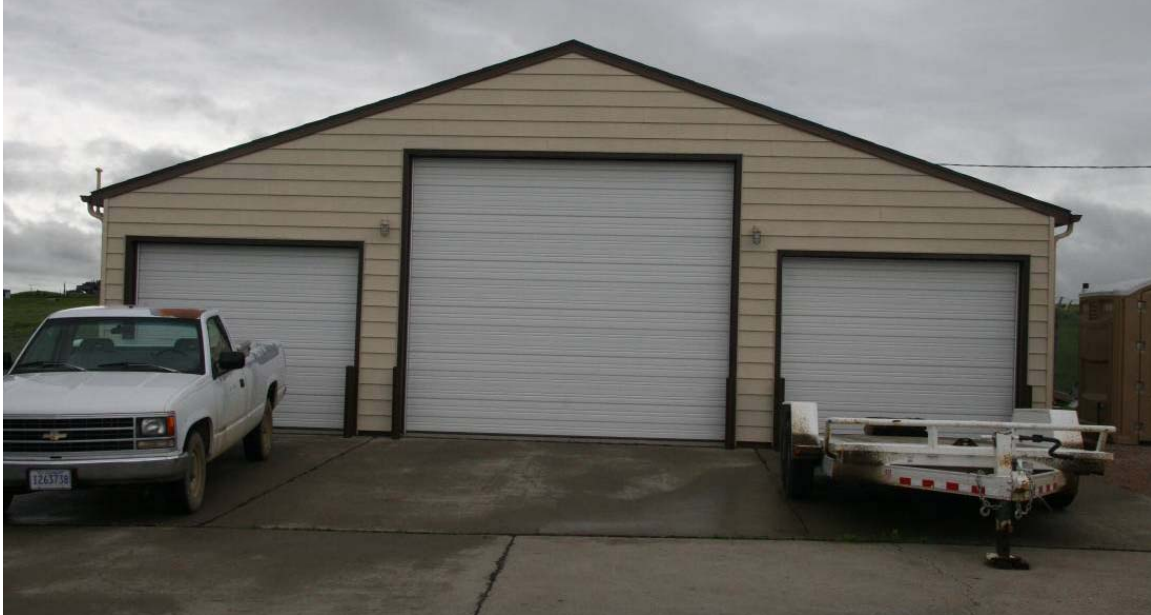
Figure 3- 66: Vehicle Heated Storage Building, south elevation (source: QEA 0019)

Siding: The pre-finished tan colored, wood grain embossed, prefabricated steel siding (8" exposure), which replaced the original asbestos cement shingle siding in the mid-1980s, is in good condition with several dings, gouges, and dents throughout the four elevations. The exterior and interior corner trim and door surrounds (dark brown) are also in good condition. There are no indications that the siding is not functioning as expected for its age and condition.

slight variation in appearance (figure 3-66). Doors are pre-finished white and are in good condition.

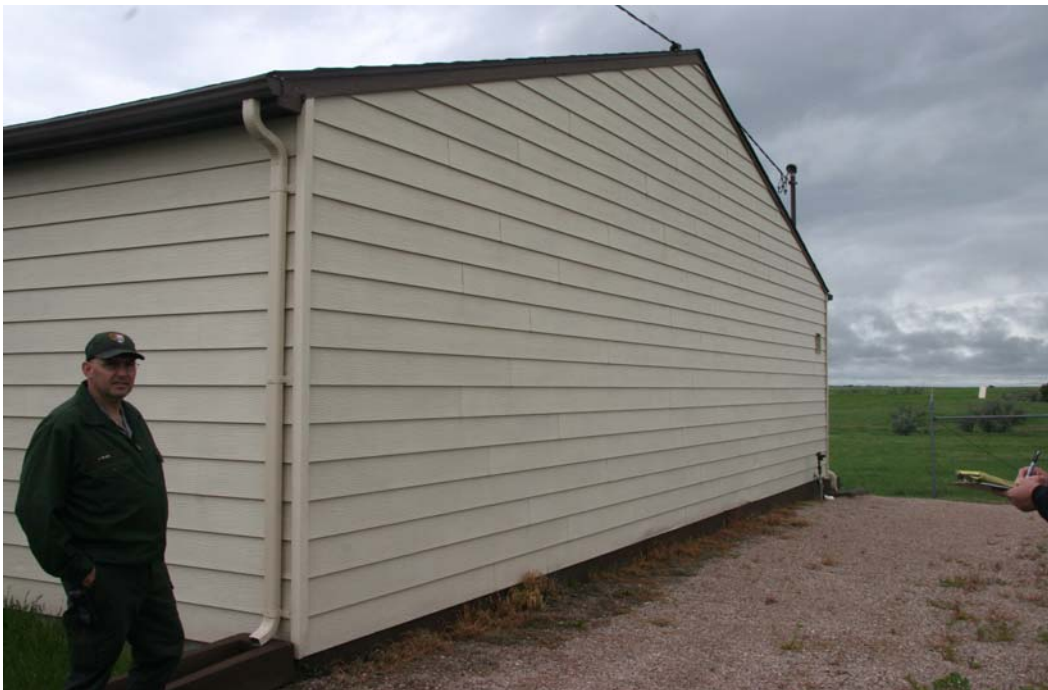
- A small intake louver with screen is high on the wall near the northwest corner and provides fresh air to the furnace in the heater room. The vent surround is tan color and the vent is in good condition (figure 3-67).
- A propane connection is stubbed-up at the northwest corner to provide fuel to a new furnace unit that will be, in the near future, replacing the extant unit.
- Two electrical conduit stubs daylight at the northwest corner and the wires penetrate the siding low on the building into the heating room.

Figure 3- 67: Vehicle Heated Storage Building, north elevation (source: QEA 0024)

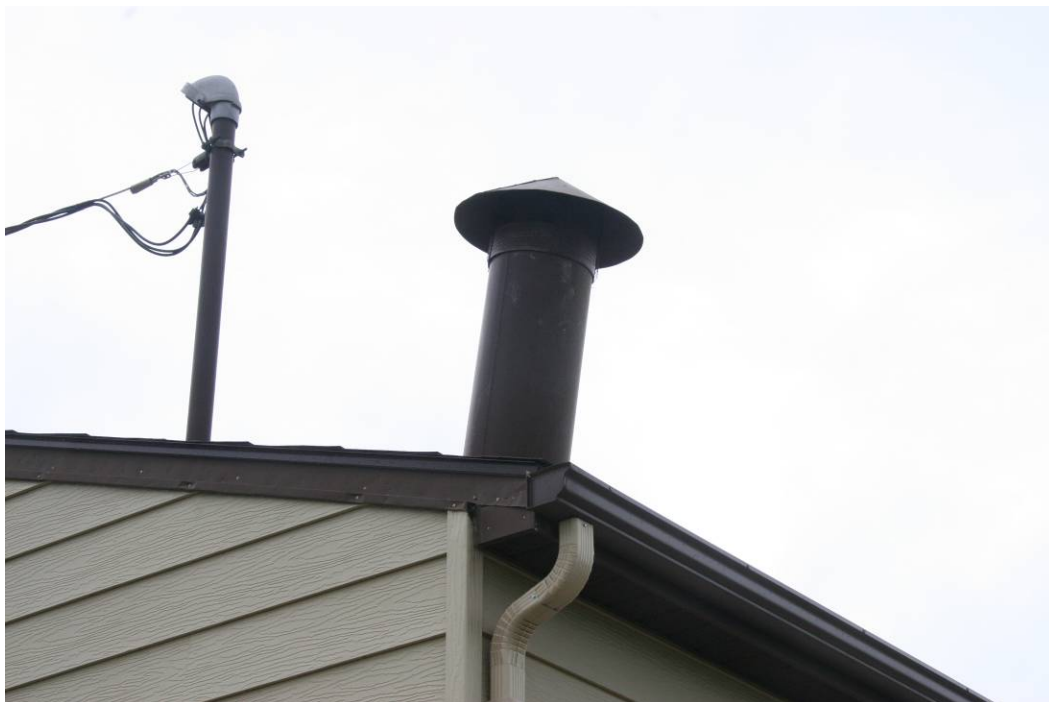
Gutters and Downspouts: The original gutters and downspouts were replaced circa 1983 with new aluminum gutters and downspouts along with new aluminum soffit and fascia panels and trim strips installed over the existing wood soffit and fascia boards. The gutters and downspouts were replaced again, in kind, by the NPS in 2008. Soffit and fascia panels, trim strips and gutters were pre-finished the dark brown trim color; downspouts are painted tan. All are in good condition (figure 3-68). New concrete splash blocks were installed at the same time, painted dark brown and are in good condition.

Figure 3- 68: Vehicle Heated Storage Building, gutters, downspouts, and vent (source: QEA 0026)
