Chapter 3: Existing Conditions / Affected Environment

The *Secretary of the Interior's Standards for the Treatment of Historic Properties* require a comprehensive understanding of the current conditions to provide a baseline for the development of treatment recommendations. This chapter provides a thorough inventory of the existing conditions of the environmental context, cultural resources (including cultural landscapes, buildings, and archeological sites), wildlife, socioeconomics, visitor experience, and park operations related to the Delta-01 and Delta-09 sites.

Minuteman Missile National Historic Site
Historic Structures Report/Cultural Landscape Report/Environmental Assessment

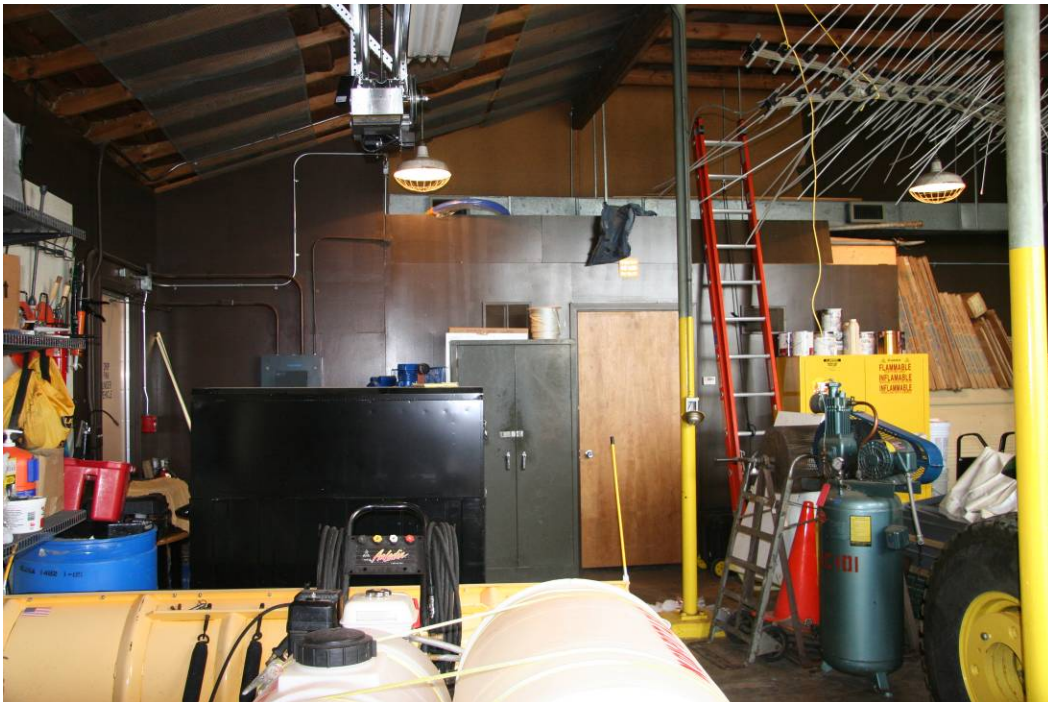
Floor: Original concrete in fair condition showing moderate wear and tear. It appears that it has previously been sealed and waxed and the wax may have yellowed with age.

Walls: Painted and unpainted hardboard in good condition, with some minor wear and tear (figure 3-69).

Figure 3- 69: Vehicle Heated Storage Building interior, looking north (source: QEA 0049)

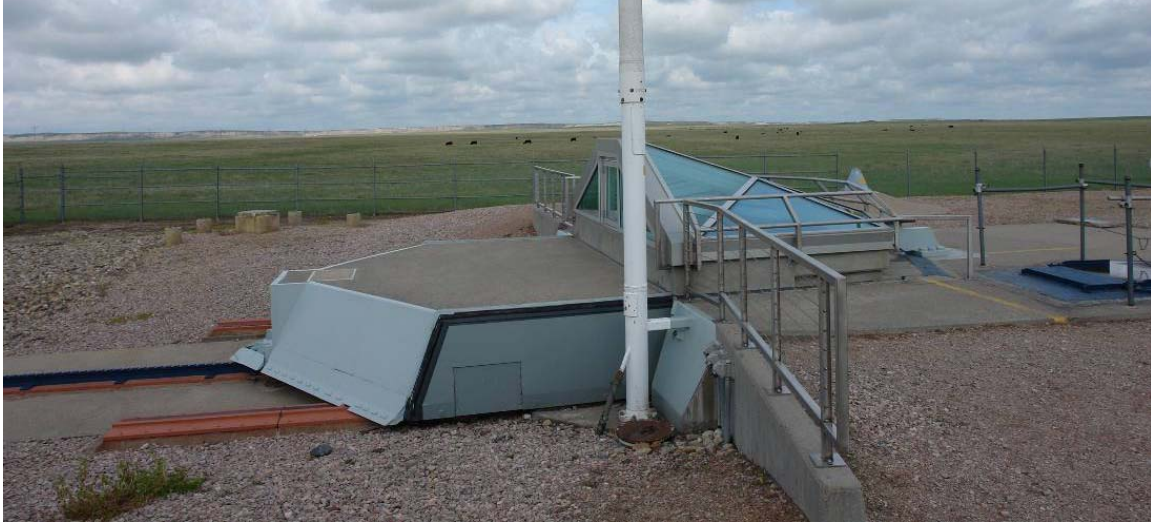
The original concrete apron is in good condition with some moderate spalling and cracking in selective areas around the perimeter, along with some paint erosion (figure 3-70).

- The original Launcher closure concrete and steel plating is in good condition, repainted in 2001 when the viewing enclosure was installed.
- The original concrete retaining walls are in good condition with some minor cracking and spalling on the south faces.
- The original concrete and steel closure tracks are in good condition, repainted in 2001 when the viewing enclosure was installed.
- The steel personnel access hatch is in good condition. The caulking at the perimeter edge has lost its adhesion and should be replaced.
- The original painted steel pylons are in good condition, repainted in 2001 when the viewing enclosure was installed.

Figure 3- 70: Delta-09 Launch Facility launch closure and viewing enclosure, looking west
(source: QEA 8308)

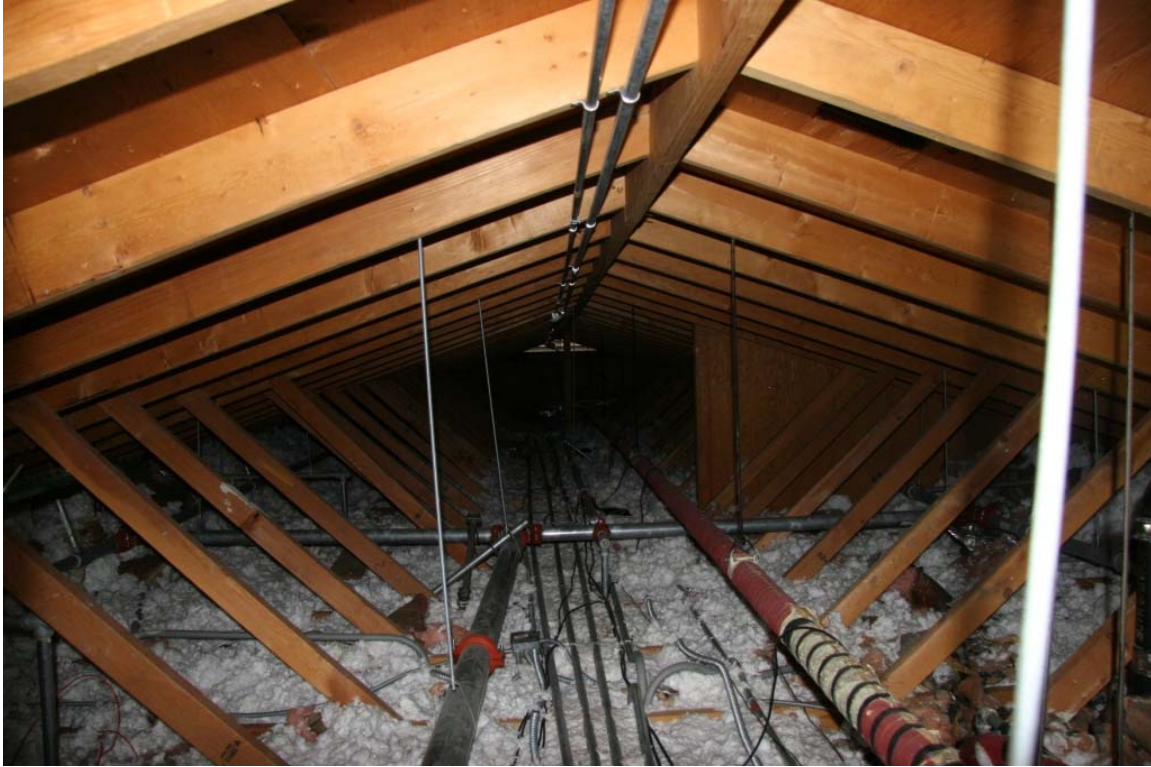
Roof Framing: Access was gained to the attic space of the LCF. The wood framing generally conforms to the Parsons-Staven drawings and appeared in good condition (see figure 3-72). The roof ridge lines appeared to be straight and true. Some flaking paint was noted at the ceiling of the Generator Room 105 (see figure 3-73). This occurred at the edge of the roof ventilator and is likely due to a flashing problem around the ventilator curb. Reportedly, the problem has been corrected.

It was not possible to access the connection between the roof and the wall framing to determine the resistance to wind load. Review of the Parsons-Staven drawings (Job No. 1880-1, dated 1961) does not show the specific mechanical connection between these elements. However, drawing sheets 370, 371, and 372 indicate that the wall framing has “let-in” 1” x 4” diagonal bracing. This occurs at all exterior walls as well as many of the interior partitions both in the longitudinal and transverse directions. Additionally, the details show ½” diameter anchor bolts through the wall sill plates at 4 foot centers at the exterior walls and the interior partitions. This would certainly indicate that high wind load was considered in the original design. Also, the roof appears in good condition with no apparent distress from wind load over the life of the building (early 1960s). It would be prudent to visually inspect the connection at some time when roof repairs or re-roofing is needed to determine how the roof is anchored to the walls by removal of isolated areas of sheathing.

Figure 3- 72: Launch Control Support Building attic (source: FSE 1054)

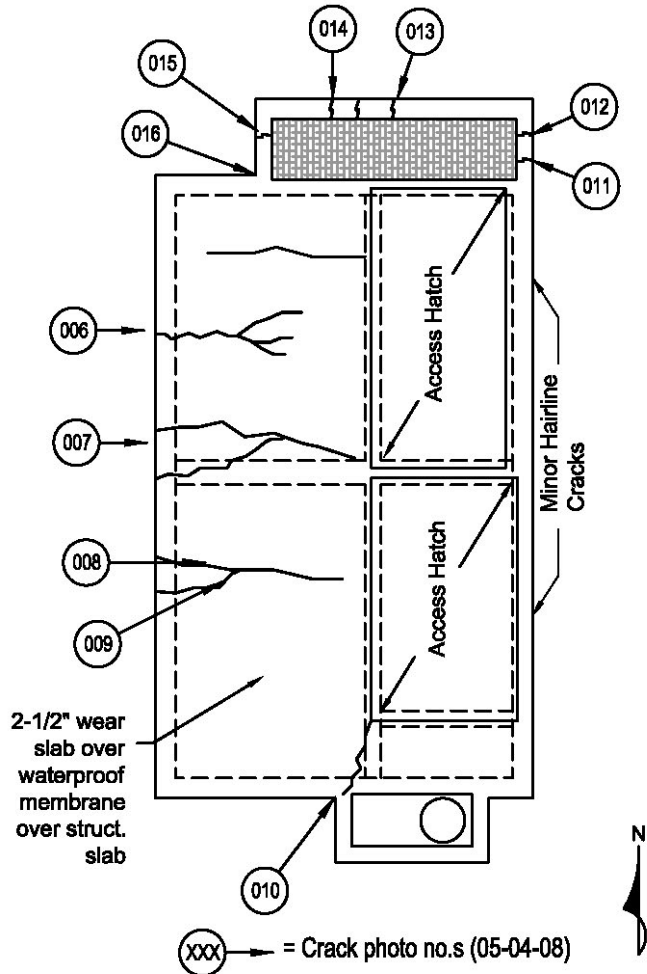
Figure 3- 74: Top Plan View of Vault

Generator Vault: The support building for the LF is a concrete vault below grade that houses a generator, electrical equipment and panels, and communications equipment. The interior of the vault measures 14'-0" x 24'-2" in plan according to the Parsons-Staven drawings. The vault room is shown as 11'-0" from top of foundation slab to top of vault slab. There are two large covered access hatches in the top slab. The covers rest on short concrete stub walls. Areaway extensions occur at the north and south ends of the vault. The south areaway is covered with steel plate. The north areaway is covered with steel grating and vertical access into the vault by ladder is located at this areaway. The foundation is a 12 inch thick slab below the entire vault and there is a sump pit below the generator. Vaults walls are shown as 10" thick at the exterior (grade against the walls) and 8" thick elsewhere. A plan layout is shown in figure 3-74. A 2-1/2" concrete wearing slab containing wire fabric reinforcing was placed over the structural slab at the top of the vault. This wearing slab is separated from the structural slab with a 'WATERPROOFING POLYVINYL SPRAY MEMBRANE' according to sheet 378 (A-9) of the Parsons-Staven drawings. Generally, the drawings indicate that the vault was well detailed and properly reinforced.
