**Scotts Bluff National Monument  
Oregon Trail Ruts Landscape Study  
and Environmental Assessment ■ 100% Report**

281 **Character Area A**

286 **Existing Condition**

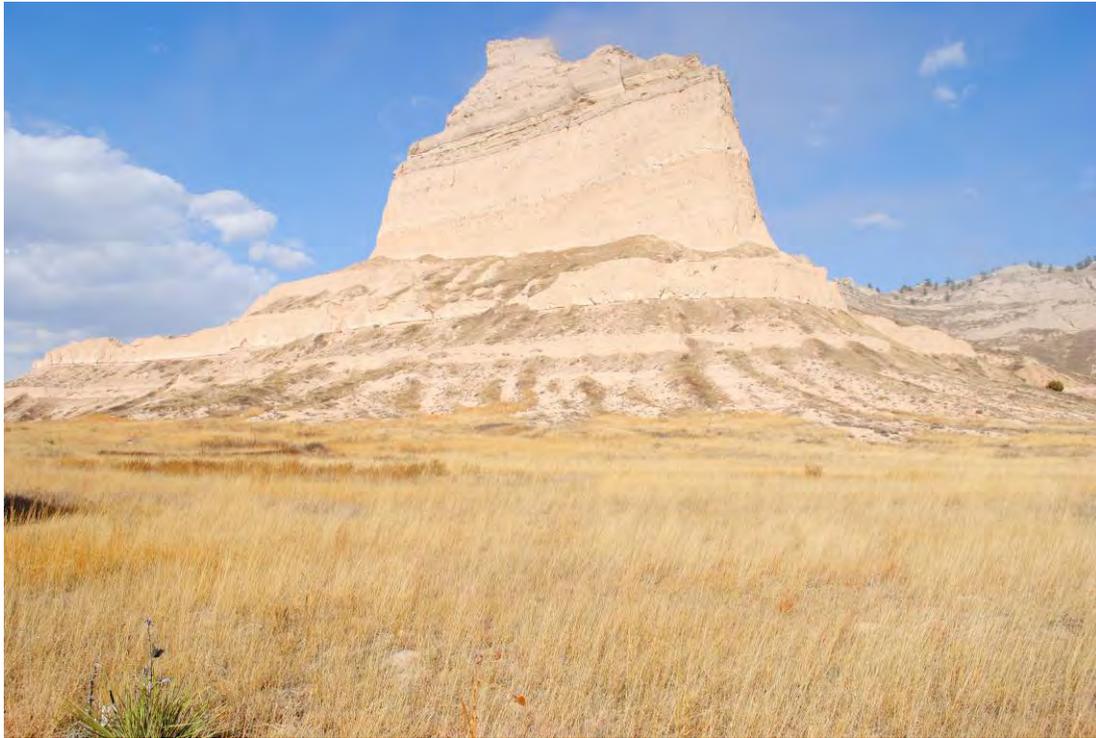
**Figure 3 - 10.** View of Eagle Rock from asphalt trail from Visitor Center in Character Area A. (2009) (MBD DSC\_0045.jpg)

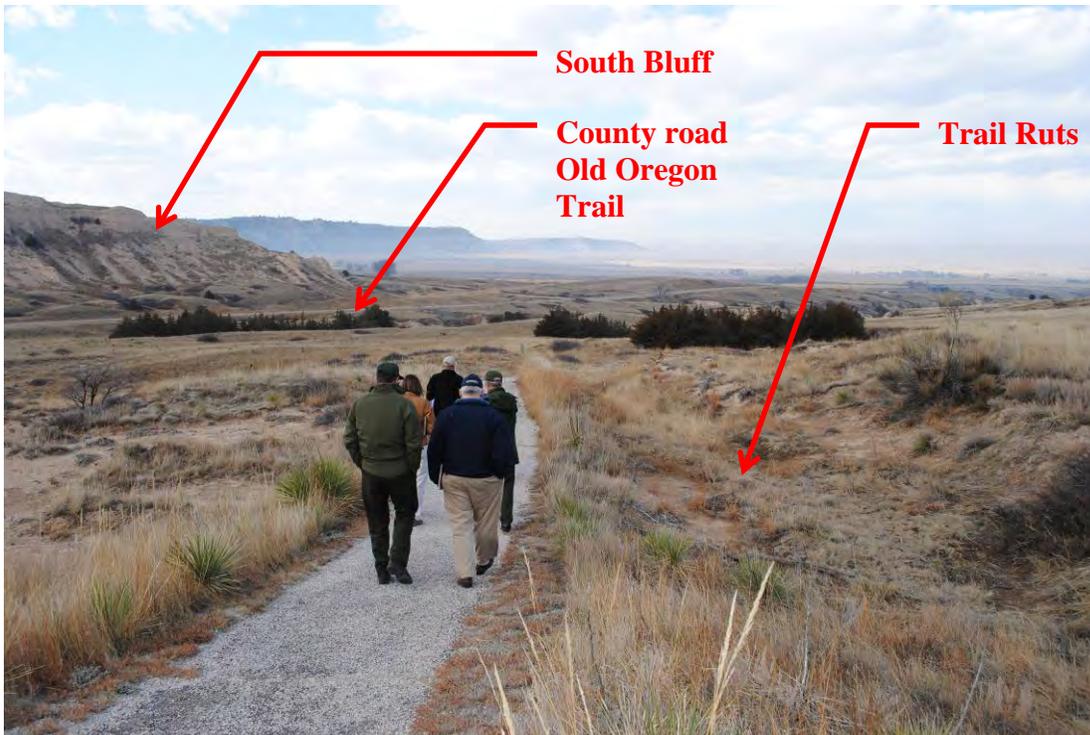
**Figure 3 - 11.** View of county road Old Oregon Trail and South Bluff in Character Area A from asphalt trail (2009) (MBD DSC\_0040.jpg)

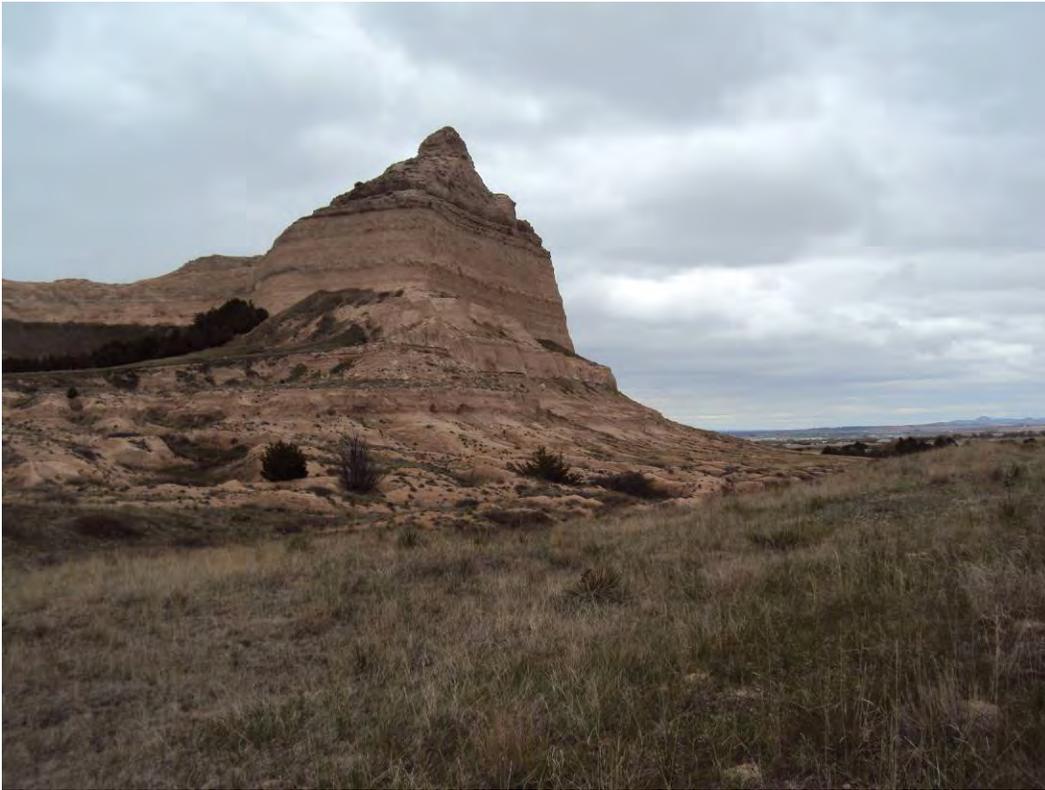
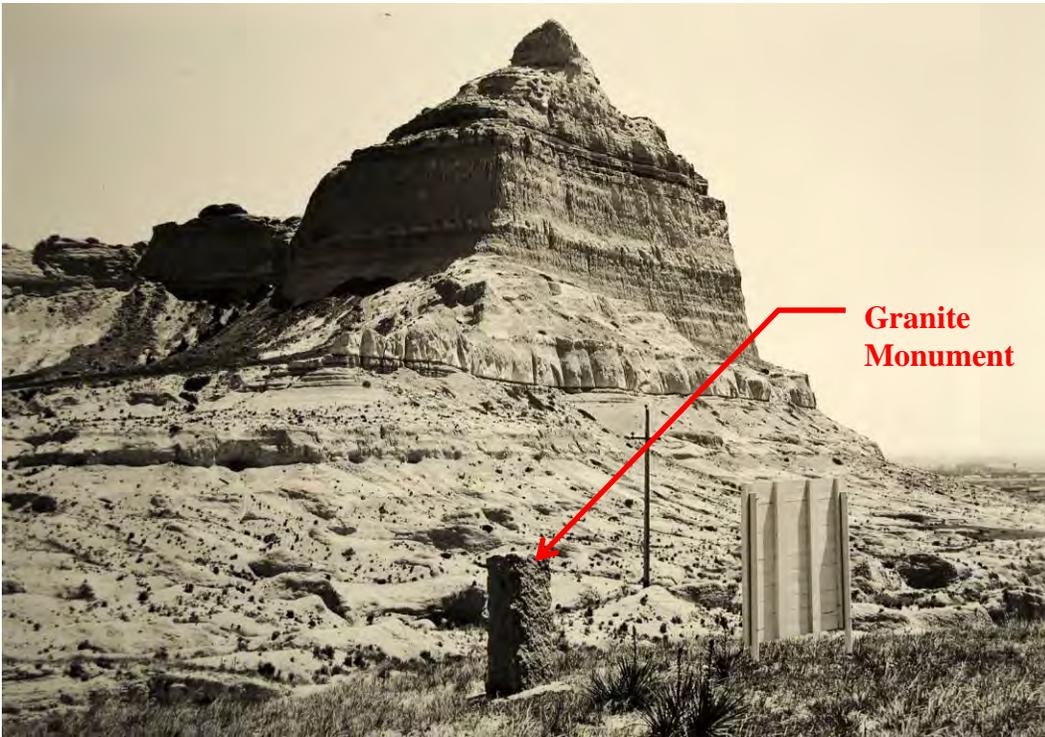
**Figure 3 - 13.** Character Area A *Above*- Eagle Rock, north wall looking northeast (2010) (MBD DSC00157.jpg); *Below* - Eagle Rock, north wall from old memorial site on road (c. 1935) (MBD DSC\_0203.jpg) (source: SCBL archives)

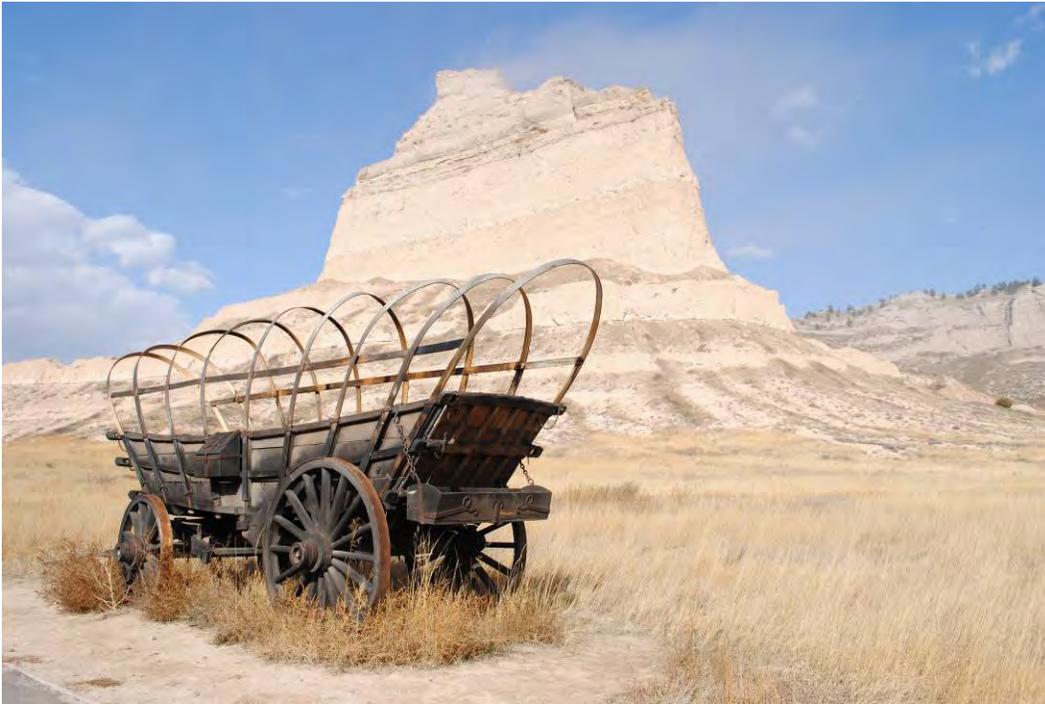
**Figure 3 - 15.** Replica Murphy wagon located adjacent to the asphalt trail in Character Area A (2009) (MBD DSC\_0043.JPG)

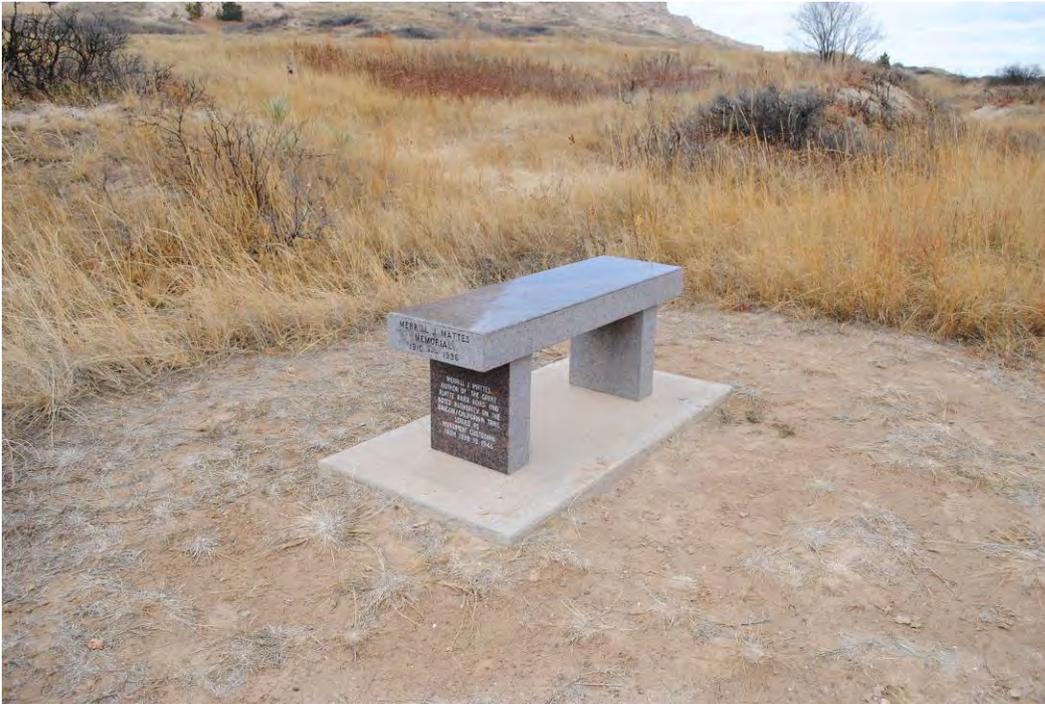
**Figure 3 - 17.** Granite memorial bench at wayside in Character Area A (2009) (MBD DSC\_0013.JPG)

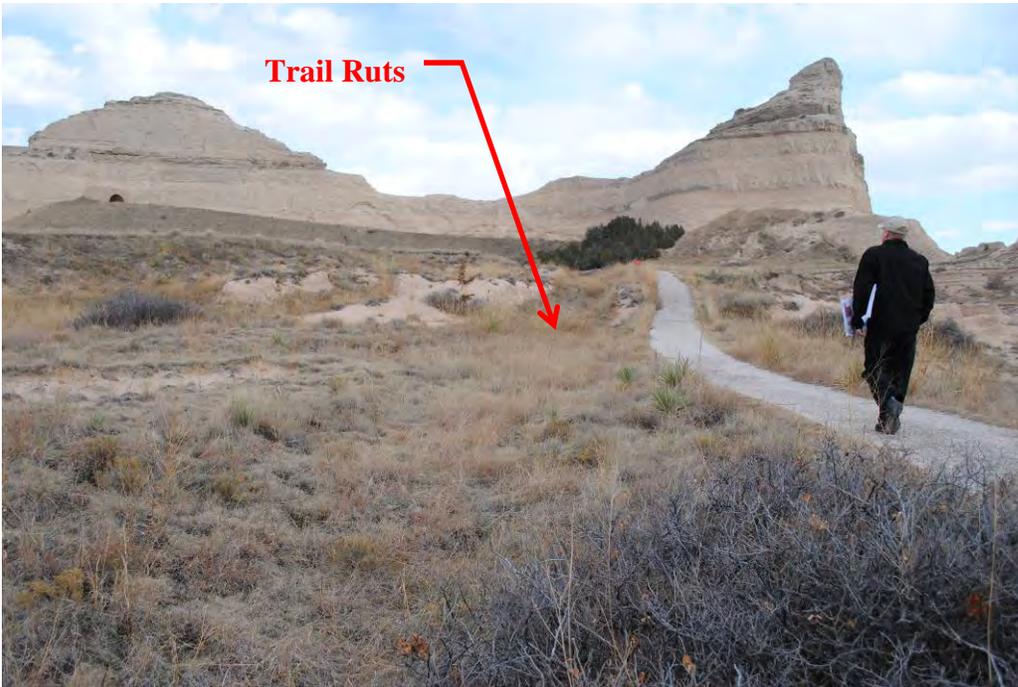
437  
438 **Figure 3 - 20.** Asphalt trail in Character Area A (2009) (MBD DSC\_0074.JPG)  
439

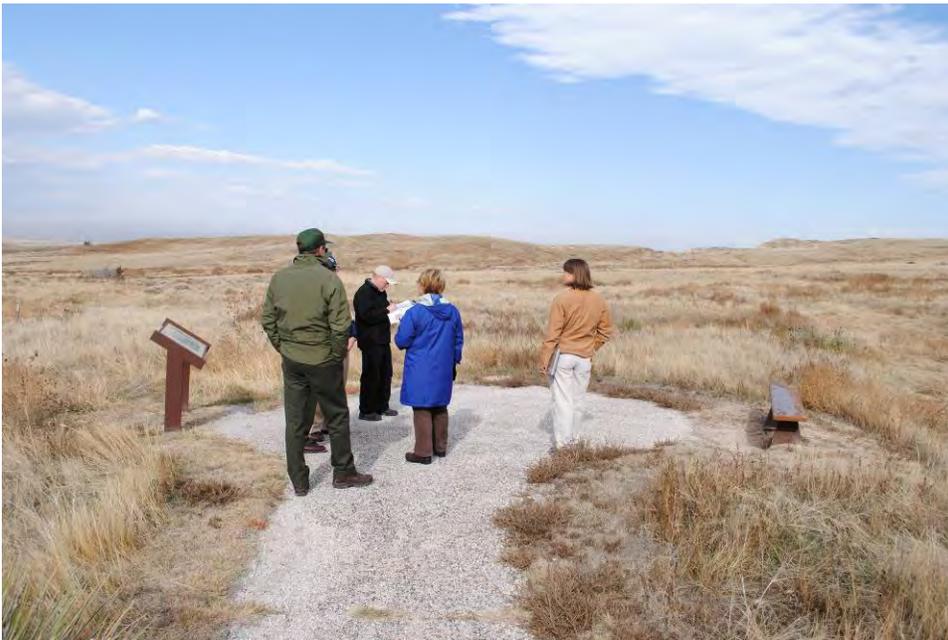
<i>Feature</i>	<i>Figure #</i>	<i>Description</i>	<i>Condition</i>	<i>Contributing/Non-contributing</i>
<b>Interpretive sign for W. H. Jackson's campsite</b>	3-22	Interpretive sign with metal frame in wayside in Character Area A at historic location of W.H. Jackson Campsite	Good	non-contributing compatible <i>outside period of significance</i>
<b>Wood bench</b>	3-23	Concrete base with wood seat in wayside in Character Area A at historic location of W.H. Jackson Campsite	Poor	non-contributing non-compatible <i>outside period of significance</i> <i>materials non-compatible</i>
<b>Boy Scout Trail Marker</b>	3-24	Wood post with emblems indicating trail location of Oregon Trail/California Trail/Pony Express	Good	non-contributing compatible <i>outside period of significance</i>

444  
445 **Figure 3 - 22.** W.H. Jackson Campsite. Interpretive sign with information about W. H.  
446 Jackson's 1866 campsite in Character Area A (2009) (MBD DSC\_0036.JPG)  
447

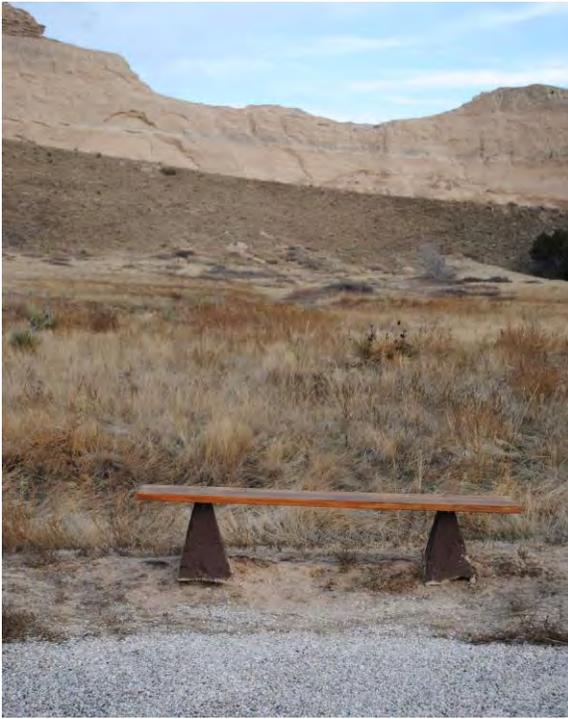
**Figure 3 - 23.** Wood bench at W. H. Jackson campsite in Character Area A (2009) (MBD DSC\_0117.JPG)

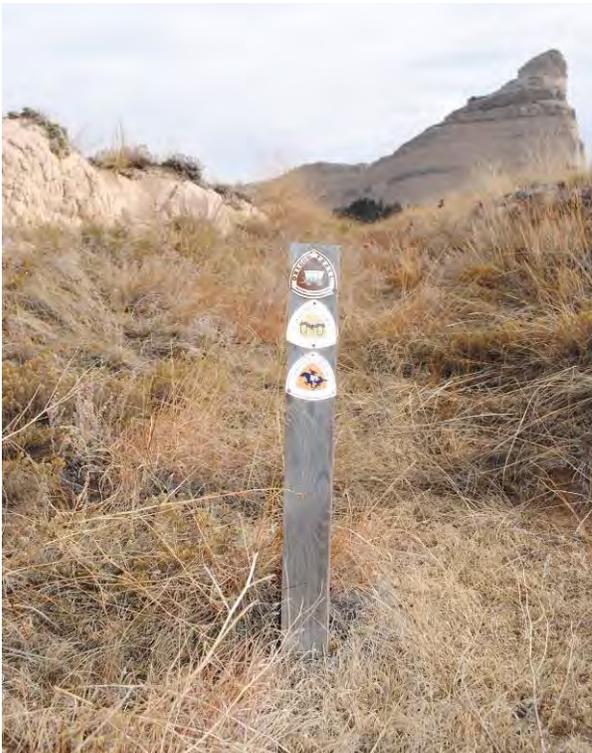
**Figure 3 - 24.** Boy Scout Trail Marker in Character Area A (found throughout study area) (2009) (MBD DSC\_0029.JPG)

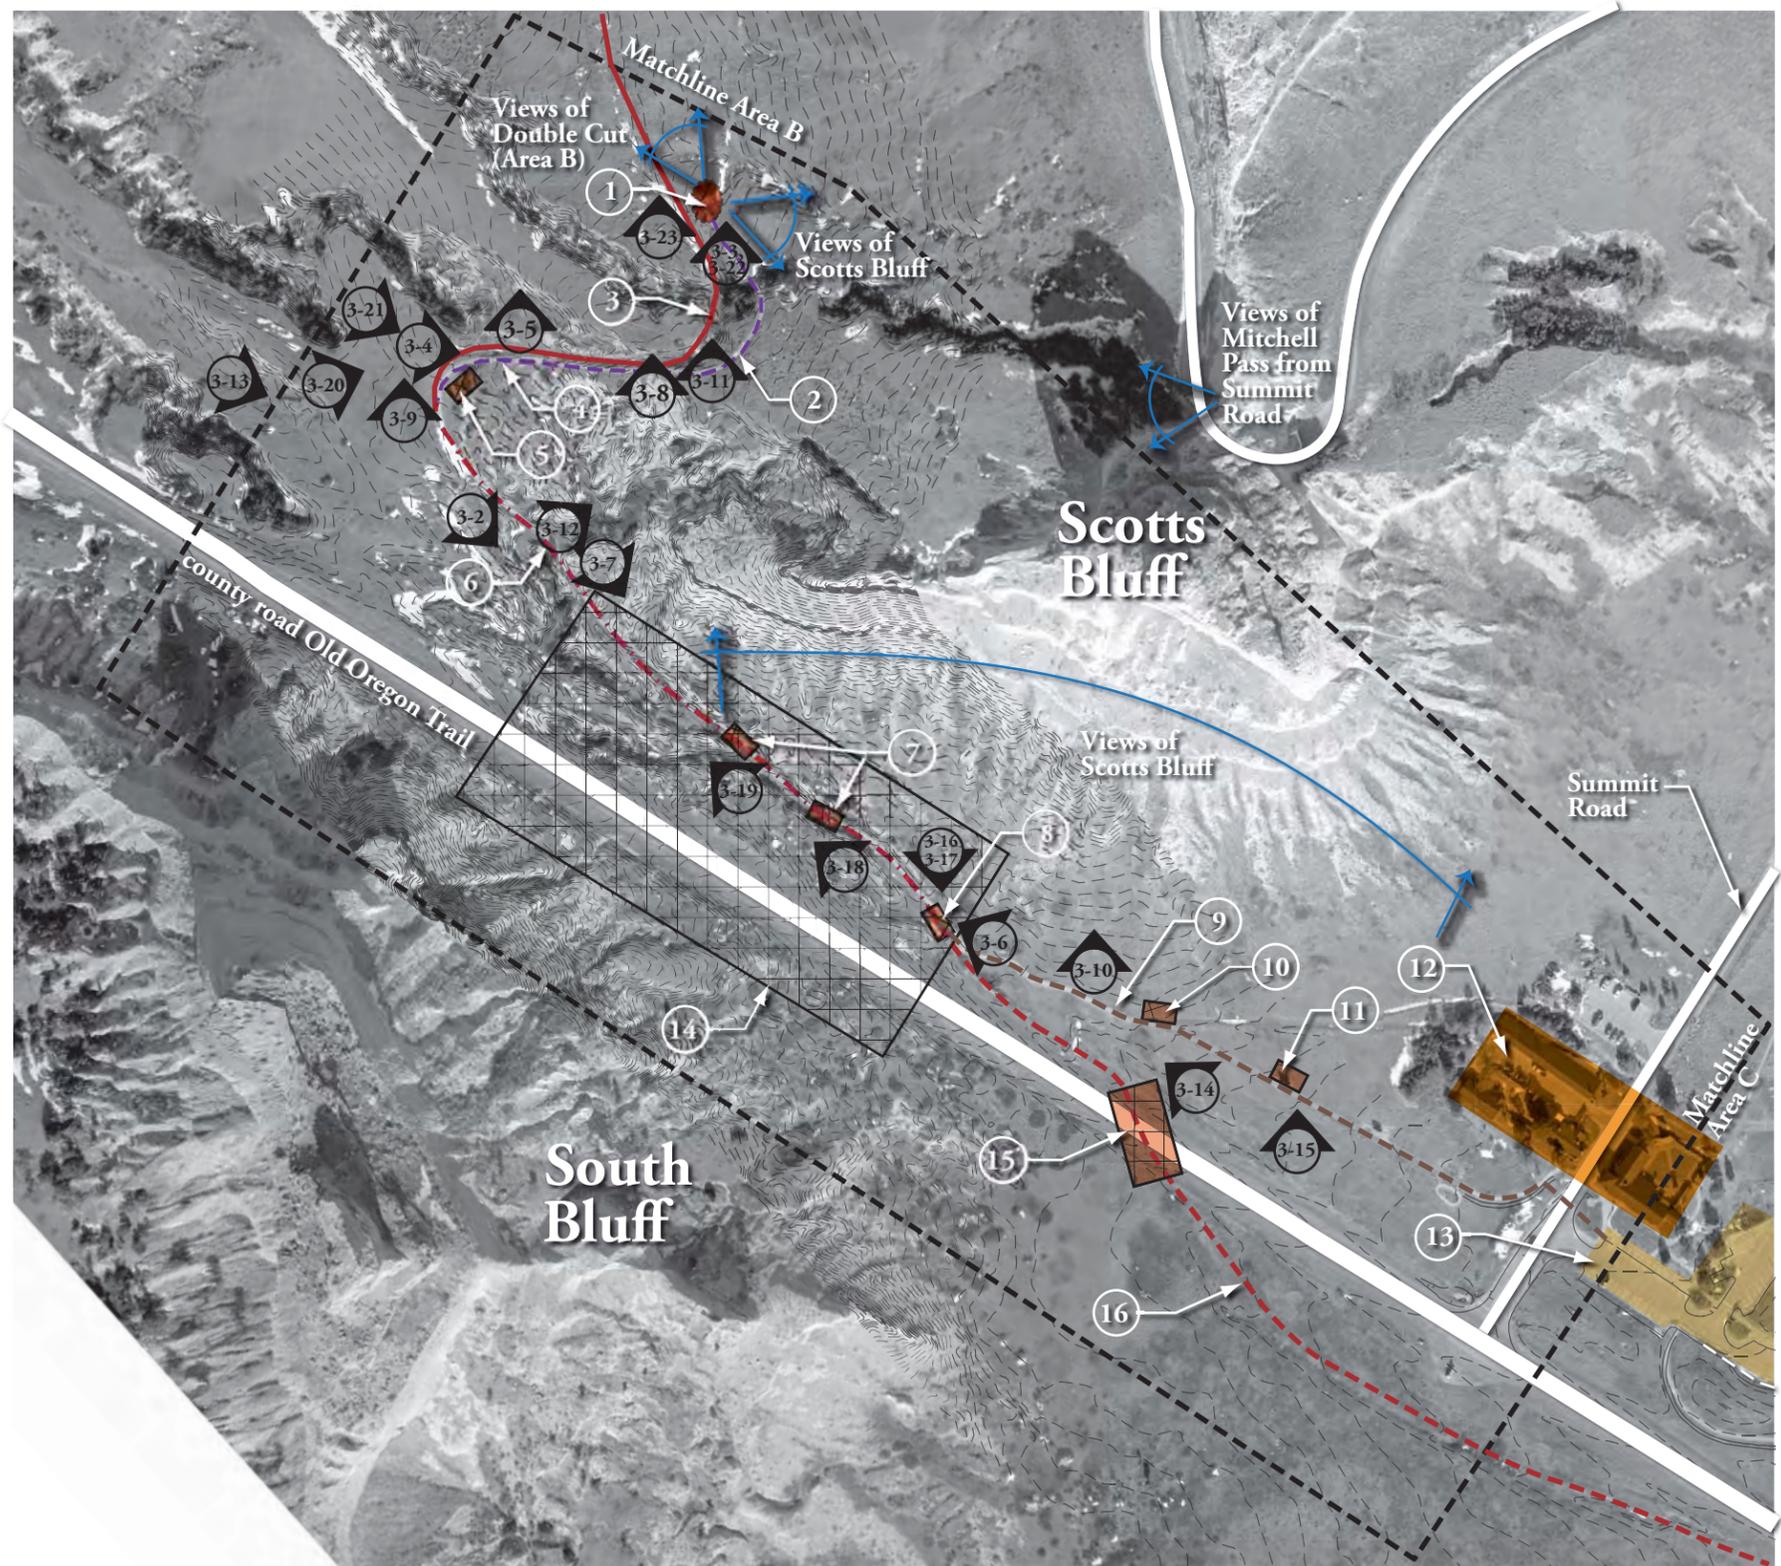
- 323         ○ Drainage ditches and culverts have been constructed to control runoff  
324         and damage to the resources with limited success.
- 325     ■ Approximately 25% of the emigrant trail resource remains intact and is classified a  
326     Class 1 (unaltered original trail). The Class 1 section of the trail is located adjacent to  
327     the paved trail extending past the W.H. Jackson site and toward Character Area B.  
328     This section of trail in this character area is contributing.

<b>FIGURE 3 - 25</b> UNITED STATES DEPARTMENT OF THE INTERIOR NATIONAL PARK SERVICE SCOTTS BLUFF NATIONAL MONUMENT	TITLE OF PROJECT <b>OREGON TRAIL RUTS LANDSCAPE STUDY</b> ENVIRONMENTAL ASSESSMENT DRAWING TITLE <b>CHARACTER AREA A - EXISTING CONDITIONS</b> NAME OF PARK <b>SCOTTS BLUFF NATIONAL MONUMENT</b> REGION COUNTY STATE MIDWEST SCOTTS BLUFF NEBRASKA
--	---
