1/25/10 10:45 BROEDER R17 \\FS1\JUAREZ MONUMENT\875\_83420 NAMA INVESTIGATIVE CONDITION ASSESSMENT AND REPORT FOR BENITO PABLO JUAREZ MONUMENT AND PLAZA\FINAL AE DELIVERABLES\01 DRAWINGS\CADD\ARCH\EXISTING CONDITIONS\A2.3 - SECTIONS.DWG XREFS: ..\XREF\A-MONUMENT.DWG;

BENITO PABLO JUAREZ MONUMENT CONDITION ASSESSMENT  
OEHRLEIN & ASSOCIATES ARCHITECTS

**SUBJECT: Report of Vibration Monitoring  
The General Juarez Memorial  
Washington, DC  
FEA Project No. R01.2009.006314**

**BENITO JUAREZ MONUMENT**  
**Petrographic and Chemical Studies of Mortar**

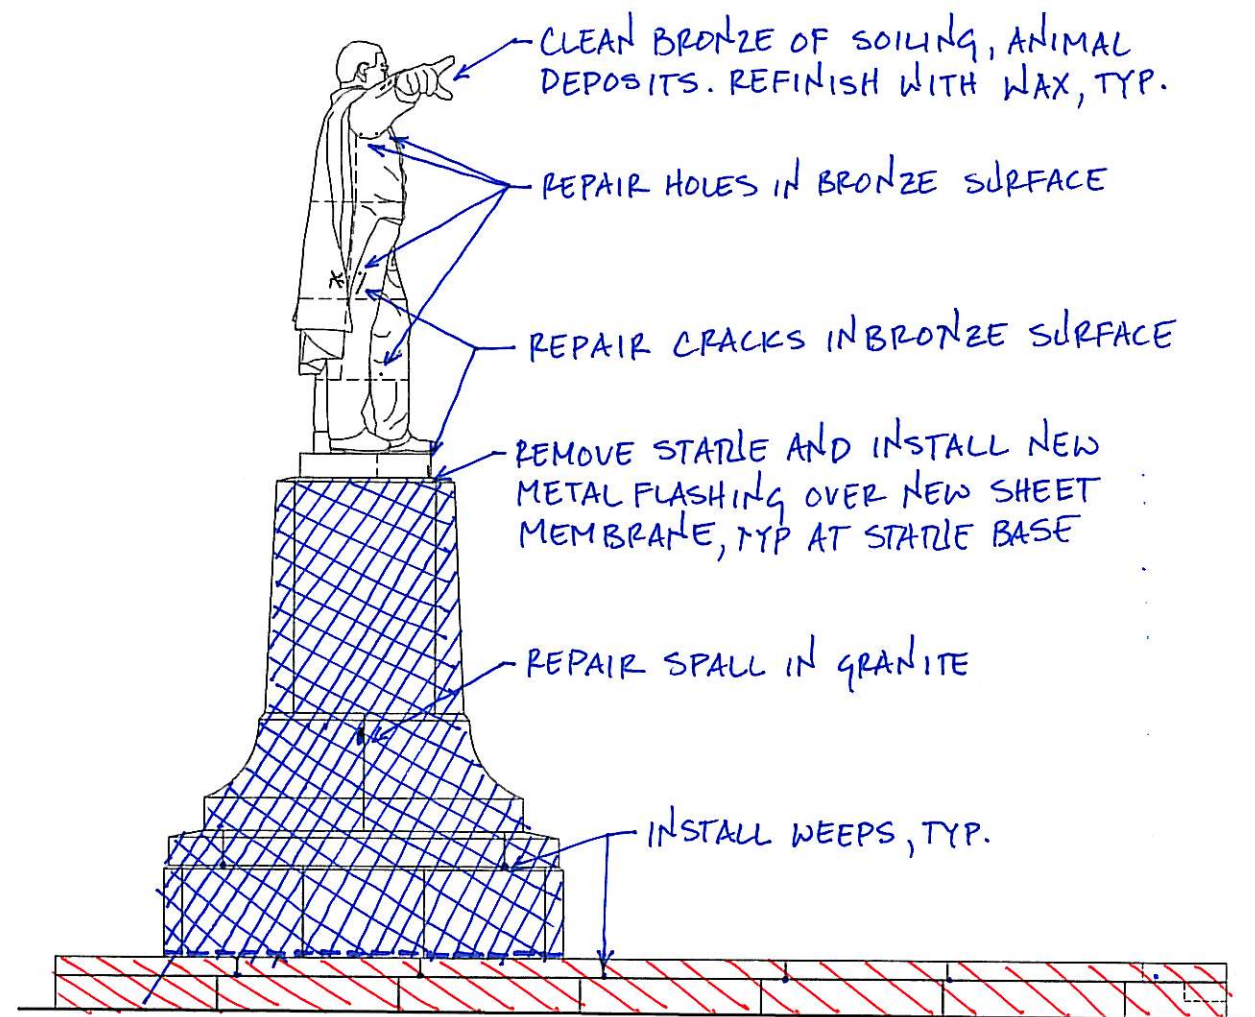
A NORTH ELEVATION  
A2.1

NOTE: CLEAN GRANITE OF SOILING, ANIMAL DEPOSITS, AND BIOLOGICAL GROWTH, TYP.

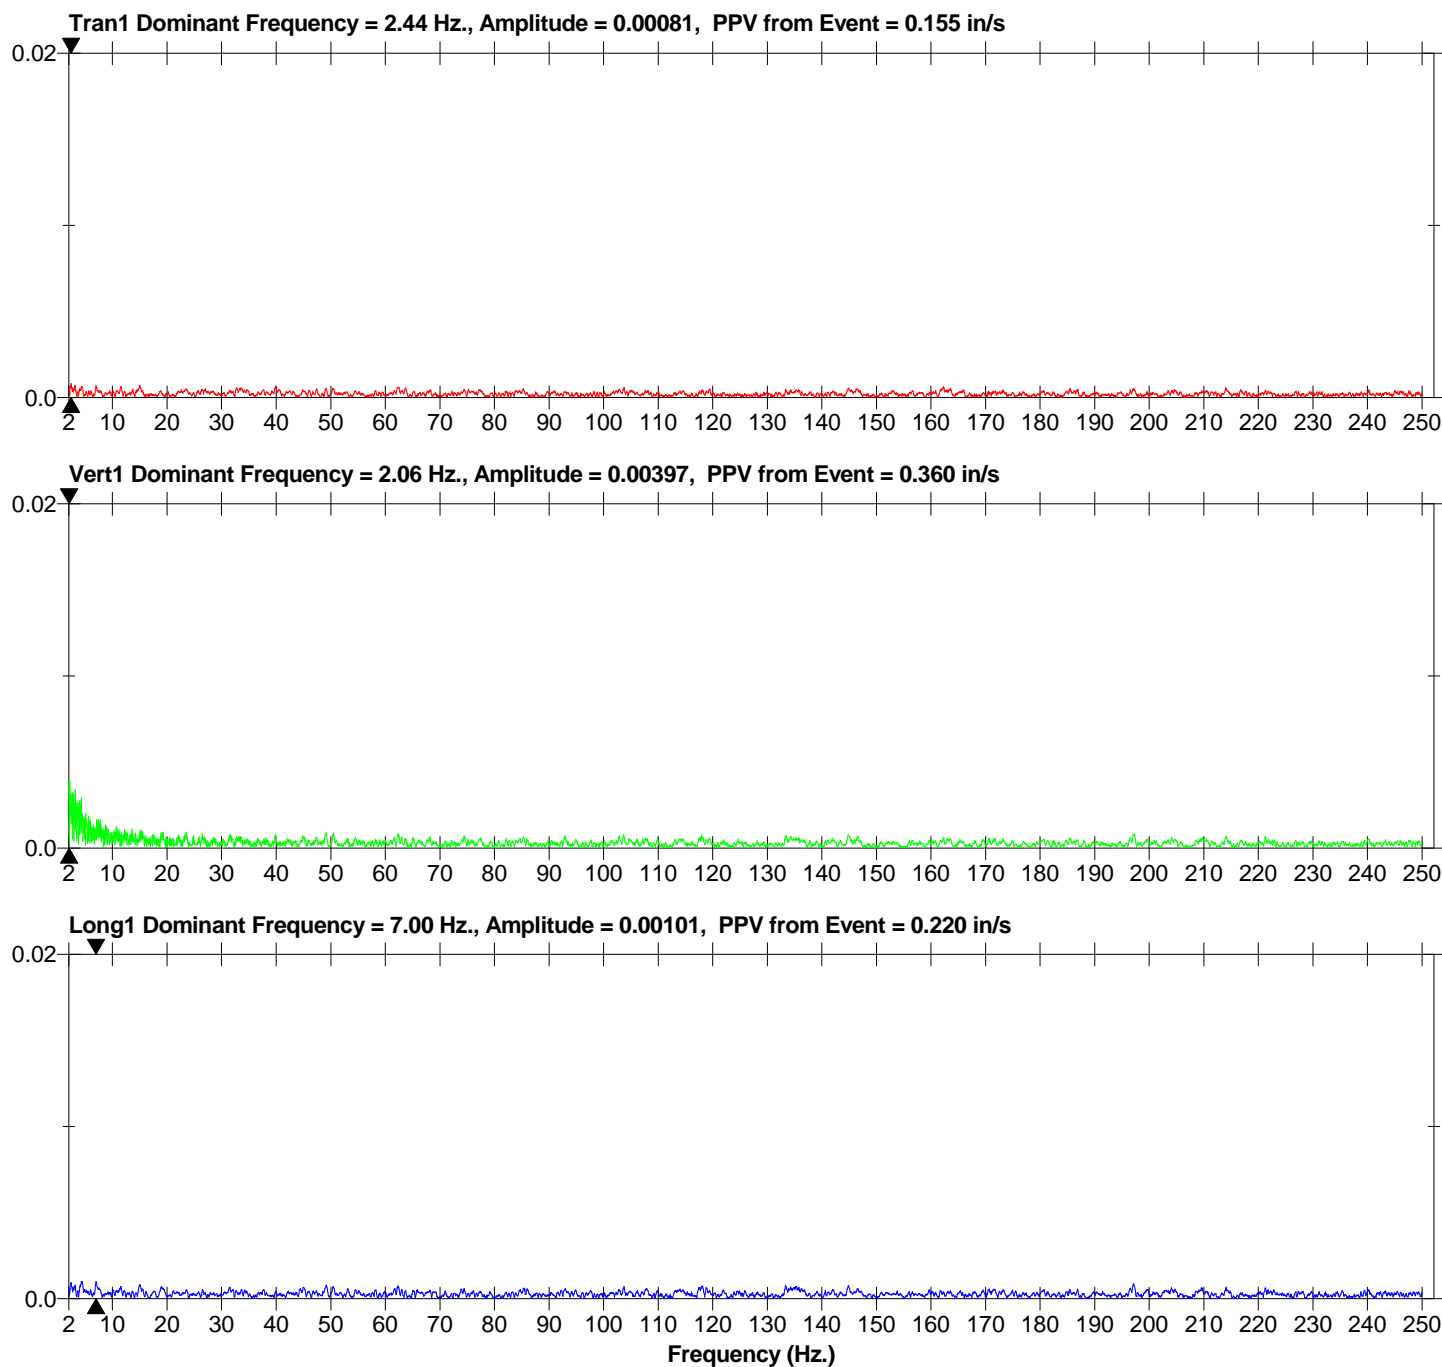
The short-duration events were also only observed when it rained, but the vibration levels were greater in all directions during these events. Each event was only recorded for a one-minute period, showing a spike in the readings. The short-duration events were greater in the sensor at the base of the pedestal, which is the opposite of what was observed during long-term events. These events may be caused from the weather; however, this cannot be determined as a certainty as no personnel were on-site at the time of these events. However, all PPV values recorded during the monitoring period were less than the generally acceptable threshold for vibrations affecting structural integrity.

**Date/Time** Vert1 at 23:33:33 November 24, 2009  
**Trigger Source** Geo: 0.200 in/s  
**Range** Geo :10.00 in/s  
**Record Time** 9.622 sec at 1024 sps
