Chapter 3. Existing Conditions and Analysis

DECEMBER 2012		HSTR 492 116050	
UNITED STATES DEPARTMENT OF THE INTERIOR TRUMAN FARM NATIONAL HISTORIC SITE		TITLE OF PROJECT TRUMAN FARM CULTURAL LANDSCAPE REPORT TITLE OF DRAWING CONTRIBUTING FEATURES	
		NAME OF PARK TRUMAN FARM - HARRY S TRUMAN NATIONAL HISTORIC SITE	
REGION MIDWEST		COUNTY JACKSON	STATE MISSOURI

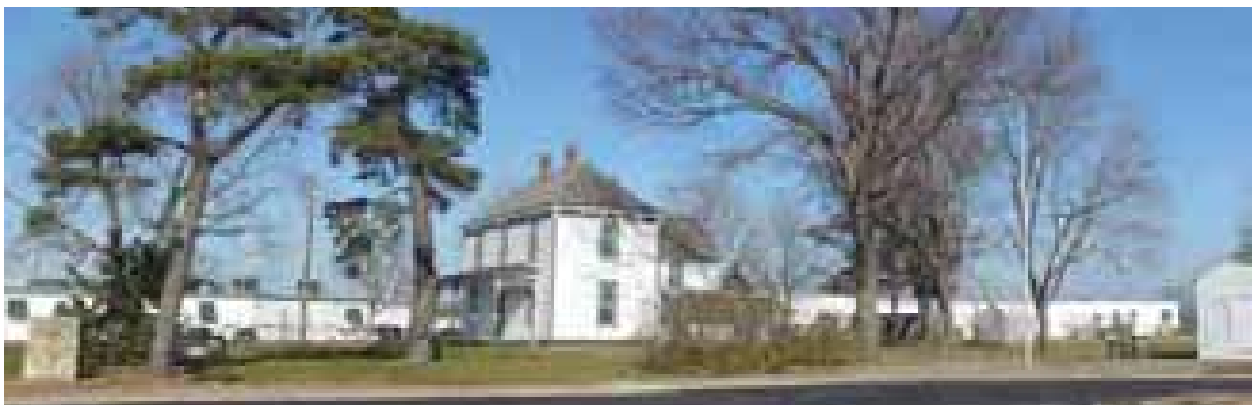
³¹ **Figure 3-8.** The Farm Home yard remains similar to its appearance during the period of significance,
³² with mown lawn and few ornamental plantings. However, the fence that once separated the space
³³ from other farm spaces is gone and the division of space between Farm Home yard, garden, and
³⁴ barnyard have become blurred. SS 12/6/11

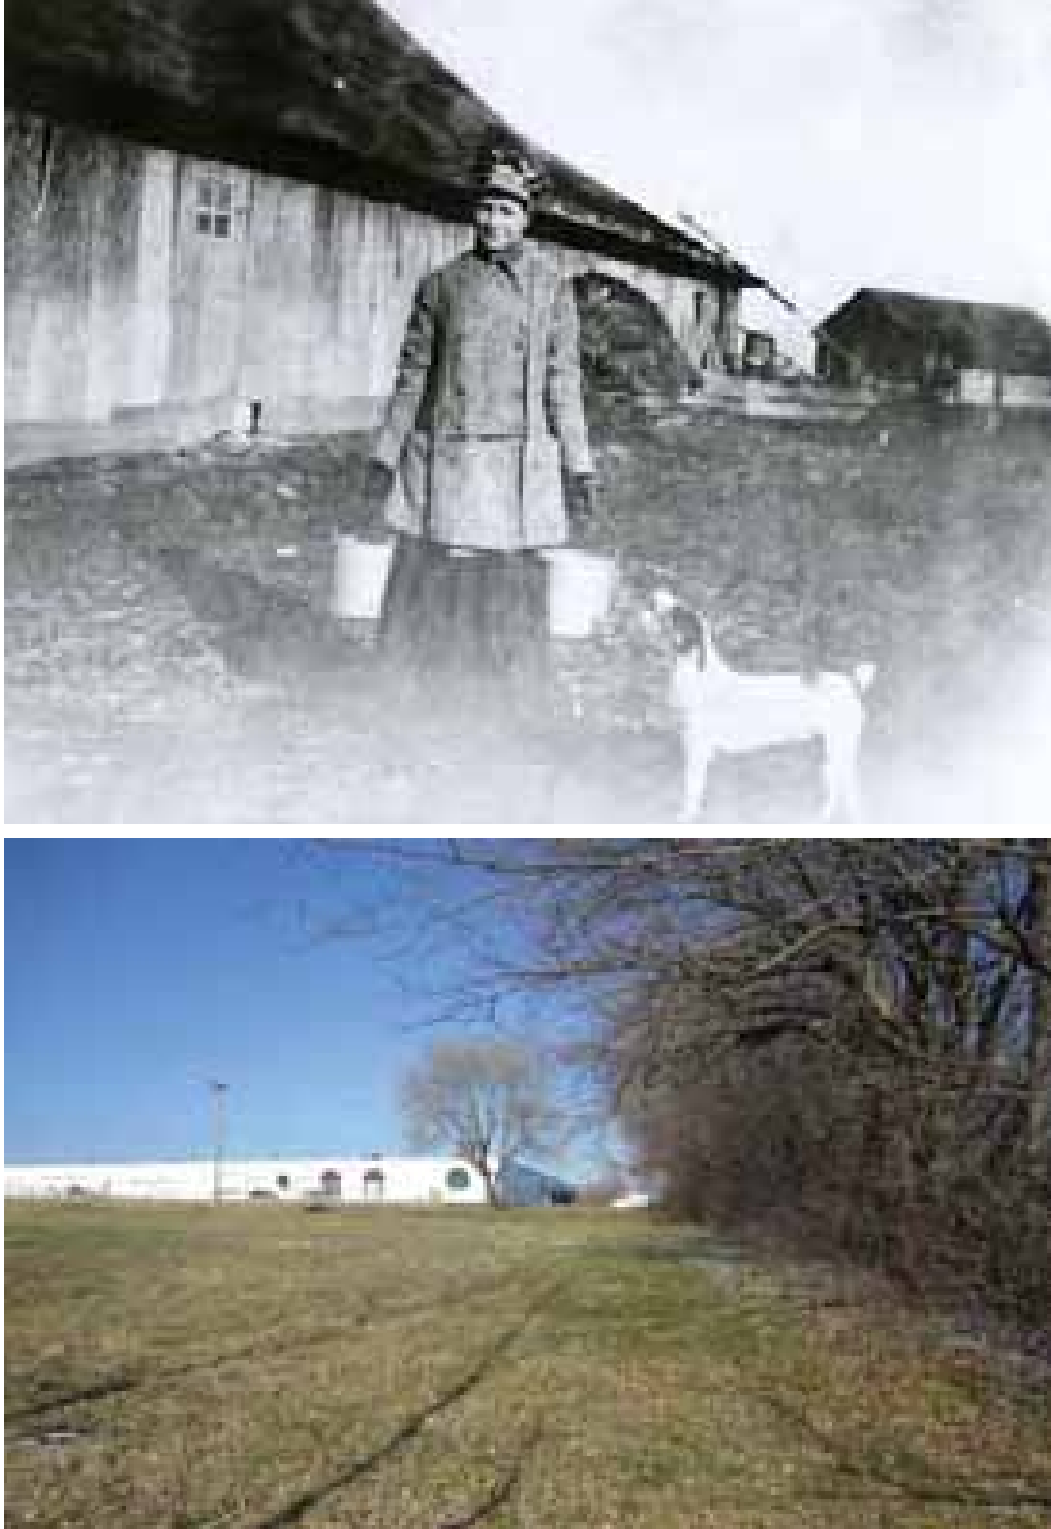
¹ Figure 3-10. The barnyard is the easternmost space on the Truman Farm today. Historically, the
² barnyard was dominated on the north by the Solomon Young Barn (top) built in 1867 which burned
³ in 1966 and was removed. Today, the space remains, however the loss of the barn, granary, and
⁴ fencing makes it difficult to identify the space as a barnyard (bottom). Trees and native understory
⁵ vegetation have naturalized along the east boundary. HSTL 84-17, c.1906; SS 12/6/11
⁶

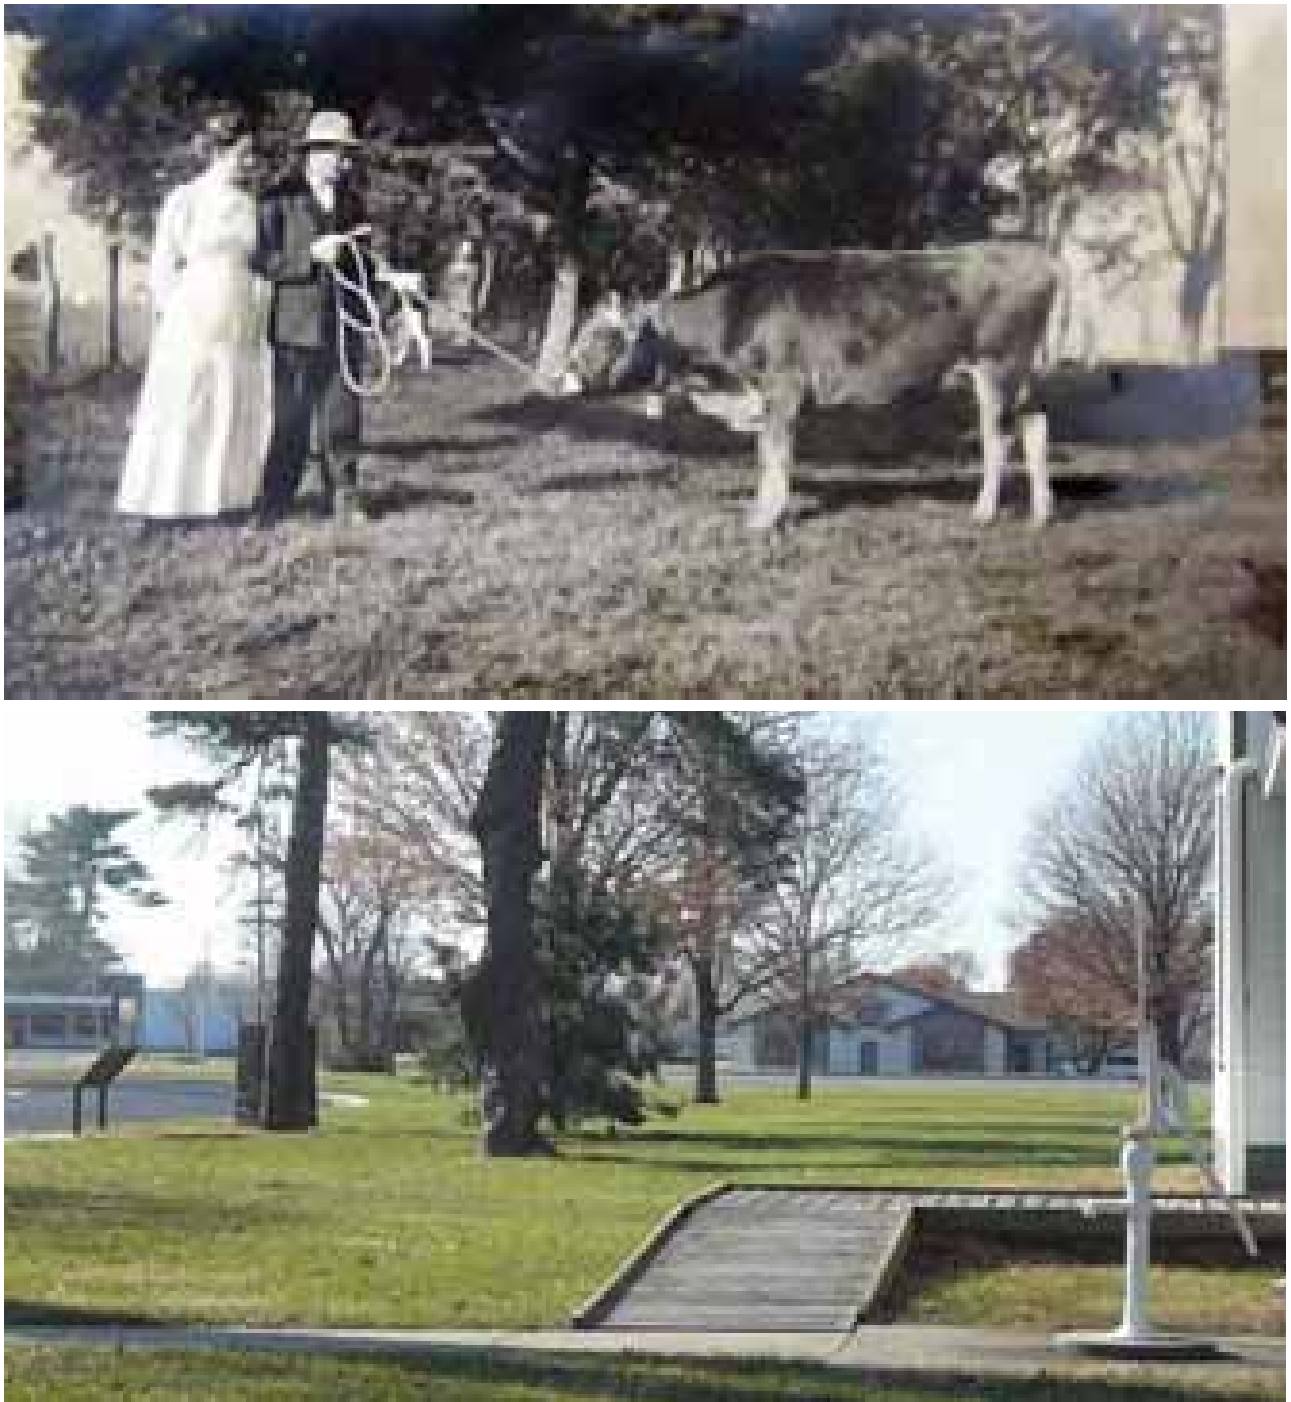
¹ Figure 3-11. The Farm Home yard space remains, defined by the sugar maple grove on the west, Poultry
² House on the east, and evergreen trees on the south. At the center, is the Farm Home. Missing is the
³ fencing that enclosed the yard. HSTL 72-3594, c.1911; SS 12/6/11
⁴

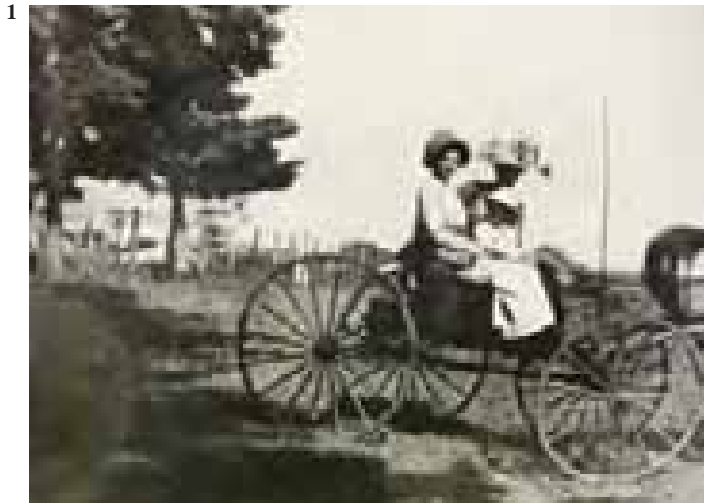
3 **Figure 3-21.** Historically, the entrance road continued
4 beyond the Garage, past the kitchen garden, to the
5 barnyard (top). Today, this road is barely visible as it
6 was allowed to fade once farming waned and the barns
7 were removed (bottom). HSTL 80-8, c. 1910; SS 12/6/11

16 Archeological evidence and historic
17 aerials indicate that historically the
18 entrance road continued beyond the
19 Garage, and the kitchen garden to the
20 barnyard between the Solomon Young
21 Barn and the granary. This road was
22 likely present from Solomon Young's time
23 on the farm (1867) and appears clearly in
24 an aerial photograph from 1959. It likely
25 faded after farming activities ceased and
26 the Solomon Young Barn burned in 1966.
27 Traces of this road are visible today.

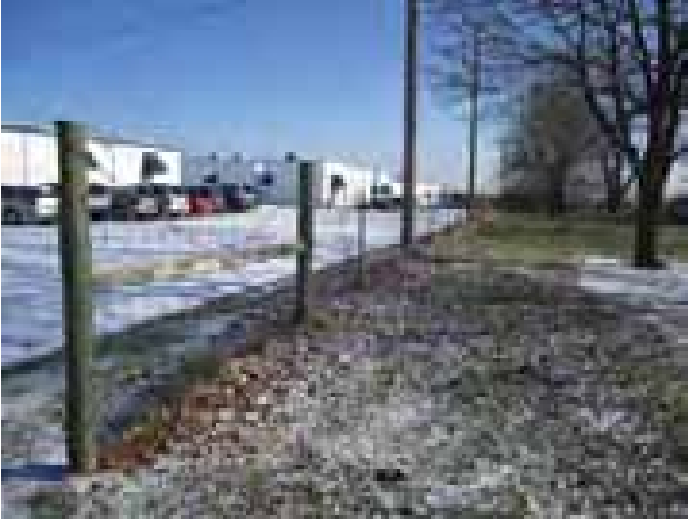
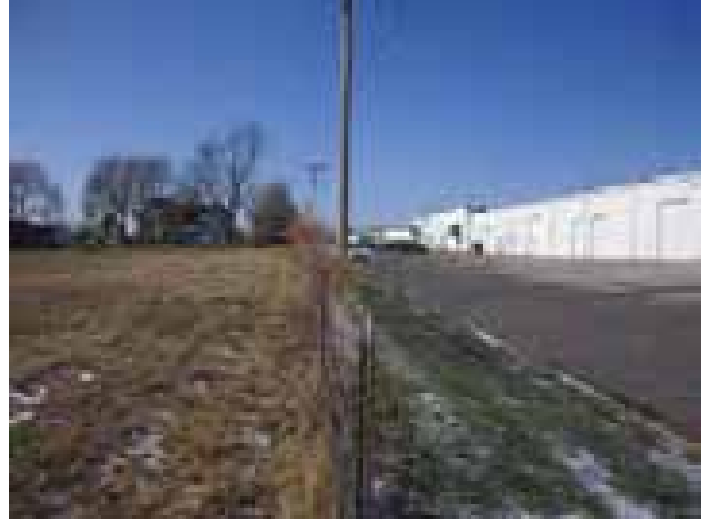
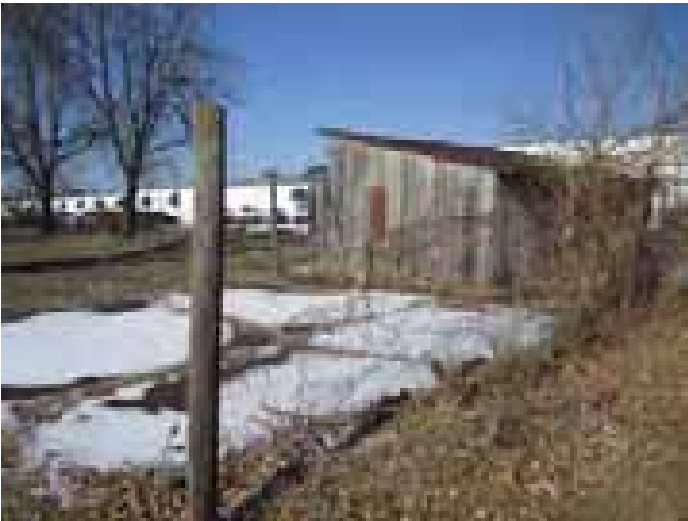
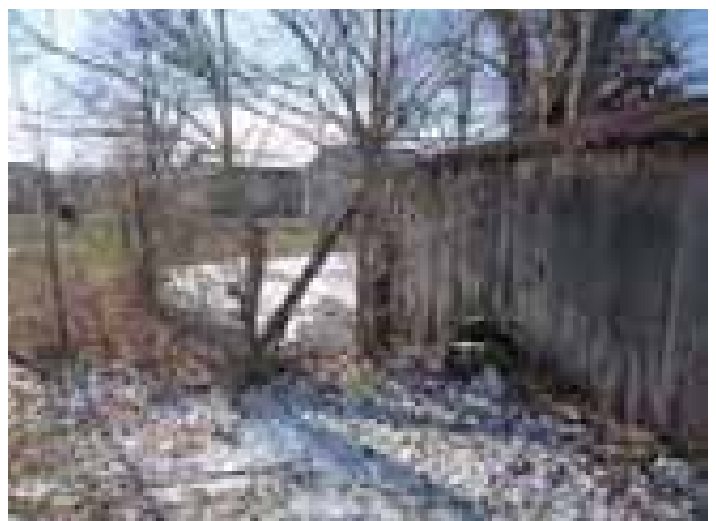
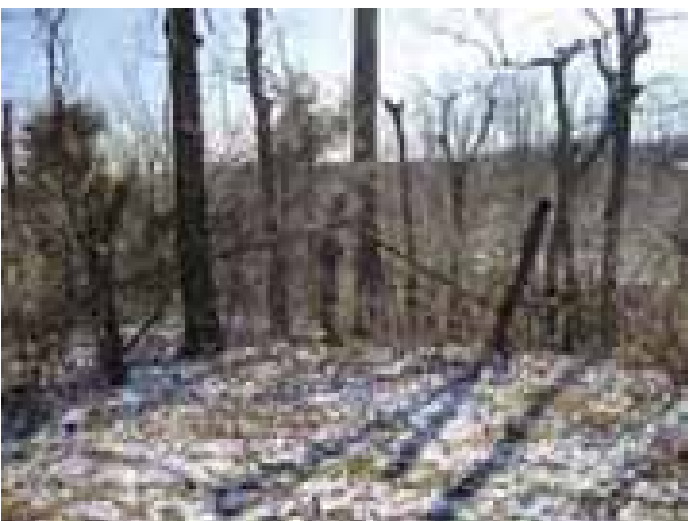
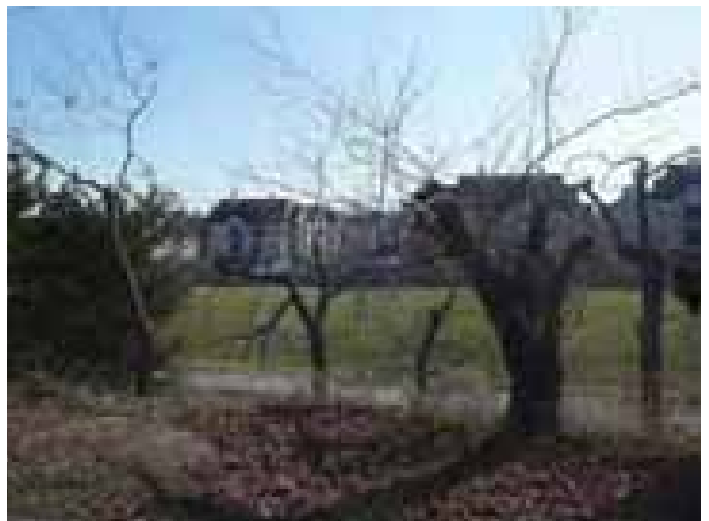
1 **Figure 3-24.** Fences enclose three sides of the Truman Farm and include three fence types. A post and wire fence is on
2 the north edge (top), and around the Poultry House (middle); a post, mesh, and barbwire fence occurs at the east and
3 southeast edges (bottom left), and post and barbwire fence at the south edge (bottom right). SS 12/6/11
4

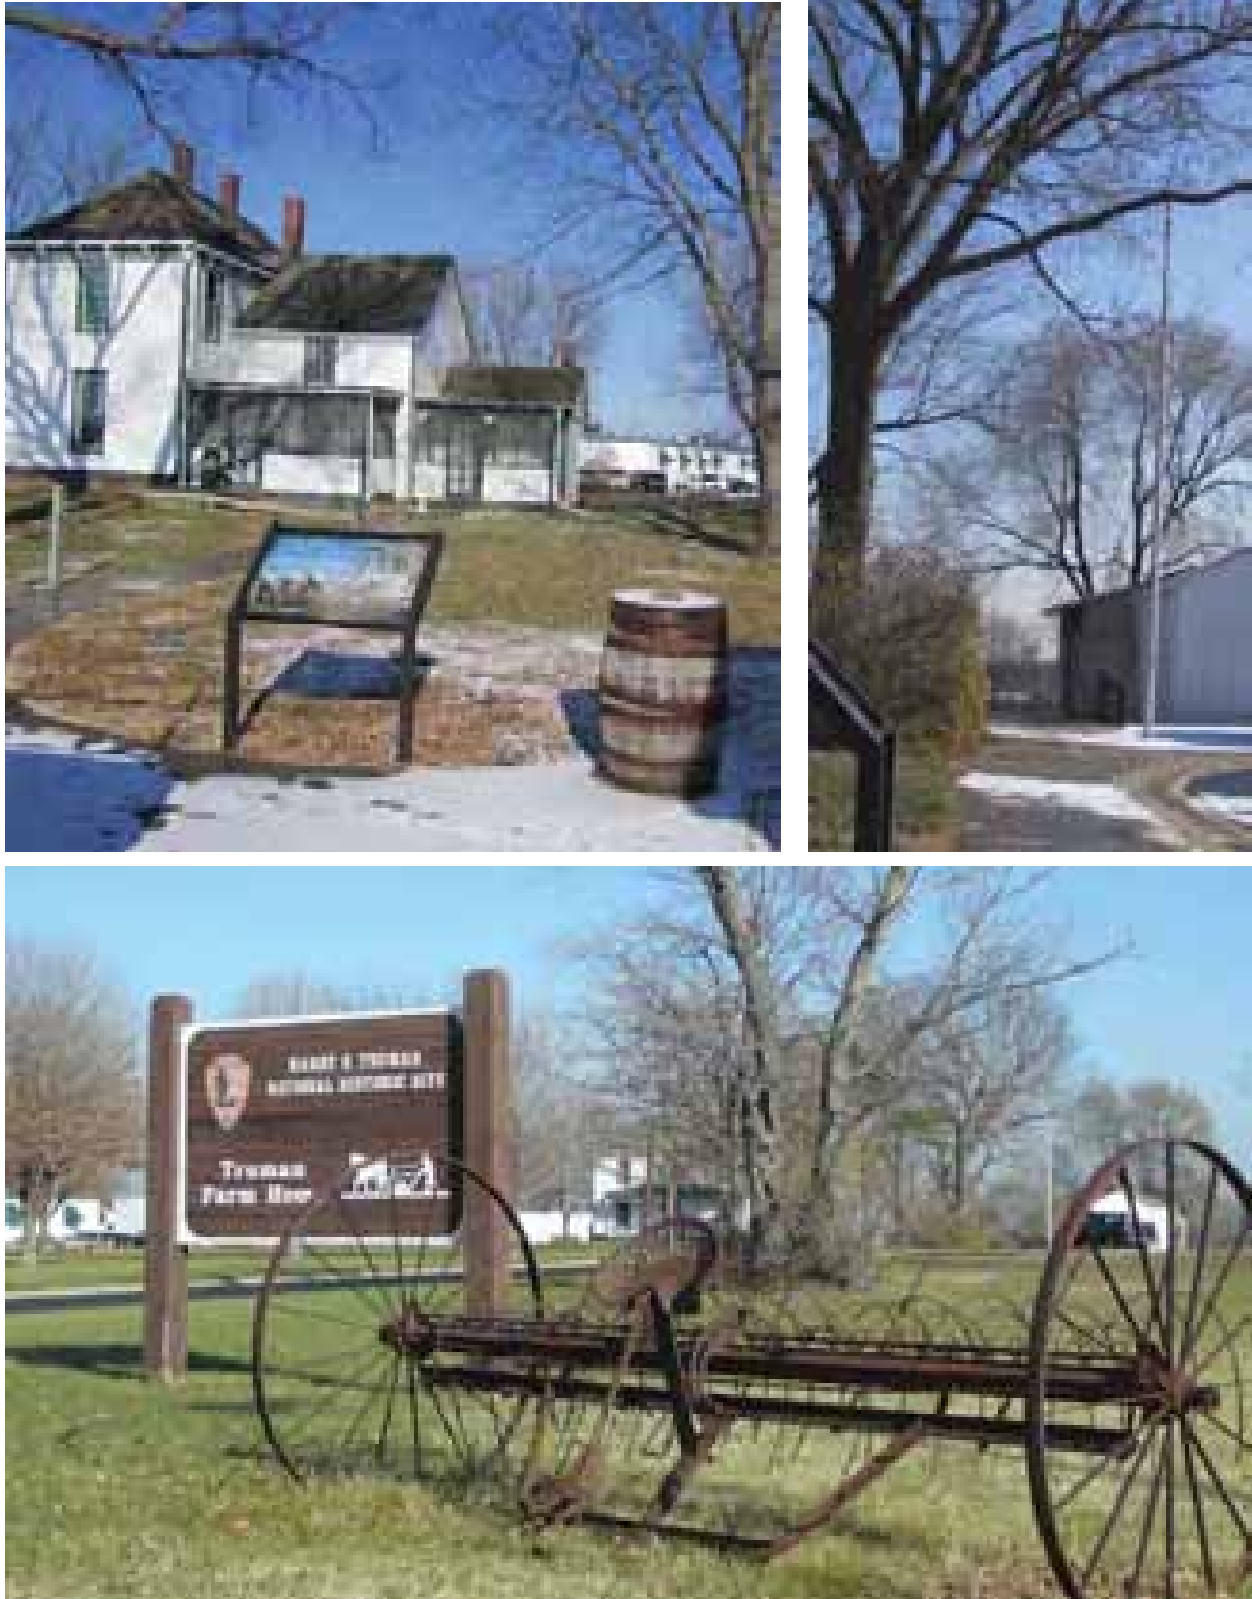
¹ Figure 3-25. Small scale features within the Truman Farm include features of contemporary
² construction that facilitate interpretation of the site, such as yard lights, signage, and the flagpole
³ (top). An antique hayrake near the entrance is the only piece of farm equipment on display at the
⁴ farm (bottom). SS 12/6/11; BN 11/23/11

Adjacent to the entrance sign is a rusted hayrake. It is the only piece of antique farm equipment on display.

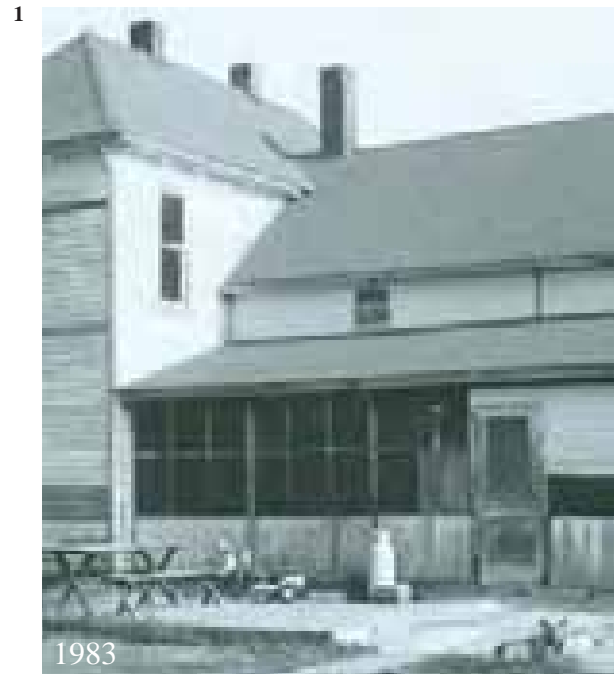
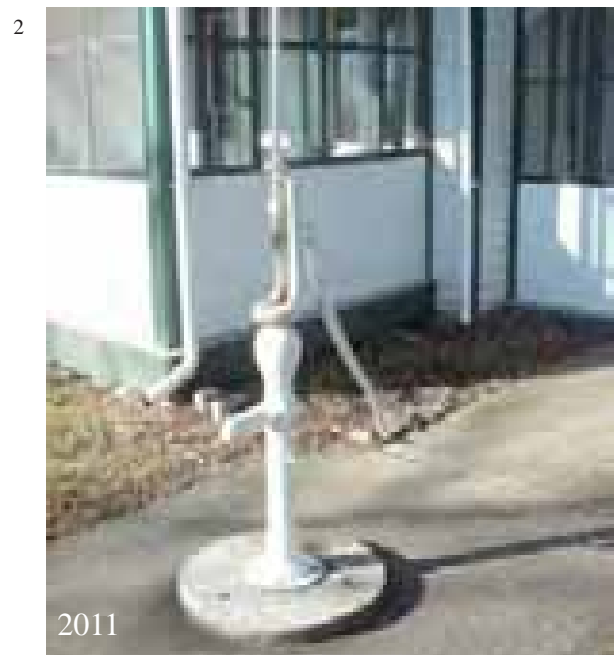
30
31 Between 1984 and 1995 a replica of the
32 white pump was placed over the well,
33 with a bronze plaque in memory of Harry
34 S Truman (now in the museum collection).
35 In 2003, the pump handle and pump
36 were stolen, and it was replaced with the
37 current pump and handle in 2007. This
38 pump is oriented slightly different from
39 how it appeared historically. The pump
40 handle is oriented to the north as it was
41 historically, but the spigot faces south
42 where as historically it was to the east.

3 **Figure 3-27.** The Farm Home received running
4 water in 1949 and the well was no longer
5 needed for domestic use. After the period of
6 significance, the pump was removed and the
7 well was covered with a concrete pad. Today's
8 pump is a replacement sited similarly to how
9 it appeared historically. Al O'Bright 8/83, SS
12/6/11

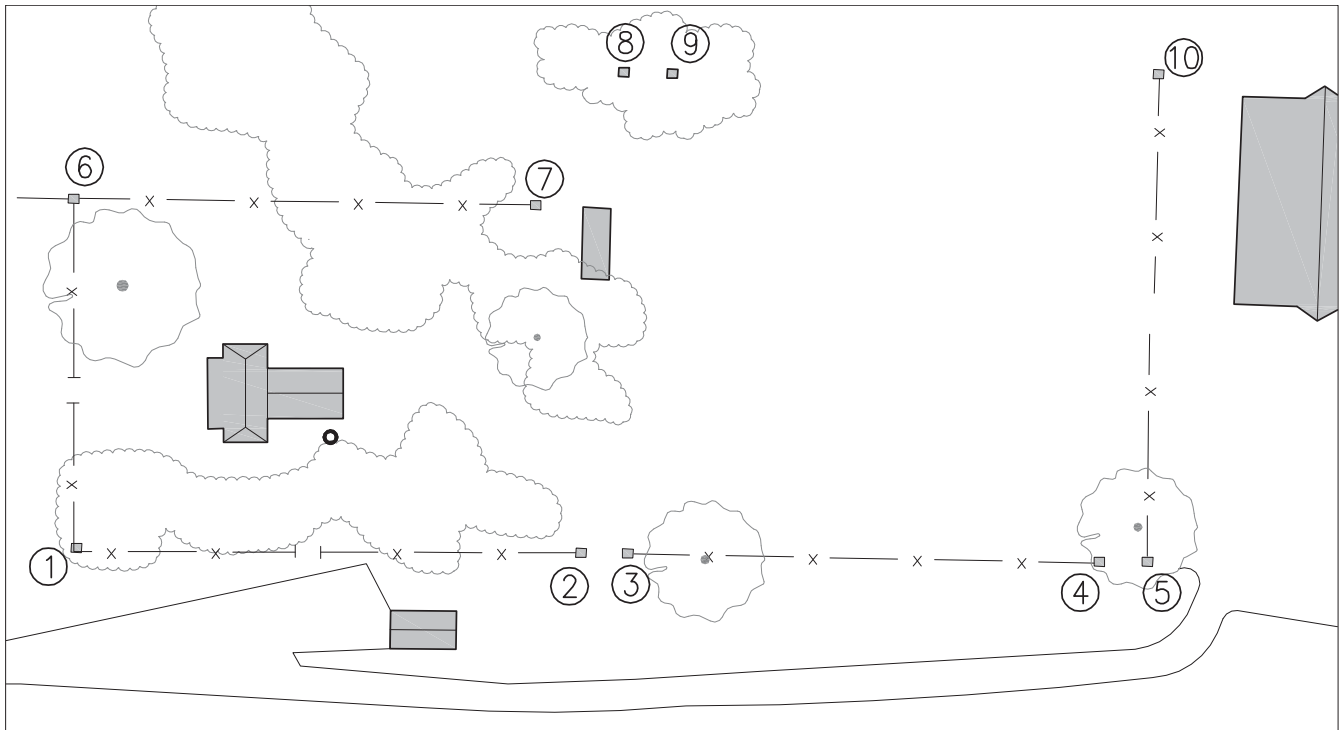
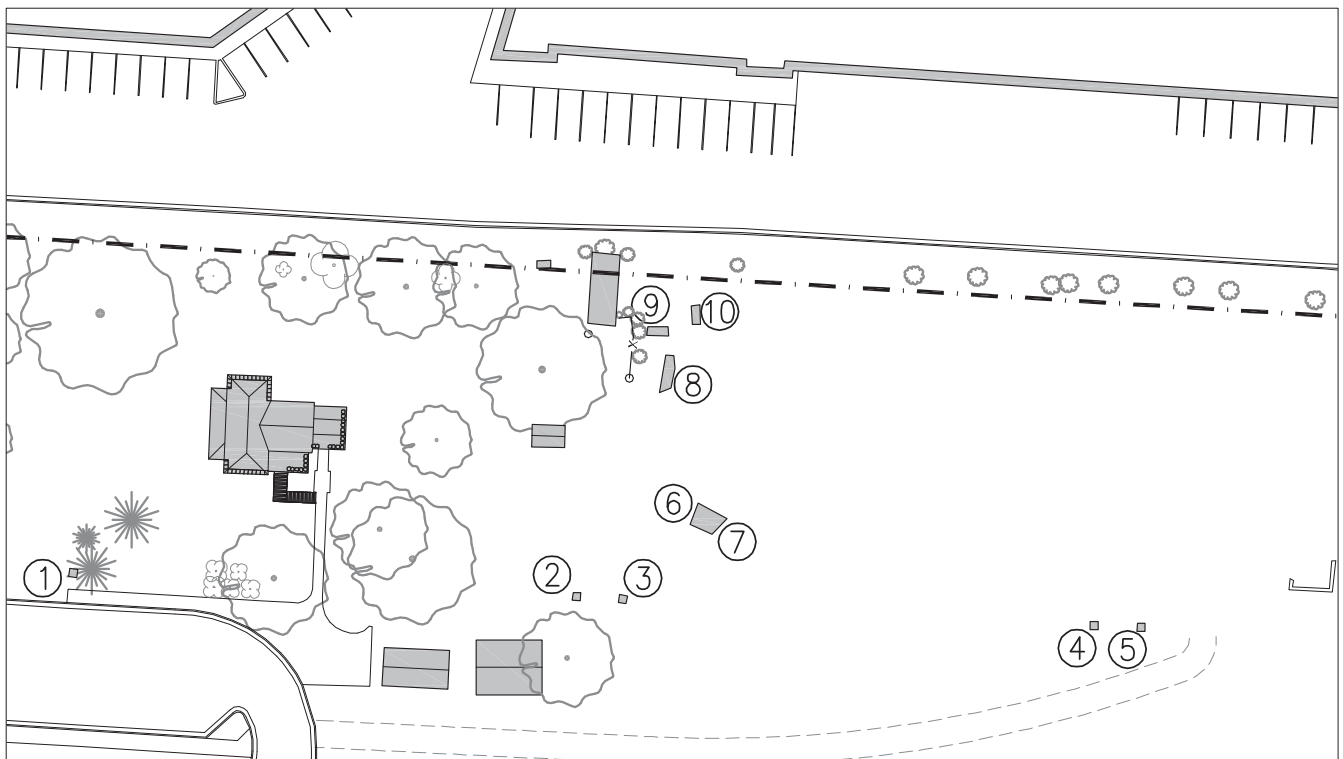
Figure 3-28. The stone posts at the Truman farm likely date from c.1920 to 1930. After the shopping center to the north of the farm was developed in 1987, several of the stone posts (Posts 6 through 10) were removed and placed, on their sides, on the farm property. MBD

33
34 Posts 1 to 5 are in their original locations.
35 The other five posts (Posts 6 to 10) were
36 removed during the 1987 construction
37 of the Truman Farm Shopping Center
38 on land that was historically Vivian
39 Truman's farm. These posts were placed
40 in the field east of the Farm Home. Posts
41 6 through 10 are broken and lying on
42 their sides and it is somewhat difficult to
43 distinguish one post from another. The
44 posts are contributing features of the farm
45 landscape.

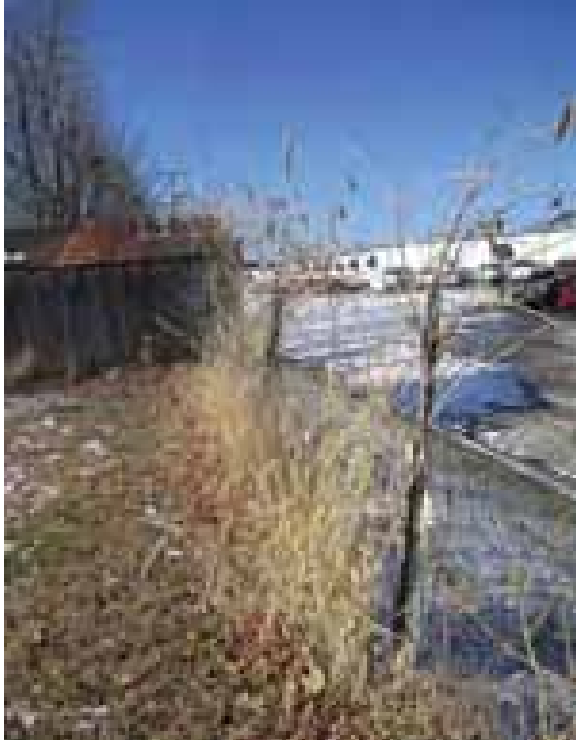
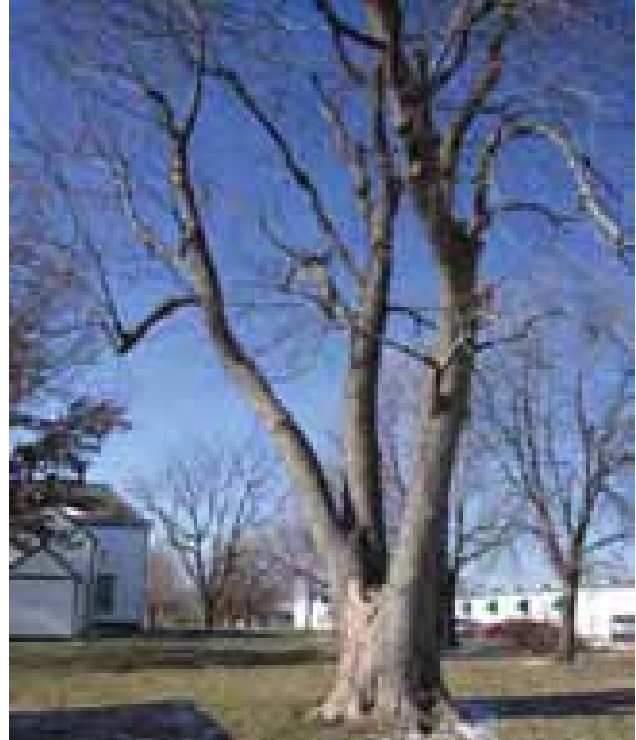
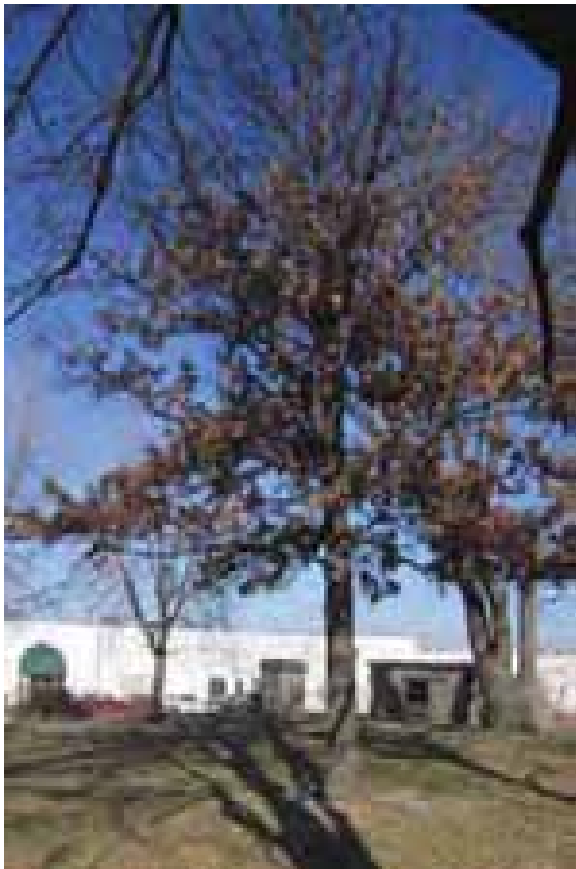
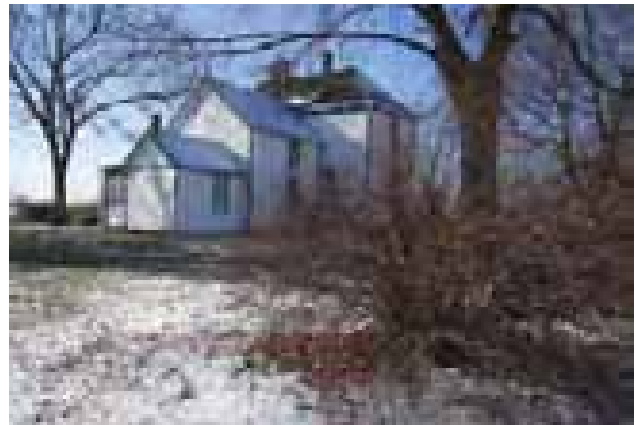
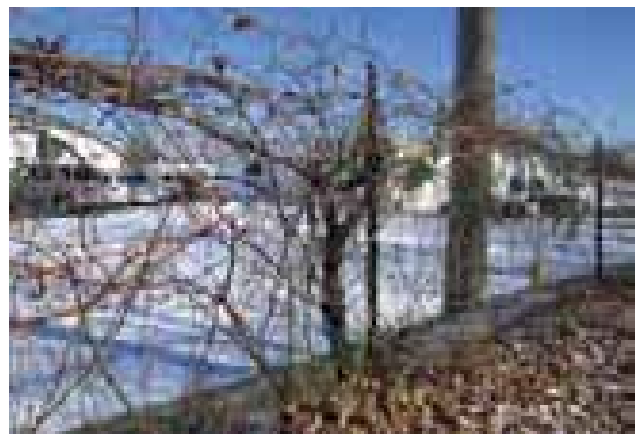
1 **Figure 3-33.** Volunteer grasses grow taller along the north boundary fence (upper left). A few trees
2 remain from the period of significance, including a 72" maple (upper right), while the few ornamental
3 plantings include spirea (middle right) and grapevines along the north fence (lower right). A native
4 pin oak is located just behind the Farm Home, planted in 1987 (lower left). SS 12/6/11
5

25 The other trees are in fair to poor
26 condition. The 72-inches in diameter
27 maple near the Poultry House, likely
28 established during the period of
29 significance, is in fair condition. A native
30 pin oak is east of the Farm Home, planted
31 by the National Association of Retired
32 Federal Employees in 1987 and is in good
33 condition.
34

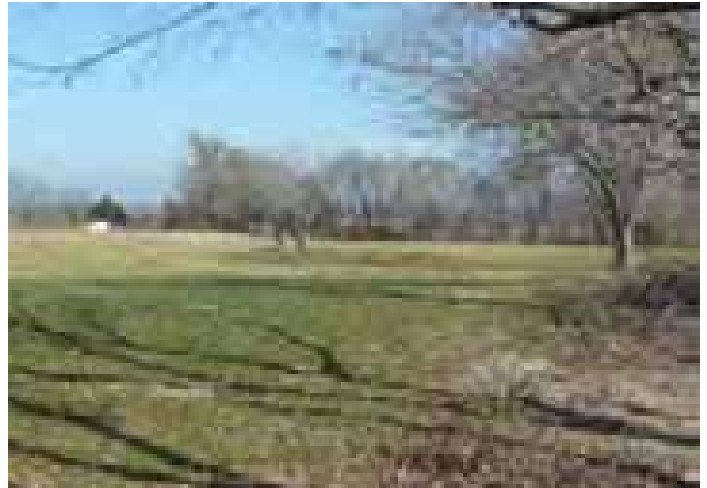
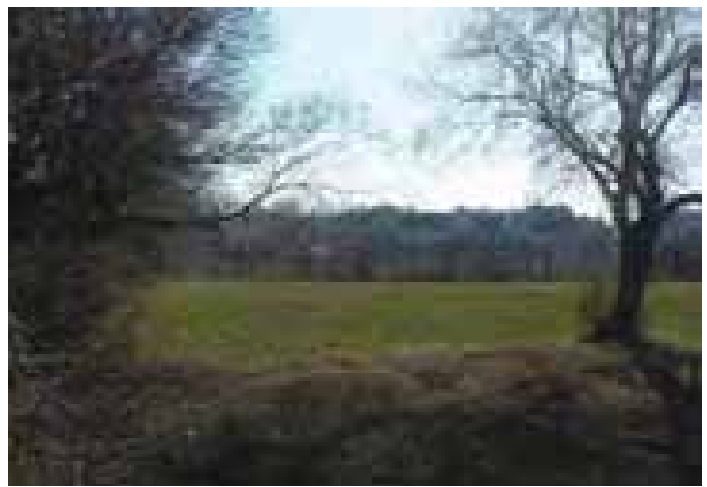
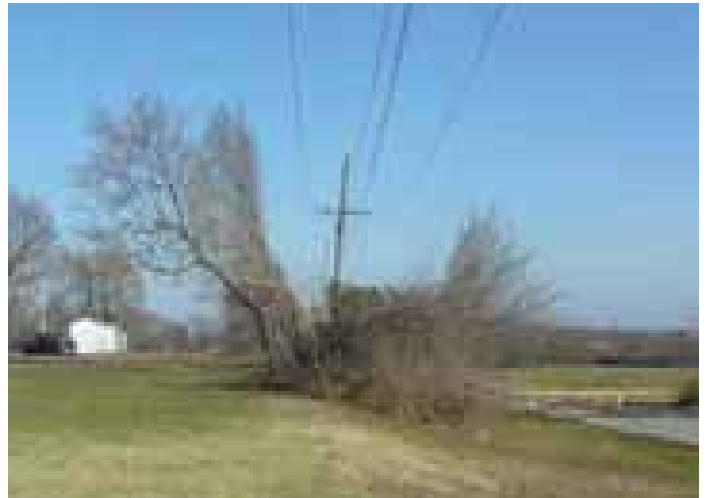
1 Figure 3-34. Mown lawn covers most of the property.
2 Volunteer vegetation grows along fence lines (top and
3 middle). A thick line of trees that have been extensively
4 pruned to accommodate power lines occur along the
5 fence line between the north and south portions of the
6 property (bottom). SS 12/6/11; BN 11/23/11

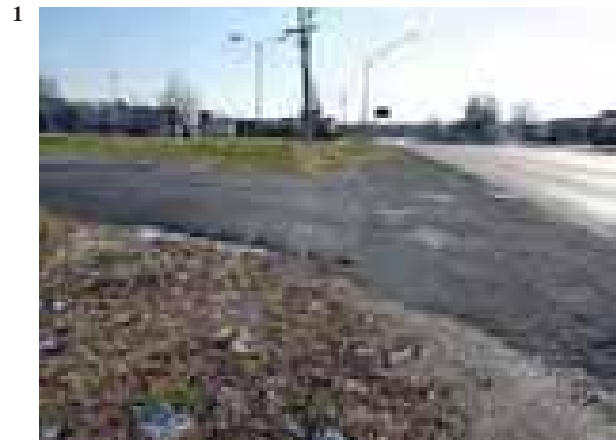
2 Figure 3-44. Entrance drive at Blue Ridge
Boulevard. MT 12/6/11

20
21 The entrance drive has wide cracks and
22 alligator cracking along most areas which
23 indicates poor sub-grade preparation.
24 If this drive remains, the asphalt will
25 need to be fully removed and replaced,
26 and consultations with a geotechnical
27 engineer will be necessary for proper
28 reconditioning of the sub-grade along
29 with a new asphalt design section. If this
30 paving were to be removed, consultation
31 with a geotechnical engineer will be
32 needed for best practices in protecting the
33 below-grade geothermal system.

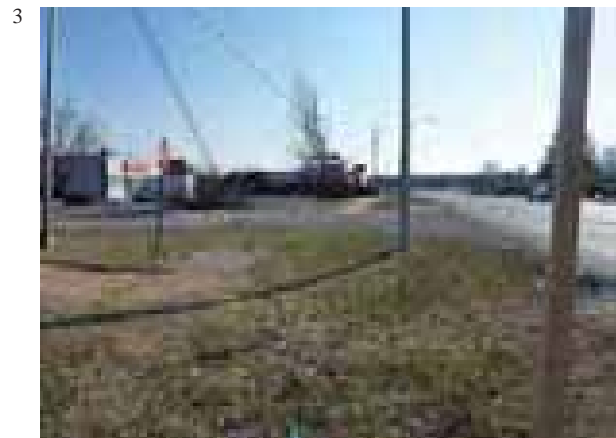
4 Figure 3-45. North drive at Tract 3. MT 12/6/11

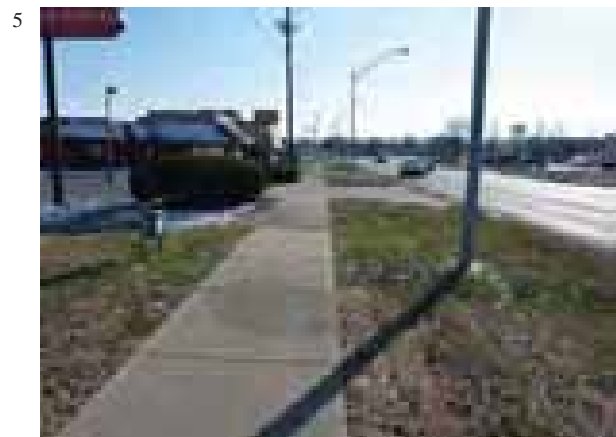
6 Figure 3-46. South drive at Tract 3. MT 12/6/11

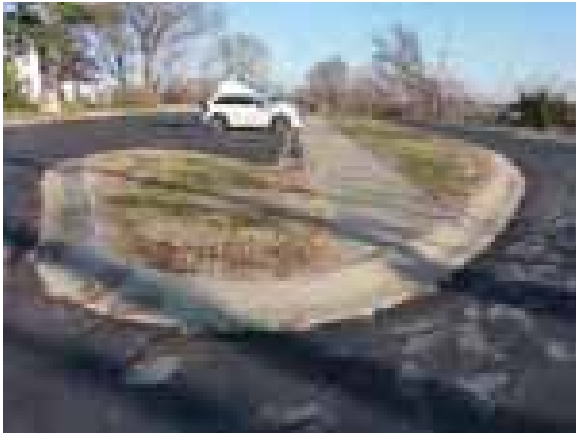
24 The parking area and drive aisle shed
25 stormwater to the east toward a grassed
26 area. This grassy area drains south
27 over a steep hill into the south field.
28 Higher velocity flows down this hill are
29 eroding the hillside. If the parking area
30 were to remain, water quality measures
31 and erosion control would be necessary
32 and would likely negatively impact the
33 historic setting and topography. A small
34 water quality pond near the east end of
35 the drive could be considered with a small
36 release outlet and installation of riprap
37 armoring down the hillside to mitigate
38 additional erosion. If this parking area
39 was removed, these measures would not
40 be required.
41

Figure 3-47. Parking area. MT 12/6/11

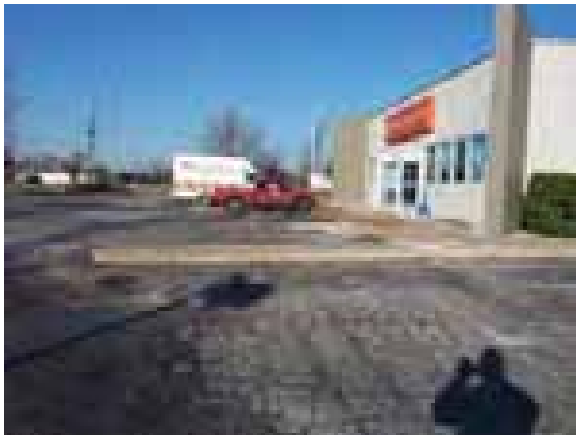
Figure 3-48. Parking area in Tract 3. MT 12/6/11

43
44 If Tract 3 becomes new park facilities, the
45 asphalt parking and concrete sidewalks
46 should be fully replaced as they are in
47 poor condition. The sidewalks exhibit
48 severe spalling and deterioration.
