BUILDINGS AND STRUCTURES

BUILDINGS EXISTING CONDITIONS & CONDITION ASSESSMENTS

NOVEMBER 2012	TITLE OF PROJECT TRUMAN FARM HISTORIC STRUCTURES REPORT		
UNITED STATES DEPARTMENT OF THE INTERIOR TRUMAN FARM NATIONAL HISTORIC SITE	TITLE OF DRAWING COVER & INDEX		
EXISTING CONDITION DRAWINGS SHEET 1 OF 11	NAME OF PARK TRUMAN FARM - HARRY S TRUMAN NATIONAL HISTORIC SITE		
	REGION MIDWEST	COUNTY JACKSON	STATE MISSOURI

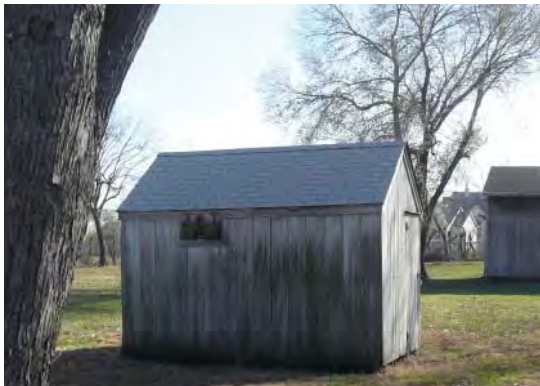
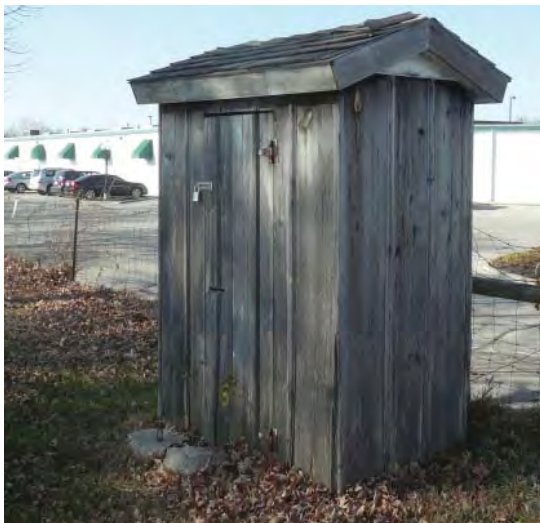
Figure 3-50: Three non-contributing structures exist on the Truman Farm. The maintenance shed was added by the NPS in 1995 (top). The smokehouse was moved to the Truman Farm by the Truman Farm Home Foundation in 1985 (middle), and the outhouse was placed on the property c.1985 (bottom). SS 12/6/11

39
40 The shed is in good condition. It is not
41 a historic structure and its presence
42 detracts from the historic setting. The
43 shed is to be removed once storage for
44 maintenance equipment is provided at
45 Tract 3 or an alternate facility.

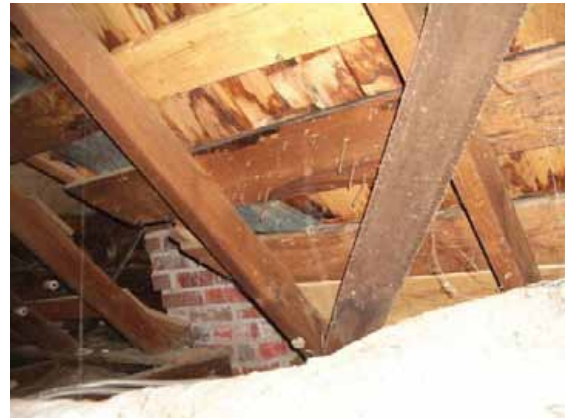
From the underside of the attic it was determined that the sheathing consists of 1 x 6 boards with approximately 3" spacing with the exception of +/- 2' from the eave which is newer solid sheathing. The spaced sheathing indicates that wood shingles were the original roofing and is consistent with historic photographs. Park records indicate that the original roof remained the base layer for succeeding roofs until 1984 when it was all removed along with three layers of subsequent composition shingle above it.

Figure 3-55: Underside of the roof, as viewed from the attic, EMH 12/6/11

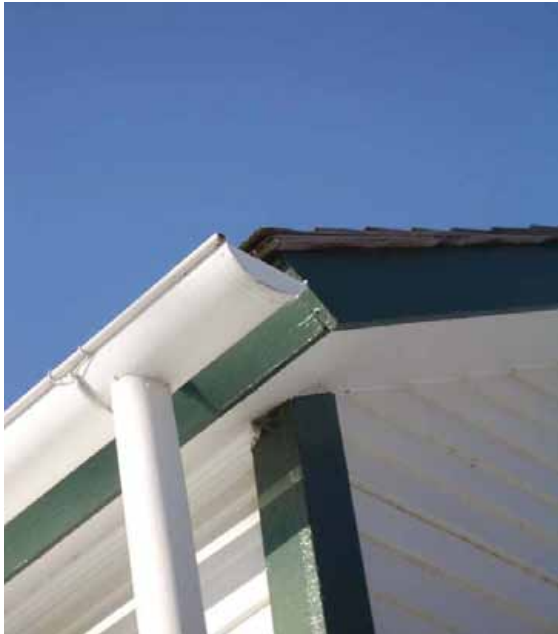
The west (front) porch and east additions have 5" half round gutters, painted white. The front porch drains to two 3" round

downspouts on the north and south ends of the porch each having a 3' extension at grade. The east wing has a series of 3" round downspouts. The south east porch has no gutter but this low slope roof area drains to the southeast corner to a fourth 3" round downspout and 3' extension at grade.

Figure 3-57: Half round gutter and round downspout, EMH 12/6/11

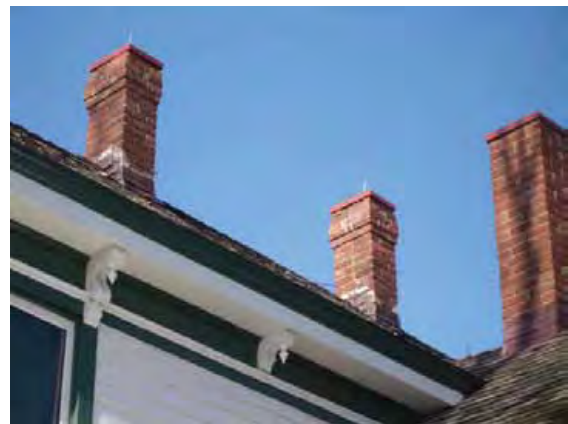
There are four red brick running bond chimneys on the house; two at the west wing of the house with corbelled detailing at the upper portion, one at the two-story central wing and one newer chimney at the east wing. All have newer prefinished red caps and all have prefinished brown stepped flashing at the roof intersections. The two chimneys at the west wing roof and the one chimney on the central wing are connected to the lightning protection system. There is minor face of brick spalls at the corbelled coursing of the two west wing chimneys.

Figure 3-59: Chimneys, as viewed looking northeast, EMH 12/6/11

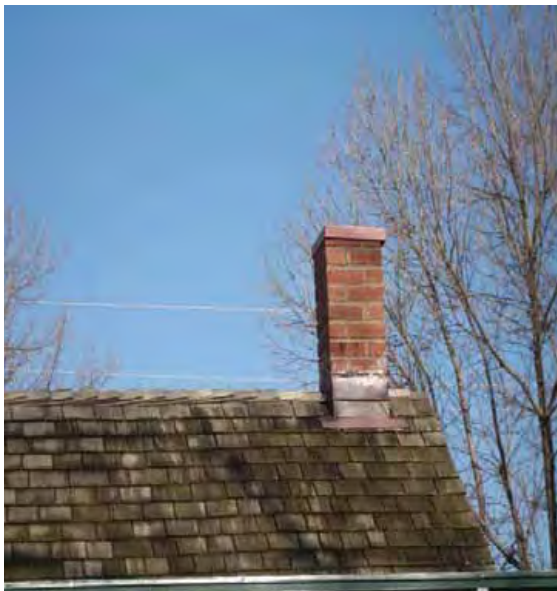
The east wing chimney is currently in a different location (offset of the main east ridge) than can be seen in the historic photograph below, c. 1935, when the east chimney aligned with the ridge.

The 12"x 12" exterior dimensions also indicate it was rebuilt inaccurately because the interior allowable fire area would be virtually non-functional historically.

Figure 3-61: East chimney existing location, EMH 12/6/11

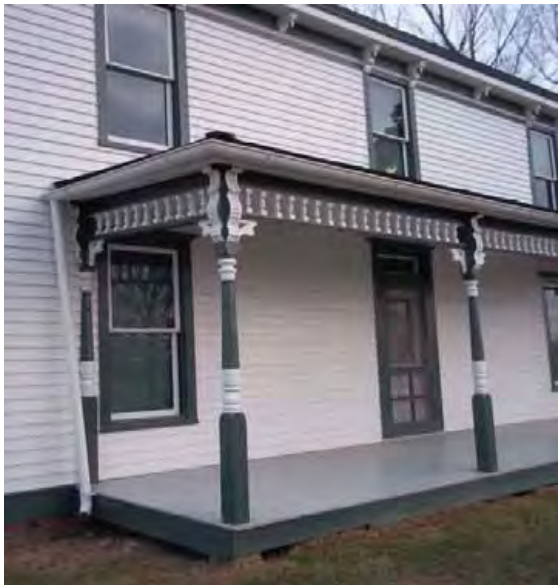
The front porch has a hipped roof and is open. It is approximately 13” above grade with no steps. The existing porch framing and flooring was replaced between 1994 and 2009, per park records. The porch is supported by six wood turned posts, the western four of which have been replaced. The 1984 work indicated that the porch was shored up, so it is possible the roof framing is original. The smaller spindle and bracket work below the porch eave was also reported to have been replaced in 1984.

Figure 3-62: Front porch, ABA 12/6/11

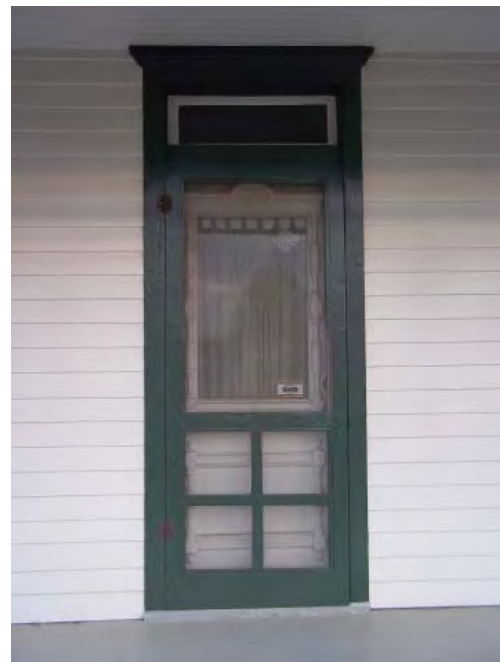
West Wing: The entry screen door is 2'-10" x 6'-11" (door 101A), half-lite screen over four equal screen panels. The wood frame and 1 x 4 trim are painted. Hardware consists of a spring closer and two surface mounted hinges. There is no handle on the exterior. The door does not match any of the historic photos and appears to be a recent construction. The screen door style varied as per historic documents and photographs.

Figure 3-70: West entry screen door 101A, main door 101 and transom, NAA 12/6/11

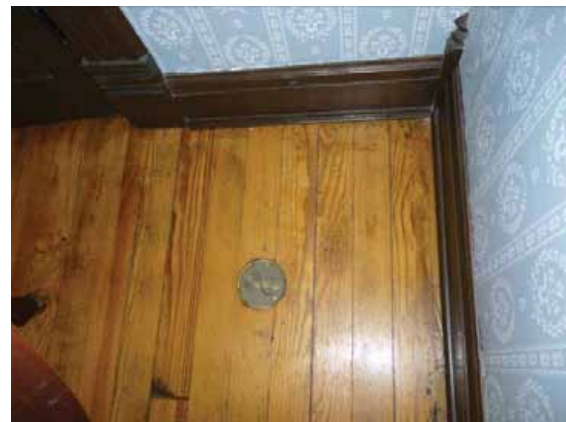
West Wing: The base trim (on both floors) in this portion of the Farm Home are the most decorative. The wood base is 7 ½" tall, stained dark, with a matching 1 ¼" tall by 1" wide base shoe. Both have ornate ogee style profiles. In the corners, there are base corner moldings that are similarly ornate. These corner pieces are 12" tall, 1 ½" wide with a matching dark stain and profile. From George Fogelsong's work records, it is mentioned that the historic trim was replicated by a professional millworker and re-installed. All recreated pieces were numbered and dated, according to the 1983 specifications.

Figure 3-79: West wing room 103 base trim and floor, ABA 12/6/11

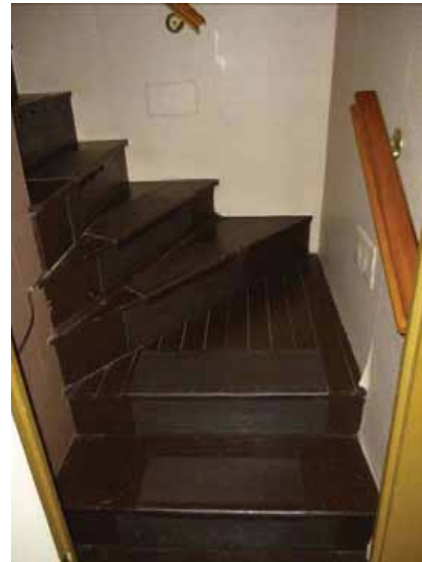
Central Wing: The winder stair up to room 204 has 12 risers 7-7 ½" high and is 3'-1" wide. It has tread and riser rubber protectors installed over the painted wood stairs and no base trim. The stair has a contemporary handrail along the exterior walls which is 2" wide and 30" above finished floor. It is discontinuous and does not have any extensions.

Figure 3-84: Central wing stair and handrails to room 204, ABA 12/6/11

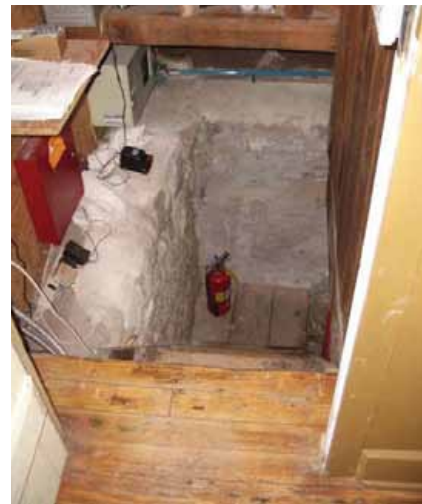
The basement stair has six open risers at 10" high and one open riser at 6" high. The width of the stair is 2'-3" and there are no handrails.

Figure 3-85: Central wing basement stair, ABA 12/6/11

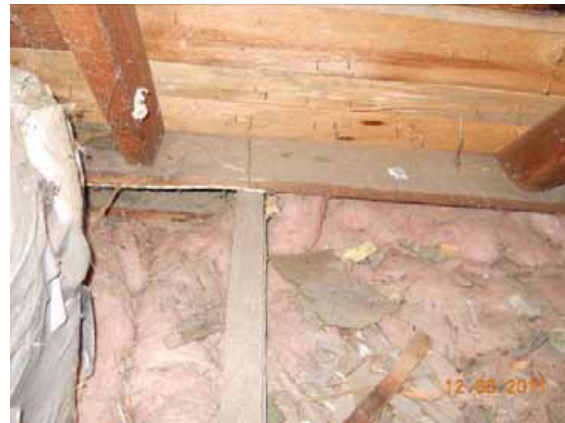
The roof framing over the west wing consists of 1 1/2" x 3 1/2" rafters spaced at about 24". The rafters span east-west approximately 8' (horizontal dimension) between the exterior wall and the

nominal 1 x 4 ridge board. The rafters are sheathed with spaced 1 x 6 (nominal) solid wood underlayment spaced at 10" o.c. The hip roofs are framed in the same manner with nominal 2 x 4 rafters spanning from the exterior wall to the hip ridge. The hip ridge member is a single nominal 2 x 4. All the rafters are supported by a nominal 1 x 6 flat board at the exterior wall, and the rafters do not line up with the ceiling joists (figure 3-87). The 1 x 6 flat board supports the rafter and the 1x board spans to the ceiling joists. The hip roofs do not have ceiling joists or blocking to resist thrust from the rafters.

Figure 3-87: West wing attic, rafters do not align with ceiling joists, PD 12/6/11

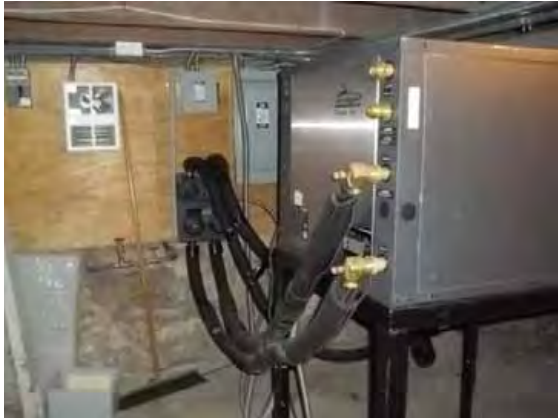
Figure 3-88: Air handling unit in basement, DMD 12/6/11

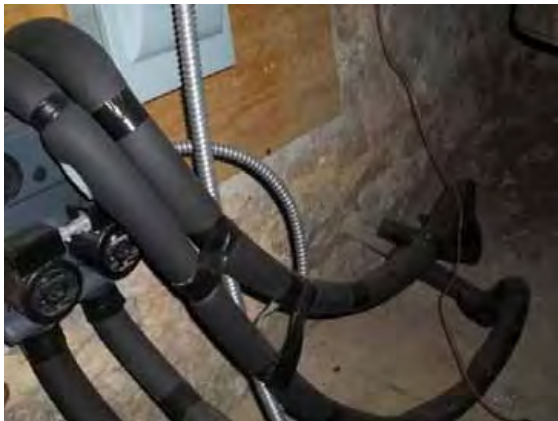
Figure 3-89: Condenser water line entry into basement, DMD 12/6/11

New condenser water lines and a new vertical bore field were installed for the geothermal system. The vertical borefield is located in the parking lot south of the building and consists of five bores approximately 300' in depth. The borefield piping is routed from top of each borefield well, ganged together and routed into the south side of the basement. Disturbed ground on the south edge of the house is evident as well as the asphalt repair in the parking lot and a replaced concrete curb section.

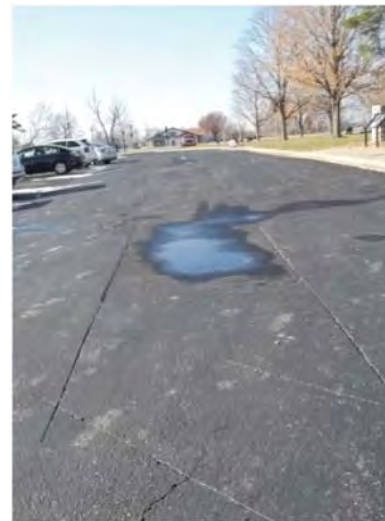
Figure 3-91: Patched asphalt where geothermal wells installed in parking lot, DMD 12/6/11

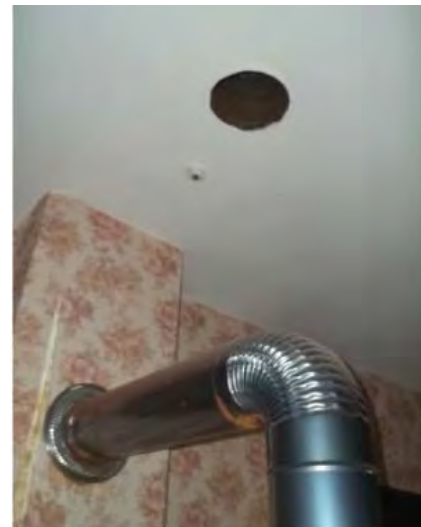
opening is covered with a decorative cover. The cooking stove in kitchen 105 and the two heating stoves in rooms 102 and 103 are connected to adjacent chimneys via single wall flue venting. Room 202 also has a hole in the ceiling that appears to have been for a heating stove at some point. This opening is not covered.

Figure 3-103: Room 202 vent opening in ceiling, DMD 12/6/11

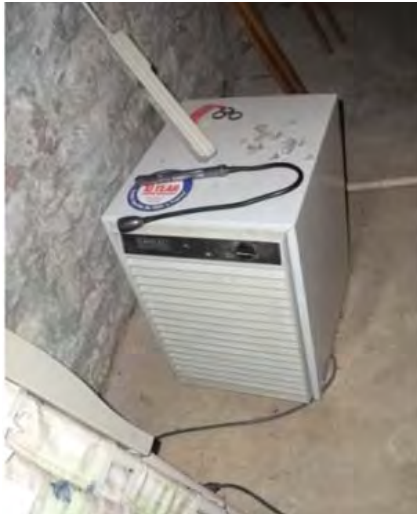
Throughout the Farm Home are signs of humidity control problems including the peeling of wallpaper. This is also evident by a stand alone portable dehumidification unit that is located in the basement. This unit sits at the

bottom of the basement stairs and can be transported and plugged in to help control the humidity level in the house. The park staff monitors the humidity level in the Farm Home and plug-in and unplug the dehumidifier as needed. This dehumidification control is not automated and requires manual interaction to start and stop the unit.

Figure 3-104: Portable dehumidifier in basement, DMD 12/6/11

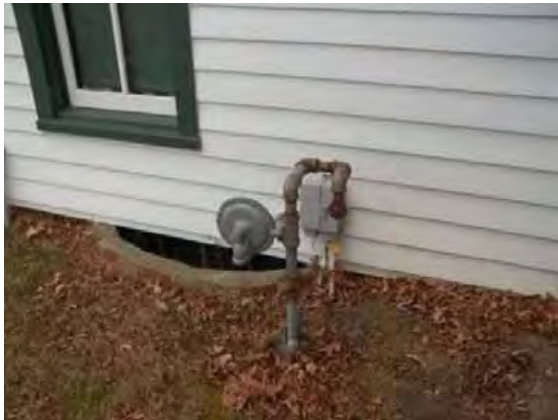
In 2007 when the geothermal system was installed, the natural gas line for the house was abandoned. Currently there is no gas piping in the house and the natural gas line is stubbed up outside on the north side of the house and contains a pressure regulator, but no meter.

Figure 3-107: Gas line stubbed up with pressure regulator and no meter, DMD 12/6/11

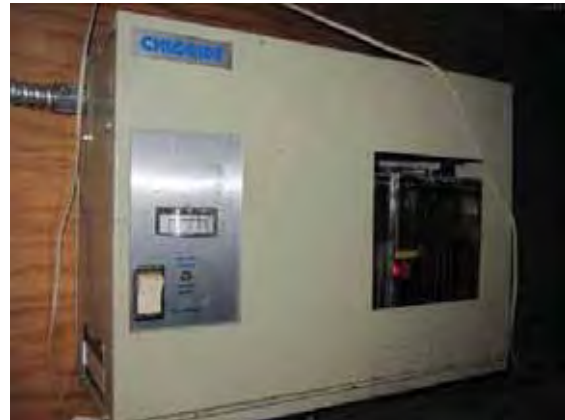
Battery backed up egress lighting is provided by a Chloride 250 watt battery backup inverter which is connected to four incandescent step lights, two located at the main stair and two located at the secondary stair. These fixtures are operated by a standard toggle light switch located near the electrical panel within the stair access down to the basement. The battery system was functional at the time of the site observation (however, it was not tested for a full 90 minutes of backup). These lights only provide egress illumination along the stair treads, supplemental egress lighting in other areas of the Farm Home may be needed for proper egress illumination in the event of a power failure. If it is agreed that the Farm Home is not to be utilized during hours of darkness and the existing light levels provided by daylighting are adequate for egress, supplemental battery powered egress illumination may not be required.

Figure 3-113: Existing battery backup system,
Jon Brooks 12/6/11

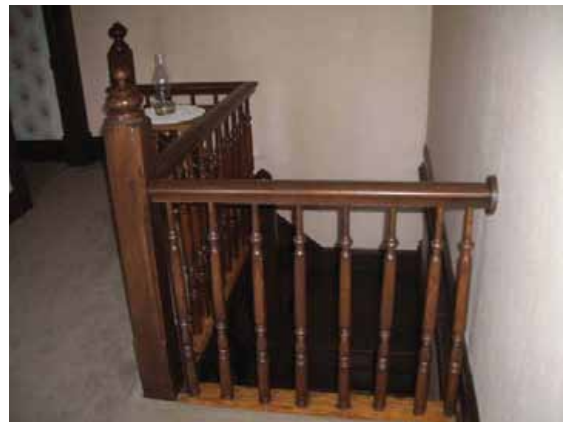
West Wing: The primary staircase leading to the two bedrooms is in good condition. However, it does not have sufficient handrails and railing height at the second floor to meet current code requirements of 42".

Figure 3-120: Primary staircase railing in hall 201, ABA 12/6/11

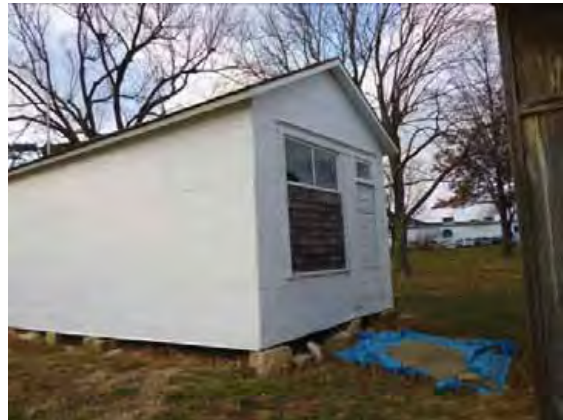
Exterior walls consist of nominal 2 x 4 framing with 1 x 12 board sheathing and metal stamped siding to replicate brick. The pattern of the stamped metal is of running bond and is 2'-4" x 4'-8" sheets, painted white. The existing siding is a reproduction of original stamped metal siding, which was replaced in 2008. Park staff report the original stamped metal siding is currently in park storage. There is a flashing drip edge at the base of the siding.

Figure 3-133: Exterior of Garage, east elevation, ABA 12/6/11

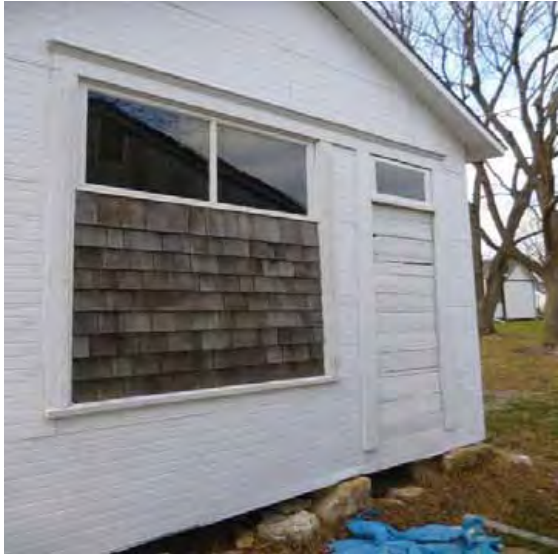
The Garage has three extant windows. One is located on the north elevation and the other two are on the east elevation. One of the east windows is a transom above the infilled door (see door description below). The other east window has a divided lite transom but has been infilled with wood shingles below. Per park staff, the north window is original. All three windows are fixed, though the large window on the east elevation has remnants of historic thumb turn locks, and were replaced in 2008.

Figure 3-134: East elevation, windows and door, ABA 12/6/11

The three extant windows are in good condition; however the shingle infill panel is poor.

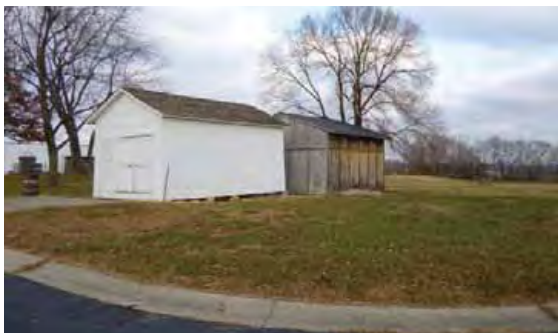
Figure 3-135: Exterior of Garage, west elevation and barn doors, ABA 12/6/11

The barn doors are in fair condition with weathered paint and misaligned hinges that affect the angle in which the doors operate. The 1x wood infill of missing doors is poor.

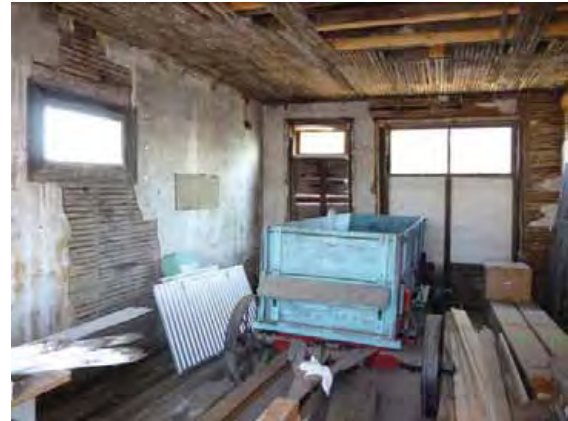
Portions of the original plaster are attached to the remaining lath along the wood frame walls. Plaster sample number 5 was taken of this wall plaster and showed a skim coat of lime and a plaster composed of horse hair (see Appendix F for in-depth analysis of the results).

Figure 3-136: Interior Garage wall finishes, ABA 12/6/11

The remaining lath and plaster are in poor condition.

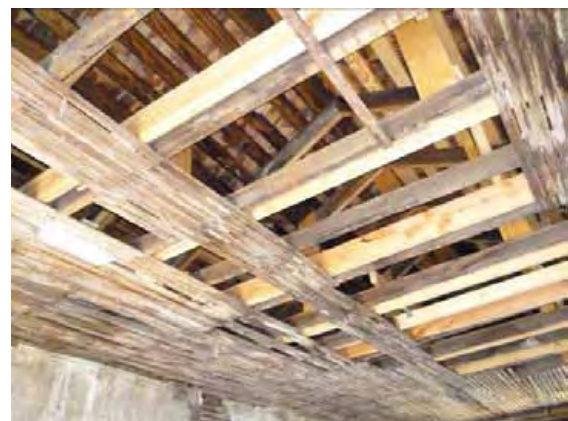
The ceiling retains small areas of the original lath. Remnants of plaster remain (typically between the lath and roof framing).

Figure 3-137: Interior Garage ceiling and roof structure, ABA 12/6/11

The remaining lath and minimal plaster are in poor condition.

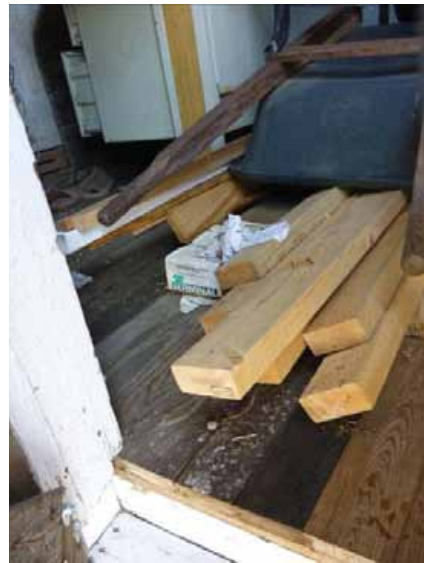
The tongue and groove wood flooring runs east-west and shows obvious signs of large portions having been replaced. It is assured this floor is not original due to its previous use for car storage.

Figure 3-138: Interior Garage tongue and groove flooring, ABA 12/6/11

There historic wood floor is heavily worn and stained; it is clear to see where newer flooring has been installed.

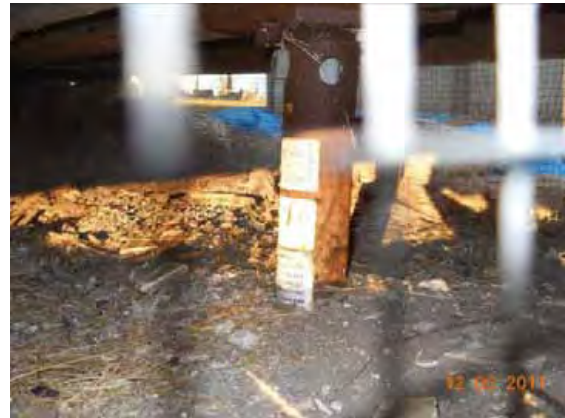
Garage is now supported on six helical piles (Chance C150-0132). The helical piers are unfinished steel and show signs of surface rust (figure 3-139).

Figure 3-139: Helical pile, PD 12/6/11

The six helical piles appear to be performing fine. The piles are not galvanized and show signs of rusting. It's unknown whether the piles were designed to accommodate corrosion.

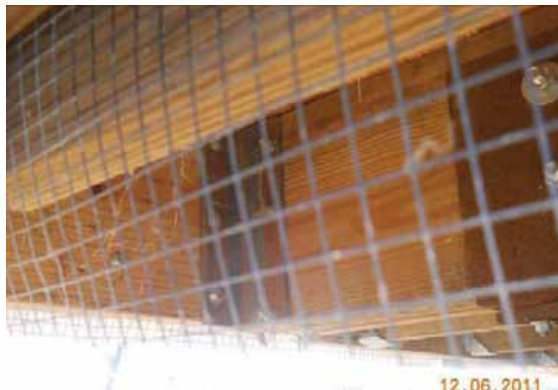
thru bolts and connect to the rim joist with 3 approximately 3/8" diameter lag screws. On the north side the rim joist is continuous and rests on top of the built-up beams. The rim joists support 2x12 floor joists that span north-south approximately 14' between rim joists. A 3/4" solid tongue and groove (T&G) flooring spans 16" to the 2x12 joists. The T&G flooring is about 50% original reused wood and 50% new wood.

Figure 3-140: Angle connecting rim joist to built-up beam, PD 12/6/11

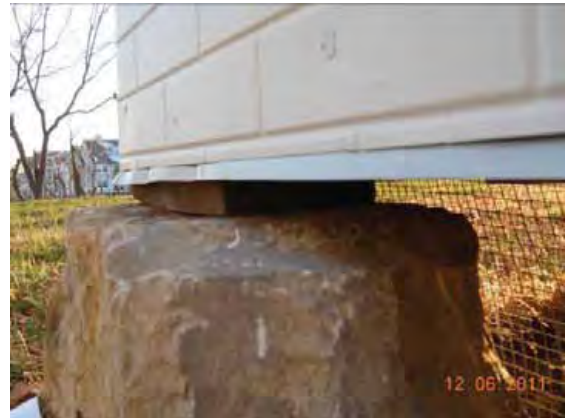
The floor joists between the last built-up beam and the east wall are supported by a 2'-6" length of rim joist on the south side. This rim joist cantilevers off the steel angle connection at the built-up beam. This construction is very weak. A stone has been placed under the corner of the Garage and offers support for the weak framing (following figure). The same condition occurs at the southwest corner.

Figure 3-141: Stone supporting Garage corner, PD 12/6/11

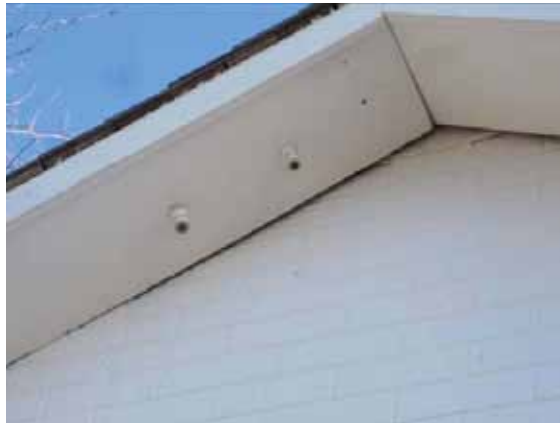
No electrical systems exist on this building. It appears that there was electrical connected to this building near its original construction as is evidenced by the existing porcelain knob and tube connectors located under the roof eave above the Garage entry door.

Figure 3-142: Garage Building Knob and Tube Connectors, Jon Brooks 12/6/11

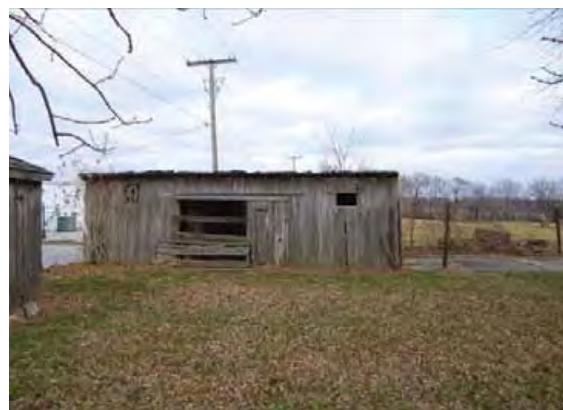
The Poultry House has board (10 1/4" wide) and batten (2 1/4" wide) siding. The west wall is approximately 3" out of plumb per field documentation. There are various gaps and holes in the boards.

Figure 3-148: Poultry House west elevation, ABA 12/6/11

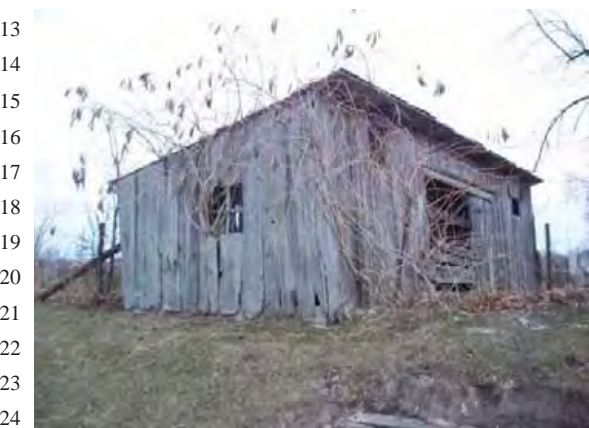
There are four openings in this structure – three are approximately 1'-10" x 1'-5" and the remaining opening is a large expanse measuring 5'-11" x 5'-9 1/2". None of the openings have glazing but all have chicken wire covering most of the openings. Two of the windows have muntins (north window on the west elevation and window on the north elevation).

Figure 3-149: Poultry House north elevation, ABA 12/6/11

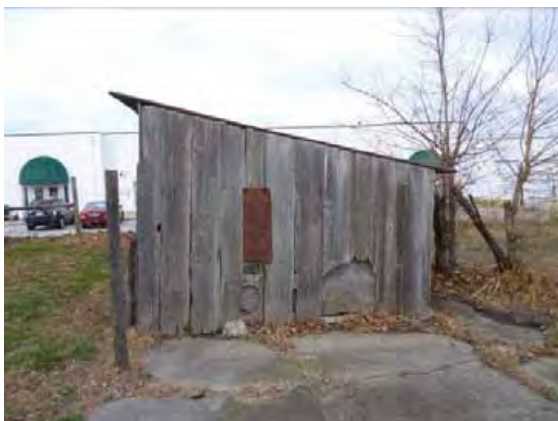
Approximately 2/3 of the interior of the structure has a concrete pad. The concrete pad extends past the south elevation of the structure to provide an exterior pad area. The one portion of the structure (northern portion) which does not have the concrete floor has a packed earth floor.

Figure 3-151: Poultry House south elevation and concrete floor extension, ABA 12/6/11
